Commercial Report

Inspection Date: 2 Jul 2021

Property Address: Outer Suburbs Area

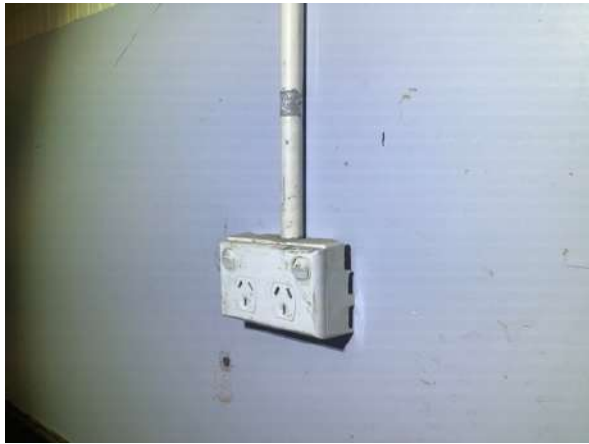
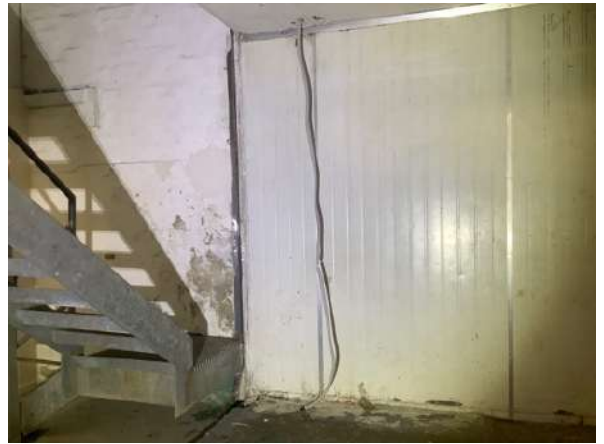
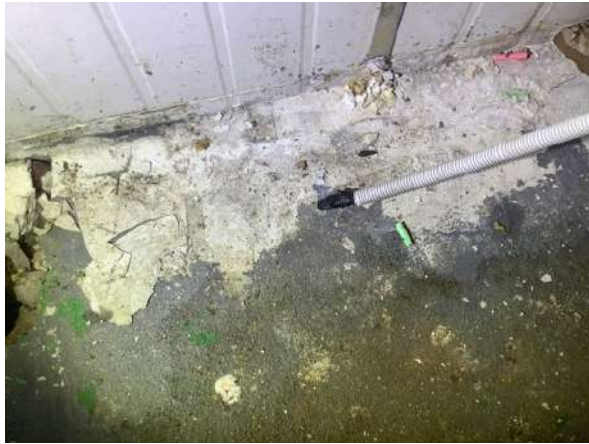
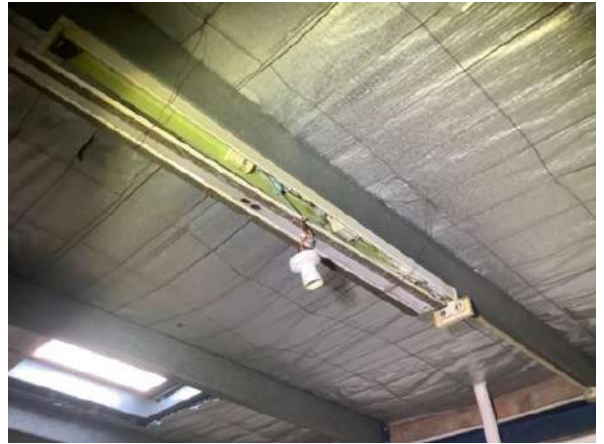
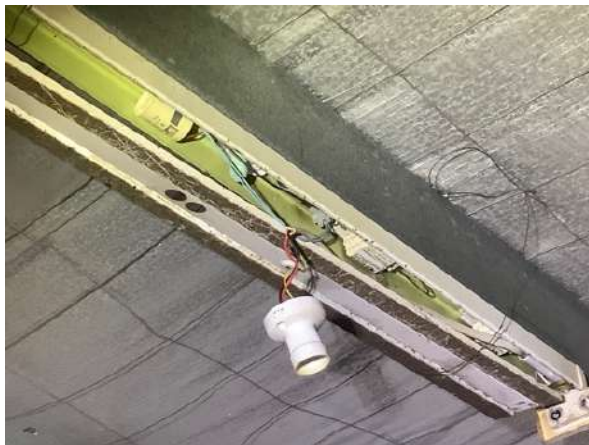
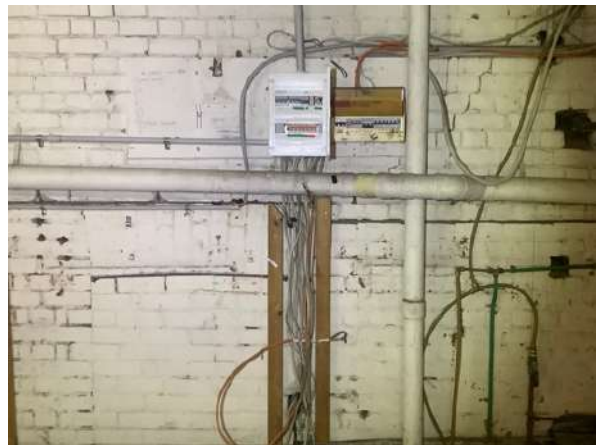
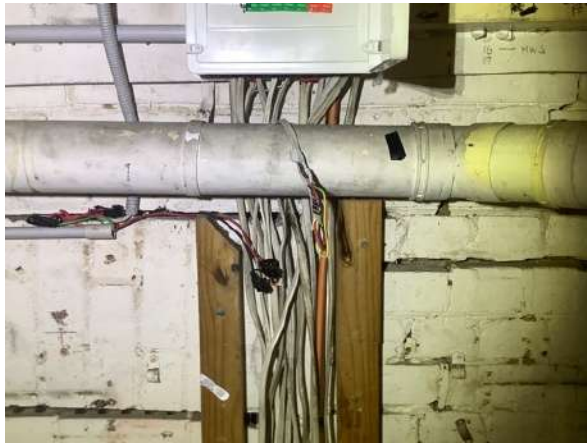
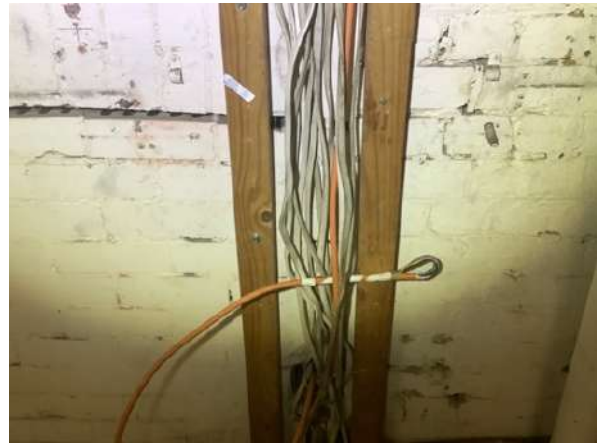
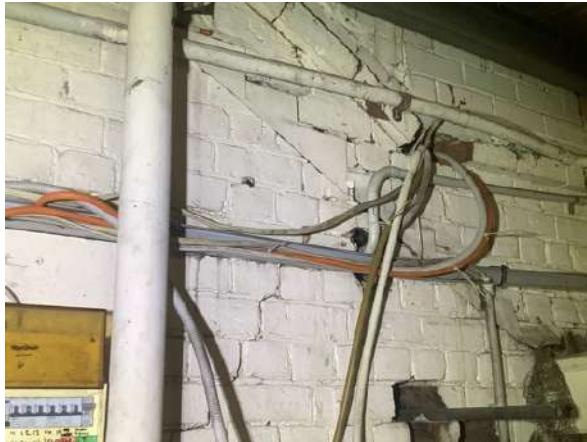
Safety Hazard 1.02

Location: Electrical - All Areas
 Finding: Electrical - Defective / Unsafe / Non Compliant.

It appears that the electrical installation does not comply with today's electrical safety standards and electrical regulation codes of AS3000-2018 in all areas, and/or has faulty unsafe electrical items on the property.

We HIGHLY RECOMMEND that the purchaser engage a licensed electrical contractor to check compliance and make good any defective wiring or unsafe items throughout the entire property.

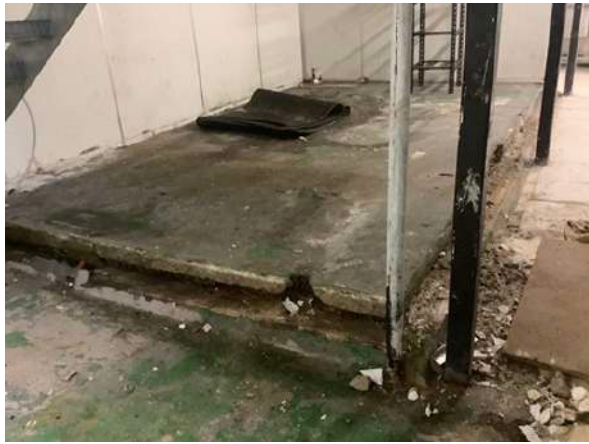
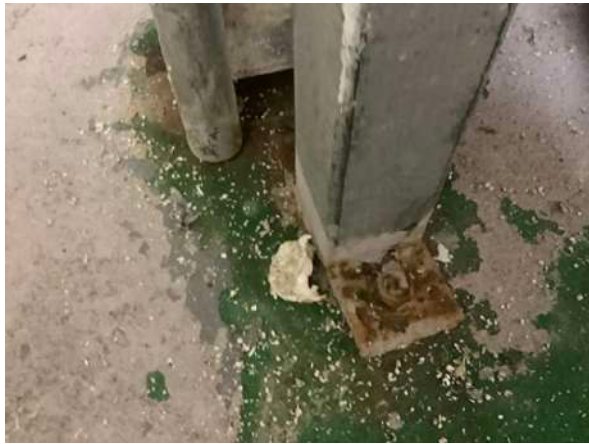
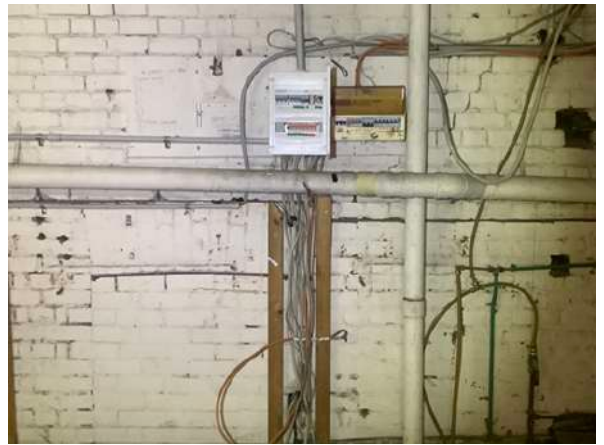
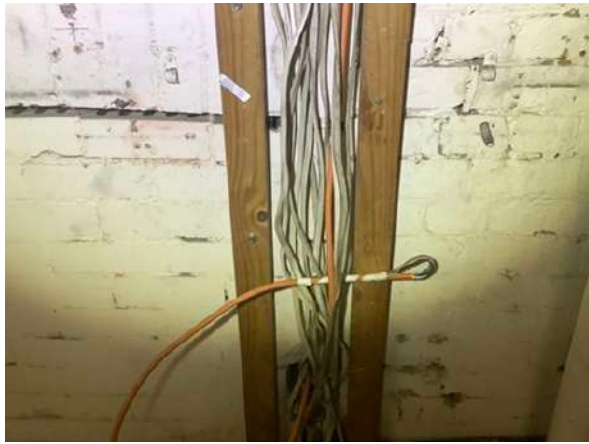
Major Defect 2.05

Location: Steel Support Beams & Posts

Finding: Rusted / Corroded - Building Materials - Major Items

This building element shows evidence of rusting and corrosion, which is likely to have developed as a result of excessive exposure to moisture.

As surface rust provides no protection to the underlying iron, the deteriorating condition is likely to worsen if not addressed in the short-term future.

Rusting and corrosion should be managed by ideally removing or limiting the affected surface from exposure to moisture.

Depending on repair, A registered builder, competent person or handyman may be appointed to replace any building elements that have been severely affected by rust or water damage.

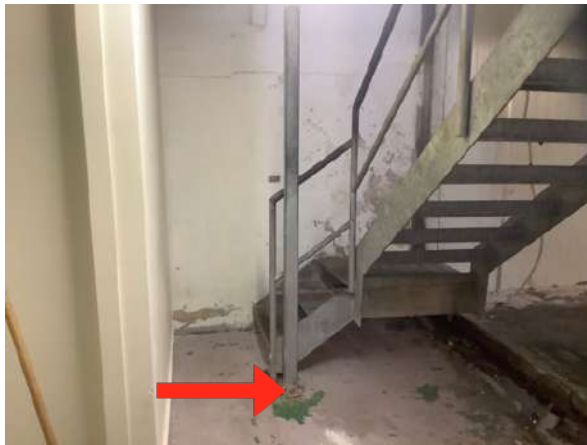
Major Defect 2.06

Location: Perimeter & Separating Walls

This building has severe damp rising unfortunate not just to the lower part of the building as it is spread throughout the perimeter walls and is going to take some time to determine all the damages and without a structural engineer, plumber and registered builder working together it will be difficult to determine all costs involved.

The first step in addressing rising damp is to diagnose the cause. The identified cause should be addressed first before addressing the appearance and other defects which have resulted from the rising damp. If the original cause is not resolved, further cases of damp are likely to ensue, resulting in secondary defects.

Consultation with a PLUMBER, BUILDER AND OR STRUCTURAL ENGINEER AND SOMETIMES A GEOTECHNICAL ENGINEER, and also more then likely a structural engineer is advised immediately to identify the cause of the damp and perform remedial works as required.

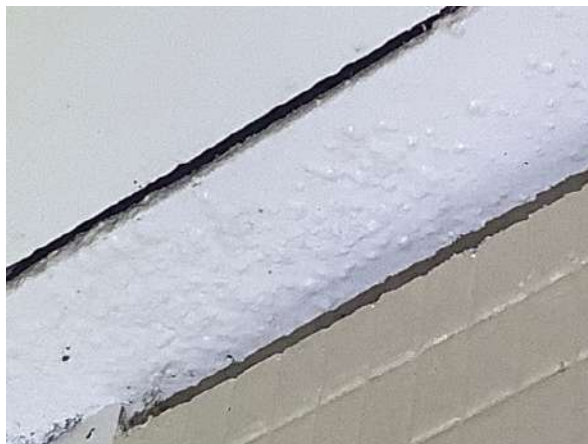
Major Defect 2.08

Finding: Steel Work - Appears Rusted

Sections of paint in this area was found to have bubbled and deteriorated. Paint bubbling is generally an indication of excessive moisture in the area, that is currently hidden by the painted surface.

The presence of excessive moisture can have major implications on associated building elements if left unattended. While only seemingly minor at this stage, the damage cannot be determined due to the paint obstructing any further inspection of the damage.

It is highly advised that the affected paint be cleaned to allow a further, more invasive inspection by a licensed plumber. Failure to act on this defect may necessitate major works in the future.

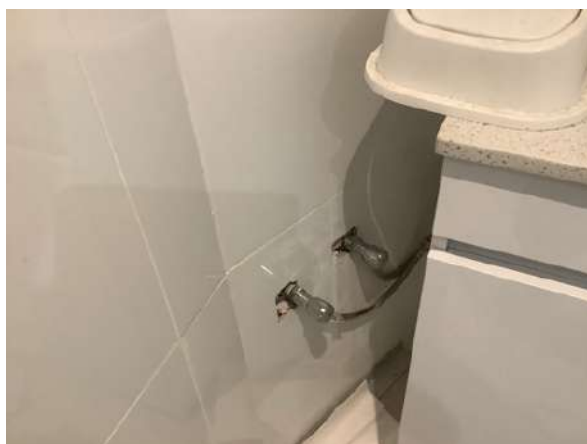
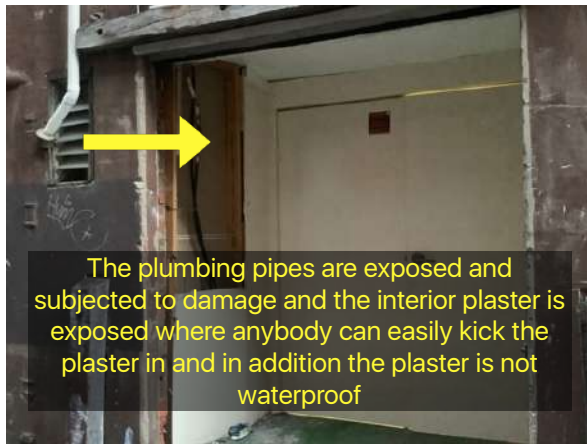
Minor Defect 3.01

These Defects are of Sub Standard Workmanship or Incomplete and not finished to a tradesmens like manner.

The installation of these building elements appear to have been completed to a substandard level of workmanship or is incomplete and does not comply with regular building practices. Unfinished and substandard building works are likely to degrade more quickly and may create potential for secondary defects to associated building elements and surrounding structures.

Where installation is substandard and/or incomplete, the client should contact the responsible trade to undertake rectification works.

The appropriate tradesperson, specialist or handyman should be appointed to complete the various items for repair and organise the appropriate QUALIFIED trades (or not pending on job) to repair and complete the works to illiminate or reduce further deterioration / disfunction.

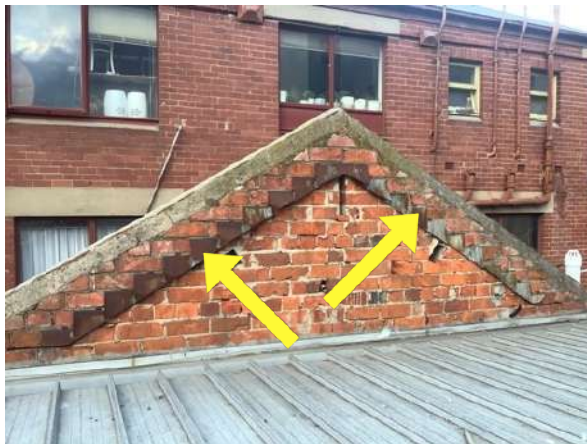
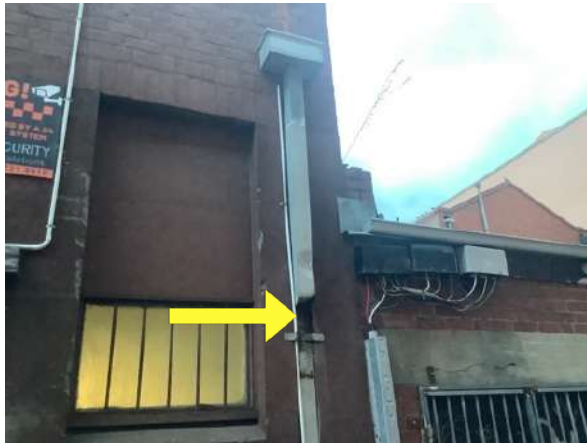
Minor Defect 3.02

Location: Roof & Stormwater Areas

Finding: Roof Sheetting, Flashing & Gutters - Rusted or Corroded

The roof plumbing has areas of rust and corrosion. It is suspected that this has been caused by blockages, resulting in pooling or standing water, that have prematurely rusted elements of the roof plumbing or sometimes just age combined with premature excess water is also a factor.

Rusted roof plumbing will generally develop holes and leaks that can affect other building elements with poor drainage of storm water. Poorly drained roof areas will also lead to damp conditions surrounding the base perimeter of the building which, if left unmanaged, can lead to a range of secondary building defects, such as timber rots to the roof framing, etc.

A licensed plumber or specialist roof restoration company should be appointed to undertake these works. It is advised that such works be completed as soon as possible to prevent any further damage and deterioration.
