Frame Report

Inspection Date: 7 Jul 2021 Property Address: Eastern Area

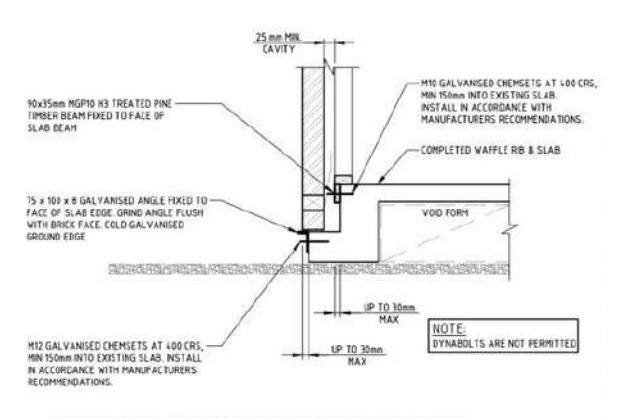
It was observed that there are areas where the bottom plate is overhanging the slab edge by more than the tolerable allowance with reference to the NCC (BCA). A maximum overhang of 10mm is acceptable if the minimum edge distance for both the bottom plate and the concrete slab fixing locations have been satisfied. It is also considered to be defective if the minimum cavity widths as prescribed in the BCA are

compromised. At the time of the inspection it was found that the framework bottom plate is overhanging the

Standards and Tolerances 2015 - Diagram 4.08 states that the maximum overhang of the framework bottom plate is 10 mm.

PROVISIONAL ALTERNATIVE EDGE RIB DETAIL FOR BRICK & FRAME OVERHANG (MAX O/H 30mm)

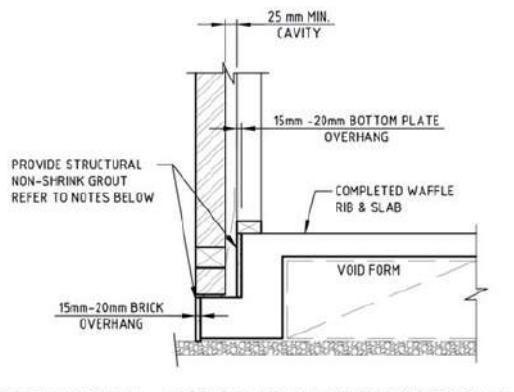
PROVISIONAL ALTERNATIVE EDGE RIB DETAIL FOR BRICK & FRAME OVERHANG (11mm TO 20mm) N.T.S.

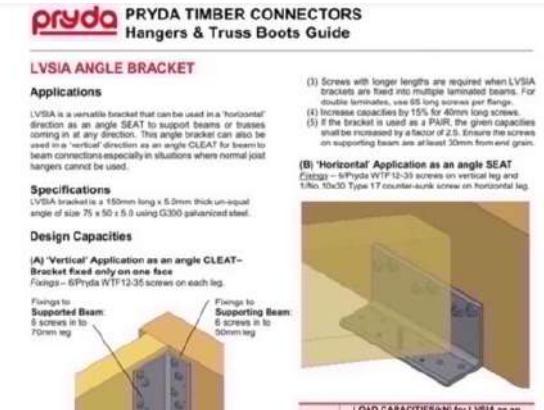
Pryda Timber Connectors Hangers & Truss Boot Guide

JOINT LOAD CAPACITIES(INI) for LVSIA as an angle seat for given Load Cases 1355 12G+15Qr 12G+15Qr Utility Page 22

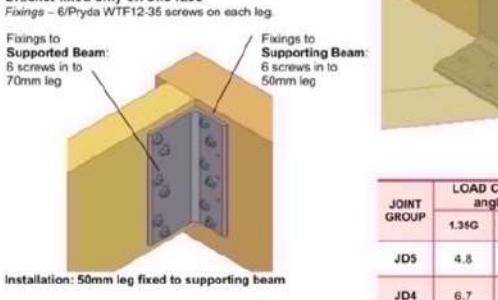
Specifications LVSIA bracket is a 150mm long x 5.0mm thick un-equal angle of size 75 x 50 x 5.0 using G300 getvanized steel. Design Capacities (A) 'Vertical' Application as an angle CLEAT– Bracket fixed only on one face Fixings - @Physia WTF1235 screws on each log.

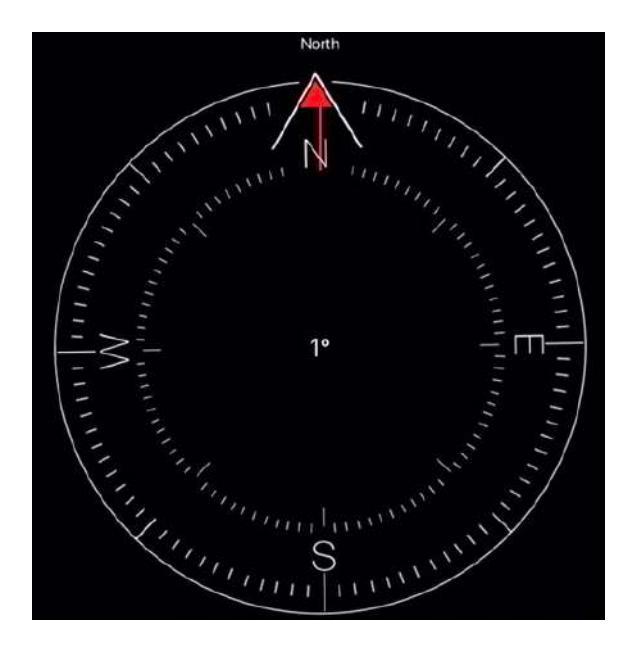
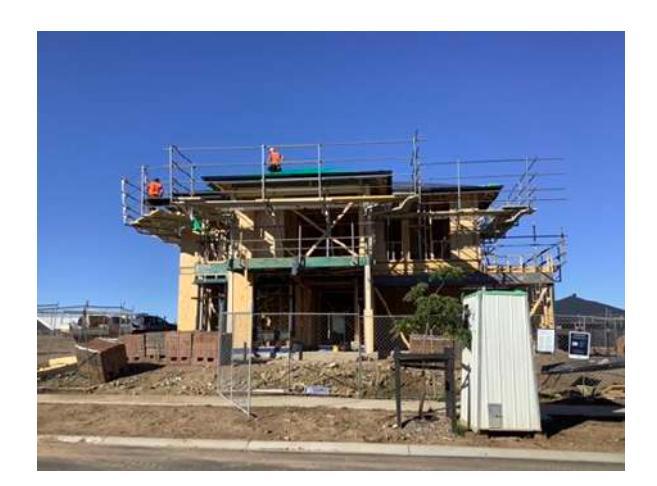
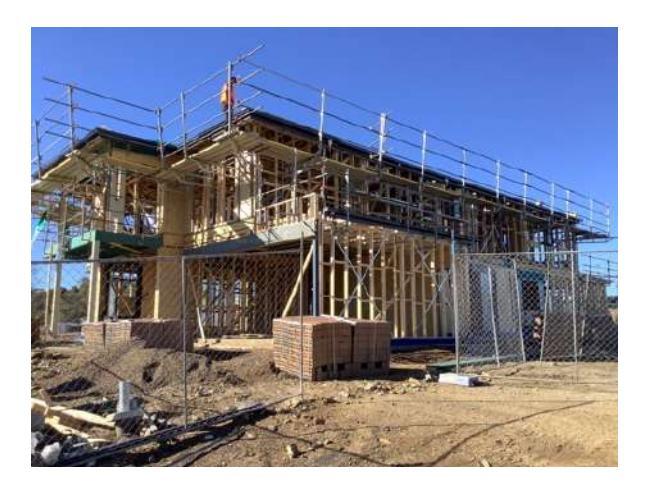
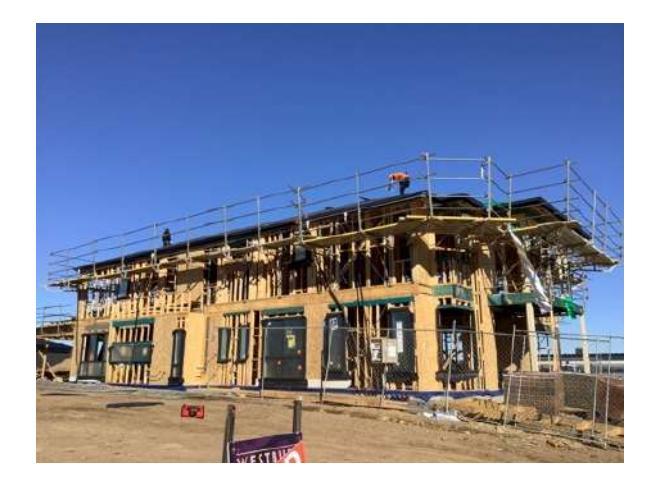
For Your Information 5.01

Location:The SiteFinding:Site PhotosAdditional photos are provided for your general reference.

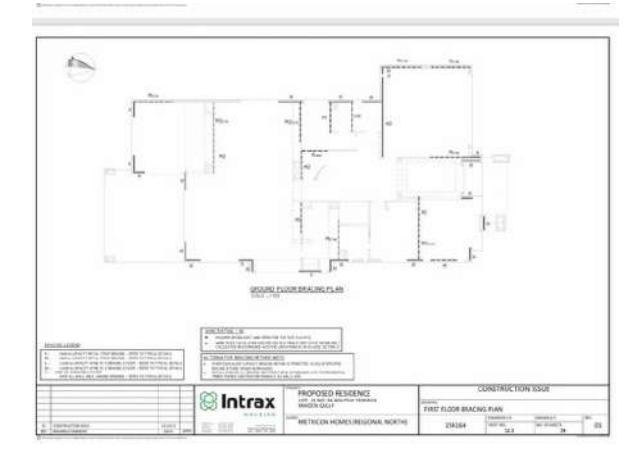
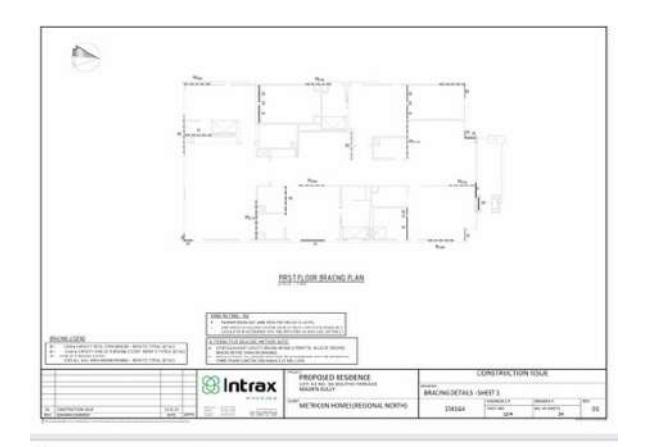
For Your Information 5.05

Location:	All Areas
Finding:	Bracing Sheets - Locations Are As Per Plans Supplied
	The bracing sheet locations are located as per the plans supplied.
