Final / Practical Completion Inspection (PCI) Report

Inspection Date: 9 Jun 2021

Property Address: Wallan Area

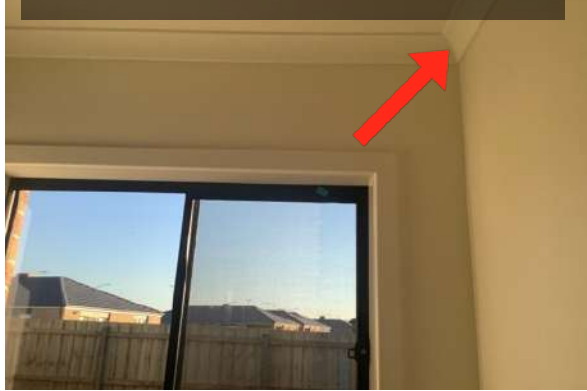
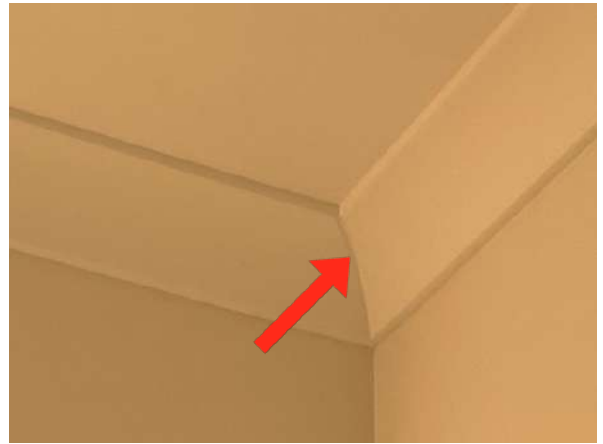
Excessive cornice junction in bathroom

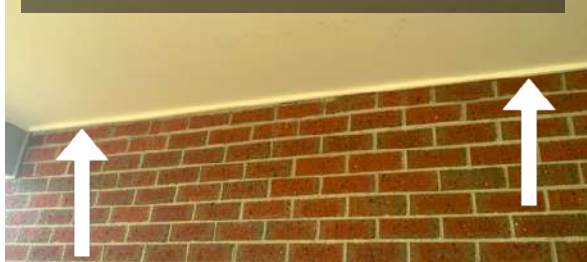
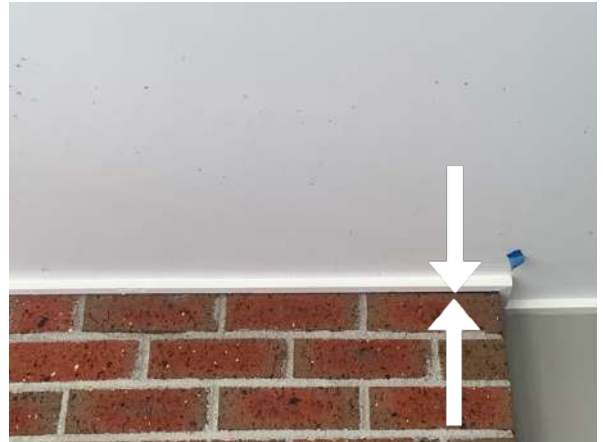
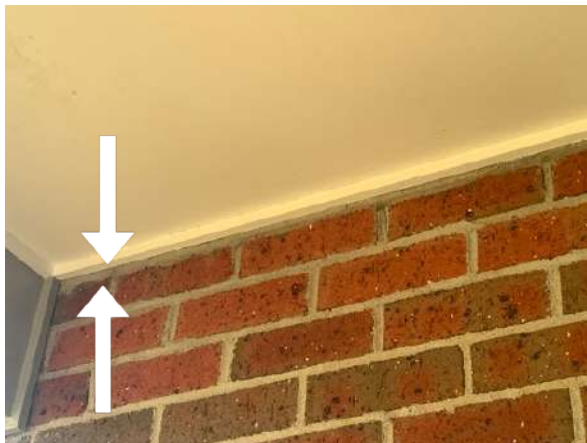
The bed joint is not running horizontally straight, you can see that the alfresco ceiling has the bed joint fully exposed of over 10 mm at one end and at the other end the bed joint is completely hidden

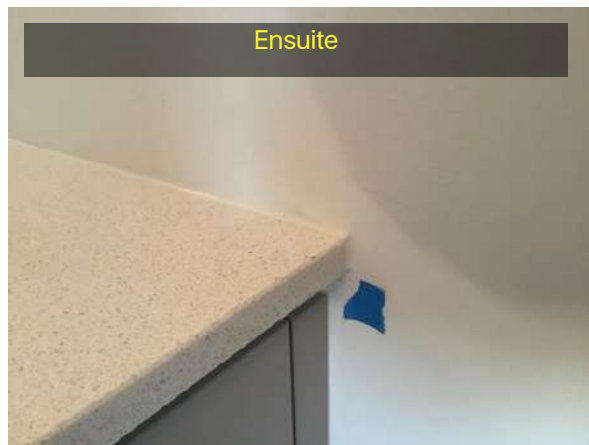
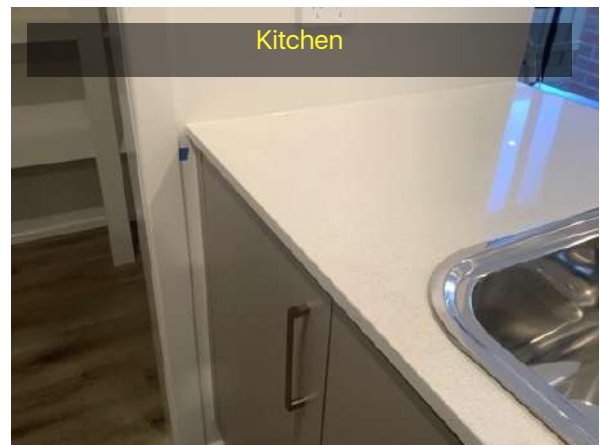
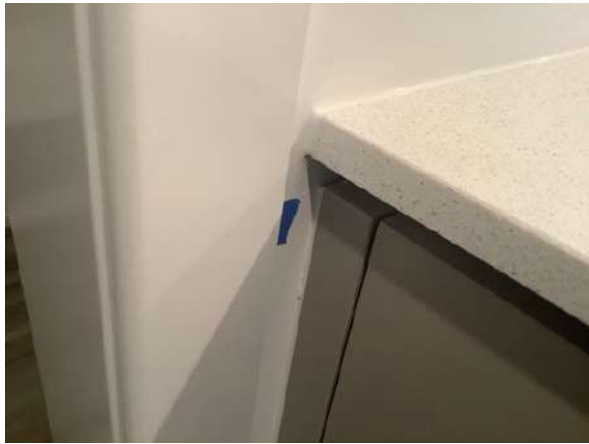
Defective Caulking To Cabinetry, Bench Tops, Tile Junctions, Cabinetry/Plaster Junctions, Etc.

It was noted on inspection that sealant is missing, inadequate and/or not completed to a tradesmens like finish.

IMPORTANT 🖱️ ONLY SAMPLE PHOTO'S of the missing or defective caulking. All AREAS to the entire property MUST be checked and repaired.

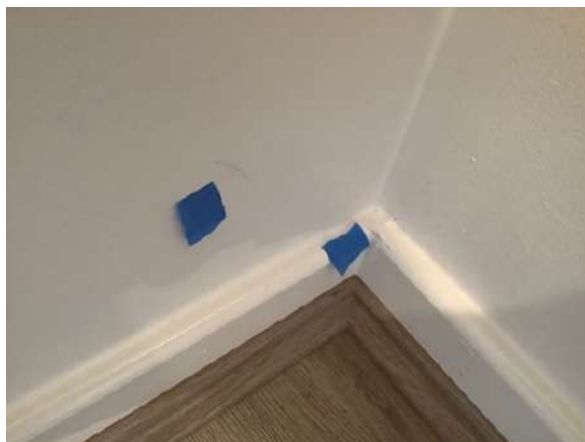
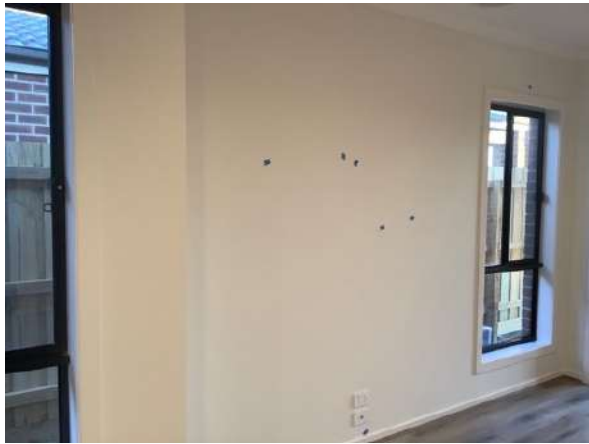
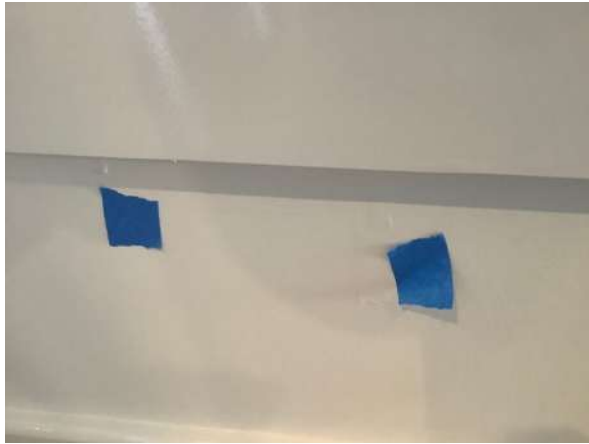
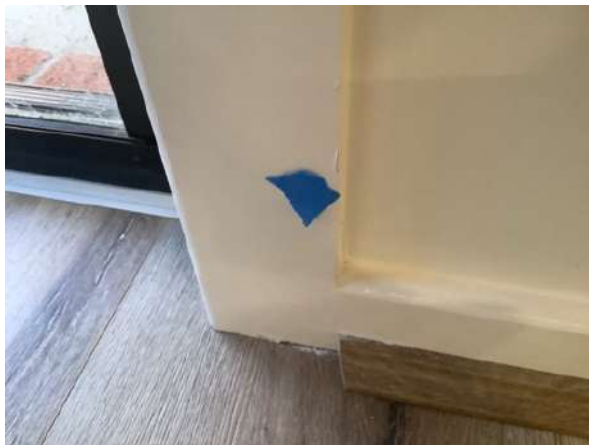
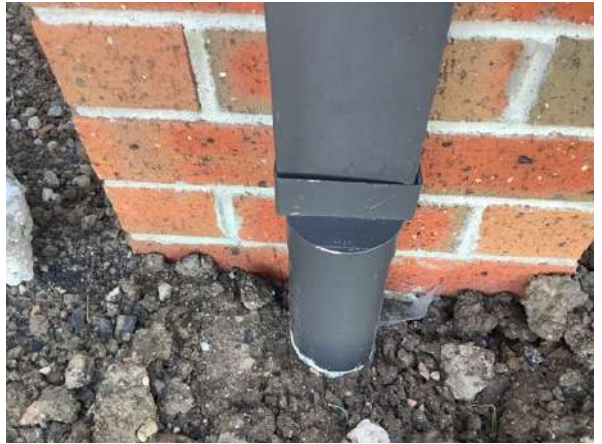
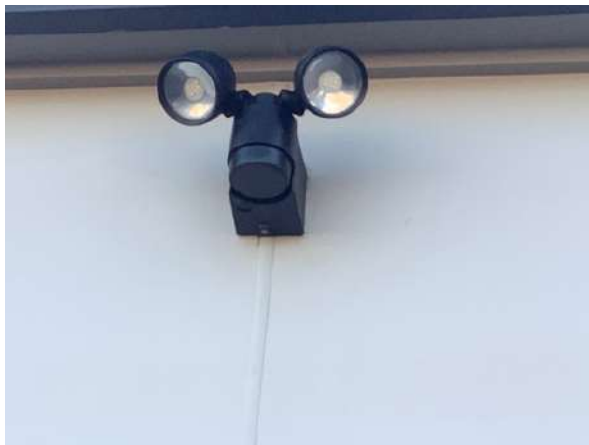
Non Compliant 2.04

Location: Painting - All Areas

Finding: Painting - Defective (AS2311)

Areas were identified where the surface finish of the painting was found to be defective. This includes areas of minor blemishes, missing painting, over-painting, paint runs, sags , paint chips, scratches and general paint imperfections.

It is up to the builder and painter to inspect and repair the paint work to ALL AREAS, TO ALL ROOMS methodically and carefully, to the plaster, timber doors, timber skirting and architraves, but limited to, so that the finishes are consistent throughout.

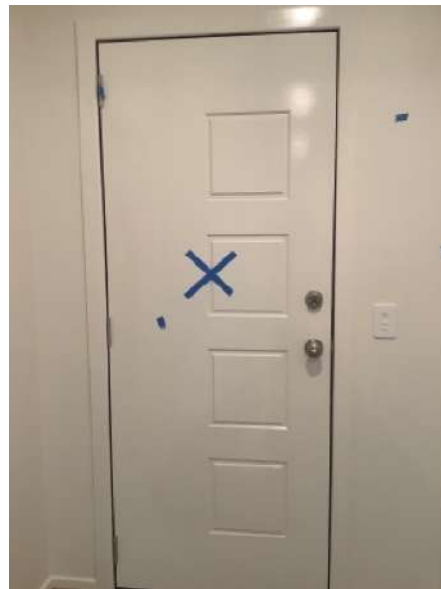
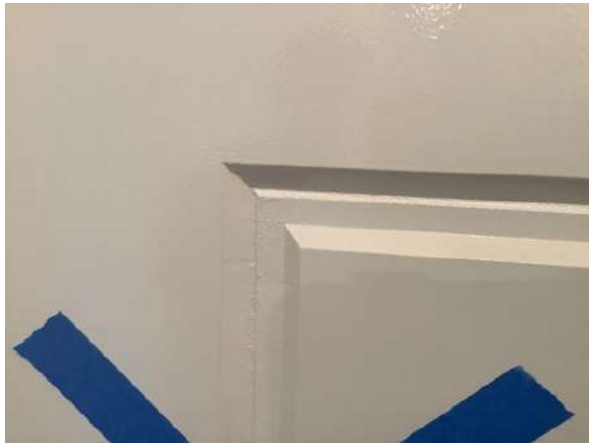
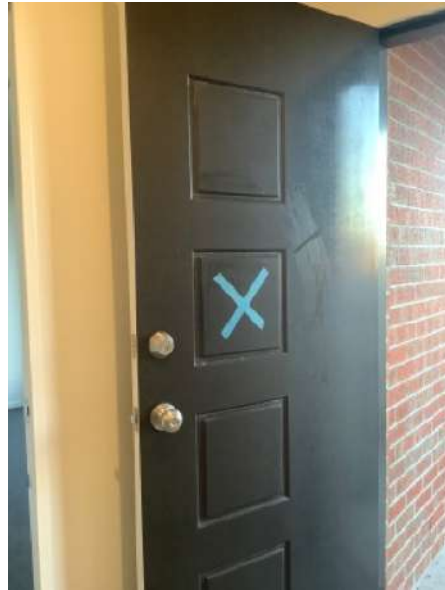
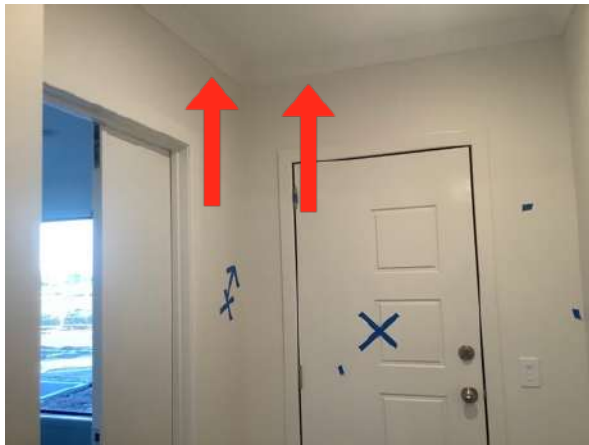
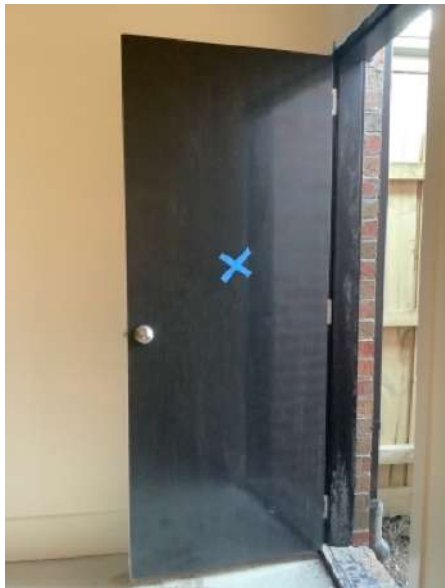
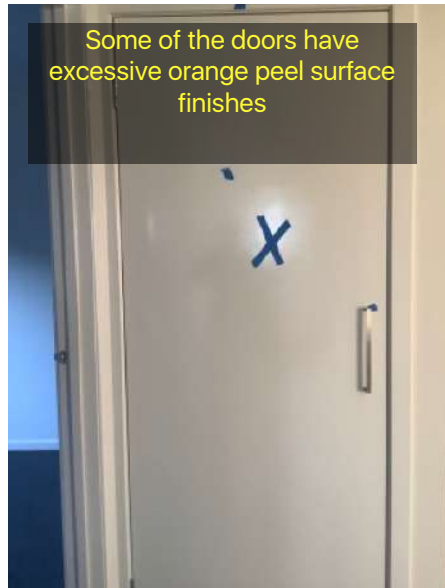
Non Compliant 2.05

Location: Painting-Under Painted / Defective-All Areas
 Finding: Paint Surface Finishes - Incomplete / Under Painted / Defective.

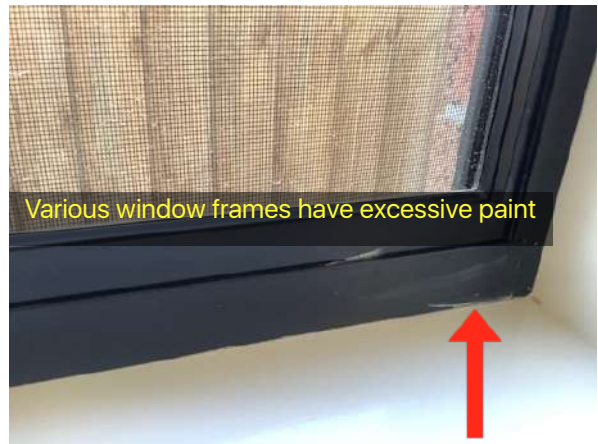
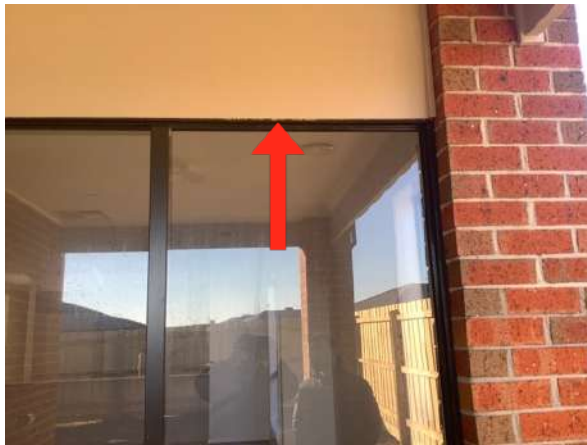
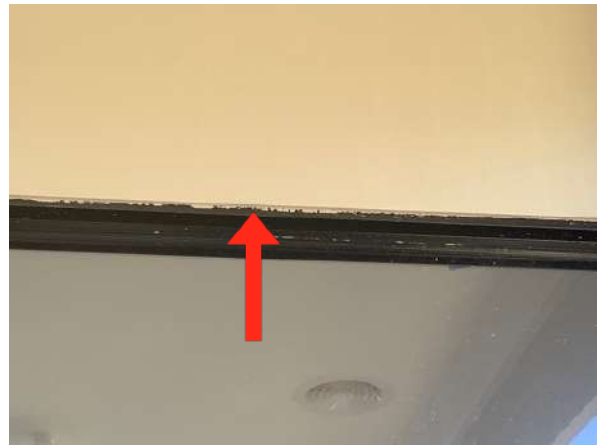
Non Compliant 2.06

Location: Painting-excessive over painting-All Areas

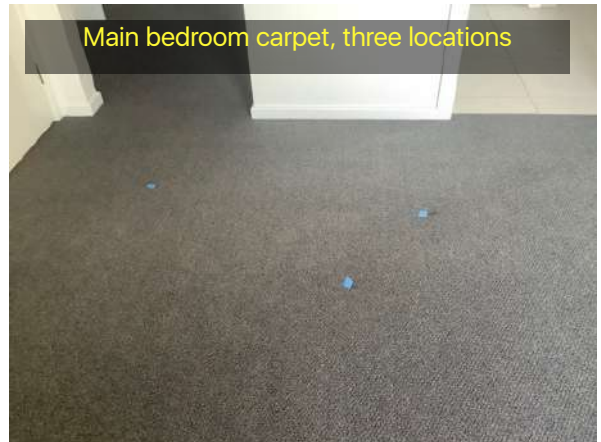
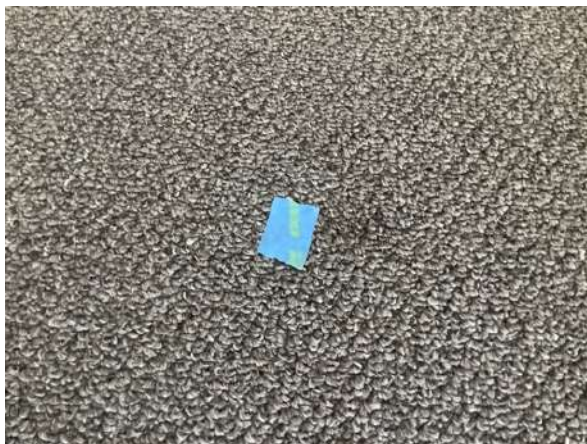
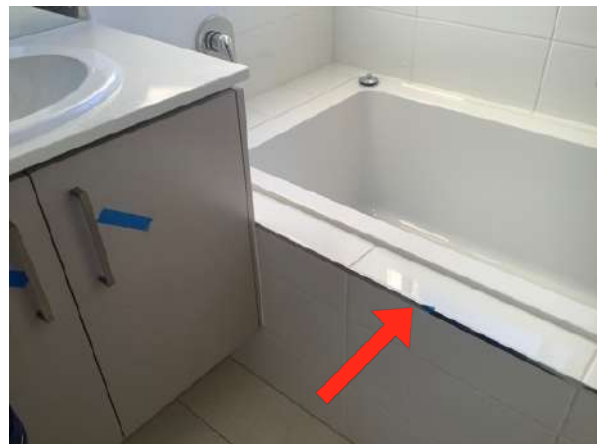
Location: Damages/ Faults - Building Materials

Finding: Damages/ Faults - Appliances / Fittings / Tiles, Building Materials, Etc

It is identified that damage or faults affecting tiles, appliances and / or fittings and/or Building Materials supplied as part of the building contract have occurred. Where this is due to the builder's workmanship or damage occurring during construction it is considered a defect with respect to Standards and Tolerances - 18.02.

Main bedroom carpet, three locations

All areas to the entire property should be checked carefully to identify any further damages of the same type.

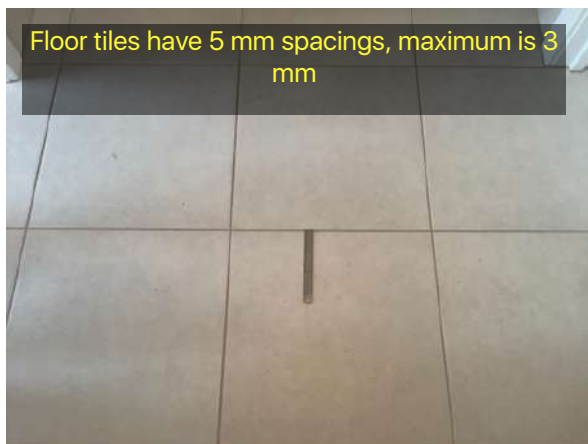
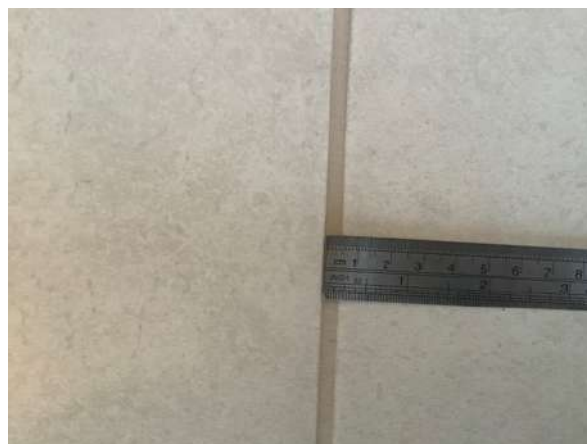
Non Compliant 2.15

Location: Tiled Areas

Excessive tile grout widths to the tiled walls and the tiled floors - This is certainly considered defective.

Floor tiles have 5 mm spacings, maximum is 3 mm

◆ Replacement & total strip out of the tiled floors and the tiled walls is required and/or is up to the discretion of the client.

Is important to note that once the builder takes any tiles out, the waterproofing must be reinspected as damage to the waterproofing, substrate, plaster and/or cement sheet is a HIGH possibility and all waterproofing must comply with the Australian standards, prior to the new tiles being installed.

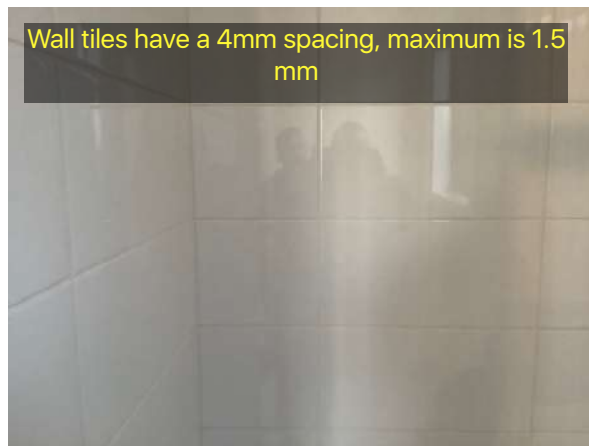
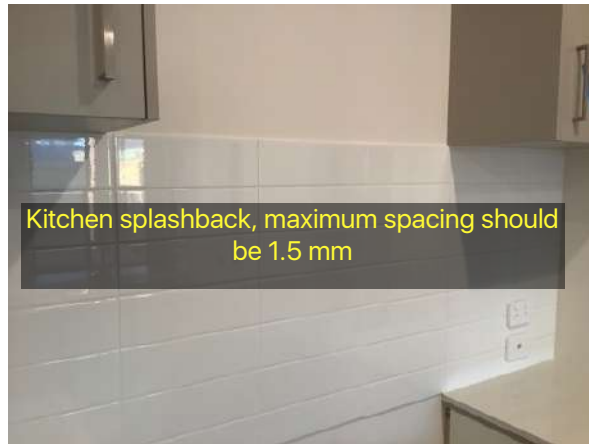
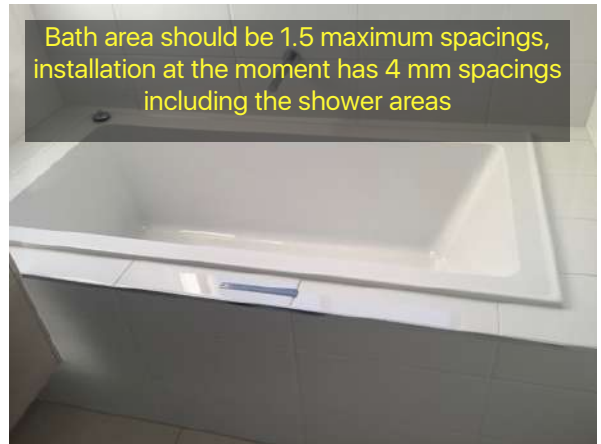
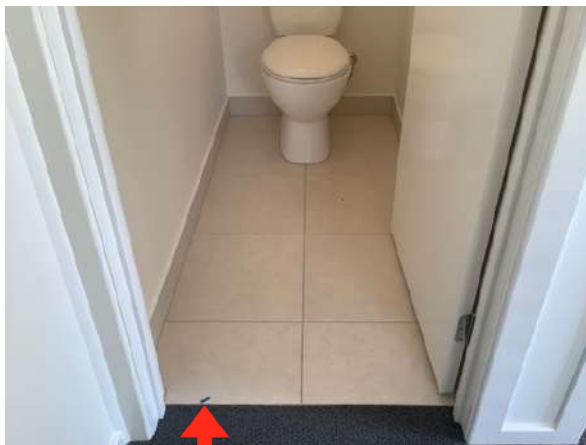
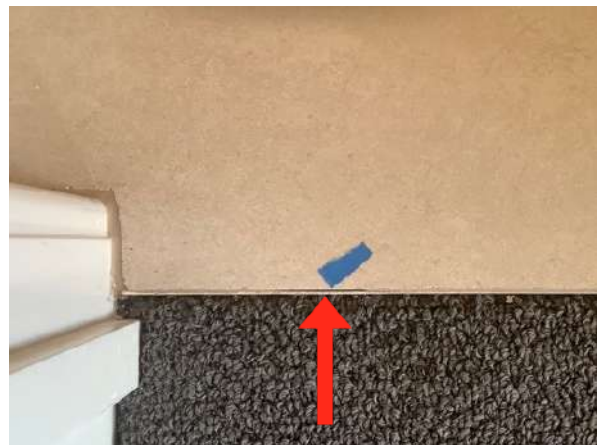
Non Compliant 2.16

Location:	Tiled Areas
Finding:	Tile grout (AS3958)Various //. Poorly applied //. Tile grout - not flush // Tile Grout - Unfinished Areas of grouting were identified in this area which are not applied or installed to the requirements of AS3958.1.

Where grouting is missing or incomplete, the area is not sealed against water penetration, increasing the likelihood of water damage to flooring and other associated building elements. Also

Areas where the tile grout does not finish to the cushion on cushion edge tiles and / or flush with square edge tiles (except for tooling) is considered a defect with reference to AS3958.1.

Adequate repair to grouting for all the above defects and must be applied to the affected area prior to final handover.

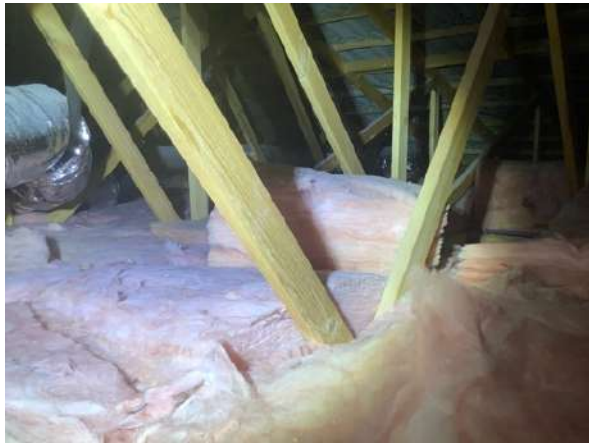
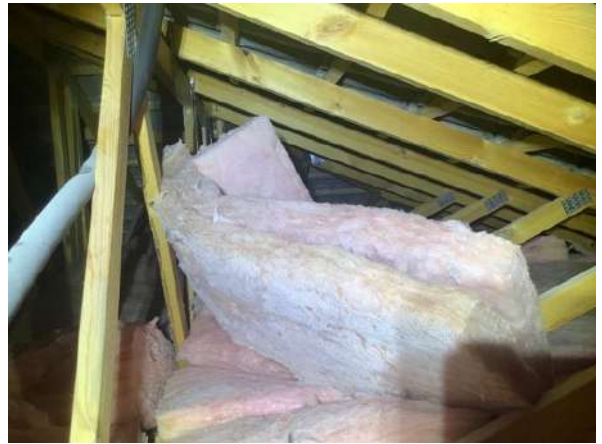
**Non Compliant 2.17**

Location: Roof Space

As a general rule, a 5% gap in the insulation creates potential for a 50% decrease in the energy efficiency of the property.

All insulation batts should be reinstated to comply with standards and to ensure maximal energy efficiency within the property. Failure to do so results in non-compliance with AS4859.1 Materials for Thermal Insulation of Buildings.

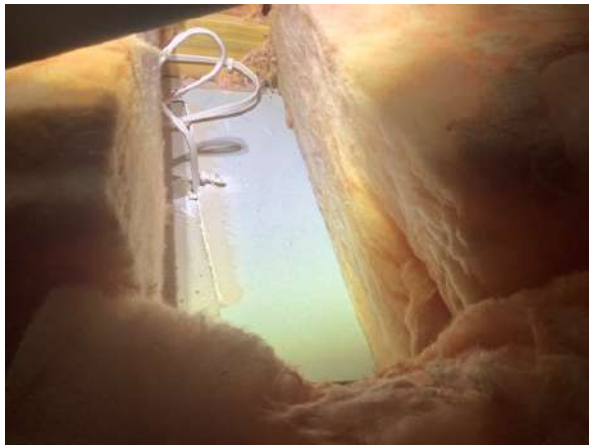
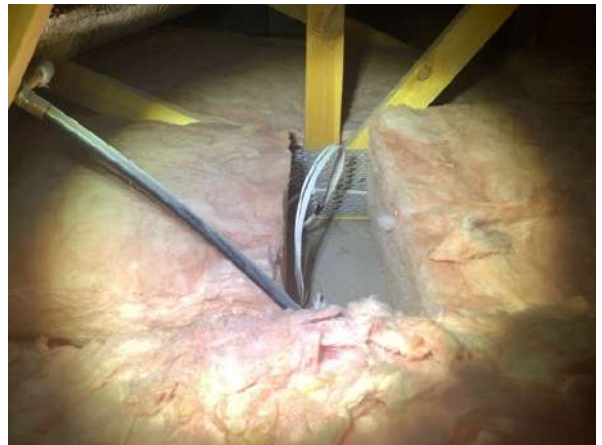
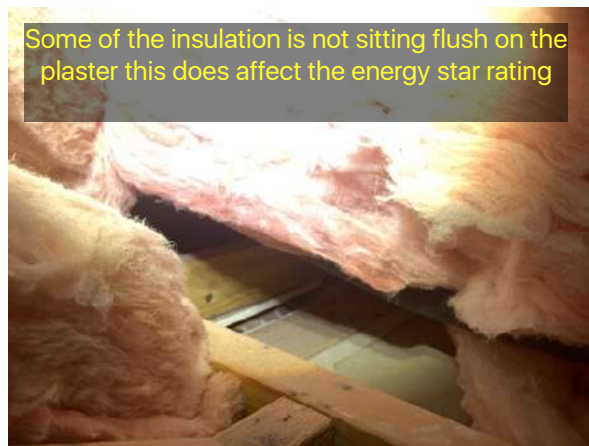
Non Compliant 2.18

Location: Roof Space

Finding: Insulation - missing (AS4859)

Insufficient insulation will result in a comparatively higher cost to heat and cool a property as there is a lack of Insulation (or uneven coverage of insulation) which works as a barrier to heat transfer. This helps to keep out unwanted heat in summer and preserves warmth inside your home in winter. It can also help soundproof your home from unwanted airborne noise transfer.

Installation of adequate insulation is required according to Australian Standards and should be conducted as soon as possible.

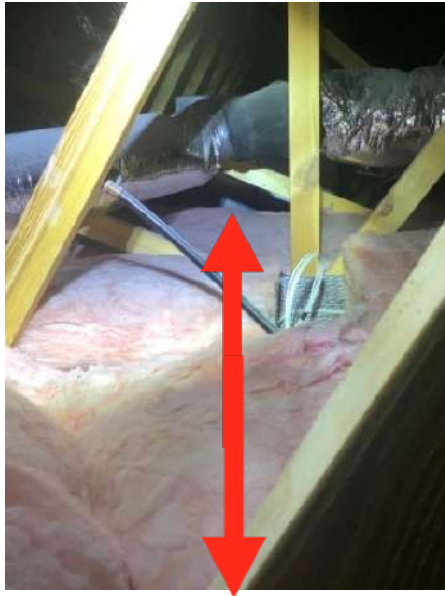
Non Compliant 2.19

Location: Roof Space

- (i) at least 600 mm wide from the access point to the appliance;
 - (ii) where required around the appliance, at least 750 mm;
 - (iii) permanently fixed to the building; and

- (iv) capable of supporting the weight of a person.

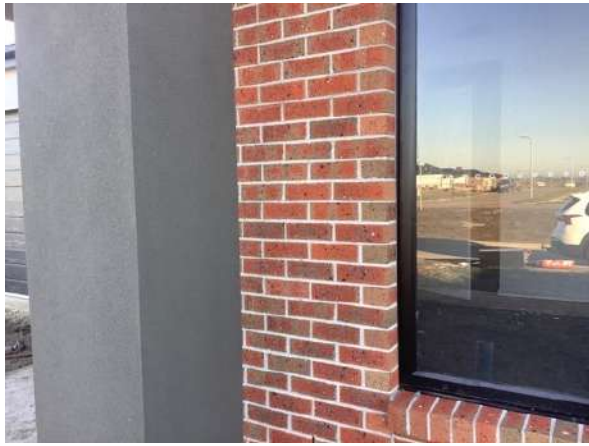
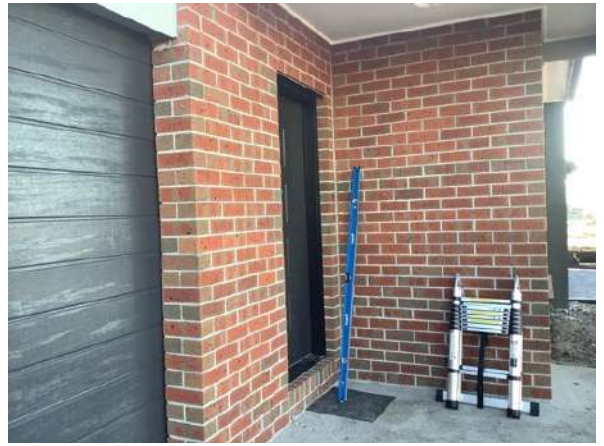
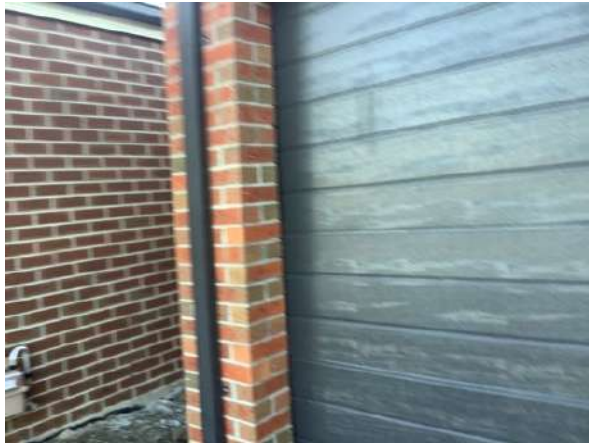
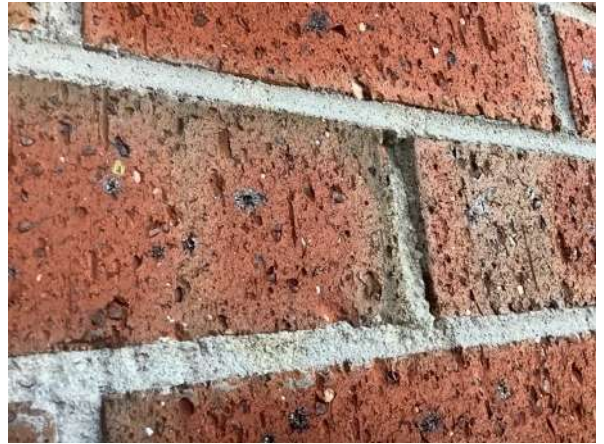
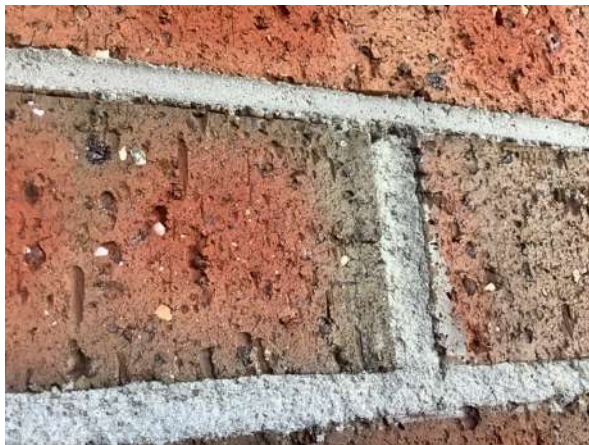
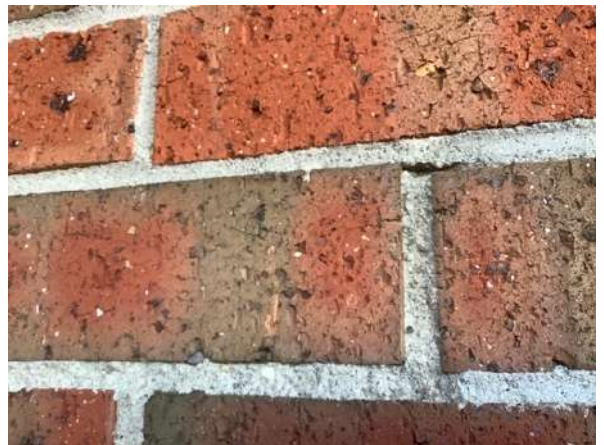
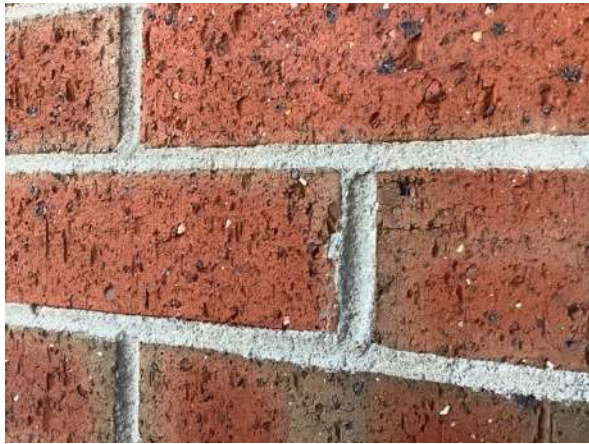
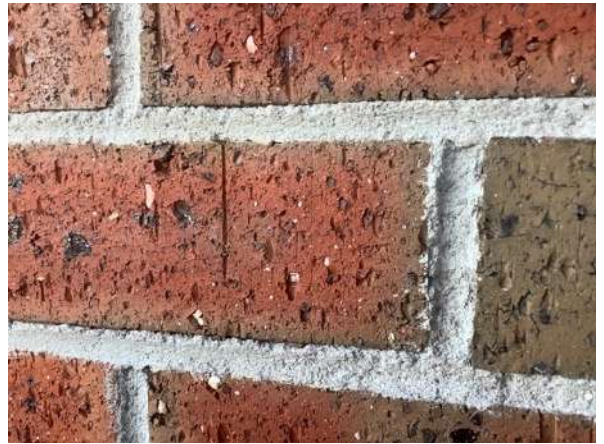
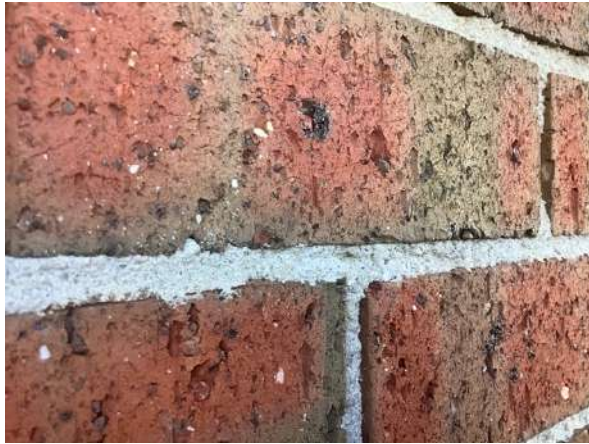
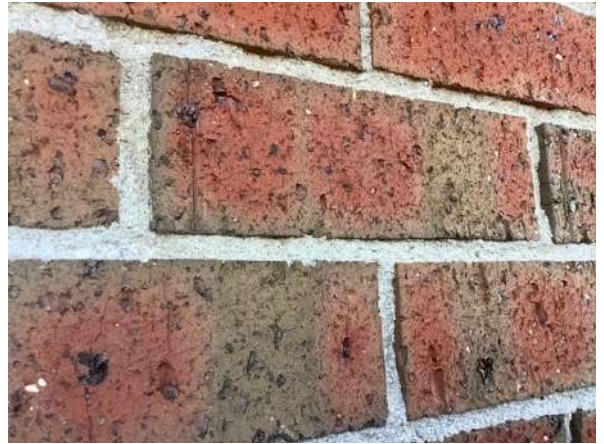
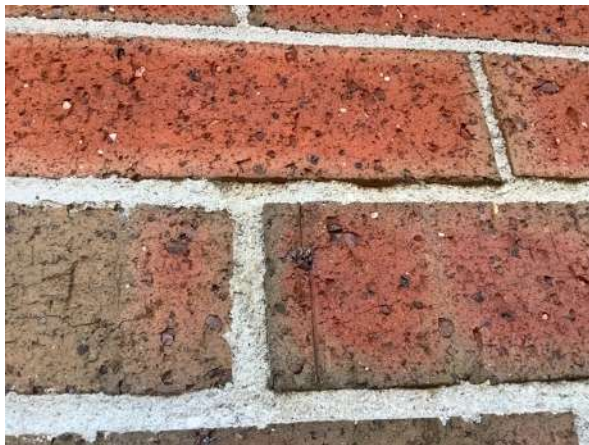
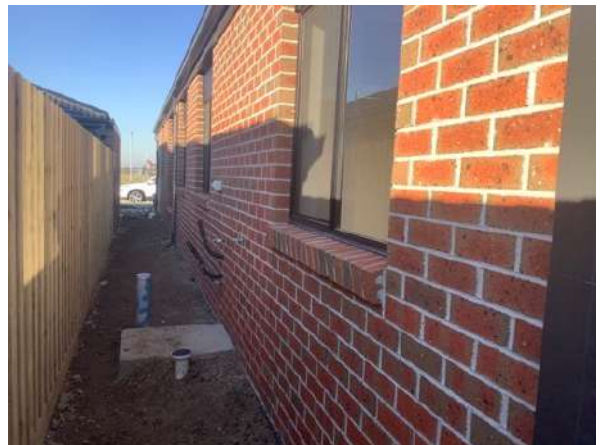
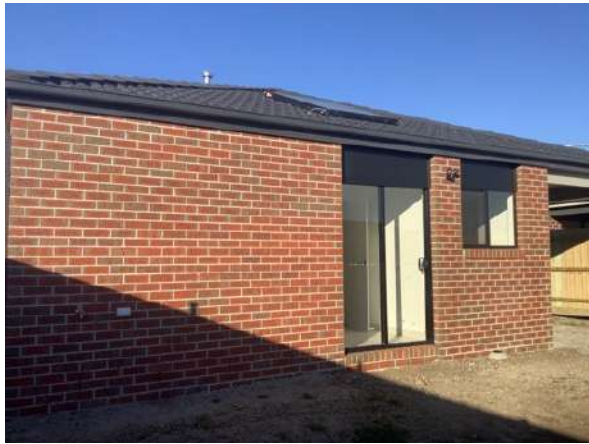
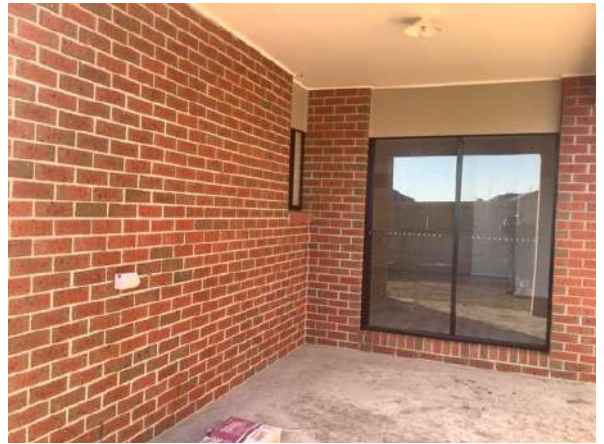
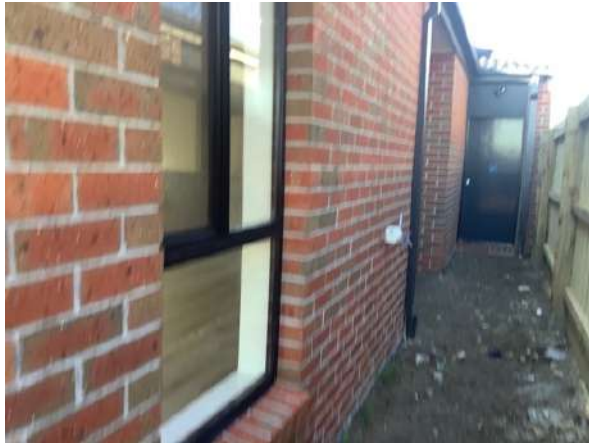
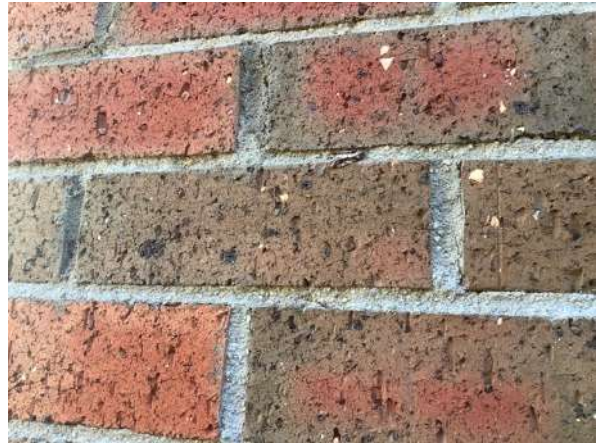
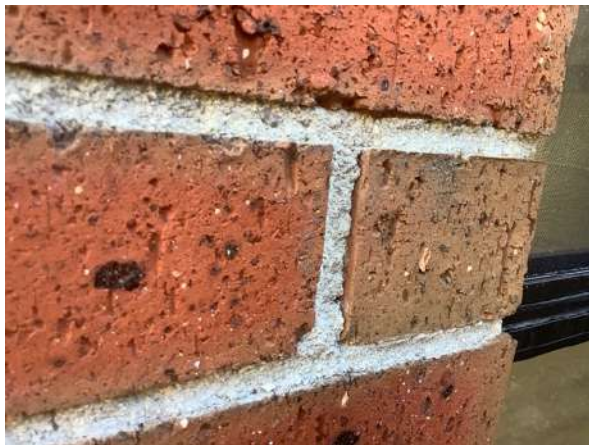
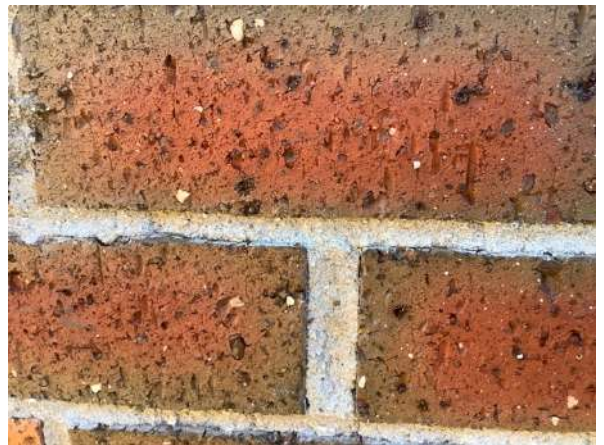
Non Compliant 2.23

Location: Brick Work - Exterior Perimeter Of Building

IMPORTANT 📌 ONLY SAMPLE PHOTO'S of the Brick Excessive mortar defects. All AREAS to the entire property MUST be checked and repaired.

It was observed at the time of inspection that several bricks in this area of brickwork require cleaning to remove excessive mortar. While not likely to cause secondary defects, excessive mortar detracts from the overall appearance of the area and should therefore be removed.

The Building Commission's Guide to Standards and Tolerances clause 3.07, Masonry Facing states that:- 'Masonry faces are defective if they are not cleaned and free of excess mortar' and clause 3.11, Cleaning, Mortar Smears & Stains states that:- 'Stains, mortar smears and damage caused by cleaning are defects if they are visible from a normal viewing positioning.' The faces and edges of the bricks within the wall around this home will have to be properly re-cleaned to remove all traces of the mortar residue from across them.

Finding: Brick Base bed joints (exposed)- defective

It was observed that the exposed base bed joints is defective. Exposed base bed joints in masonry walls which are above the finished ground level or exposed are considered to be defective if they exceed 20mm in thickness which is the allowable Standards and Tolerances.

IMPORTANT 🖱️ ONLY SAMPLE PHOTO'S of the Brick Perp Ends & Bed Joint defects. All AREAS to the entire property MUST be checked and repaired.

It is observed that there is an excessive deviation from the documented thickness of the brick per ends.

There are variations in excess of 10mm which is excessively higher than the acceptable levels of workmanship regardless if it is the bricklayers defective workmanship and/or defective sizing or seconds brick supplied by the builder.

The maximum non-structural framework tolerance is 3mm. This identified defect exceeds the maximum allowable tolerance and is therefore considered a defect.

The relevant Australian Standard, A.S.3700-2001 Masonry Structures, states that 'the maximum deviation from a specified thickness of a perpend joints for non-structural face brickwork is +/- 5mm on average' as well as that 'the maximum difference in perpend thickness in any non-structural face brick wall is 8mm' and also that 'the minimum perpend thickness for non-structural face brick wall is 5mm'.

Generally the remedial works are demolition of brick work and/or at the clients consent render.

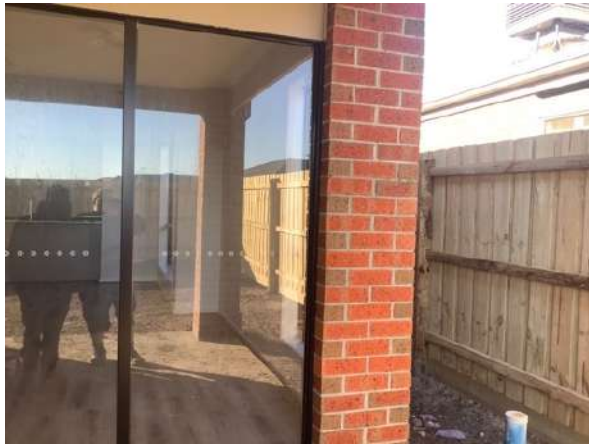
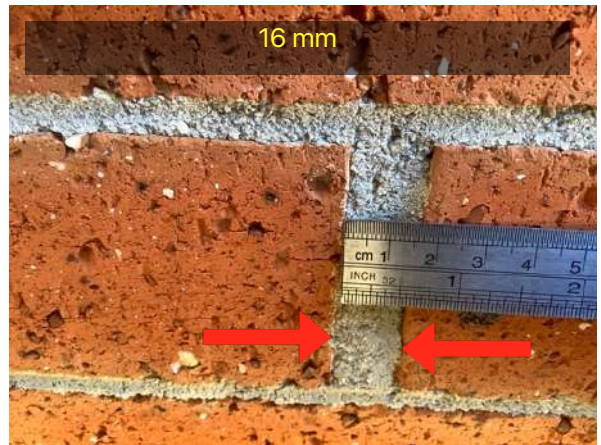
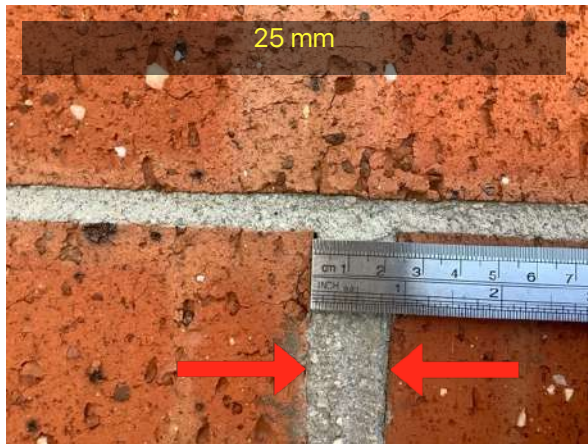
Non Compliant 2.26

Location: Brick Work - Exterior Perimeter Of Building

I have ONLY taken LIMITED photos of this defect and attached are LIMITED photos of this defect in SOME AREAS ONLY.

All AREAS to the entire property should be checked CAREFULLY to identify any further defects that are the same, as this defect is in other areas of the property.

At the time of the inspection it was found that the brickwork is overhanging the slab by more than 15 mm.

Standards and Tolerances 2015 - Diagram 4.08 states that the maximum overhang of the brick work is 15 mm.

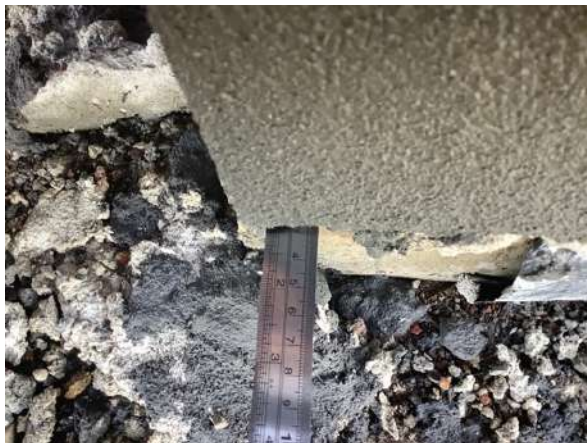
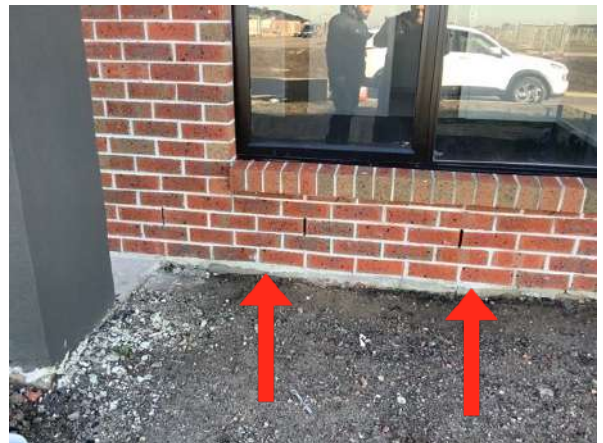
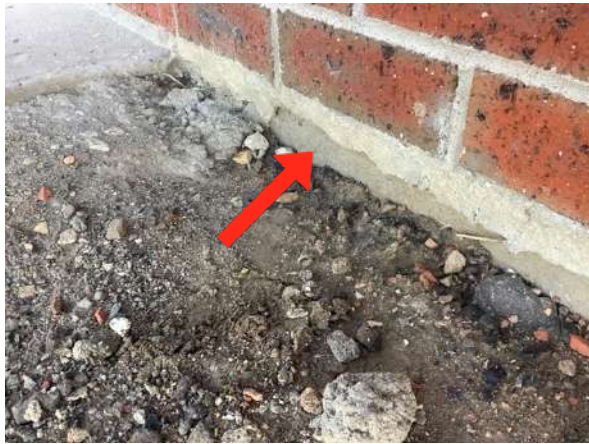
Non Compliant 2.27

Location: Render - Exterior

Finding: Render marked - defective

Marks caused by paint, etc due to the composition of the materials and / or any other blemish or damage which is obvious from a normal viewing position is considered a defect with reference to Standards and Tolerances.

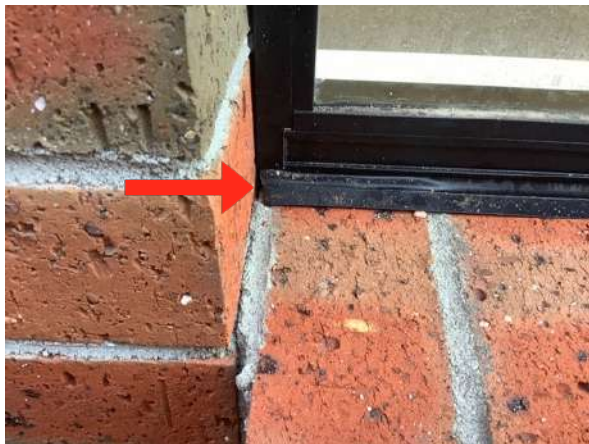
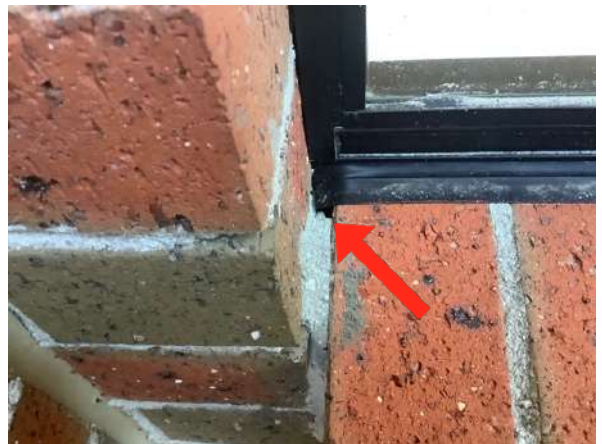
Non Compliant 2.29

Location: Concrete Slab - Perimeter To All Areas

Finding: Vapour barrier - Defective (AS2870- 2011)

IMPORTANT 🖱️ ONLY SAMPLE PHOTO'S of the vapour barrier defects. All AREAS to the entire property MUST be checked and repaired.

It is a requirement of AS 2870-2011 5.3.3.4 that vapour barriers are turned up and terminated at ground level above pavement adjacent footing. The vapour barrier is defective if building materials and fill has been left on top of the membrane, as this prevents it from being pulled up against the slab when installing perimeter paving as it is intended to be.

Defective Vapour Barrier Installation - Damaged/Punctured and/or overlapping Defective.

It was noted at the time of inspection that a vapour barrier had not be installed in accordance with AS2870 and BCA Part 3.2.2.6.

The polyethylene vapour barrier from beneath the concrete floor slab must be turned up the external side faces of its edge beams. Failing to install the vapour barrier correctly will allow moisture ingress via slab edge dampness into the internal timber wall skins and/or the floor coverings if not done.

I HIGHLY RECOMMEND that the builders dig the perimeter carefully,, sometimes the entire perimeter, pending of the severity of the vapour barrier (plastic) damage, pending on slab over pour, pending on excessive builders concrete (debris).

2/ All the rips and/or damaged area needs to be taped.

4/ Some areas whilst listed above are Damaged / Ripped / Not Consistent And Sealed with 200mm Overlay And Taped / Not High Enough / Non Existent must ALL be repaired.

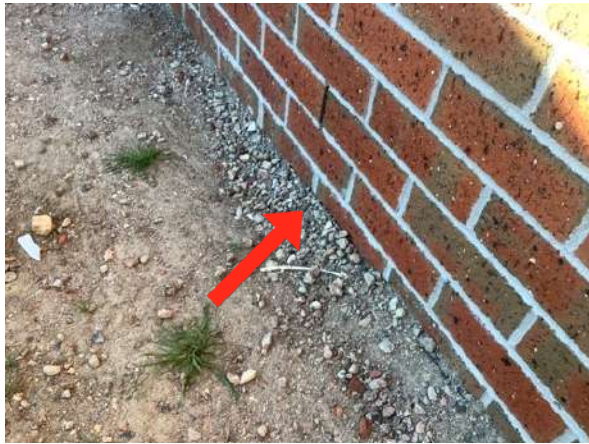
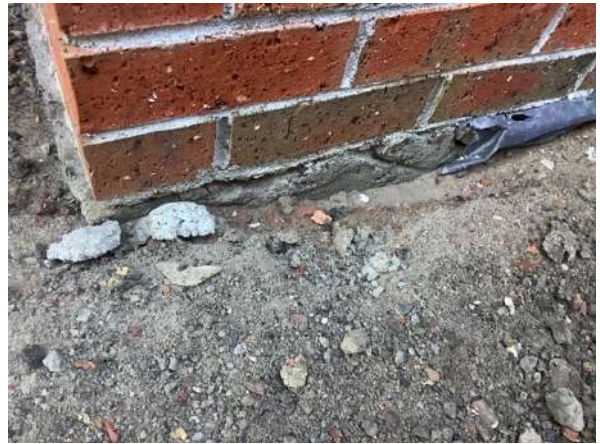
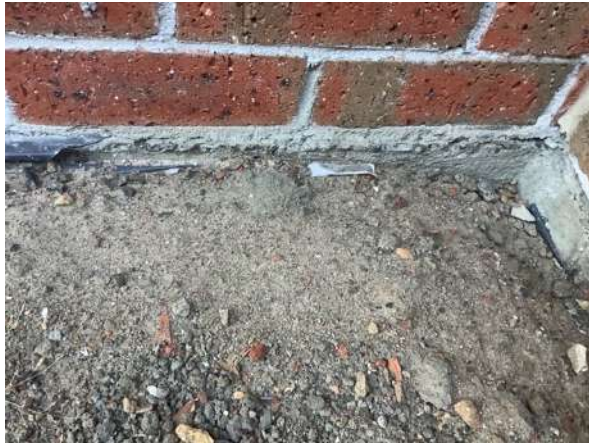
Non Compliant 2.30

Location: Concrete Slab - Perimeter To All Areas

- / Seek engineering process and design for rectification of this defect.

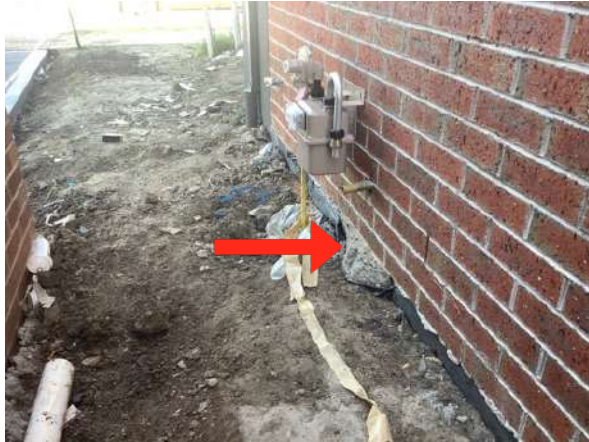
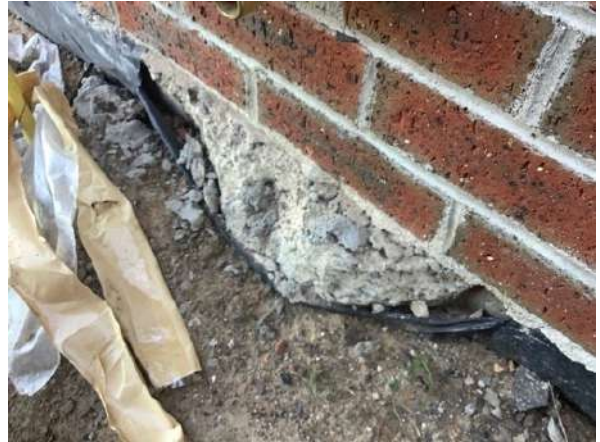
THIS WILL EFFECT THE VAPOUR BARRIER SYSTEM, WHICH IS EXTREMELY IMPORTANT AND MAY ALSO EFFECT THE APPEARANCE OF THE HOME, ONCE THE CONCRETE PAVING AND/OR GARDEN IS COMPLETE.

- / Satisfy the defect has not been hidden by placing soil over the edge beam of the over poured slab.

I HIGHLY RECOMMEND WITHOUT ANY COMPROMISE, THAT THE BUILDER RECTIFY THE DEFECTIVE CONCRETE SLAB PERIMETER WITHOUT COVERING WITH SOIL , CRUSH ROCK, BRICK LAYERS MORTAR DEBRI OR ANYTHING ELSE.

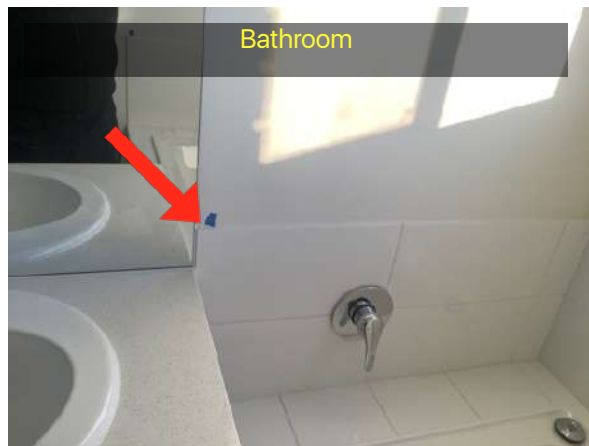
Substandard Workmanship 3.01

Location: Skirting/Wall Tiles - Edges Defective Finishes

Finding: Tile grout on top of tile skirtings / tile trims – Defective

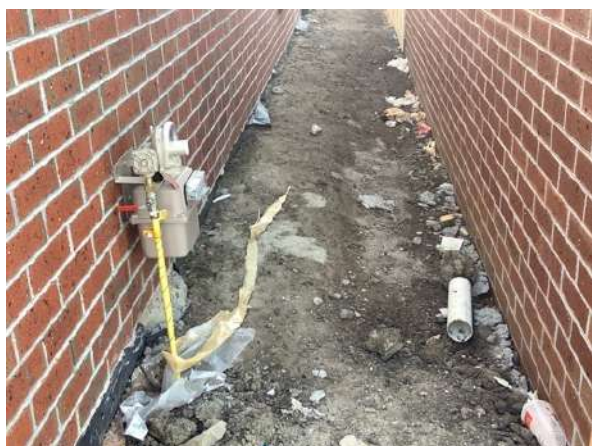
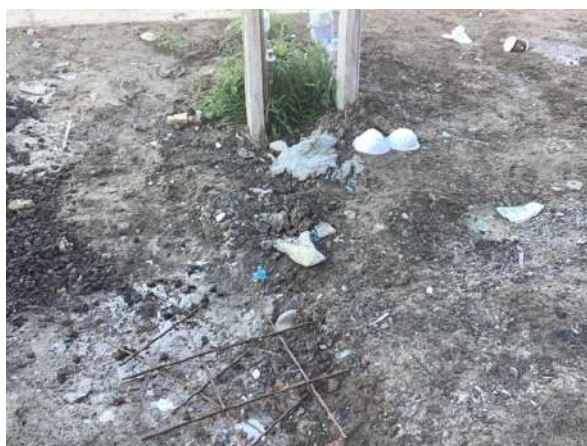
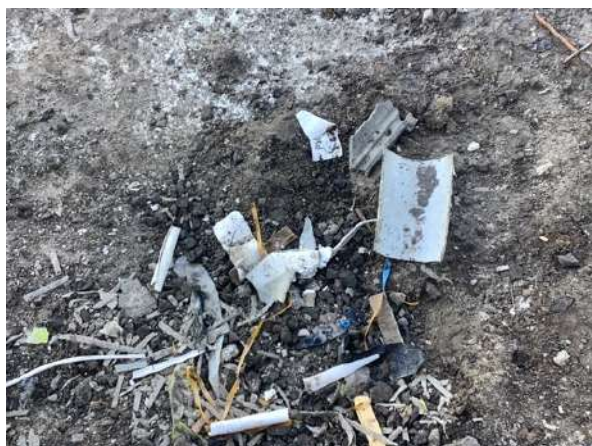
It was observed that builder's debris was present on site. Builders debris remaining, such as building materials, rocks, pieces of bricks and any other materials on the property or around the property is deemed defective and incomplete as the builder is to present the home with clean dirt only and clean areas internally as well, unless there is a variation in the contract.

This is a defect with reference to Standards and Tolerances.

The Building Commission's, Guide to Standards and Tolerances clause 18.09 Cleaning, states- 'Owners are entitled to expect that the building site and works are clean and tidy on completion. Building works are defective where windows are not clean, floors are not swept, mopped or vacuumed as appropriate, tiles, sinks, basins, troughs, baths, etc. are not cleaned and shelving, drawers and cupboards ready for use.'

Once the cleaners have properly completed all of this work, all of the glazing, mirrors, cupboards, baths, shower bases, shower screens, floor coverings, walls, stairs, garage floor, fixtures and fitting etc, should all be thoroughly checked again for any scratches and damage which may have occurred, prior to handover proceeding.
