Final / Practical Completion Inspection (PCI) Report

Inspection Date: 9 Jun 2021

Property Address: Wallan Area

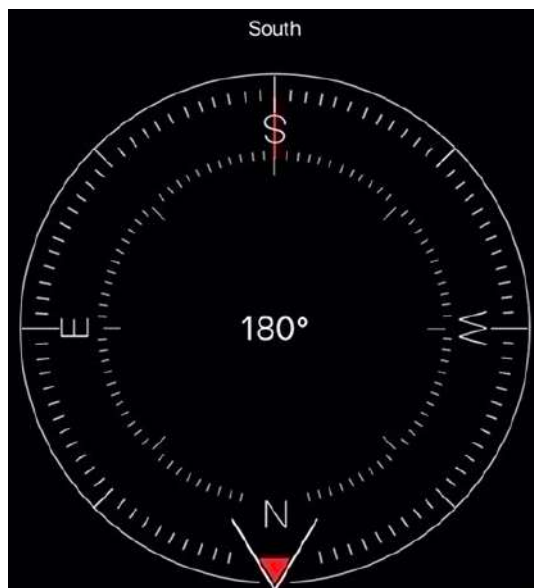
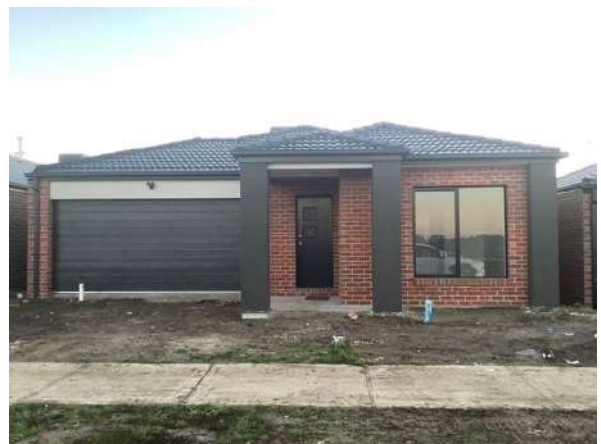
For Your Information 5.01

Location: Site Photos & Areas Of Interest.
 Finding: Site Photos.
 Additional photos are provided for your general reference.

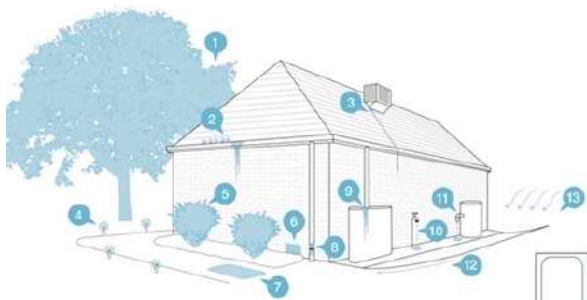
An important part of building maintenance is maintaining a consistent moisture level in the foundation soils around the building. This is important in order to prevent excessive wetting (expansion) or drying (shrinking) of the foundation soils and subsequent building movement.

Many things can adversely alter the moisture level in the foundation soils around the building, but most of them are preventable with careful ongoing maintenance. Diagram 18.09 lists common causes of excessive wetting and drying that are likely to alter moisture level in foundation soils around the building if not managed effectively.

Consideration of the items listed in Diagram 18.09 should all be a normal part of a homeowner's maintenance plan.
