# **Handover Report**

## Inspection Date: 10 Jul 2021 Property Address: Elwood, Vic - Area

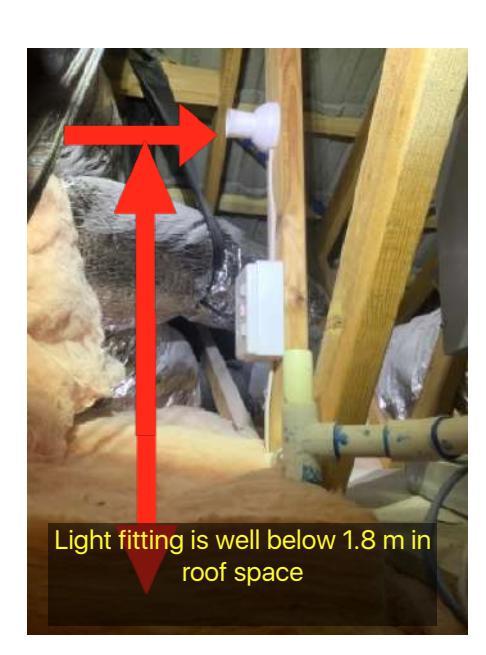
Roof Space

Roof Void Light batten - Minimum height 1.8 mtrs requires covered light. The light batten holder in the ceiling space have been installed below 1.8 Metres. As such it needs to be covered with a protective shroud as per AS 3000 section 4.5.1.1.

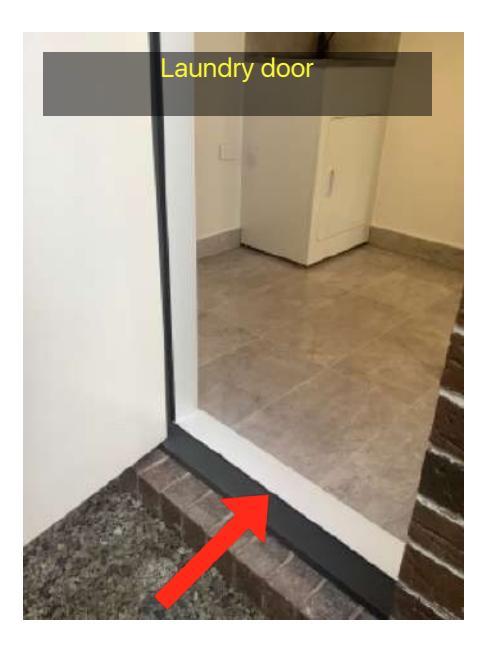
Garage Door, Class 1 to Class 10 Door - Defective

The cavity sliding door from the living area which is class 1 to the garage which is class 10 does not appear to be appropriate and I highly recommend you take further action with the surveyor on this important non-compliant item.

As required you need to seal the door for your energy star rating and a cavity sliding door cannot be sealed as per the regulations, as the requirement is inclusive of all perimeter internal doors, including the garage door leading into the house.

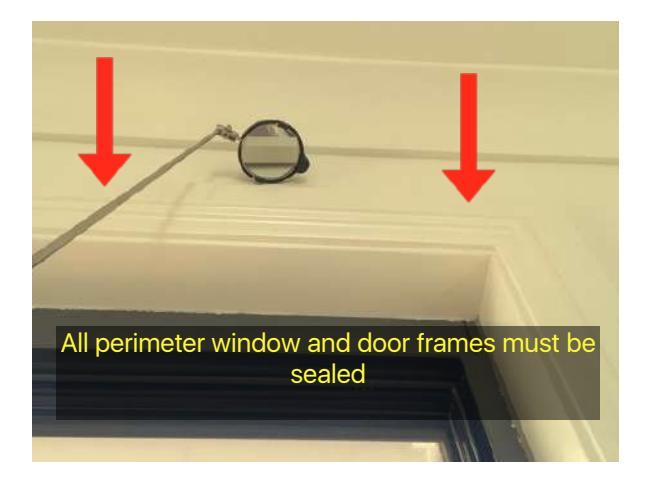
Location: Internal Perimeters

The gaps between the architrave and the plaster above and below all windows and above all door frames must be filled, in accordance with AS 2047 Window ion and installation.

The current gap is allowing a volume of air to enter the dwelling. BCA 3.12.3.3, in addition to relevant Australian Standards, also calls for all gaps around windows and doors to be sealed.

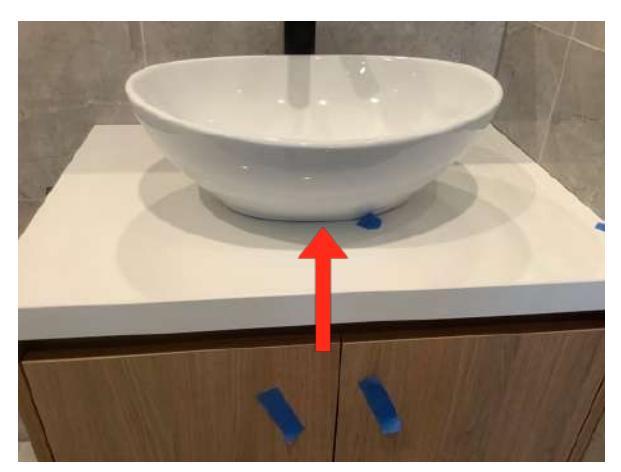
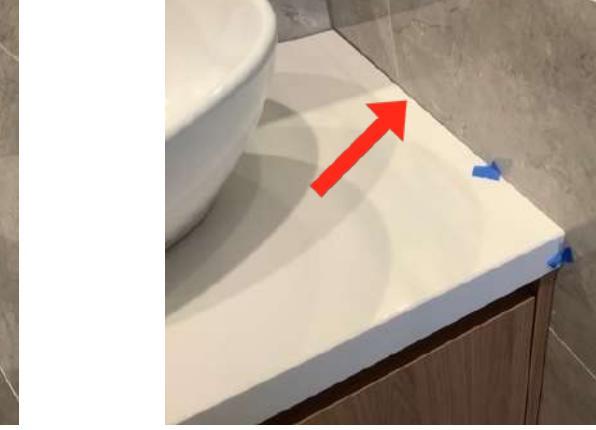
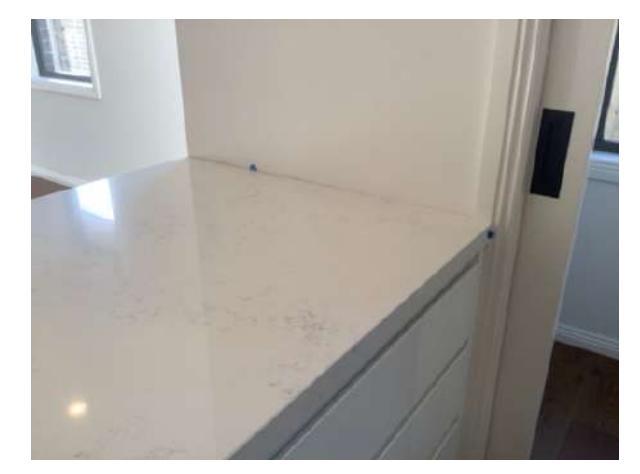
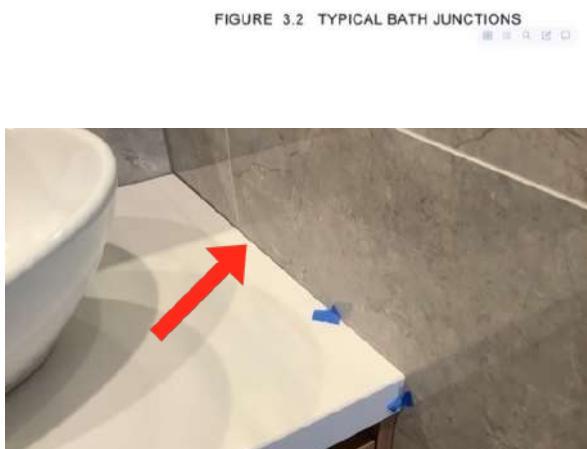
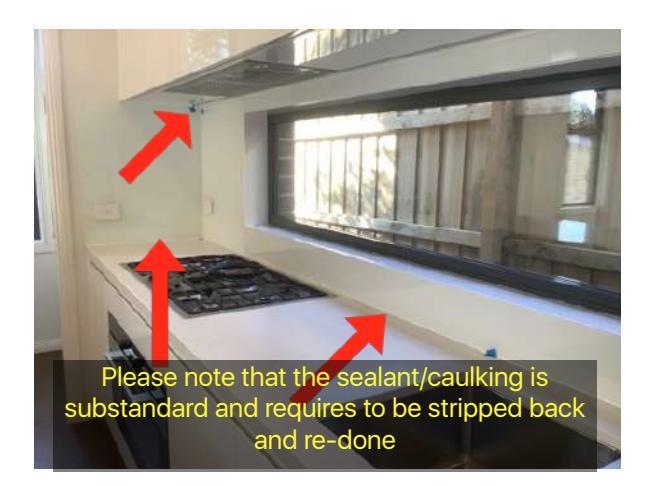
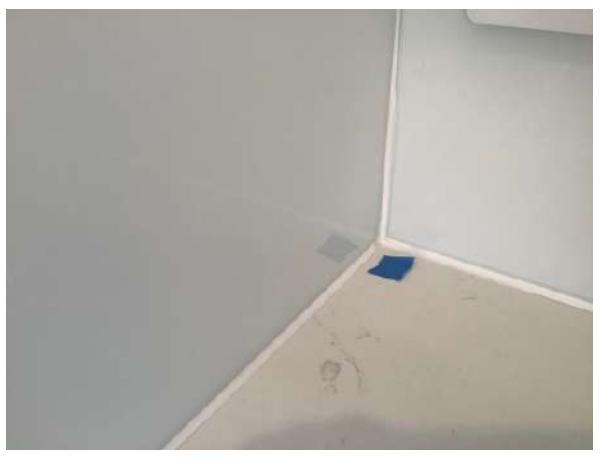
Defective Caulking To Cabinetry, Bench Tops, Tile Junctions, Cabinetry/Plaster Junctions, Etc.

It was noted on inspection that sealant is missing, inadequate and/or not completed to a tradesmens like finish.

10.09 Sealing around benches and items installed in benches Where required, junctions between bench tops and adjoining surfaces are defective if they are not sealed with a suitable flexible sealant of matching or agreed colour. Seals around items such as sinks, hand basins or the like are defective if the joint leaks or they are not installed in accordance with the manufacturer's installation requirements.

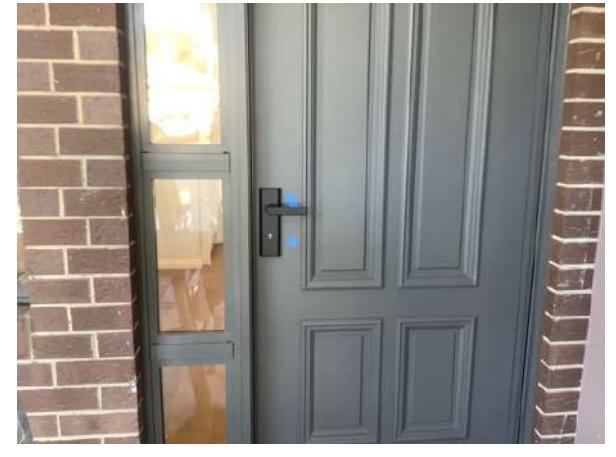
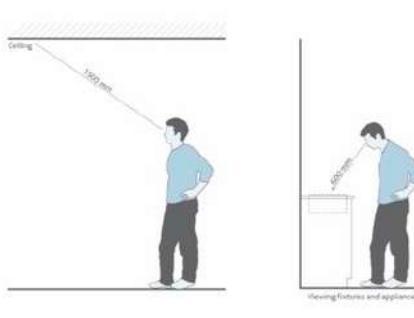
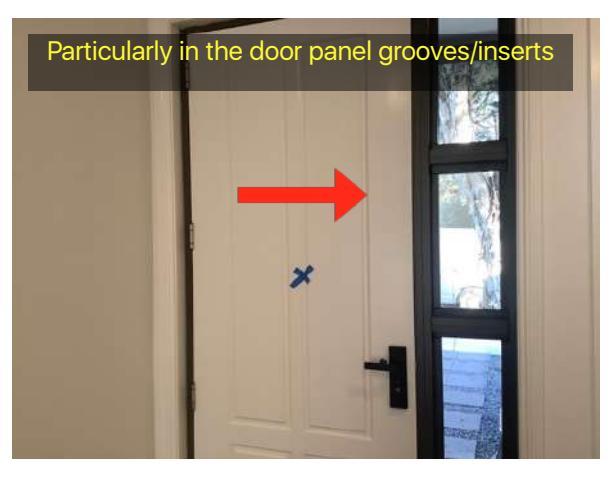
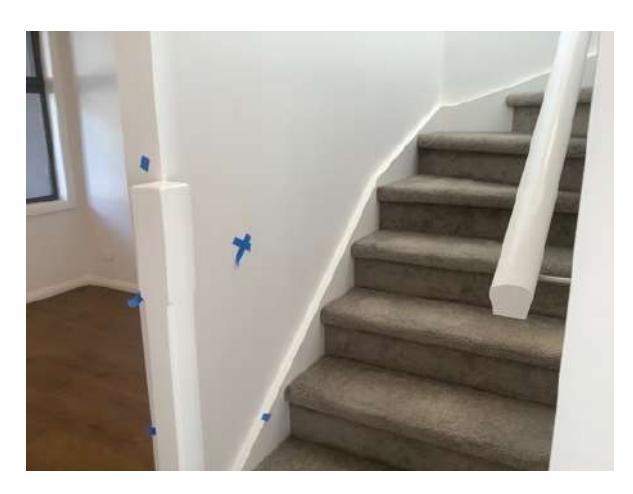
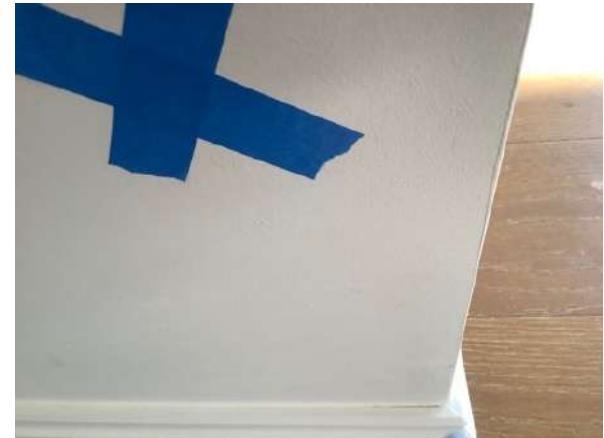
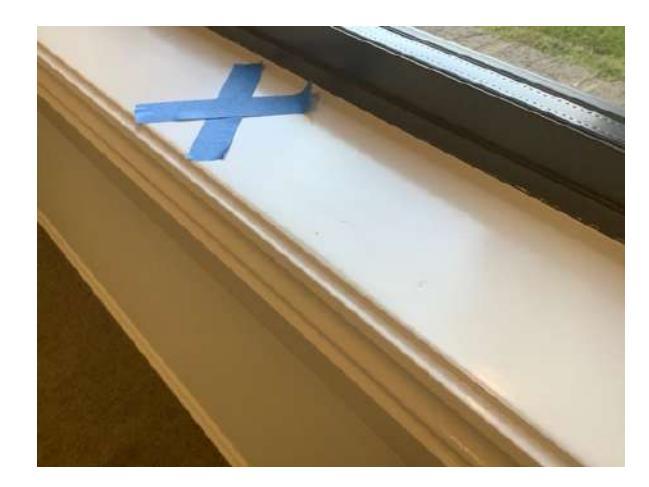
Painting - Defective (AS2311)

Areas were identified where the surface finish of the painting was found to be defective. This includes areas of minor blemishes, missing painting, over-painting, paint runs, sags, paint chips, scratches and general paint imperfections.

Paintwork is defective if the application has blemishes such as paint runs, paint sags, wrinkling, dust, bare or starved painted areas, colour variations, surface cracks, irregular and coarse brush marks, sanding marks, blistering, non-uniformity of gloss level and other irregularities in the surface that are visible from a normal viewing position. Paintwork is defective if the application results in excessive over-painting of fittings, trims, skirtings, architraves, glazing and other finished edges.

It is up to the builder and painter to inspect and repair the paint work to ALL AREAS, TO ALL ROOMS methodically and carefully, to the plaster, timber doors, timber skirting and architraves, but limited to, so that the finishes are consistent throughout.

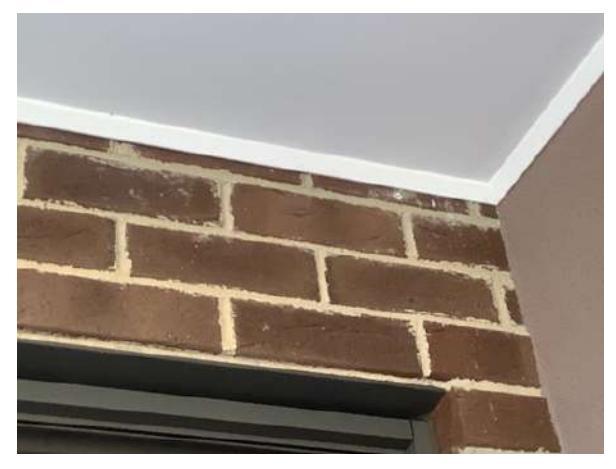
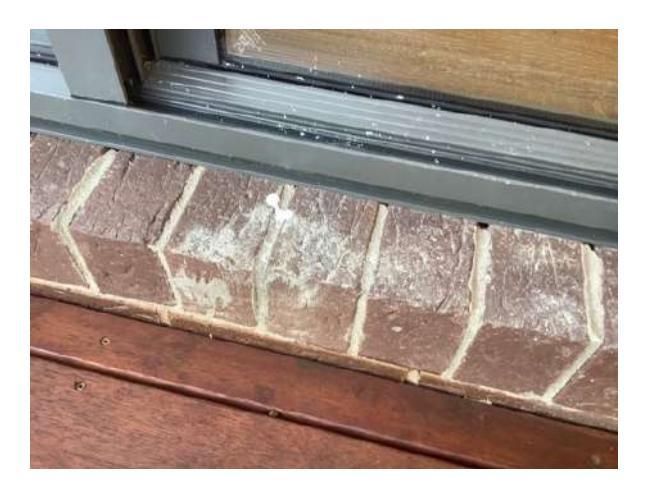
IMPORTANT *C*ONLY SAMPLE PHOTO'S of the Brick Excessive mortar defects. All AREAS to the entire property MUST be checked and repaired.

It was observed at the time of inspection that several bricks in this area of brickwork require cleaning to remove excessive mortar. While not likely to cause secondary defects, excessive mortar detracts from the overall appearance of the area and should therefore be removed.

The Building Commission's Guide to Standards and Tolerances clause 3.07, MasonryFacing states that:- 'Masonry faces are defective if they are not cleaned and free of excess mortar' and clause 3.11, Cleaning, Mortar Smears & Stains states that:- 'Stains, mortar smears and damage caused by cleaning are defects if they are visible from a normal viewing positioning.' The faces and edges of the bricks within the wall around this home will have to be properly recleaned to remove all traces of the mortar residue from across them.

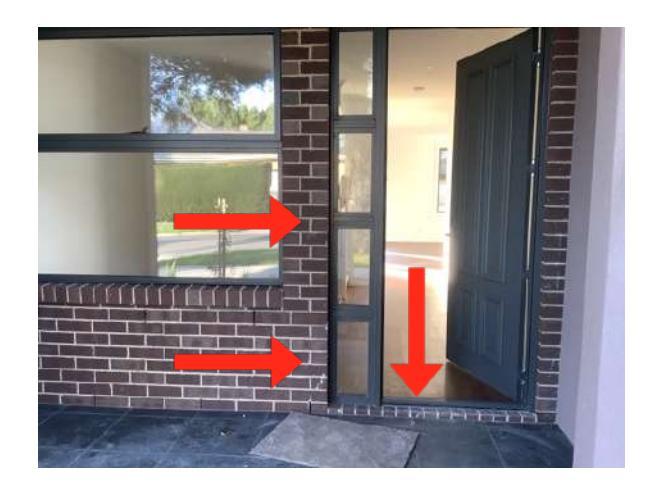
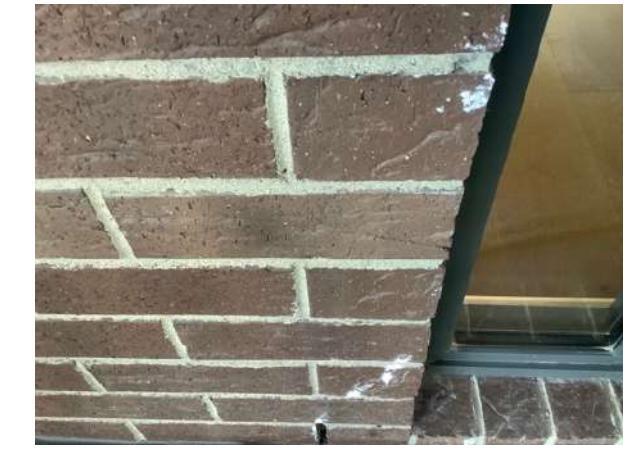
### Non Compliant 2.18

Render marked - defective

Marks caused by paint, etc due to the composition of the materials and / or any other blemish or damage which is obvious from a normal viewing position is considered a defect with reference to Standards and Tolerances.

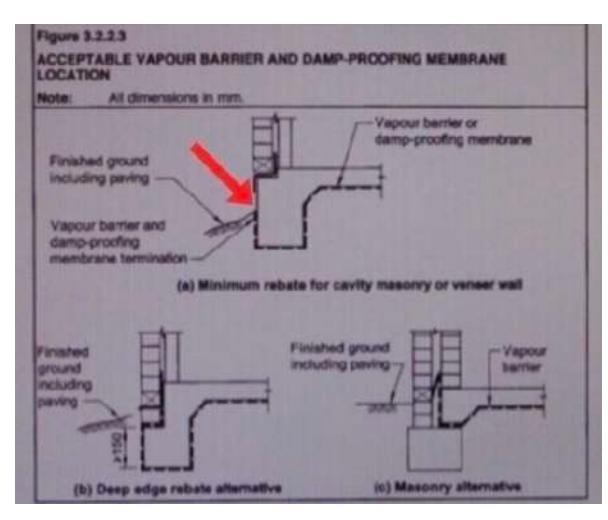
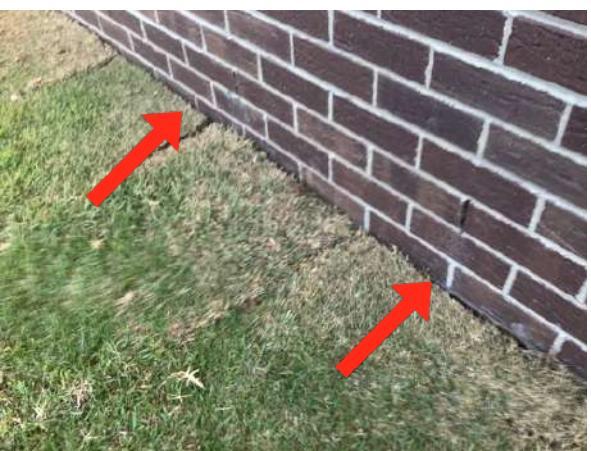
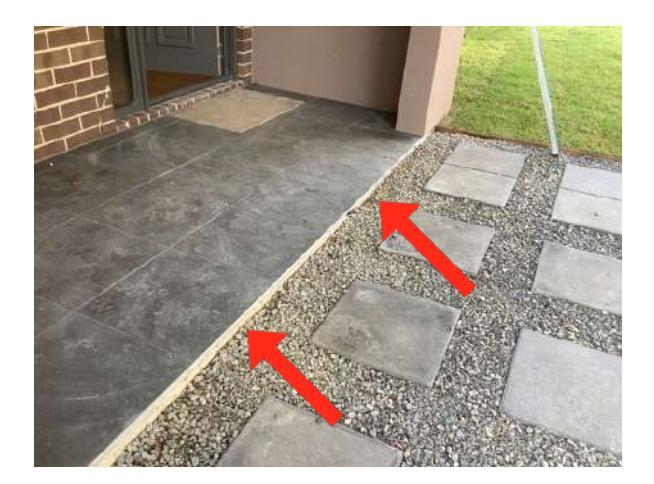
Drainage - Exterior

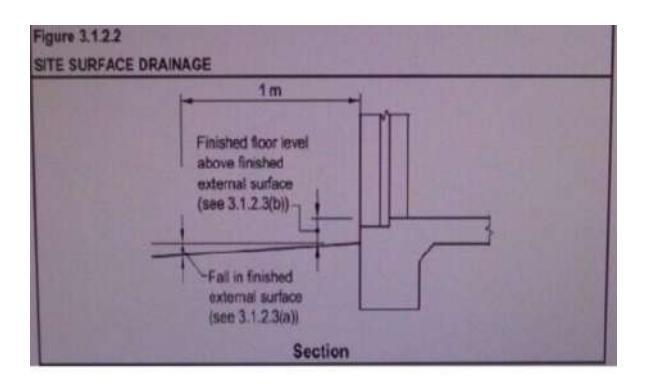
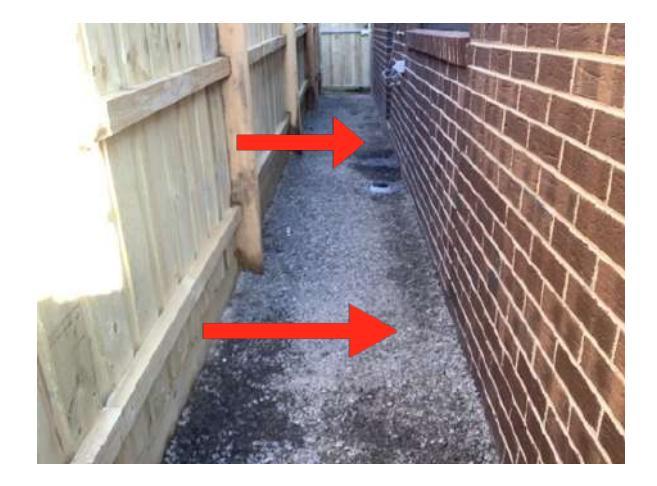
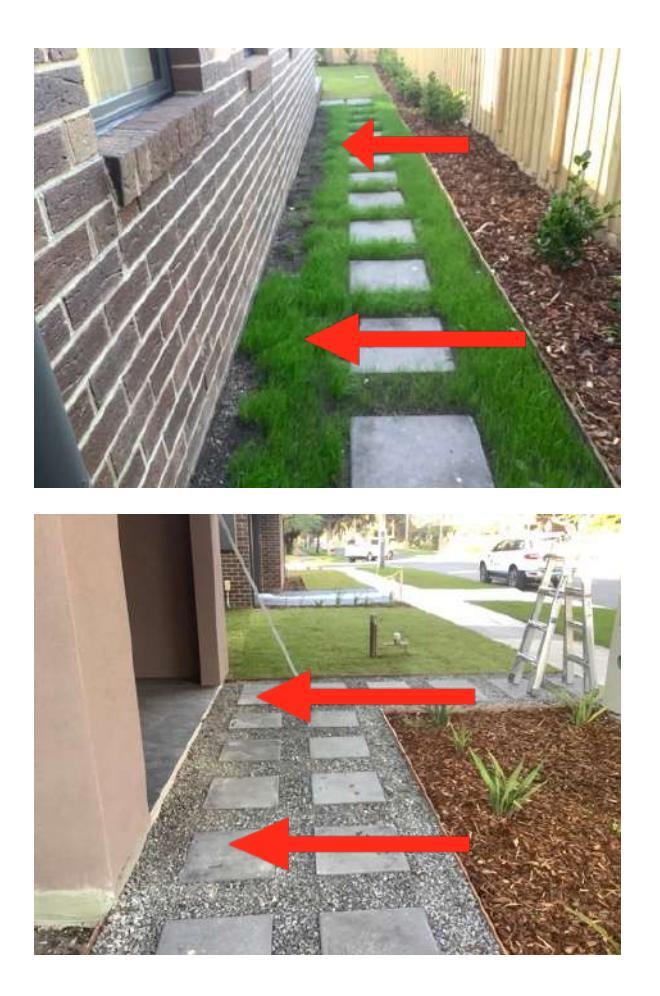
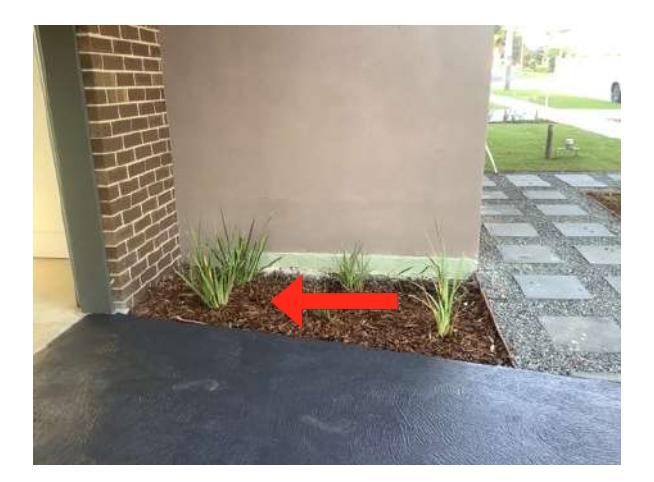
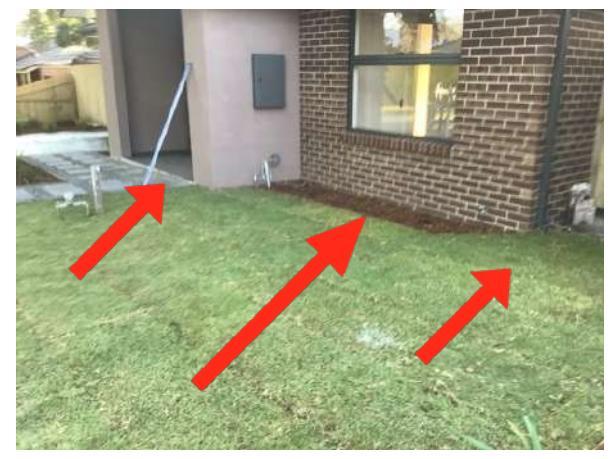
Location:	Drainage - Exterior
-----------	---------------------

♦ IMPORTANT INFORMATION - The soil levels around several footings need to be adjusted to ensure that footings and foundations are protected from excessive moisture. It is critical that good site drainage is maintained at all times around the building. At no time should water be allowed to pond on the surface near or against the footings or flow towards the perimeter of the building. As a minimum these works should comply with Clauses 5.2.1 and 5.6.3 of AS 2870-2011. Generally, the surrounding ground surface must be permanently graded away from the footing and building works with a slope of at least 50 mm over the first 1.0 metre. All runoff water should be collected via a drain in the ground level and/or run away from the building, not allowing the run off water to remain near the building or neighbouring buildings as well. It is preferably that the grading is achieved by excavation rather than top soil type filling. If soil filling is to be used to grade the ground surface away, granular filling must be avoided and the area back filled with clean well compacted clay filling placed at the appropriate moisture content.
