## Lock Up Report

Inspection Date: 29 Jun 2021

Property Address: Niddrie Area

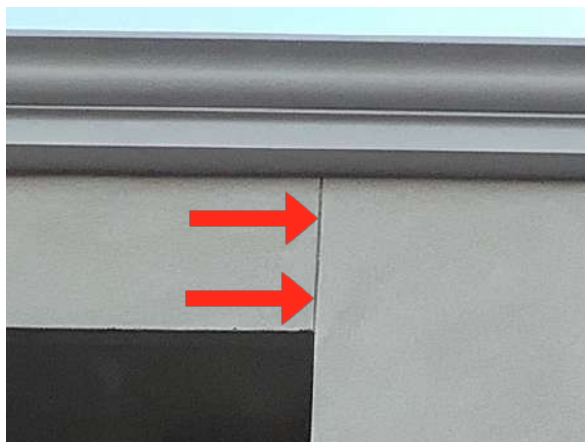
Finding: Articulation Joint - Render Covering Joint - Defective

-----  
-----  
It was observed that render or other similar applied finishes are covering articulation and control joints this is considered a defect with reference to Standards and Tolerances.

sealant that is UV rated.

NO paint or render is to go over the sealant to the articulation joints.

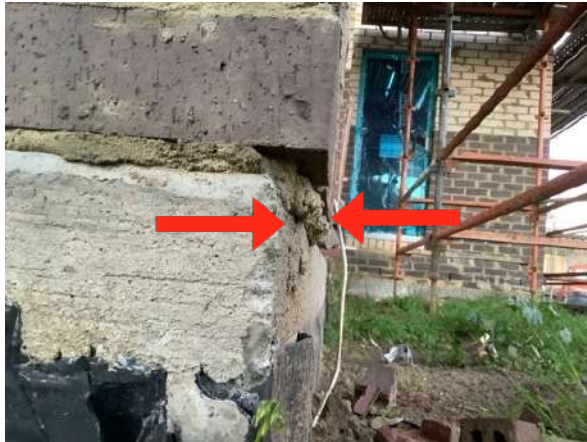
## Non Compliant 2.07

Finding: Brick Base bed joints (concealed) - defective

It was observed that the concealed base bed joint is defective. Concealed base bed joints in masonry walls are considered to be defective if they exceed 40mm in thickness which is the allowable Standards and Tolerances.

At the time of the inspection it was found that the brickwork is overhanging the slab by more than 15 mm.

Standards and Tolerances 2015 - Diagram 4.08 states that the maximum overhang of the brick work is 15 mm.

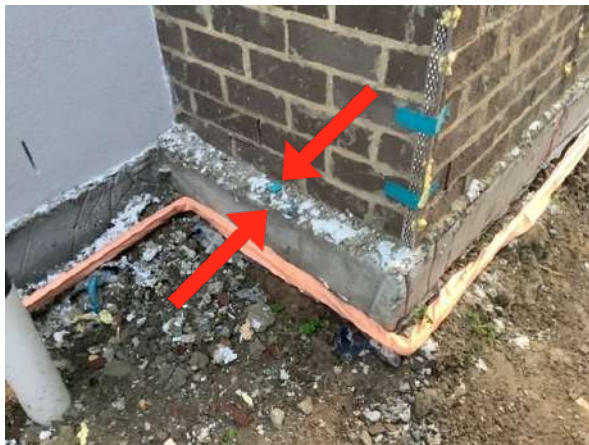
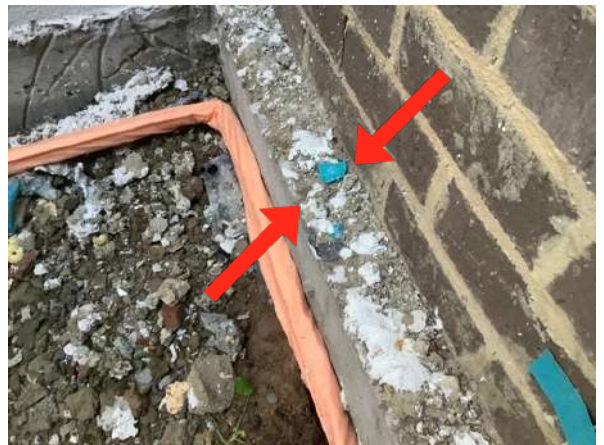
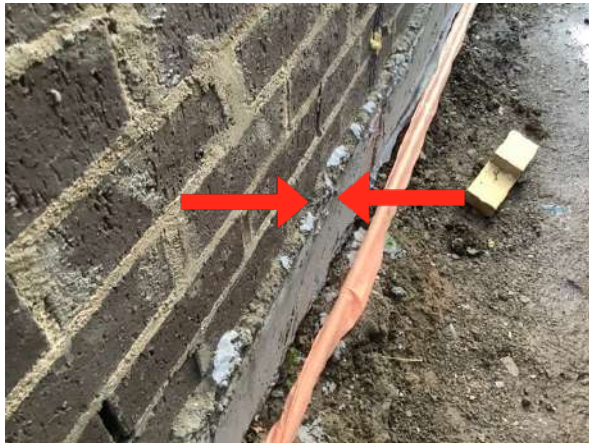
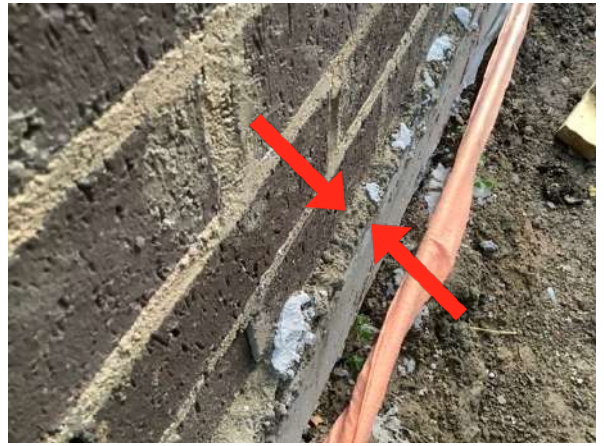
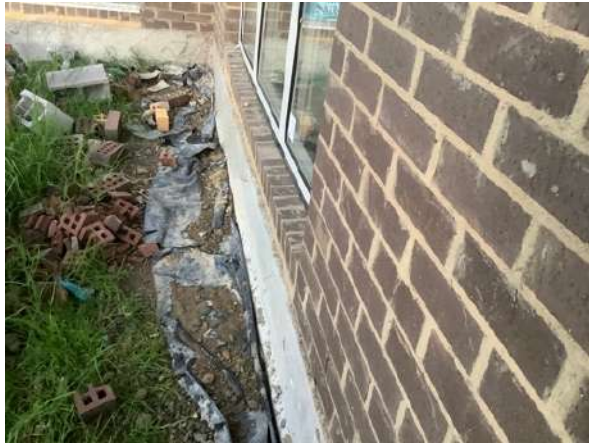
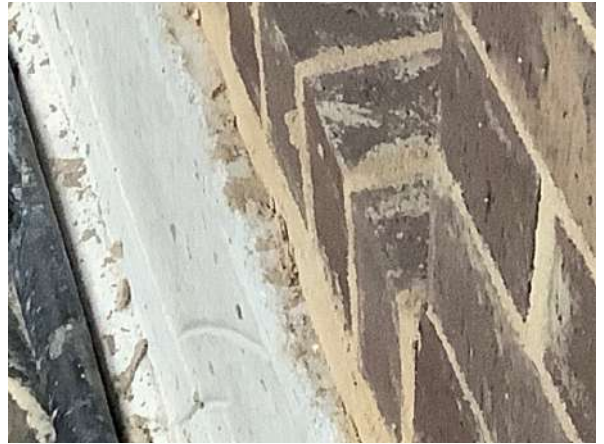
## Non Compliant 2.09

It was observed that there are MANY areas where the edge of the slab protrudes past the document finished dimension of the slab.

It is very important that if cutting the concrete slab back, which appears to be the method that will have to be taken, the vapour barrier will more than likely be damaged and compromised . The builder must repair all the vapour barrier if it gets compromised in any way. Once the builder cuts all the excessive slab around the perimeter of the building , The vapour barrier more than likely will get damaged. So in order for the vapour barrier to comply and provide the job that it is intended to do, I HIGHLY RECOMMEND that the builders dig the perimeter carefully,, sometimes the entire perimeter, pending of the severity of the vapour barrier (plastic) damage, pending on slab over pour, pending on excessive builders concrete (debris). It is important to dig along the slab perimeter without damaging the plastic and to extend the vapour barrier plastic higher than the slab rebate as would have been in the post slab report if we performed one.

- 1/ All over laps are to be taped as described below.
- 2/ All the rips and/or damaged area needs to be taped.
- 3/ All areas of vapour barrier are to be up to the future ground and/or finished paving or concrete heights and must be extended with 200mm overlay and taped.

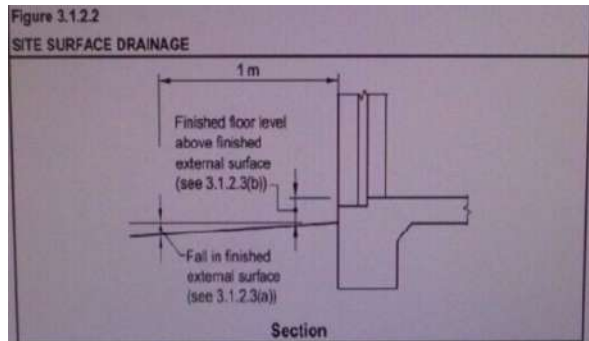
Whilst I am unaware of the level of works that will be performed prior to handover in relation to drainage, I would like to bring to your attention the slab height is low in relation to the existing land levels and high ground levels is potentially a VERY HIGH RISK CONCERN to a concrete slab and it is absolutely imperative that on completion of the home, the client be very aware of who is responsible for the drainage around the entire perimeter of the concrete slab, is it the builder ? if the builder has provided the garden or perimeter concrete or is it the client ? It is also important to note that just a concrete perimeter of approximately 1 m around the slab even if the concrete has the correct falls is not always enough drainage to protect a concrete slab gaining excessive moisture and/or water ingress.

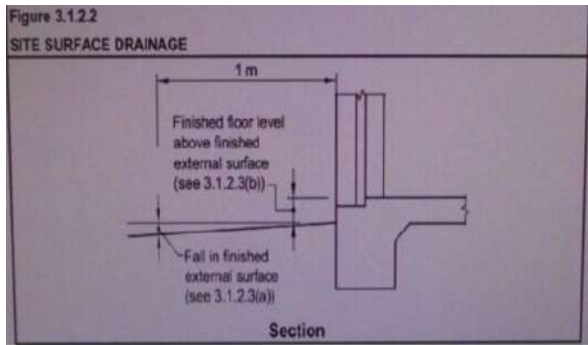
## Non Compliant 2.14

The drainage has been of great concern from the very start pre-slab inspection on this job and I have made it very clear from day one. It does appear that there is excessive water pooling around the property and this is of great concern, because with excessive water over a long period of time, creates the soil to contract which can very much compromise the structural integrity of the concrete slab and brickwork. Drainage should've been determined by now. Regardless of who is going to be handling the drainage, it is the builders responsibility through the build process to not allow such excessive water pooling.

The builder in normal circumstances has this all explained in the contractual agreements between the builder and the client. This is absolutely a very important item that must be addressed as concrete slab sinking, concrete slab heaving is a very common problem that the client and builder dispute in time, when a home shows movement in the brickwork, the frame, the plaster work and other building materials, so prevention is absolutely imperative and for both parties to know who is responsible in the end for correct drainage to entire perimeter of the building.
