Post-Concrete Pour Slab Report

Inspection Date: 9 Jul 2021

Property Address: Niddrie area

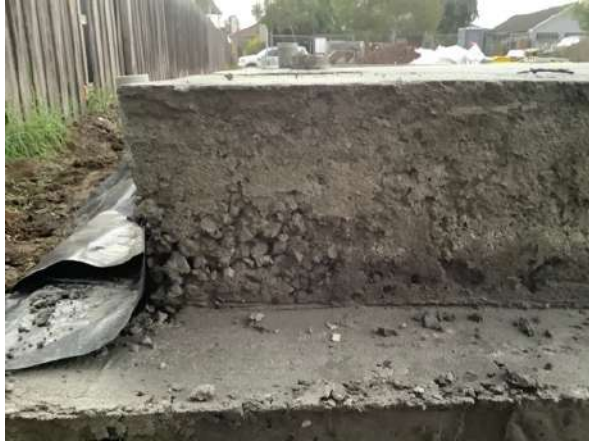
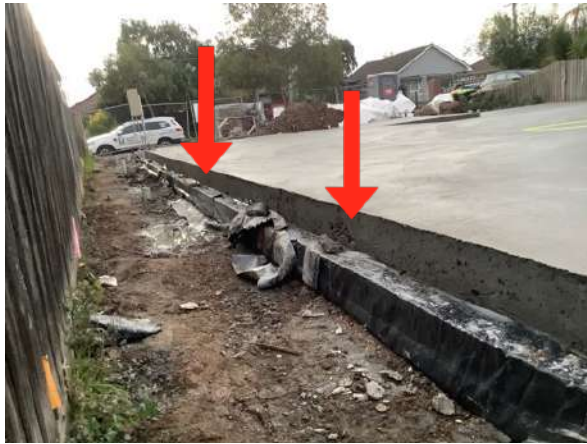
Non Compliant 2.02

Location: All Areas

The vapour barrier system has NOT been completed and installed in accordance with AS2870 and BCA Part 3.2.2.6. ALL areas of non compliance are required to be repaired.

-/ Seek engineering process and design for rectification of this defect.

-/ Have the site surveyor witness the repair of the slab to ensure that the builder has carried out the works in accordance with the process's and rectification statements in the engineering documentation.

-/ Satisfy the defect has not been hidden by placing soil over the edge beam of the over poured slab.

I HIGHLY RECOMMEND WITHOUT ANY COMPROMISE, THAT THE BUILDER RECTIFY THE DEFECTIVE CONCRETE SLAB PERIMETER WITHOUT COVERING WITH SOIL , CRUSH ROCK, BRICK LAYERS MORTAR DEBRI OR ANYTHING ELSE.

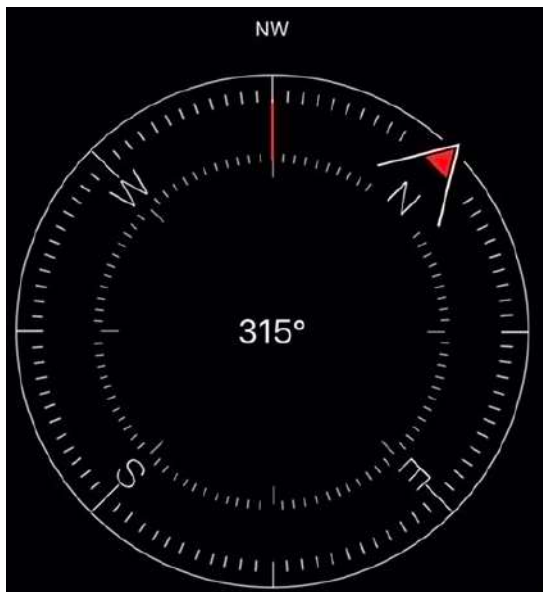
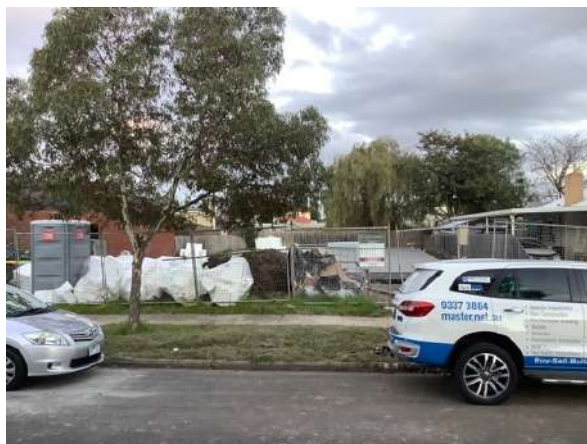
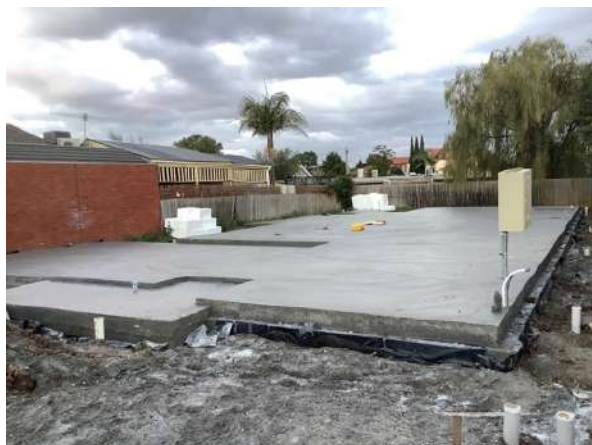
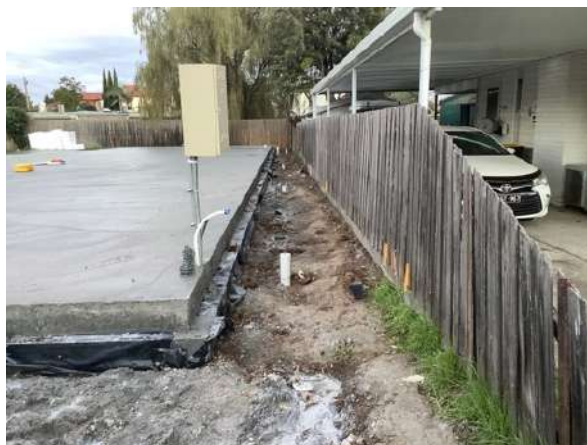
Location: General Site Photos.

Finding: Site Photos
General site photos are provided for your general reference.
