# Pre-Paint (Plaster & Waterproofing ) Report

Inspection Date: 9 Jul 2021

Property Address: North Melbourne area

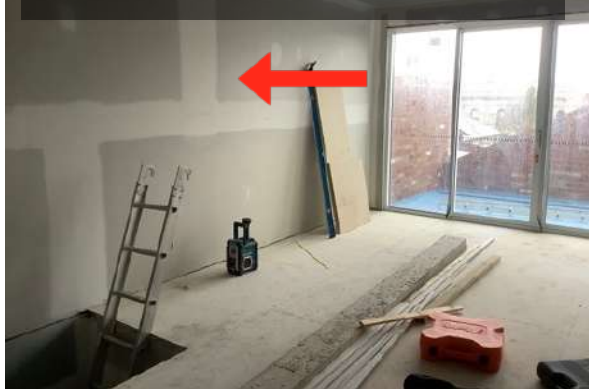
TV area, out by 12 mm over 1.8 m, vertically

Nº 2  
OUT VERTICALLY  
BY 12 mm  
TV AREA

A registered builder should be appointed to assess the defect and perform rectification works as necessary.

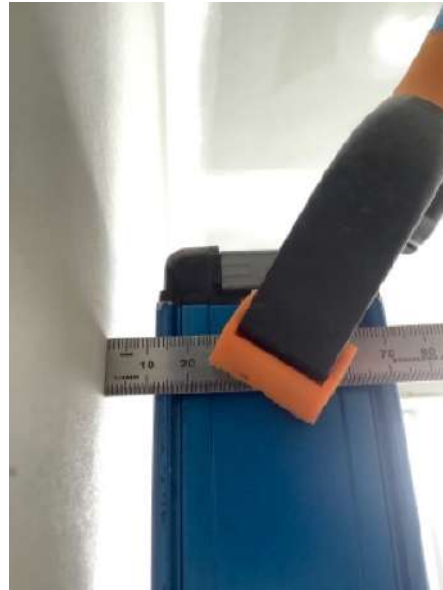
Upstairs hallway, out vertically by 10 mm over 1.8 m

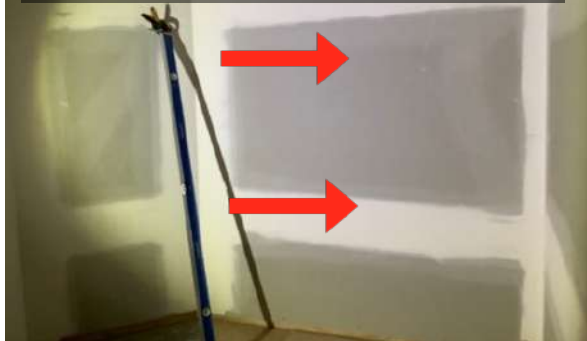
Upstairs middle bedroom on the east wall. The wall is out 12 mm over 1.8 m

N<sup>o</sup> 4  
OUT VERTICALLY  
BY 12mm  
UPSTAIRS MIDDLE S/ROOM  
EAST WALL

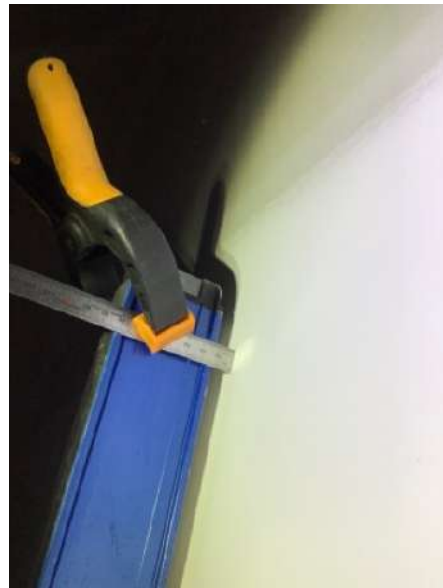
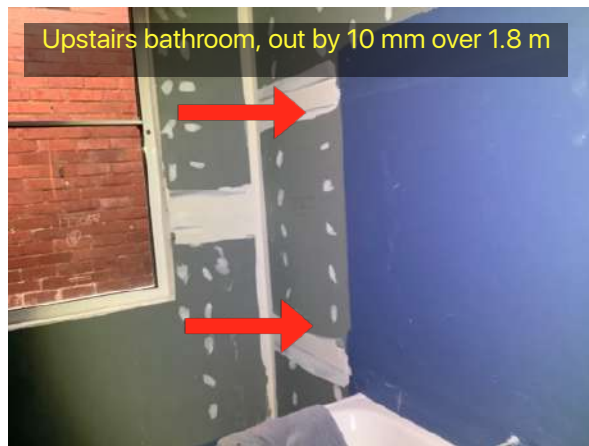
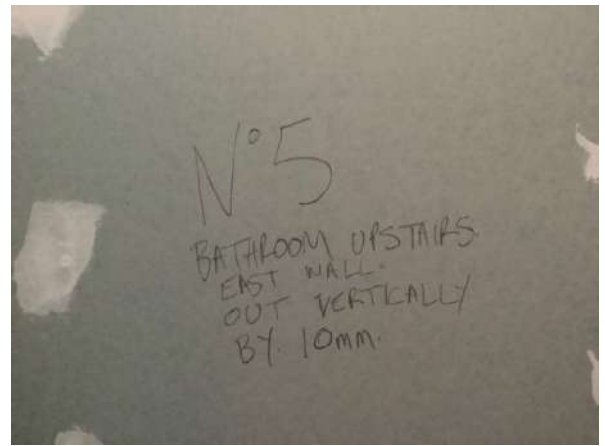
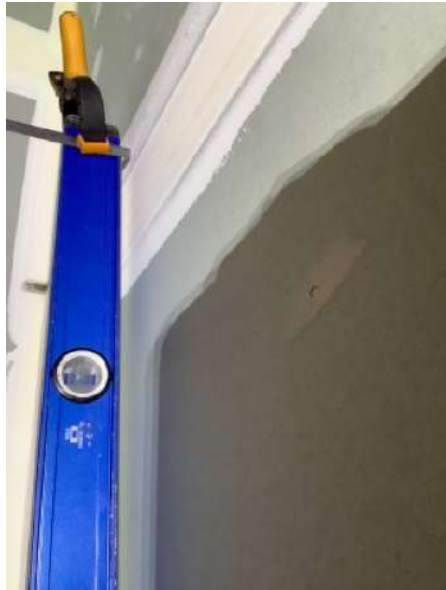
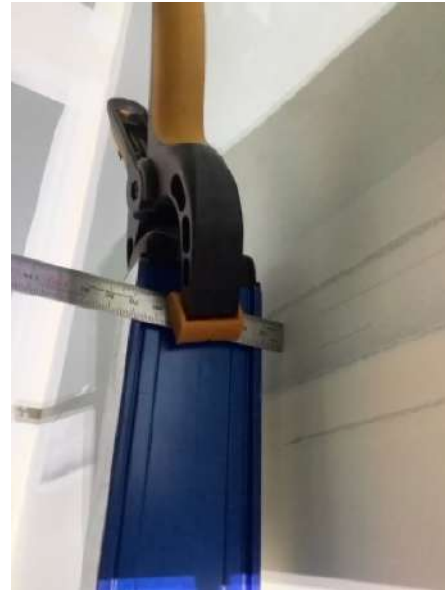
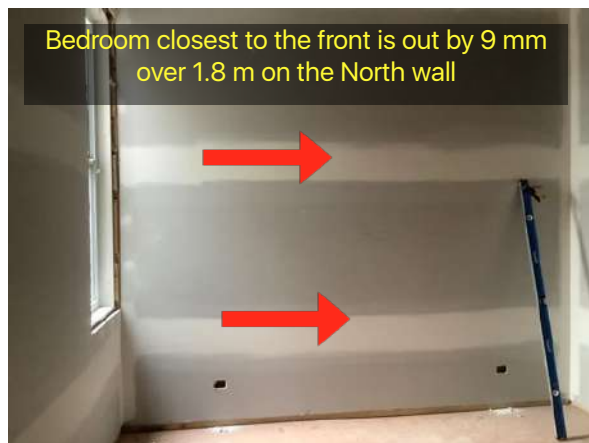
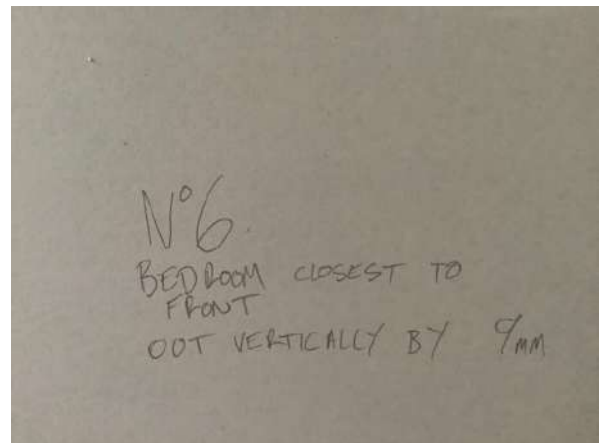
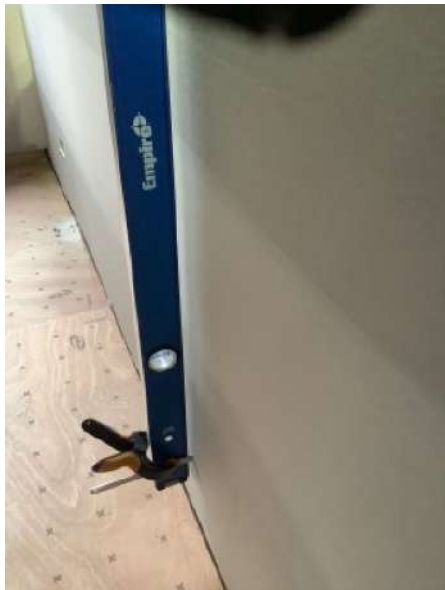
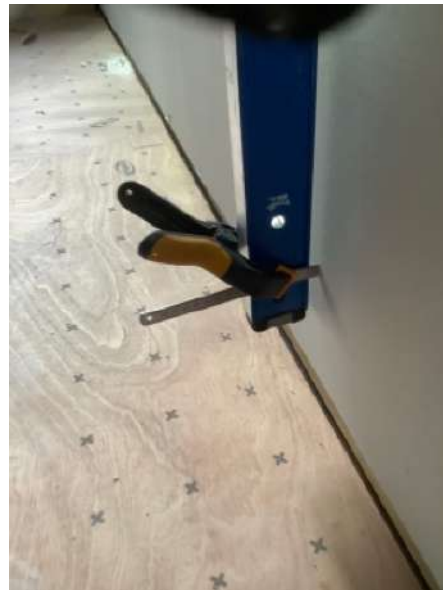
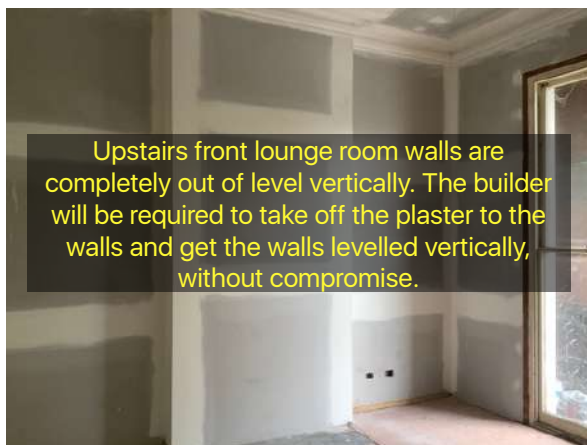
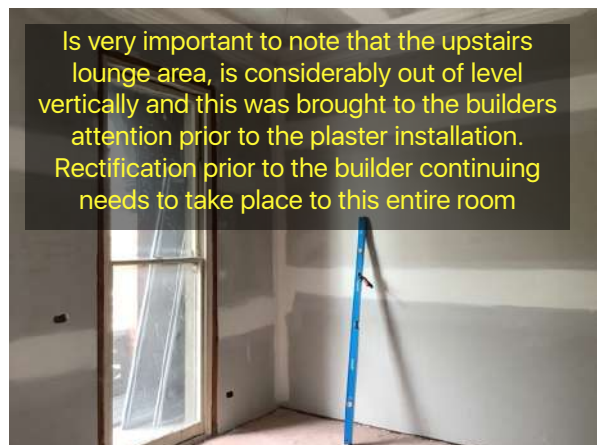
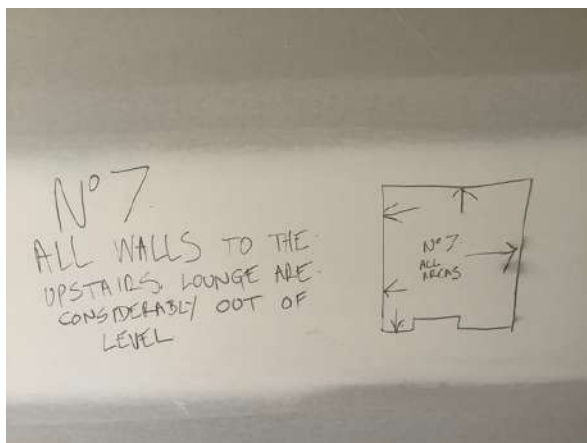
A deviation ( large bow ) exceeding 4mm measured across a 2 mtr straight edge was identified in all the areas as per the photos attached & any gaps larger then 4mm is considered a defect and requires considerable re-working of the plaster and possible timber framing ( pending on how out of tolerance the frame is ) in all the areas to rectify the defects.

It is observed that plaster walls / frames are defective as there is a deviation from a vertical or straight plumb line in any direction which exceeds 4mm within any 2m of height / length. This is a technical defect and may result in subsequent structural defects if left unmanaged.

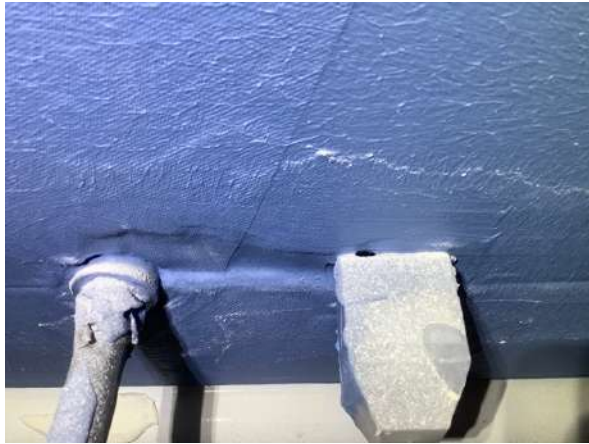
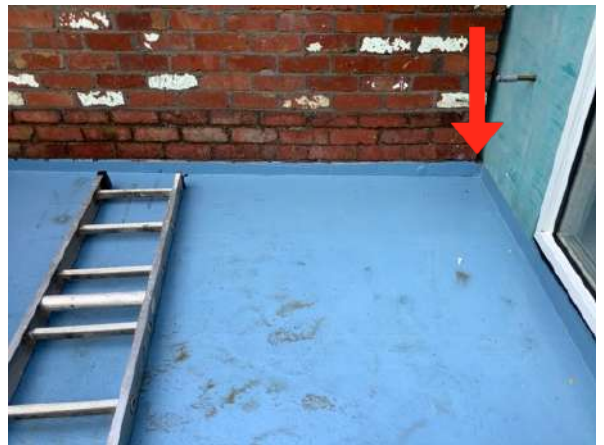
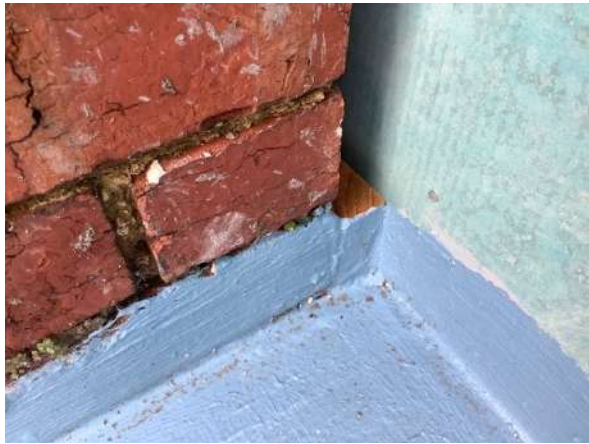
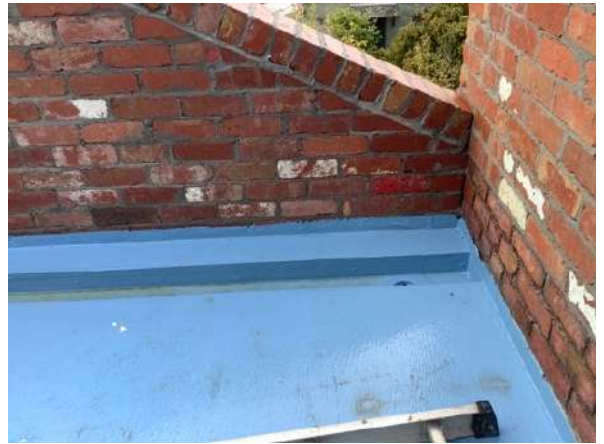
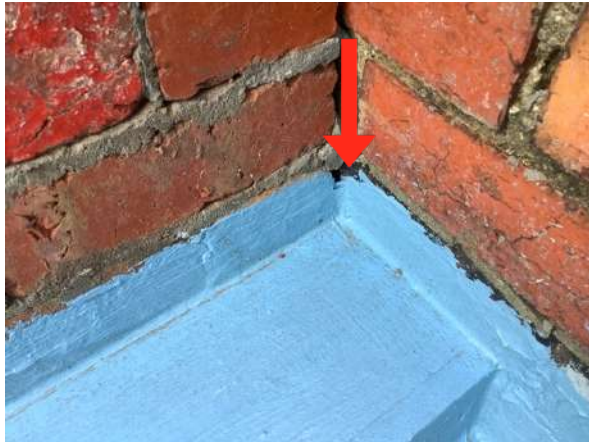
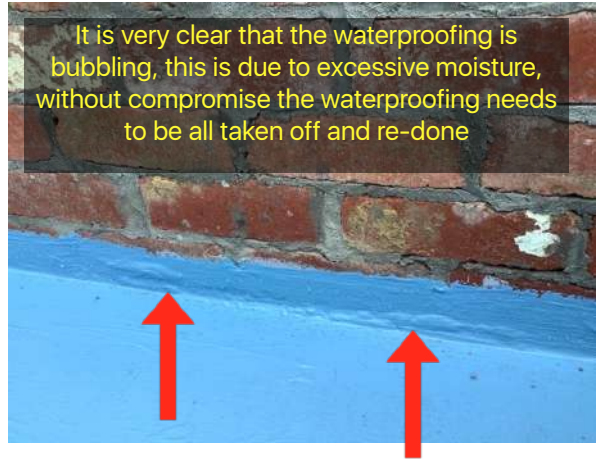
Finding: Water Proofing - Inadequate / Defective - Non Compliant

The photos are examples of the non-compliant and defective works. It is very difficult to inspect some areas of the waterproofing due to the lack of care to the waterproofing.

It is highly advised that adequate waterproofing materials be installed to all wet areas to comply with Australian Standards and protect all areas against water damage.

All repairs must be completed prior to the installation of the tiling and/or any other products used .

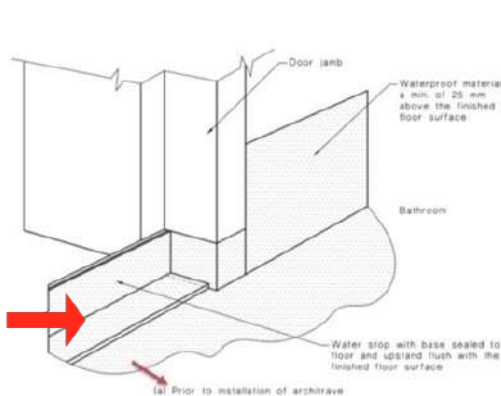
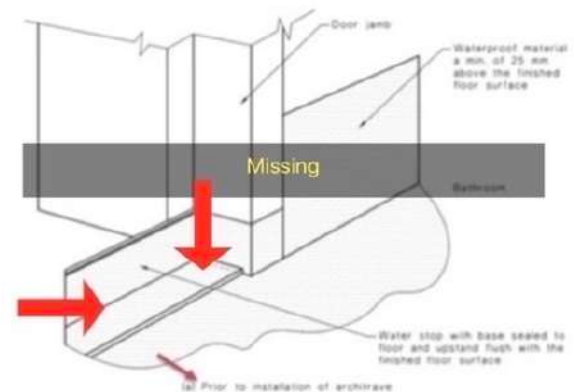
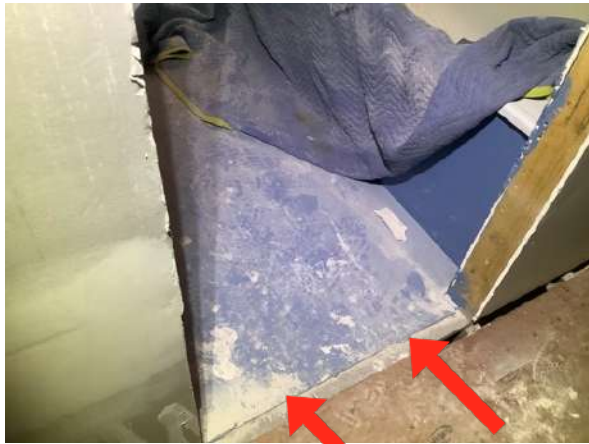
The builder may argue and suggest that the tiler will install the water stop at the time of tiling as it becomes a neater job, this is not an acceptable reason why the tiler needs to install the water stop. If the tiler measures the tiles before cutting and starting he will get actual accurate tile measurements. The builder may also argue that the tiler will install the waterstop so that it doesn't get damaged, there are many areas of a home that get damaged during construction build and its up to the builder to educate the contractors or protect the waterstop or any other areas of the build construction home.

As stated above, the builder must install the water stop and complete the waterproofing, before the tiles are installed.

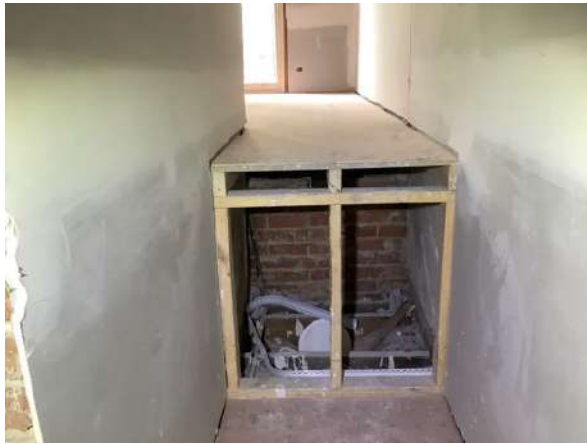
Location: Builders Debris  
Finding: Excessive Builders Debris

All areas should be cleaned from excessive builders debris regardless if the areas can be seen or not.

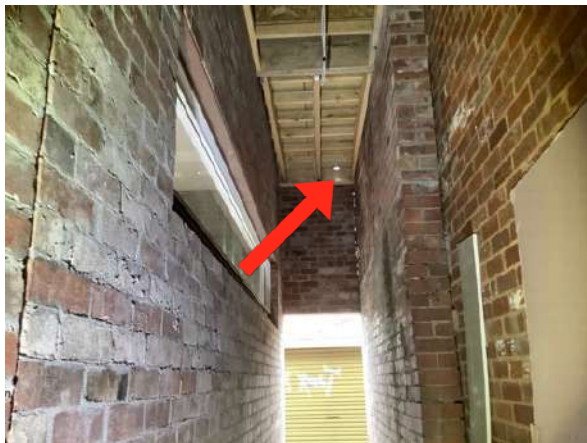
At the time of the inspection the drainage for the balcony was not complete, this would be part of the reason the plaster would not be installed as yet.

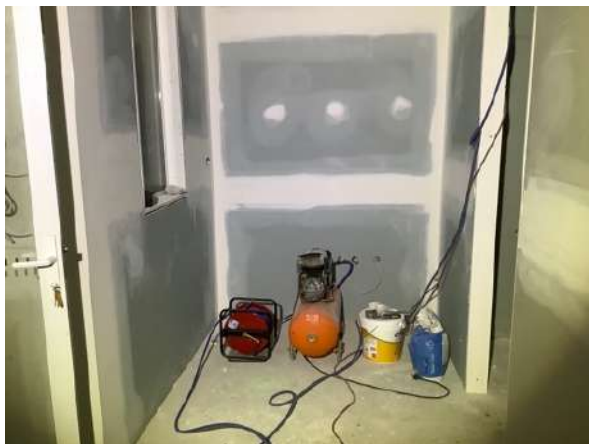
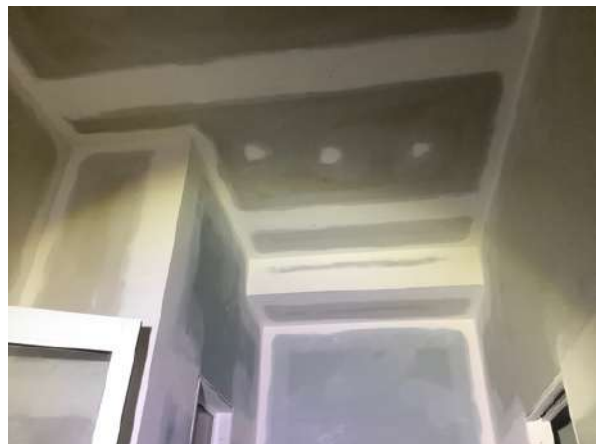
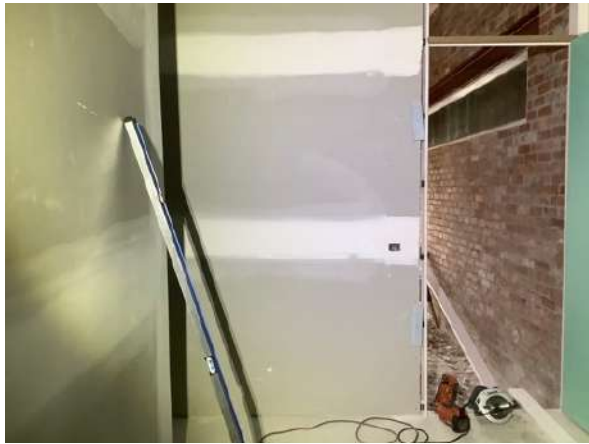
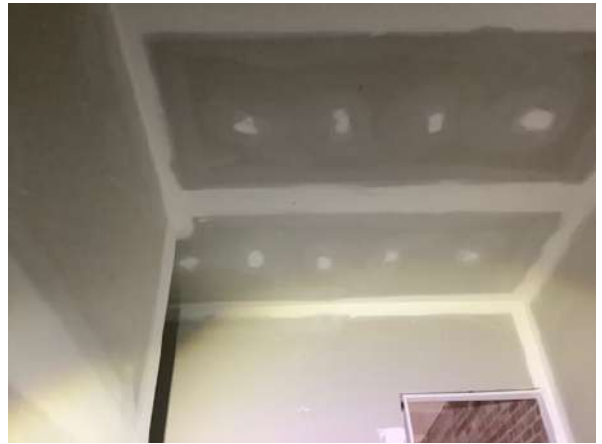
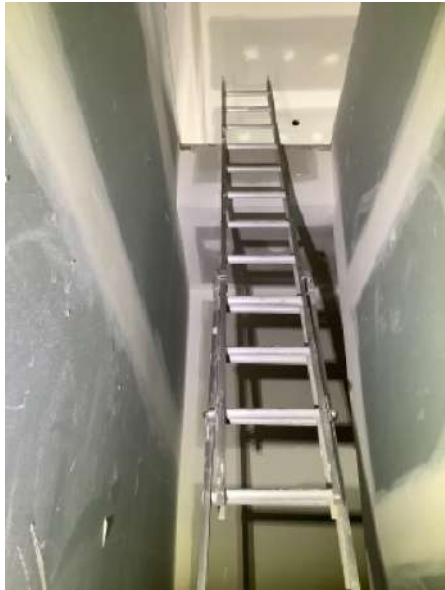
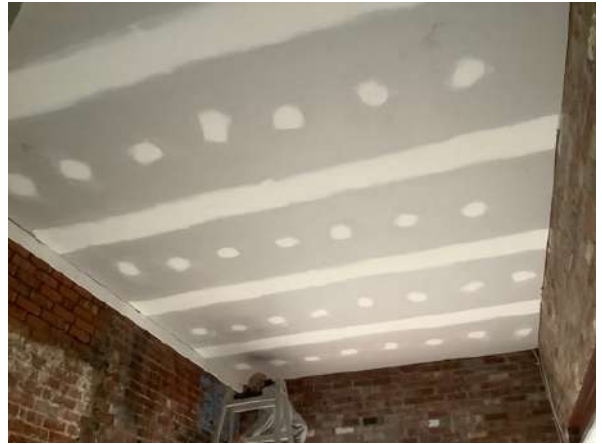
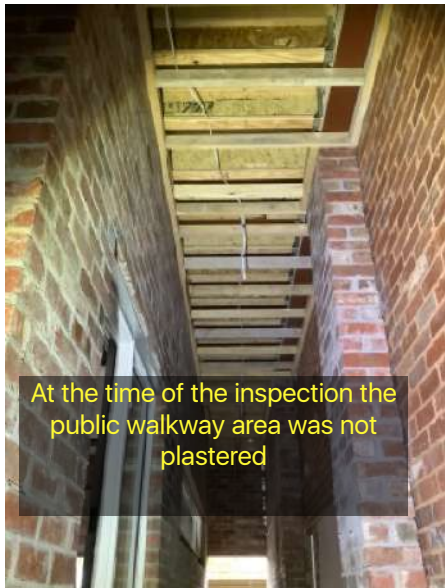
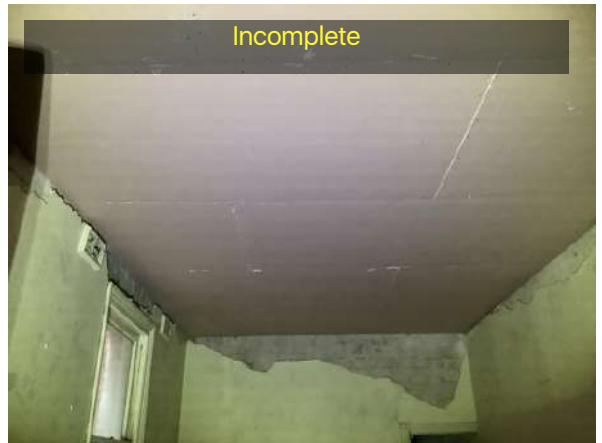
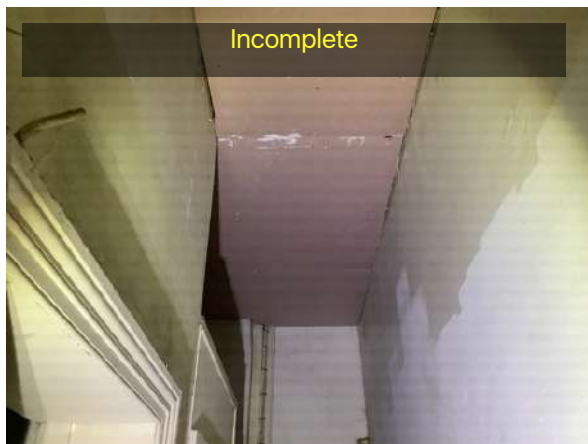
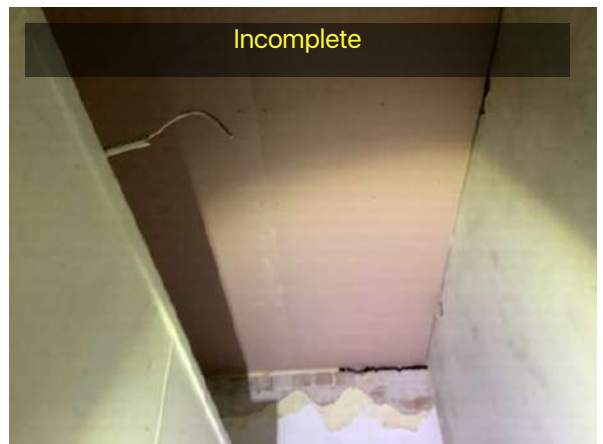
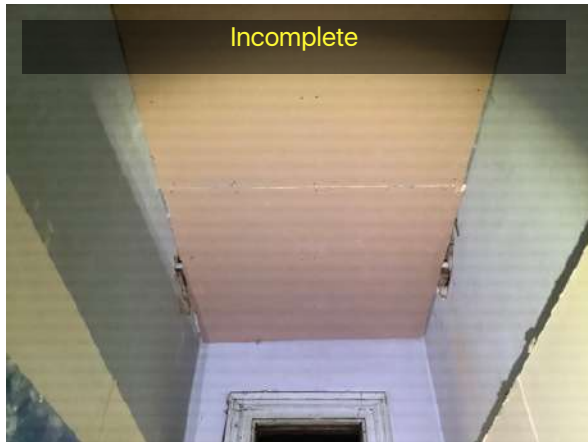
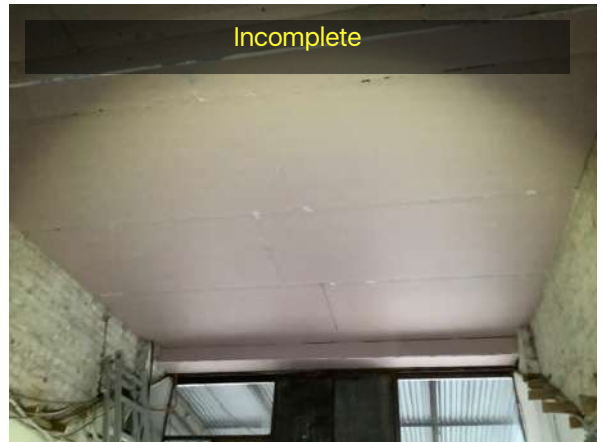
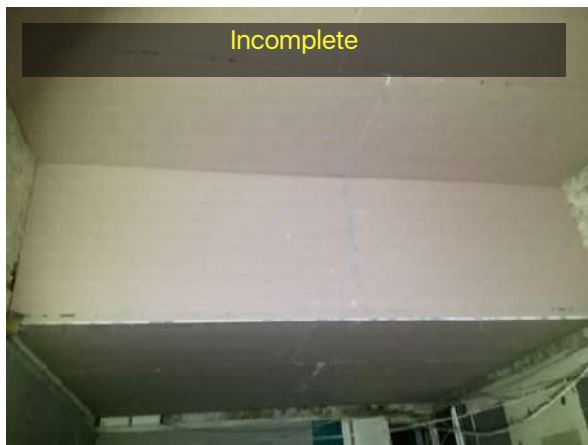
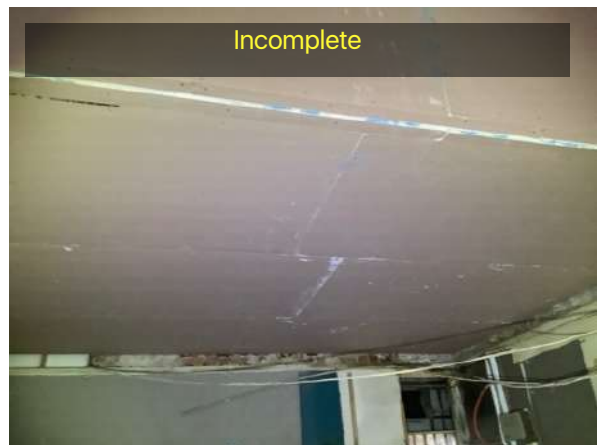
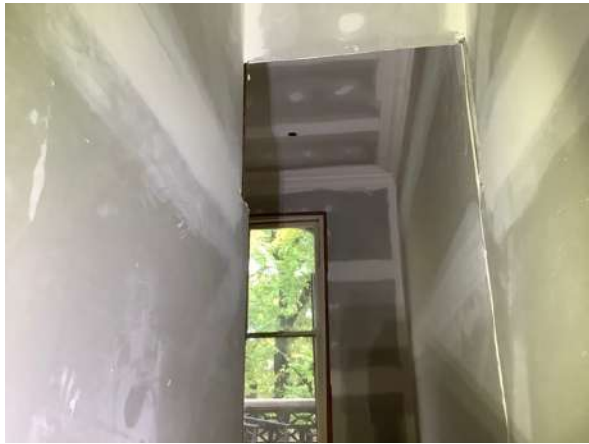
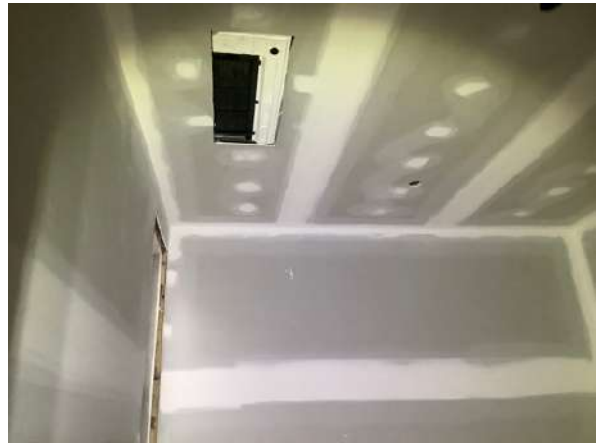
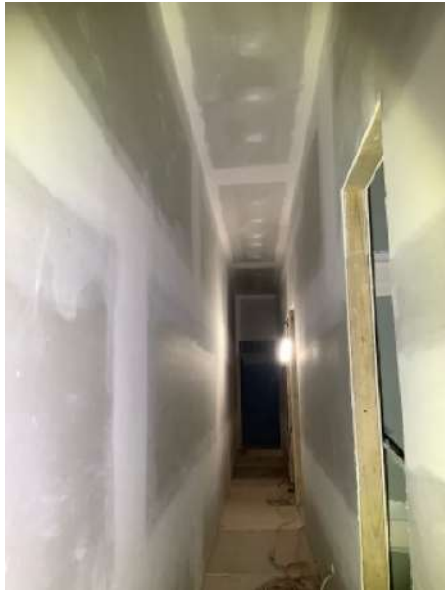
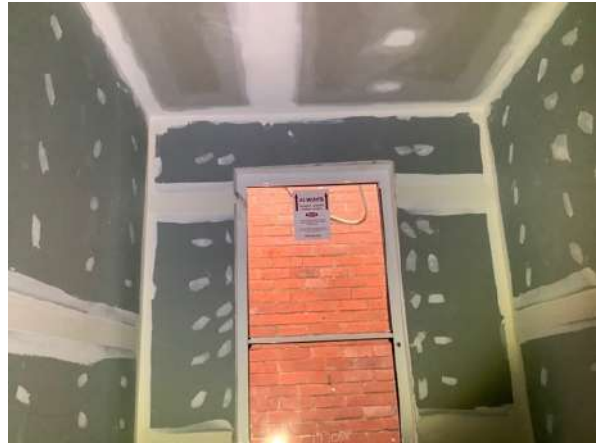
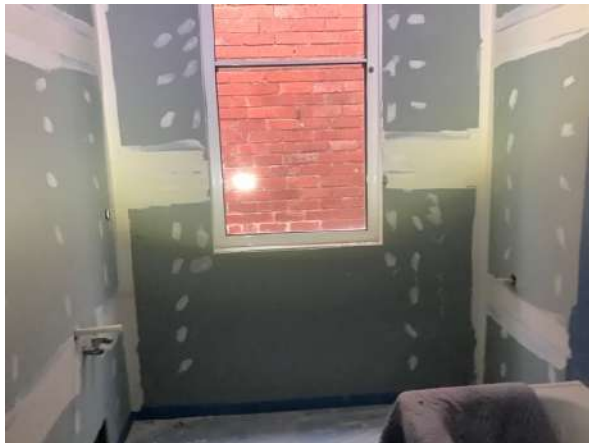
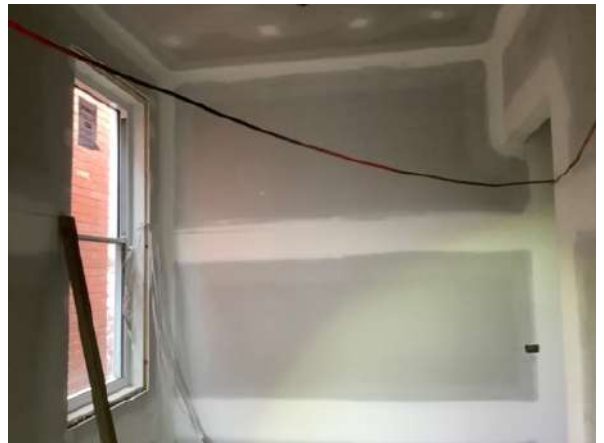
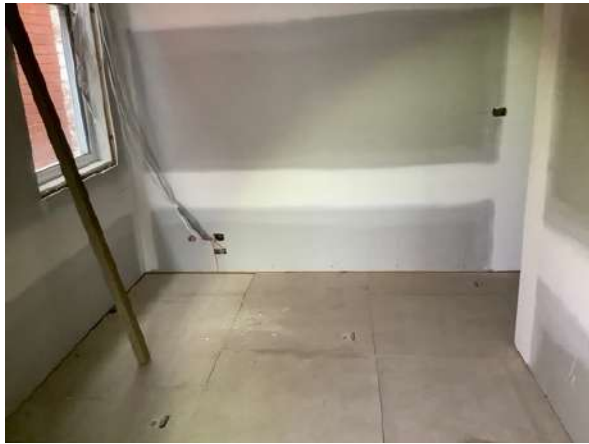
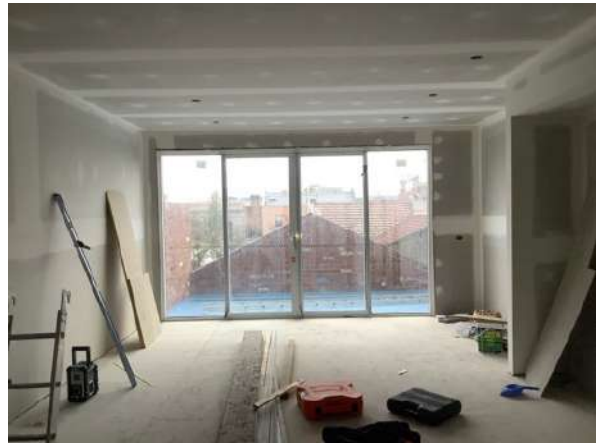
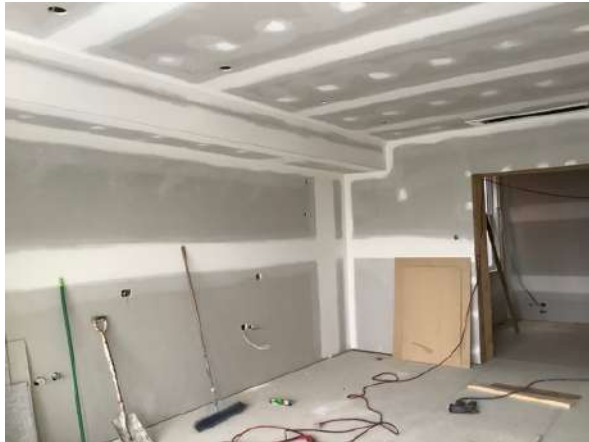
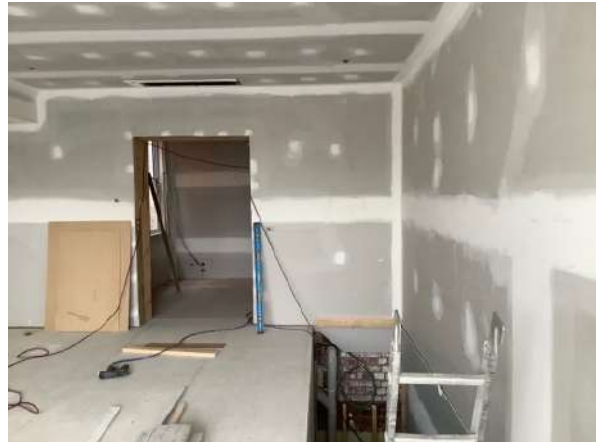
### For Your Information 5.03

Location: Internal Site Photos  
Finding: Plaster Site Photos - Internal Areas  
Additional Internal Plaster Site Photos - Provided for your general reference.

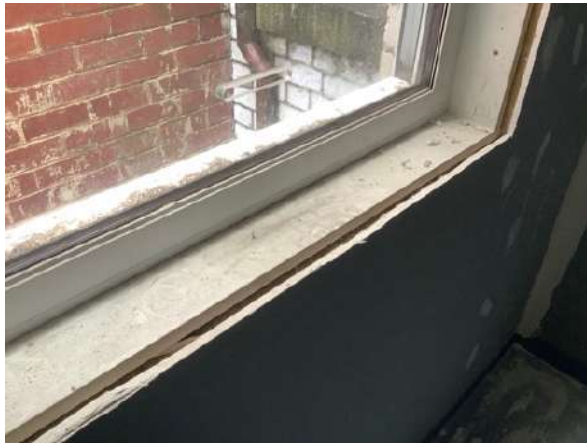
Location: Incomplete Areas  
 Finding: Areas Around Windows

It is important that the builder complete around the windows to a satisfactory level.
