Pre-Plaster Report

Inspection Date: 6 Jul 2021

Property Address: 3 Madel Avenue Strathmore, VIC, Australia

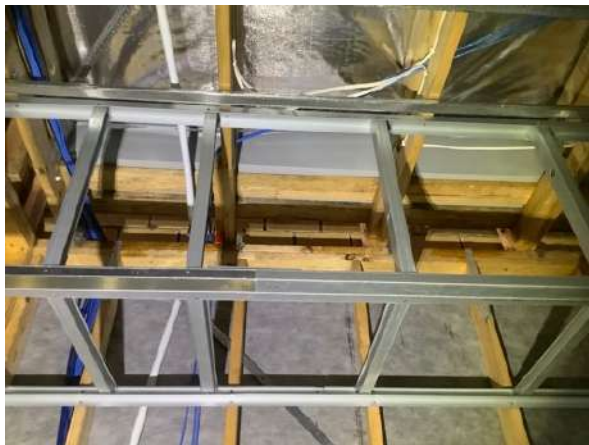
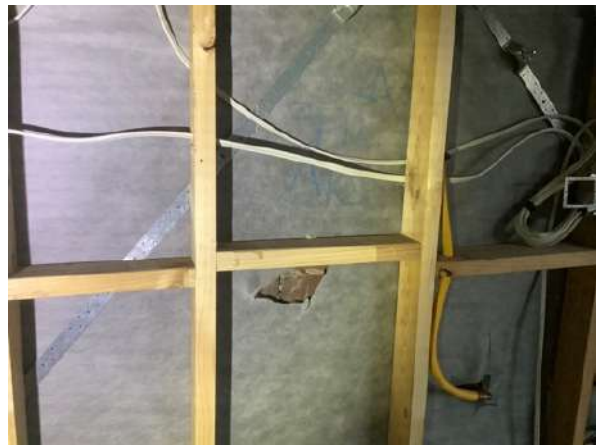
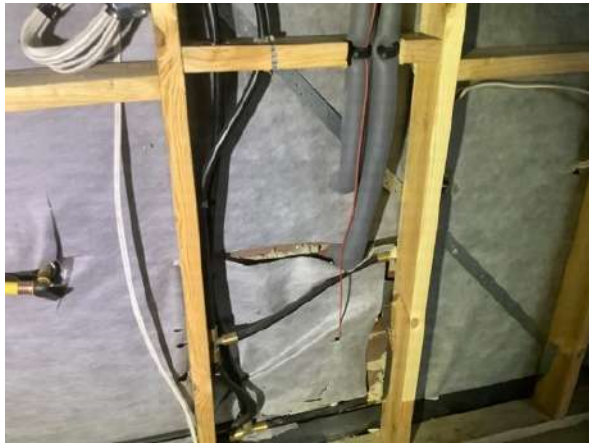
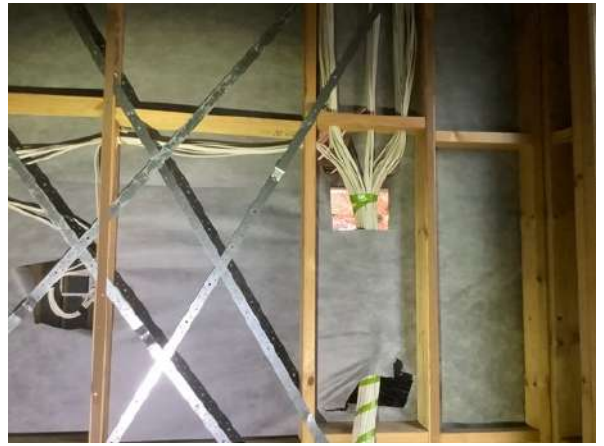
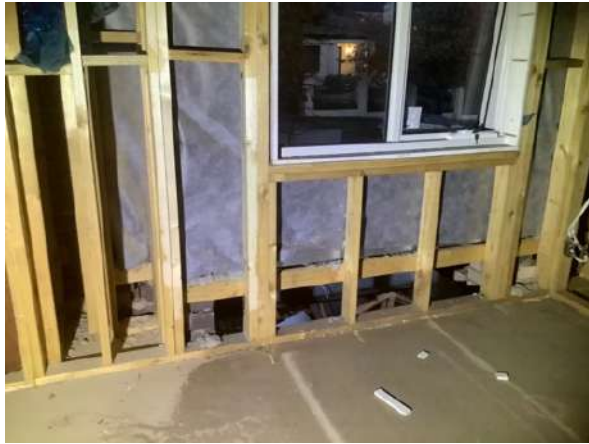
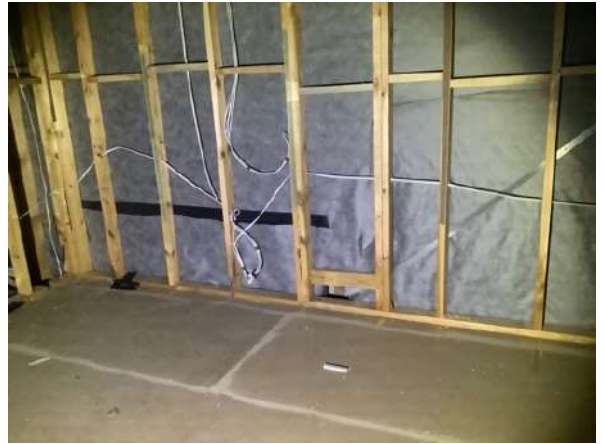
Finding: Sisalation - not installed correctly, deterioration and damage.

IMPORTANT 🖱️ ONLY SAMPLE PHOTO'S of this frame defect. All AREAS to the frame MUST be checked and repaired.

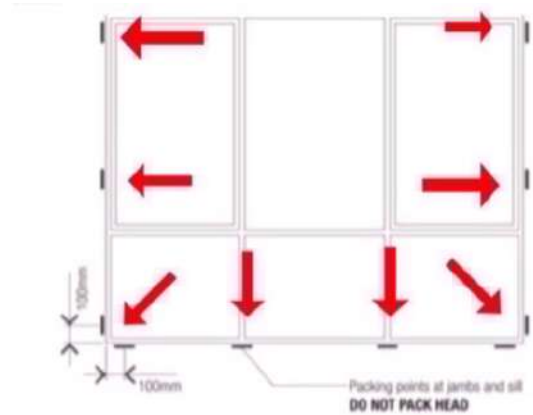
7.3 THERMAL AND STRUCTURAL MOVEMENT

7.3.1 General A gap shall be provided between the window and the surrounding structure sufficient to prevent loads being imposed on the window, allowing for thermal expansion of the window and for structural movement as described in Clauses 7.3.2 and 7.3.3.

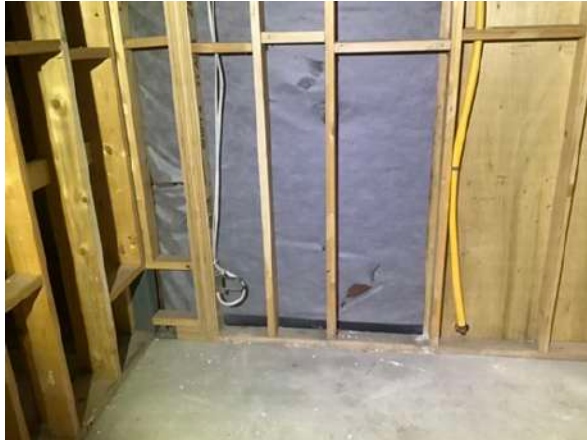
At the time of the pre-plaster inspection the insulation to the roof upstairs and the walls upstairs was not installed and in addition the insulation to downstairs all areas was not installed. In addition any other areas as required in the contract.

Normally for a pre-plaster inspection and report as mentioned above these items are normally 100% complete ready for the clients private building consultant to inspect as that is part of the pre-plaster report.

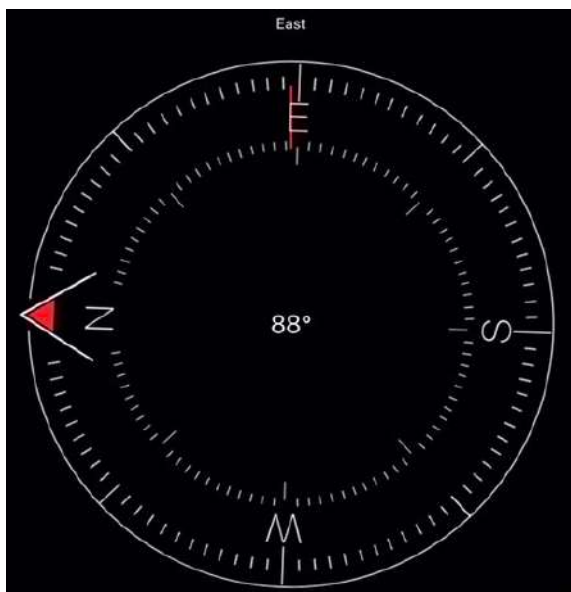
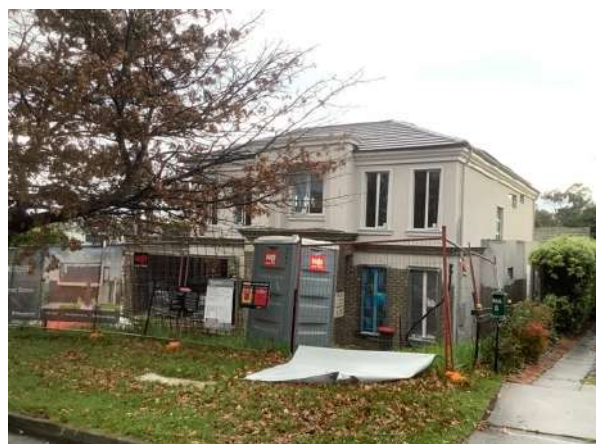
Finding: Site Photos

Additional photos are provided for your general reference.
