Property Condition Report

Inspection Date: 7 Jul 2021

Property Address: Glenroy Area

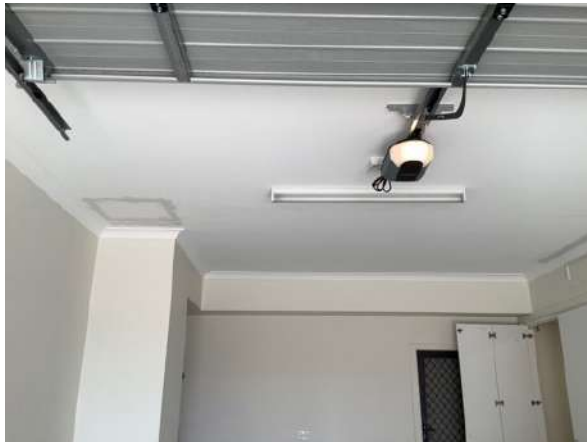
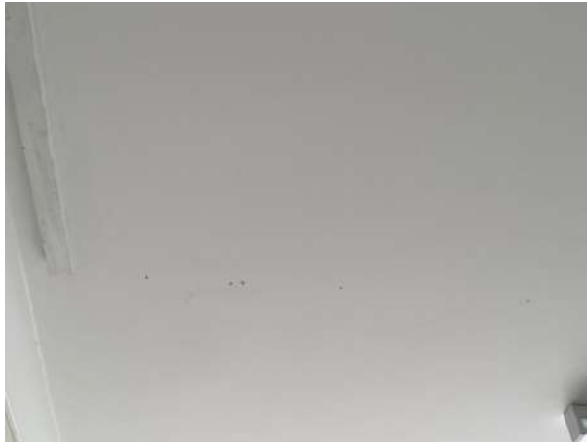
Safety Hazard 1.01

Finding: Garage - Plaster & Duct Damage

Due to the electrical works, alarm installation and camera installation, also the disassembly in part of the electrical, alarm and camera installation, there is now various damage taken place to the plasterwork and paint work.

There has been very crude and substandard workmanship repair done, however certainly not satisfactory for a property of 7 to 8 months old.

A qualified electrician, plasterer and painter is required, but due to the illegal electrical work that can be seen, we do not know the severity of the damage in the ceiling space area of electrical work that may be a fire risk and safety hazard and I highly recommend further invasive works to the plaster in order to visually see the ceiling space areas to identify any illegal wiring that is a fire risk or a safety hazard. All electrical is to be inspected by a qualified electrician. Once the electrical is all repaired and safe the plasterwork repairs and painting can then be finished.

A registered builder should take control of this job so that all the appropriate works are done in the appropriate orders.

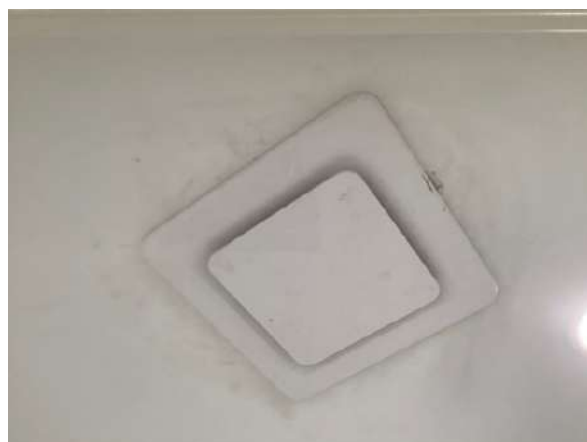
Safety Hazard 1.02

Finding: Laundry - Plaster & Duct Damage

Due to the electrical works, alarm installation and camera installation, also the disassembly in part of the electrical, alarm and camera installation, there is now various damage taken place to the plasterwork and paint work.

There has been very crude and substandard workmanship repair done, however certainly not satisfactory for a property of 7 to 8 months old.

You can identify that the exhaust fan vent has been taken out by the damaged painted ceiling, This is how some of the the electrical wiring has been performed between the floor levels and ceilings spaces.

All electrical is to be inspected by a qualified electrician. Once the electrical is all repaired and safe the plasterwork repairs and painting can then be finished.

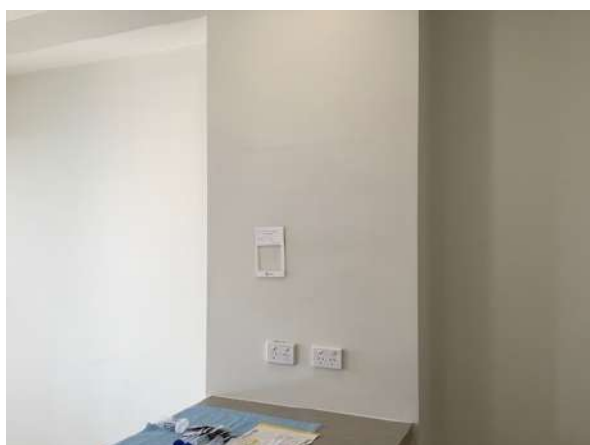
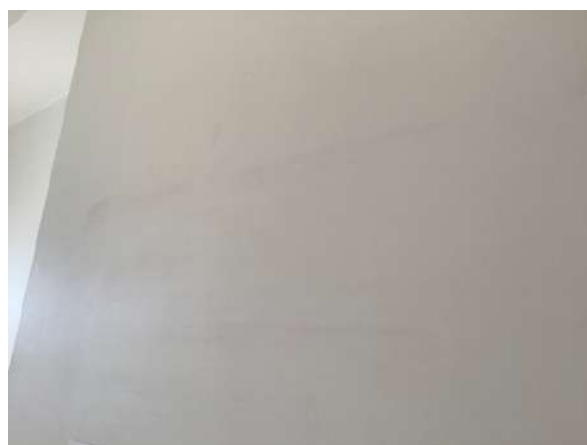
Safety Hazard 1.03

Also there appears to be what may have been a TV bracket on the wall and the crude plasterwork and patchwork is well below acceptable tradesmen like qualities including all other plaster and paint repairs are all well below try to like quality.

A registered builder should take control of this job so that all the appropriate works are done in the appropriate orders.

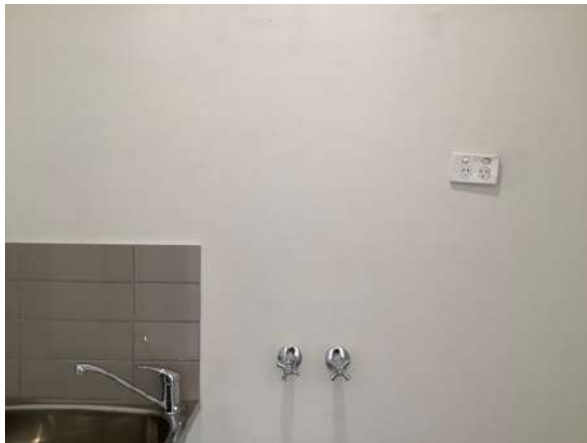
Safety Hazard 1.04

Finding: Damaged Power Point

The PowerPoint is structurally compromised and very much a safety hazard. This PowerPoint should not be used until it is replaced and the electrical wiring is inspected to this location and all locations.

It is unknown as to how this type of damage can occur in this location.

There is the strong possibility that this PowerPoint is compromised due to excessive power load caused by illegal activity and this PowerPoint could have something to do with the illegal wiring outside as well.

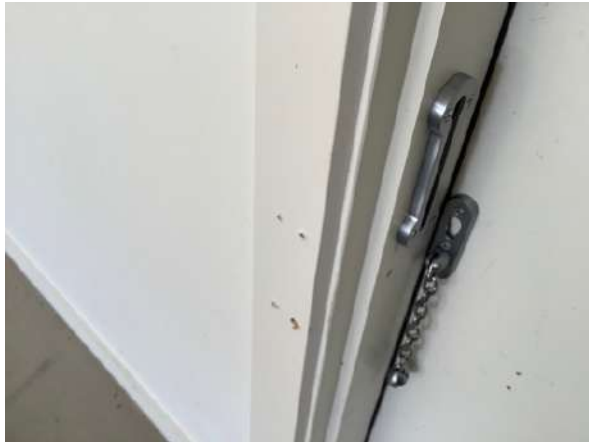
Safety Hazard 1.05

Finding: Garage Back Door Damaged

The door frame, door and security door are all damaged

Garage backdoor severely damaged , Due to somebody trying to break in, once again this would certainly be related to the illegal activity that was being performed in this property. You can also identify that the tenant has added additional security locks as well three in fact. It is certainly not typical to have three different locks on one door.

A carpenter and security door expert are required to complete all the repairs, followed by a painter.

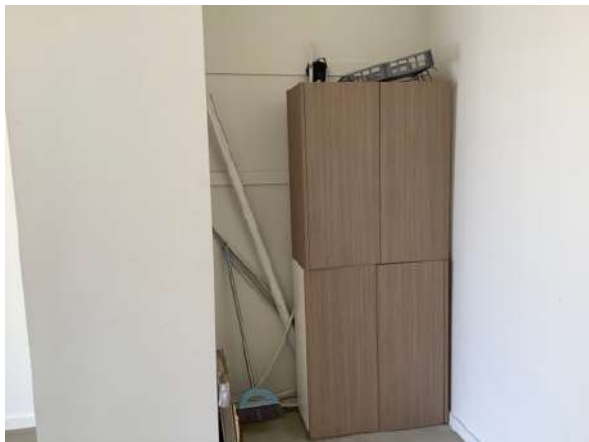
Safety Hazard 1.06

These cupboards are not from this property, and in addition all this ductwork is part of the electrical, camera and alarm systems that have been partially taken out.

All this material needs to be taken away for rubbish. It is very important as the place is contaminated with methamphetamine that this product be treated as contaminated as well.

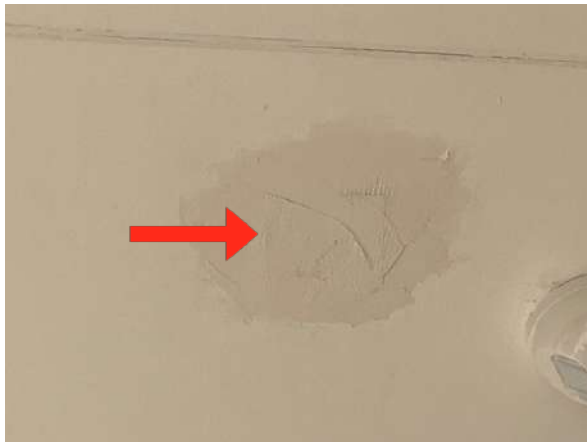
Safety Hazard 1.07

Finding: Damage due to old cameras and alarms

The front exterior ceiling area is damaged by the camera system that has been taken out and there has been crude workmanship taken place that is certainly not acceptable.

Once the alarm system gets taken out there will be damage as well, not just at this location there will be varied locations damaged inside the property and outside the property as well from the alarm system to the plaster, timber work, brickwork, exterior render , door switches etc.

Due to the crude workmanship no work that has been performed by this tenant can stay on this property as it may affect the builders warranty and also be a fire risk.

Varied trades are required and once again all should be overlooked by a registered builder.

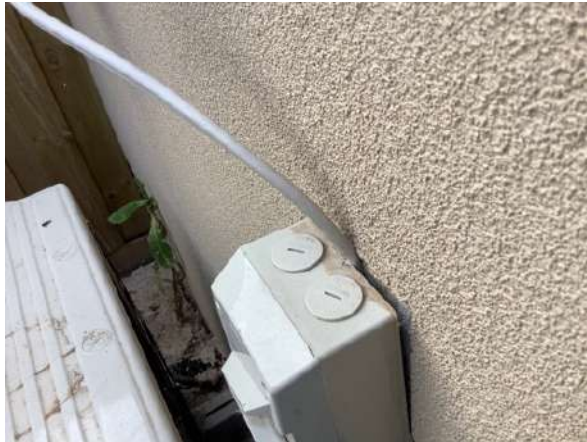
Safety Hazard 1.08

Finding: Illegal wiring performed

The tenant stated to the managing agent that this wiring was like this at the time of signing her contract. This is an absurd comment to make and once again the managing agent has all her photos to identify this property was brand-new and this illegal electrical work is only one location of many that needs to be taken out and once again a qualified electrician needs to check all locations are safe and put back to normal, so that the builders warranty is not compromised and also people's lives will not be at risk.

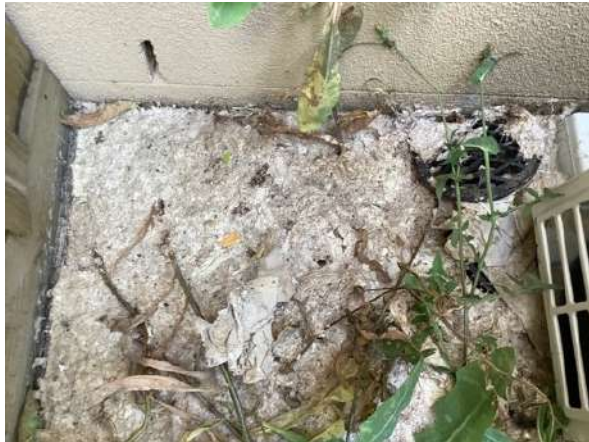
Safety Hazard 1.09

Evidence of suspected methamphetamine use, or potentially its manufacture, was found during the inspection.

However the more significant issue is that there may be residual environmental contamination throughout the property if Methamphetamine has been used or manufactured in the property. Residual environmental contamination caused by Methamphetamine use can have serious health implications and effects on occupants. Consequently we have listed this as a Safety Hazard.

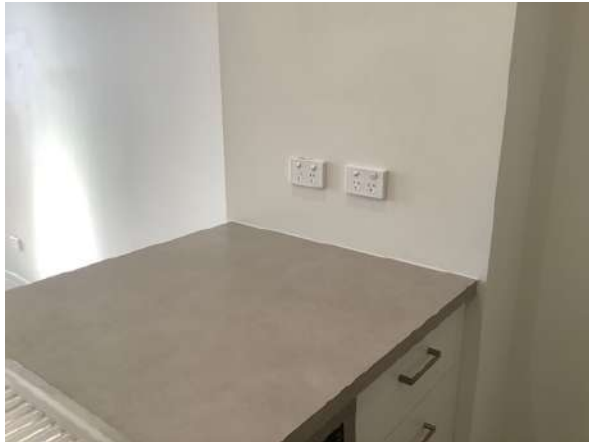
Safety Hazard 1.11

Finding: PowerPoint Installed in kitchen.

There was already a PowerPoint above the bench in the kitchen. A PowerPoint in this location is more than enough, however this tenant had installed camera system and you can see the crude workmanship repair of the shelf in this location and now an additional PowerPoint has been installed a legally and once again this PowerPoint needs to be removed the electrical wiring place back to its original state and the plasterwork and paintwork repaired.

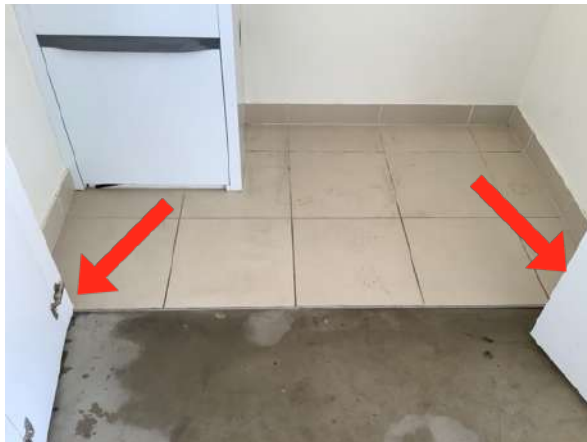
Finding: Timber Damage

The timber work has wood rot, this is due to excessive water on the ground caused by carelessness . Once again this was a brand-new property under eight months ago.

A qualified carpenter is required to do all the timber repairs following a painter.

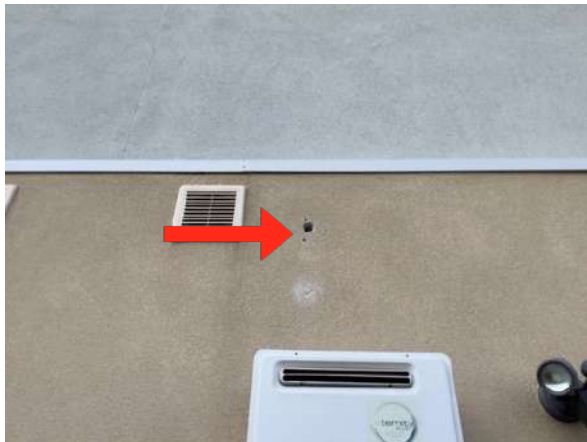
For Your Information 5.04

Finding: Damage to the exterior wall

This appears to be damage from the old camera system the brickwork needs to be repaired and the render needs to be repaired and also the electrician needs to check the ceiling space areas that there are no fire hazards or any legal wiring left.

Once again this should all be overseen by a registered builder.

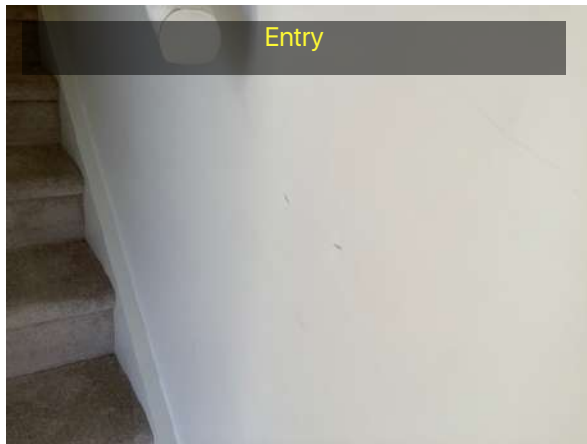
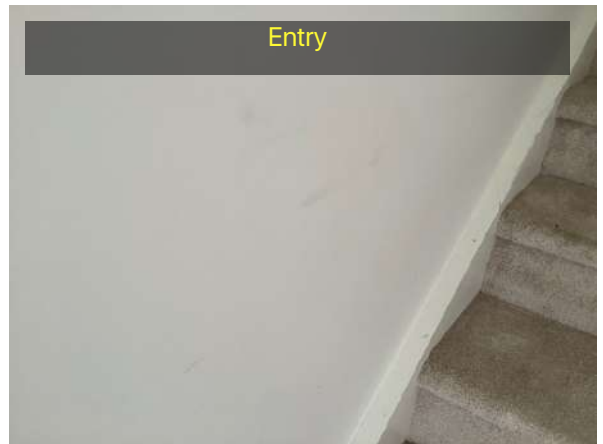
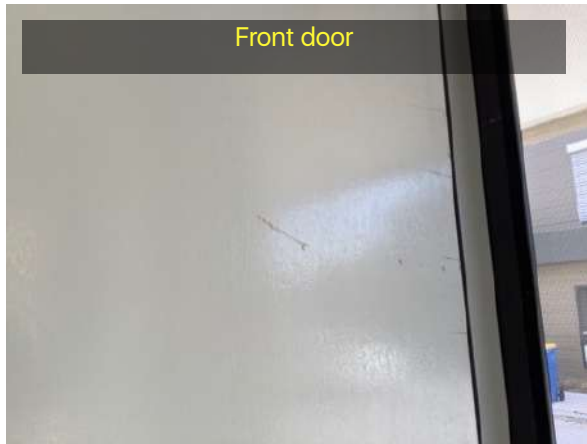
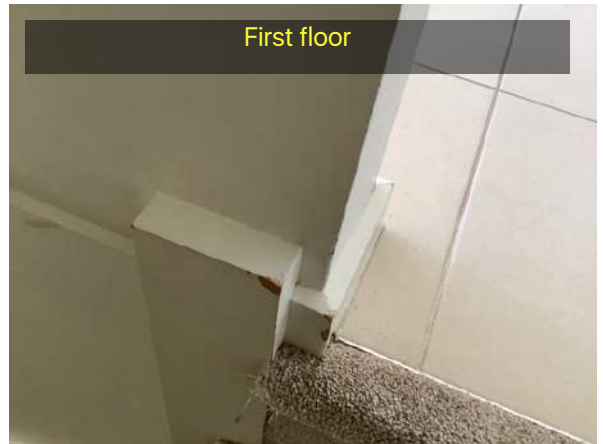
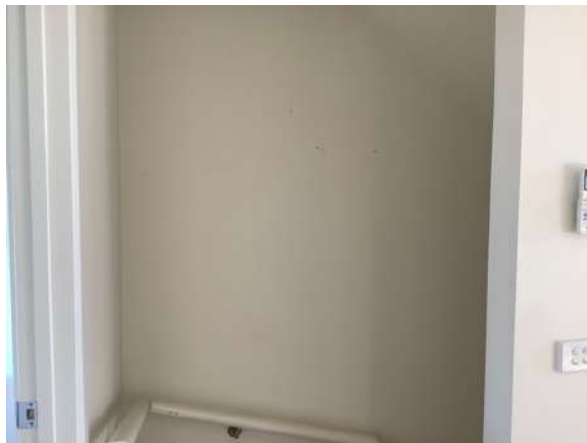
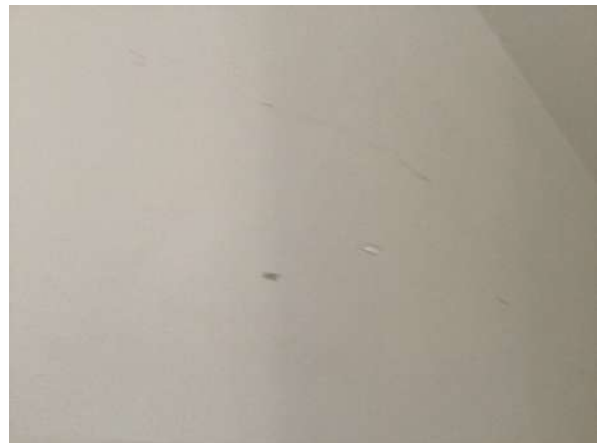
Location: Paint And Plaster Damage Throughout The Property

Finding: There is paint and plaster damage throughout the property.

There is paint and plaster damage throughout the property, some of it related to the tenant installing ilegal electrical works, the alarm system and cameras and due to their ilegal activity and some of it is through the general carelessness.

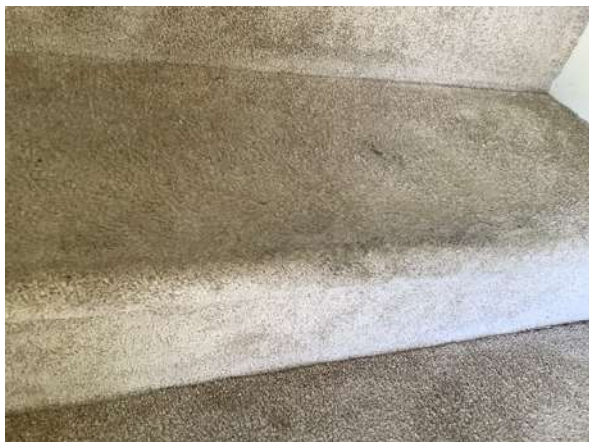
For Your Information 5.07

Finding: Carpet on staircase is well worn

The carpet on the staircase is well worn and stained, please note that this property has only been rented For under eight months and the damage is not just wear and tear, it has stains and marks and once again due to the activity of this property, in which the activity what type of activity has added to the damage.

The carpet requires replacement.

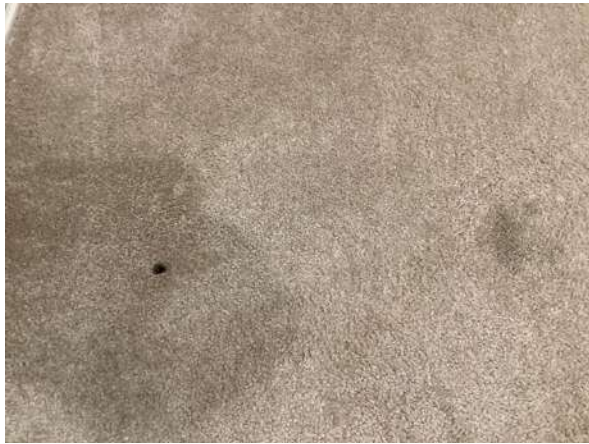
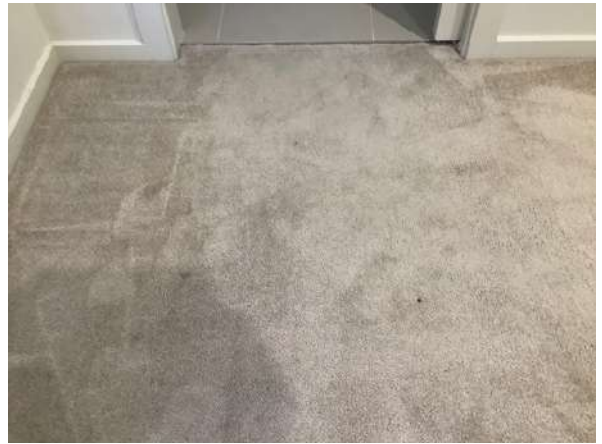
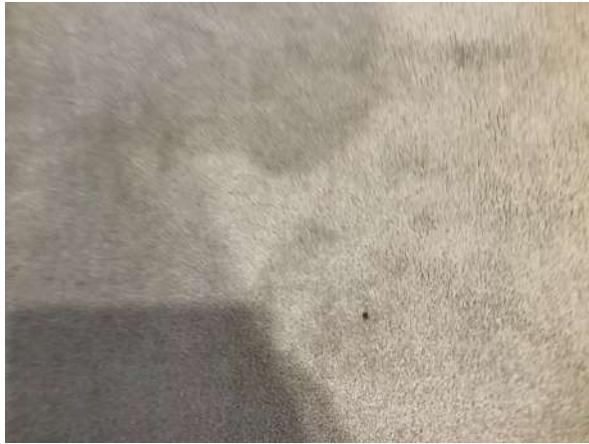
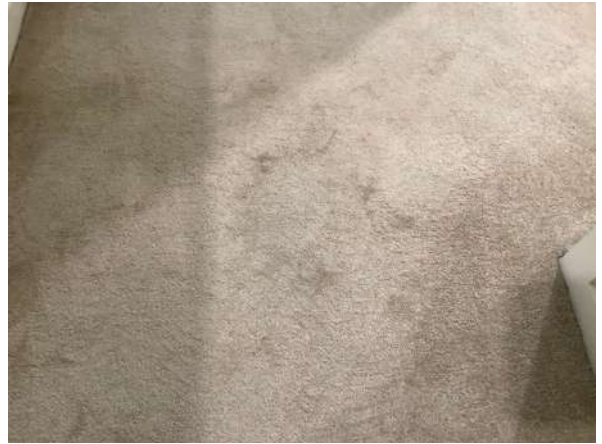
Finding: Suspicious burn marks in the carpet

Evidence of suspected methamphetamine use, or potentially its manufacture, was found during the inspection.

The evidence identified was staining and marking of surfaces that could be consistent with use or manufacture of methamphetamine. Evidence of suspected methamphetamine use

The evidence identified was staining of surfaces consistent with use of particular chemicals that are present in meth and can be used in its Manufacture.

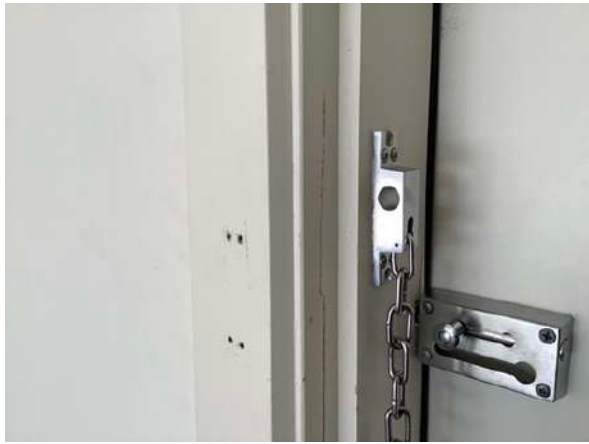
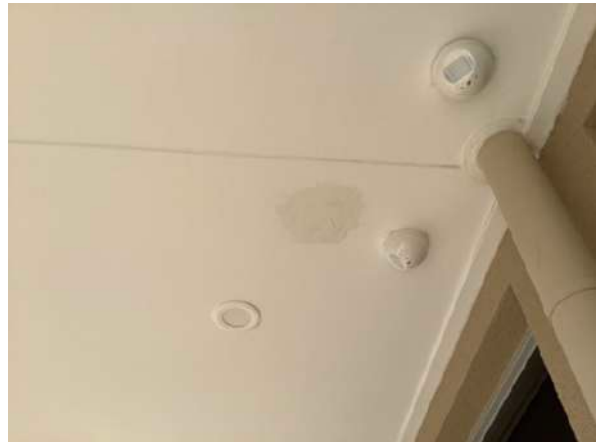
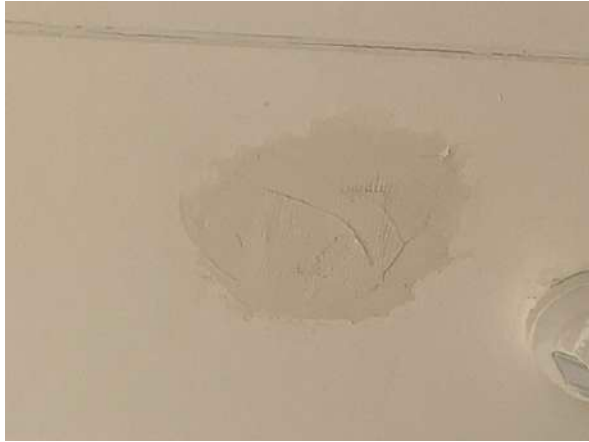
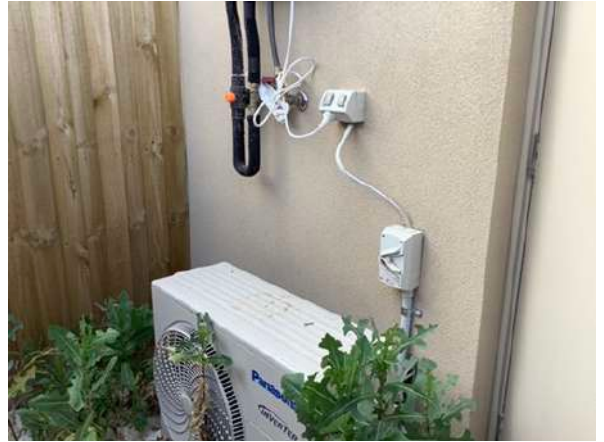
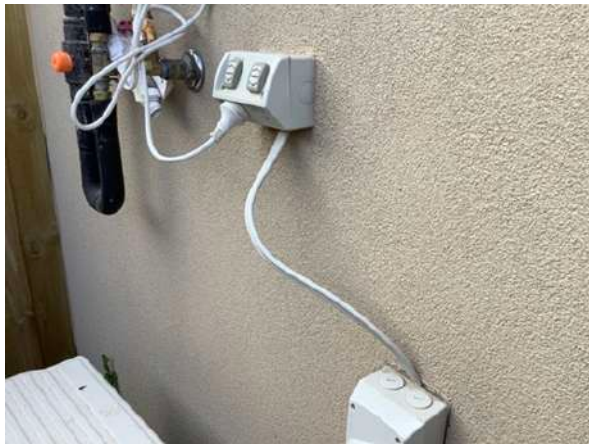
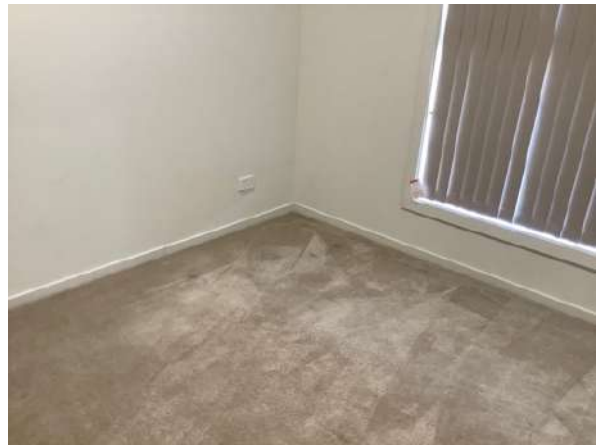
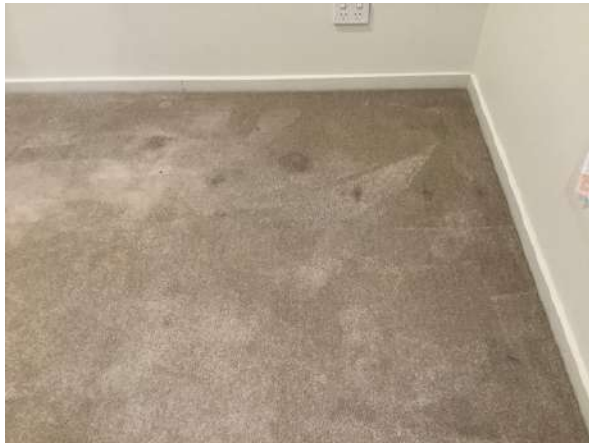
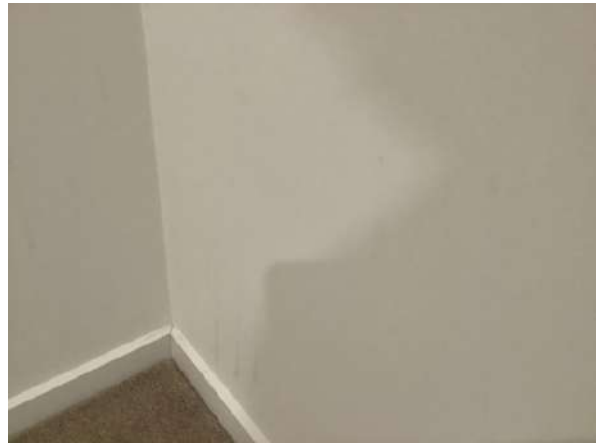
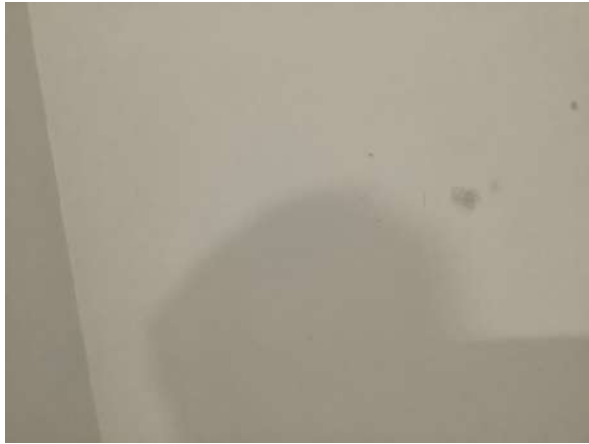
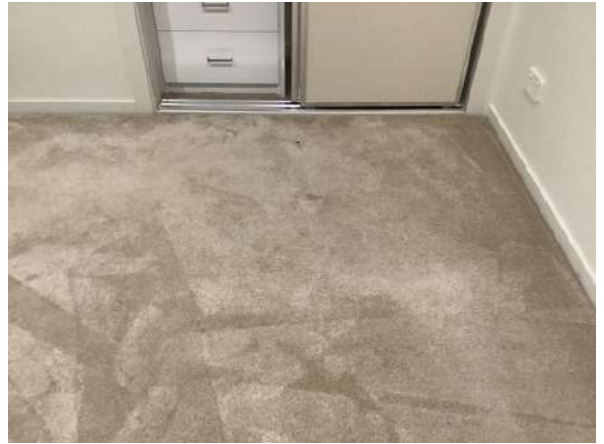
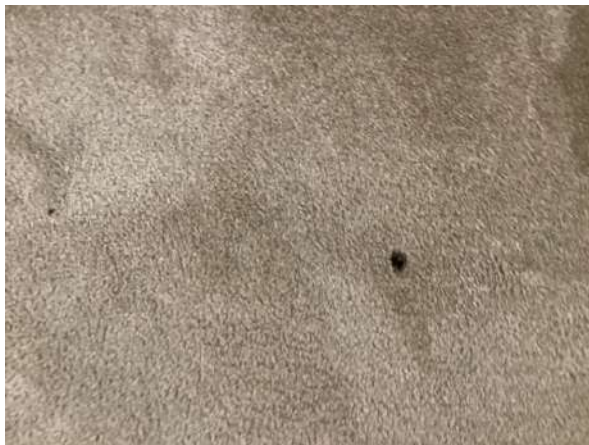
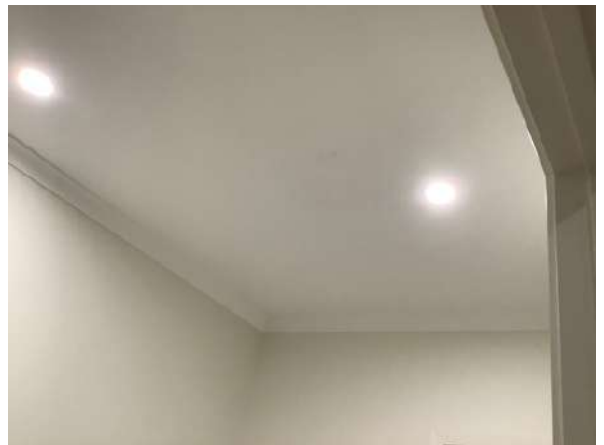
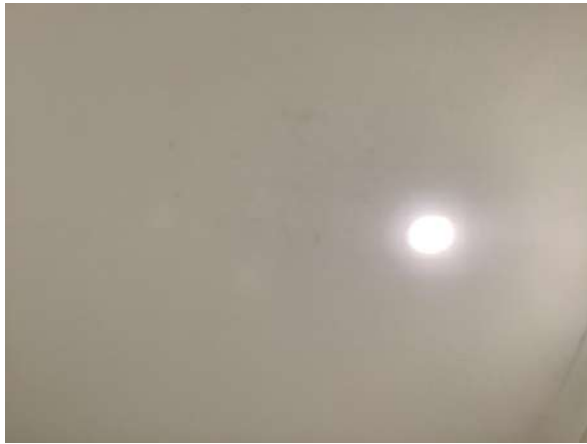
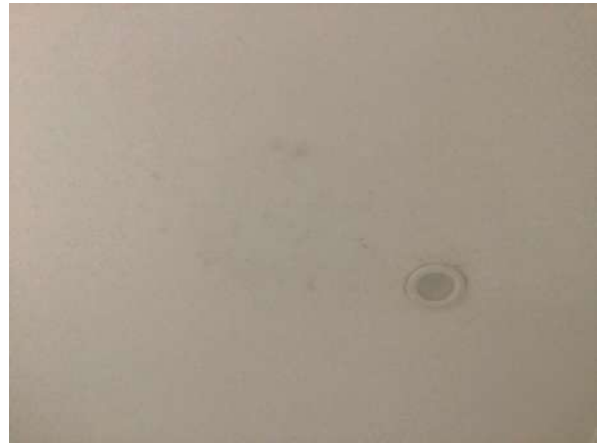
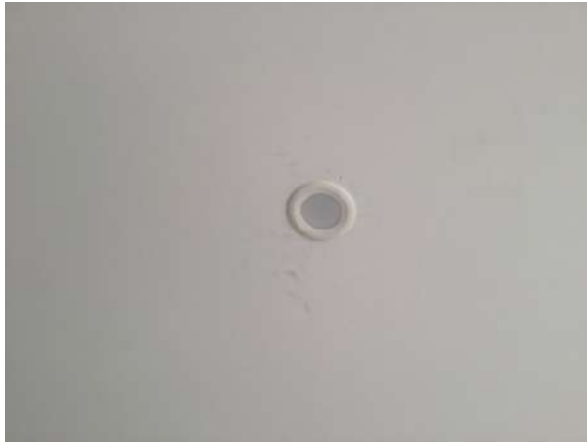
There is various suspicious building material activity in this property, various cameras spread throughout, alarm system installed, additional back locks, additional power points put in the kitchen, illegal wiring, upstairs suspicious staining on the walls and carpet, burn marks in carpet, Suspicious stains on the ceilings, Various stains to the ceilings as down-lights, vents have been taken out .

Once again the tenant had no right to do such extensive works to the property as this has now impacted the builders warranty insurance and all the ceiling spaces, to all three levels need to be fully inspected by a qualified electrician and registered builder and sign off that the building is as per it was built as without this we may have a compromise builders warranty.
