Rental Safety Report

Inspection Date: 7 Jul 2021

Property Address: Glenroy area

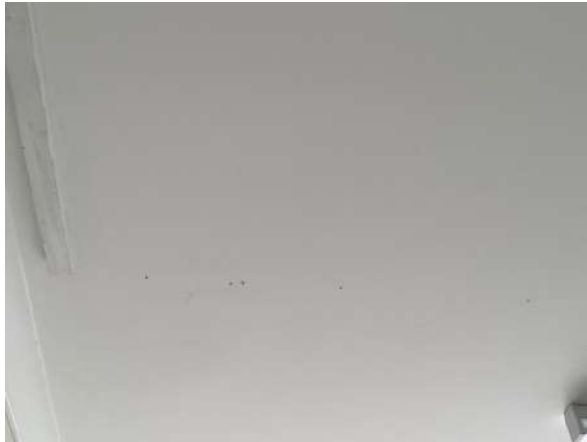
Safety Hazard 1.01

Finding: Garage - Plaster & Duct Damage

Due to the electrical works, alarm installation and camera installation, also the disassembly in part of the electrical, alarm and camera installation, there is now various damage taken place to the plasterwork and paint work.

There has been very crude and substandard workmanship repair done, however certainly not satisfactory for a property of 7 to 8 months old.

A qualified electrician, plasterer and painter is required, but due to the illegal electrical work that can be seen, we do not know the severity of the damage in the ceiling space area of electrical work that may be a fire risk and safety hazard and I highly recommend further invasive works to the plaster in order to visually see the ceiling space areas to identify any illegal wiring that is a fire risk or a safety hazard. All electrical is to be inspected by a qualified electrician. Once the electrical is all repaired and safe the plasterwork repairs and painting can then be finished.

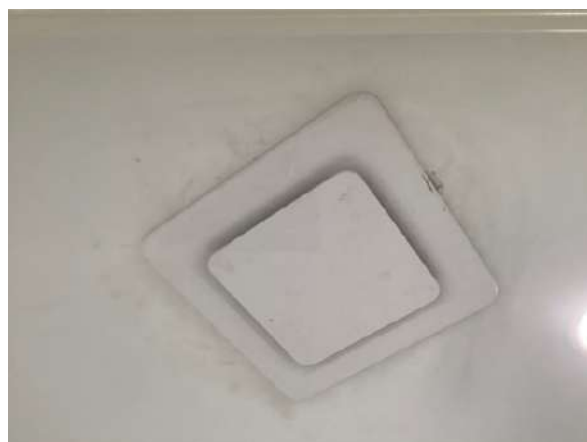
Safety Hazard 1.02

Finding: Laundry - Plaster & Duct Damage

Due to the electrical works, alarm installation and camera installation, also the disassembly in part of the electrical, alarm and camera installation, there is now various damage taken place to the plasterwork and paint work.

There has been very crude and substandard workmanship repair done, however certainly not satisfactory for a property of 7 to 8 months old.

You can identify that the exhaust fan vent has been taken out by the damaged painted ceiling, This is how some of the the electrical wiring has been performed between the floor levels and ceilings spaces.

A qualified electrician, plasterer and painter is required, but due to the illegal electrical work that can be seen, we do not know the severity of the damage in the ceiling space area of electrical work that may be a fire risk and safety hazard and I highly recommend further invasive works to the plaster in order to visually see the ceiling space areas to identify any illegal wiring that is a fire risk or a safety hazard.

All electrical is to be inspected by a qualified electrician. Once the electrical is all repaired and safe the plasterwork repairs and painting can then be finished.

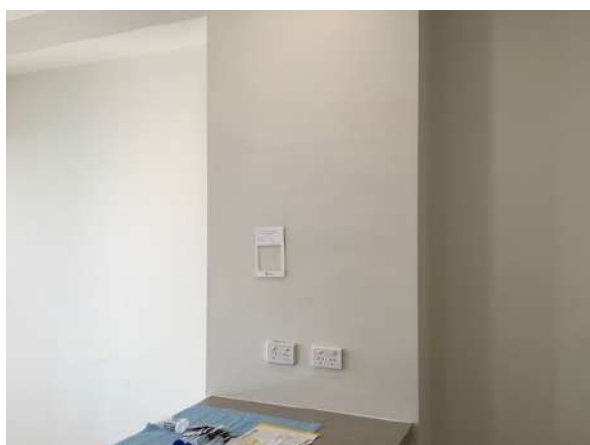
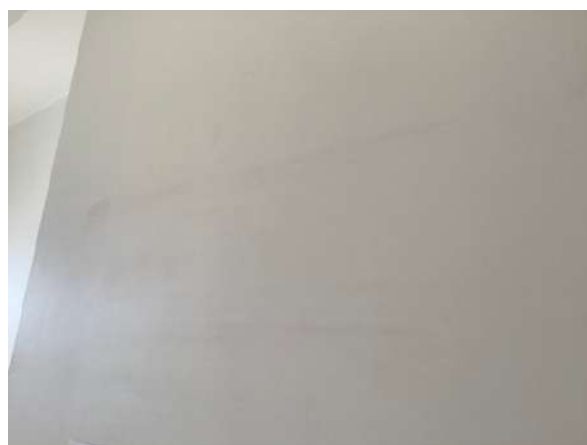
Safety Hazard 1.03

Also there appears to be what may have been a TV bracket on the wall and the crude plasterwork and patchwork is well below acceptable tradesmen like qualities including all other plaster and paint repairs are all well below try to like quality.

A registered builder should take control of this job so that all the appropriate works are done in the appropriate orders.

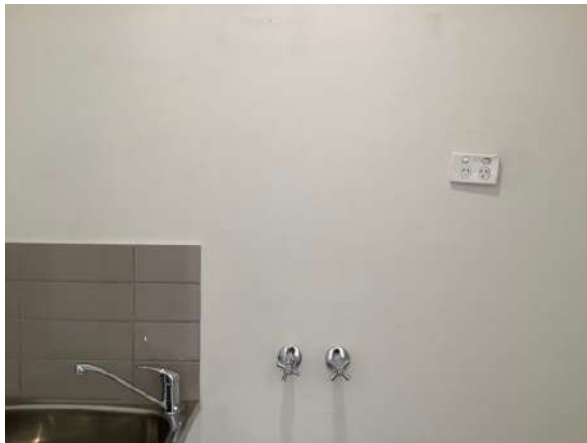
Safety Hazard 1.04

Finding: Damaged Power Point

The PowerPoint is structurally compromised and very much a safety hazard. This PowerPoint should not be used until it is replaced and the electrical wiring is inspected to this location and all locations.

It is unknown as to how this type of damage can occur in this location.

There is the strong possibility that this PowerPoint is compromised due to excessive power load caused by illegal activity and this PowerPoint could have something to do with the illegal wiring outside as well.

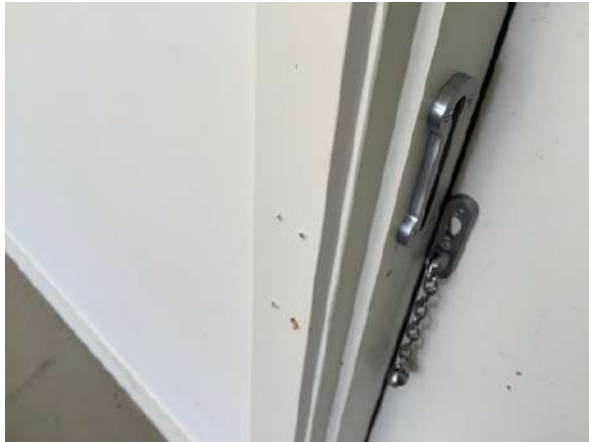
Safety Hazard 1.05

Finding: Garage Back Door Damaged

The door frame, door and security door are all damaged

Garage backdoor severely damaged , Due to somebody trying to break in, once again this would certainly be related to the illegal activity that was being performed in this property. You can also identify that the tenant has added additional security locks as well three in fact. It is certainly not typical to have three different locks on one door.

A carpenter and security door expert are required to complete all the repairs, followed by a painter.

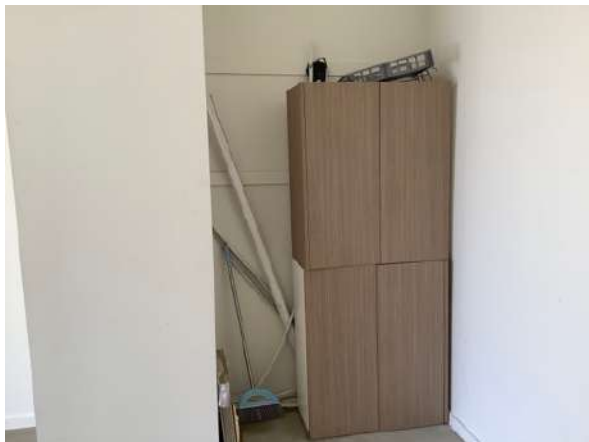
Safety Hazard 1.06

These cupboards are not from this property, and in addition all this ductwork is part of the electrical, camera and alarm systems that have been partially taken out.

All this material needs to be taken away for rubbish. It is very important as the place is contaminated with methamphetamine that this product be treated as contaminated as well.

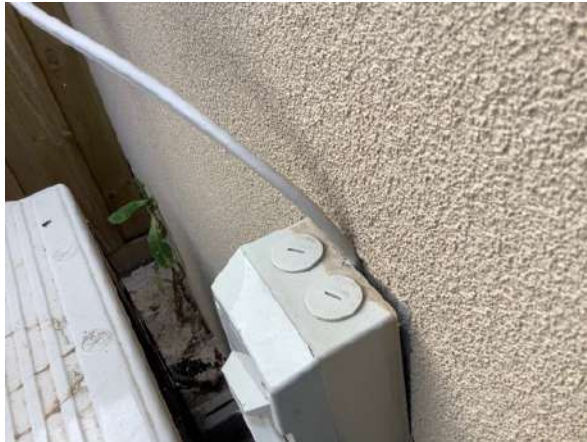
Safety Hazard 1.08

Finding: Illegal wiring performed

The tenant stated to the managing agent that this wiring was like this at the time of signing her contract. This is an absurd comment to make and once again the managing agent has all her photos to identify this property was brand-new and this illegal electrical work is only one location of many that needs to be taken out and once again a qualified electrician needs to check all locations are safe and put back to normal, so that the builders warranty is not compromised and also people's lives will not be at risk.

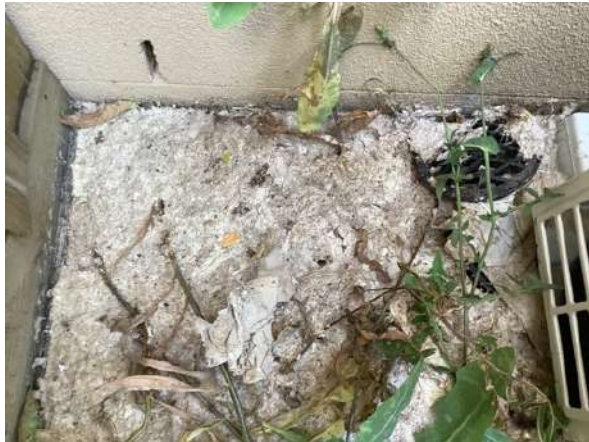
Safety Hazard 1.09

Evidence of suspected methamphetamine use, or potentially its manufacture, was found during the inspection.

However the more significant issue is that there may be residual environmental contamination throughout the property if Methamphetamine has been used or manufactured in the property. Residual environmental contamination caused by Methamphetamine use can have serious health implications and effects on occupants. Consequently we have listed this as a Safety Hazard.

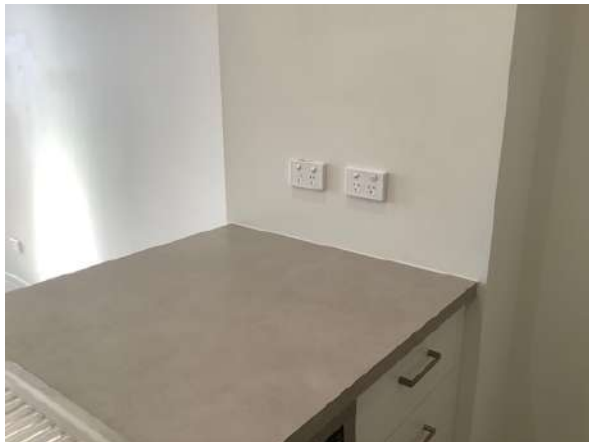
Safety Hazard 1.11

Finding: PowerPoint Installed in kitchen.

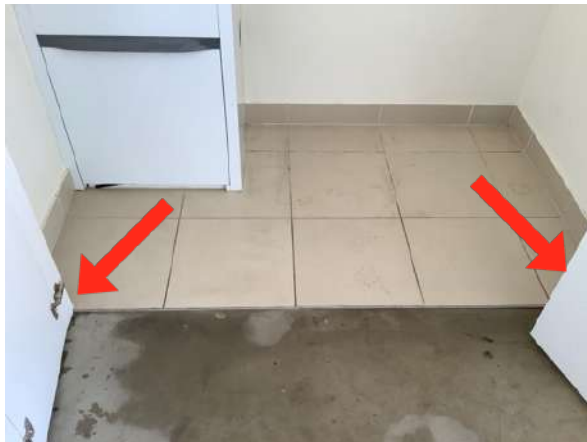
Finding: Timber Damage

The timber work has wood rot, this is due to excessive water on the ground caused by carelessness . Once again this was a brand-new property under eight months ago.

A qualified carpenter is required to do all the timber repairs following a painter.

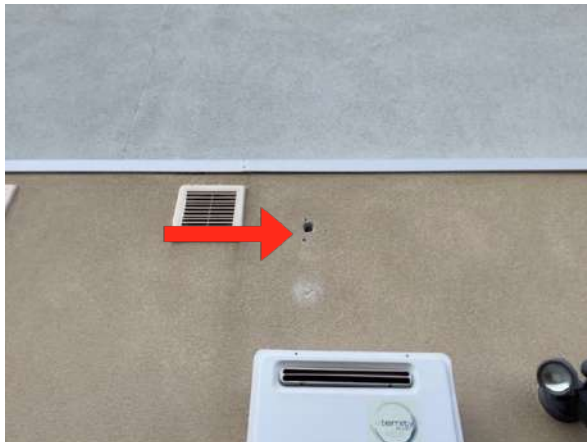
For Your Information 5.04

Finding: Damage to the exterior wall

This appears to be damage from the old camera system the brickwork needs to be repaired and the render needs to be repaired and also the electrician needs to check the ceiling space areas that there are no fire hazards or any legal wiring left.

Once again this should all be overseen by a registered builder.

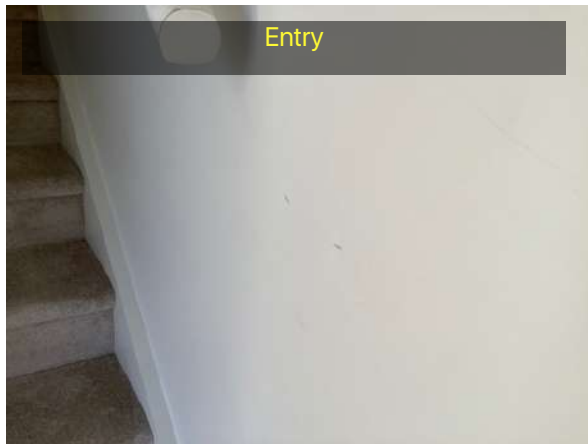
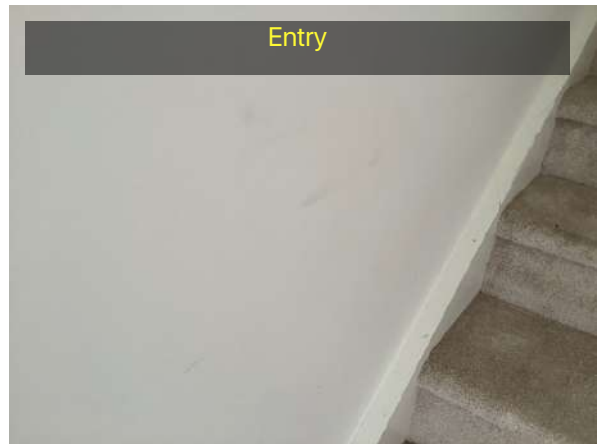
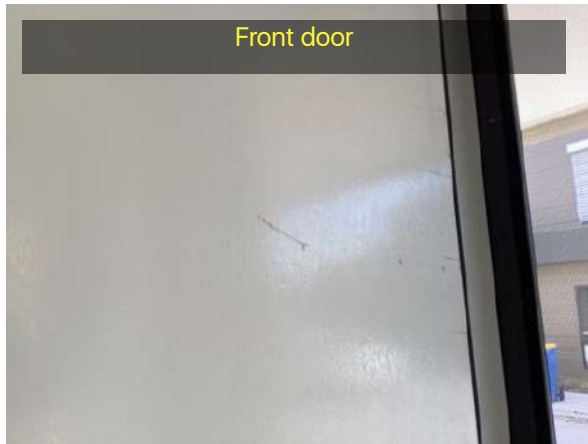
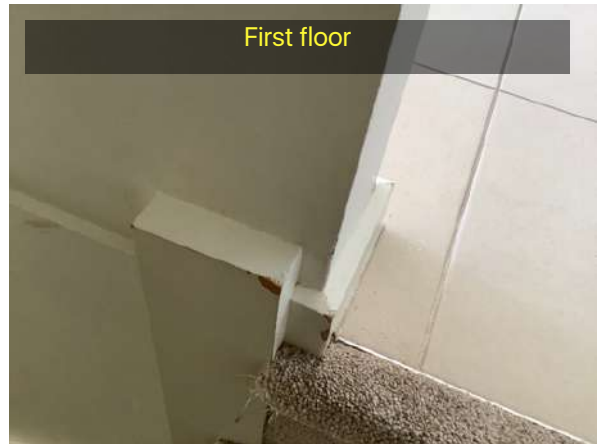
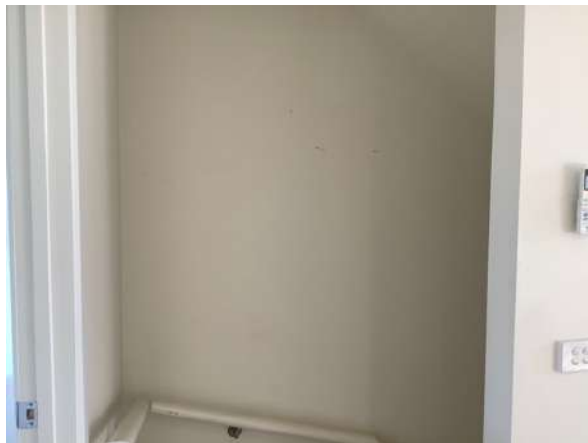
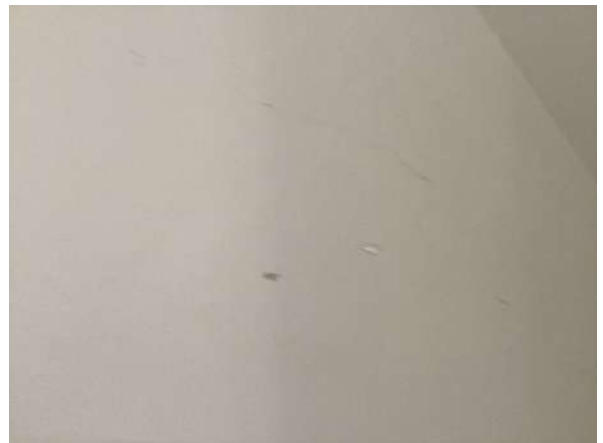
Location: Paint And Plaster Damage Throughout The Property

Finding: There is paint and plaster damage throughout the property.

I would like to remind the reader that this property was brand-new and never been lived in, Only under eight months ago.

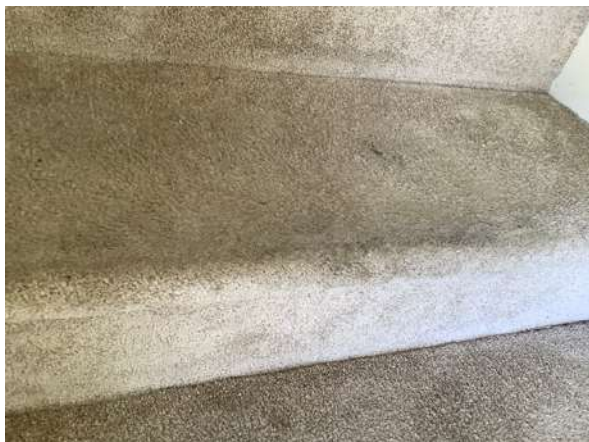
For Your Information 5.07

Finding: Carpet on staircase is well worn

The carpet on the staircase is well worn and stained, please note that this property has only been rented For under eight months and the damage is not just wear and tear, it has stains and marks and once again due to the activity of this property, in which the activity what type of activity has added to the damage.

The carpet requires replacement.

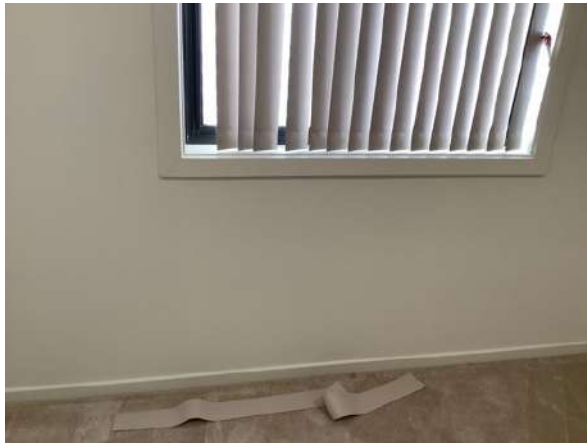
For Your Information 5.09

Location: Upstairs Bedroom
Finding: Broken blind
The blind appears to be broken

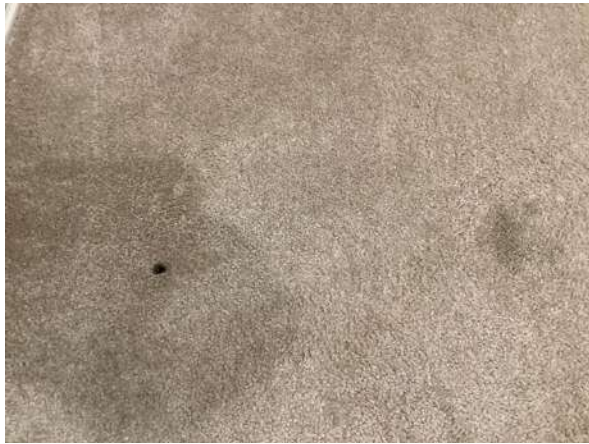
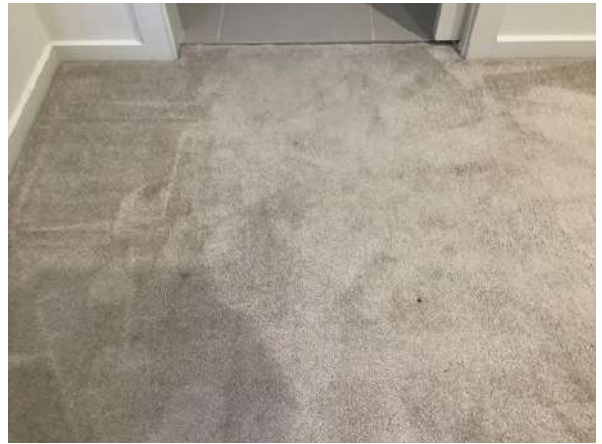
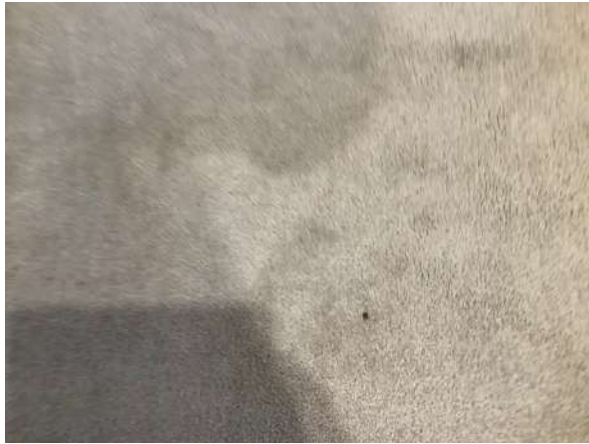
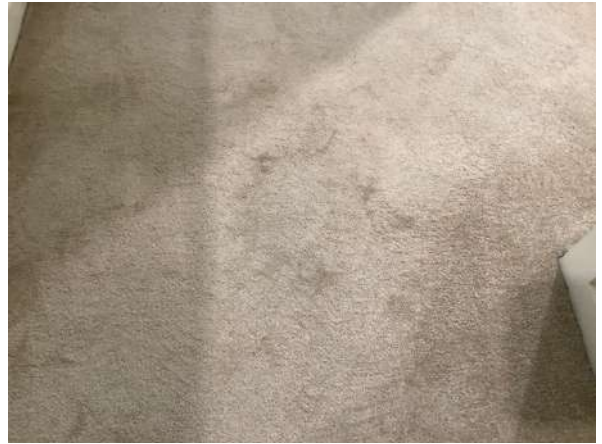
For Your Information 5.10

Finding: Suspicious burn marks in the carpet

Evidence of suspected methamphetamine use, or potentially its manufacture, was found during the inspection.

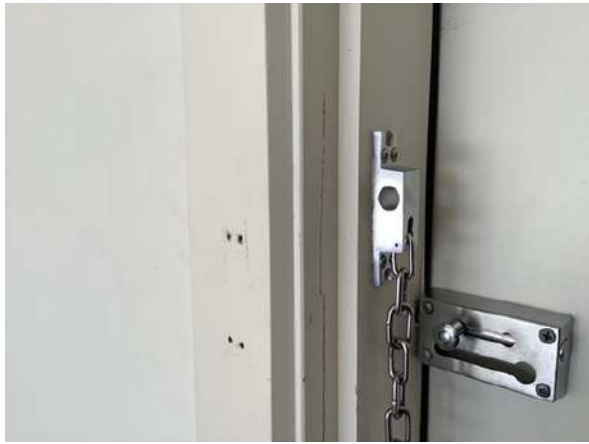
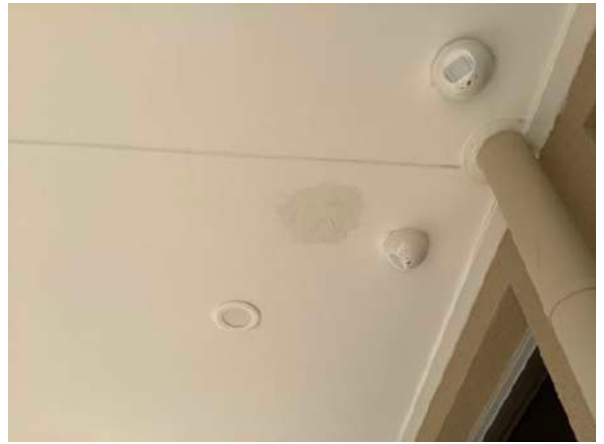
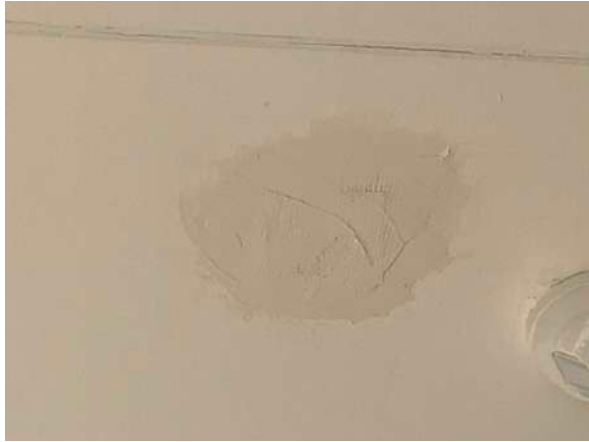
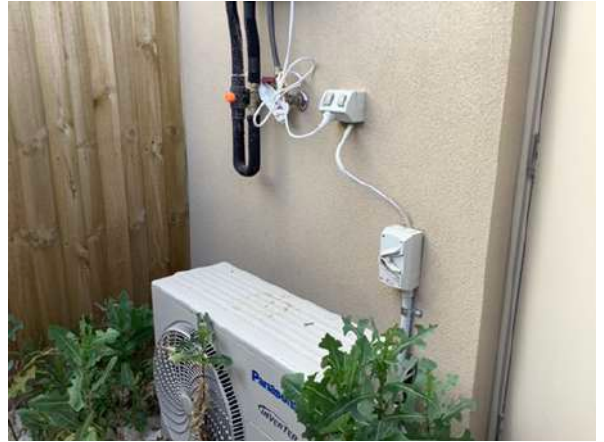
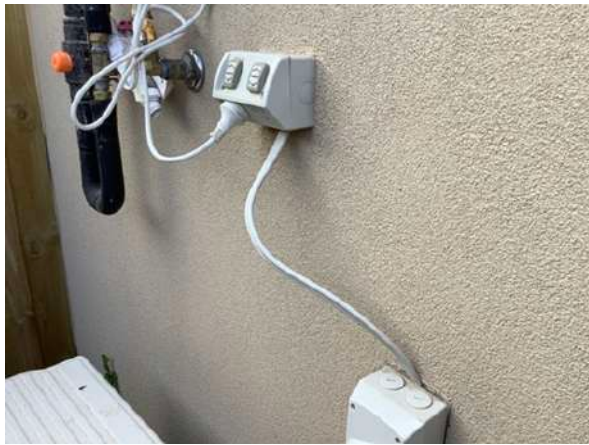
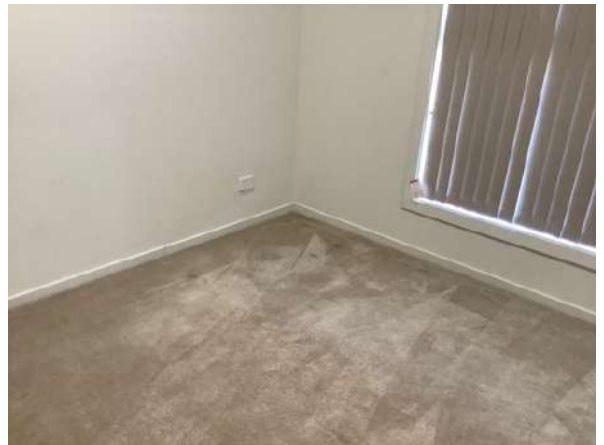
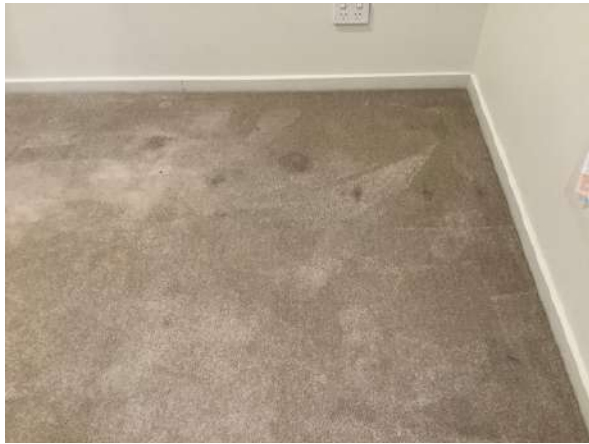
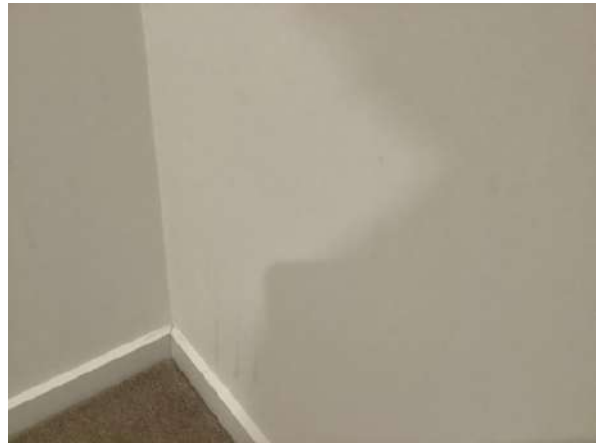
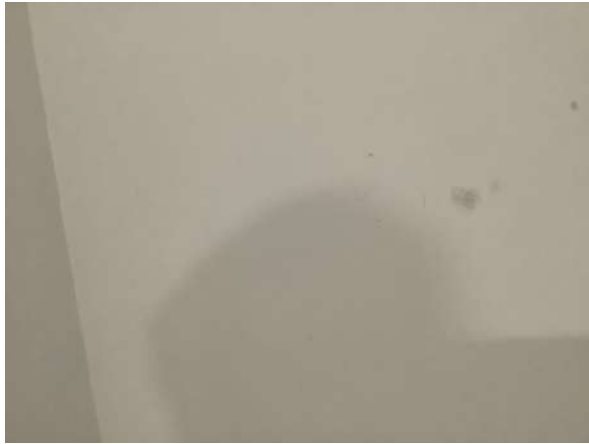
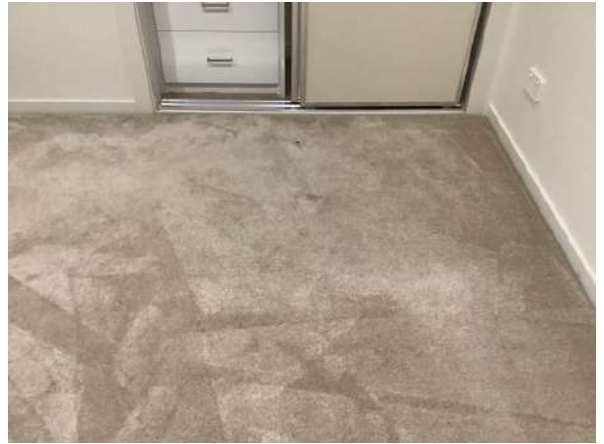
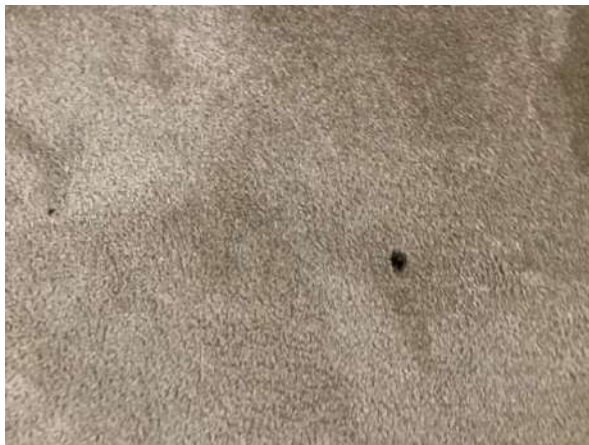
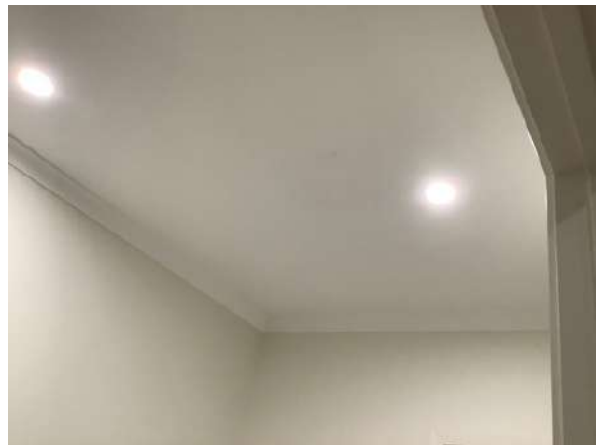
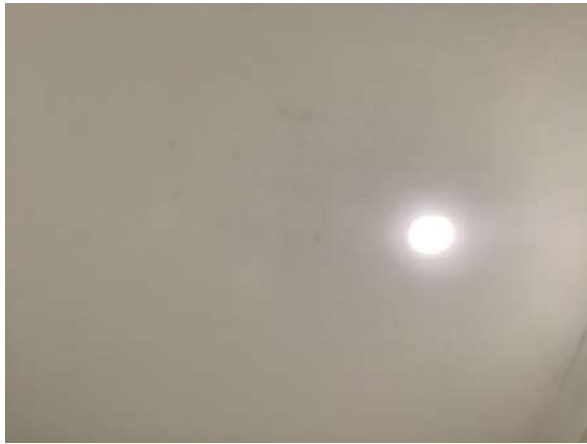
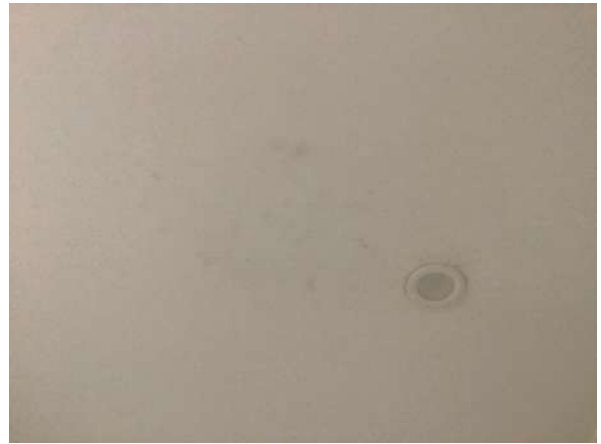
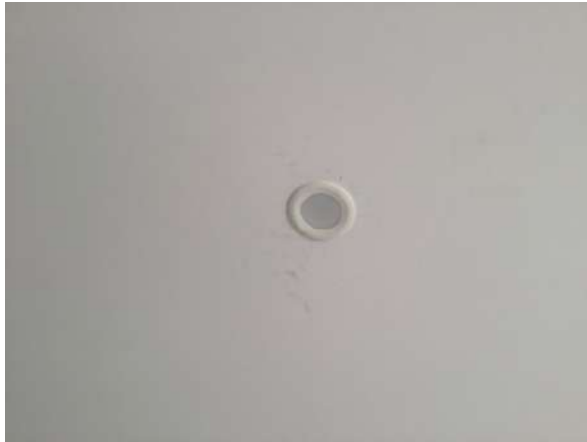
There is various suspicious building material activity in this property, various cameras spread throughout, alarm system installed, additional back locks, additional power points put in the kitchen, illegal wiring, upstairs suspicious staining on the walls and carpet, burn marks in carpet, Suspicious stains on the ceilings, Various stains to the ceilings as down-lights, vents have been taken out .

Once again the tenant had no right to do such extensive works to the property as this has now impacted the builders warranty insurance and all the ceiling spaces, to all three levels need to be fully inspected by a qualified electrician and registered builder and sign off that the building is as per it was built as without this we may have a compromise builders warranty.
