Termite/Timber Pest Report (includes Termatrac Radar Detection)

Inspection Date: 1 Jul 2021

Property Address: Kinglake area

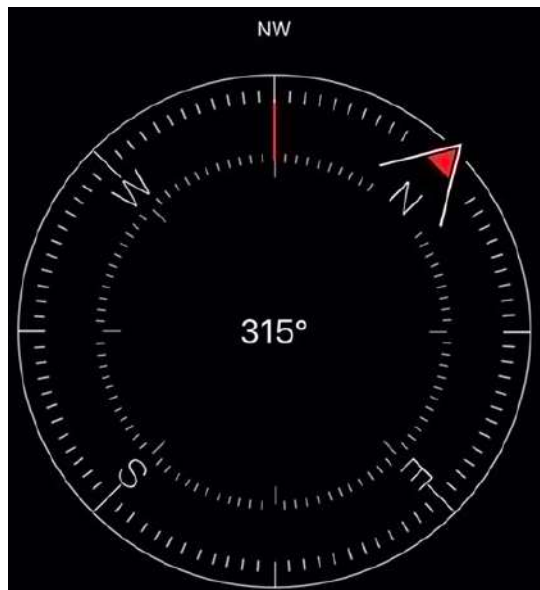
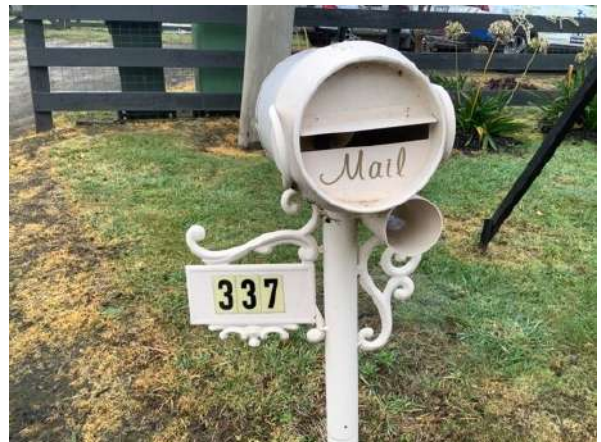
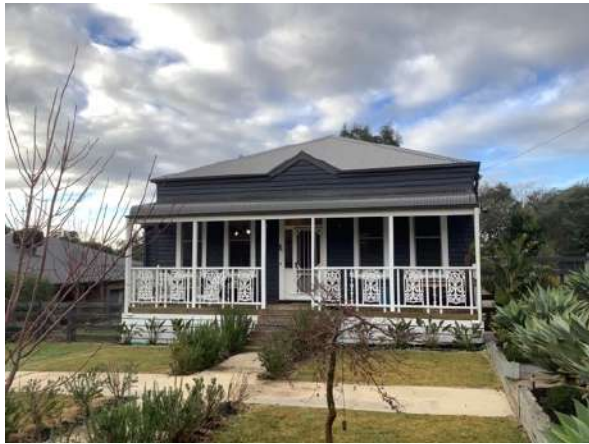
For your information 1.11

Location: For Your Information
 Finding: General Site Photos & Compass
 General site photos and other areas of interest are provided for your general reference.

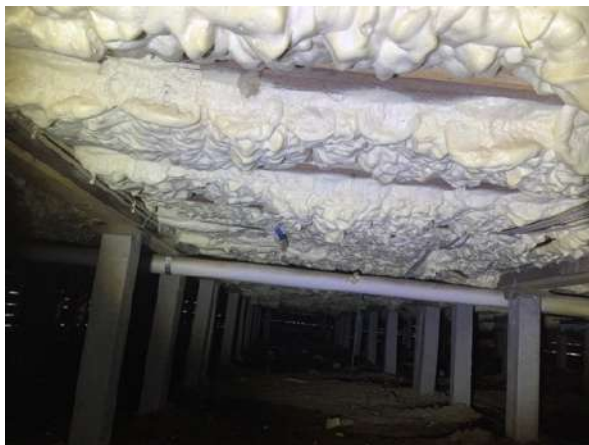
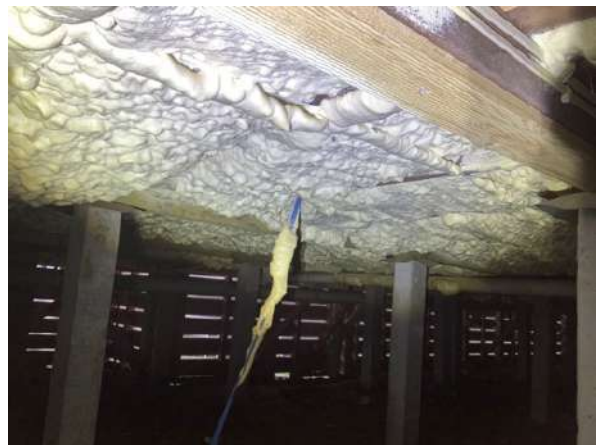
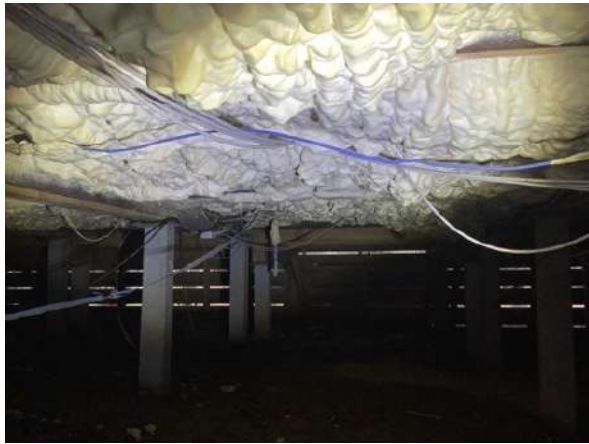
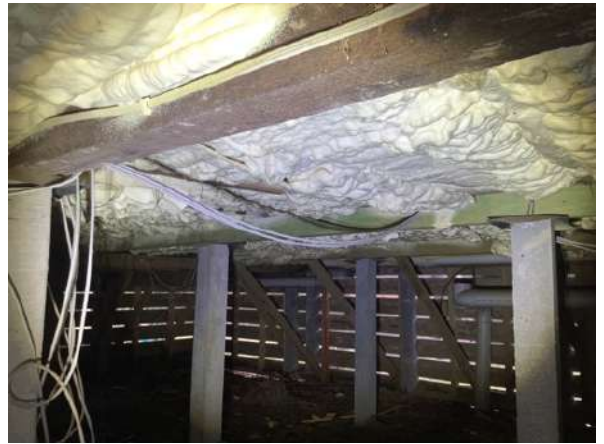
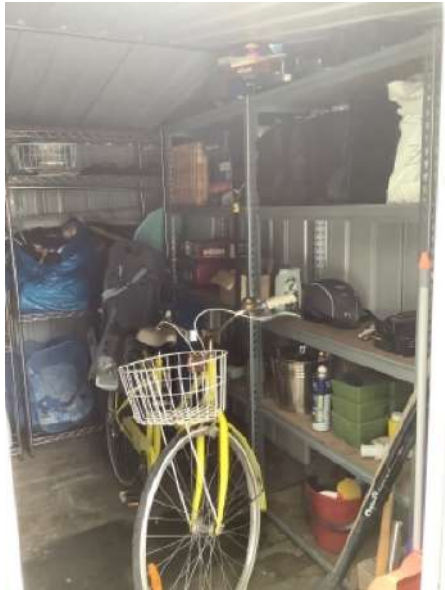
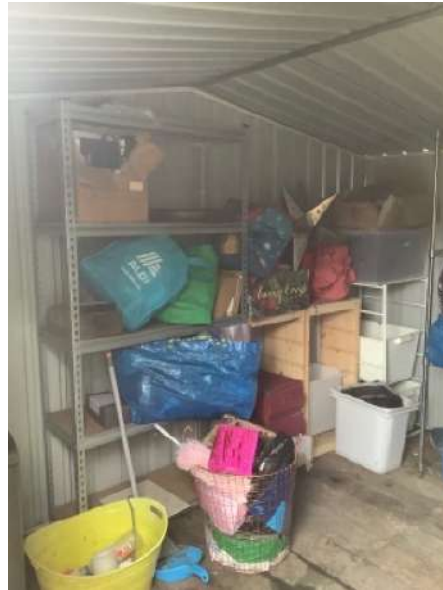
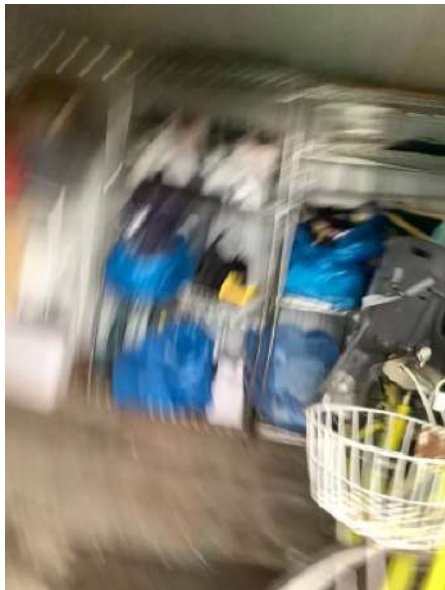
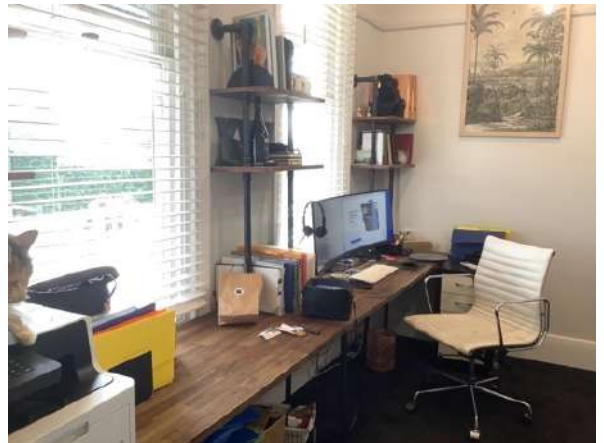
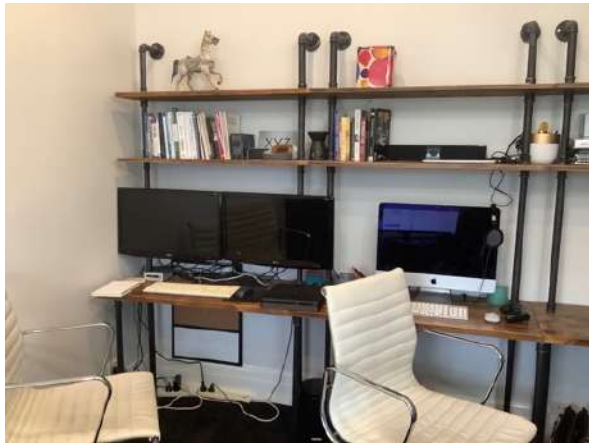
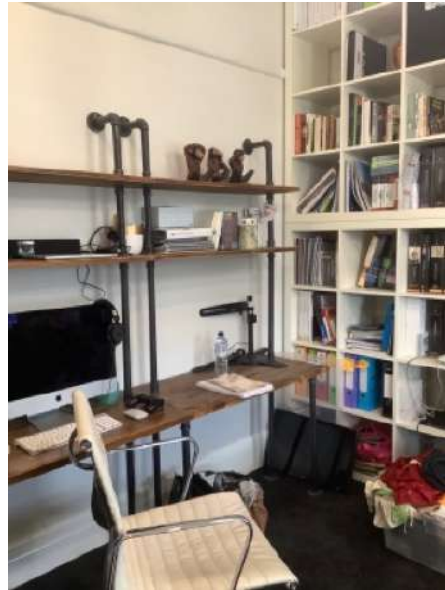
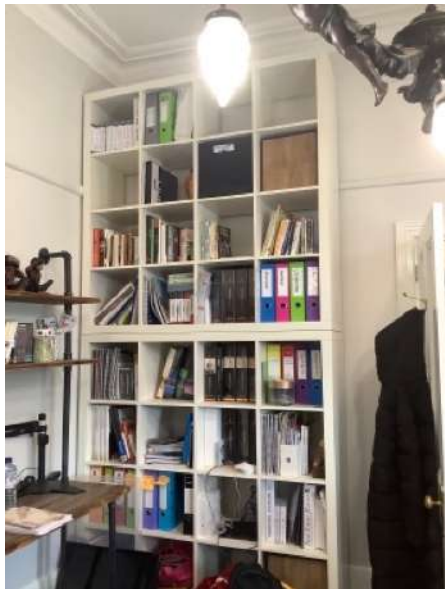
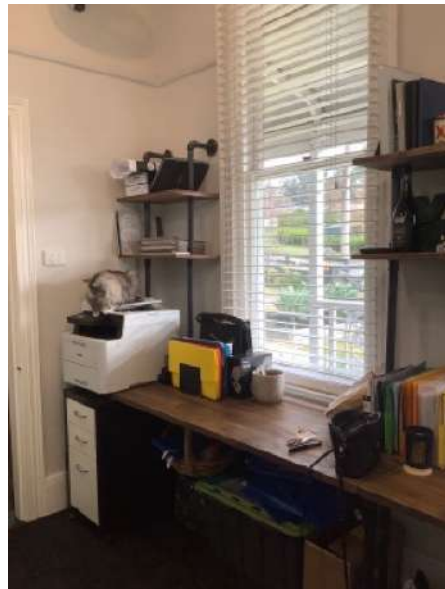
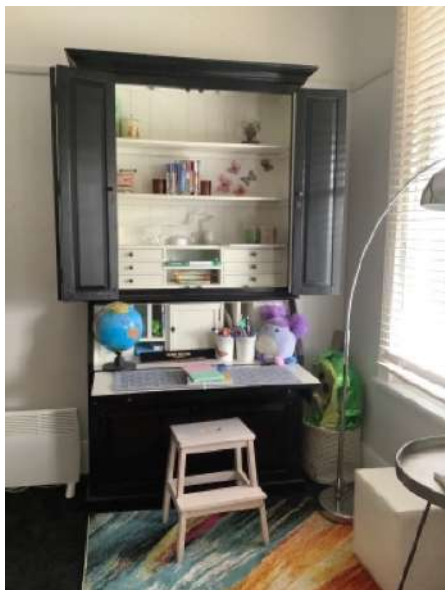
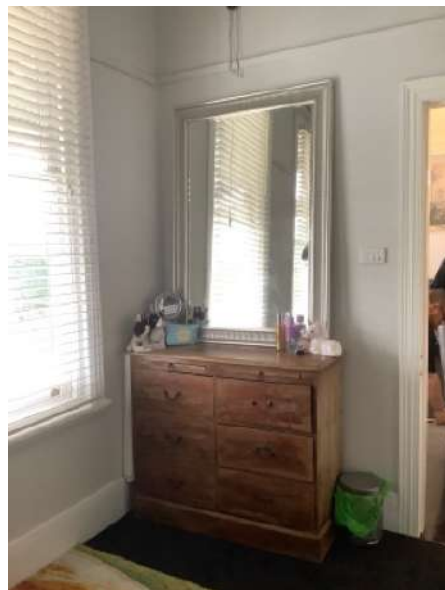
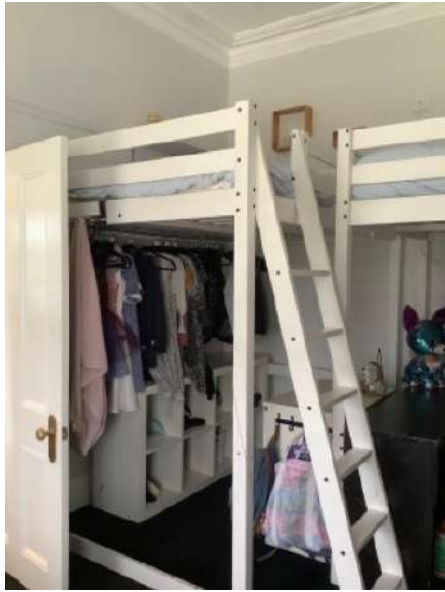
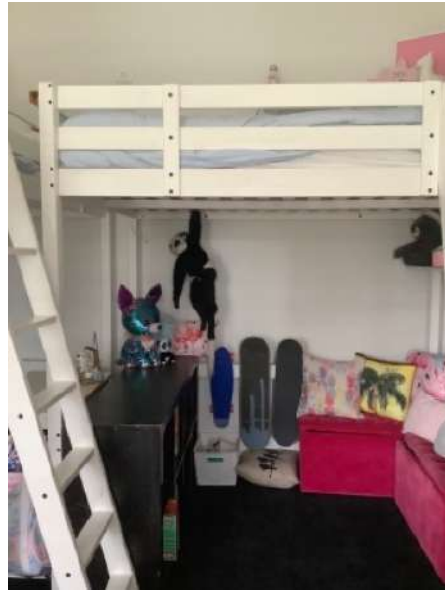
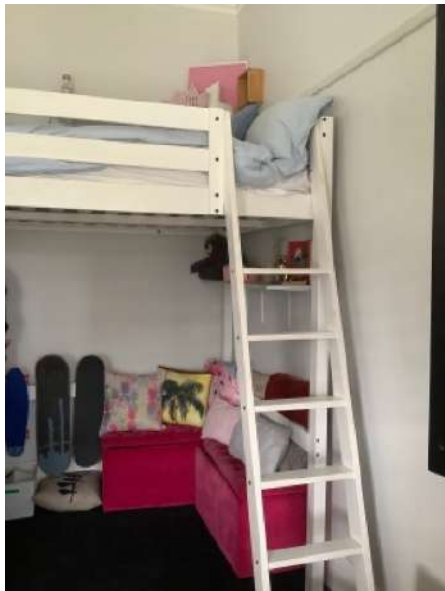
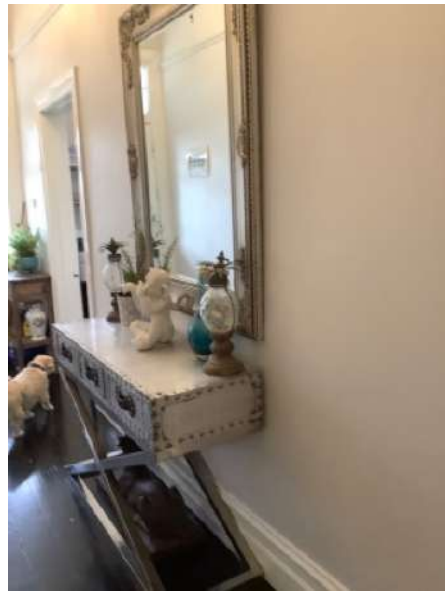
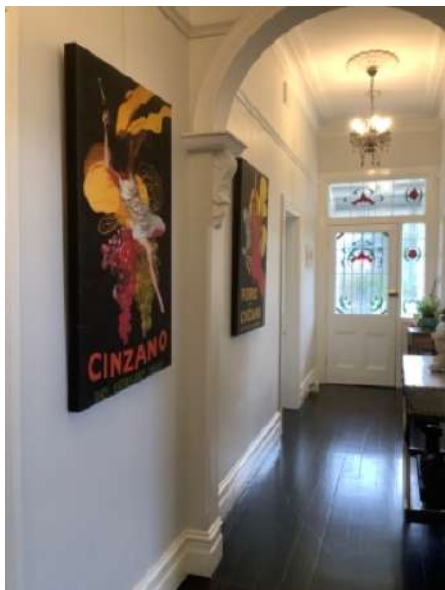
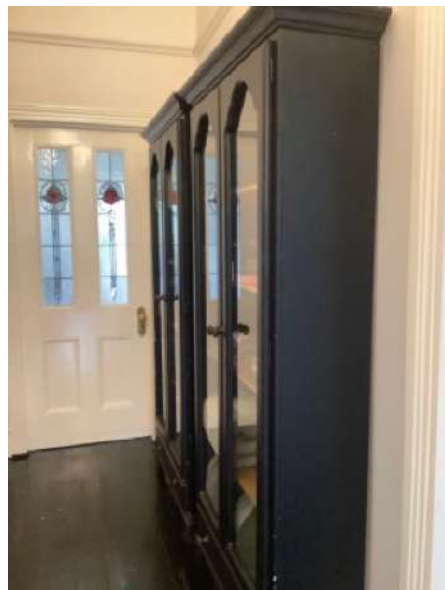
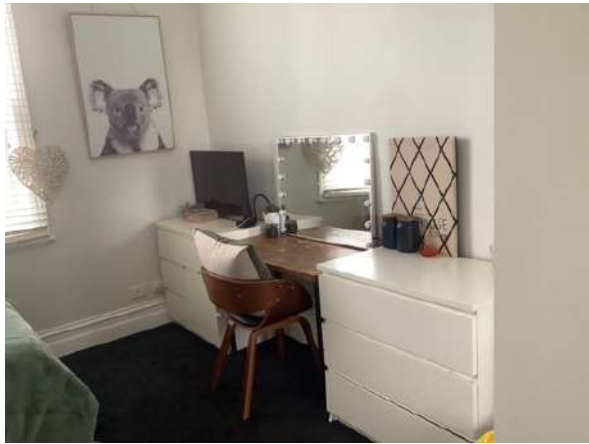
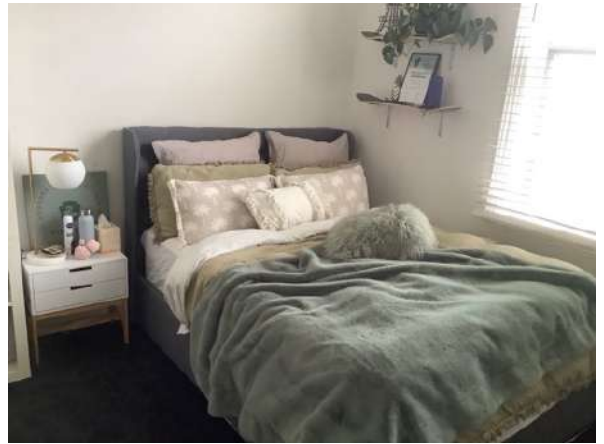
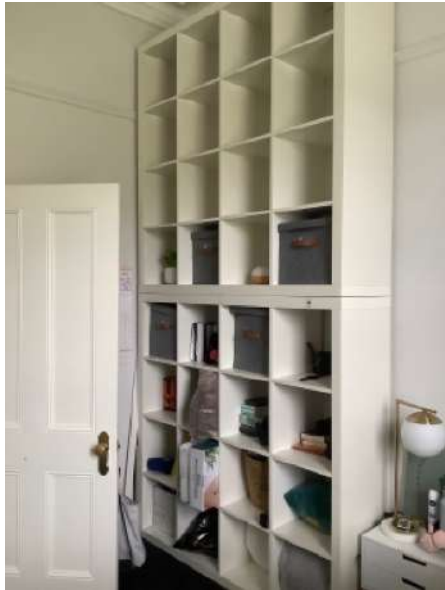
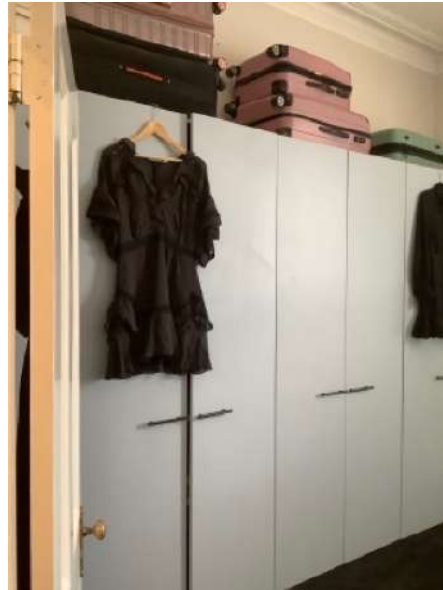
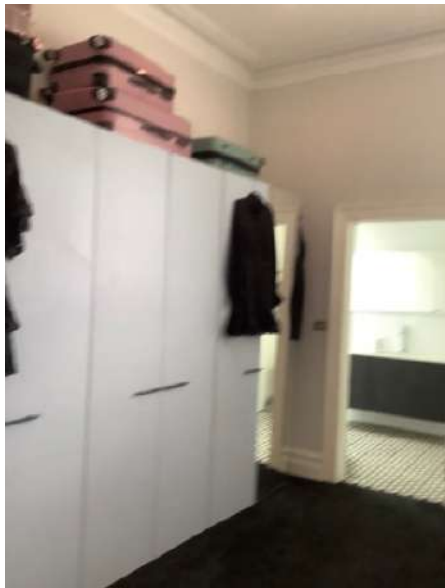
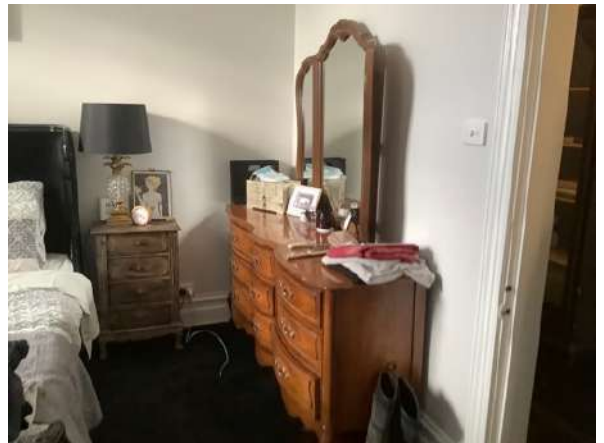
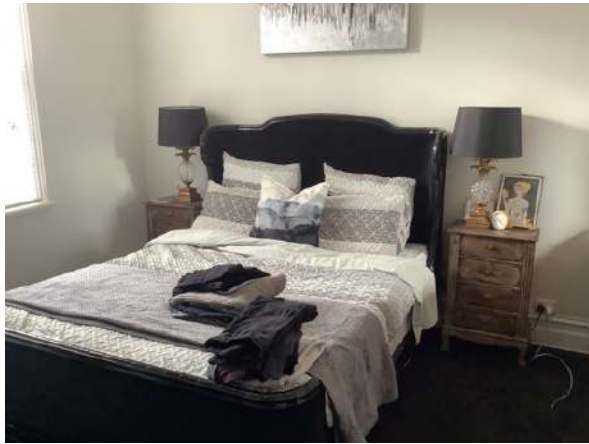
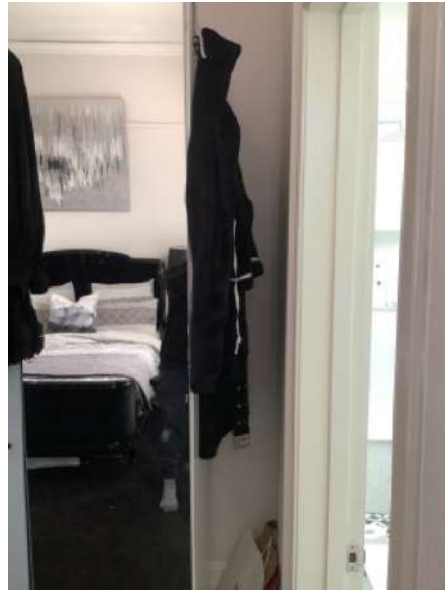
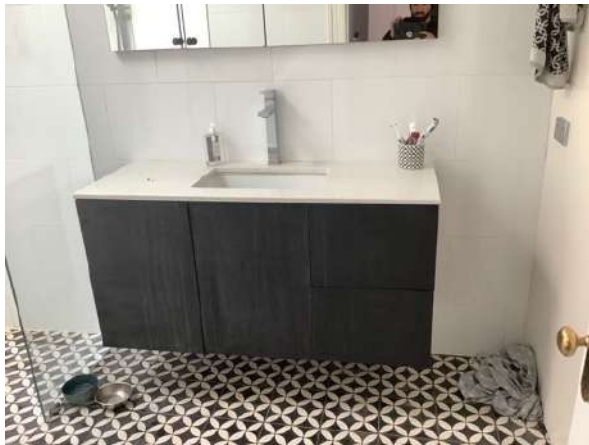
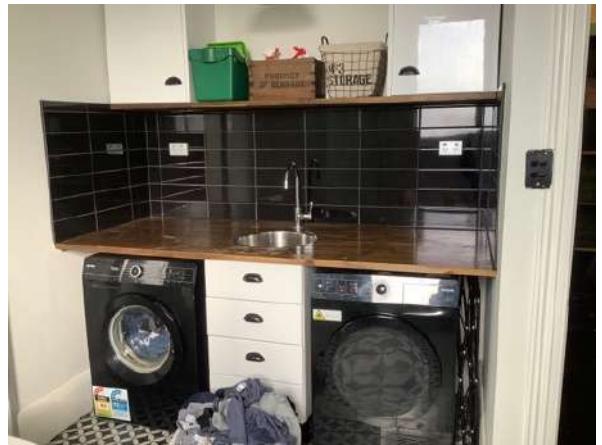
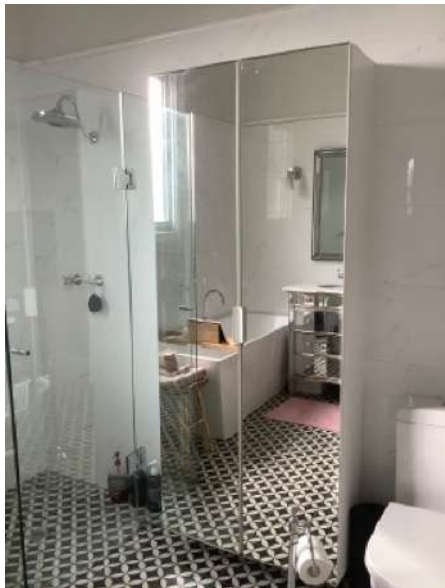
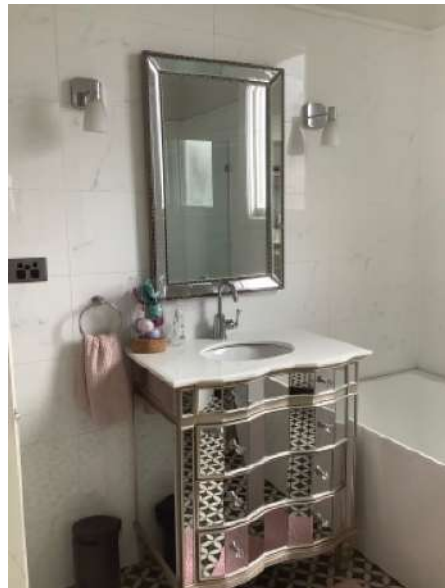
For your information 1.12

Location: The Site

These photos in the report are for you to understand the type of obstructions and limitations on site, that restricted our inspection process.

Once the property is emptied, a re-inspection is at the client's discretion.

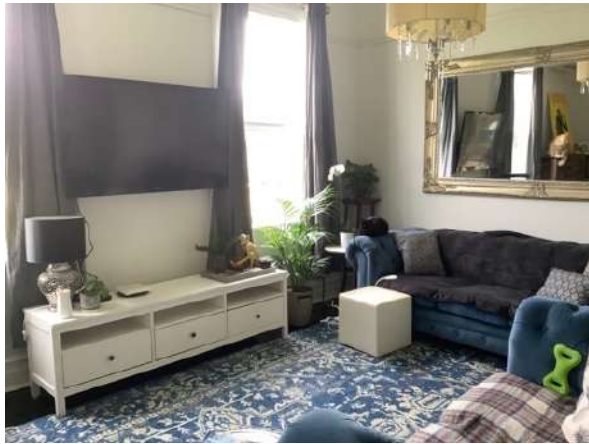
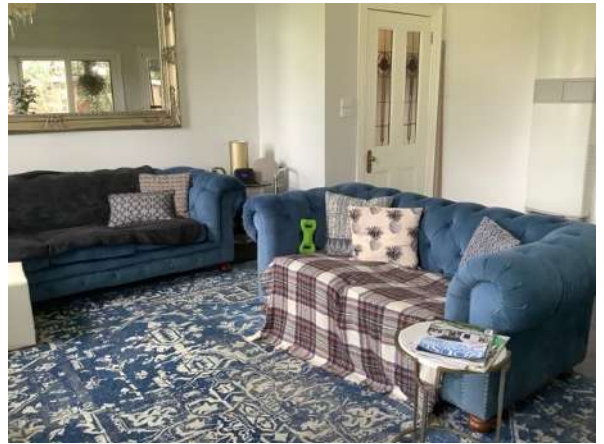
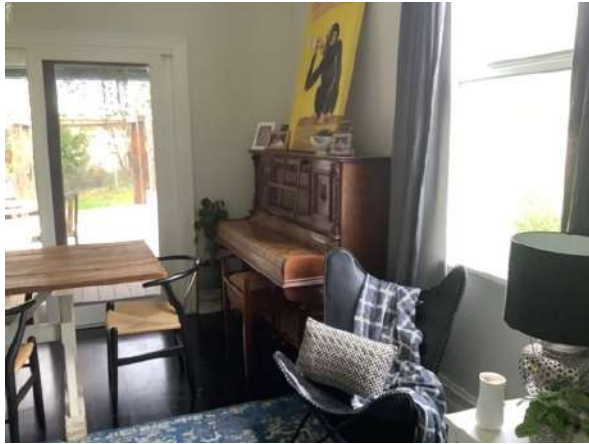
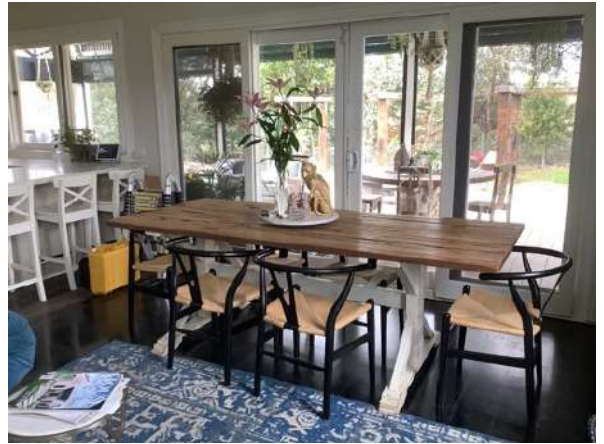
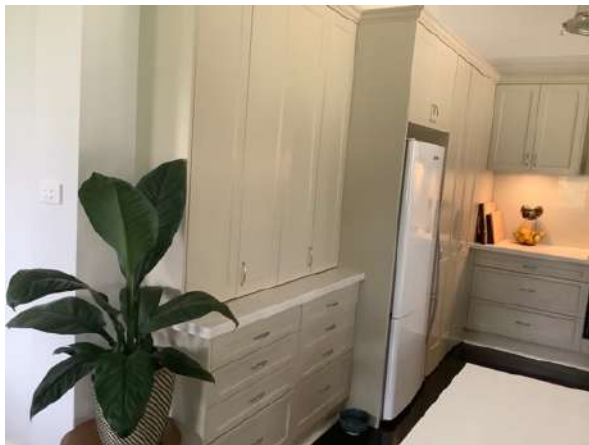
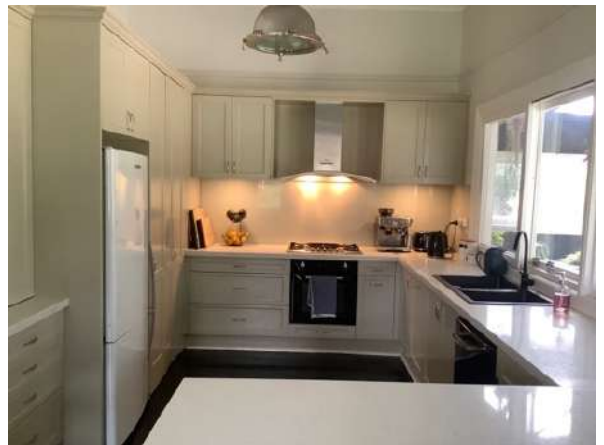
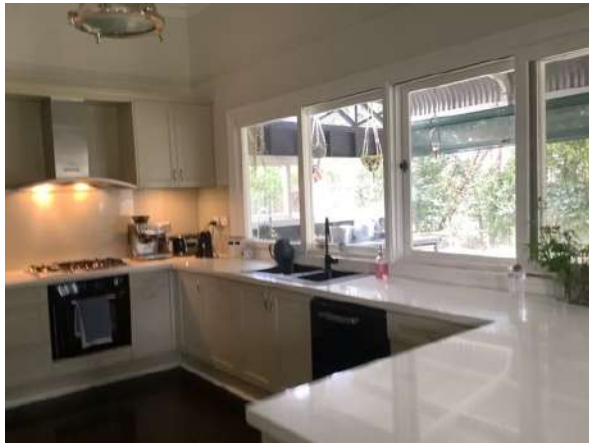
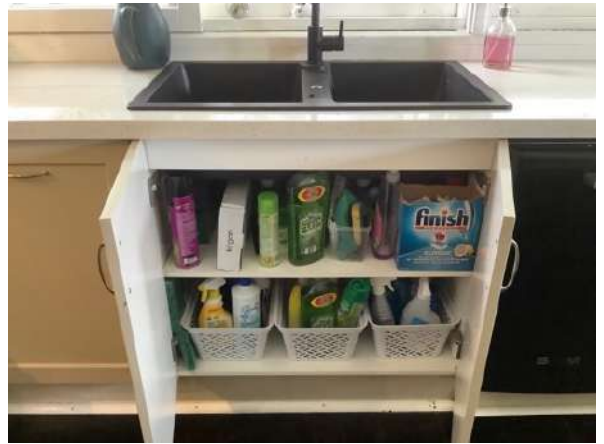
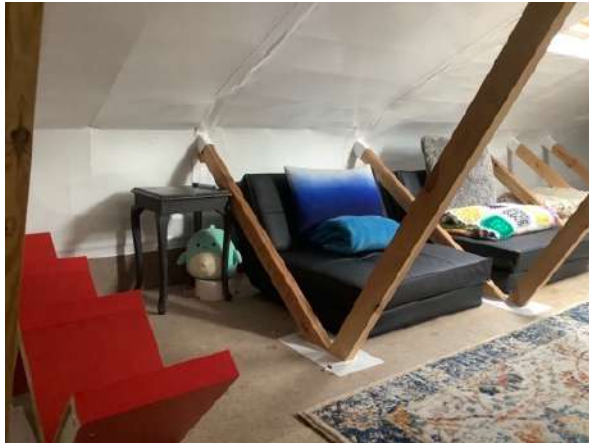
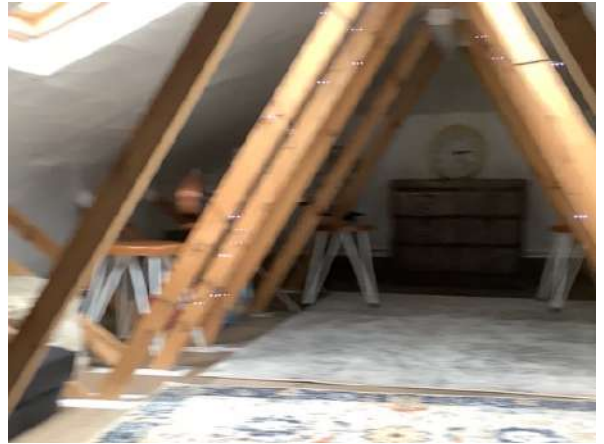
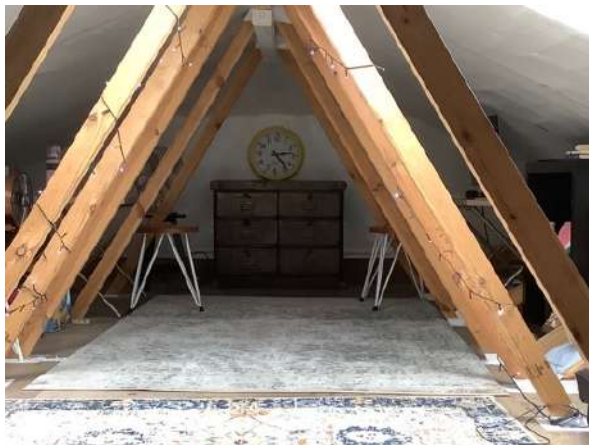
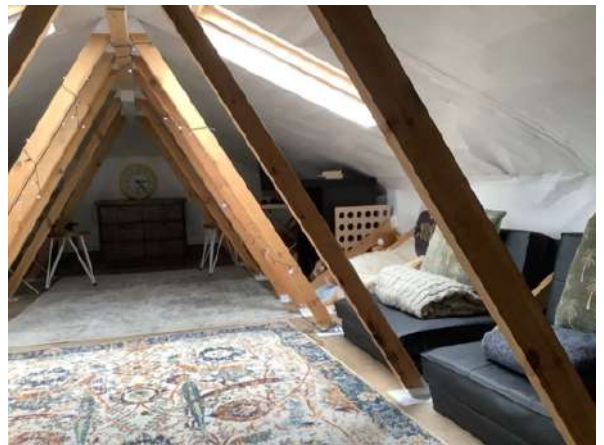
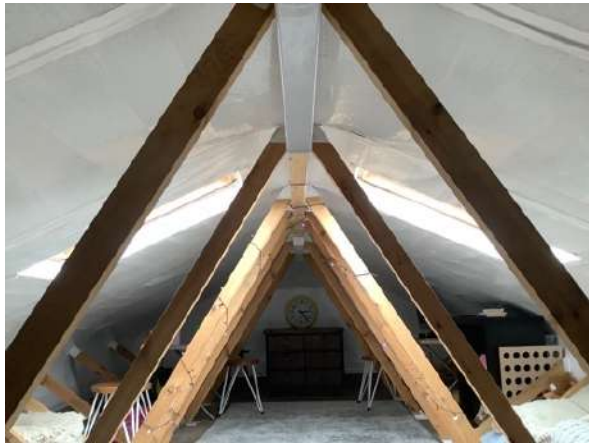
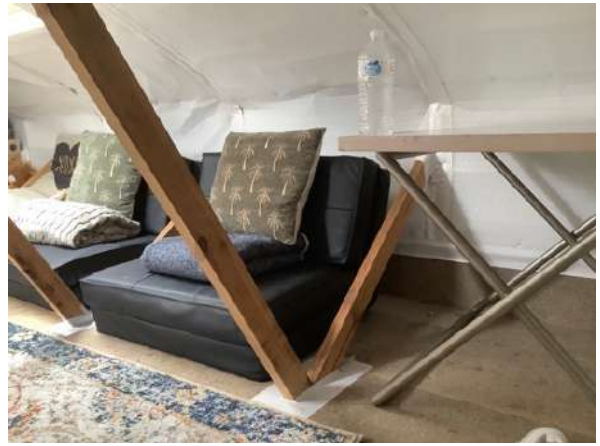
For your information 1.13

Location: The Site

All areas accessible of the dwelling are checked with particular attention paid to the wet areas which were closely assessed to check for excessive levels of moisture and temperature anomalies.

◆ The moisture content variation was within the acceptable range of 5% to 20%.

At the time of the inspection there was evidence of (timber pest) damage / activity and visually accessible timber damage caused by termites and / or timber pest.

The levels of moisture in all areas were found to be in the normal range.

As all areas are not able to be inspected due obstructions and limitations, we therefore can not rule out the possibility of concealed timber pest activity.

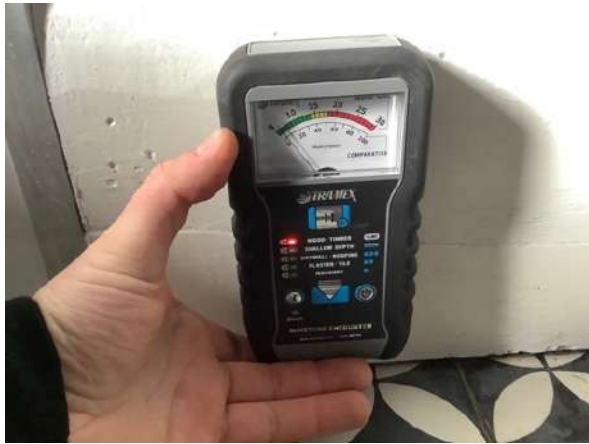
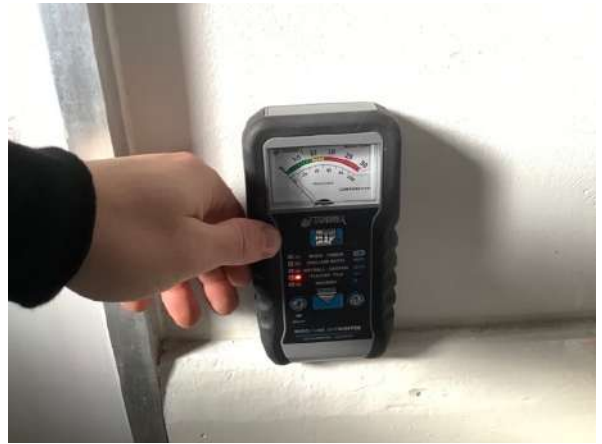
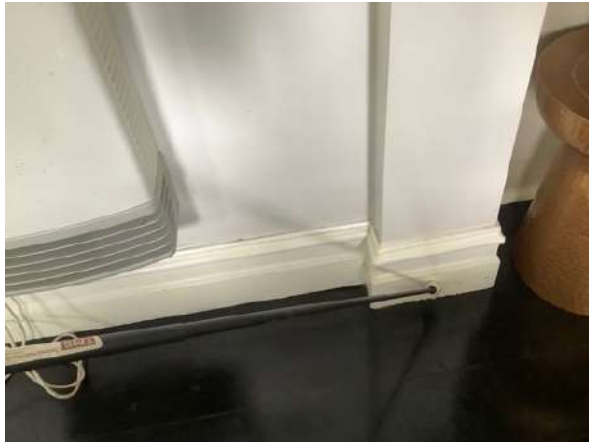
For your information 1.14

Location: The Site

At the time of the inspection there WAS EVIDENCE of termite (timber pest) activity and no visually accessible timber damage caused by termites and timber pest.

◆ It is very important to note that whilst it appears that the durable notice (sign) in the meter box is valid, the writing on the notice is very very hard to read so we highly recommend you contact the company to determine if the chemical termite barrier system is still valid to be 100% accurate.

The application of a post-construction chemical termite barrier and/or baiting stations or the like is highly recommended for all properties, particularly if live termite activity has been found on the site previously. Such barriers are highly effective in preventing termite attack on any timber building elements throughout the property.

We HIGHLY RECOMMEND the client may consider gaining further advice from a pest controller as to the costs and procedures involved with this application.

It is recommended that obtaining such advice be treated as HIGH PRIORITY.

The client IS HIGHLY RECOMMEND gaining further advice from a licensed pest controller as to the costs and procedures involved with application of a termite management system and/or eradication, which should be treated as HIGH PRIORITY.
