Termite/Timber Pest Report

Inspection Date: 1 Jul 2021

Property Address: King Lake area

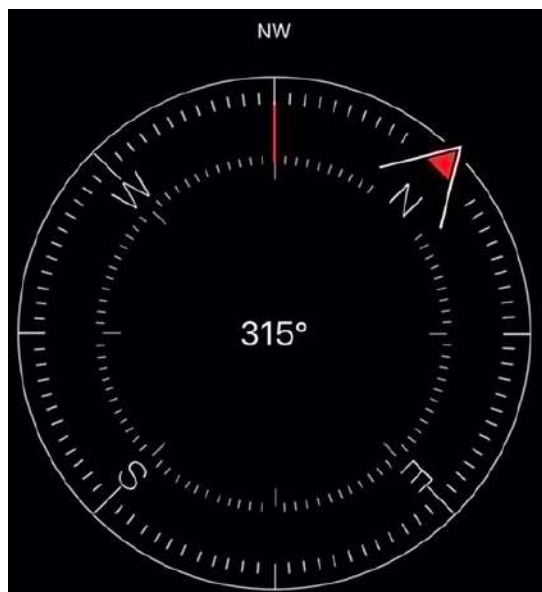
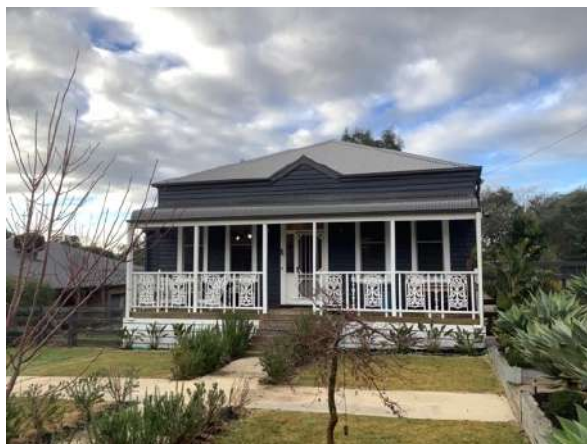
For your information 1.11

Location: For Your Information
 Finding: General Site Photos & Compass
 General site photos and other areas of interest are provided for your general reference.

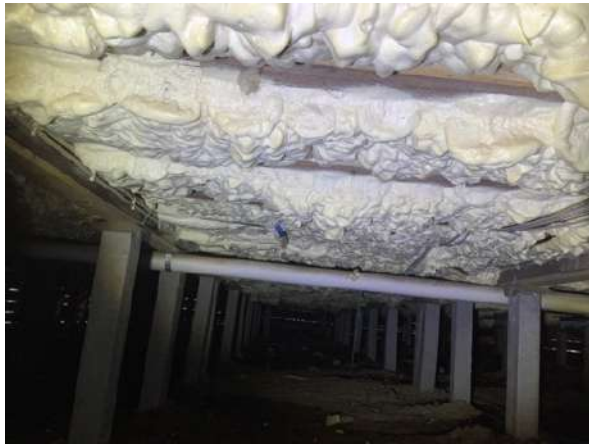
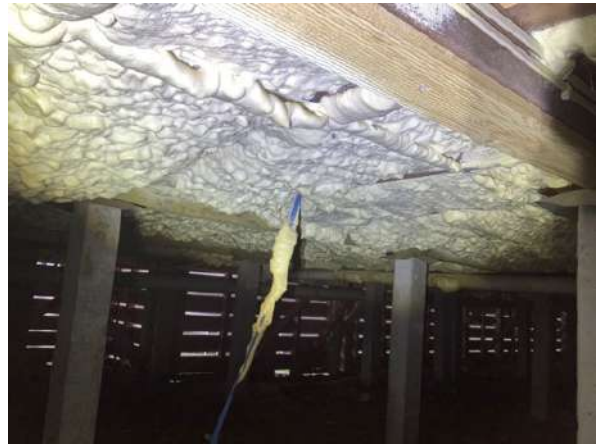
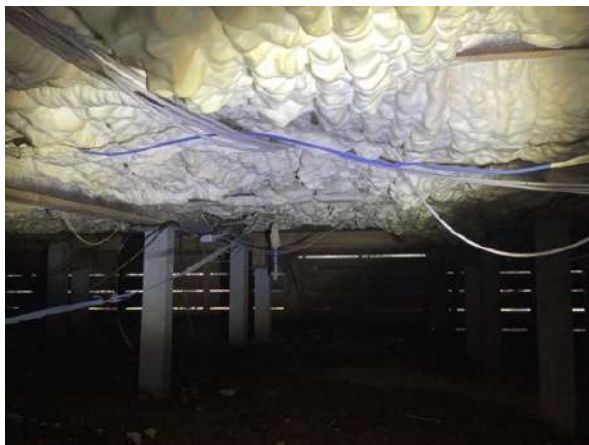
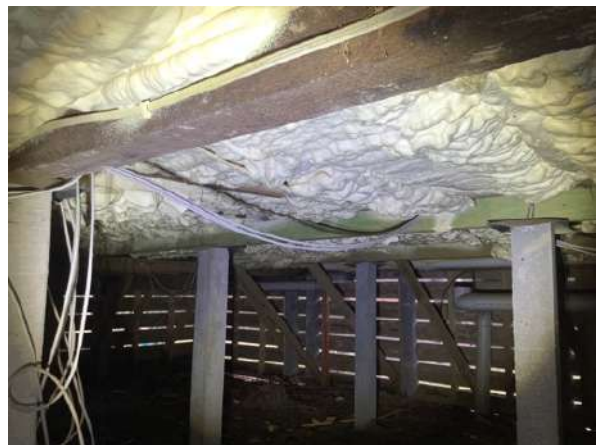
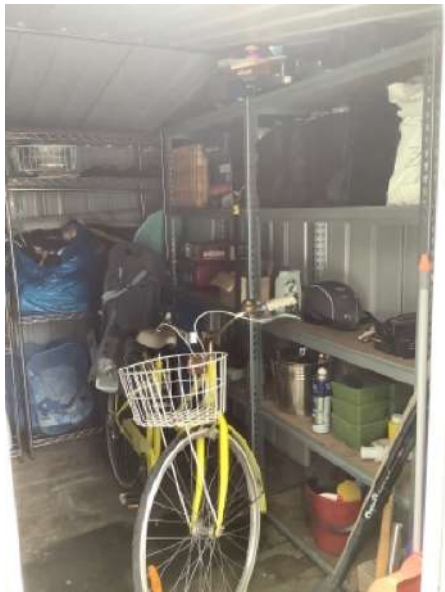
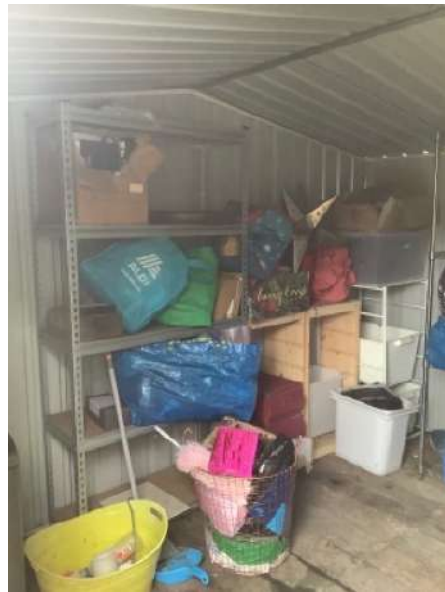
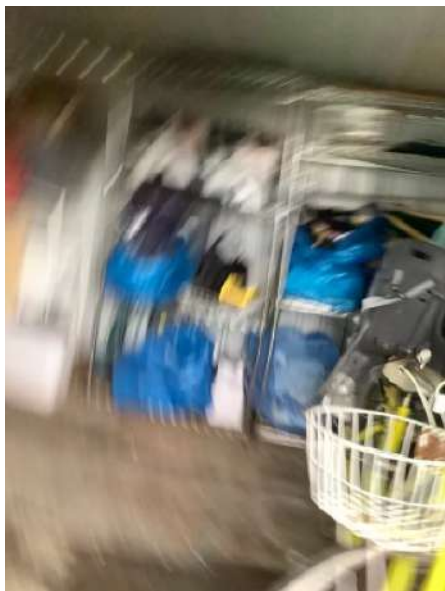
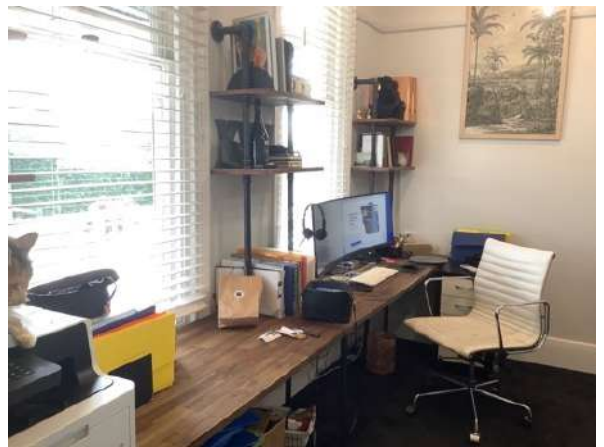
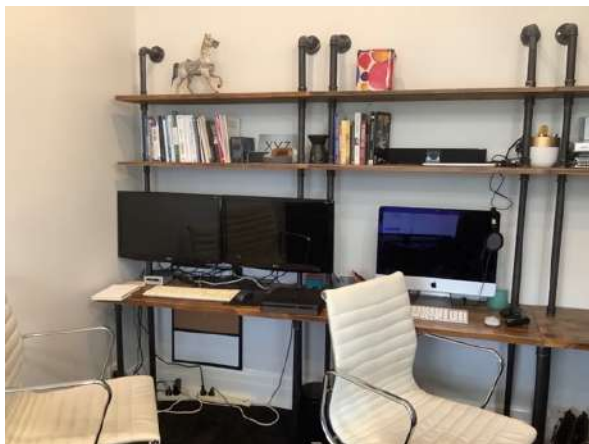
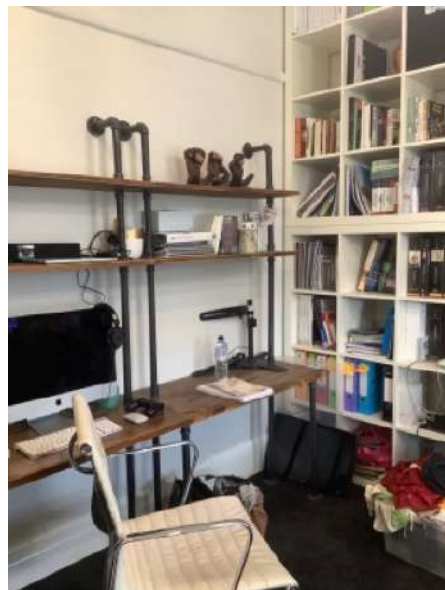
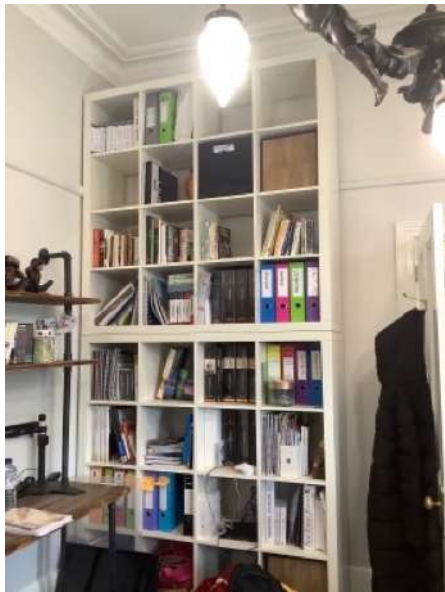
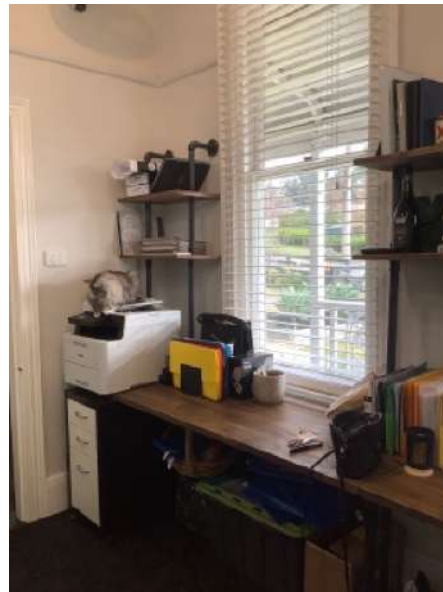
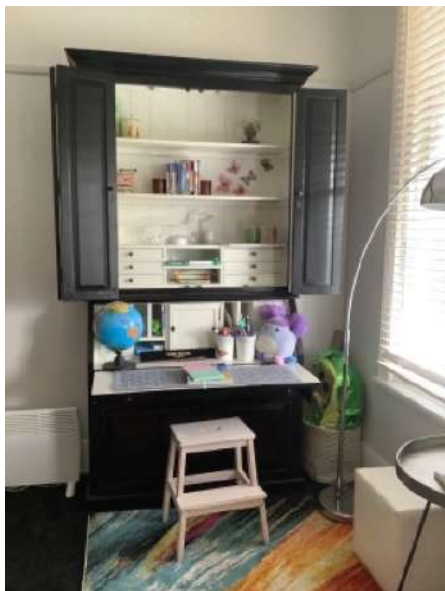
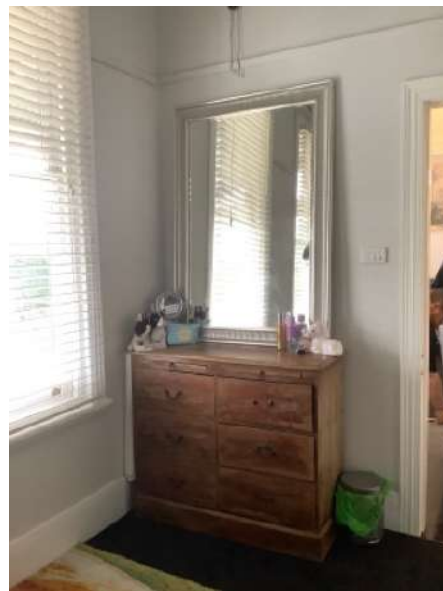
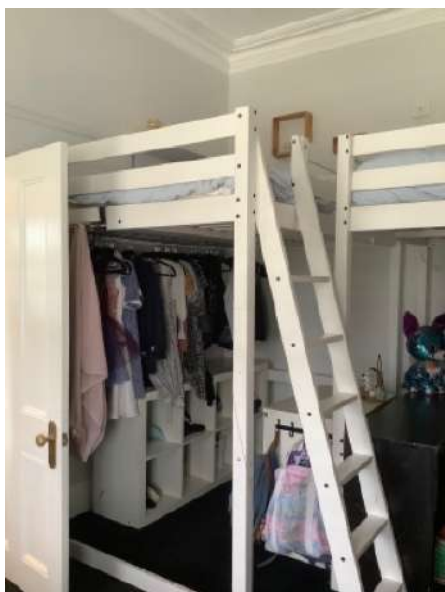
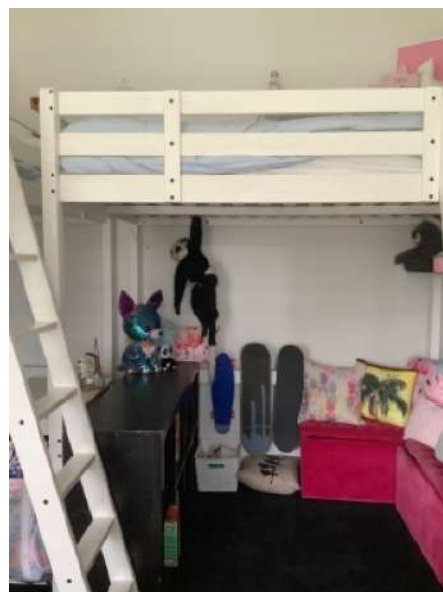
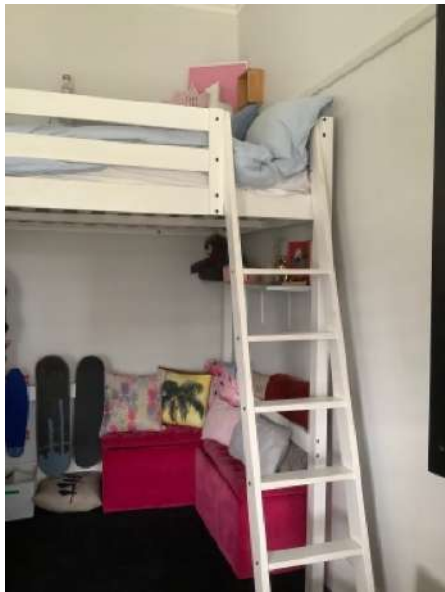
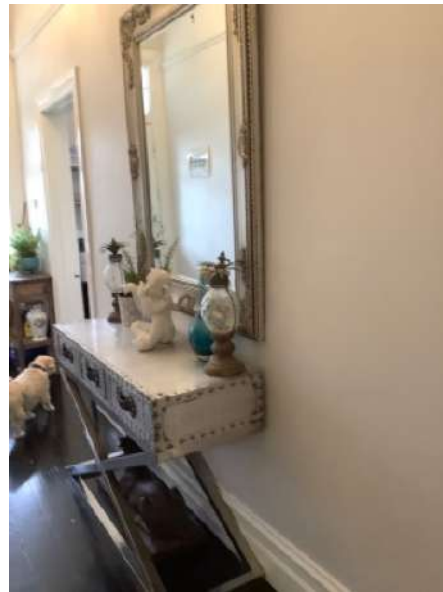
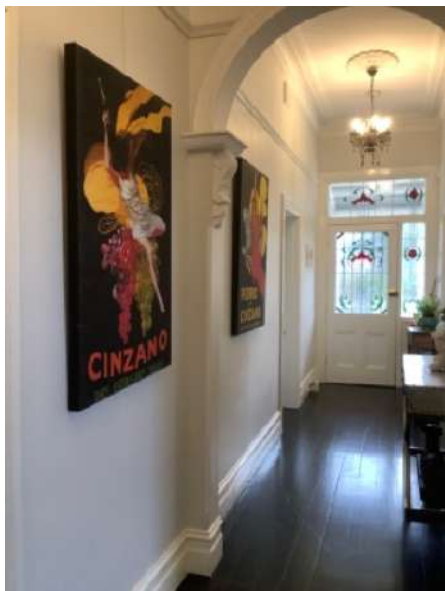
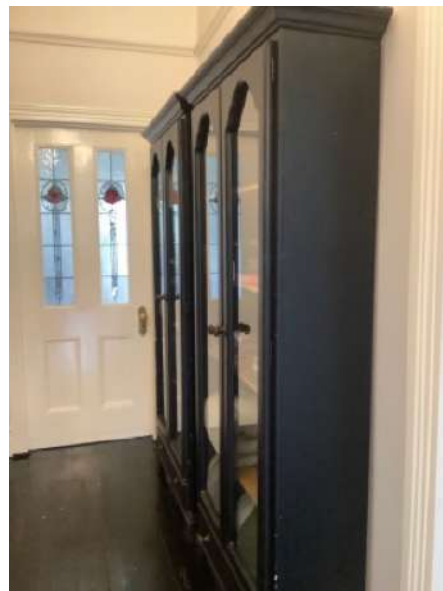
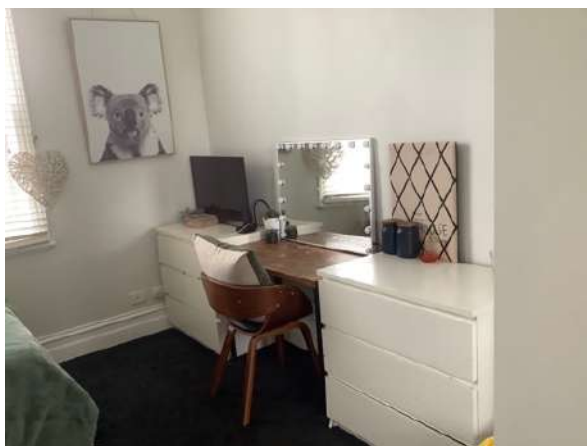
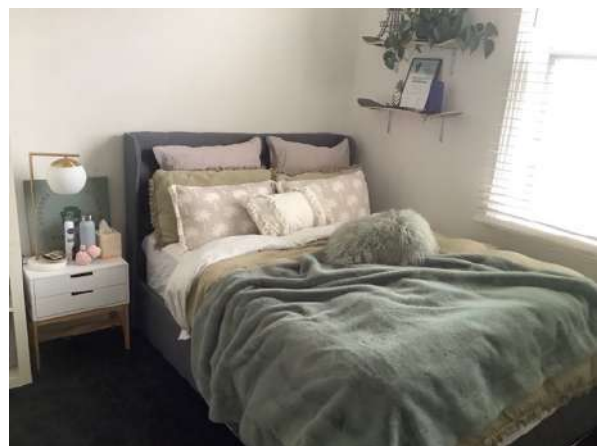
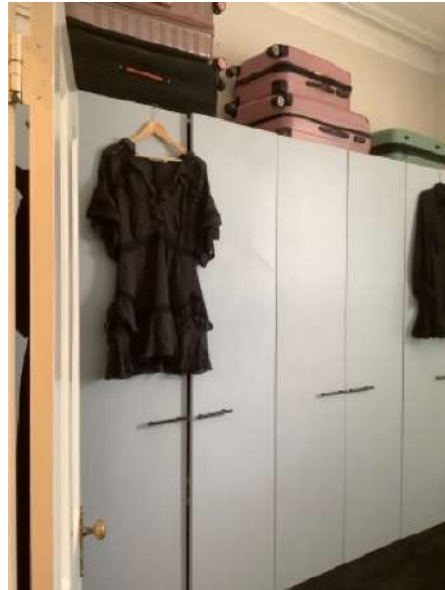
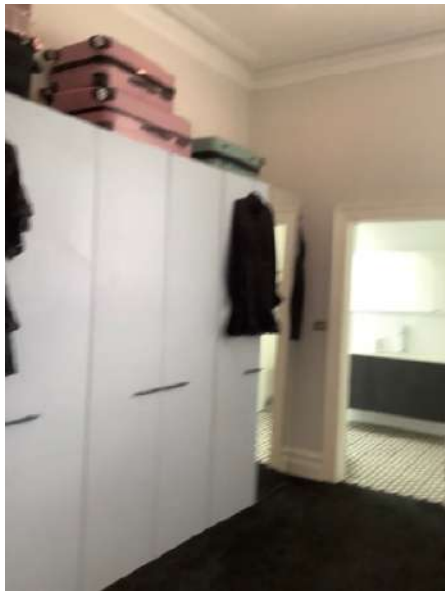
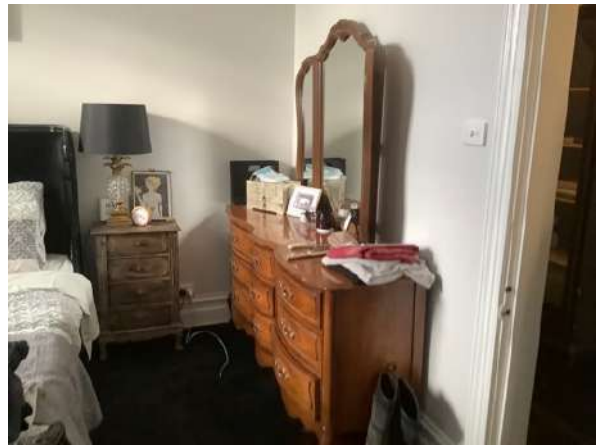
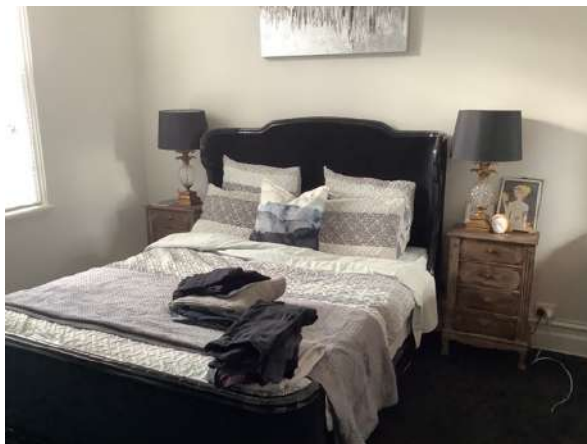
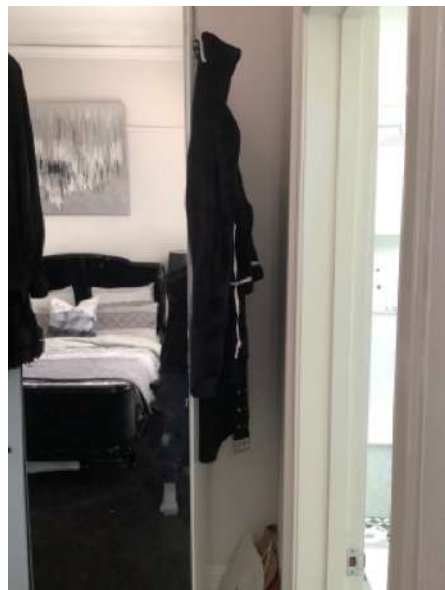
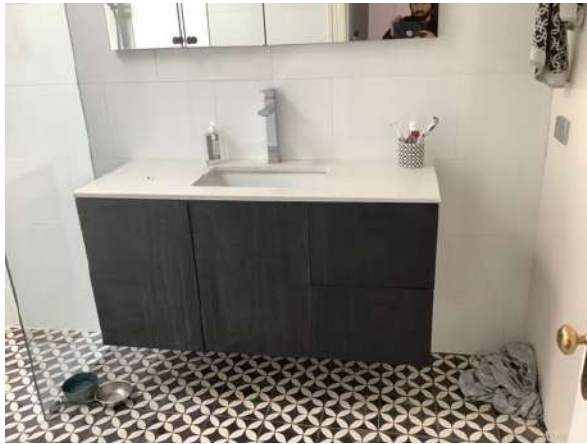
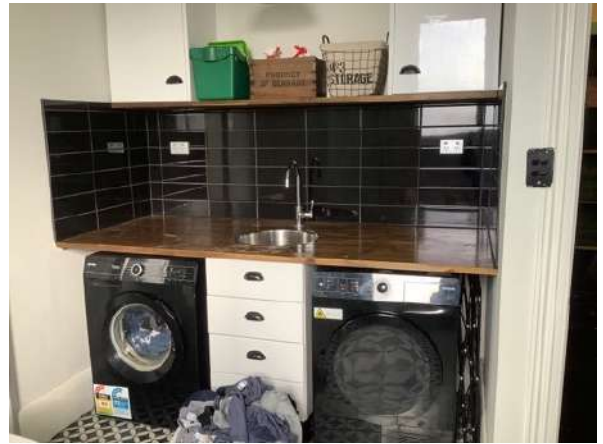
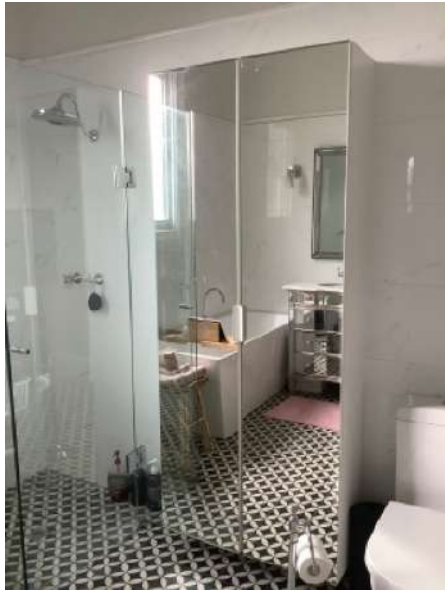
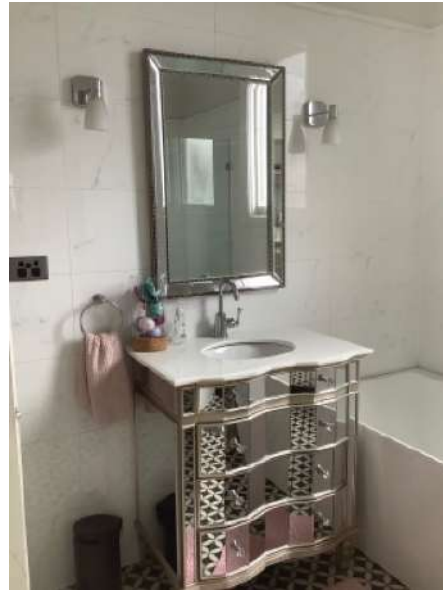
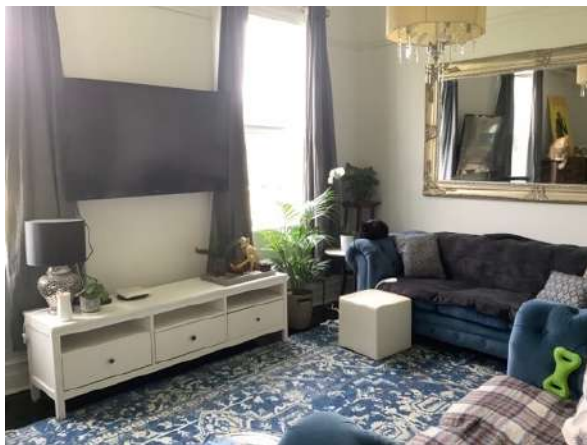
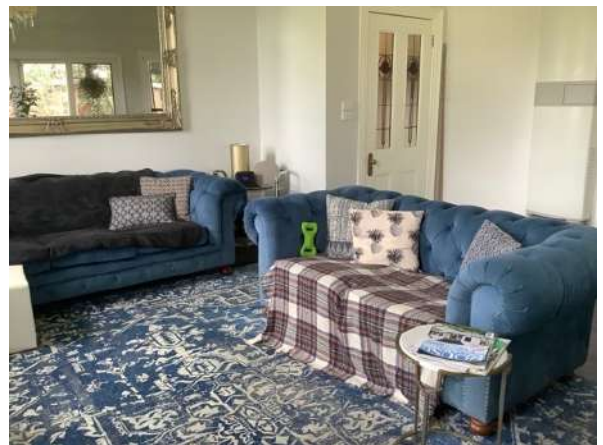
For your information 1.12

Location: The Site

These photos in the report are for you to understand the type of obstructions and limitations on site, that restricted our inspection process.

Once the property is emptied, a re-inspection is at the client's discretion.

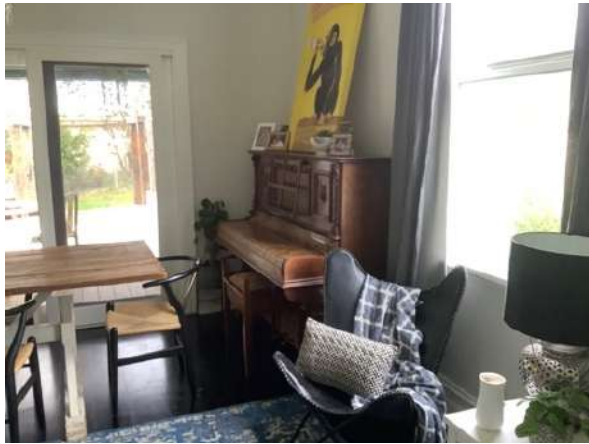
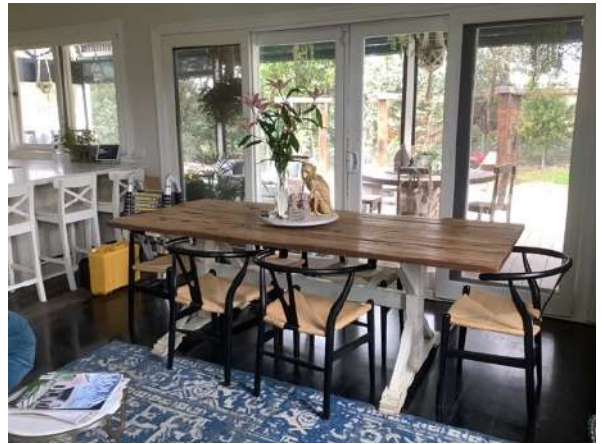
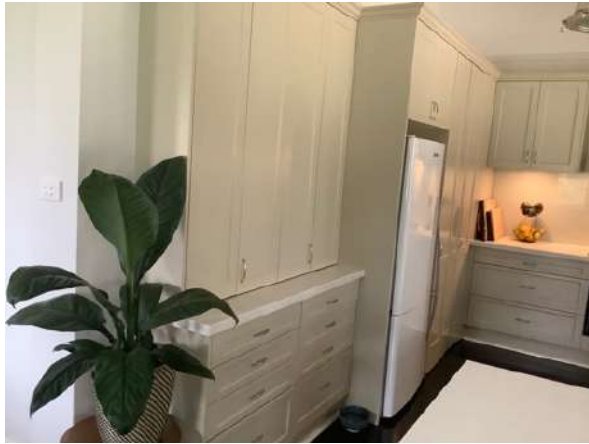
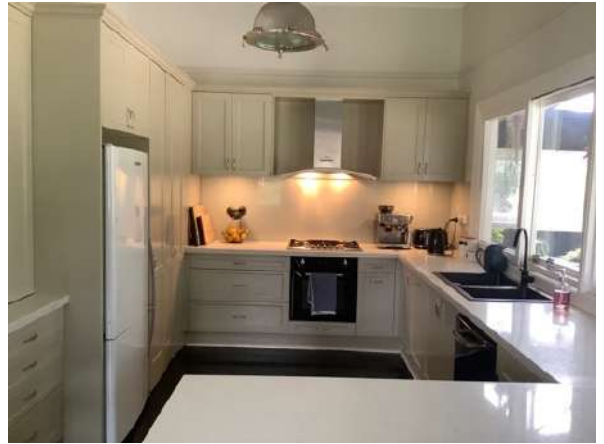
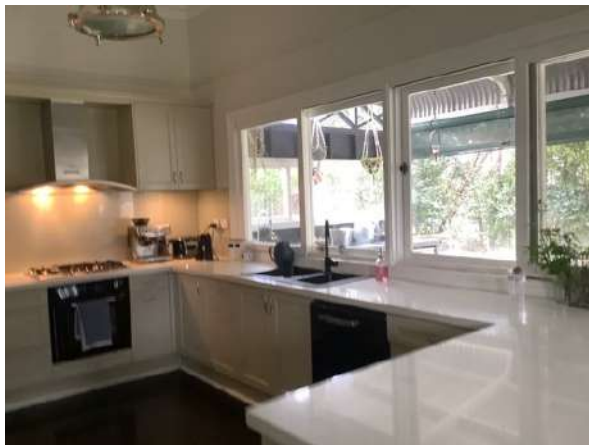
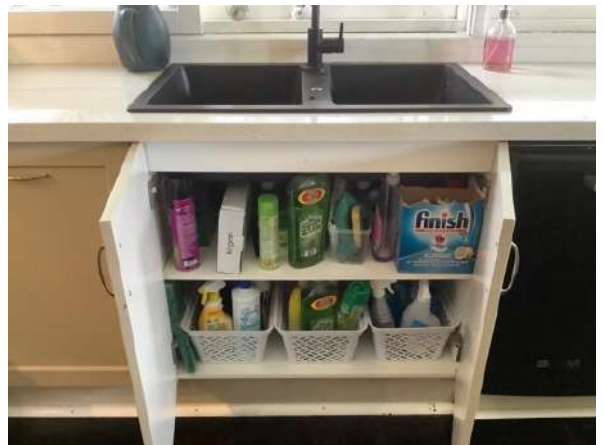
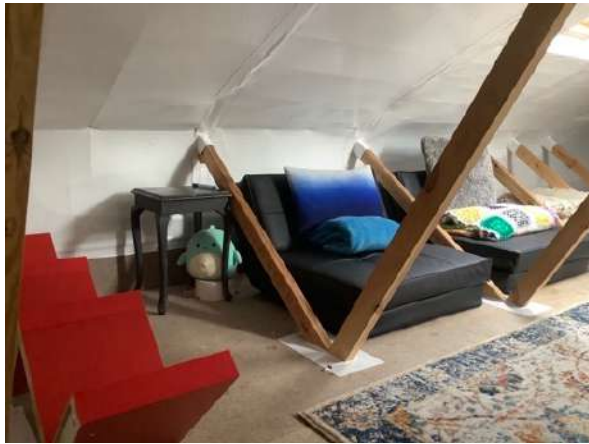
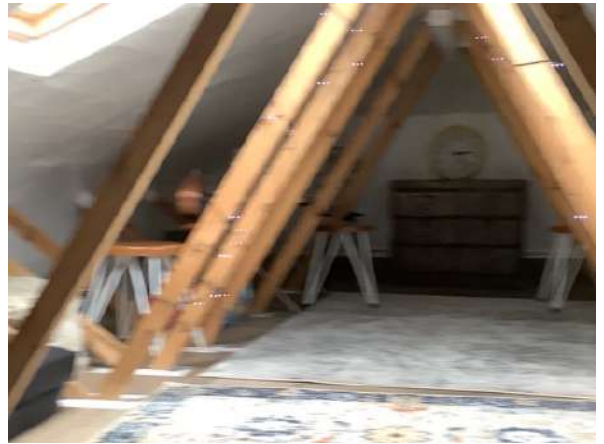
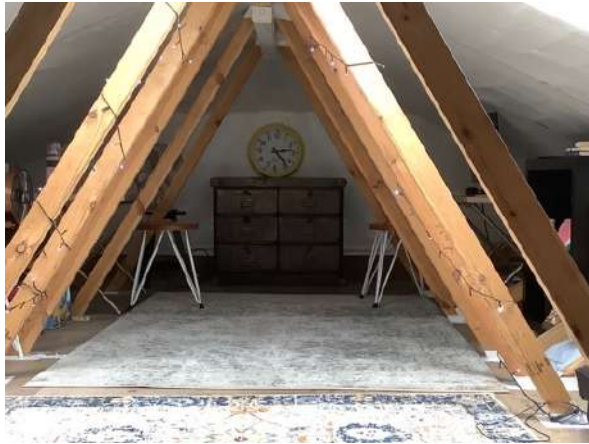
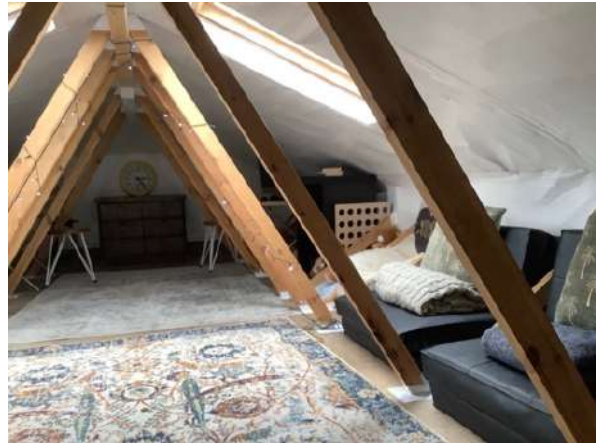
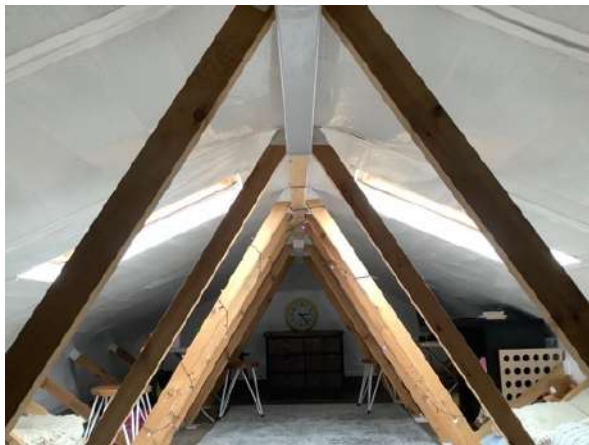
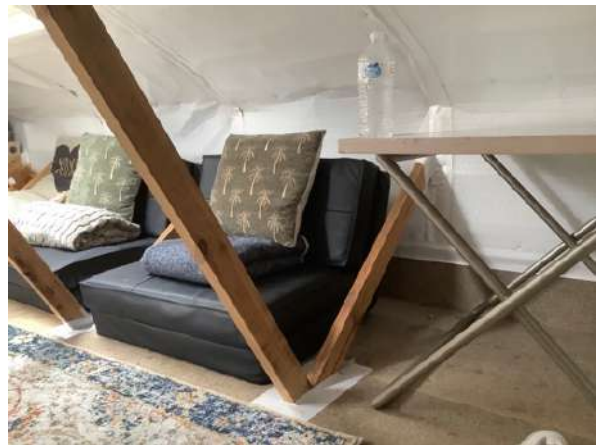
For your information 1.13

Location: The Site

All areas accessible of the dwelling are checked with particular attention paid to the wet areas which were closely assessed to check for excessive levels of moisture and temperature anomalies.

◆ The moisture content variation was within the acceptable range of 5% to 20%.

At the time of the inspection there was evidence of (timber pest) damage / activity and visually accessible timber damage caused by termites and / or timber pest.

The levels of moisture in all areas were found to be in the normal range.

As all areas are not able to be inspected due obstructions and limitations, we therefore can not rule out the possibility of concealed timber pest activity.

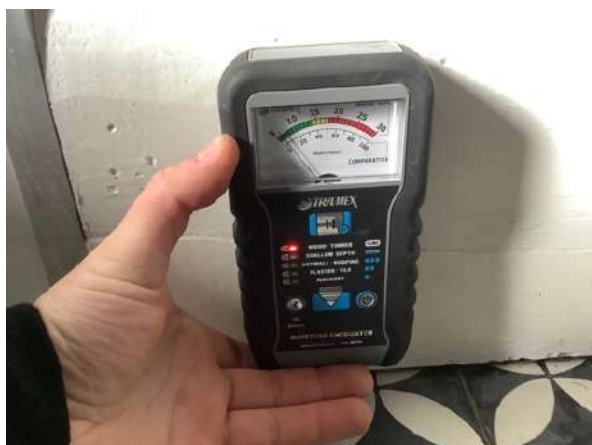
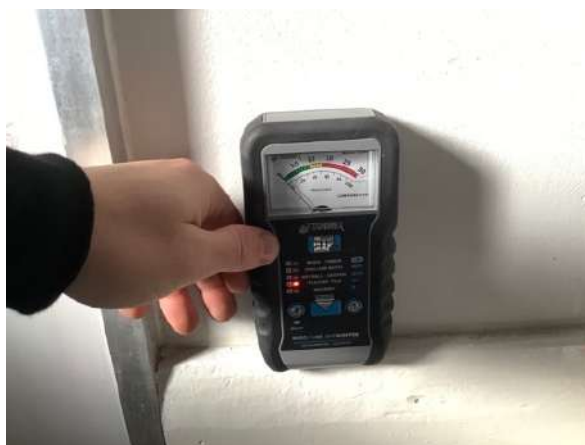
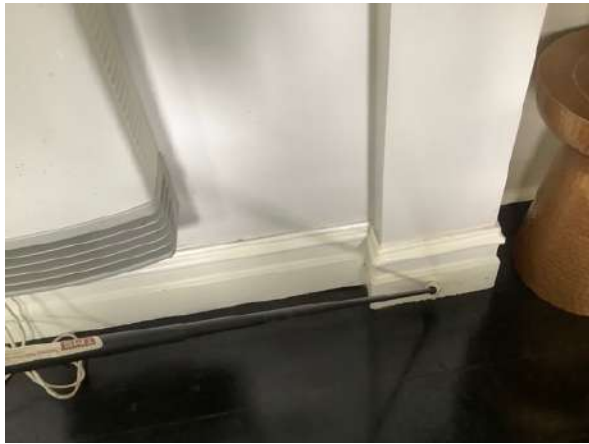
For your information 1.14

Location: The Site

At the time of the inspection there WAS EVIDENCE of termite (timber pest) activity and no visually accessible timber damage caused by termites and timber pest.

◆ It is very important to note that whilst it appears that the durable notice (sign) in the meter box is valid, the writing on the notice is very very hard to read so we highly recommend you contact the company to determine if the chemical termite barrier system is still valid to be 100% accurate.

The application of a post-construction chemical termite barrier and/or baiting stations or the like is highly recommended for all properties, particularly if live termite activity has been found on the site previously. Such barriers are highly effective in preventing termite attack on any timber building elements throughout the property.

We HIGHLY RECOMMEND the client may consider gaining further advice from a pest controller as to the costs and procedures involved with this application.

The client IS HIGHLY RECOMMEND gaining further advice from a licensed pest controller as to the costs and procedures involved with application of a termite management system and/or eradication, which should be treated as HIGH PRIORITY.
