Vendors Report - Building & Termite/Timber Pest

Inspection Date: 7 Jul 2021

Property Address: Glenroy area

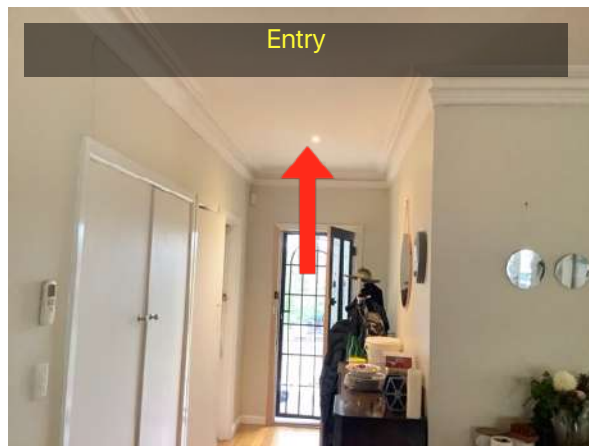
Please note that this defect is highlighted as a caution only. We suspect, based on our experience in the building industry, that the absence of smoke detectors should be addressed as a matter of urgency to improve occupant safety.

A qualified electrician is required do these works for hard wiring.

Upon completion a safety certificate is required to be supplied to the owner of the building.

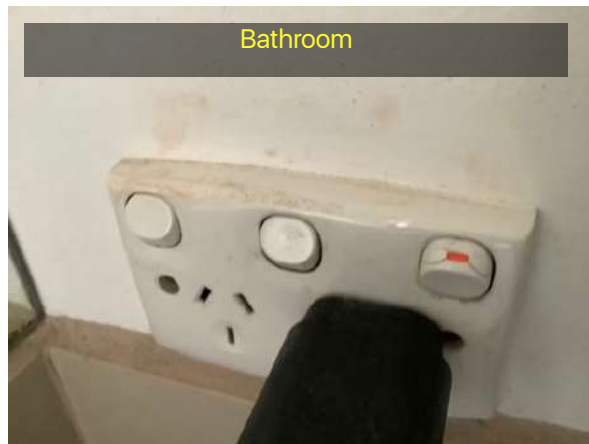
Serious Safety Hazard 1.02

Location: Electrical - All Areas

Finding: Electrical Power Points - Damaged/Faulty

The power points in areas were found to be damaged or faulty at the time of inspection. This occurs generally when the power point plate or the switch mechanisms have either worn, decayed or burnt out as a result of electrical arching.

Repair and/or replacement of the power points is advised to ensure the fixture and it's associated structures are safe and fully operational.

A licensed electrician should be appointed to repair/replace the power points as soon as possible.

Please engage a licensed electrician to further inspect the property for the repairs and replacements as required.

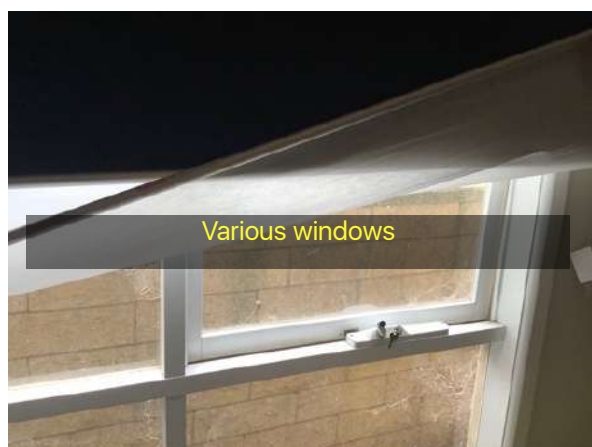
Serious Safety Hazard 1.03

Location: Windows - Internal Areas

Several windows throughout the property were jammed and difficult to operate at the time of the inspection. Windows provide ventilation to the adjoining area and should be at a fully operational level to ensure user comfort. Restricted function of the window may also pose as a potential safety hazard if required for emergency egress from the building.

Generally, factors such as general age of the building element and a lack of maintenance are the usual causes for this type of defect.

The windows may have several causes, ranging from minor defects as outlined above through to major structural issues, such as damage and/or subsidence (sinking) to subfloor structures or concrete slabs.

For minor causes of repair, replacement where window hardware or frame may be required, as well as minor repairs and cleaning, a qualified carpenter, registered builder, window specialist/ company or general handy person will be required to repair the affected windows.

Windows MUST function as a safety requirement and we HIGHLY RECOMMEND that you engage an appropriate professional as soon as possible to check all windows to the property.

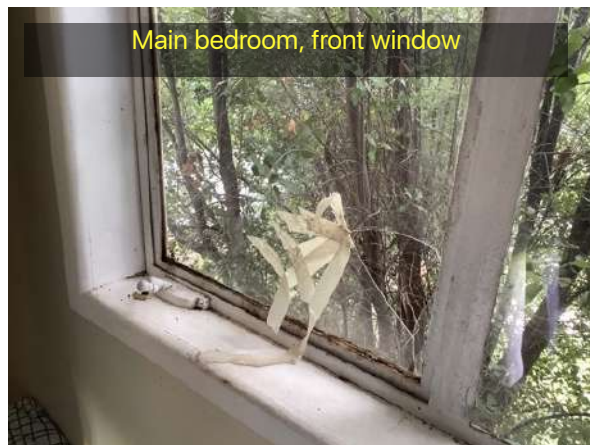
Serious Safety Hazard 1.04

Location: Windows - Internal Areas

Finding: Window - Cracked

Cracks were identified in the windows. Cracking in windows is generally the result of impact damage, windows not operating smoothly and/or building movement and is likely to develop further when left unmanaged.

The likelihood of this window pane further cracking and shattering is increased exponentially, providing a safety hazard in the area. The cracked window also impairs the weather tightness of the building, creating potential for minor water leaks.

Please be advised that any persons coming into contact with the cracked window should do so with due caution to avoid any personal injury that may ensue.

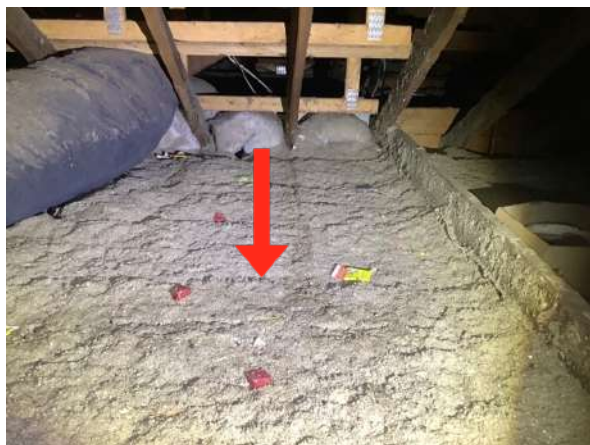
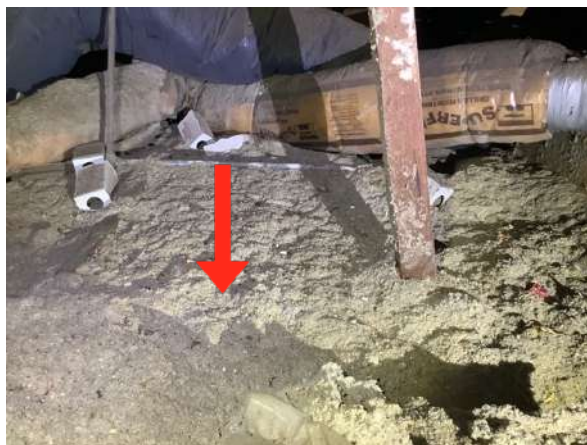
Serious Safety Hazard 1.05

Location: Roof Space

Finding: Down Lights / Insulation - Fire Hazard.

A minimum distance of clearance from the down light to the insulation is required pending on the type of light and we **HIGHLY RECOMMEND** that this fire hazard defect be attended to as a matter of urgency.

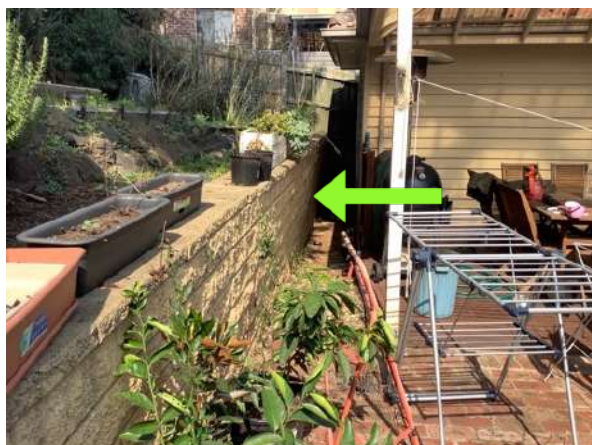
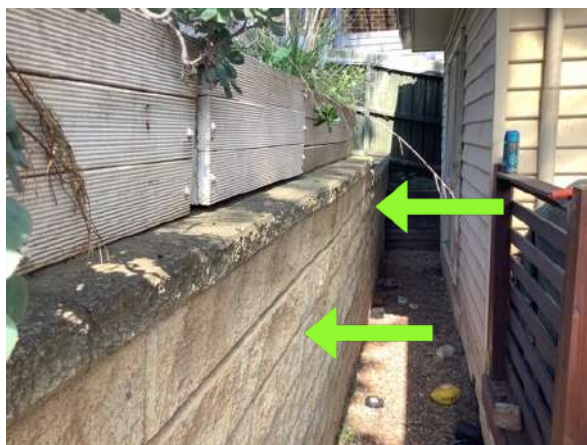
Serious Safety Hazard 1.06

Location: External Areas

Finding: Retaining Wall - Defective

If left unmanaged, the retaining wall may become a safety hazard if it continues to destabilise. Where retaining walls further rot and decay, an environment is created that is conducive to termite and pest infestation.

Significant repair and replacement should be expected. Where retaining walls are considered structural walls, a structural engineer / surveyor should be consulted regarding required remedial works. Otherwise, a landscaper or retaining wall installer may be appointed to repair or replace the wall, at the discretion of the client.

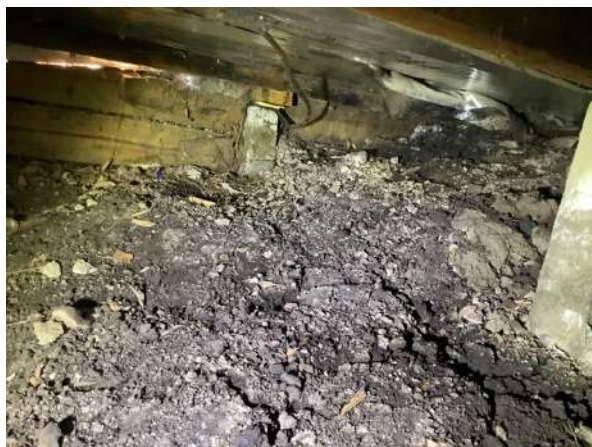
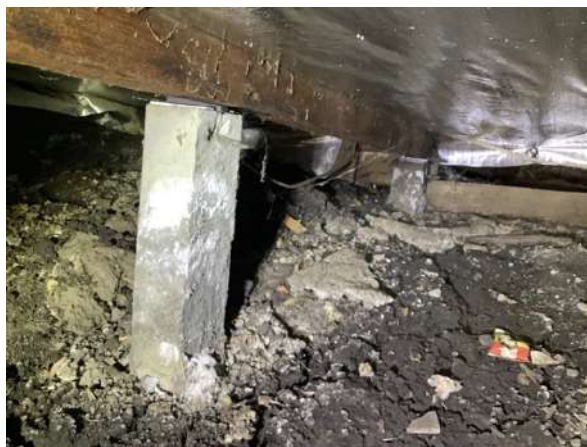
Serious Safety Hazard 1.07

Location: Subfloor

Finally the cause or source of the mould MUST BE TAKEN CARE OF URGENTLY.

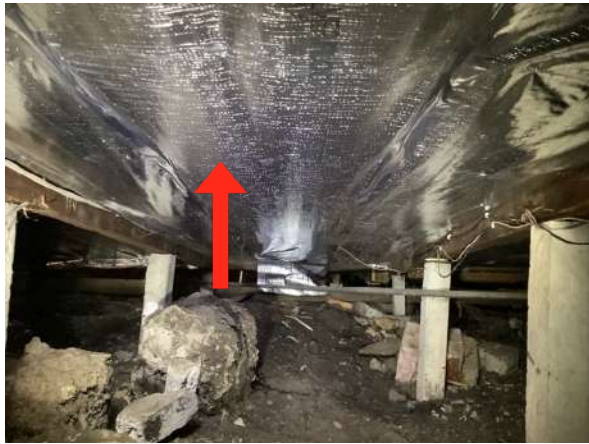
Serious Safety Hazard 1.08

Location: Subfloor

Finding: Silver insulation

The silver insulation under the subfloor area is a high safety hazard as this product is an electrical conductor and in the event electricity is to come in contact with this product, the subfloor area maybe come live with 240 V, putting potential lives at risk.

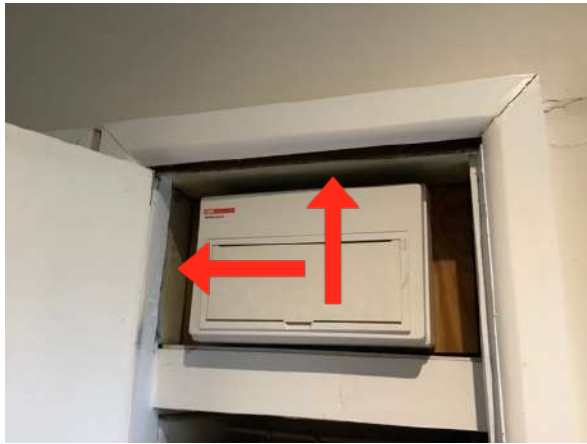
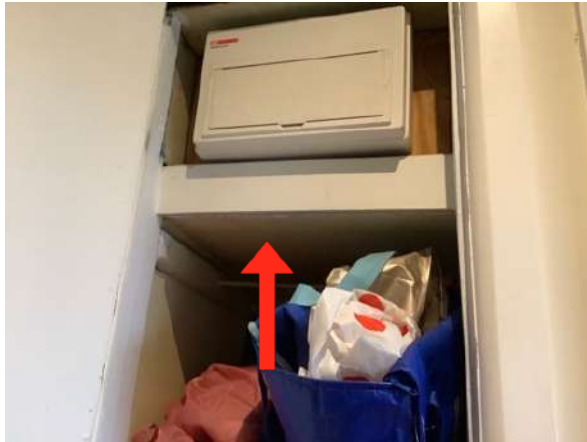
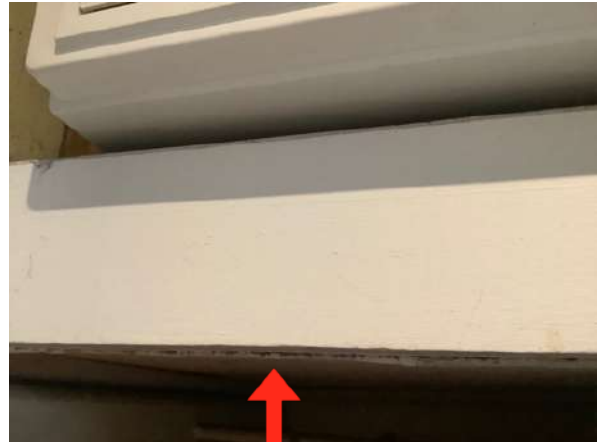
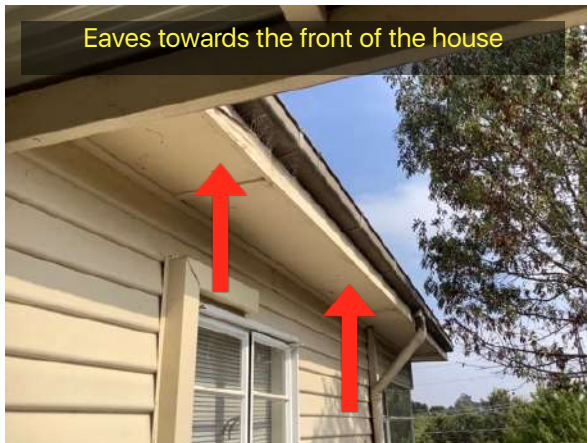
Serious Safety Hazard 1.09

Location: Asbestos - Various Areas

In the interim, the client is advised to act with caution, especially when considering any damage to building materials general wear and tear renovations extensions demolition and general maintenance activities due to the suspected presence of Asbestos.

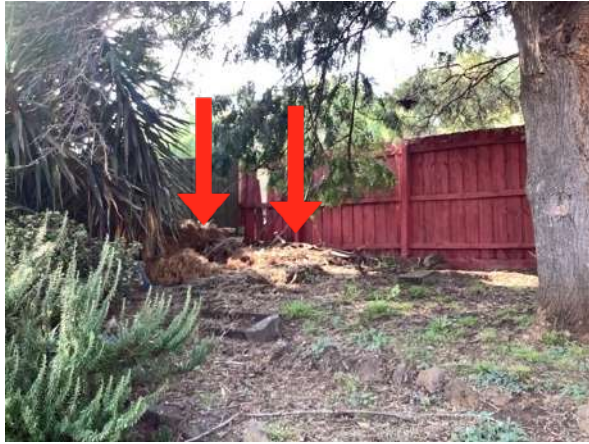
Serious Safety Hazard 1.10

Location: Garden Areas - All Areas

This type of environment also creates a very conducive environment for termites as well.

I highly recommend as a matter of urgency the entire area be cleaned up by a handyman, gardener or competent similar persons and in addition the possibility of Vermin/Rodents/Snakes/Etc maybe of high risk as these conditions would be perfect.

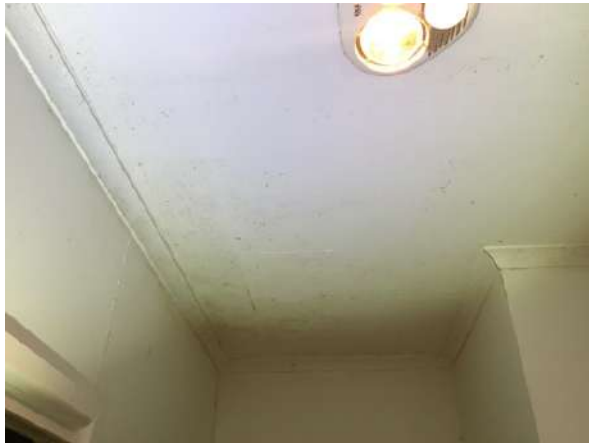
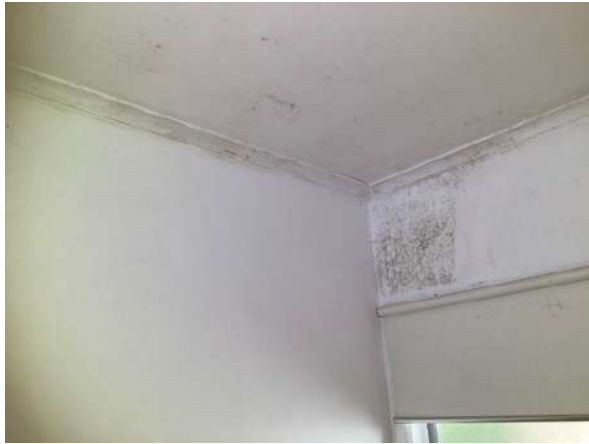
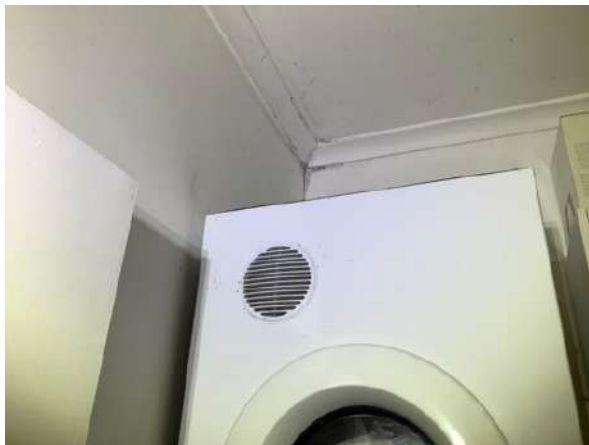
Serious Safety Hazard 1.11

Location: Bathroom And Laundry

Finally the cause or source of the mould MUST BE TAKEN CARE OF URGENTLY.

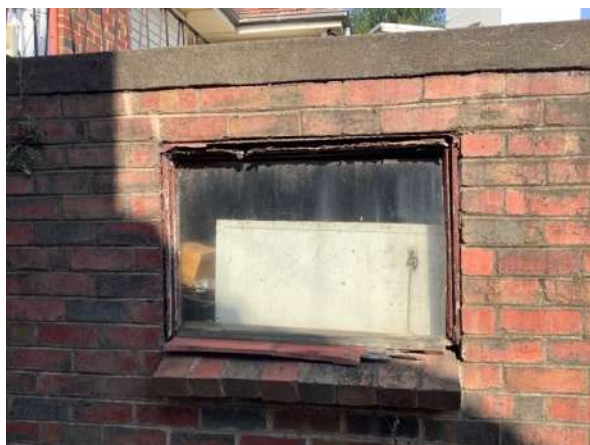
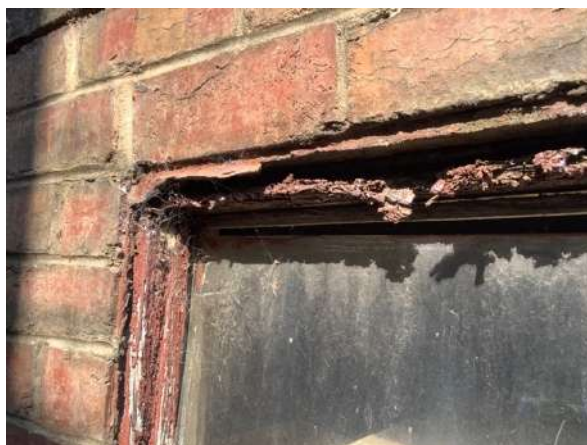
Serious Safety Hazard 1.12

Location: Garage
Finding: Windows - Wood Rot

Repair and/or replacement of affected window frames may be a necessary step in protecting surrounding building elements from such deterioration. Remedial works should be performed by a qualified carpenter or registered builder as soon as possible to prevent any further damage.

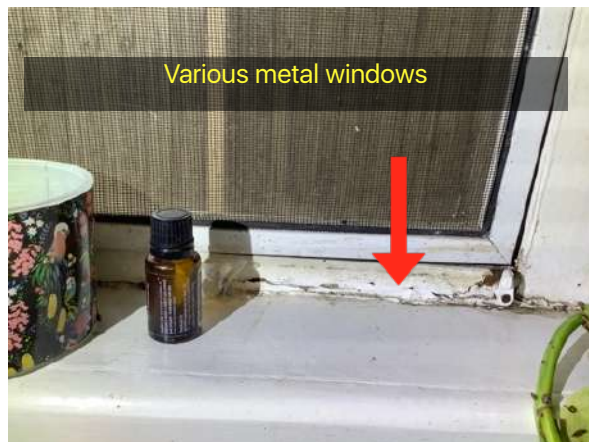
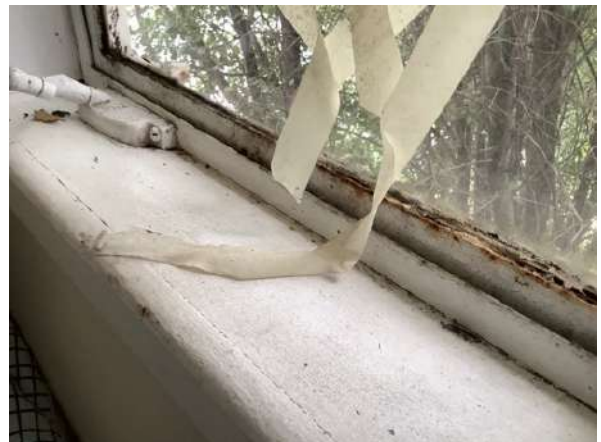
Serious Safety Hazard 1.13

Location: Windows - Interior & Exterior

Rusting and corrosion should be managed by ideally removing or limiting the affected surface from exposure to moisture.

Depending on repair, A registered builder, competent person or handyman may be appointed to replace any building elements that have been severely affected by rust or water damage.

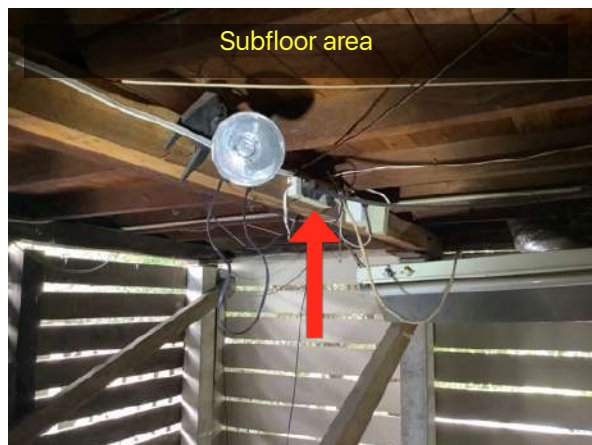
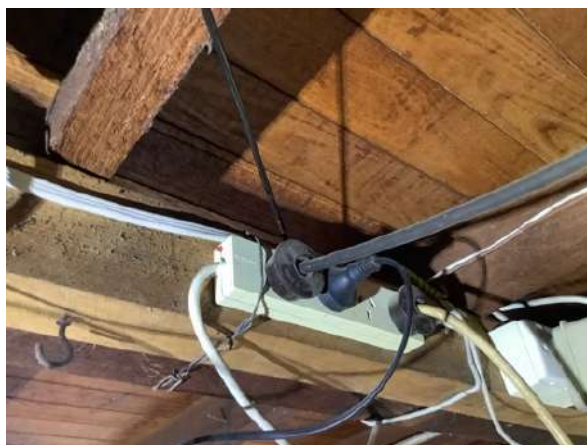
Serious Safety Hazard 1.14

Location: Subfloor Electrical
 Finding: Electrical - Defective / Unsafe / Non Compliant.

A Certificate of Electrical Safety is ALWAYS required for all electrical works and repairs performed by the electrician on completion of there works, without compromise.

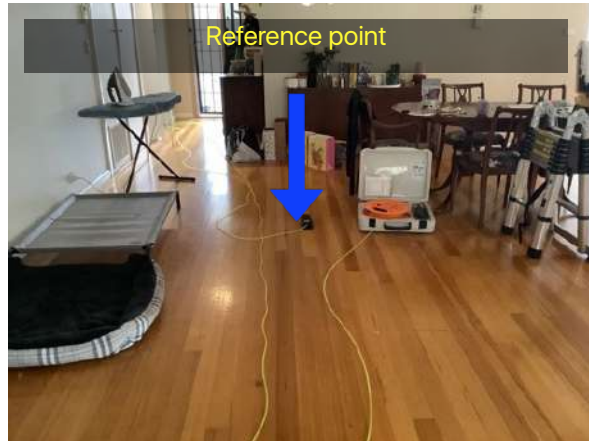
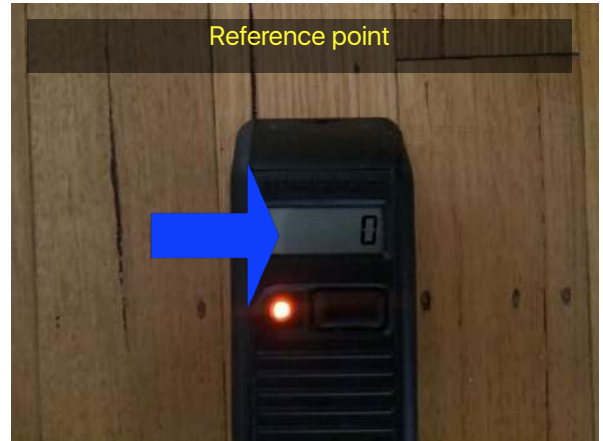
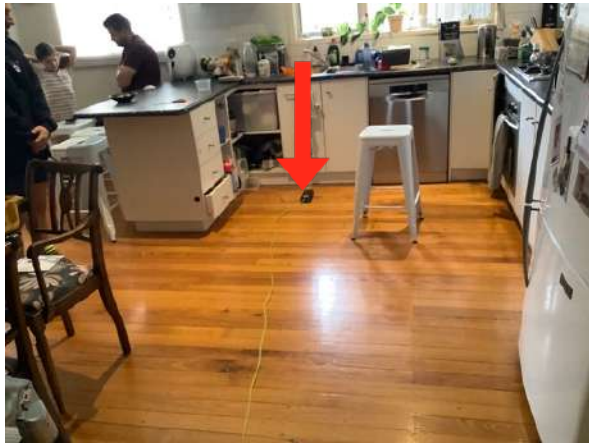
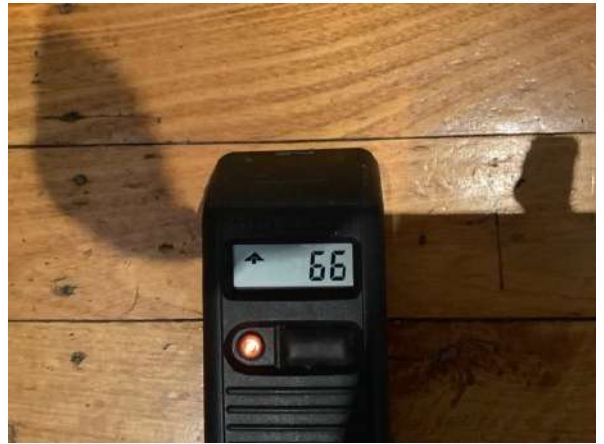
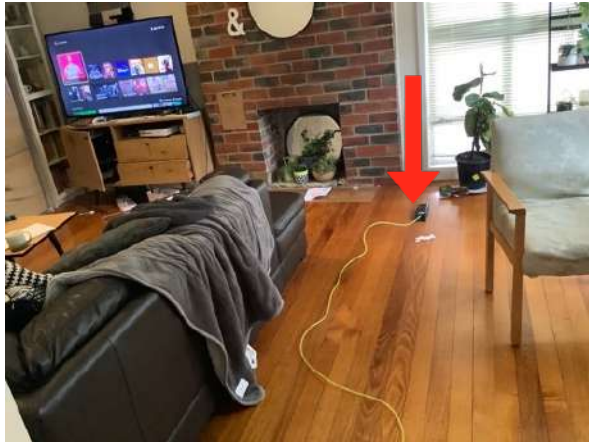
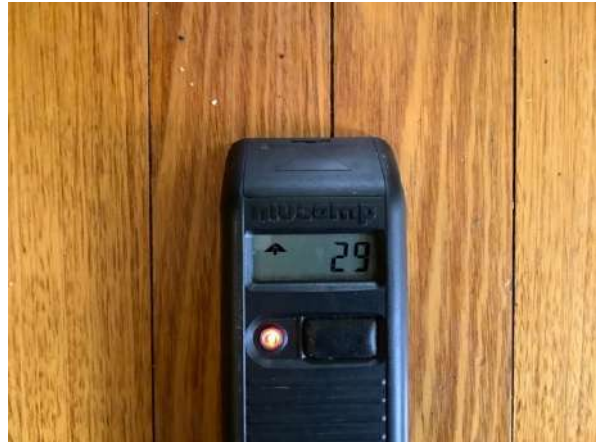
Major Defect 2.01

IMPORTANT TO NOTE : It will be important to note that the likelihood of cracking and movement to plaster, floor and wall tiles, doors requiring re-working, windows requiring re-working, kitchen cupboards, etc will be high once the home is jacked up and re-leveled to the correct height, the amount of repairs can be nothing to many areas. There will more then likely be the repairs of plaster, paint and the other repair concerns mentioned.

A Registered Builder who is experienced in flooring, stumps and re-stumping would then generally carry out works or be associated with re-stumpers as advised by a Structural Engineer and/or a geotechnical engineer, if required.

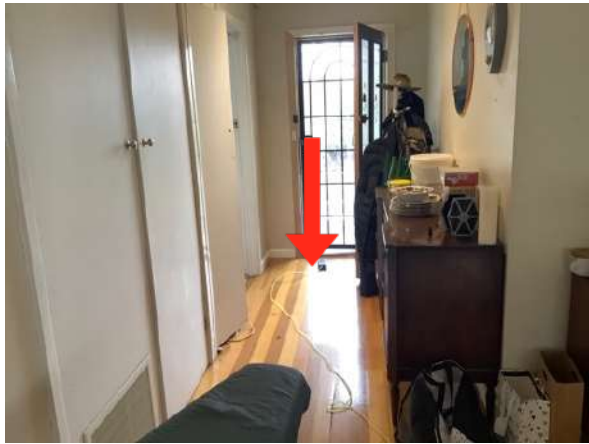
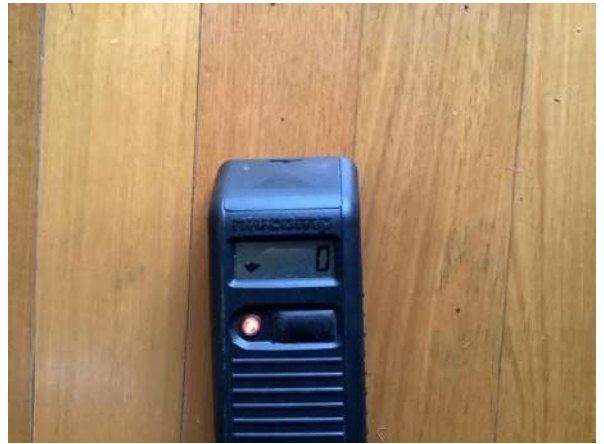
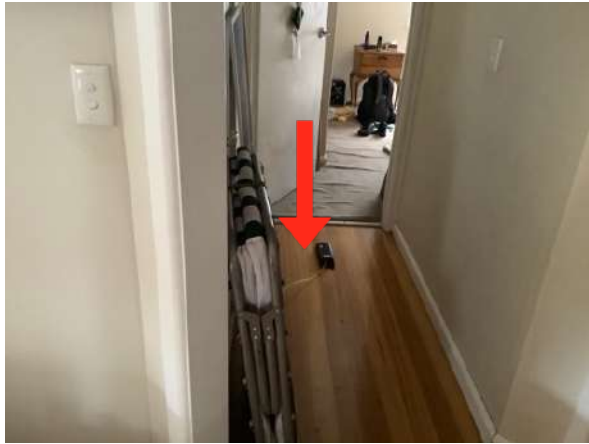
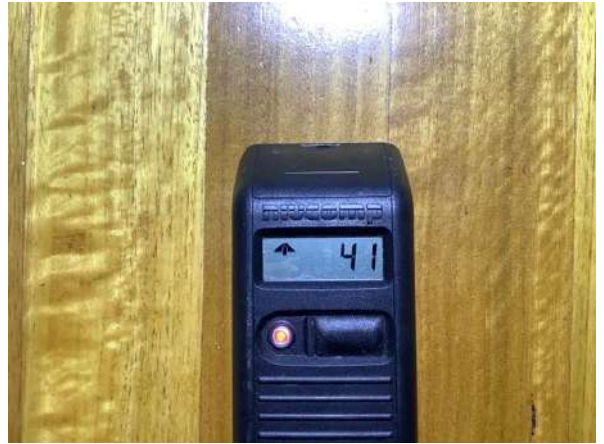
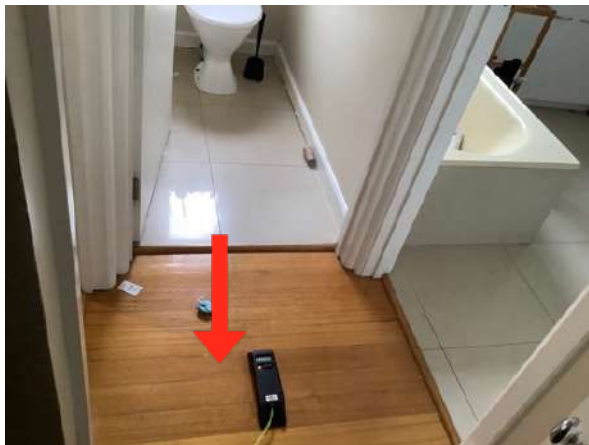
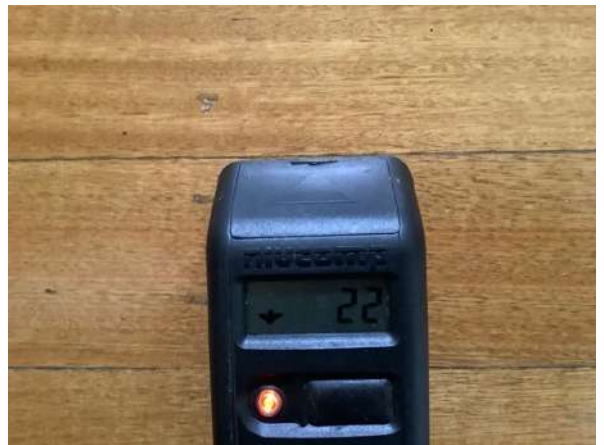
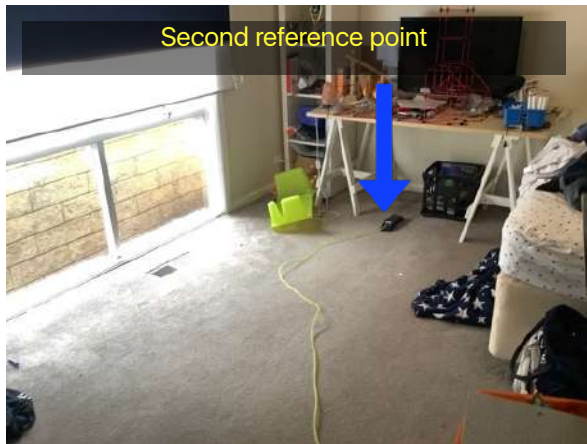
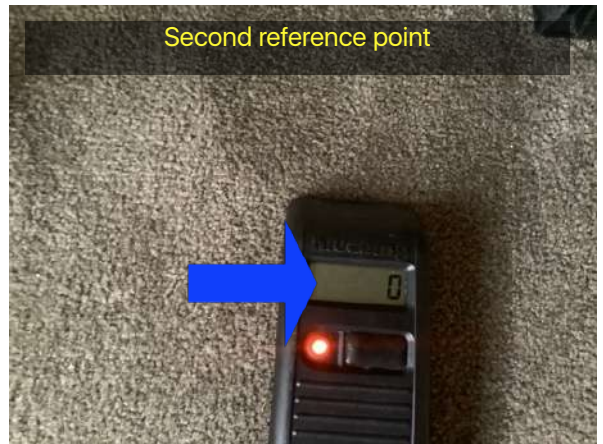
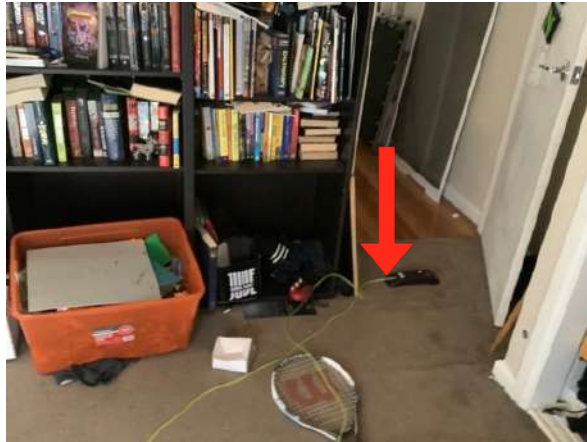
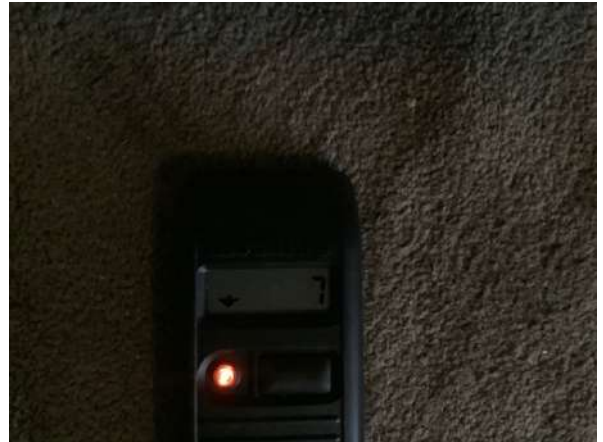
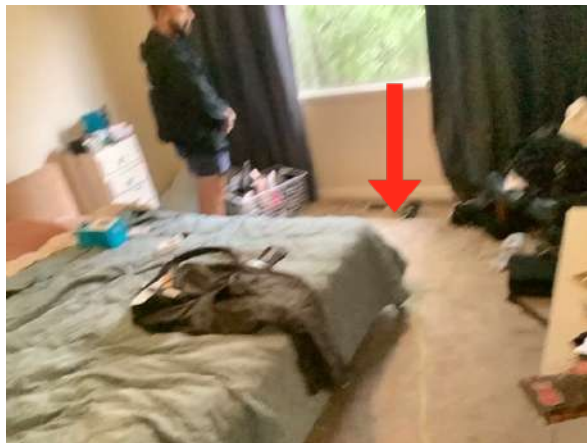
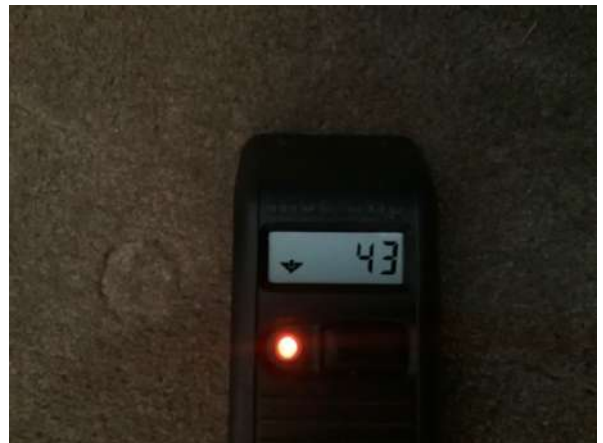
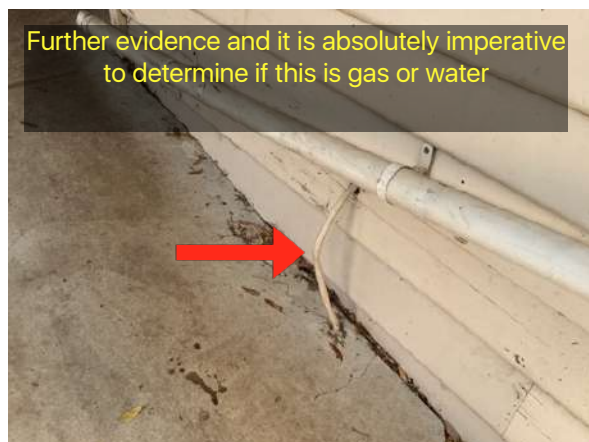
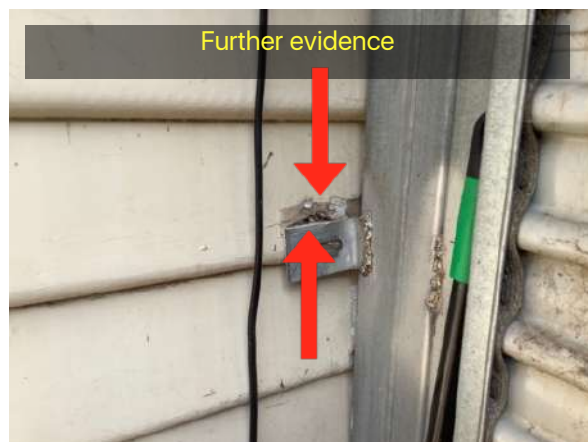
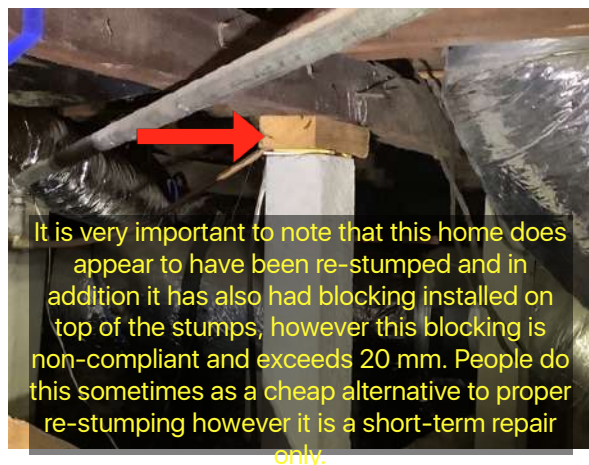
The internal flooring in areas is out of level and uneven. Uneven flooring is likely to indicate minor defects such as expected movement of the foundations of the property, but may also indicate subsidence of the associated subfloor stumps.

Whilst I have stated the above, there are other reasons why flooring can become out of level, such as wood rot, termite damage, timber shrinking, etc, however generally speaking subsidence over a home is generally related to the foundations and/or stumps moving.

It is advised that the flooring be closely monitored by a building consultant, registered builder or similar proffesional to identify any further movement. Where flooring remains relatively unchanged for an extended period of time (i.e. several months or seasons) it is likely that this defect has been caused by expected movement of the foundations of the property.

Where flooring has become uneven further, potentially invasive inspection of the subfloor structures and stumps in this area is required. In this case, works to repair are likely to be required, and would be carried out by a registered builder specialising or understanding the sub floor structure and the requirements of re-stumping.

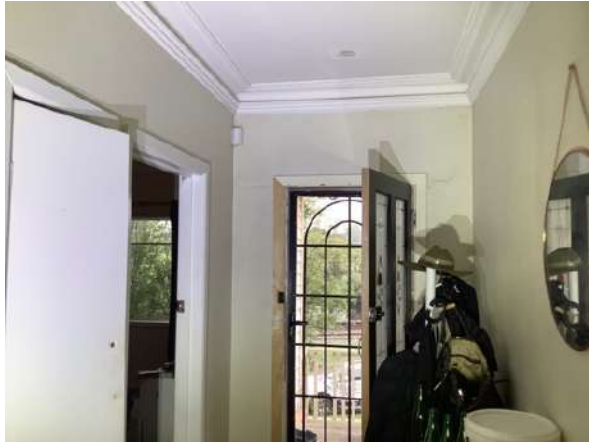
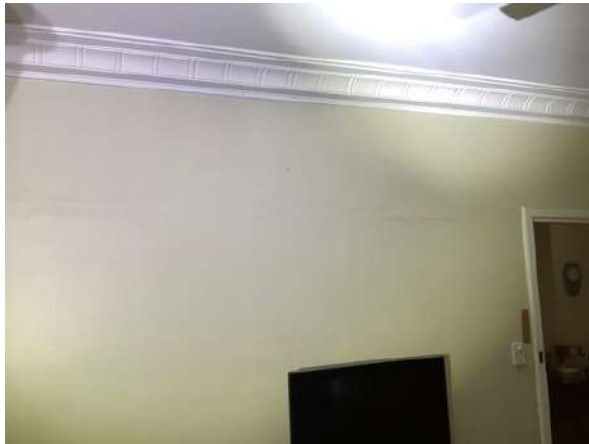
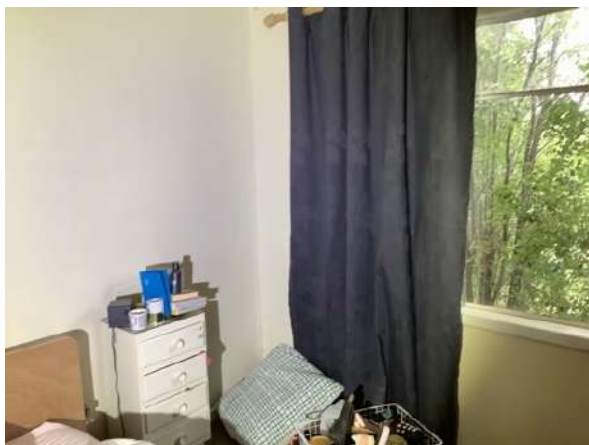
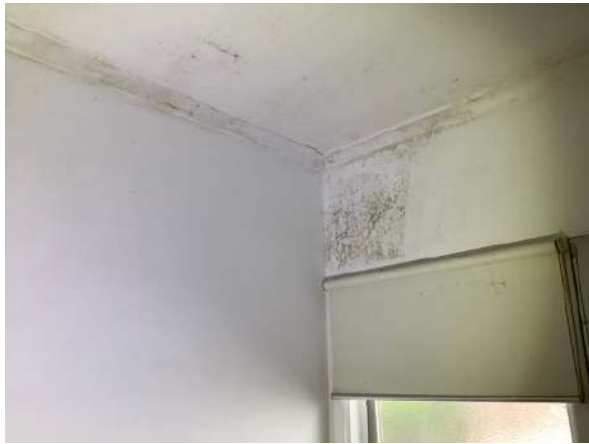
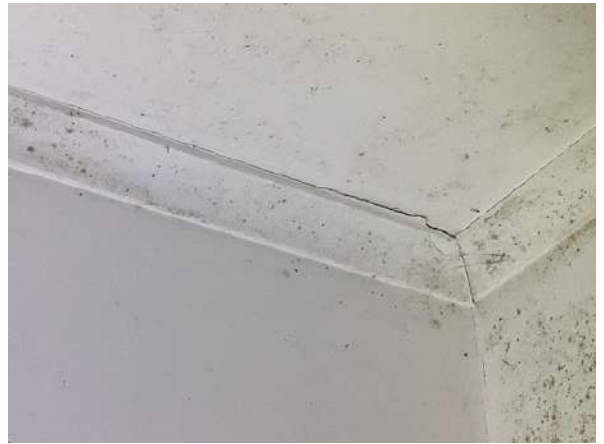
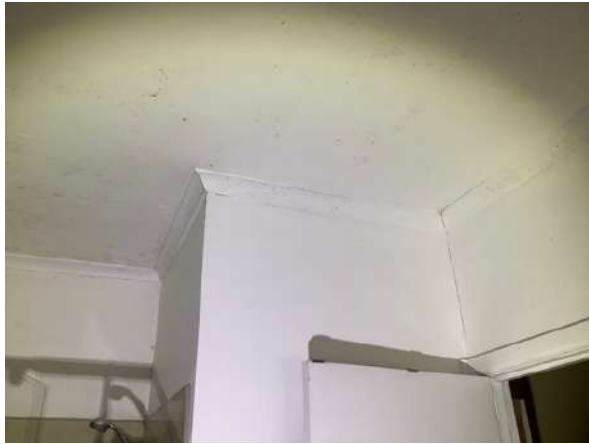
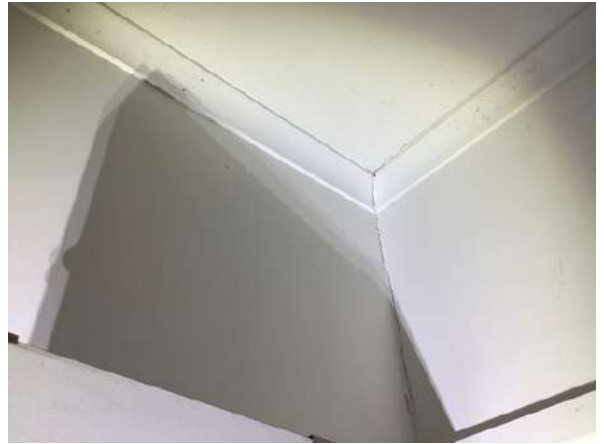
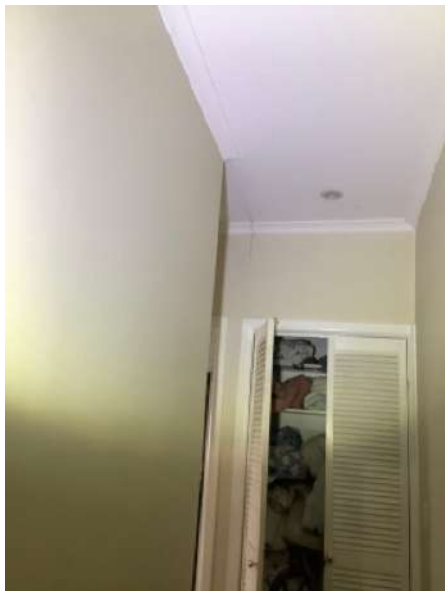
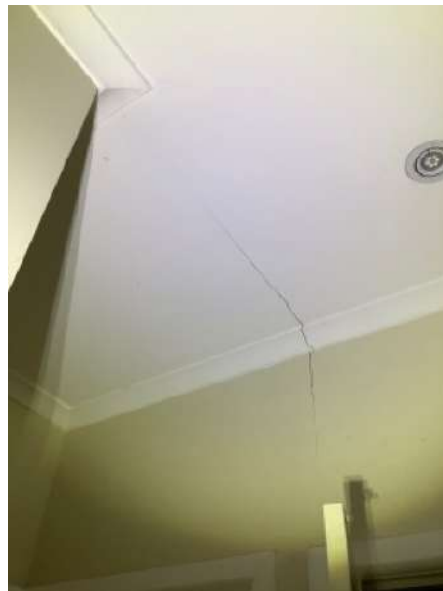
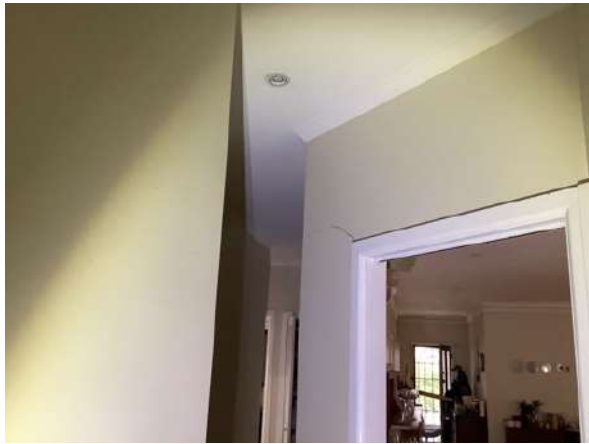
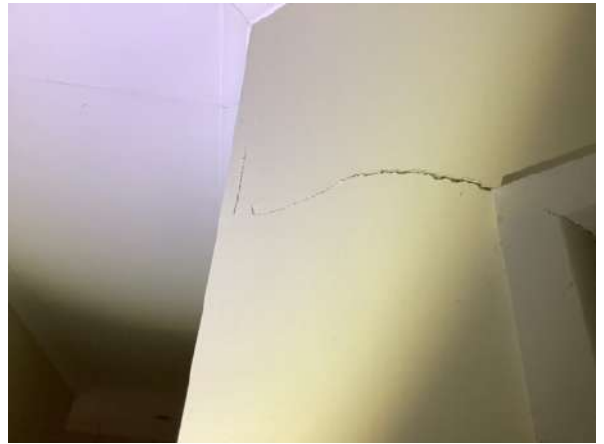
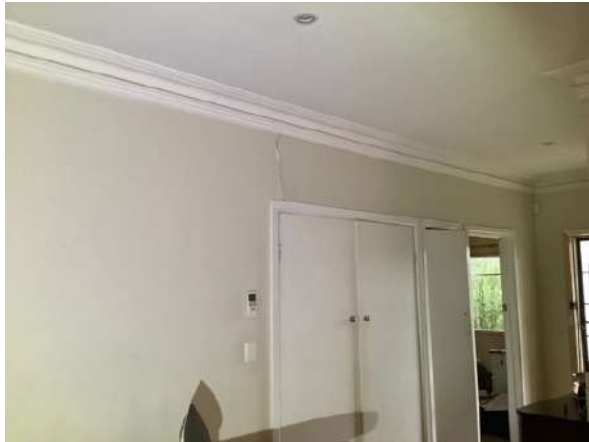
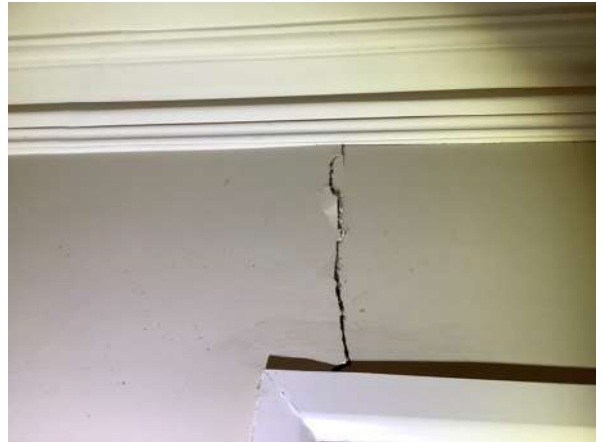
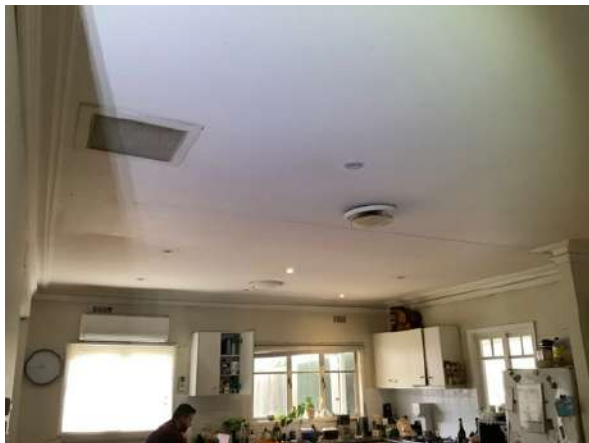
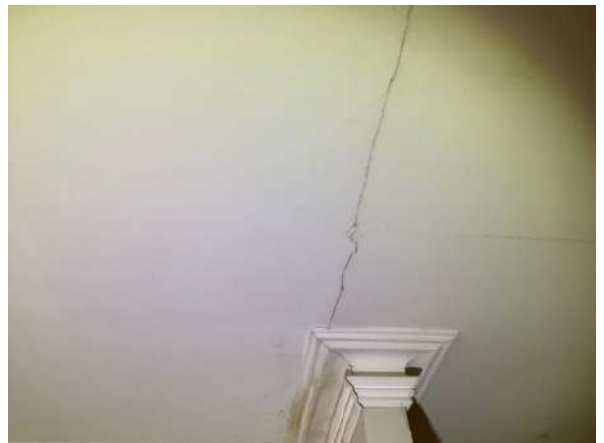
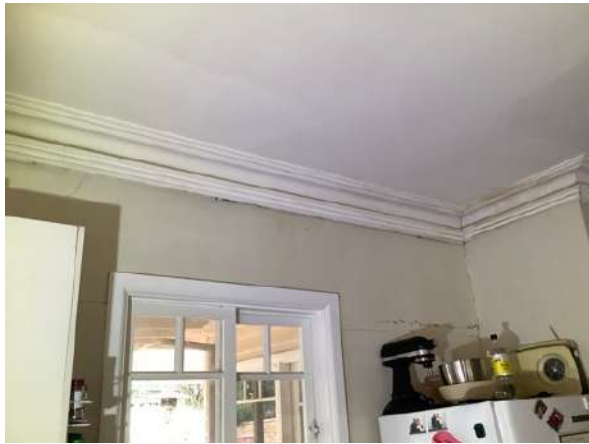
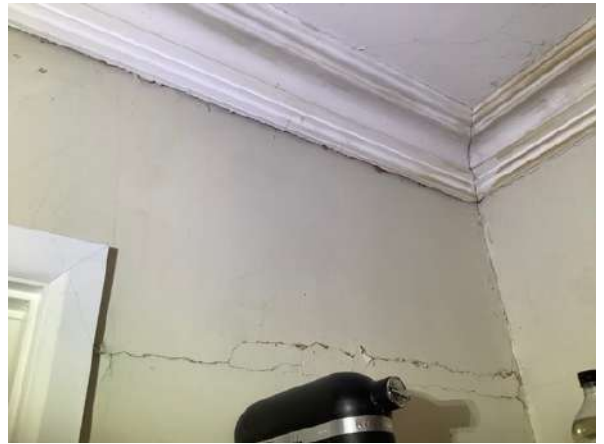
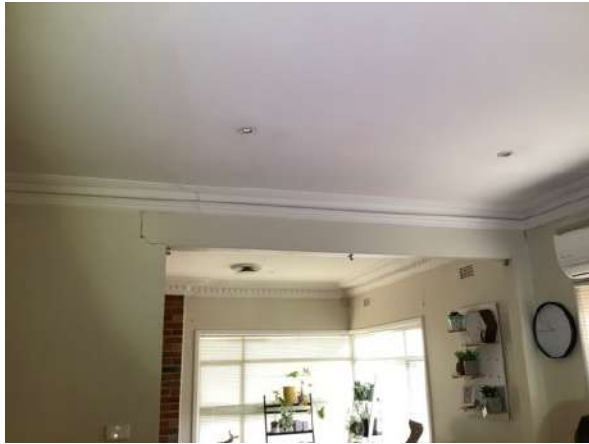
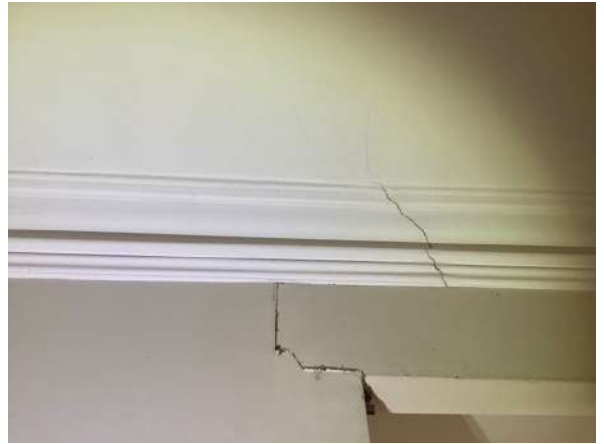
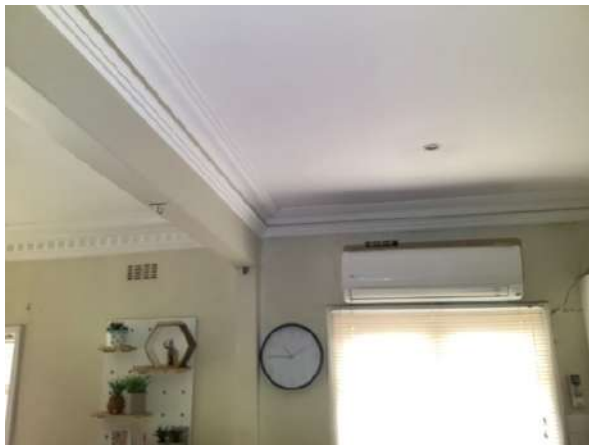
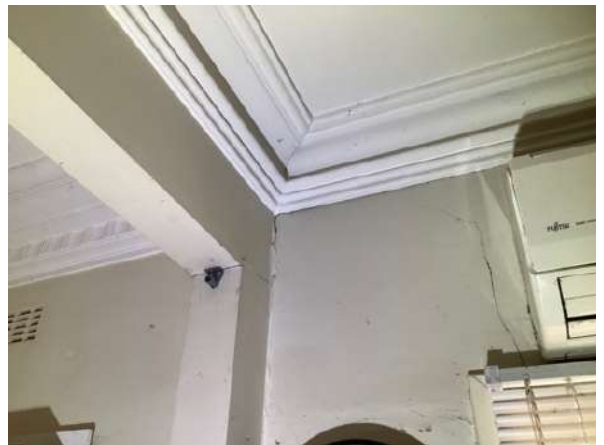
Major Defect 2.02

Location: Plaster-Variou's Area's

Finding: Plaster Cracking / Timber - Damage Category 3 - Repair Required (5mm-15mm or a grouping or cluster of cracks of 3mm or more)

This defect statement is known as a major defect and a major structural defect as per the Australian Standards for pre-purchase building inspections (AS 4349.1-2007)

The cause and effect of cracking of this degree is almost always structural and related to movement of key structural elements.

Extensive repair work is generally required when managing cracking of this degree. This may involve breaking out and replacing wall sections, especially over doors and windows. Doorframes and window frames are often distorted, causing windows and doors to jam and stick. The property may already be affected by leaning or bulging walls, and loss of some load bearing in the beams. This may also result if the source of the cracking is unmanaged. Service pipes may already be disrupted or could become disrupted in the future.

Always contact a building inspector or engineer should cracks widen, lengthen or become more numerous, even after reparation works.

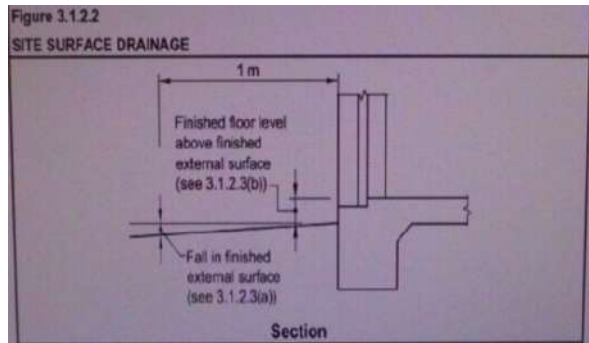
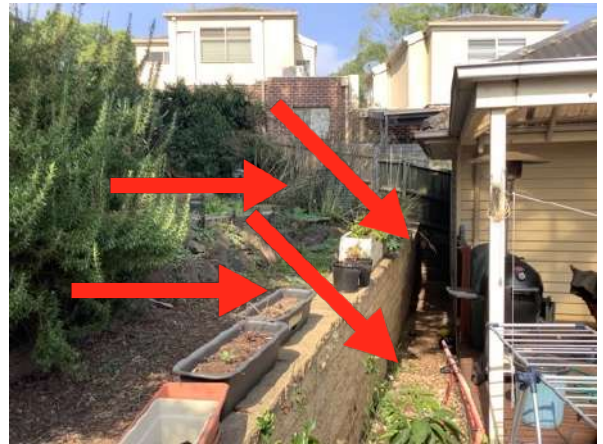
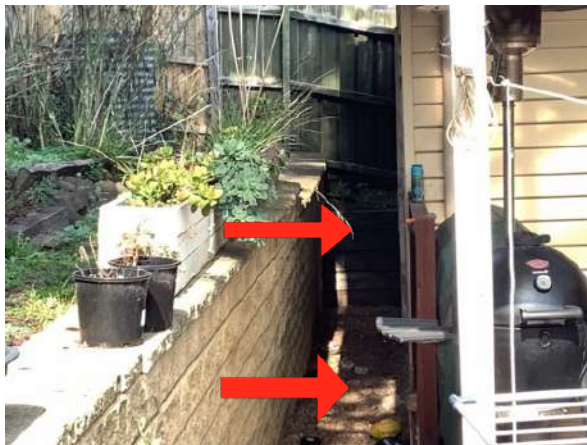
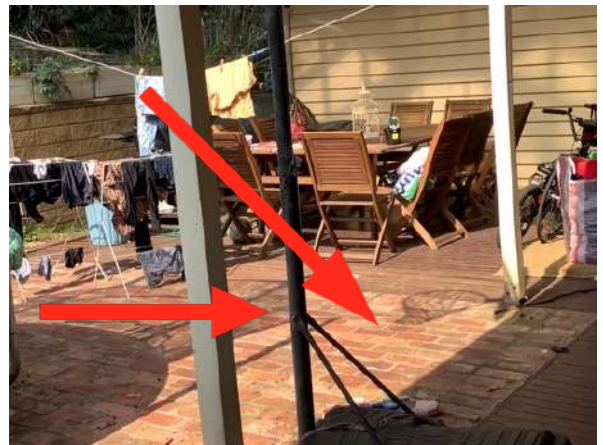
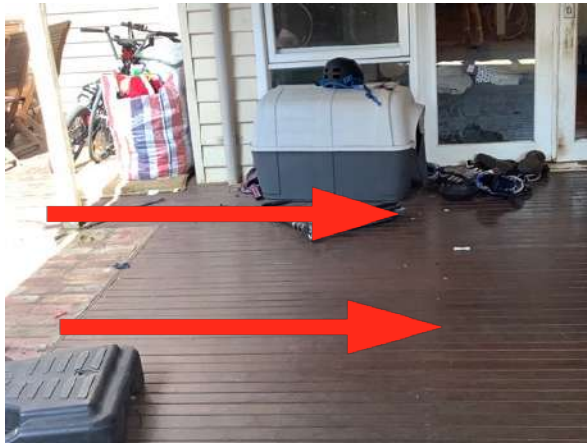
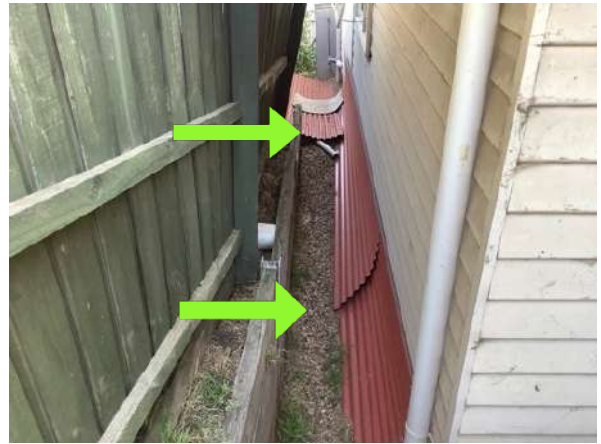
Major Defect 2.05

Location: Brickwork

This defect statement is known as a major defect and a major structural defect as per the Australian Standards for prepurchase building inspections (AS 4349.1-2007)

There are areas of noticeable major cracks to the property. These cracks usually coincide with openings (windows and doors) however they can present in other areas also. Cracks of this type are likely to have been caused by minor expected movement of building elements, but may also have a structural cause that is more significant.

Structural issues are generally the underlying cause of such cracking. It is suspected that this damage has been created due to movement of key structural elements or general subsidence of associated footings.

Major cracking is evident to the brickwork in this area. When managing this degree of cracking, major extensive repair work is generally required. Such work is likely to involve replacement of sections of affected brickwork.

I believe that the building warrants a structural engineer to determine the structural integrity of the foundations.

Always contact a building inspector or engineer should cracks widen lengthen or become more numerous, even after repair works have been completed.
