Vendors Report - Building & Termite/Timber Pest

Inspection Date: 7 Jul 2021

Property Address: Glenroy area

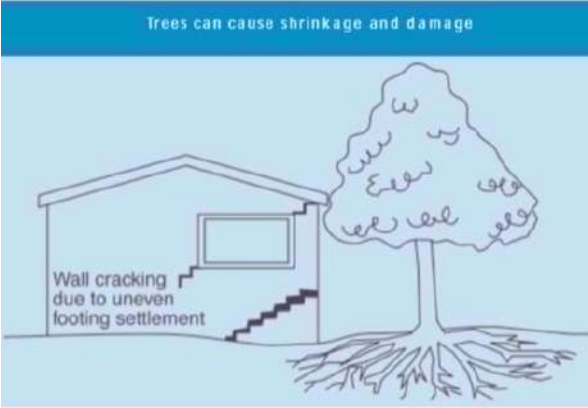
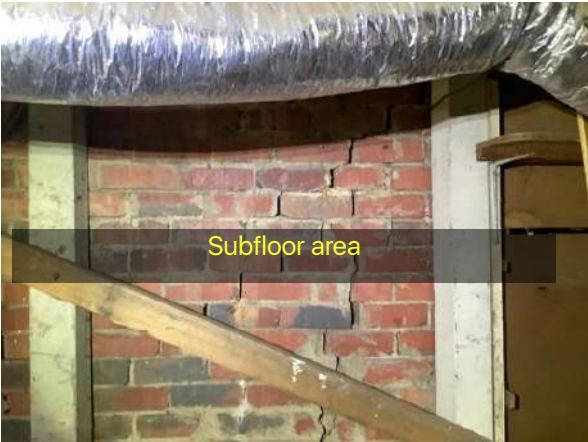
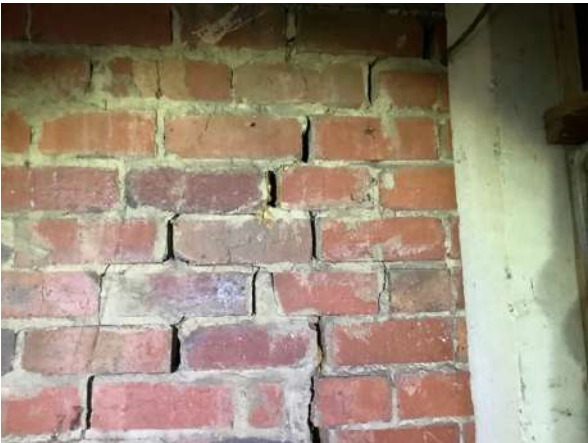
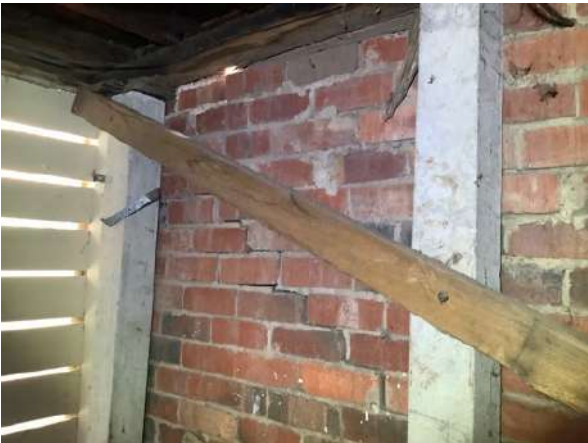
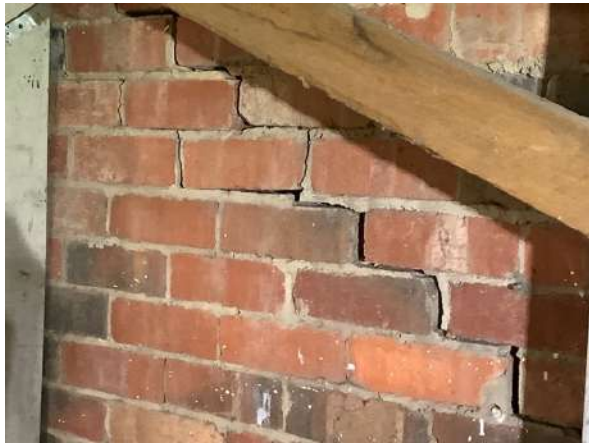
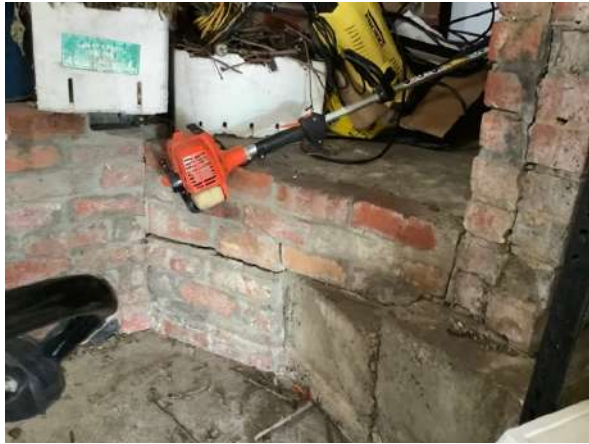
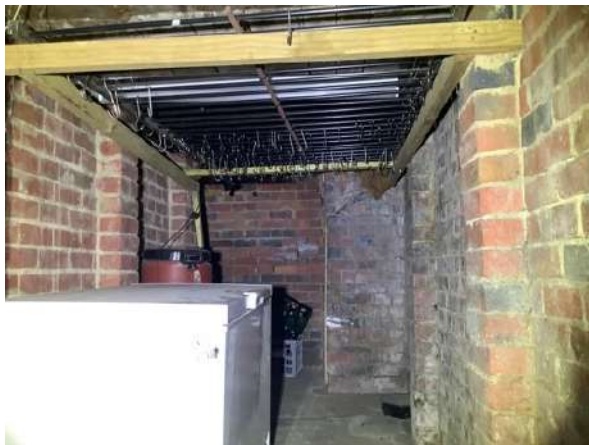
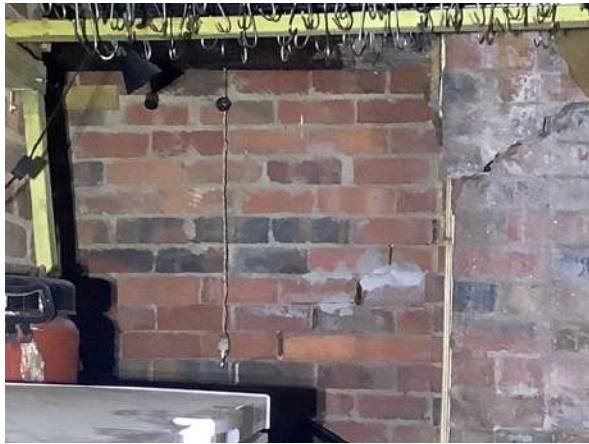
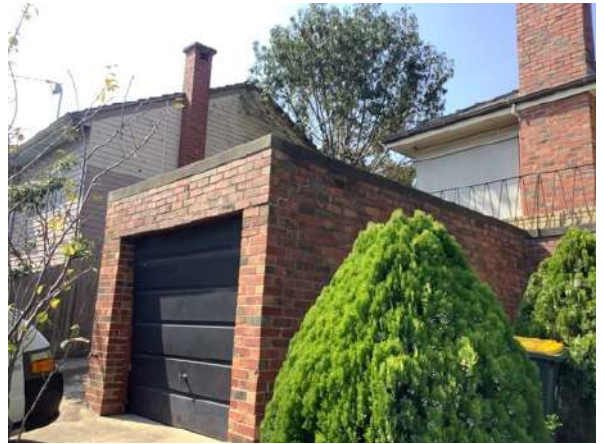
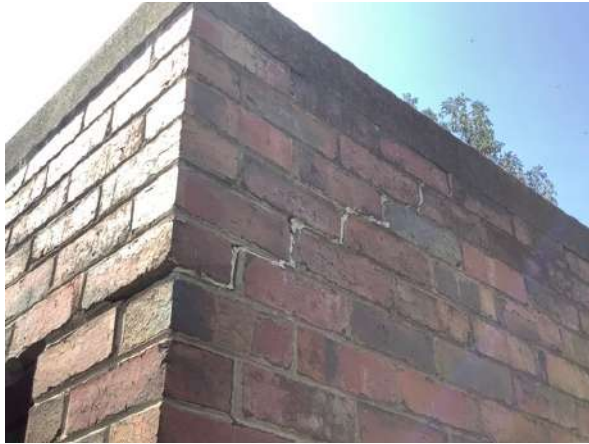
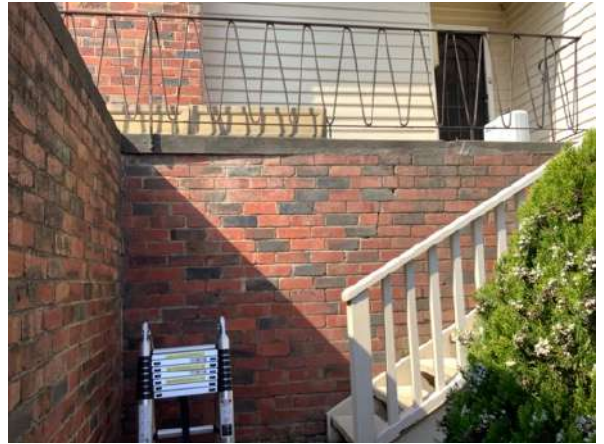
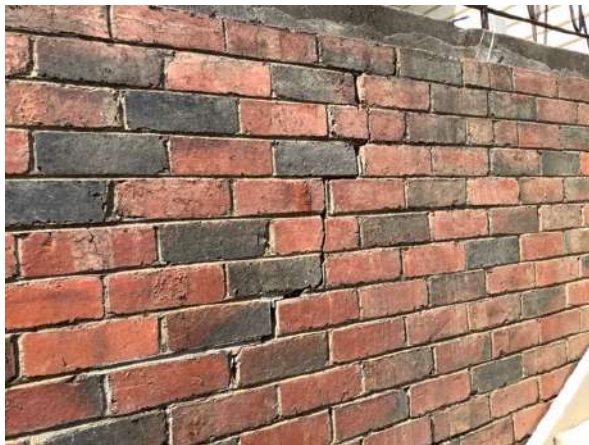
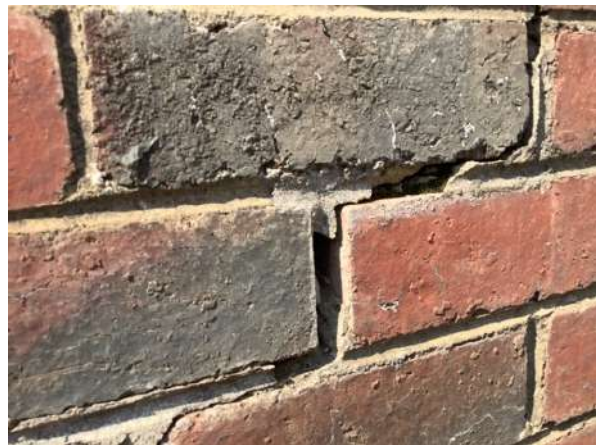
Major Defect 2.06

Location: Brickwork

This defect statement is known as a major defect and a major structural defect as per the Australian Standards for prepurchase building inspections (AS 4349.1-2007)

Other damages that may co-exist with efflorescence, pending on where efflorescence is, such as subfloors, brick walls, inside garages in the concrete or brick walls, etc may be damp rising, dampness, concrete cancer and other such serious defects.

Repeated dry brushing is an ideal treatment for eliminating this forming of efflorescence, however this is when brick and brick mortar is a minor defect not a major defect.

People can under estimate efflorescence, so we highly recommend further investigation, by a registered builder and/or a structural engineer as a starting point.

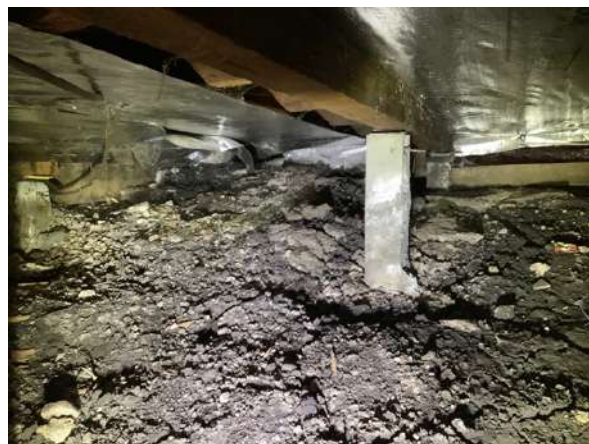
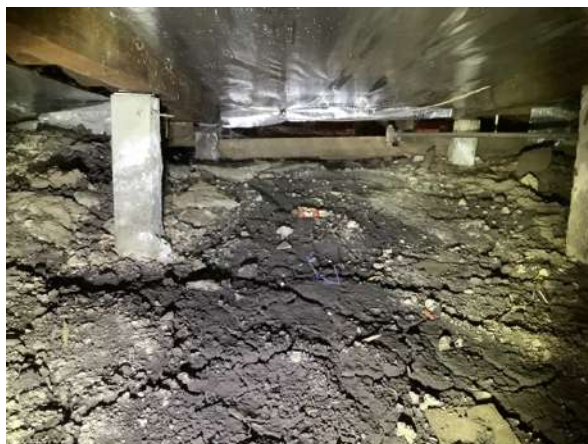
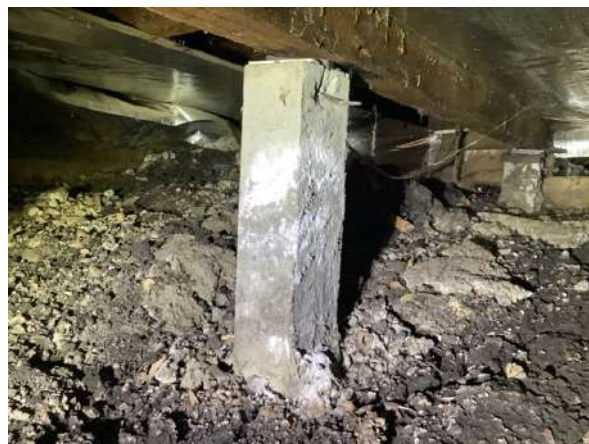
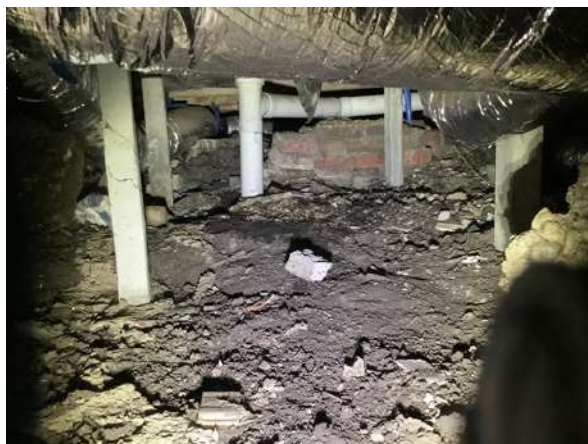
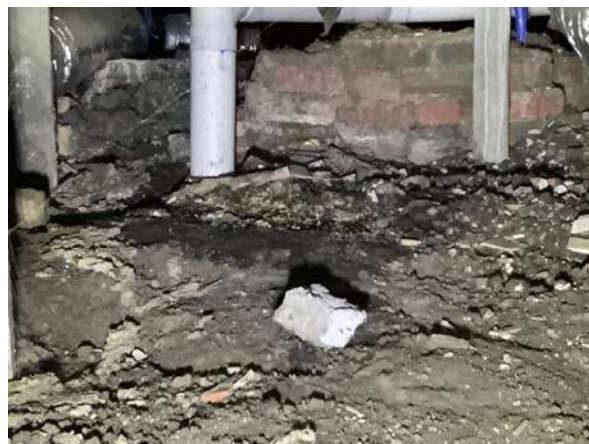
Major Defect 2.09

Major Defect 2.08

Location: Subfloor

Finding: DAMP & WET LEAK

This defect statement is known as a major defect and a major structural defect as per the Australian Standards for prepurchase building inspections (AS 4349.1-2007)

Damp (or structural damp) refers to the presence of unwanted moisture in the structure of a building, either as the result of intrusion from outside, or condensation from within the structure. Generally, structural damp is caused by rain penetration, rising damp, and leaks from plumbing pipes.

Unmanaged damp facilitates the formation and development of mould, fungi growth and wood rot, decaying associated building materials and compromising their structural integrity. Damage to finishes is also likely to occur, including lifting, bubbling, peeling and staining of paint, plaster and wallpaper.

Damp or wet conditions are generally a direct result of poor drainage an active leak or poor ventilation (or a combination of the three). Dry conditions should be maintained to prevent secondary building defects from developing.

If left unattended damp or wet conditions may have many consequences including the development of fungal decay and/or wood rot as well as providing an environment that may be conducive to termite or timber pest attack.

Consultation with a qualified plumber is advised immediately to identify the cause of damp and perform remedial works as required. Where excessive mould growth is present, further inspection by a specialist environmental health inspector should also be considered.

A qualified plumber should be appointed immediately to identify the cause of the excessive moisture in order to prevent further damage. The water leak should be resolved prior to any repairs of the damaged area which may require localised replacement of building materials and refinishing.

Once the cause is rectified further determinations may be required by a BUILDER AND OR STRUCTURAL ENGINEER AND SOMETIMES A GEOTECHNICAL ENGINEER.

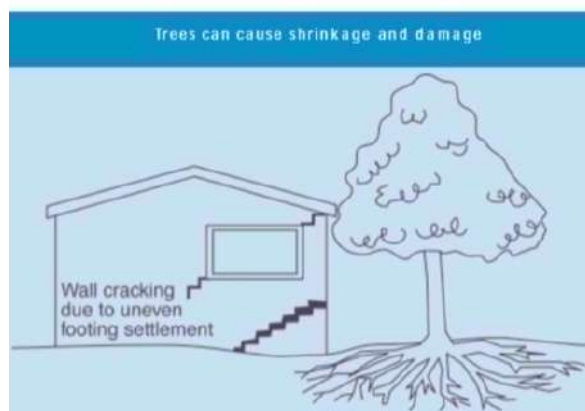
Trees and other vegetation can have a significant local effect on drying of soils. Over a number of years, especially during drought conditions, adjacent trees and vegetation may draw excessive moisture from the soils. The opposite may also occur, where swelling of the soil results when the trees decline or are removed.

As the cumulative moisture deficient is reversed, the surface level around the tree (and adjoining subfloor or concrete slab) will rise and expand laterally. This is often damaging to buildings unless the foundations have been strengthened or designed to cope with the effect.

$d = 1.0h$ (single tree)
 $d = 1.5h$ (group of trees)
 $d = 2.0h$ (row of 4 or more trees)

Subsidence can have complex and varying causes, which will influence the required remedial works. It is advised to begin by consulting a structural engineer to determine the required scope of works. This generally includes some form of underpinning, as well as addressing the underlying cause. Consultation with a geotechnical engineer may also be necessary.

A registered builder specialising in re-stumping / structural damage such as major brick cracking would then generally carry out works as advised by an Engineer and/or Geotechnical Engineer.

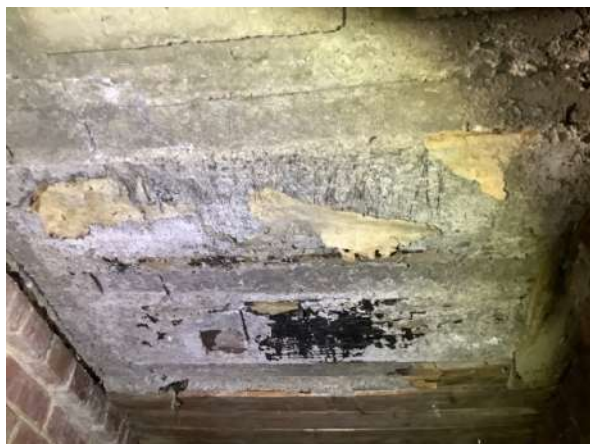
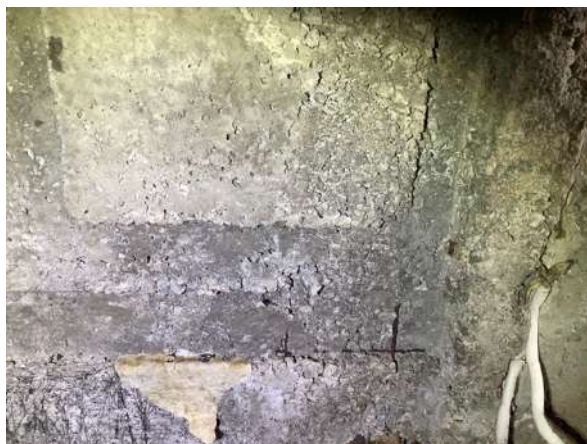
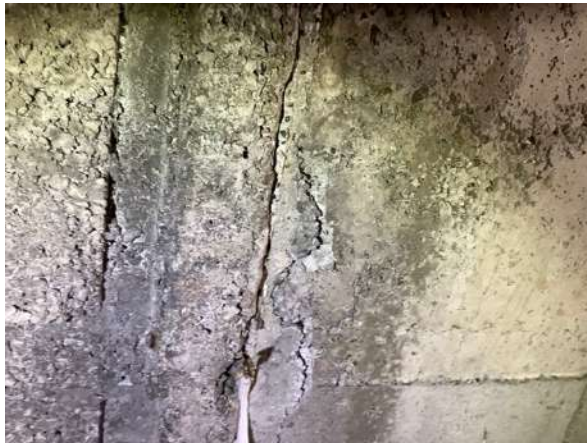
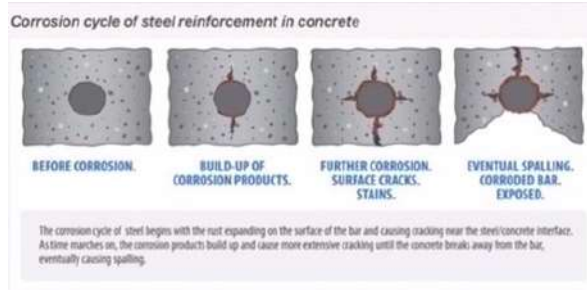
Major Defect 2.11

Location: Garage

This defect statement is known as a major defect and a major structural defect as per the Australian Standards for prepurchase building inspections (AS 4349.1-2007)

The structure appears to be in a state of decline. Evidence of the damage indicates that there is advanced corrosion to the metal elements and the concrete that encases the metal reinforcement is degraded.

Concrete cancer is the common term used to describe a number of factors which cause concrete construction to deteriorate. Generally, water penetration causes the concrete reinforcement to rust and expand, creating stresses on the surrounding concrete and in turn causing it to spall (or break away). Alternatively, if the cement component is too alkaline, reactions with the general atmosphere occurs and star-shaped cracks appear which allow rainwater to penetrate. Concrete cancer may also originate from poor original water proofing.

We recommend an assessment by a Structural Engineer particularly and we also strongly recommend further assessment prior to purchasing the property.

In some instances, repairs are possible; however, repair works will generally involve extensive works, including removal of affected concrete and the treatment or replacement of any exposed steel. Some injection of resins or special mortars may also be possible, however this depends on the size and extent of consequent damage.

The client is advised to exercise caution and to prepare for the potential cost of remedial and / or replacement works.

As noted above once again a structural engineer should be appointed to provide estimates on the required works.

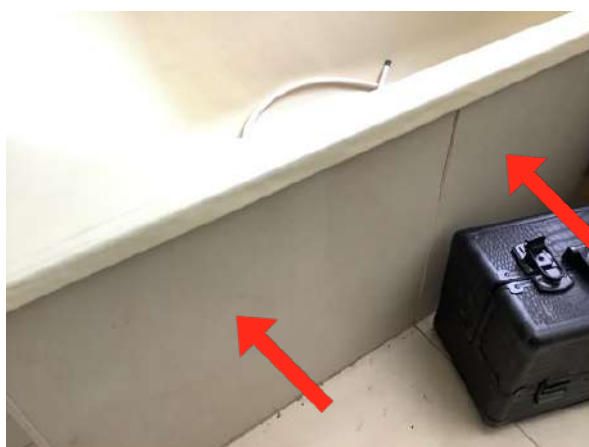
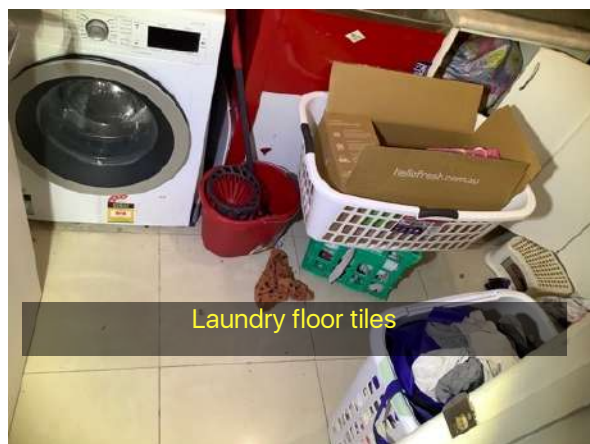
Minor Defect 3.01

Location: Tiled Areas
 Finding: Tiles - Drummy (loose / structurally compromised)

If left unmanaged, water penetration to these areas may lead to subsequent water damage, which is likely necessitate repair work to affected building elements.

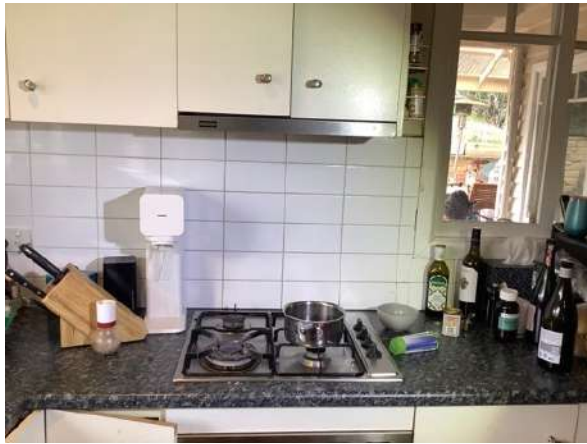
Minor Defect 3.02

Location: Tiled Areas

Where water penetration has led to water damage, appointment of a relevant tradesperson may be required to repair damaged building elements.

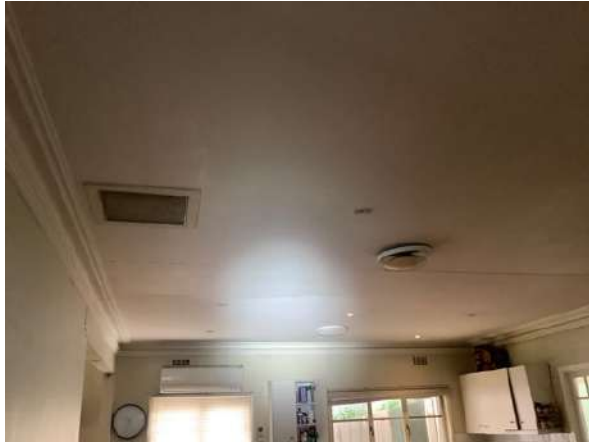
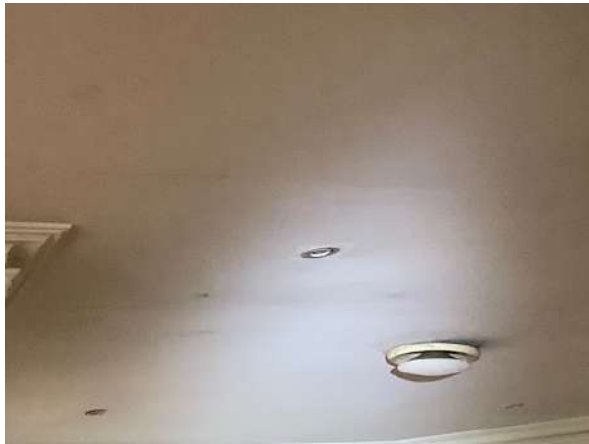
Minor Defect 3.03

Location: Plaster-Variou Area's
 Finding: Plaster Ceiling - Drummy / Sagging

Houses that do not have insulation can sometimes contribute to drummy plaster as many times the drummy plaster is in garages where there is no insulation in the roof so the plaster is subjected to moisture as it is not protected by the insulation, so this may be the only reason the plaster has become damaged / drummy , meaning no insulation to the garage or house or sometimes this may only be a contributing factor along with defective workmanship and/or others defects to the home, such as leaking roofs, etc.

Ensure that the general environment is free of moisture and humidity to aid in the prevention of drummy plaster and plaster damage. Appointment of a qualified plasterer and/or builder is advised in order to complete remedial works as necessary.

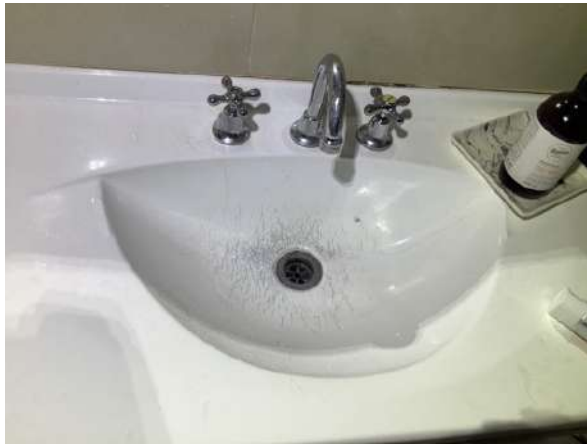
Minor Defect 3.05

Location: Bathroom

Finding: Basin - Cracked / Damaged

Cracking was evident to the basin at the time of inspection, which is suspected to have been by minor impact damage or wear and tear over time. While the cracking appears to be minor, any further impact damage sustained by the basin may lead to additional cracking.

As the cracking provides potential ingress for water, secondary water damage may occur to associated cabinetry, walls or flooring, if the cracking is left unmanaged.

Consultation with a plumber regarding basin repair or replacement is required. Remedial works may be required to protect against any further damage.

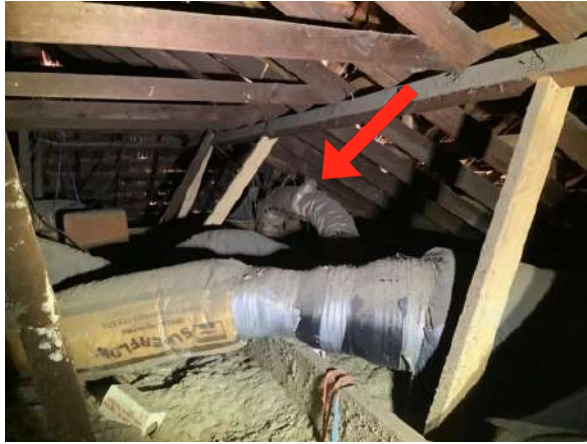
Minor Defect 3.06

Location: Roof Space

Finding: Heating / Cooling Ducts - damaged

The heating/cooling ducts were found to be damaged and not at a fully operational level. Generally, damage to ducts occurs as a result of ageing and material deterioration, but impact damage or pest damage may also be the underlying cause.

The damage sustained by the ducts detracts from the energy efficiency of the property. The airflow within the property is likely to be restricted, particularly in areas where ducting shows signs of major damage.

A heating/cooling specialist should be appointed to provide further advice on remedial work options and to perform any works deemed necessary.

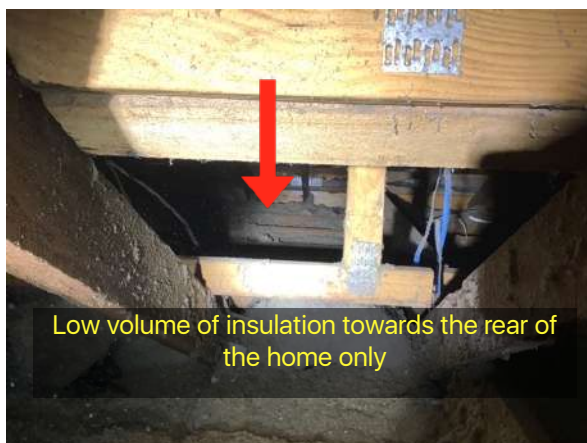
Minor Defect 3.07

Location: Roof Space

Insul-fluff is common in many older homes and is a loose form of insulation that is 'blown' into roof voids. While this type of insulation was considered effective at the time of installation, modern materials have surpassed it as the preferred insulator.

This type of insulation is susceptible to settling and reducing in volume, detracting from its effectiveness and resulting in an overall loss of energy within the household. Additionally, the reduction in volume has led to an uneven distribution of insulation within the ceiling void, further detracting from its effectiveness.

It is highly advised that this insulation be removed and replaced with a more appropriate material. This will ensure that the property is adequately insulated and will promote an increase in energy efficiency within the property. An insulation contractor should be appointed to provide further advice on replacement options and to perform works as necessary.

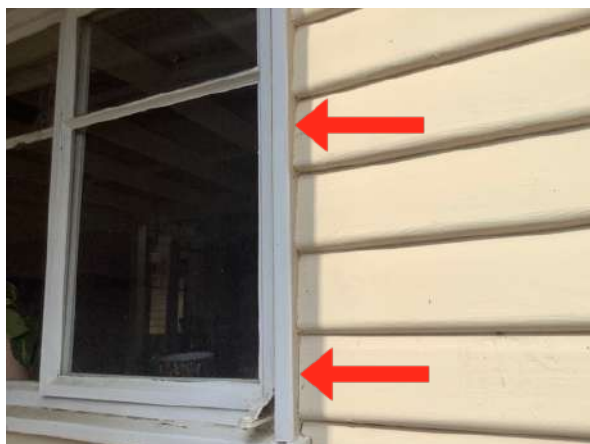
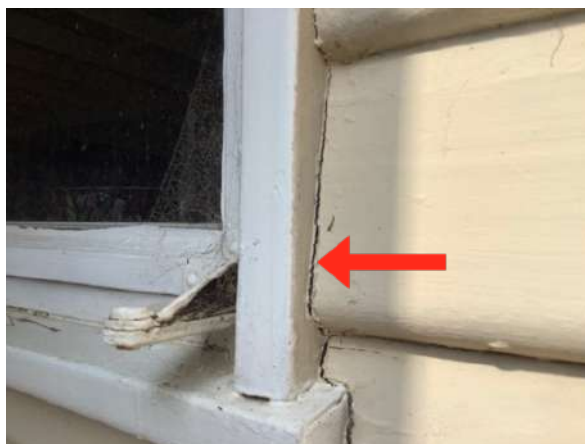
Minor Defect 3.08

Location: Perimeter Of Building - Exterior

Finding: Water Leaking & Water Ingress - External Areas

Water leaks were found to be present to the exterior sides, tops and or bottoms of the windows and/or doors and other areas as per the photos attached, such as brick expansion joints and timber and cement sheet junctions above windows , eaves and other areas.

Leaks are generally caused by deterioration of silicon or rubber seals or sometimes just defective workmanship when no caulking as ever been used .

With gaps like these that can be only a few millimeters to be exposed to weather conditions, can cause wood rott internally to the walls create a conducive environment for termites or possibly cause secondary defects the have the potential for structural damage the can be seen or in the walls internally.

Such leaking creates damp conditions in the affected area, causing potential for water pooling and subsequent water damage if left unattended. These conditions may also attract termite attack as already mentioned above, particularly if the area is subject to minimal levels of sun throughout daylight hours.

It is highly advised that a licensed plumber, handyman, builder be appointed to rectify any water leaks that may be present.

It is important to note once caulking these areas if water damage is noticeable to windows, timbers, etc, such as wood rott, it is imperative to engage the appropriate trades for replacement or repairs.

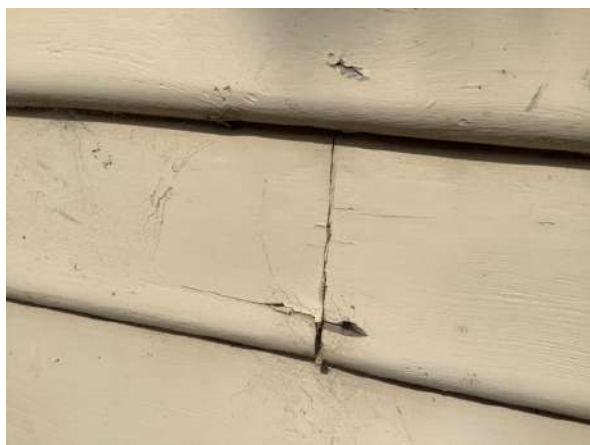
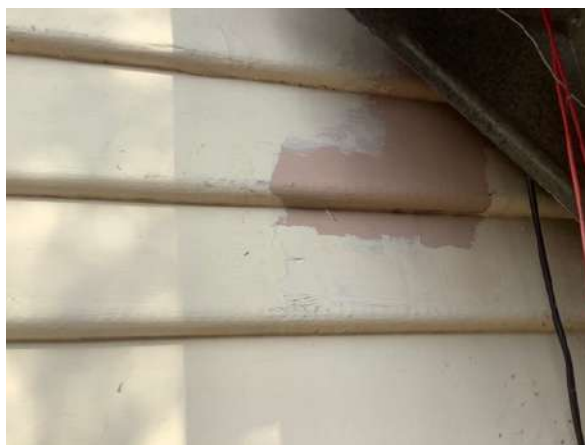
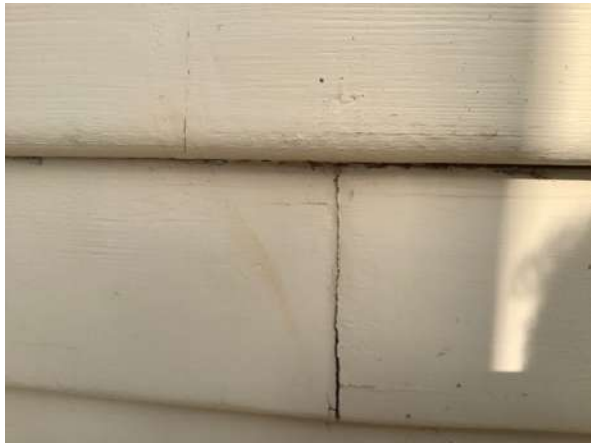
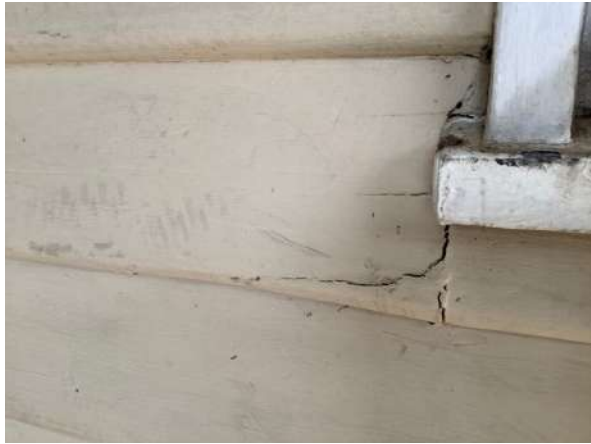
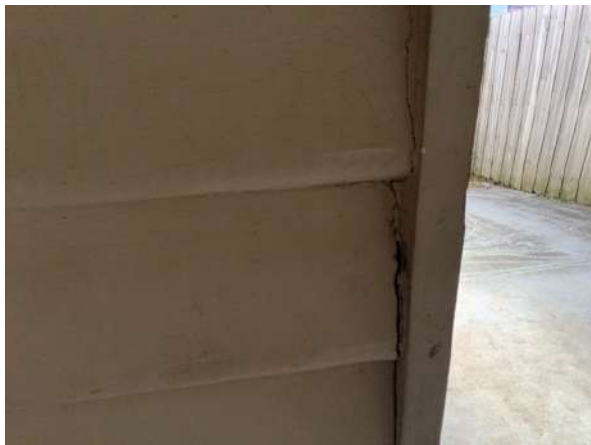
Minor Defect 3.09

Location: Timber Work - All External Areas

Finding: Timber, exposed to weather / External painting deteriorated

External timbers that are frequently exposed to harsh weather conditions require adequate protection (paint) in order to maintain their condition. Where timbers have not been painted or treated adequately, general deterioration is likely to occur at an accelerated rate.

Incomplete or missing paint finish NOT ONLY an appearance defect, it can in most cases lead to the development of secondary building defects over time. Incomplete areas of paint finish exposes the area to moisture, potentially accelerating the deterioration of underlying building materials.

Degraded paint finishes should be sanded back, filled, leveled and painted, as applicable. Where inadequate or missing paint protection has led to the deterioration of the associated building elements, meaning WOOD ROT (Decay) repair and/or replacement of this building element may be required, As if the wood rot is too severe repair of decayed timbers is generally too late.

If left unattended, replacement of these timbers is likely to be necessary in the short-term future. Adequate treatment of these timbers is required as soon as possible by a painting contractor should be appointed as soon as possible to perform necessary works to aid the appearance of the affected area and to ensure the area is protected against further deterioration. Alternatively, the homeowner following manufacturer instructions may perform these works.

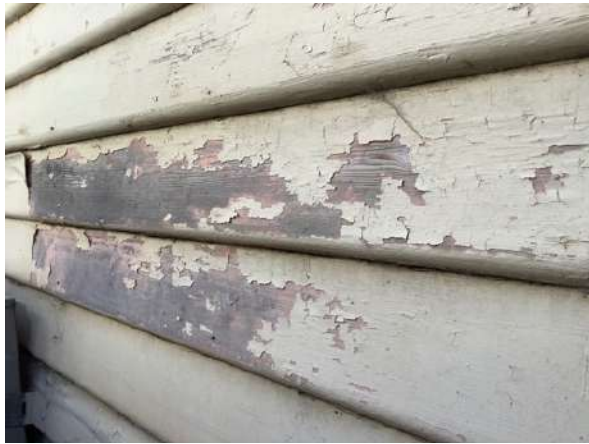
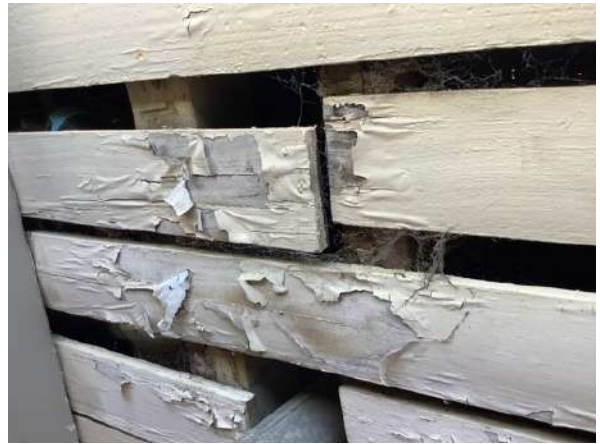
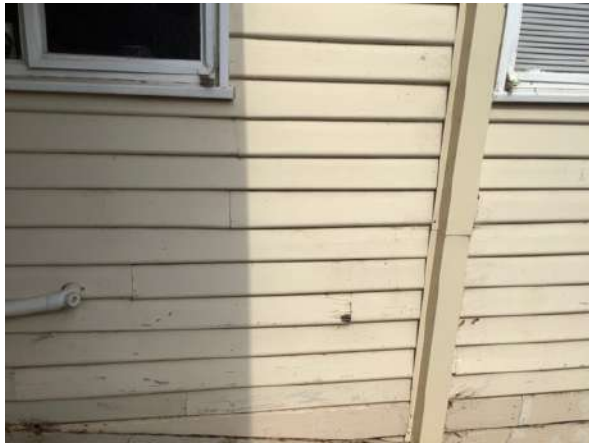
Minor Defect 3.10

Location: Timber Work - All External Areas
Finding: Weatherboards - Rotting

It is important to note that some areas of the weather boards may look ok, however upon close investigations there are many areas where the timbers are rotted under the paint. The external weatherboards show signs of fungal decay (wood rot) in several sections. This wood rot is suspected to have developed over a prolonged period of time due to frequent weather exposure, which is expected in a property of this age and condition

Weatherboards are sealed and protected by paint and other sealants. When these sealants deteriorate over time, they allow water penetration to the weatherboards, causing wood rot. If left unmanaged, the wood rot is likely to develop further, possibly necessitating major repair or replacement works in the long-term future.

To maintain the condition of the external wall cladding, any severely affected weatherboards should be substituted as soon as possible with pre-treated replacements. Where weatherboards have rotted due to excessive moisture other than rain penetration, the cause of the moisture should be identified immediately by a licensed plumber. A qualified carpenter should be appointed to repair and replace rotting weatherboards.

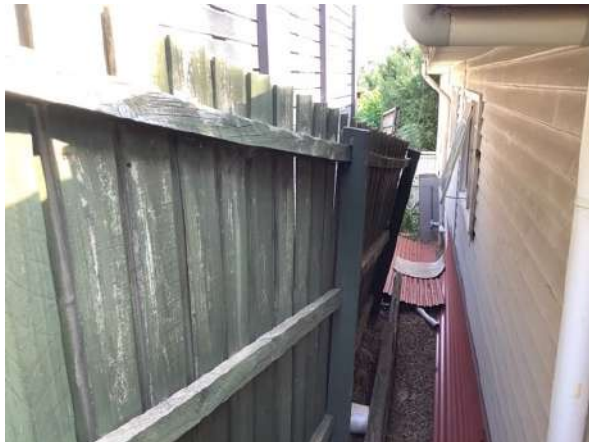
Minor Defect 3.11

Location: Fencing

Finding: Fencing - Deteriorated

It was noted at the time of inspection that sections of the fencing throughout the property have deteriorated. Typically fencing deteriorates due to age or rot which is generally expected for a structure of this age, due to prolonged exposure to weather conditions. A licensed fencing contractor should be appointed to provide further advice and perform rectification works as necessary.

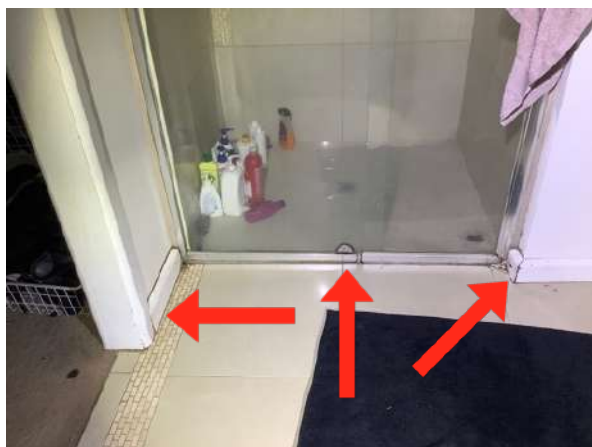
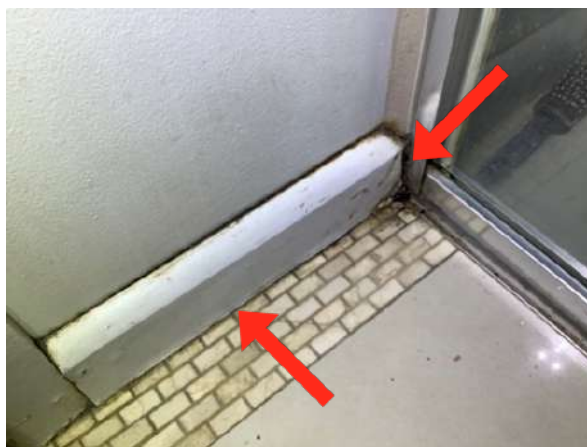
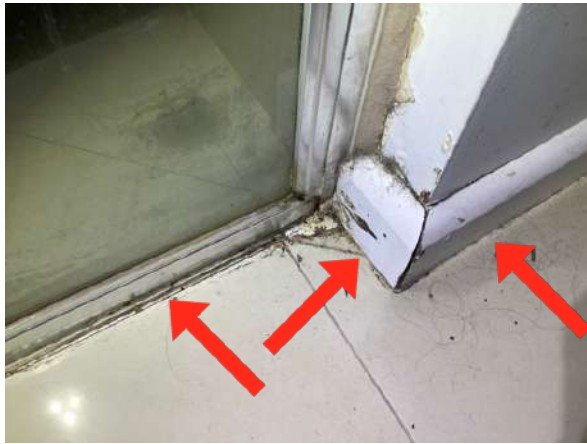
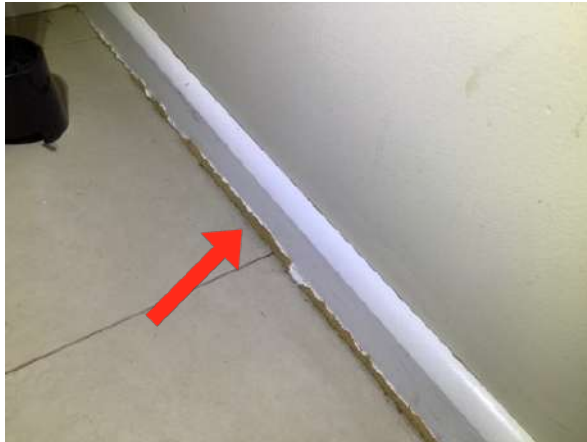
Minor Defect 3.12

Location: Bathroom And Toilet Areas

Finding: Water Rott / Water Staining - Timber Skirting & Door Frames

Water Rott / Water Staining was evident in this area or areas at the time of inspection.

Water staining indicates that surfaces have been exposed to excessive moisture / water over time. The minerals and other elements in the water lead to staining, which may graduate to corrosion and deterioration if left unmanaged.

It would appear that water has come particularly from the shower area, generally from damaged silicon, damaged shower screens and /or defective designs.

Sometimes it may be a combination of defective items. Particularly silicon should be repaired as soon as possible to stop or reduce further water damage to the building materials, particularly if the floors are timber or the tiles are damaged allowing water to ingress into the floor areas through the damaged tiles and/or tile grout.

It is important to identify the cause of water staining and STOP FURTHER DETERIORATION by the appropriate tradesperson.

Replacement of any broken or damaged structures is advised in particular if the damage has caused secondary defects that have compromised the building structure.

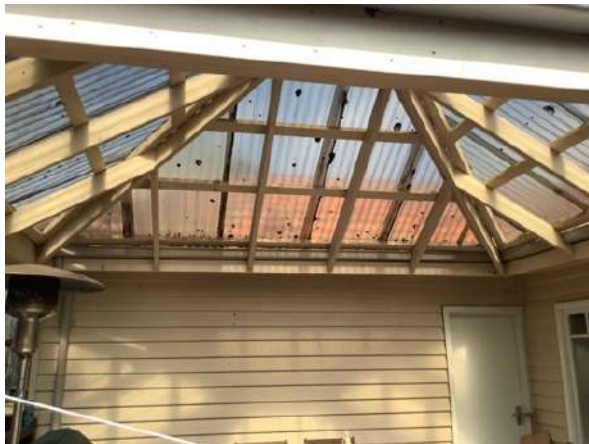
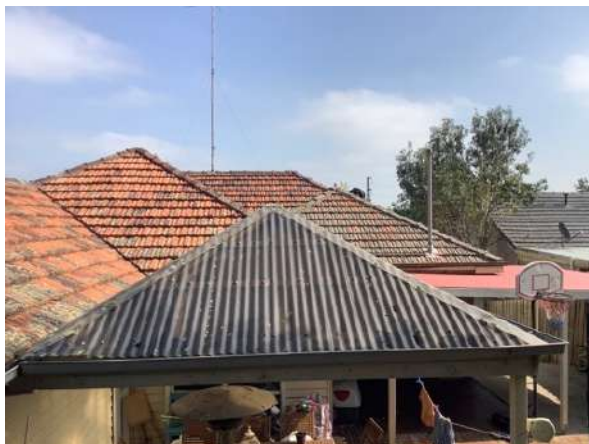
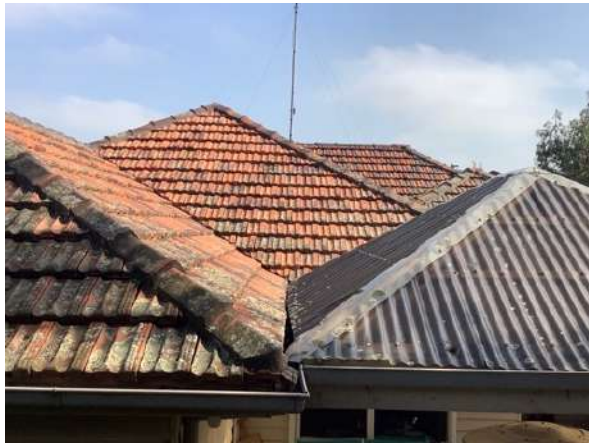
For your information 4.11

Location: Exterior Roof & Stormwater Areas
 Finding: Guttering Roof Plumbing - Insufficient Capacity & Defective Gutters/Box Gutters.

It is suspected that the roof plumbing to the exterior roof is insufficient in capacity and is not adequately managing the volume of rainwater that it is required to drain. The result is generally that the plumbing overflows during periods of heavy rainfall, creating damp conditions against external surfaces and the base of the building perimeter.

If left unmanaged, the excess moisture in this areas may allow the formation and development of an environment that is conducive to rust, corrosion and rot, creating potential for secondary defects to all associated building elements. Damp conditions are also conducive to termite and pest activity, further exacerbating the risk of the environment.

Appointment of a roofing plumber is recommended to replace any inadequate drainage systems to ensure proper drainage to this area. In the interim, it is important to ensure that all roof plumbing is free of any debris or blockages.

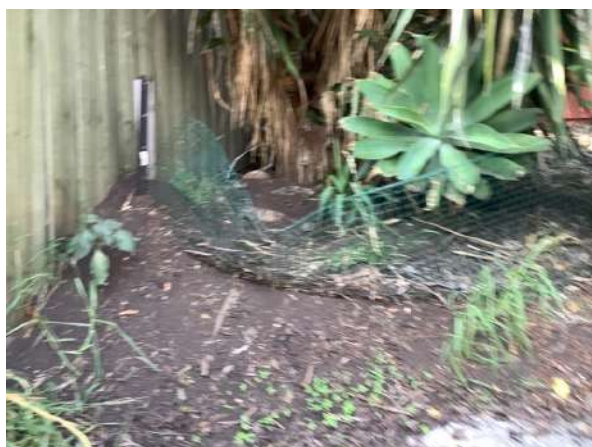
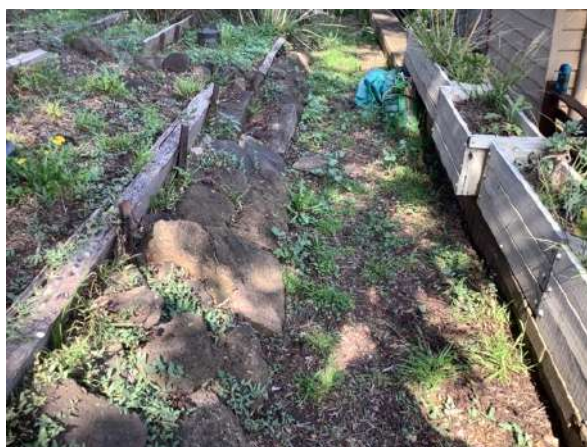
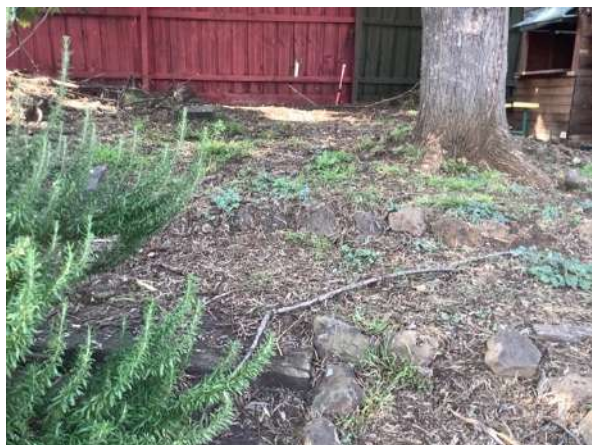
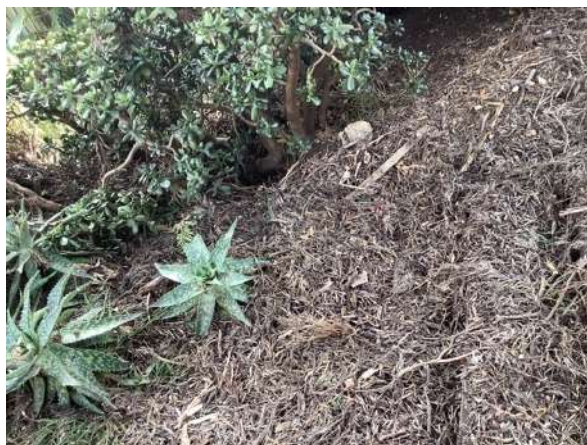
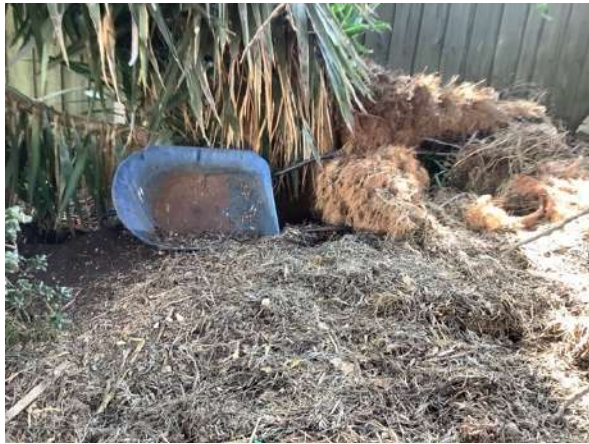
Conditions conducive to timber pest attack 4.18

Location: Garden Areas - All Areas

It is impossible to identify all areas for termites, timber pest and timber pest damage.

Please read the report carefully and Maintenance to all susceptible and conducive areas is a MUST to minimise the risk of termite and timber pest existence and timber damage.

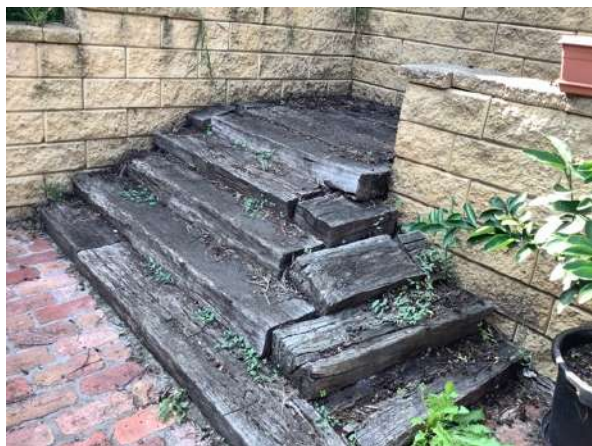
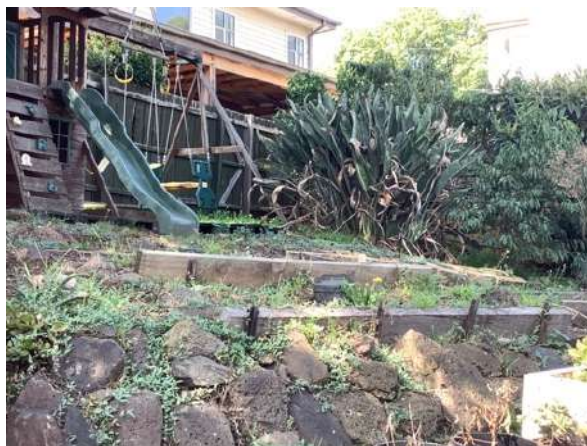
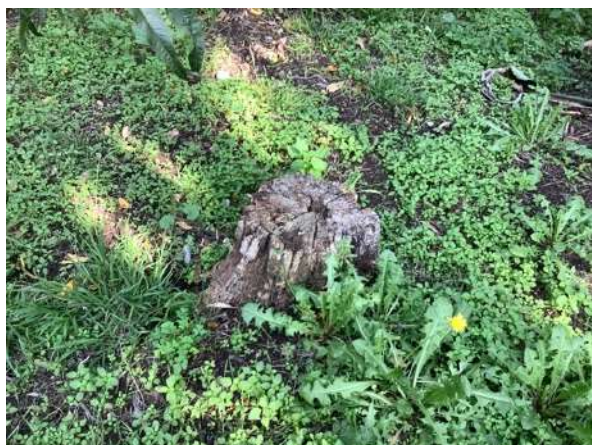
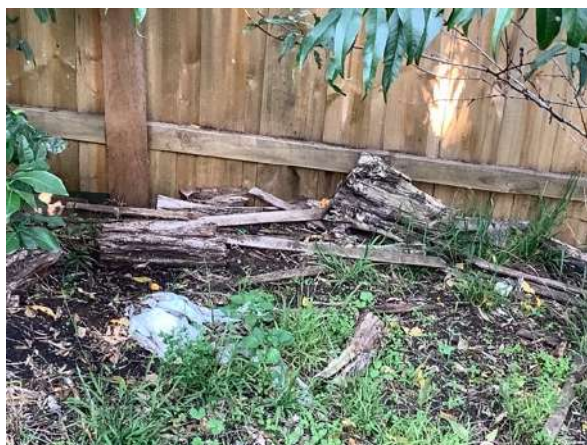
Conditions conducive to timber pest attack 4.20

UNTREATED OR NON-DURABLE TIMBER USED IN A HAZARDOUS ENVIRONMENT

Any timbers in direct ground contact provide opportunity for concealed termite entry and are likely to be subject to premature rot and decay as the soil retains moisture or damp conditions against the timbers.

When met with excessive moisture timber begins to decay and develop wood rot. Any timbers that are in direct contact with external grounds especially if left untreated or non-durable also provide ingress for subterranean termites into that particular element.

Remove untreated timber that is in direct contact with external grounds. Consider replacement with more durable materials i.e. treated timber or non timber elements.

Frequent pest inspections are advised to readily identify any termite activity in these areas.

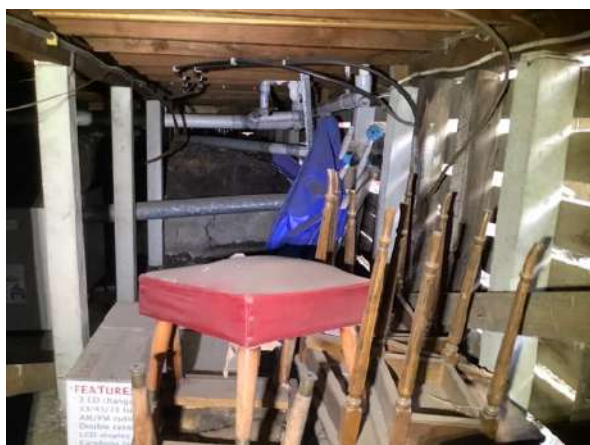
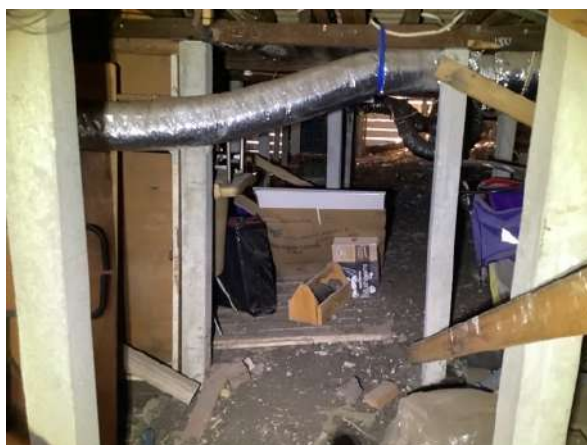
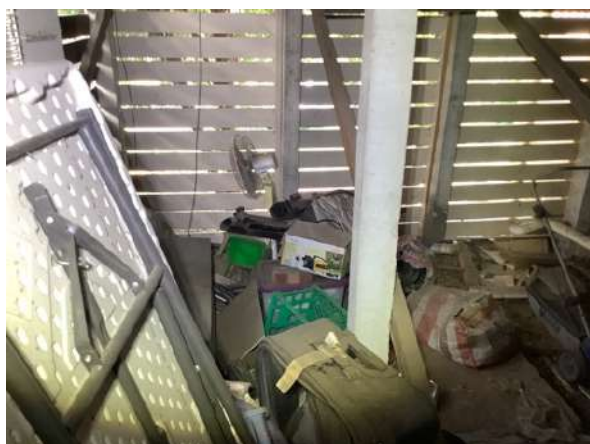
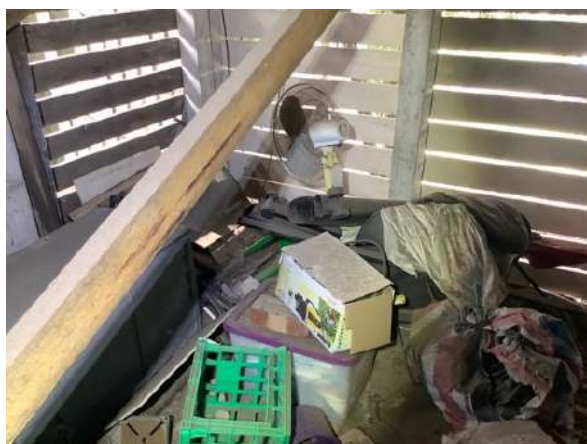
Conditions conducive to timber pest attack 4.21

OTHER CONDITIONS CONDUCTIVE TO TIMBER PEST ATTACK

The storing of timbers / debris / items in all areas of the property increases the risk of termite activity being present, as they are likely to come into contact with weather conditions or excessive moisture where wood rot is likely to develop on timbers that are not treated, or where debris or items are stored

It is highly recommended that any stored timbers / debris or items be immediately removed from areas

It is highly recommended that any stored building materials or other materials be immediately removed from areas in which they may attract any termite / timber pest attack around the perimeter and/or sub floor areas of the dwelling and a re-inspection is carried out.
