# Dilapadation Report

Inspection Date: 4 Oct 2020

Property Address: Ascot vale area.

Report Type: Dilapidation Inspection Report

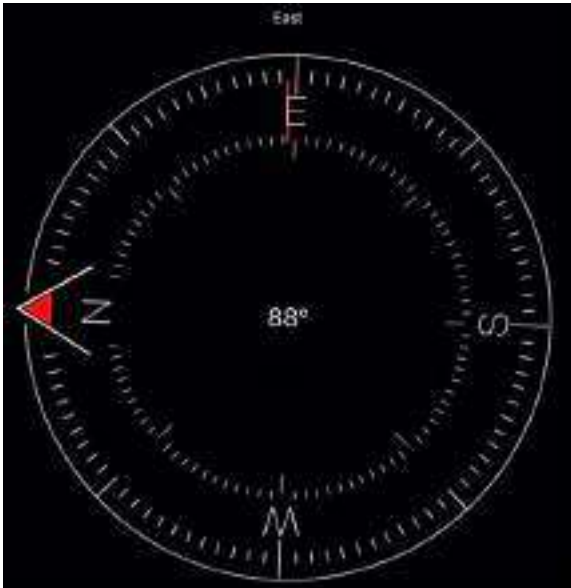
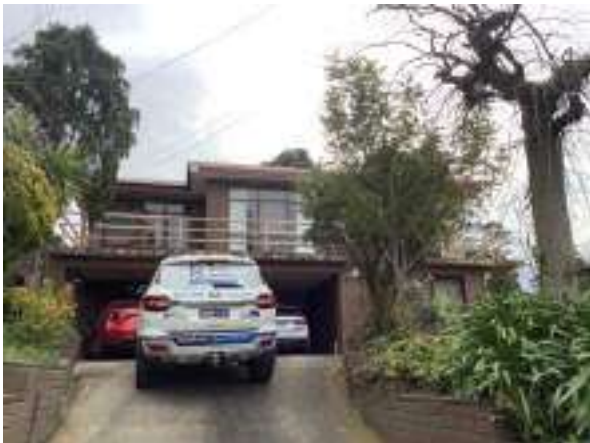
### For your information 4.02

Location: The Site  
Finding: Site Photos.  
Site photos & Additional photos are provided for your general reference.

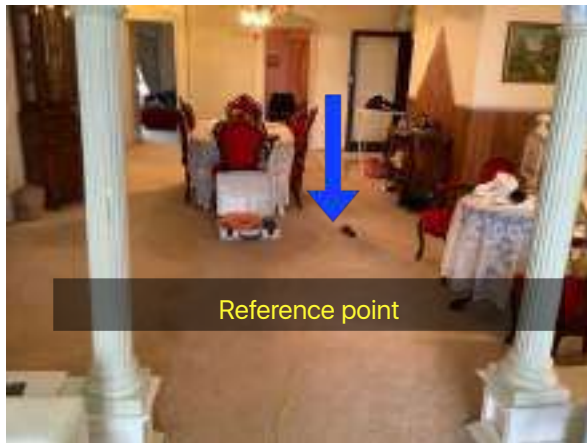
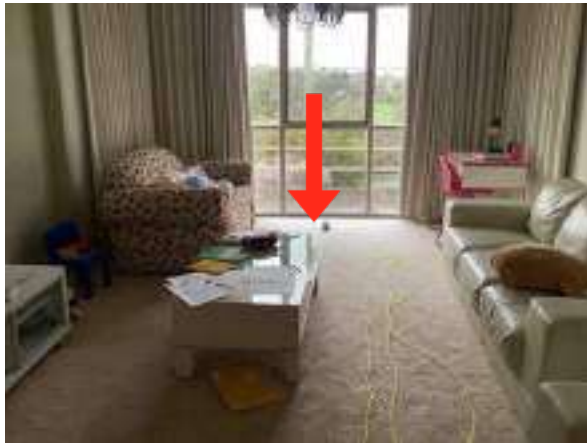
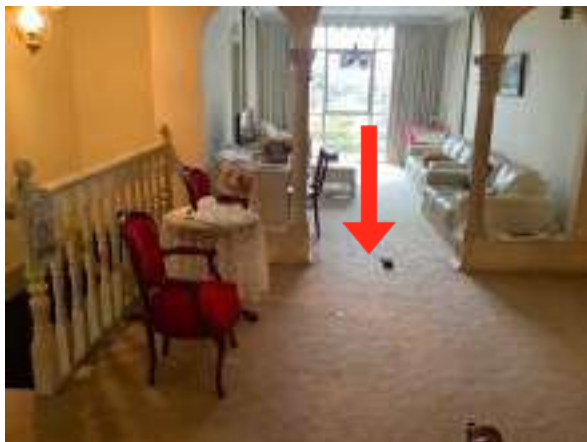
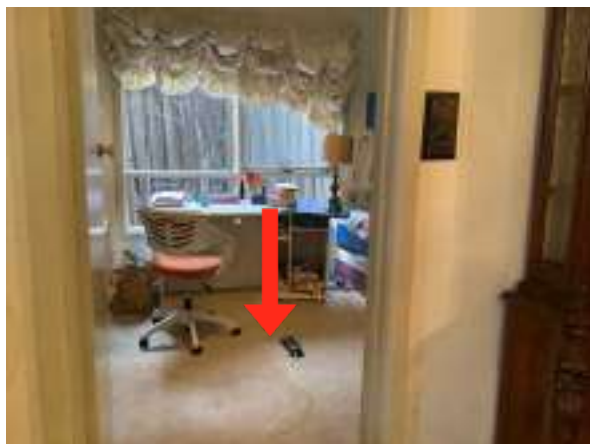
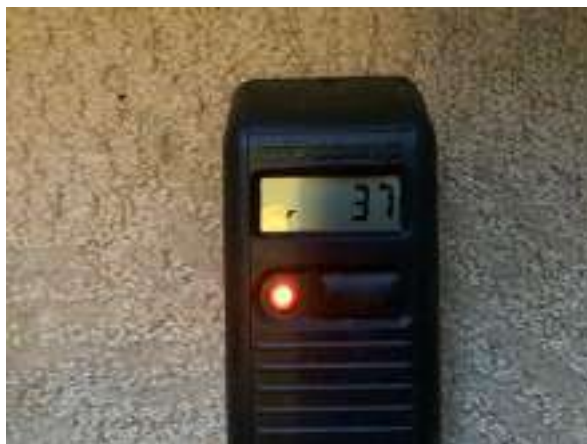
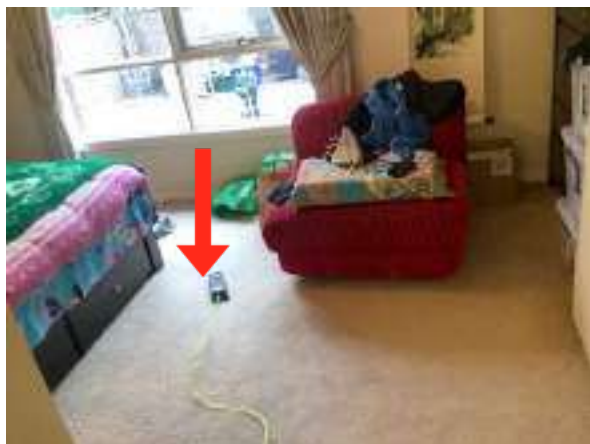
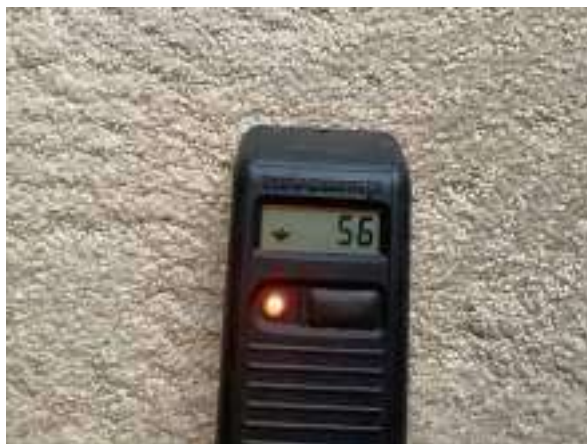
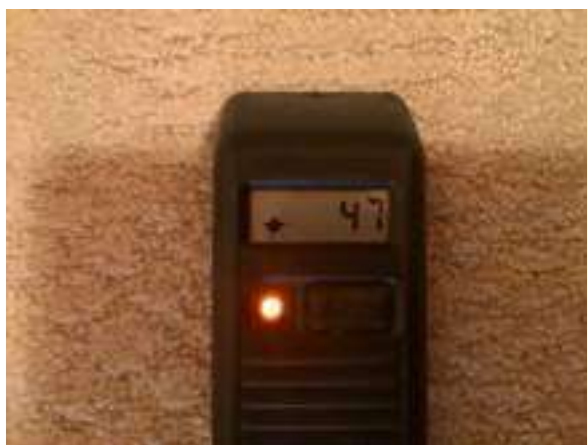
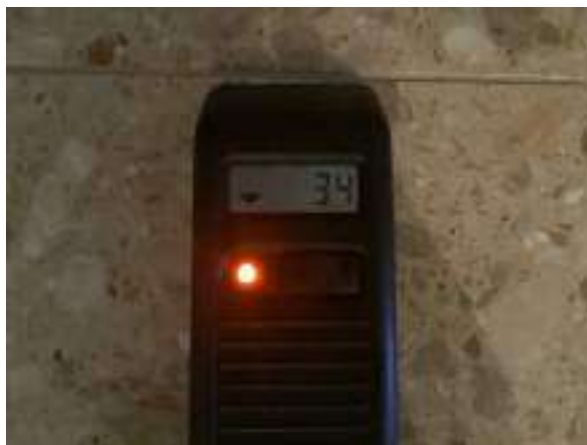
### For your information 4.03

Location: Internal Floor Levels

Finding: Floor Levels - Upper Level  
Attached are the floor levels in relation to a reference point to the upper level.

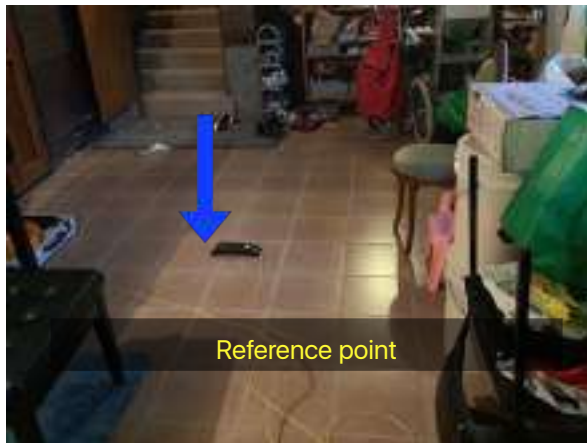
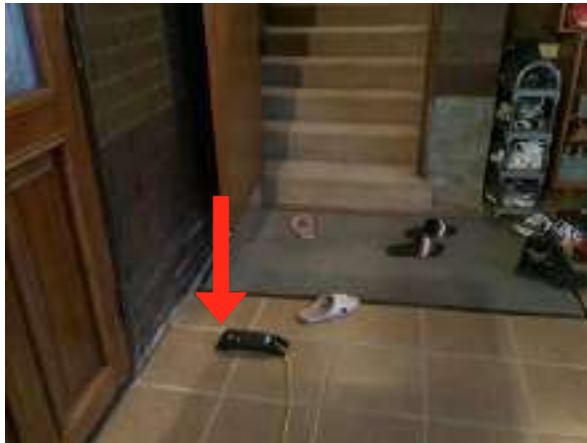
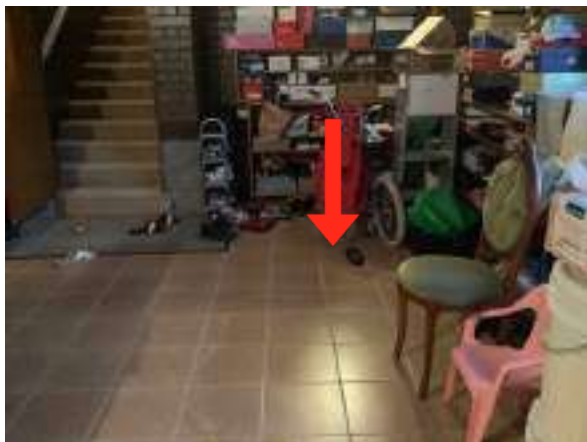
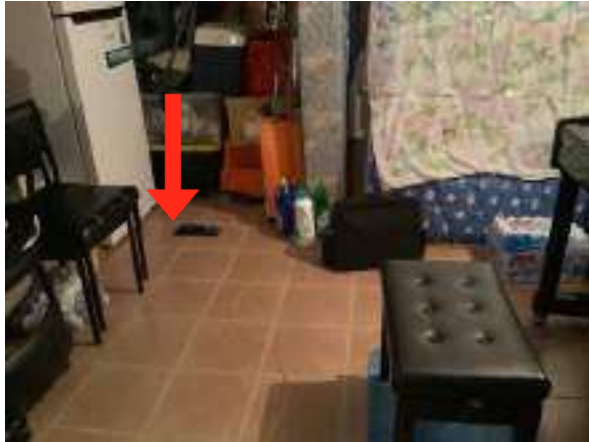
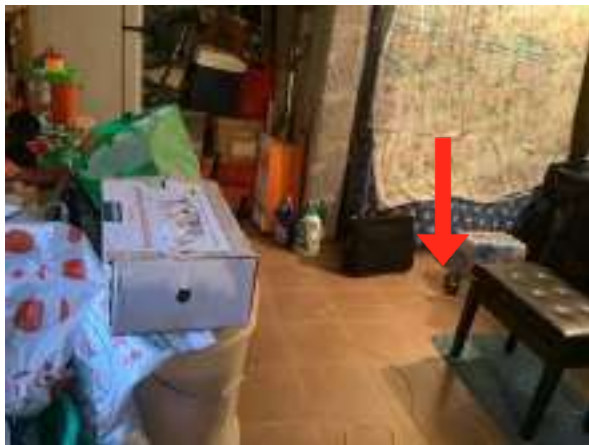
## For your information 4.04

Location: Internal Floor Levels

Finding: Floor Levels - Below Storage  
Attached are the floor levels in relation to a reference point to the lower level.

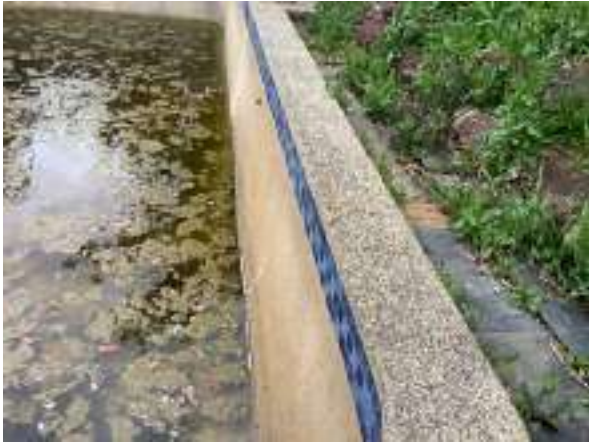
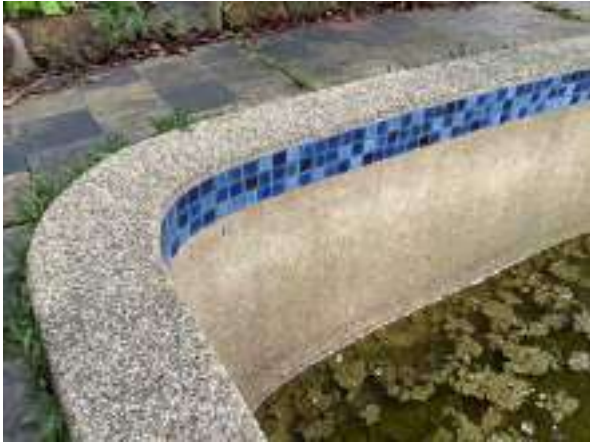
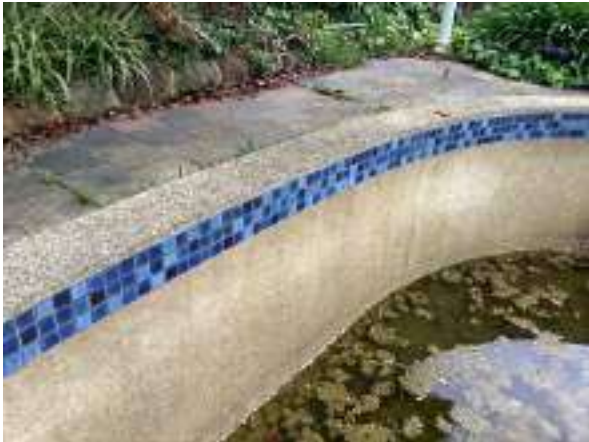
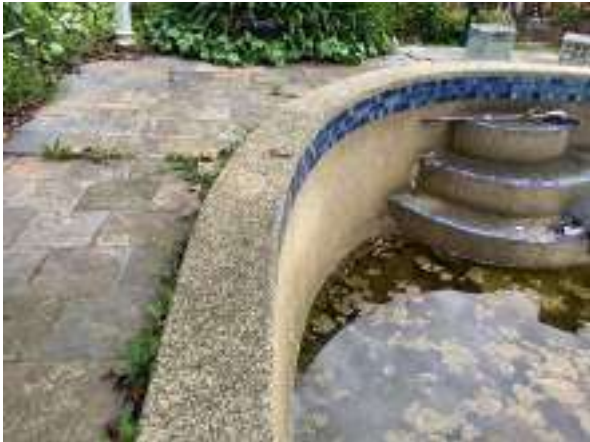
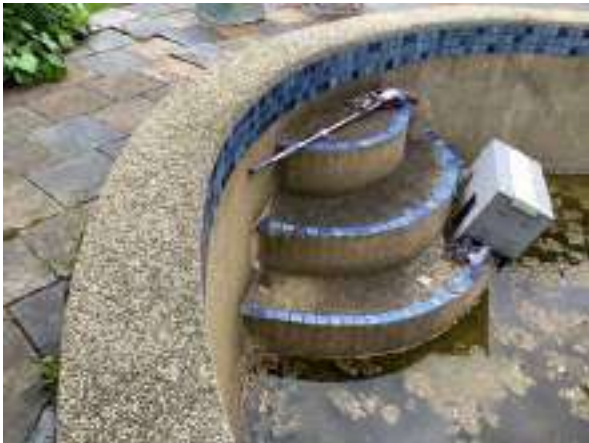
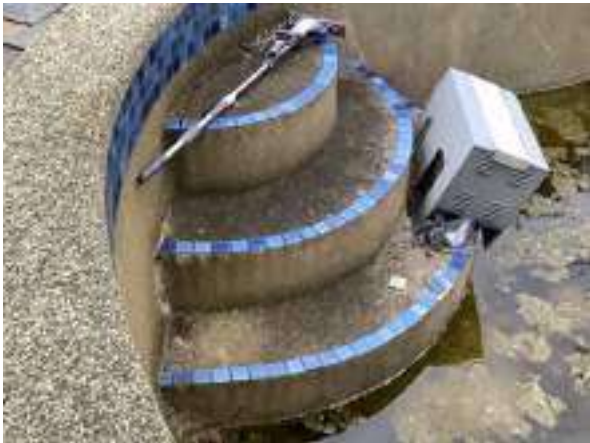
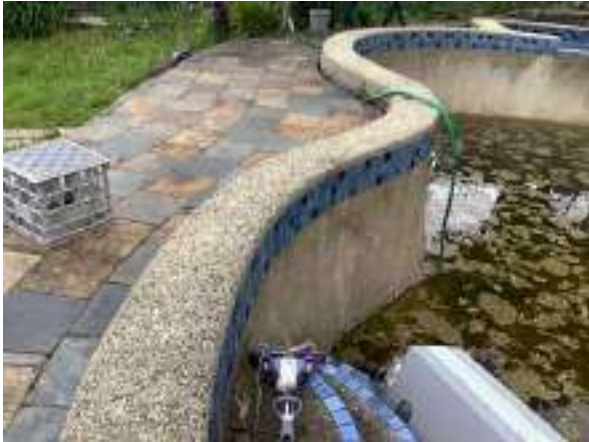
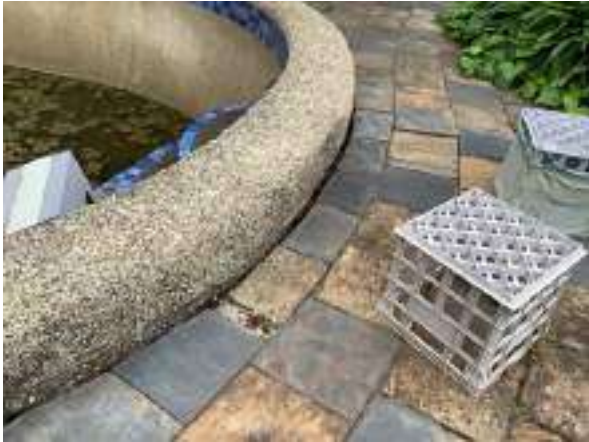
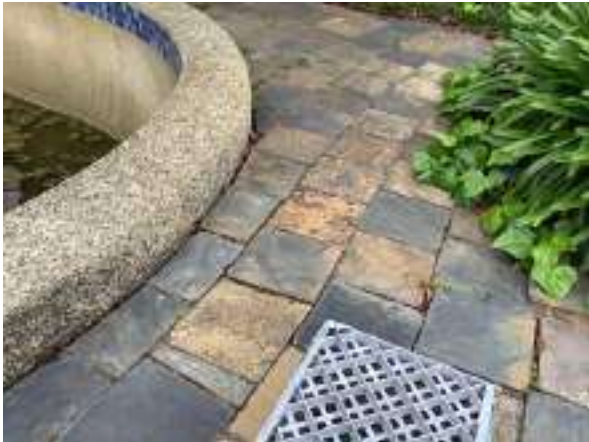
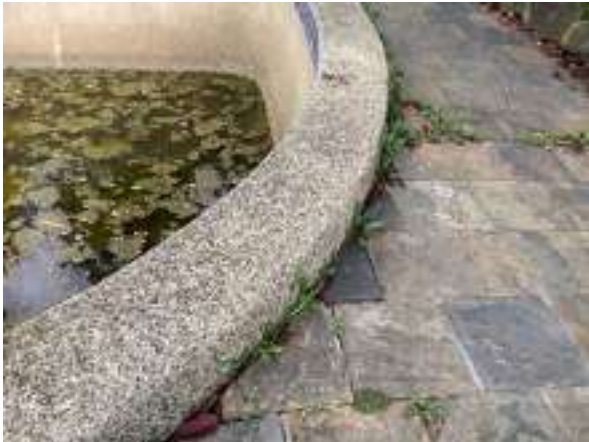
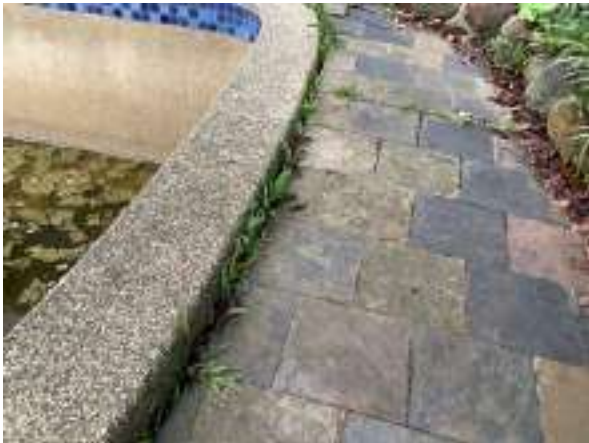
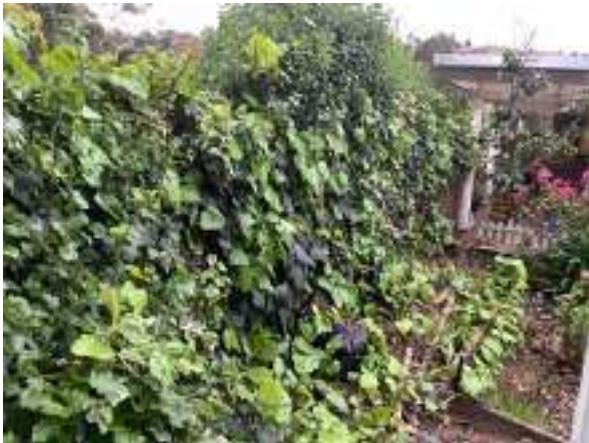
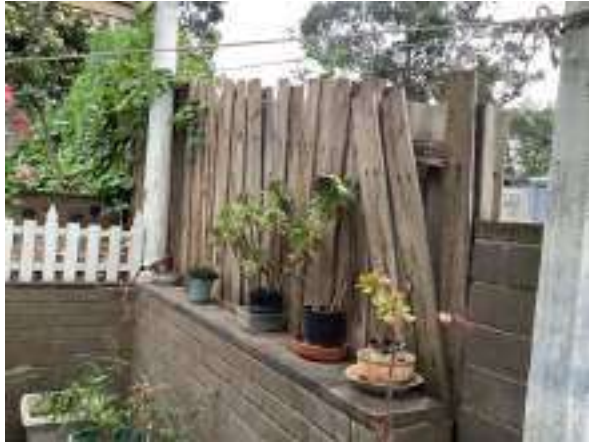
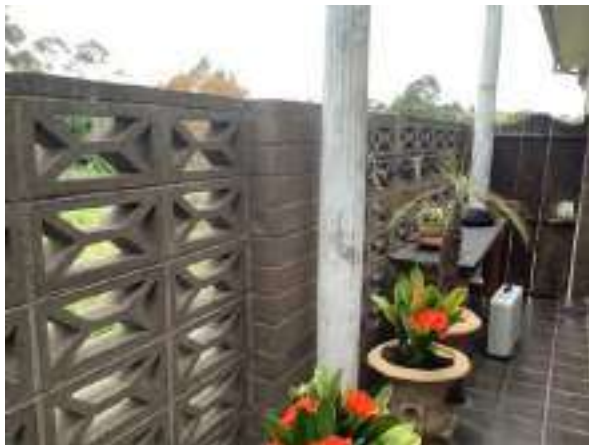
### For your information 4.05

Location: Exterior North Side

Finding: For your information – site photos ( back yard )  
Photos of interest and the condition for this location at the time of the inspection.  
In addition, various photos with a close up and/or arrows added to highlight the area of concern.

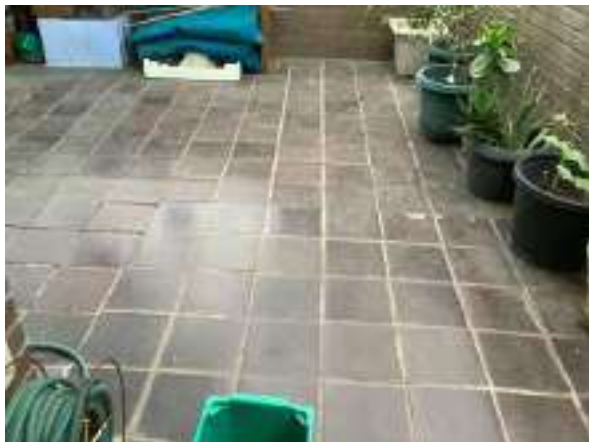
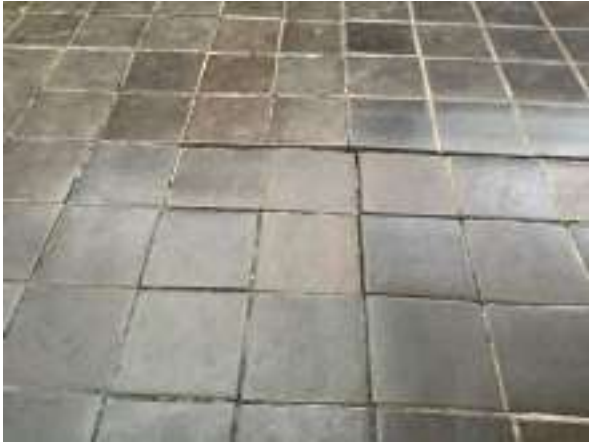
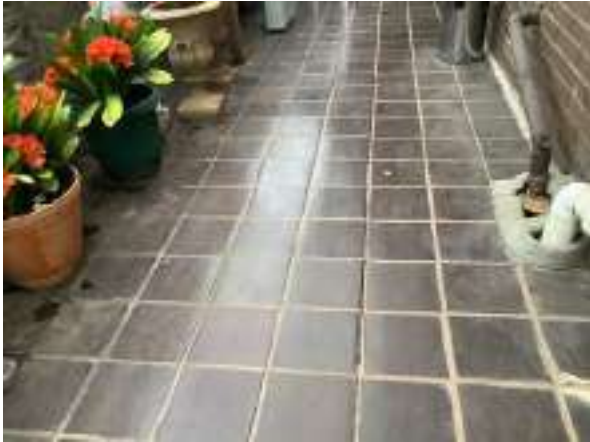
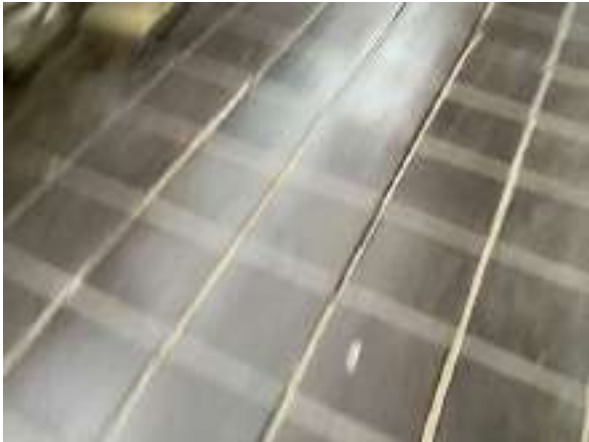
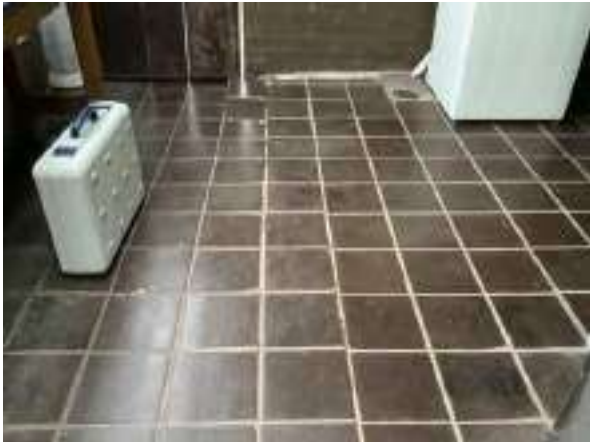
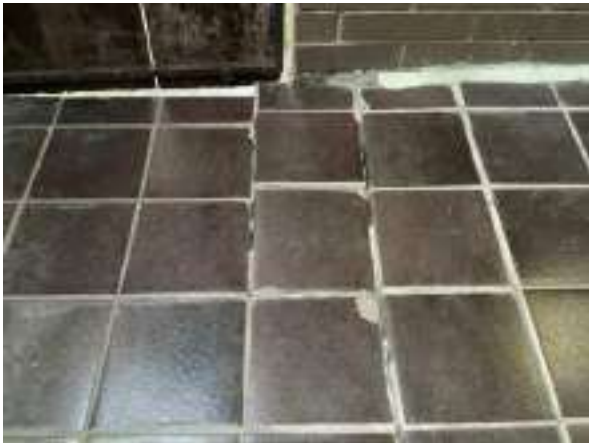
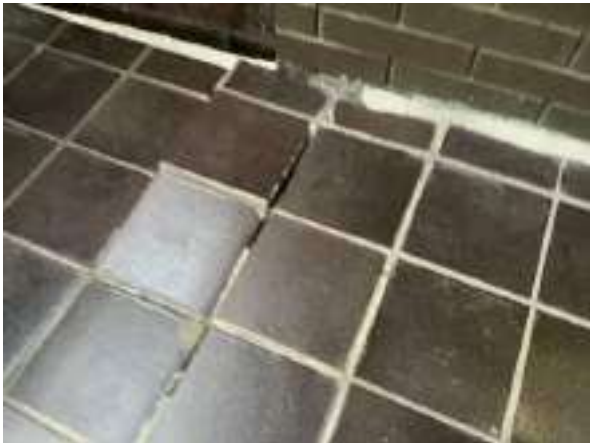
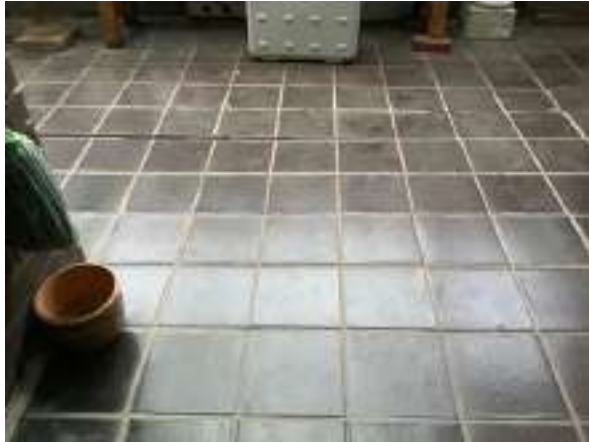
### For your information 4.06

Location: Exterior North Side

Finding: Tile Paving  
The tile paving is considerably compromised and drummy at the time of the inspection.

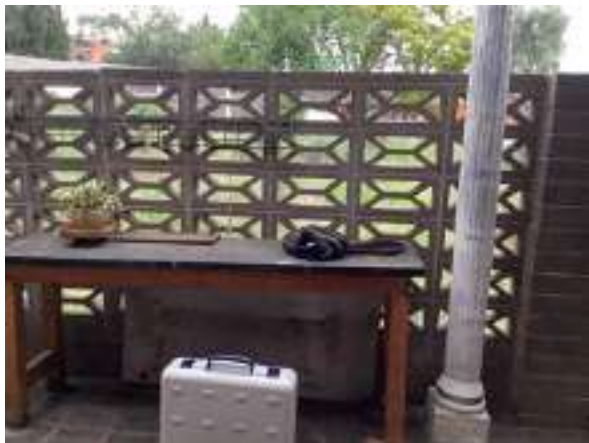
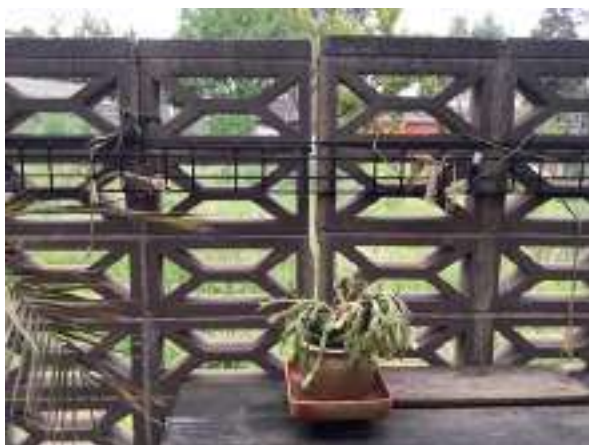
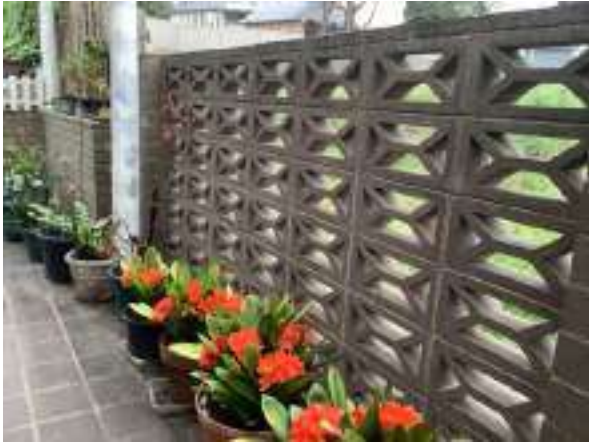
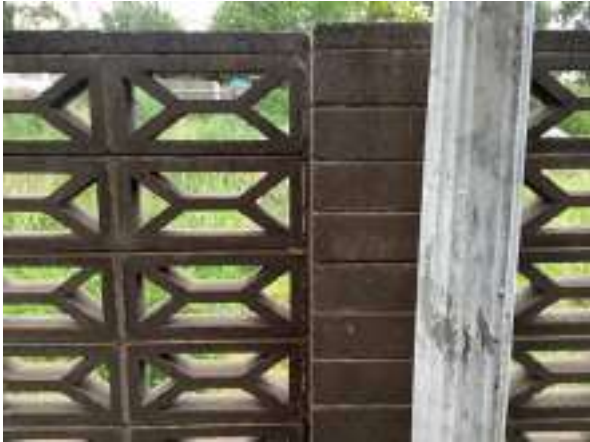
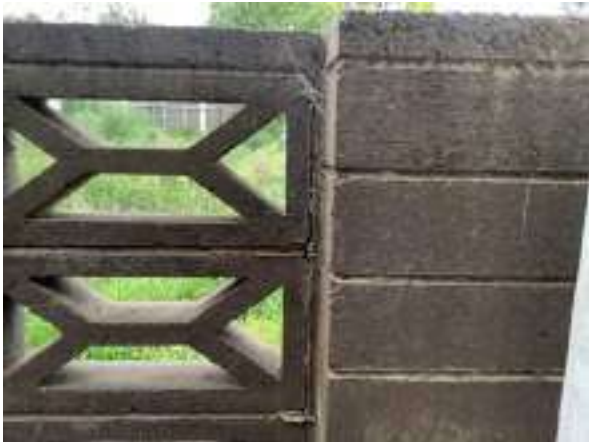
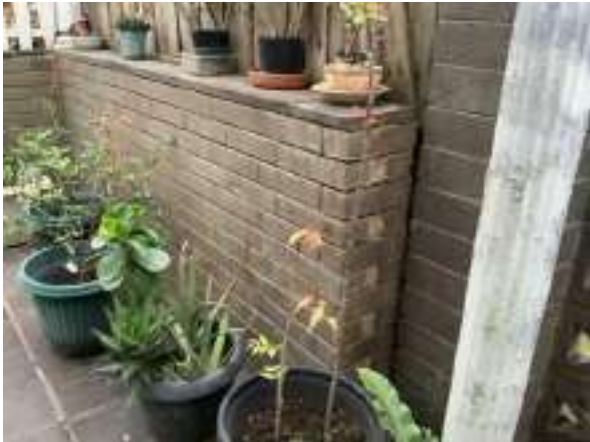
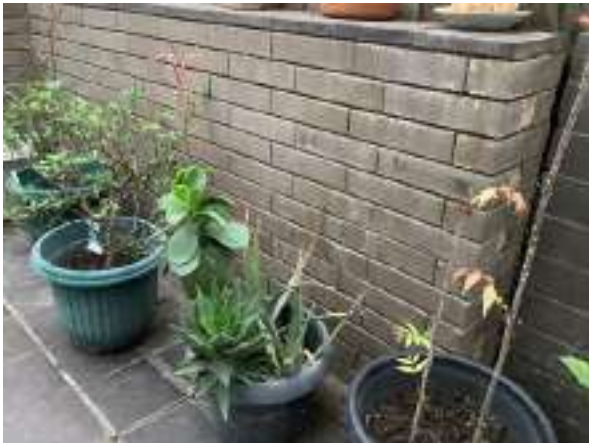
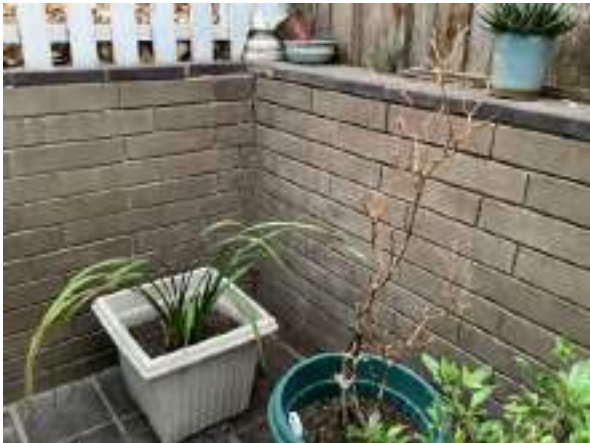
Location: Exterior North Side

Finding: Block Fencing  
At the time of the inspection the block fencing has considerable movement.

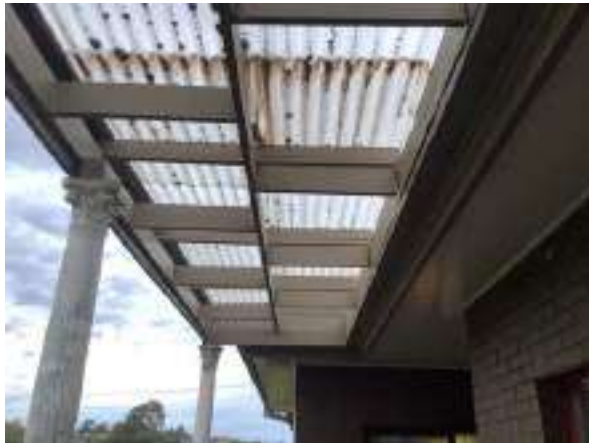
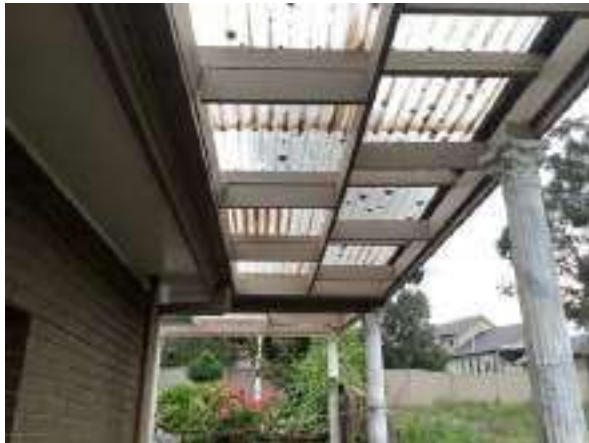
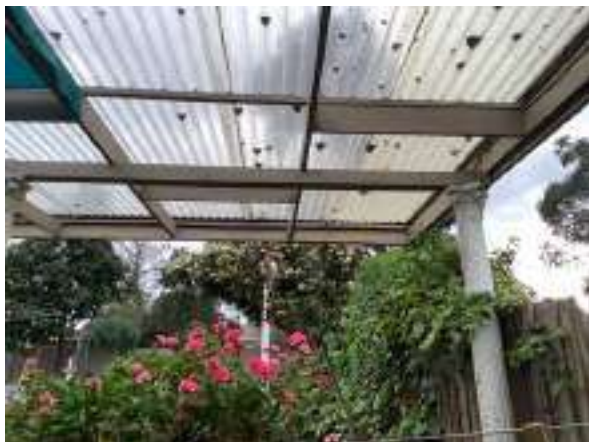
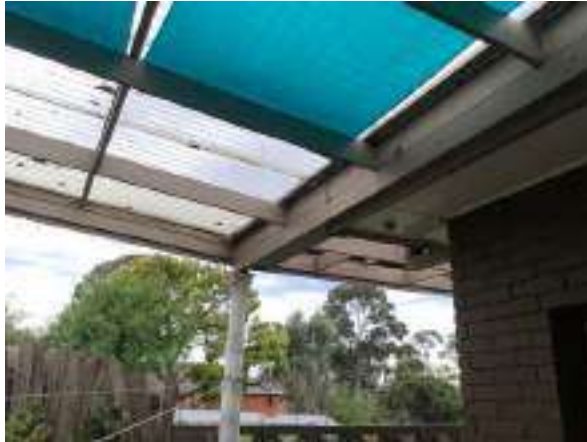
## For your information 4.08

Finding: Pergola roofing area  
Photos of the pergola roofing at the time of the inspection.

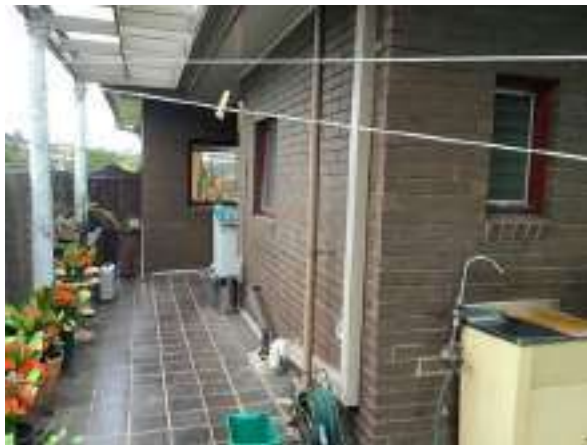
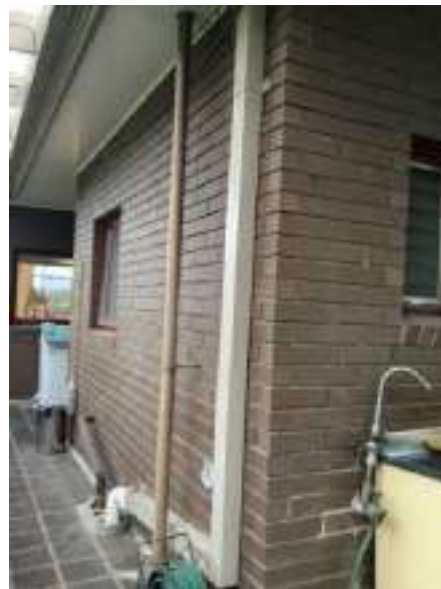
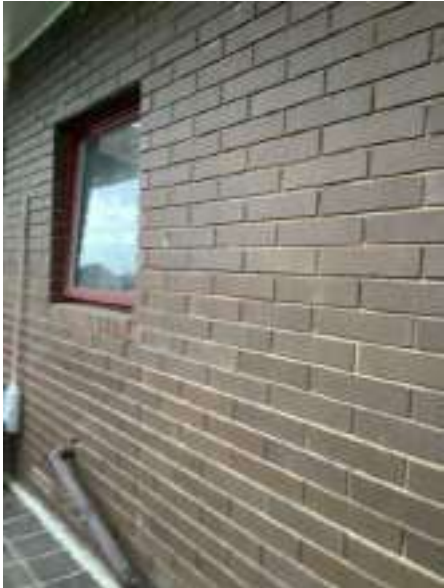
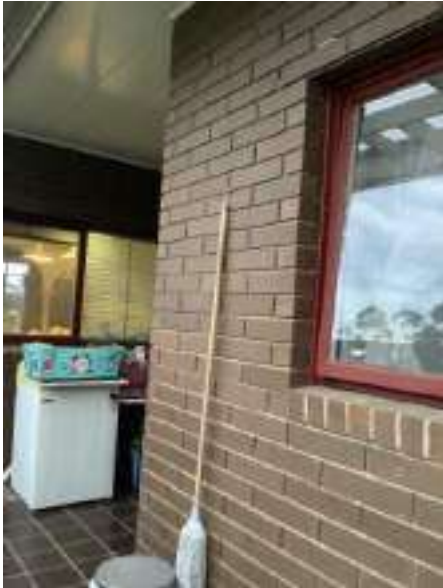
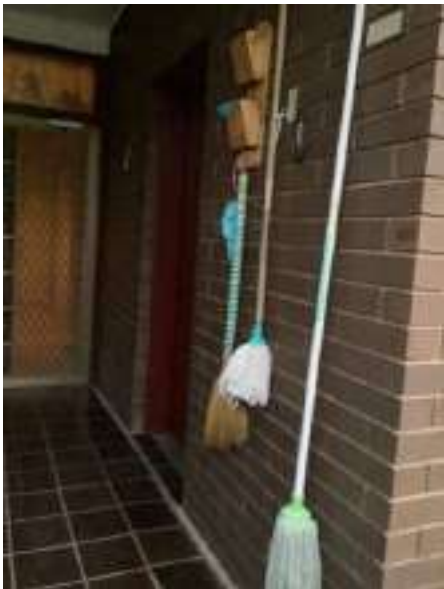
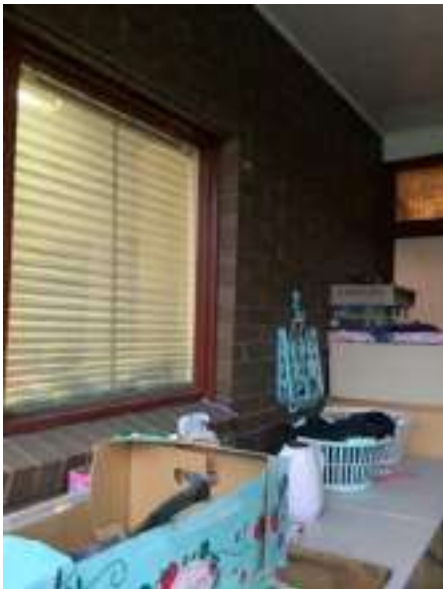
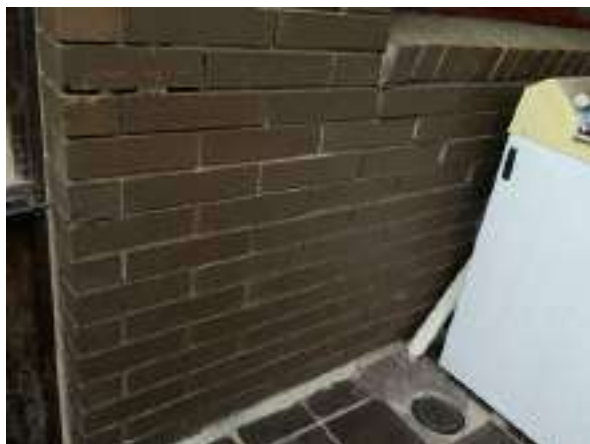
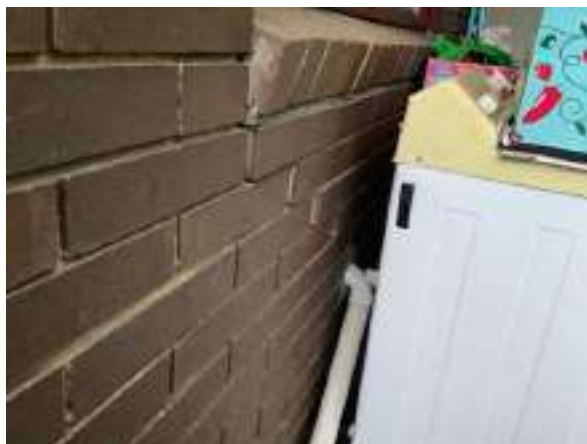
### For your information 4.09

Finding: Brickwork - Backyard ( Behind Gate )  
The photos will demonstrate that the area has movement in relation to the brickwork.

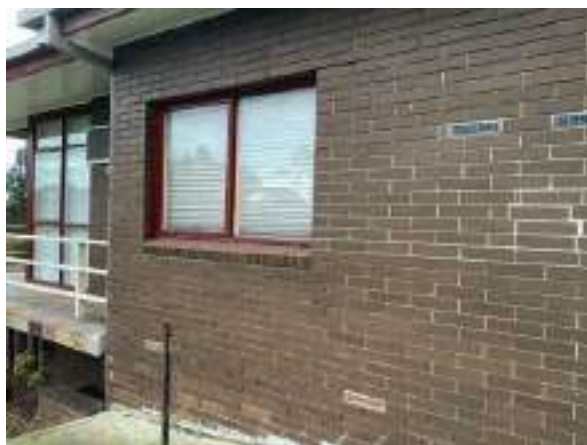
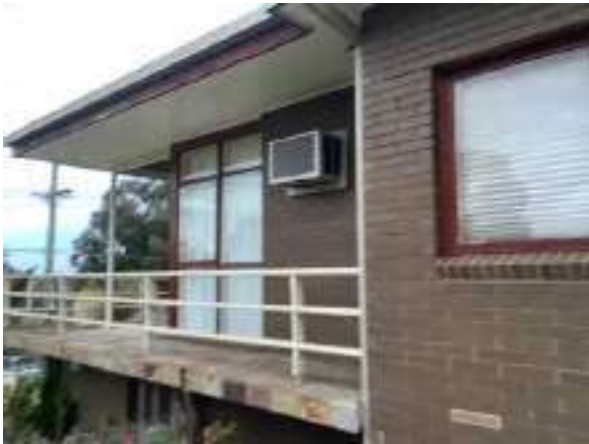
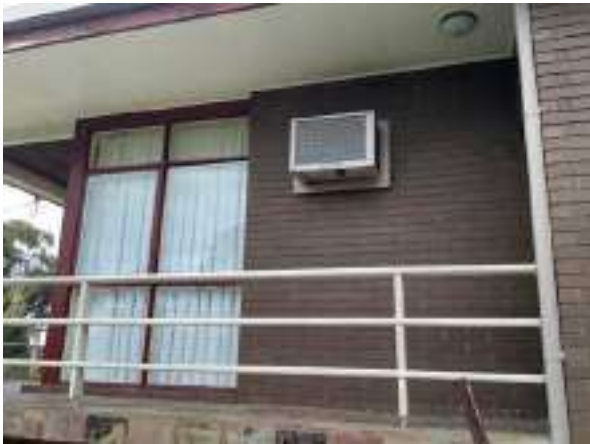
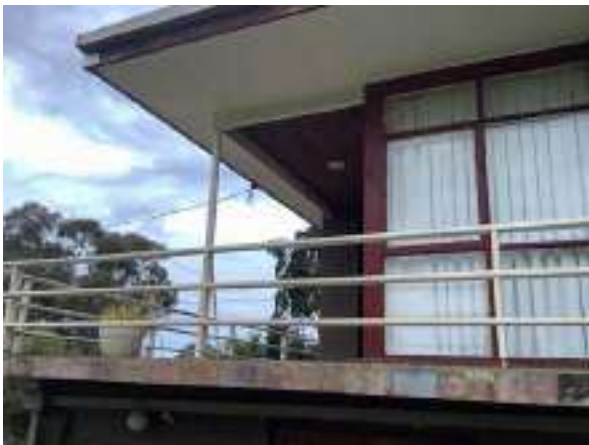
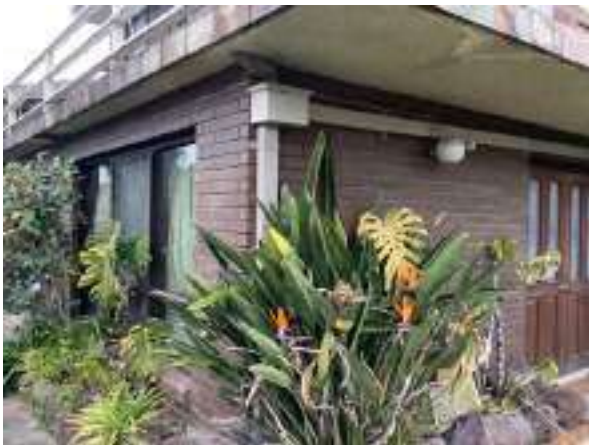
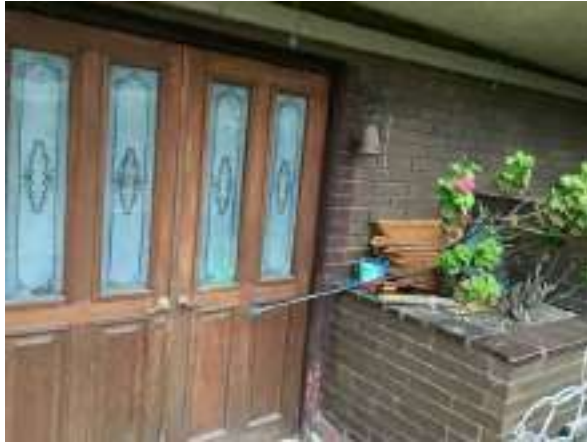
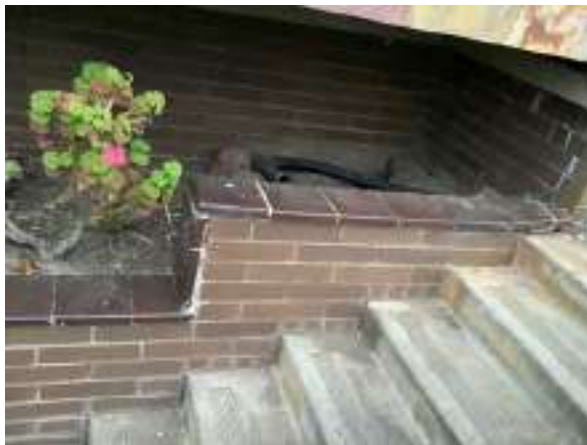
### For your information 4.10

Location: Exterior North Side  
Finding: Brickwork - In Front Of Gate  
Brick wall photos for your information.

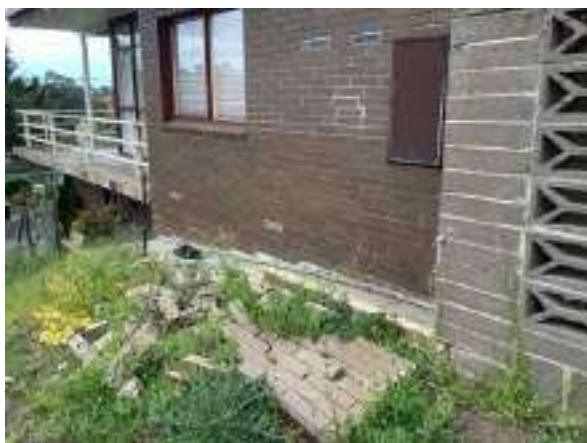
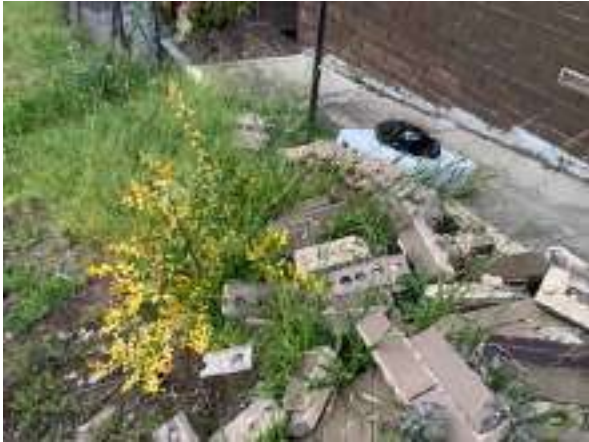
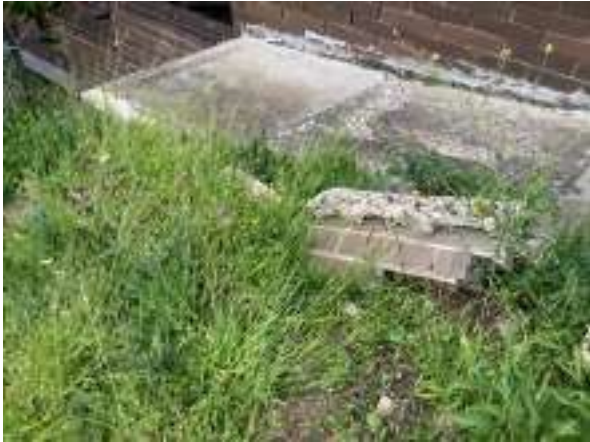
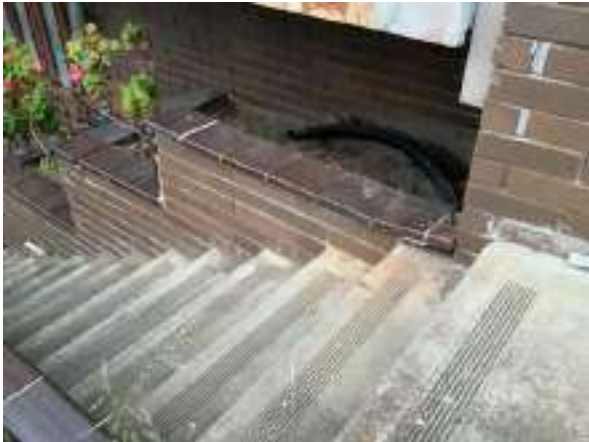
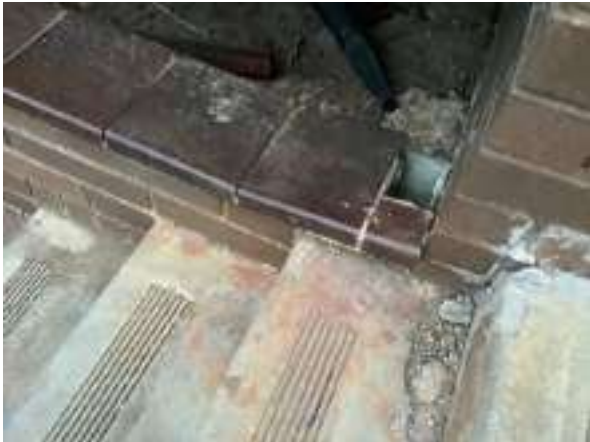
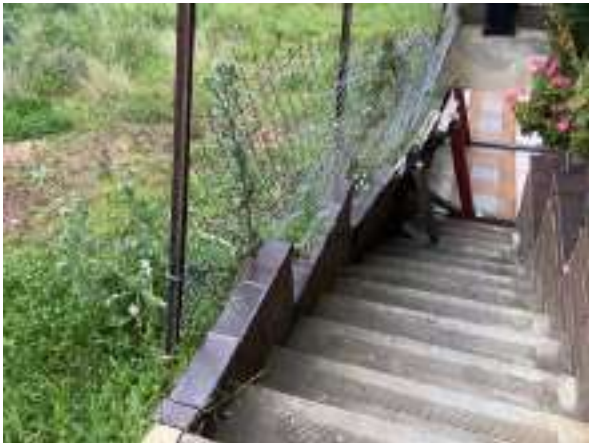
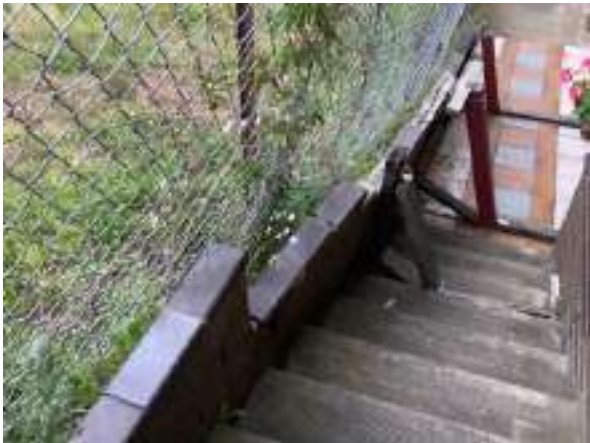
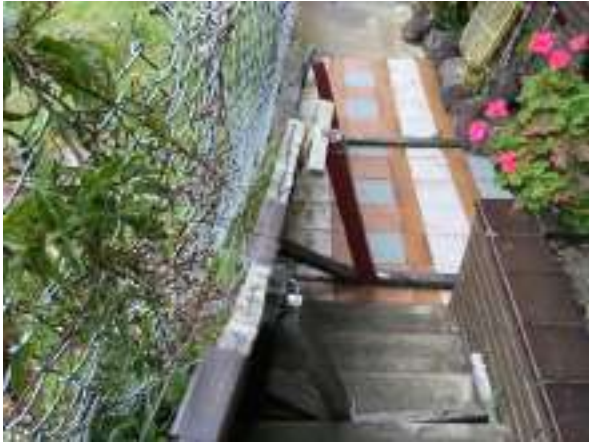
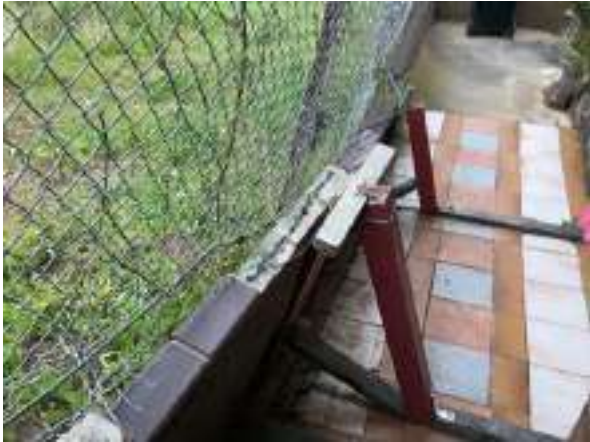
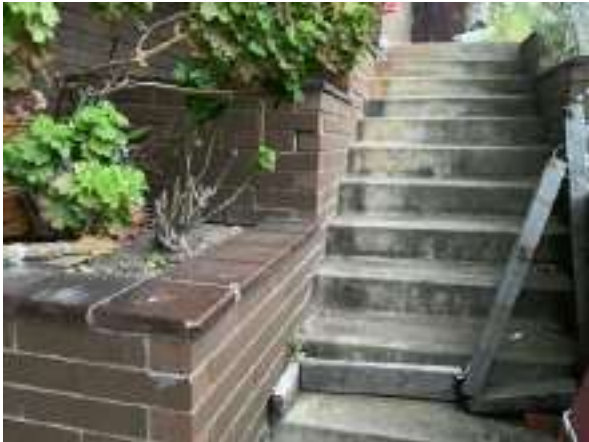
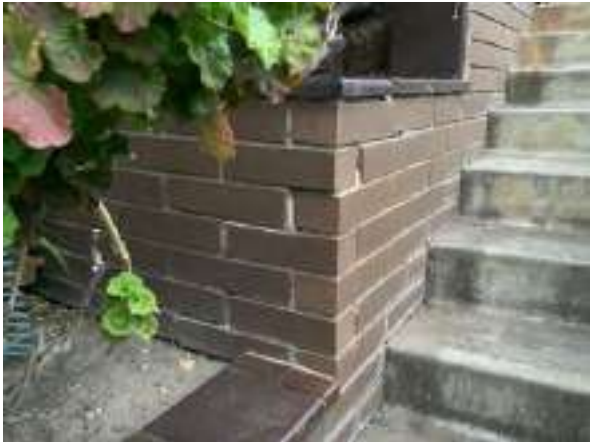
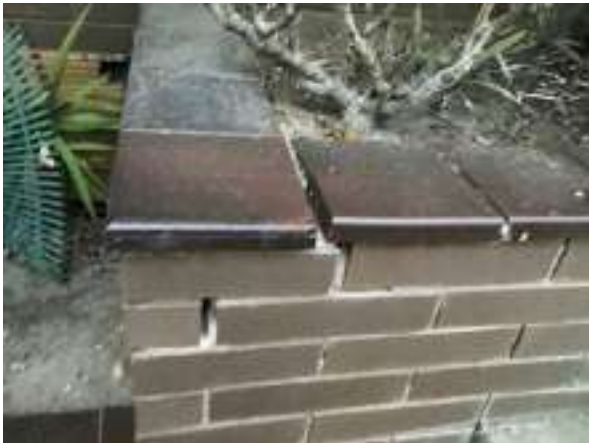
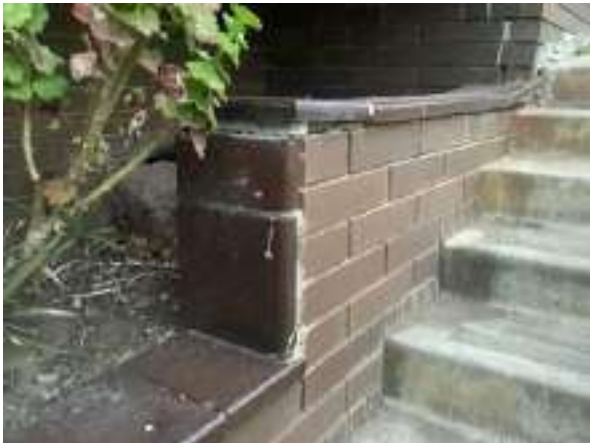
### For your information 4.11

Finding: Brick - Movement & Dilapidated ( In Front Of Gate )  
The photos will demonstrate that the brick fence is severely compromised and in a state of dilapidated which requires removal.

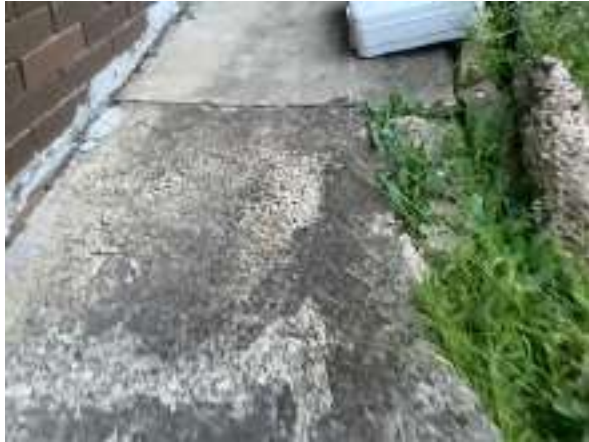
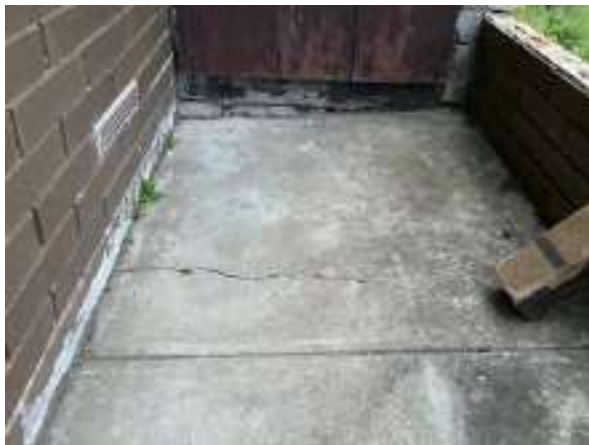
## For your information 4.12

The photos will demonstrate that the concrete path is severely compromised and in a state of dilapidated.

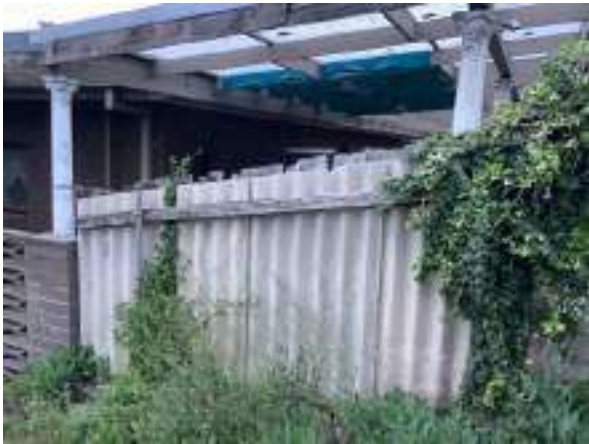
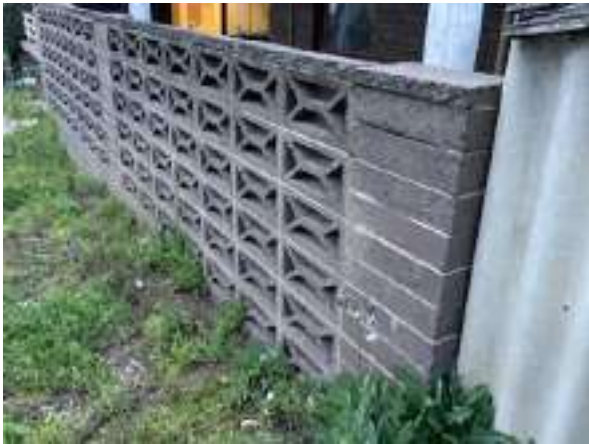
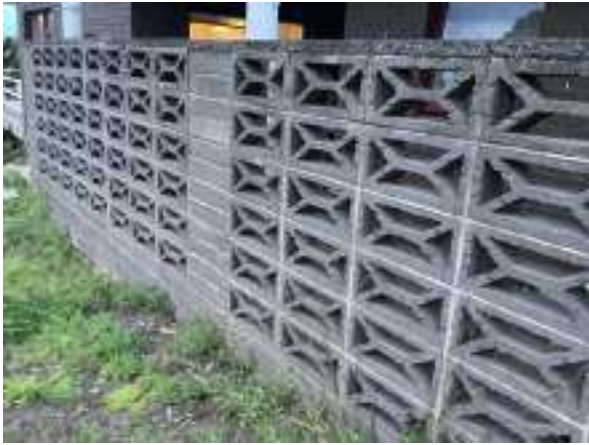
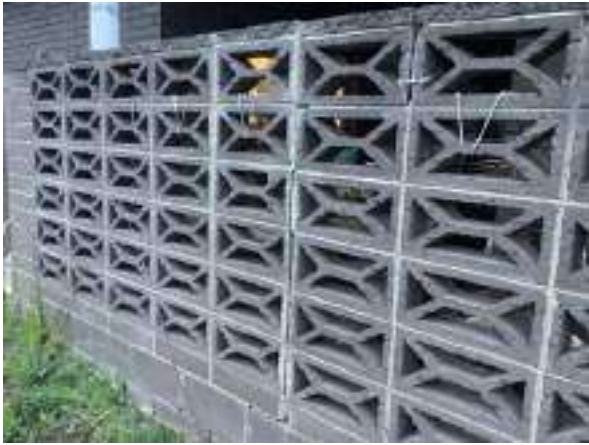
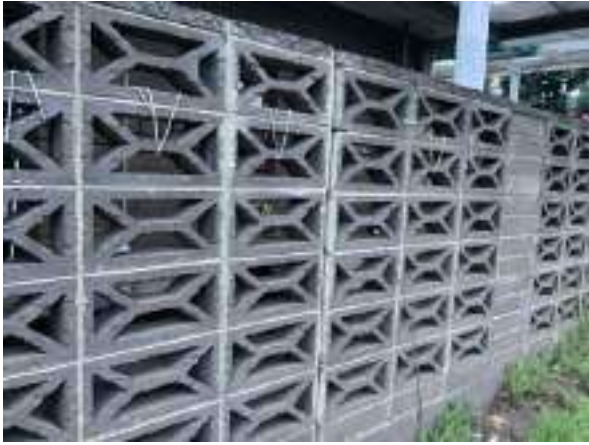
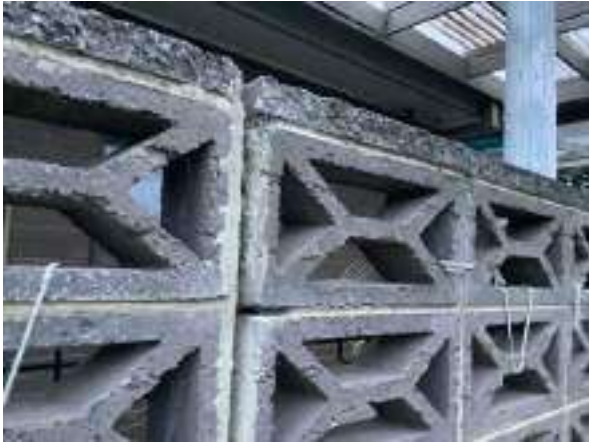
### For your information 4.13

Finding: Fencing from the proposed working site  
Photos of the fencing, various areas of damage and no fencing.
