# Dilapadation Report

Inspection Date: 4 Oct 2020

Property Address: Ascot vale area.

Report Type: Dilapidation Inspection Report

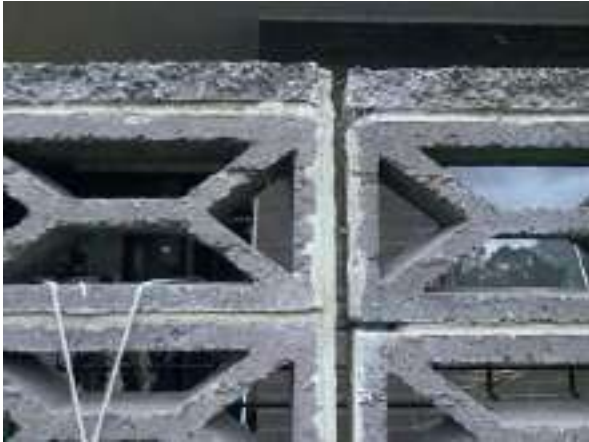
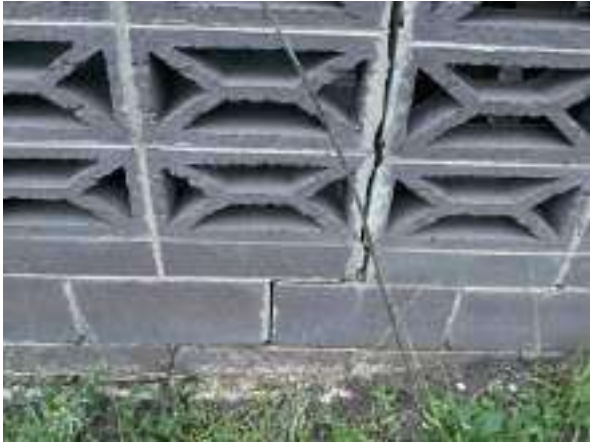
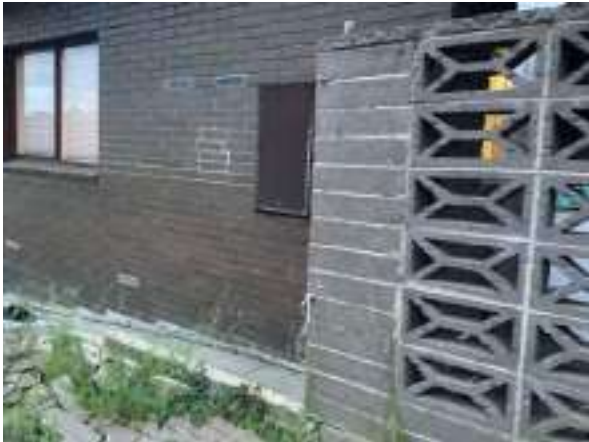
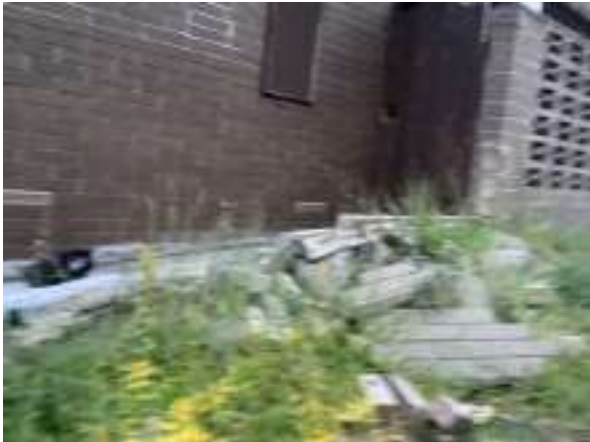
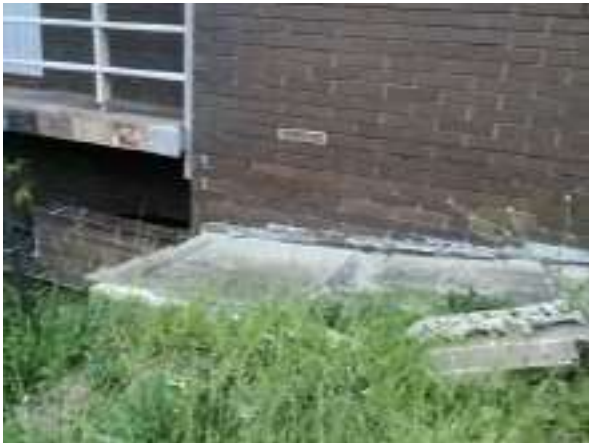
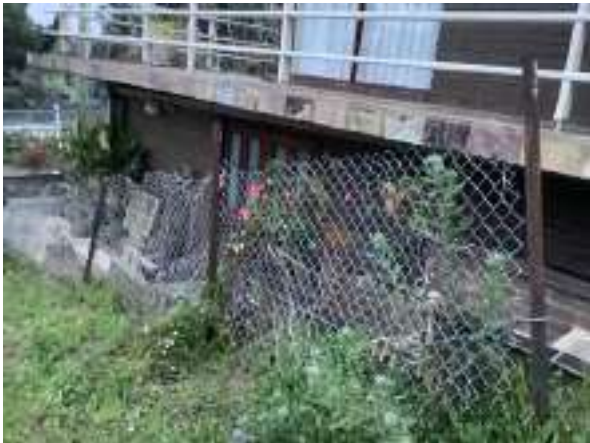
### For your information 4.13

Finding: Fencing from the proposed working site  
Photos of the fencing, various areas of damage and no fencing.

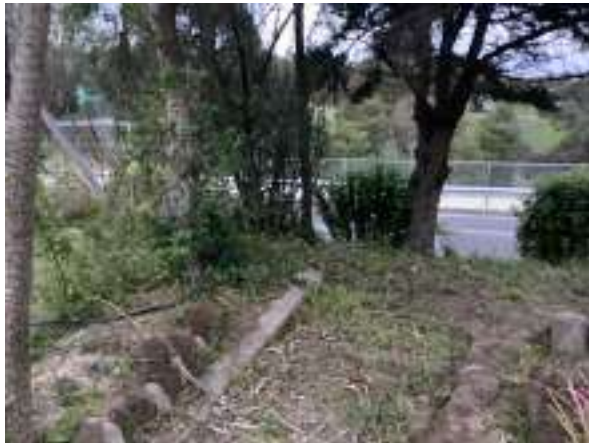
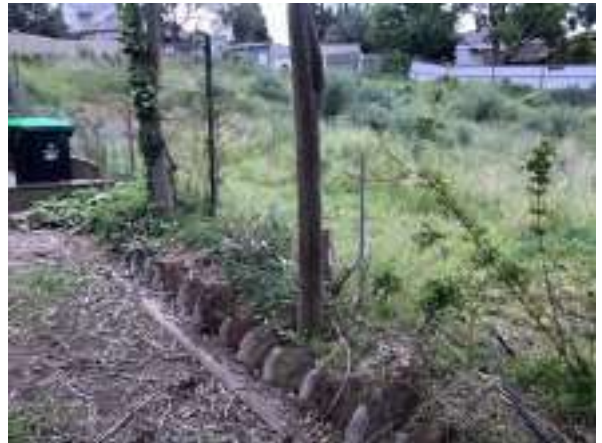
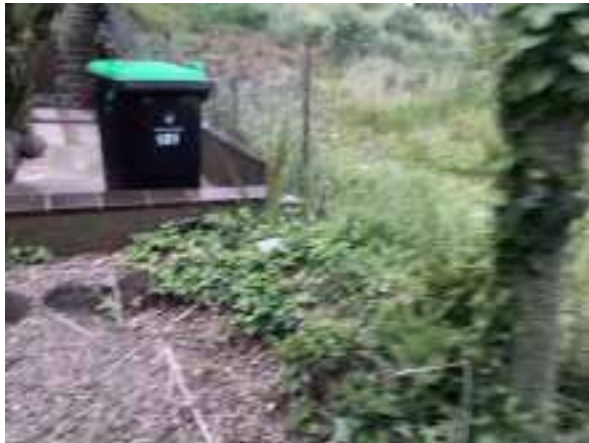
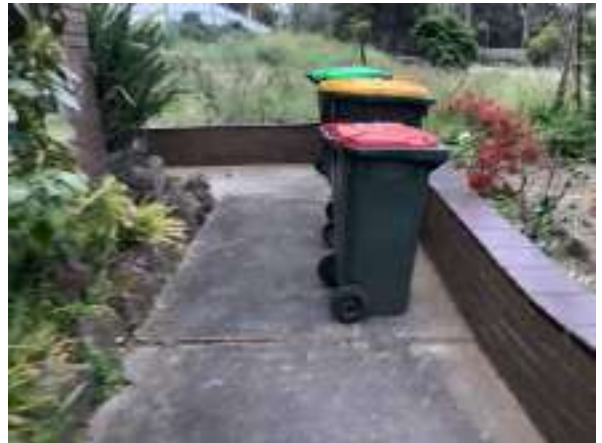
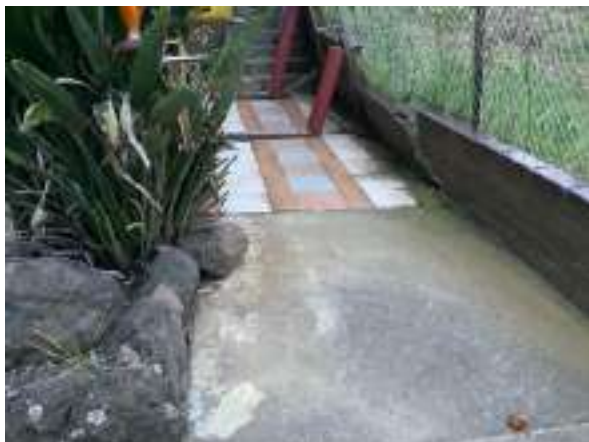
## For your information 4.14

Location: Lower Story Additional Site Photos  
Finding: Lower story additional site photos  
Additional photos are required for your information.
