Building Report - VCAT Compliant (Prepared For Court Proceedings)

Inspection Date: 29 Jul 2021

Property Address: (PRIVATE) Vic

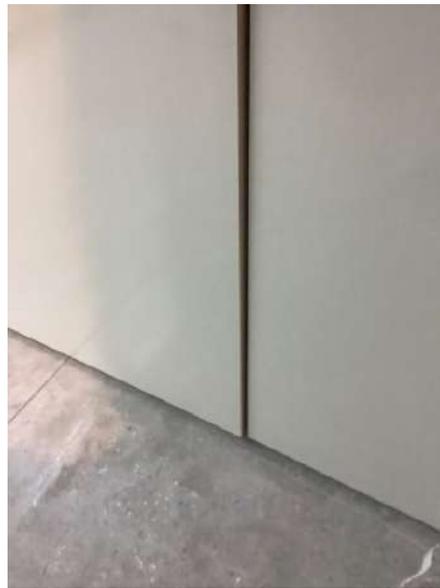
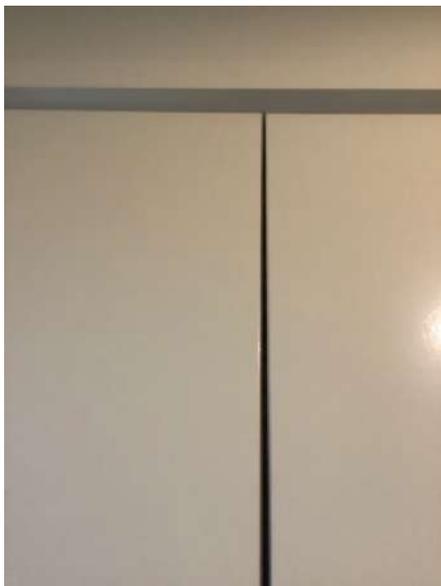
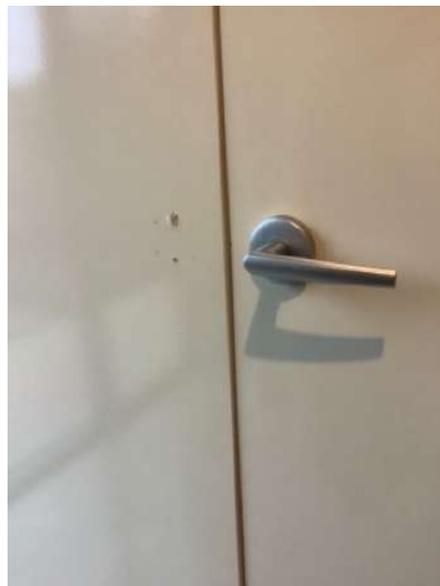
Defect 1.04

It was noted the plaster work / joints to the walls in these areas as per the photos attached are clearly visible.

1 In critical lighting conditions, surface imperfections may still be apparent in a Level 4 surface finish.

Reworking of the plaster will need to take place and painting re-done to the areas within this report, but certainly not limited. It is the builders responsibility to make good all defective plaster work / joints within this property.

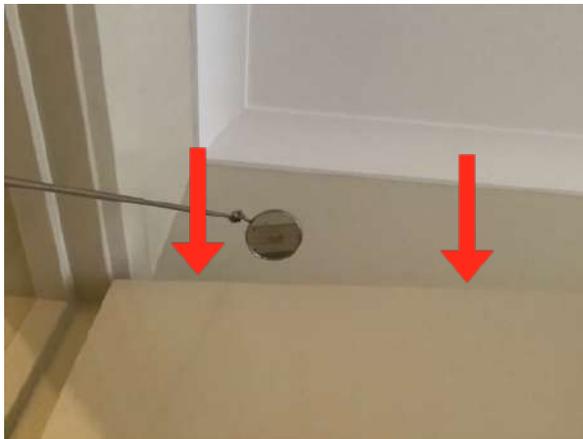
Defect 1.06

The garage requires seals the the door frame and the bottom of the door and the front doors require a seal to the vertical lip of the fixed door.

The areas with photos attached and arrows pointing to the areas required are non-compliant

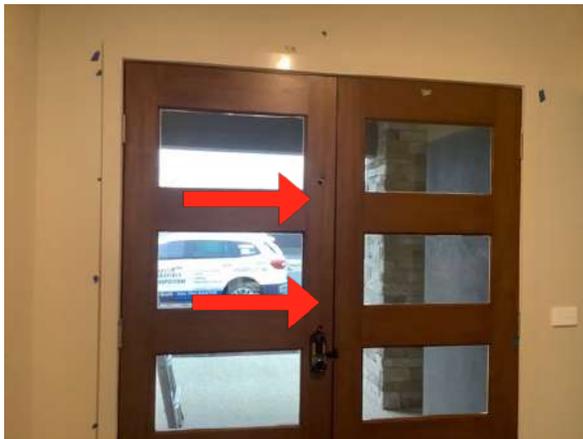
Defect 1.10

Defective paint staining and finish to the front door.

The front door has inconsistencies in the staining

Paintwork is defective if the application has blemishes such as paint runs, paint sags, wrinkling, dust, bare or starved painted areas, colour variations, surface cracks, irregular and coarse brush marks, sanding marks, blistering, non-uniformity of gloss level and other irregularities in the surface that are visible from a normal viewing position.

Paintwork is defective if the application results in excessive over-painting of fittings, trims, skirtings, architraves, glazing and other finished edges.

Sand the door back to its original bare timber finish and apply the appropriate staining and sealing.

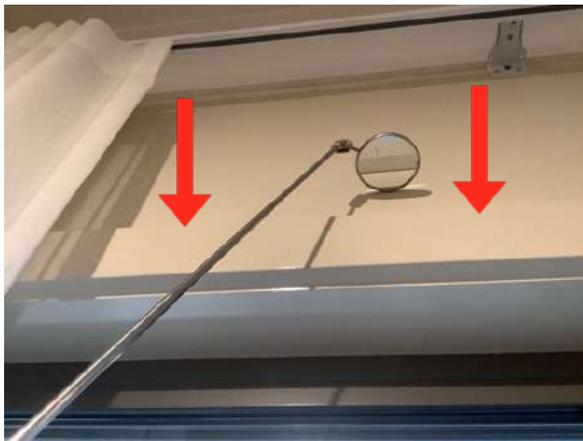
Defect 1.14

Minor repairs required.

Minor nailing and glue required. Finally repainted.

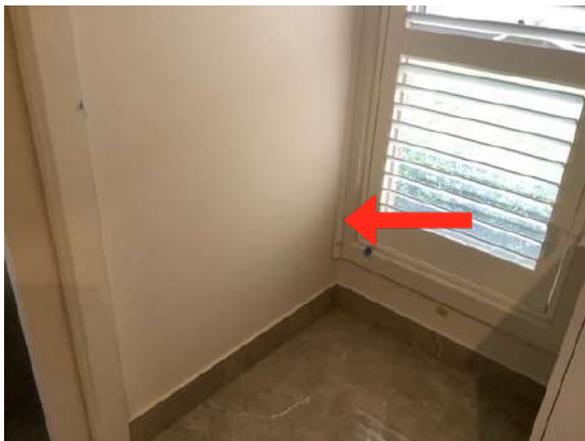
Defect 1.15

Damaged Render.

The render work to the front bedroom windows is damaged. My understanding is that the builder had to come back for maintenance issues to the windows and created this damage at the time of the repairs.

Marks caused by damage which is obvious from a normal viewing position is considered a defect with reference to Standards and Tolerances.

Render repairs required.

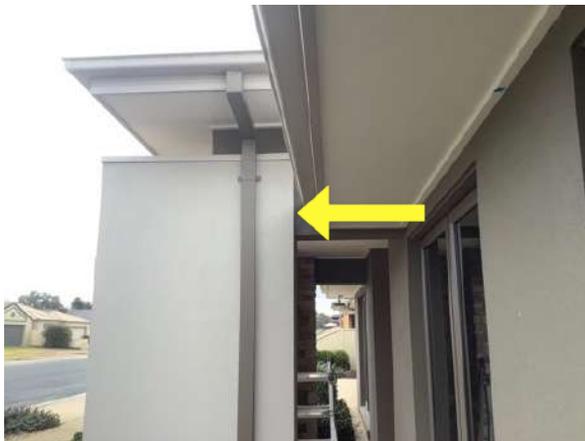
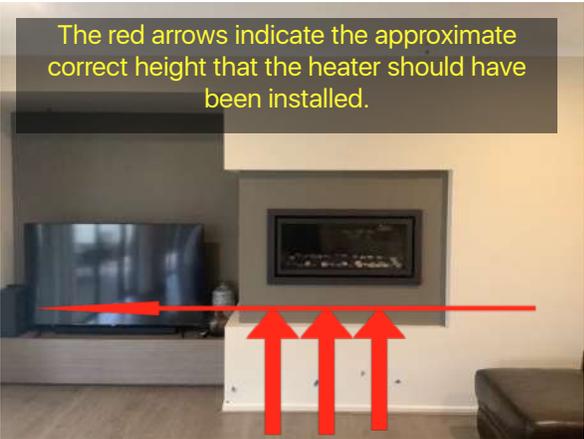
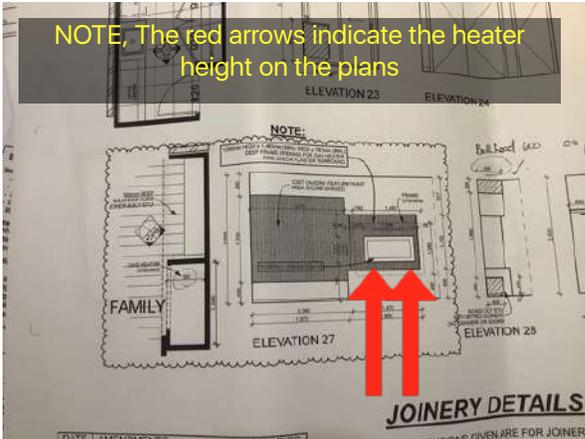
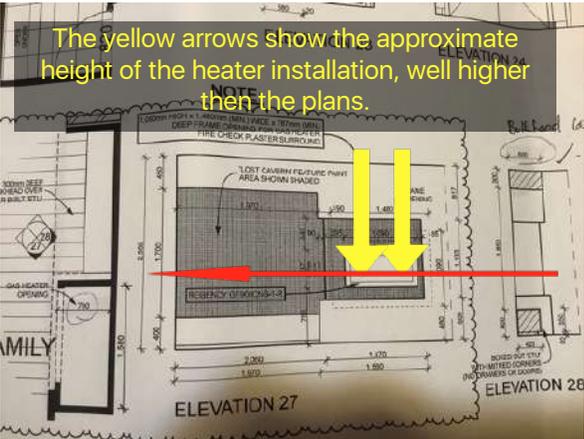
Defect 1.18

It appears that the details of the heater the the client supplied only requires 577mm of clearance, plus the 90mm rebate detail meaning that the wall was only required to move an additional 70mm (670mm, 600mm noted on plans), the bulkhead is 885mm wide as opposed to 600mm on plans.

Photos attached: 1) Clients home, 2) Joinery detail plans, 3) Gas heater dimensions/clearances, 4) Display home image (yellow arrows), 5) Contract page, 6) Appears to enough space to move the heater back-noted from the roof space.

heater to re-installed to its correct height.

These works would require major disruption to the owner as the works will create a work site environment.

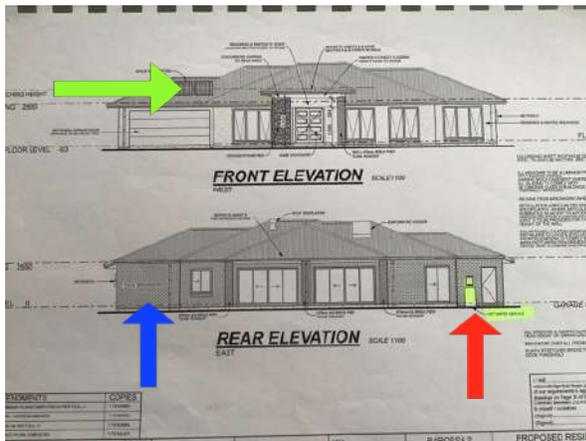
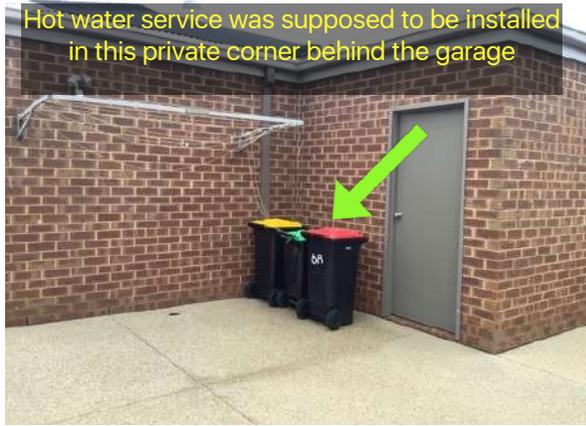
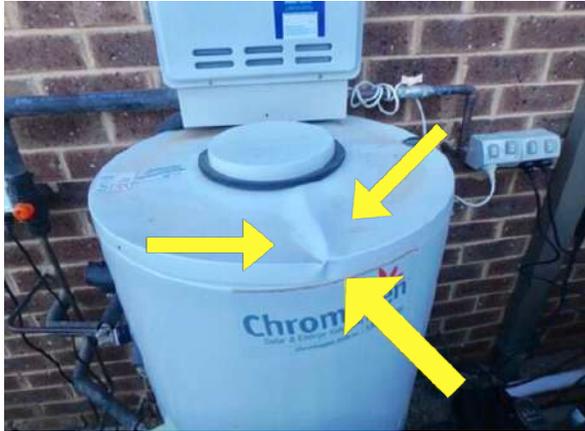
Defect 1.19

Hot water location, is not as per the plans and the unit is damaged.

In-addition the unit is damaged and must be in as new condition at handover.

Major re-plumbing works required, to relocate the Hot Water Unit to its correct location, so I would highly recommend that the solar panels be brought closer to the hot water service unit as this was discussed with the owner and she was happy for the solar panels to be closer to the hot water service instead of moving the hot water service itself. Whilst this is not the ideal situation, it is a practical situation and in addition I would recommend installing a fence around the hot water service to simply make that area near the swimming pool much more attractive.

Upon relocation of the Hot Water Unit, the unit is to be replaced or partially replaced, pending on how excessive the damage to the unit is.

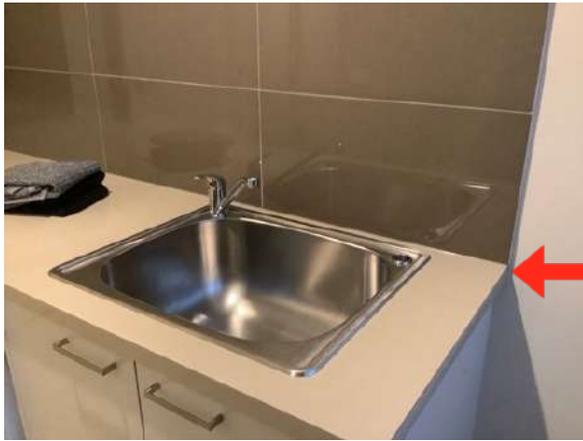
Defect 1.20

Minor area of sealant missing

It was noted on inspection that sealant is missing .
Water ingress into the bench top area creates secondary building damages.

Caulking to be installed.

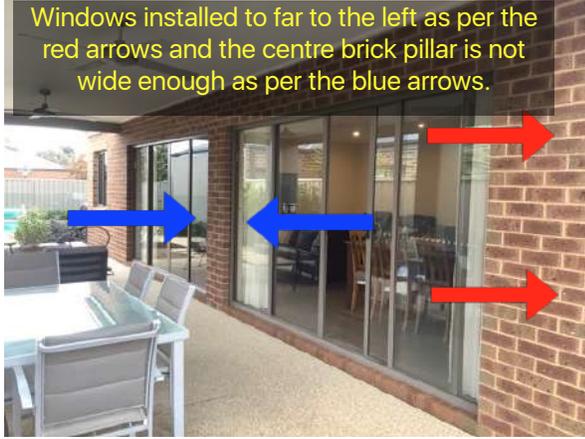
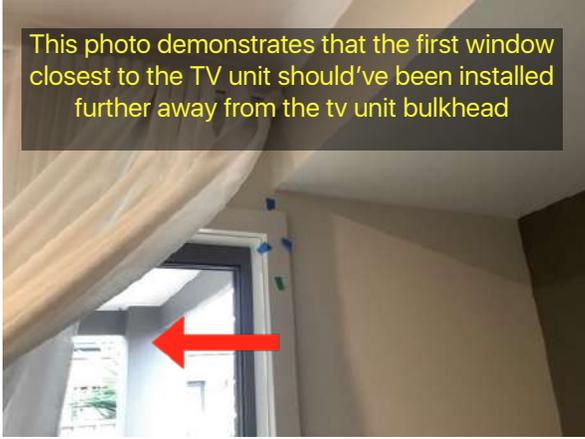
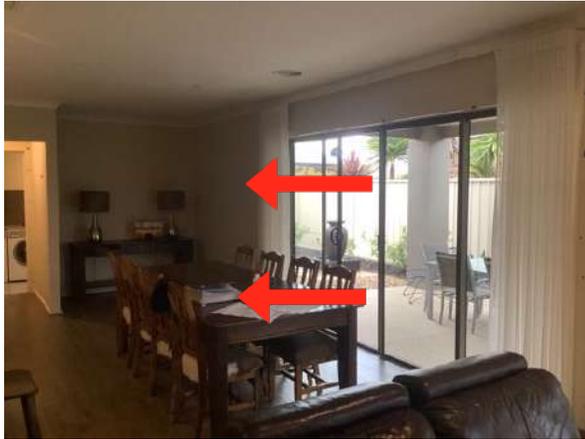
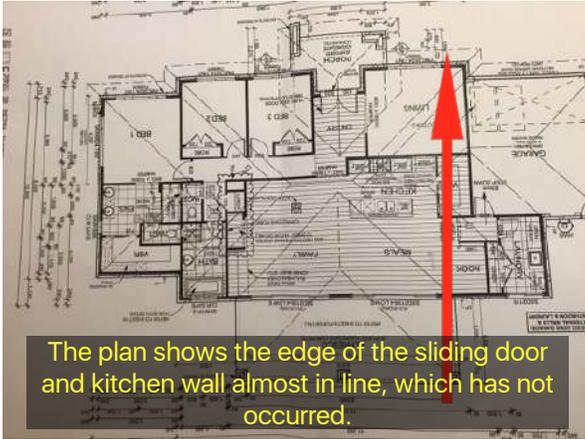
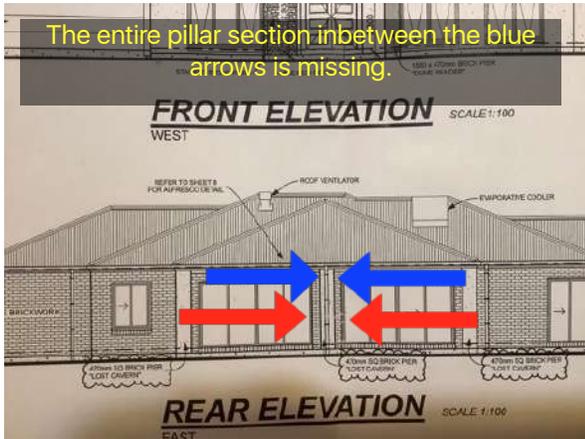
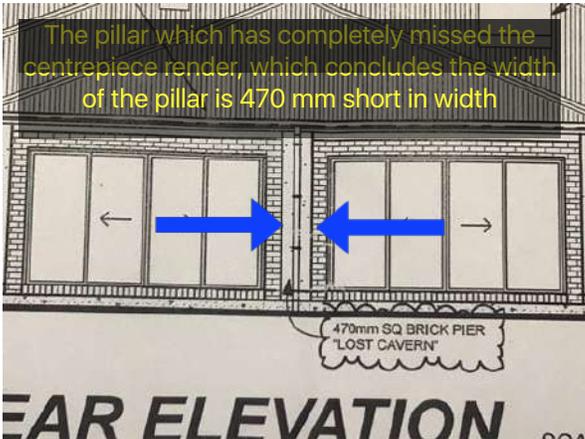
Defect 1.21

External Building Dimensions - Defective

These departures from documented dimensions are considered defective when they exceed $L/200$ where L is the documented overall length of the wall or 5mm (whichever is greater), as per standards and tolerances.

A structural engineer will need to assess the work site and supply new plans prior to any works beginning.

These works would require major disruption to the owner as the works will create a work site environment.

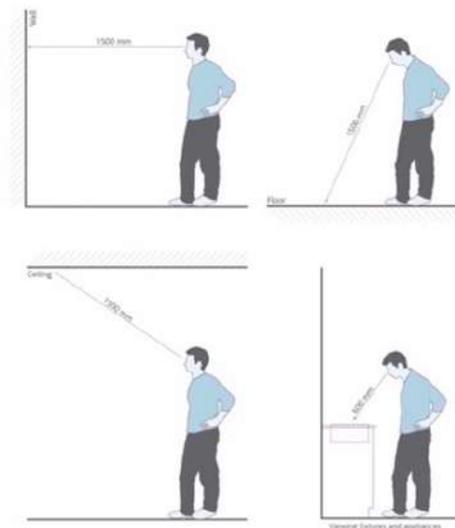
Defect 1.22

Painting - Defective (AS2311)

Areas were identified where the surface finish of the painting was found to be defective. This includes areas of minor blemishes, missing painting, over-painting, paint runs, sags, paint chips, scratches and general paint imperfections.

Paint irregularities will be apparent in different light conditions and are often hidden from view in low light conditions.

An allowance is made for critical light conditions for a Level 4 finish, which is the default level for plaster surfaces.

Paintwork is defective if the application has blemishes such as paint runs, paint sags, wrinkling, dust, bare or starved painted areas, colour variations, surface cracks, irregular and coarse brush marks, sanding marks, blistering, non-uniformity of gloss level and other irregularities in the surface that are visible from a normal viewing position.

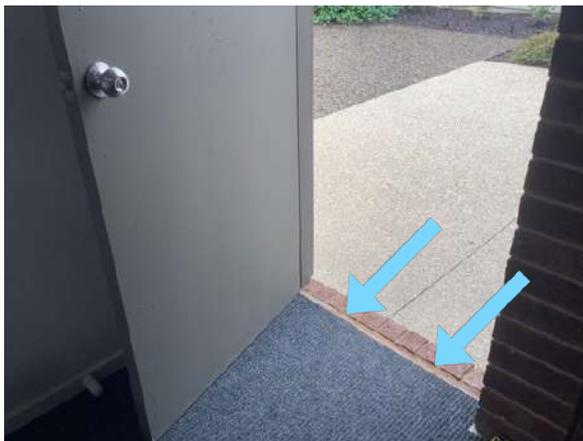
Defect 1.23

Defective mortar works to bottom of door step. The bottom of the door step should not have such excessive mortar width. Generally a maximum of 10 mm is acceptable of mortar width.

The builder is required to take out the existing bottom bricks and install the new bricks on there side so that the builder can cut the bricks with a maximum mortar width of 10mm or less. I would recommend only a 2mm gap, so that the gap may be caulked neat.

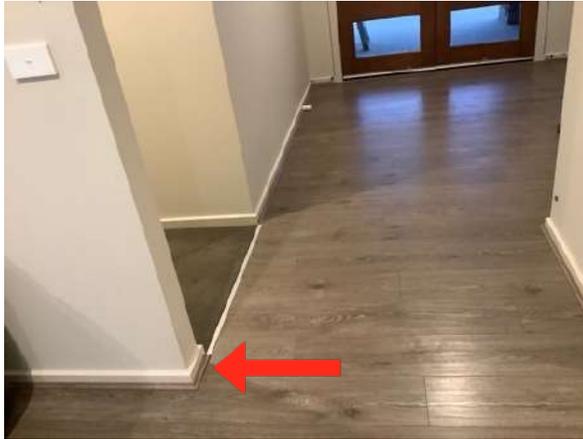
Defect 1.25

Floating Flooring - Defective Gaps

It was noted that the floating floor had gaps adjoining the skirting trim near the passage and a skirting trim was loose in the kitchen. Floor coverings/treatments should be installed as manufacturers specifications.

The builder will need to replace the short floating floor boards.

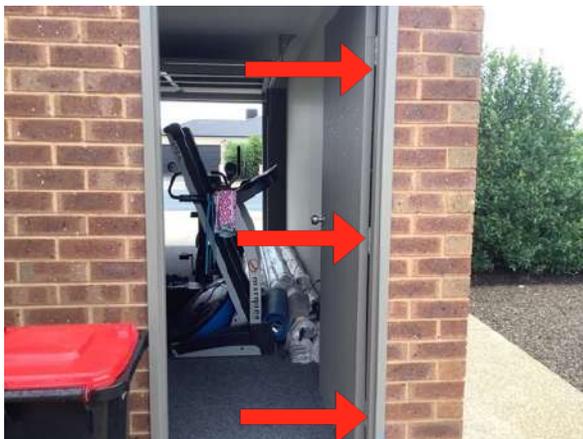
Defect 1.26

Paint finish excessive over painting - Defective and Damaged Materials

Excessive painting, some materials may require to be replaced

This area was identified where the surface finish of the door hinges is now damaged, due to excessive and defective painting.

The door hinges will need to be replaced.

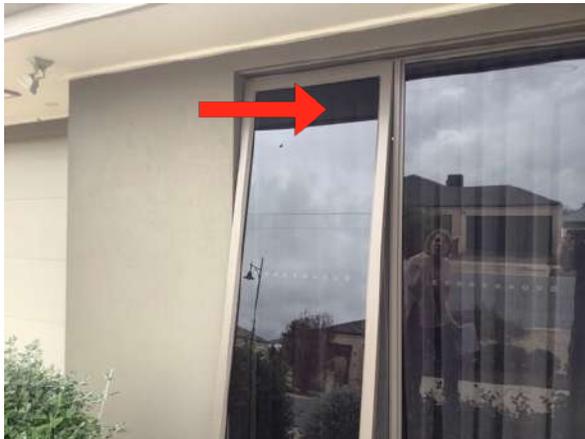
Defect 1.27

Windows are required to be presented in an `as new` condition during the final handover. Therefore, where minor rectification works are not adequate, affected windows must be replaced.

The Building Commission's, Guide to Standards and Tolerances clause 18.04 Glazing, states- 'Scratches, fractures, chips or blemishes on glazing and mirrors are defects if they are caused by the builder and can be seen from a normal viewing position. Minor scratches, fractures, chips or other blemishes that are not more than 10mm long and where there are not more than three blemishes per pane, are not defects'.

This pane of glass will have to be replaced with a new one.

The glass panel needs to be replaced.

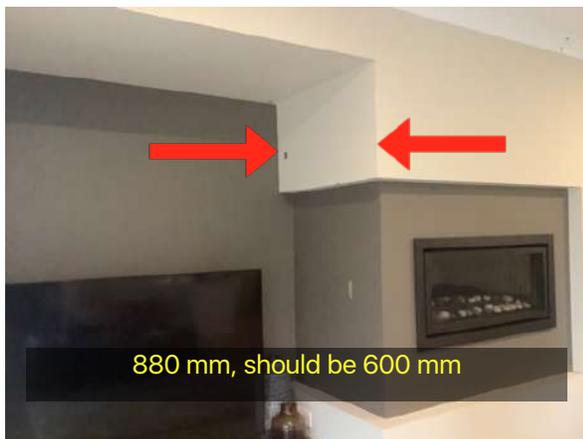
Defect 1.29

In addition to the defective design of the wall unit, I would like to bring to your attention "Addendum 'B' - DEFECT - 18" in this report with a SUGGESTED SOLUTION to completely dismantle and re-build the entire wall unit.

The wall heater needs to be dismantled for the wall unit to be TOTALLY RE-BUILT and finally the heater to re-installed to its correct height.

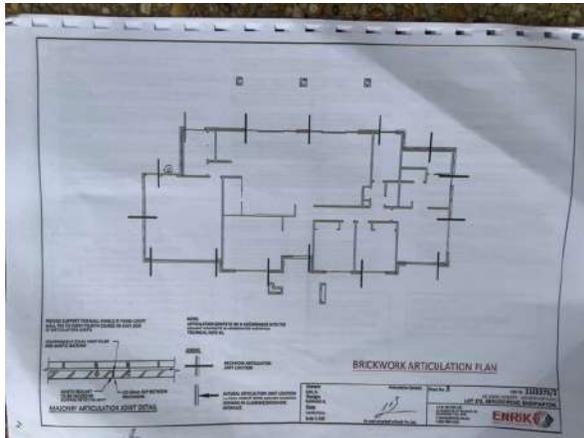
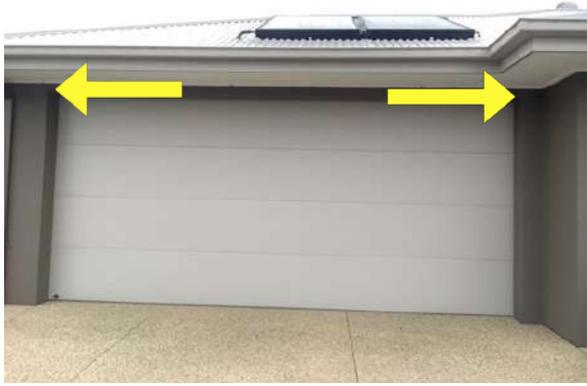
Defect 1.30

ARTICULATION JOINTS - Missing

If render is covering articulation and control joints this is considered a defect with reference to Standards and Tolerances.

Masonry work is considered to be defective if articulation and movement control joints have not been provided for as required.

If articulation joints are missing, which does appear to be the case, the structural engineer will need to make decisions, however my experience does tell me that normally the brickwork is dismantled and re-built.

The possibility of new plaster to the perimeter walls is highly likely as the brickwork's excessive brick mortar must be cleaned from the cavity walls.

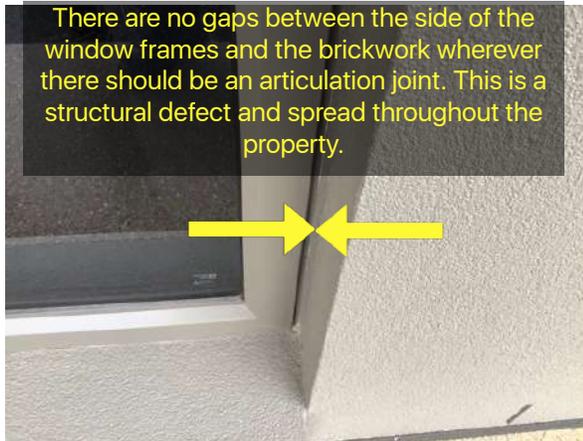
Defect 1.31

There are various defects to the articulation joints, the main defect is that there are actually many of the articulation joints not installed at all and in addition where there are no articulation joints along the side of the windows, there also must be a gap between the edge of the window frame and the brickwork in order for the articulation joints to be consistent vertically.

As per AS 3700, Articulation or control joints are defective if they do not extend from the brickwork to the window or door frames.

Failure to perform the repairs may lead to cracking to the structure during extreme weather conditions, which may carry major implications for associated building elements if left unmanaged.

If articulation joints are missing, which does appear to be the case, the structural engineer will need to make decisions, however my experience does tell me that normally the brickwork is dismantled and re-built.

The possibility of new plaster to the perimeter walls is highly likely as the brickwork's excessive brick mortar must be cleaned from the cavity walls.

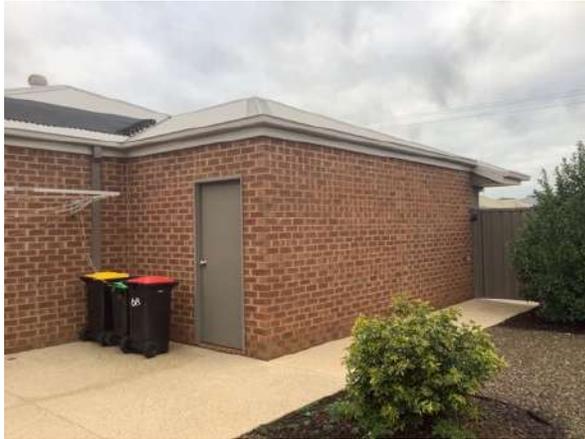
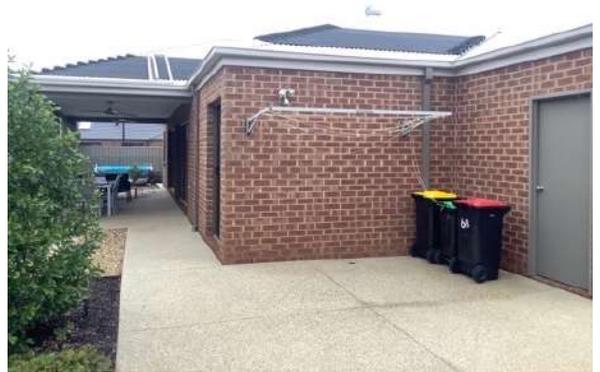
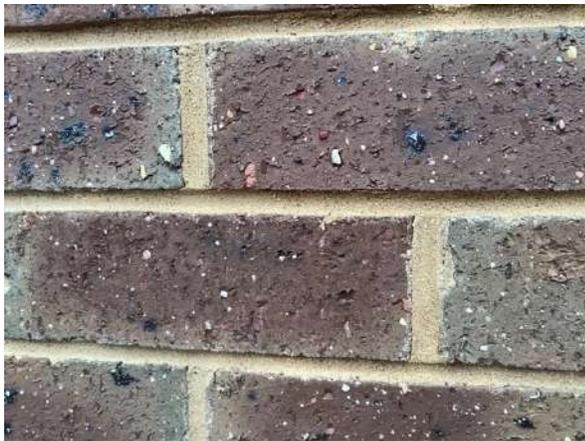
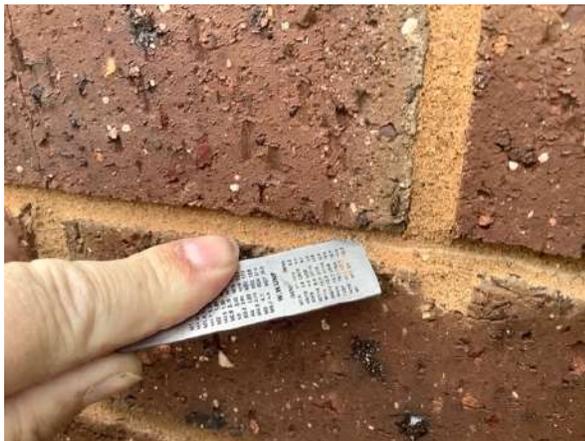
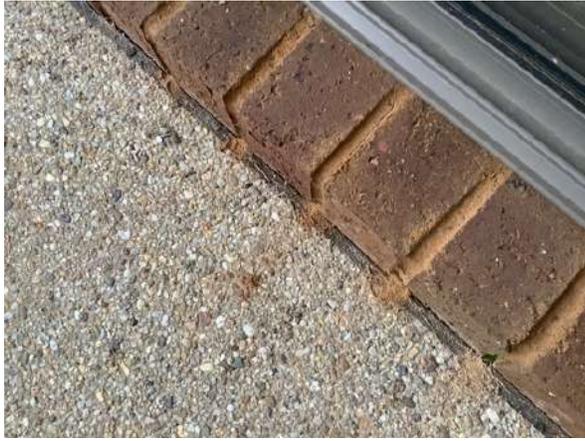
Defect 1.33

Defective and structurally compromised brick mortar.

These works would require major disruption to the owner as the works will create a work site environment.

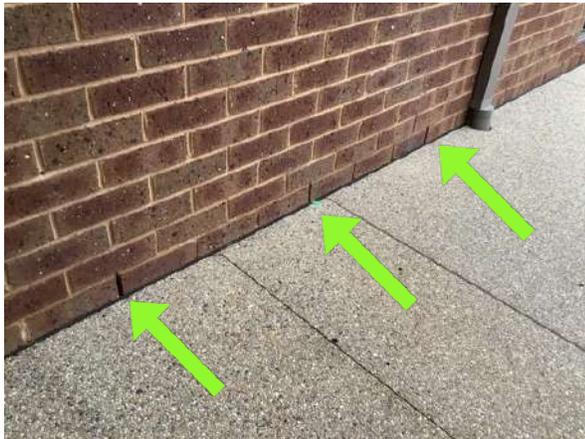
SUGGESTED SOLUTION:

As detailed in Addendum 'B' - DEFECT - 33, within this report, the brickwork is to be demolished/taken down, so the builder is to not make the same mistake, in relation to the defective weep hole heights.

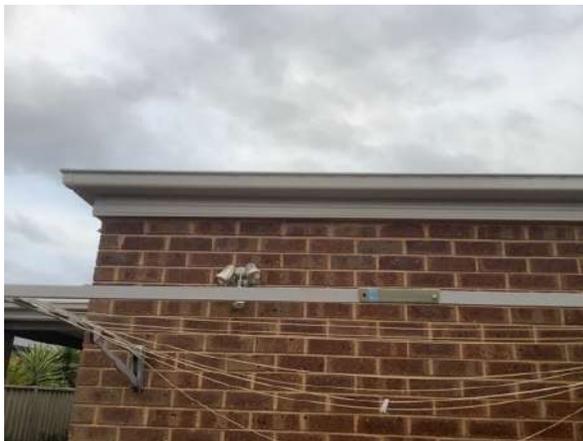
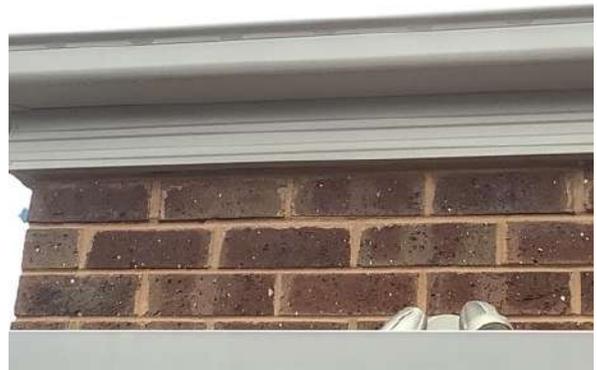
Defect 1.37

It was observed at the time of inspection that the brickwork, spread throughout various areas of the brickwork require cleaning to remove excessive mortar.

The Building Commission's Guide to Standards and Tolerances clause 3.07, Masonry Facing states that:- 'Masonry faces are defective if they are not cleaned and free of excess mortar' and clause 3.11, Cleaning, Mortar Smears & Stains states that:- 'Stains, mortar smears and damage caused by cleaning are defects if they are visible from a normal viewing positioning.' The faces and edges of the bricks within the wall around this home will have to be properly re-cleaned to remove all traces of the mortar residue from across them.

As detailed in Addendum 'B' - DEFECT - 33, within this report, the brickwork is to be demolished/taken down, so the builder is to not make the same mistake, in relation to the excessive brick mortar.

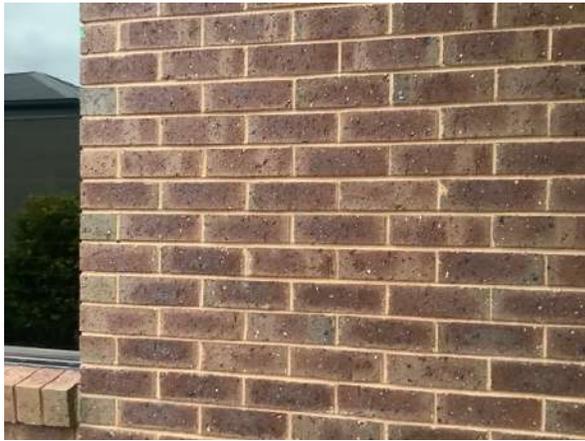
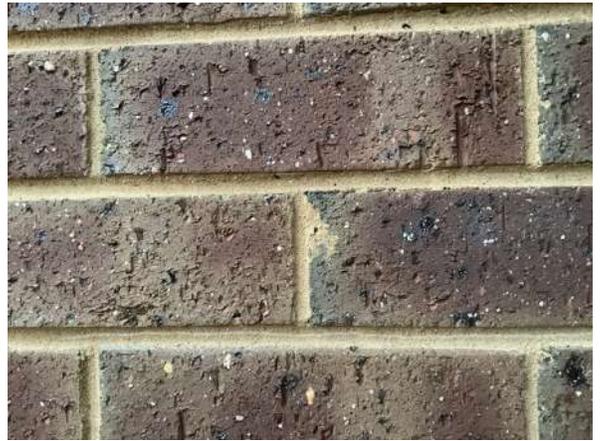
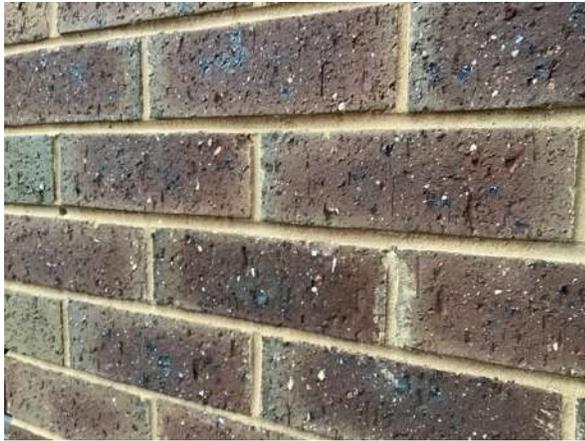
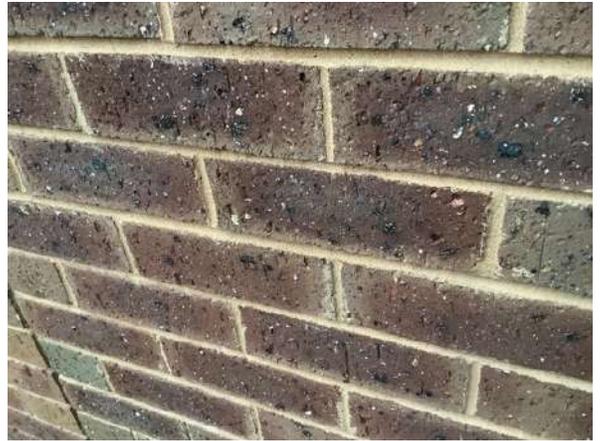
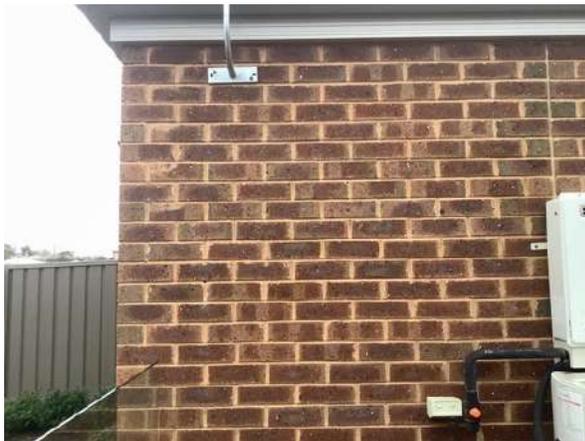
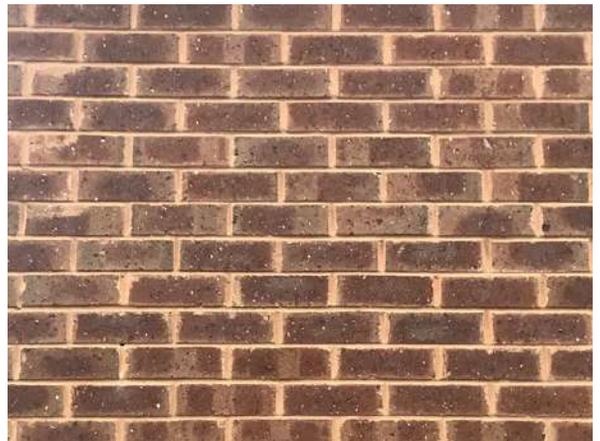
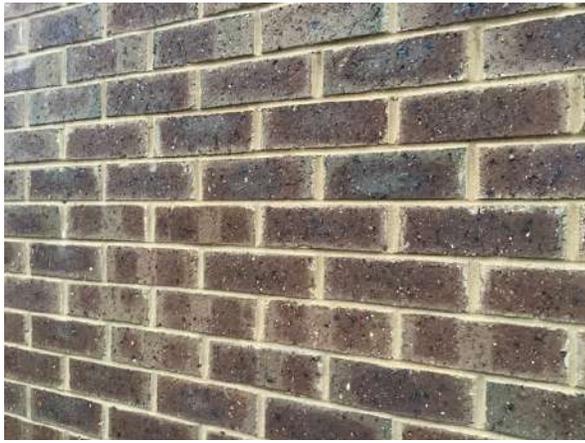
Defect 1.38

It is observed that there is an excessive deviation from the documented thickness of the brick per ends.

There are variations in excess of up to 24mm which is excessively high than the acceptable levels of workmanship regardless if it is the bricklayers defective workmanship and/or defective sizing or seconds brick supplied by the builder.

The maximum non-structural framework tolerance is 10mm. This identified defect exceeds the maximum allowable tolerance and is therefore considered a defect.

As detailed in Addendum 'B' - DEFECT - 33, within this report, the brickwork is to be demolished/taken down, so the builder is to not make the same mistake, in relation to the Brick Perp Ends To Be Excessive
