# Lock Up Report

## Inspection Date: 11 Sep 2021 Property Address: Eastern Suburbs

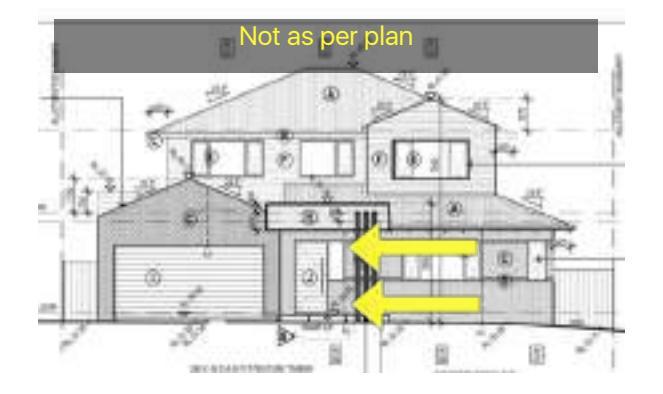
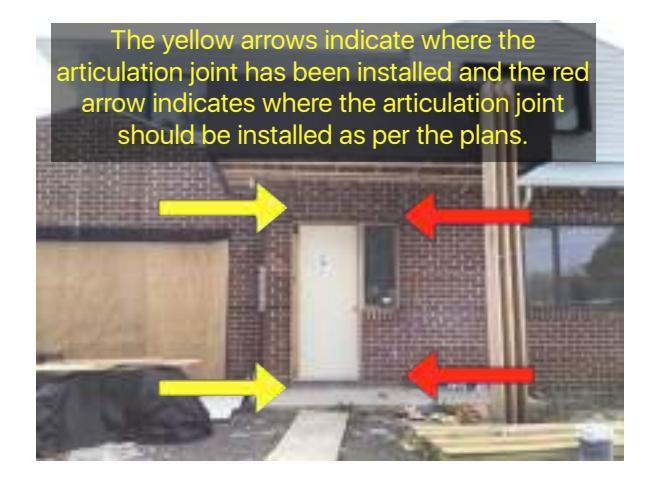
Location: A

Articulation joints - Width defective .(AS3700)

It was observed at the time of inspection that many of the articulation joints (AJ's) were obstructed by incompressiblematerial (mortar)

At the time of inspection, this area does not meet the requirements of Australian Standards AS 4455 masonry for small structures or the BCA contractual requirements regarding acceptable finishes.

All AJ's need to be cleaned out and continuous for the full length of the wall. The responsible contractor should be appointed to complete these works in order to comply with standards and regulations. Such works should be completed prior to final handover.

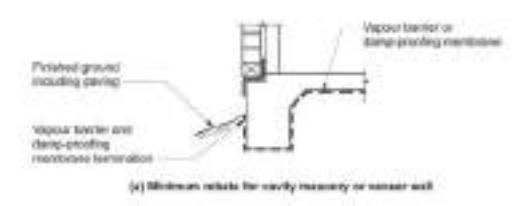
Figure 3.2.2.3 Acceptable vapour barrier and damp-providing mentionary location

extends under edge beams to finish at ground level in accordance with Figure 3.2.2.3.

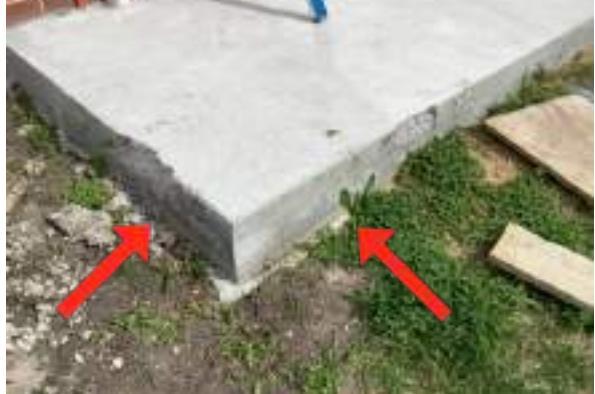
Location: Finding: Concrete - Exterior

Concrete- No Isolation Joint material between walls, pipes, downpipes and fences.

This has the potential to crack the underground stormwater pipes, brick wall and concrete paving.

The current paving installation is incorrect and must now be properly rectified or replaced.

It is recommended that a 10mm wide cut is run all the way through the concrete, thus creating an expansion and contraction line, which is then added with the isolation joint material and caulking.

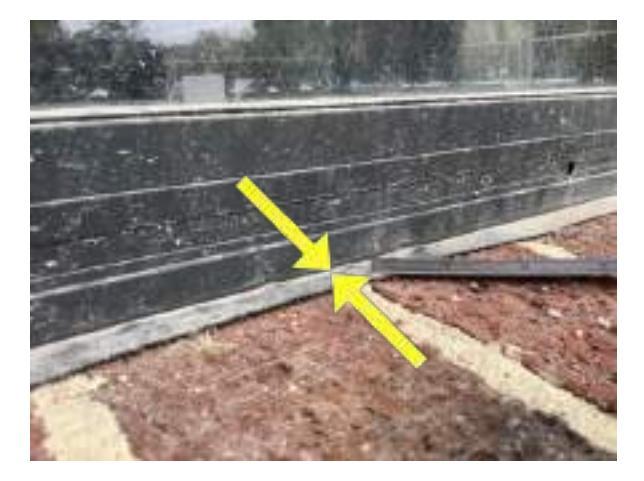
Finding:

Windows - No flashing over a window / opening (timber/ cladded)

Windows and doors are defective if they are not sealed in accordance with the requirements of the Building Code of Australia, where required.

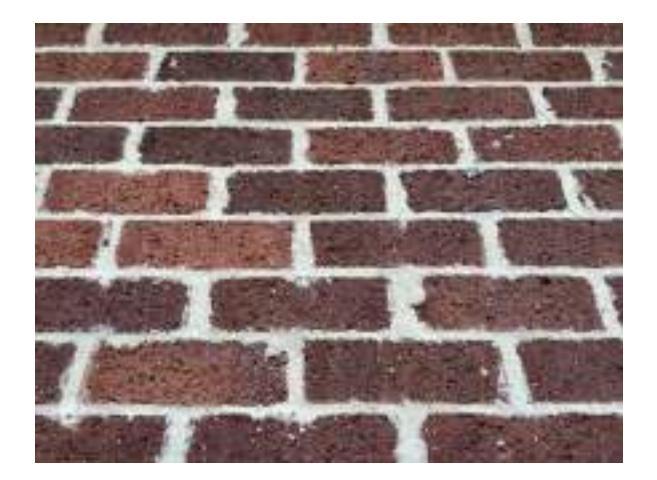
Finding:

Brickwork - Holes and Voids

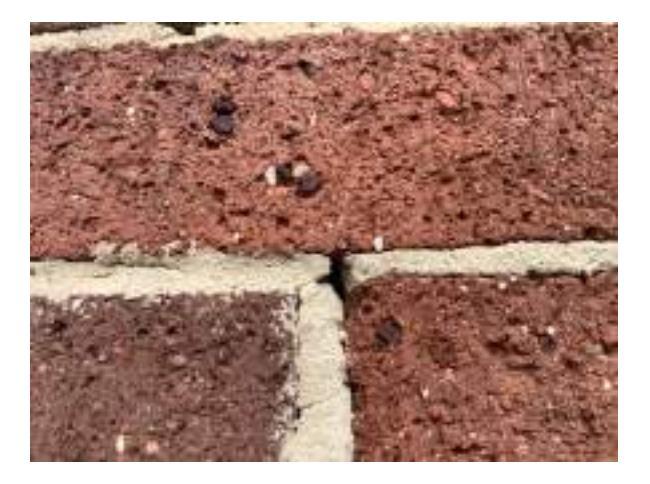
Finding:

Location:	Brick Work - All Area's
Looddon

Standards and Tolerances 2015 - Diagram 4.08 states that the maximum overhang of the brick work is 15 mm.

IMPORTANT *ONLY* SAMPLE PHOTO'S of this frame defect. All AREAS to the frame MUST be checked and repaired.

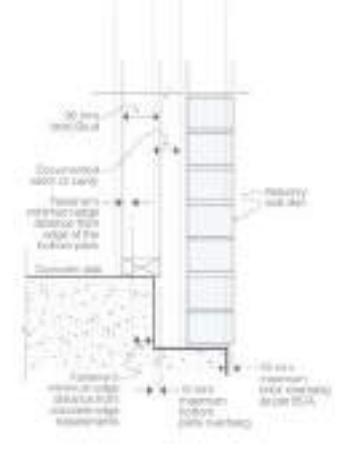
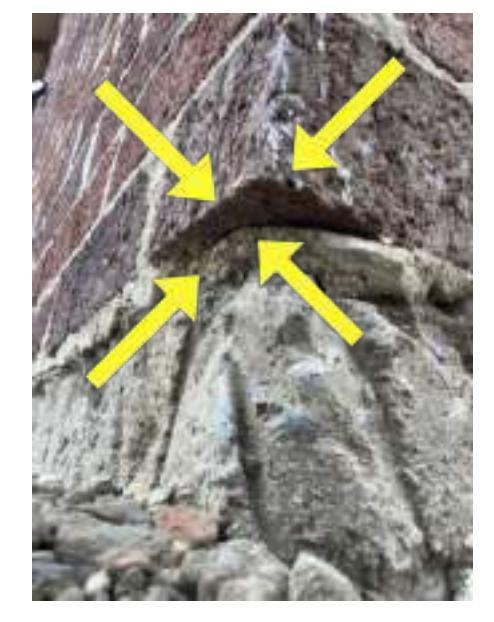
Brick Work - All Area's

Brickwork / Mortar - Cracking Noticeable.

As per VBA | GUIDE TO STANDARDS AND TOLERANCES 2015 - 3.02 Damage to masonry walls, these items in this report are defective, even if not structural and must be repaired.

Brick work / Mortar cracks are evident. Repairs required to external brickwork. Always monitor these cracks and contact a building inspector should cracks widen, lengthen, or become more numerous.

Cracked brickwork over 1mm, requires replacement.

ALL REPAIRS MUST NOT BE NOTICEABLE WITHIN 1500 mm.

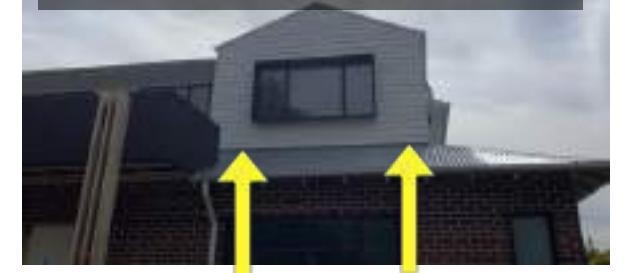
The bottom cladding has a different height variation at the both ends. Whether this is because the roof has not been installed horizontally level or whether it's another defective item. This is unacceptable.

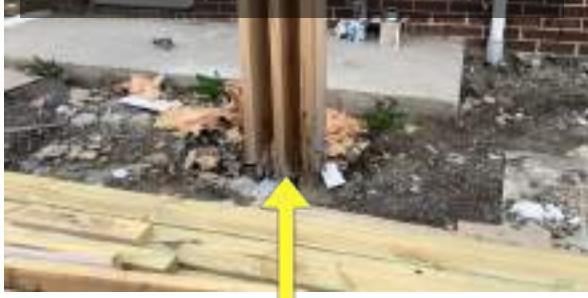
The end timbers must be painted prior to installation as it is now impossible to fully seal underneath the timbers. This is the golden rule with all situations with exterior exposed timbers
