Asbestos Visual Report

Inspection Date: 8 Apr 2020

Report Type: Asbestos Inspection and Condition Report

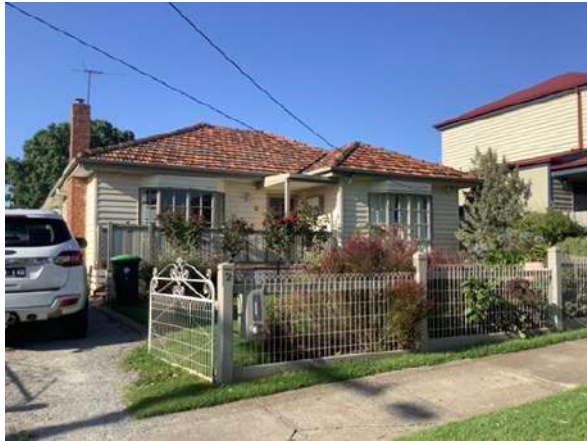
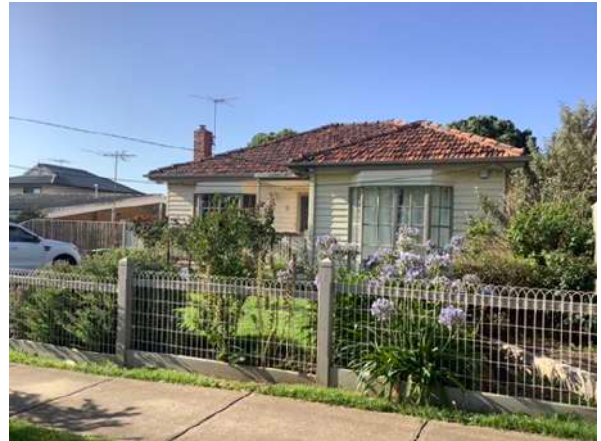
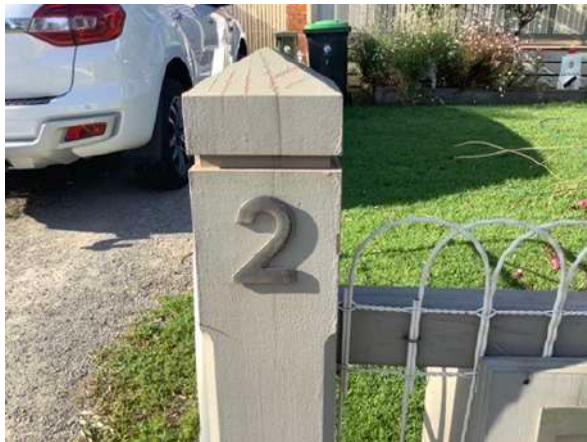
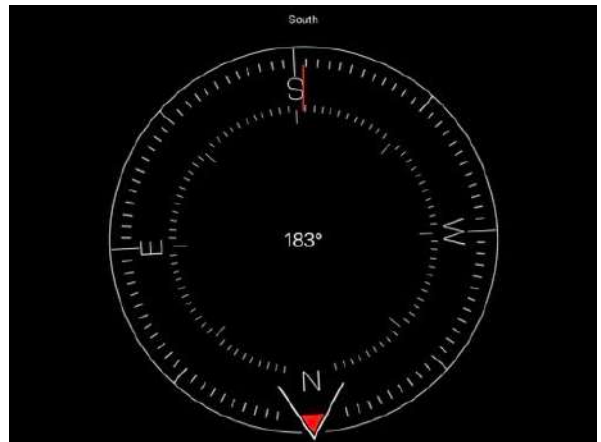
For your information 5.03

Location: The Site
Finding: Site Photos Added
Additional photos are provided for your general reference.
