# Building & Electrical (Apartment) Report

Inspection Date: 25 Feb 2020

Property Address: St Kilda Area

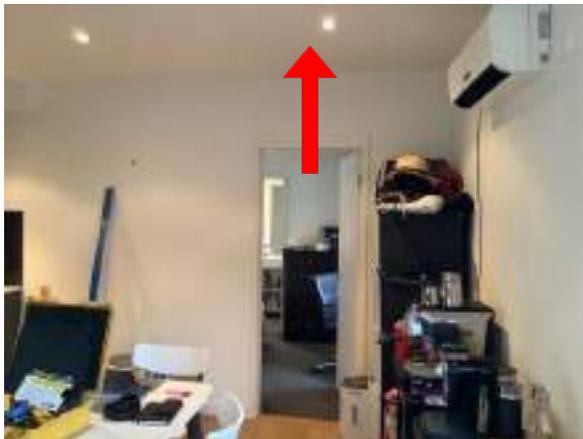
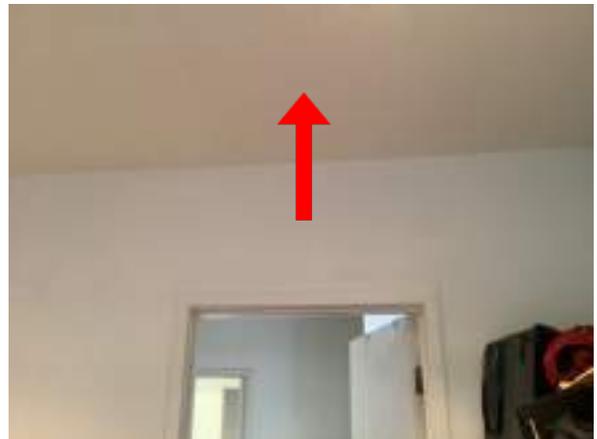
A qualified electrician is required do these works for hard wiring.

Upon completion a safety certificate is required to be supplied to the owner of the building.

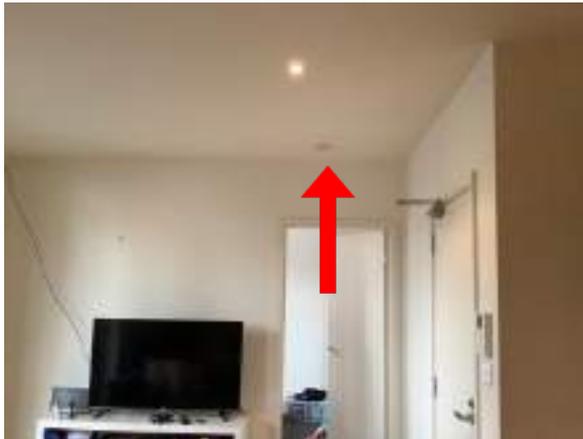
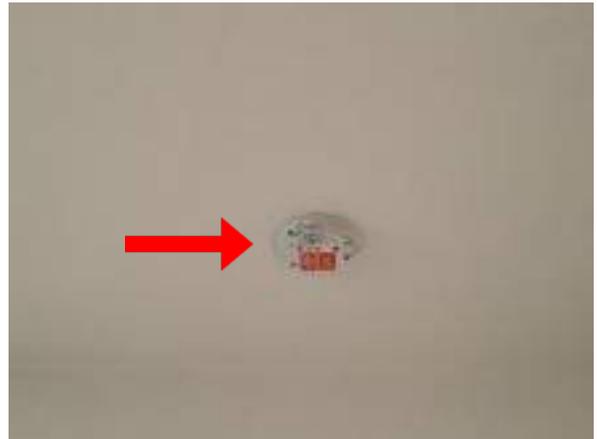
## 1.02

Testing of smoke detectors is required monthly.

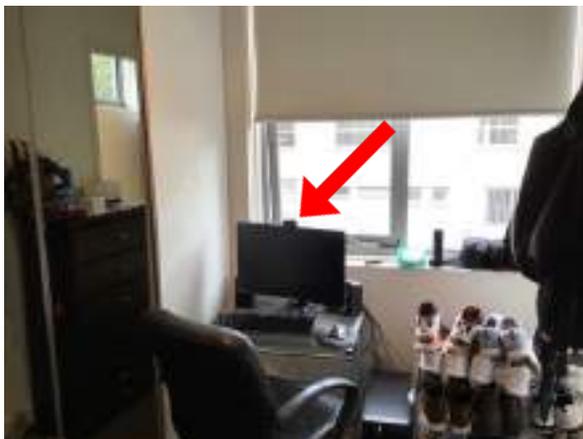
Water Staining - Damaged Materials.

It is important to identify the correct professional to perform these works, pending on each situation on how minor or major it has become.

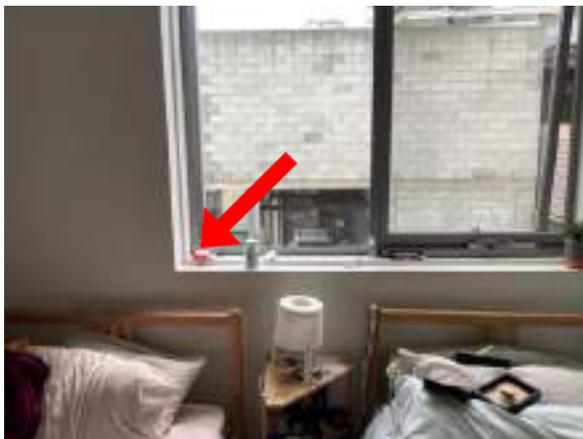
Water Staining - Damaged Materials.

It is important to identify the correct professional to perform these works, pending on each situation on how minor or major it has become.

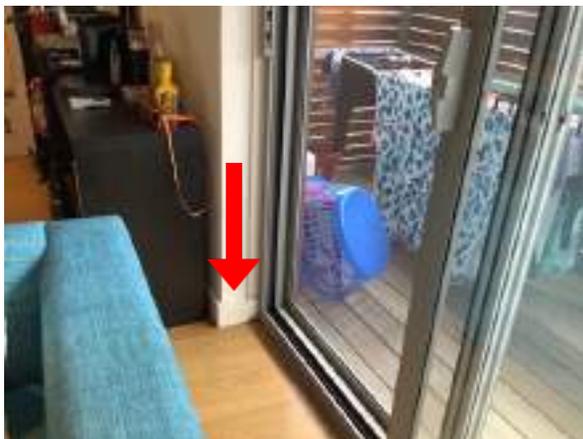
Water Staining - Damaged Materials.

It is important to identify the correct professional to perform these works, pending on each situation on how minor or major it has become.

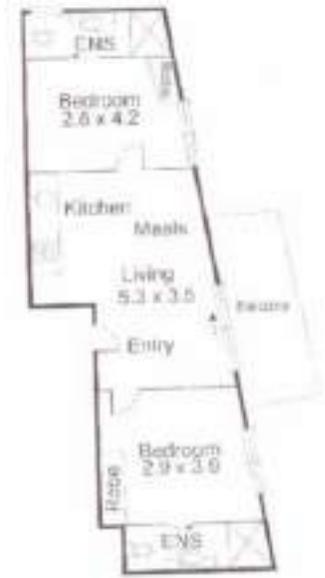
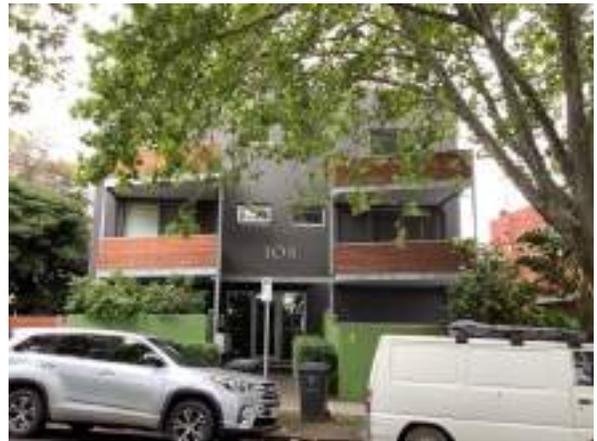
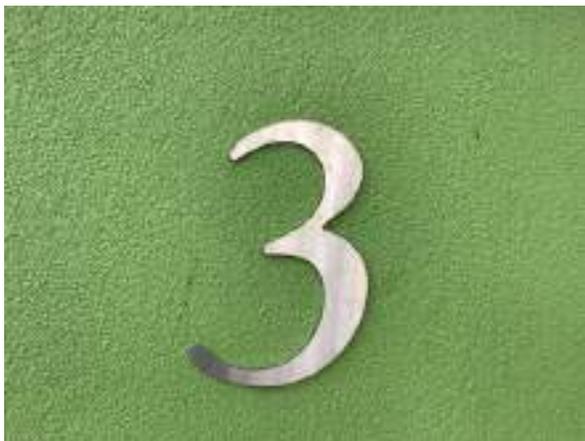
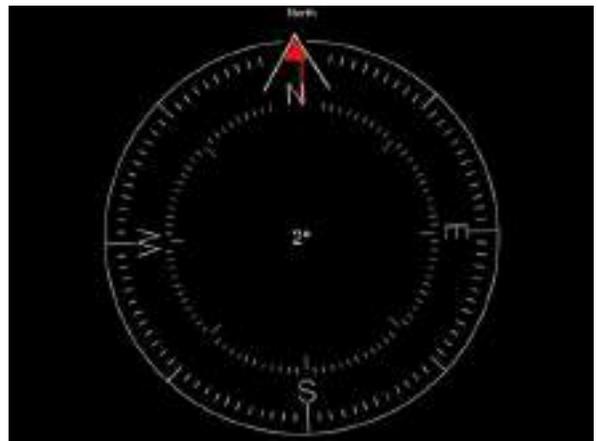
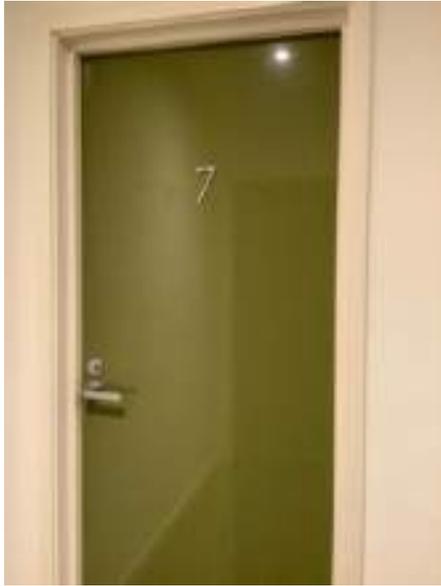
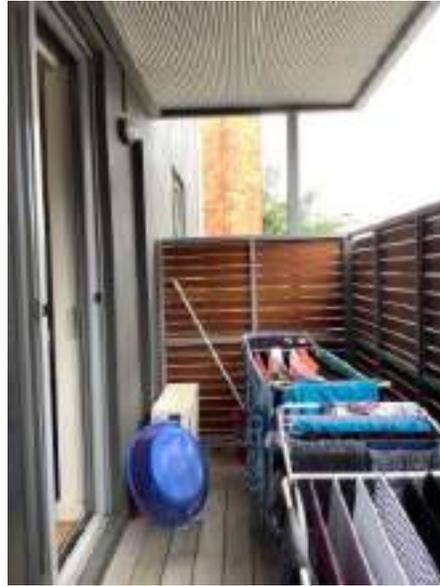
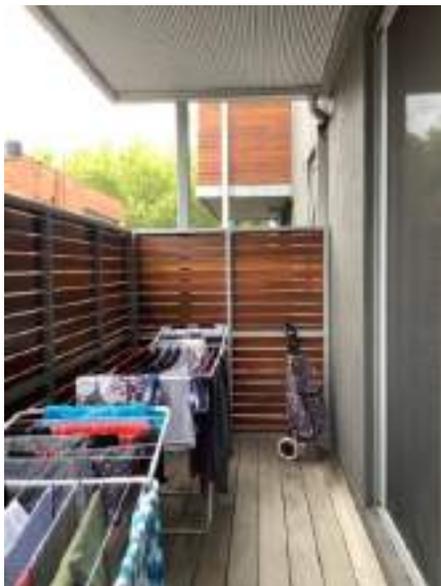
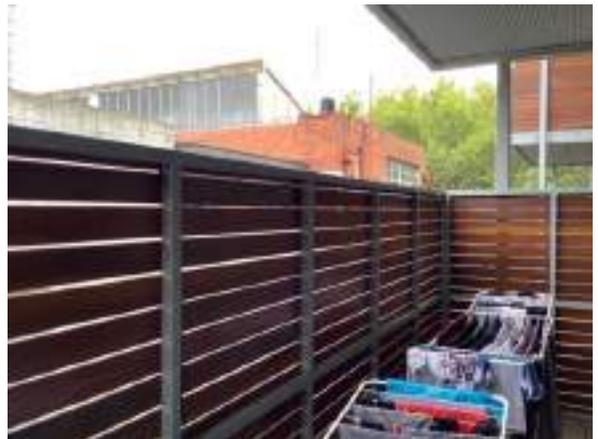
Location: The Site

Finding: General Site Photos & Compass  
General site photos and other areas of interest are provided for your general reference.

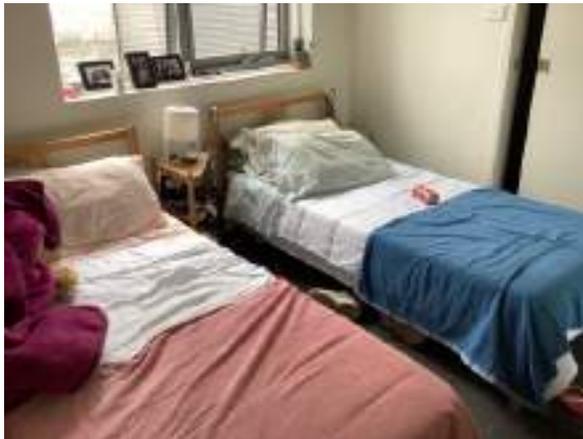
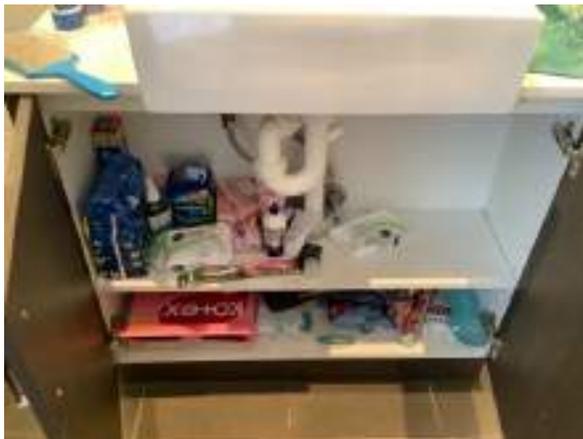
Whilst we have taken many photos of the home and surroundings of the obstructions and limitations , we have just added a few photos in the report for you to understand the type of obstructions and limitations .

A re-inspection is recommended once the areas are made accessible.

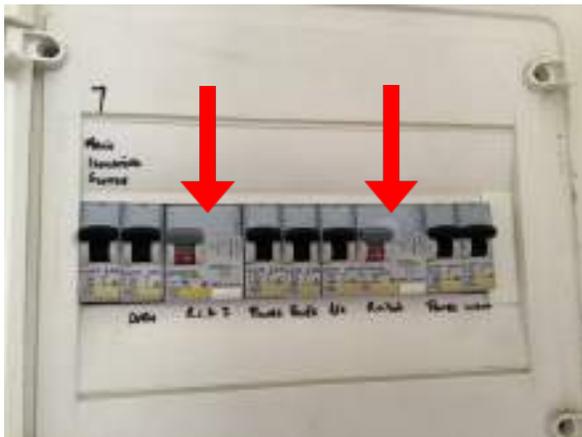
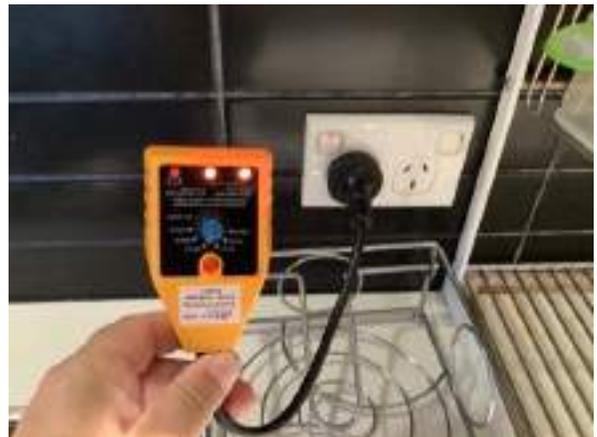
3/ Safety Switch test to trip the safety switch at less then 30 milli amps was performed.

These tests all passed the AS 3000 requirement and exceptance level.
