Building-Termite-Electrical - Report - Previous Job

Inspection Date: 28 Jan 2020

Property Address: Building-Termite-Electrical Report

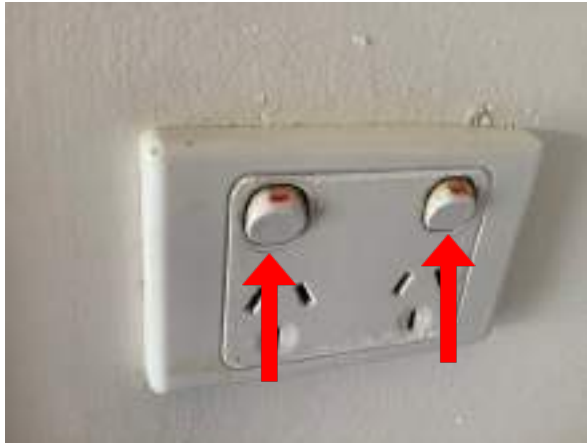
Repair and/or replacement of the switches/power points is advised to ensure the fixture and it's associated structures are safe and fully operational. A licensed electrician should be appointed to repair/replace the light switches/power points as soon as possible.

Please engage a licensed electrician to further inspect the property for the repairs and replacements as required.

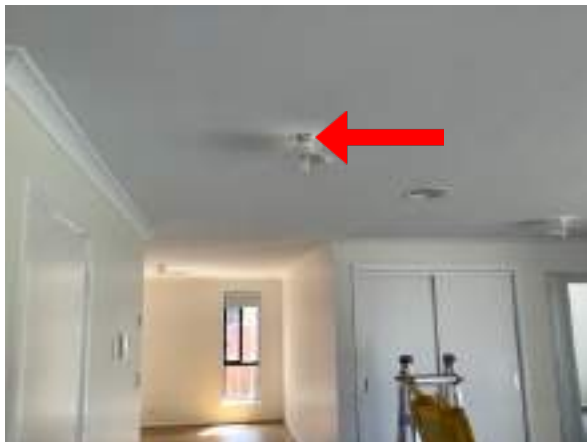
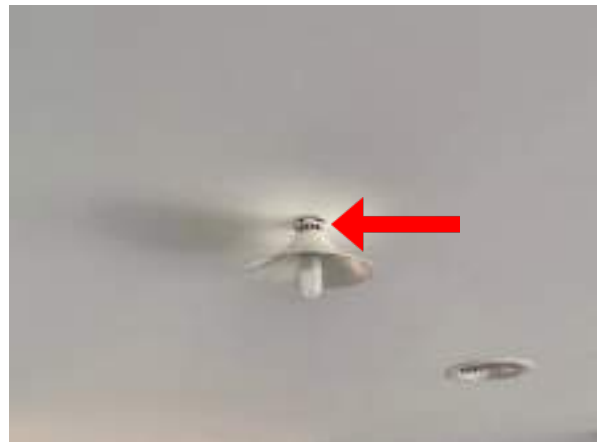
We highly recommend that you engage a qualified electrician to further test the property's earthing system and that all the tests comply with AS3000 for all testing procedures of an electrical installation and its earthing components.

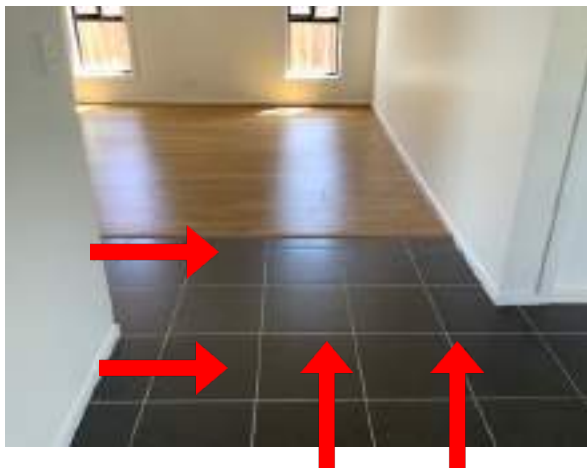
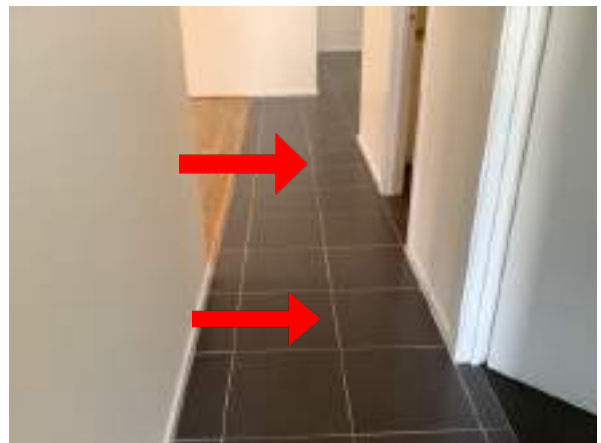
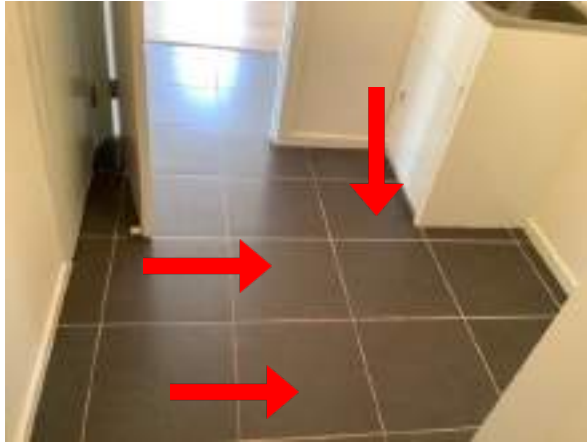
If left unmanaged, water penetration to these areas may lead to subsequent water damage, which is likely necessitate repair work to affected building elements.

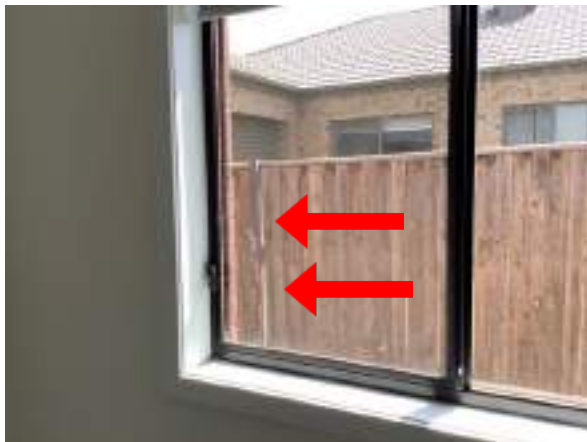
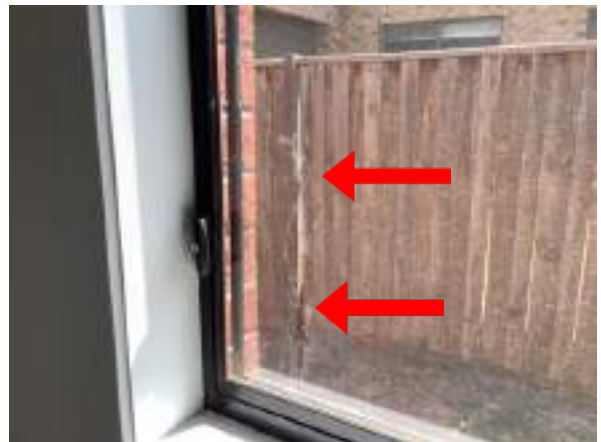
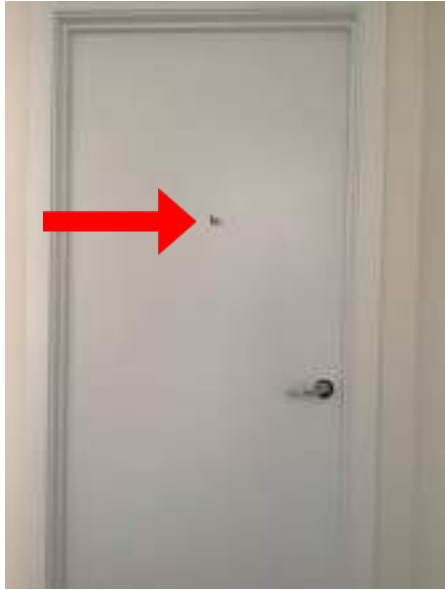
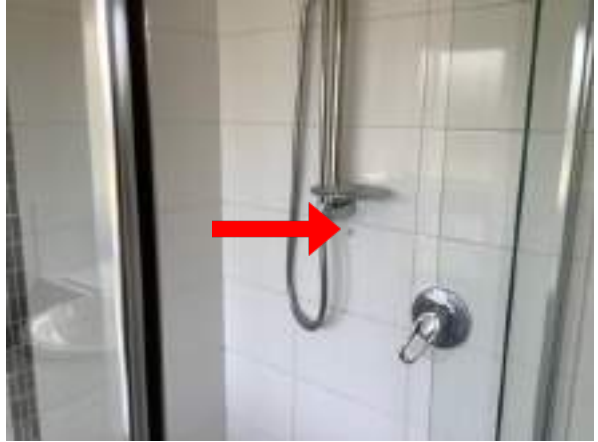
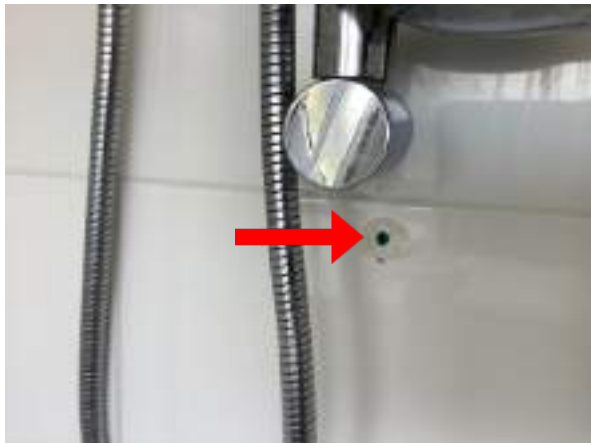
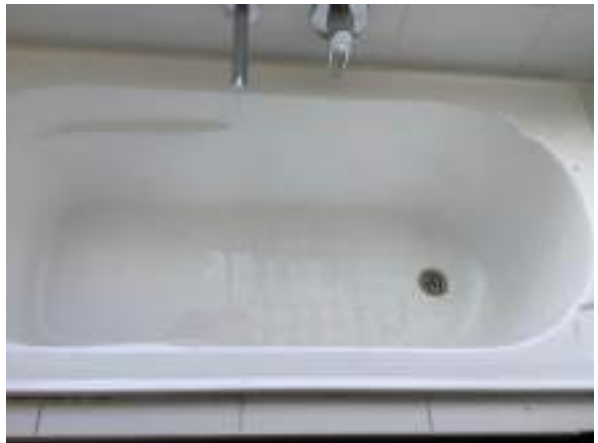
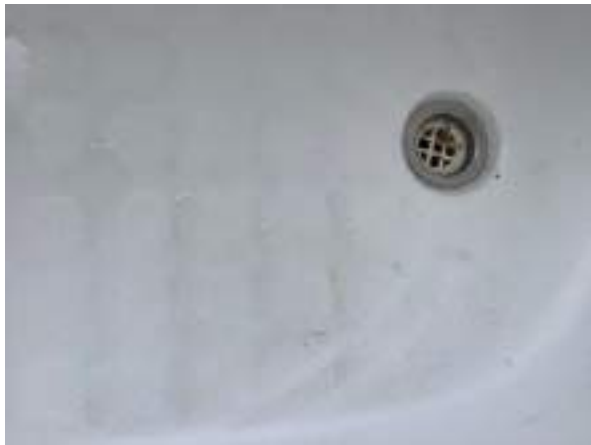
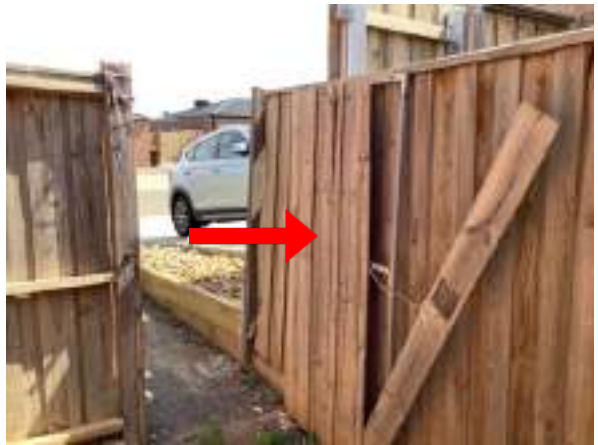
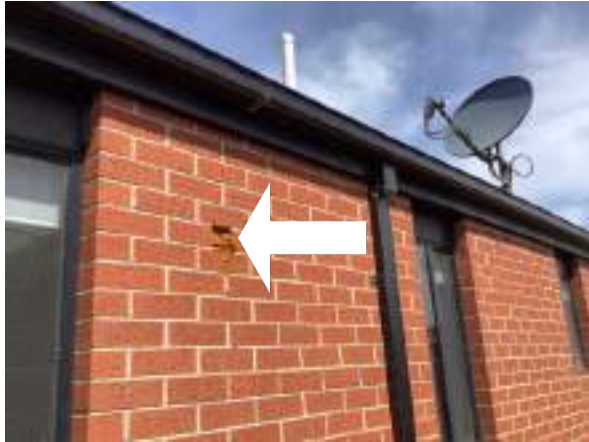
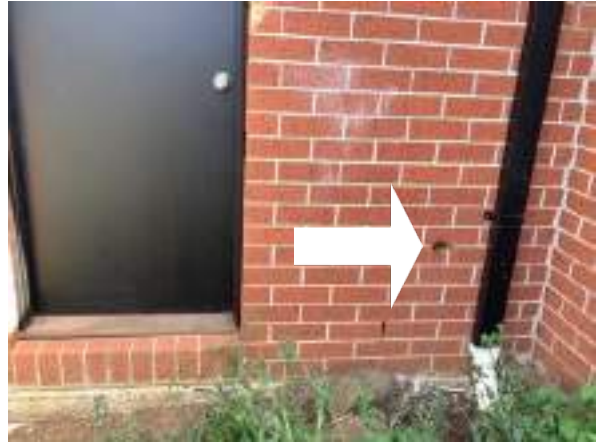
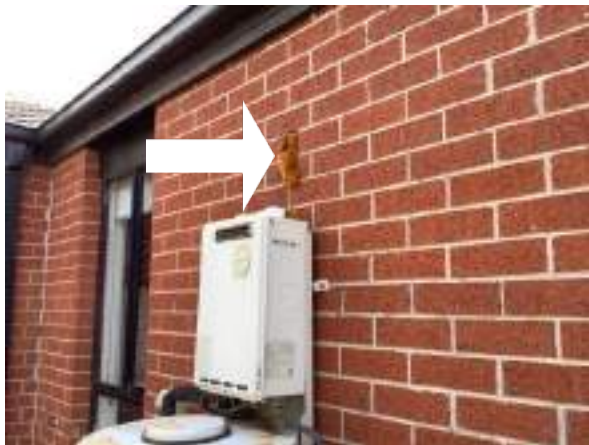
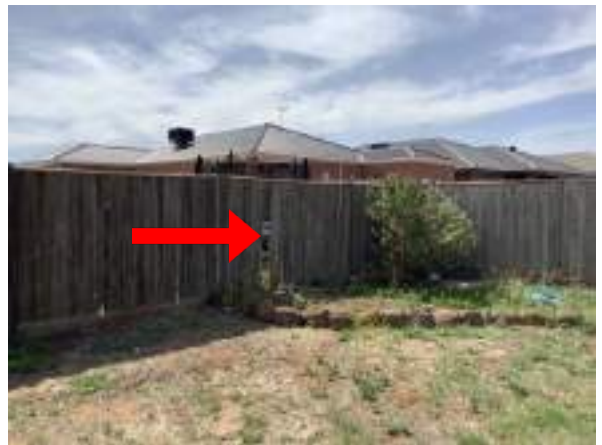
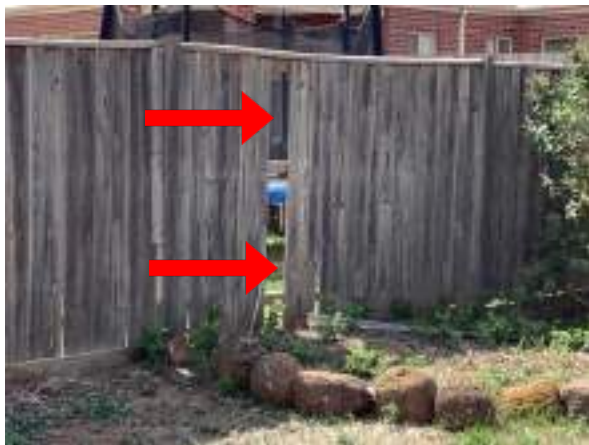
3.08

Items like cracked glass mirrors, cracked glass windows and windows not operation smoothly are defects that should be repaired by the appropriate trades.

It is IMPERATIVE that you engage registered and qualified trades and at the end of there works they must supply certificates, such as an electrical safety certificate, plumbing and gas certificate if the works are electrical or plumbing, but for items such as damaged door handles, painting an experienced carpenter or handyman can sometimes be engaged.

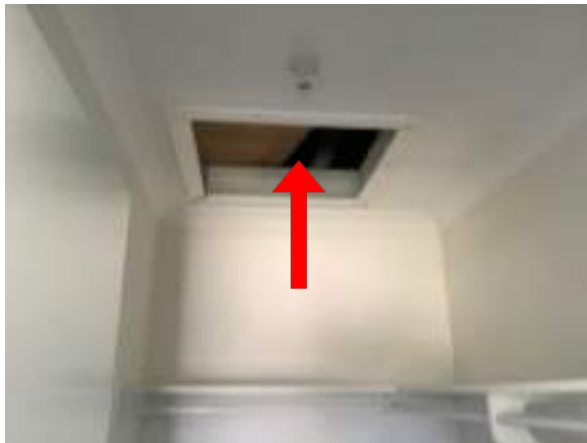
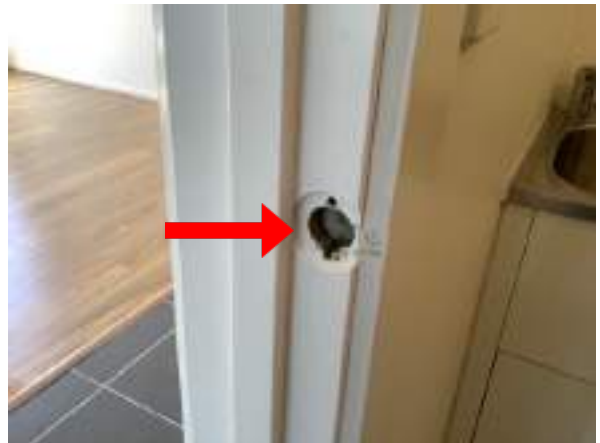
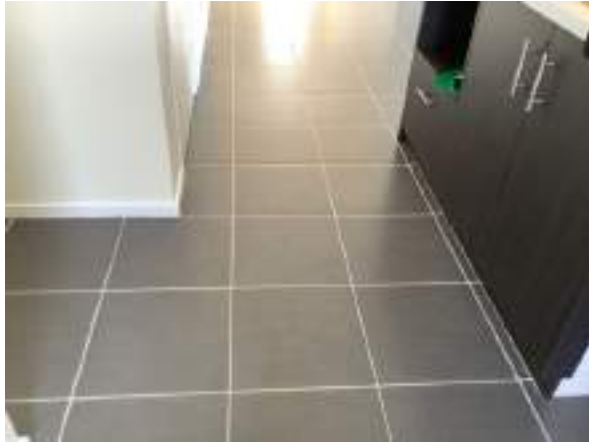
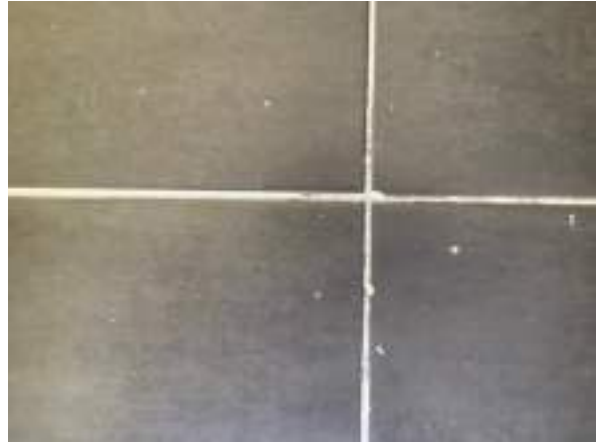
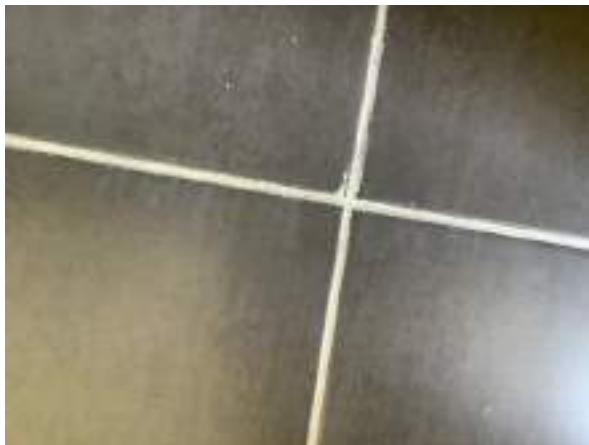
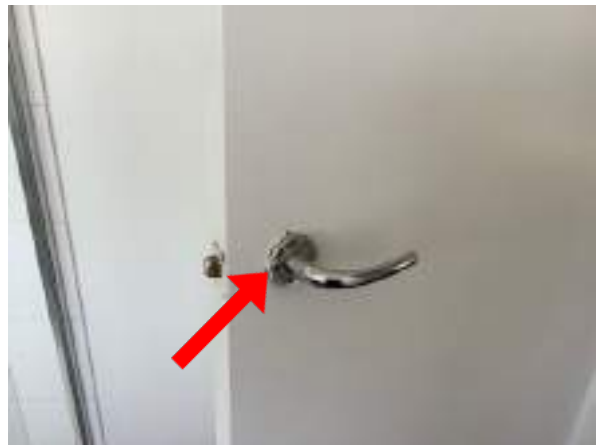
3.09

Where installation is substandard and/or incomplete, the client should contact the responsible trade to undertake rectification works, which are advised as soon as possible.

The appropriate tradesperson or specialist should be appointed to complete the various items for repair and organise the appropriate QUALIFIED trades to repair and complete the works to illiminate or reduce further deterioration / disfunction.

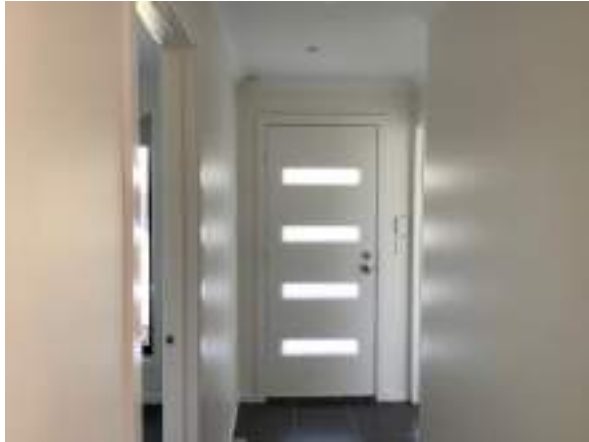
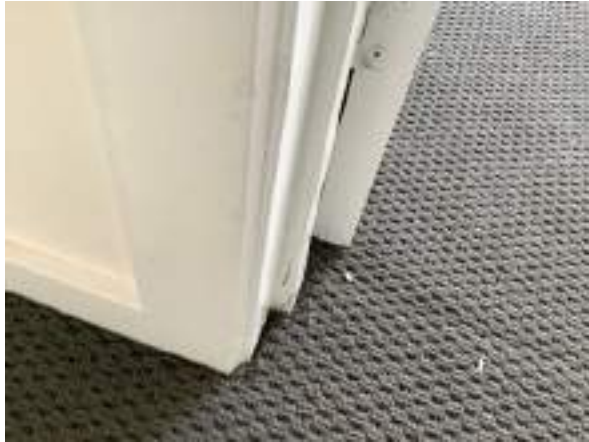
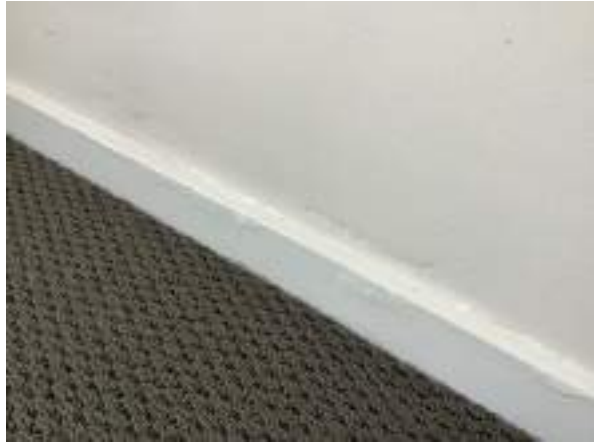
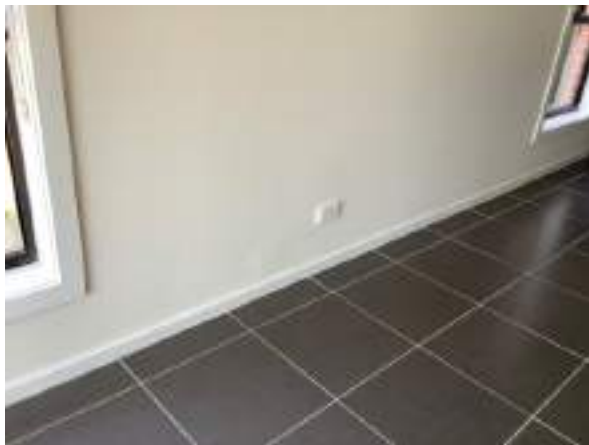
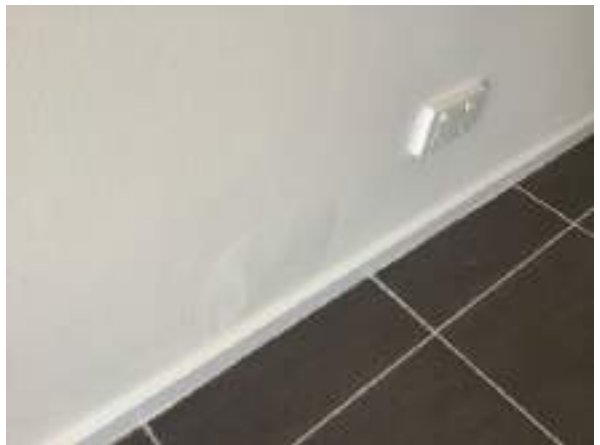
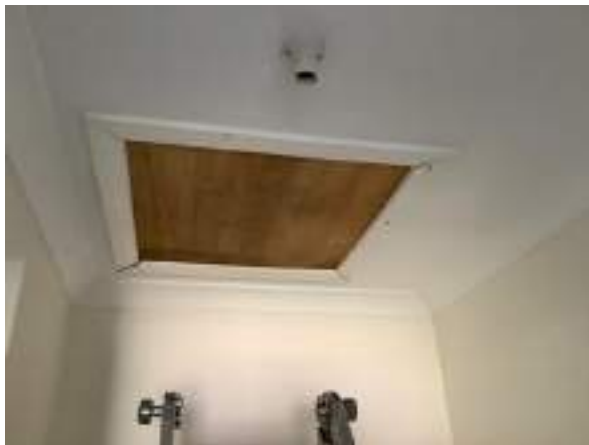
3.10

Wet areas are the main areas that MUST have SUFFICIENT paint coverage to the walls, ceilings and timber work as moisture can deteriorate the areas.

A painting contractor, builder, plasterer and/or suitable handy person may be appointed to perform necessary works to aid the appearance of the affected area and to ensure the area is protected against further deterioration.

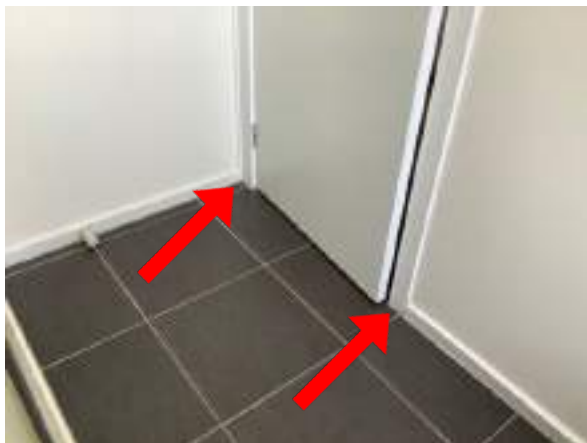
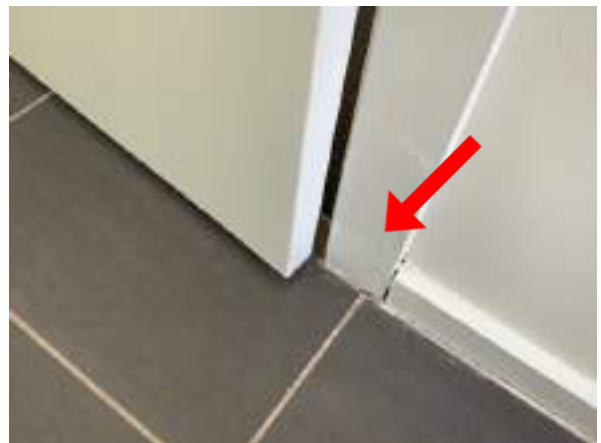
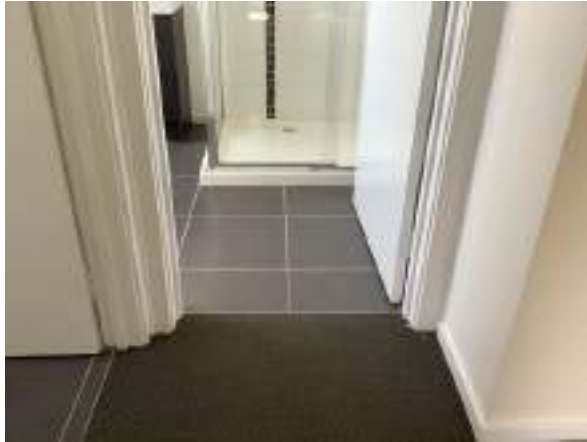
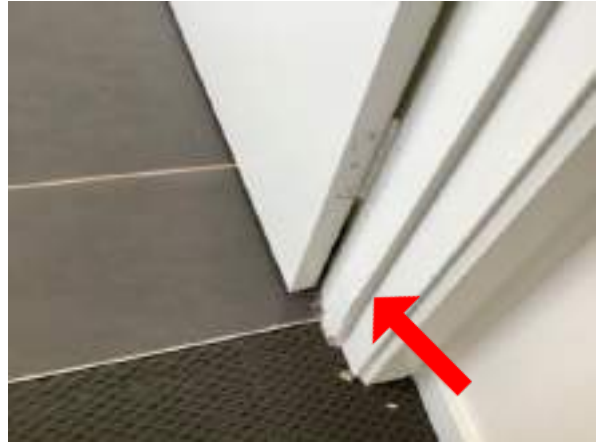
3.12

Location: Bathroom

Finding: Water Staining - Damaged Materials.
Water staining was evident in this area or areas at the time of inspection.

Water staining indicates that surfaces have been exposed to excessive moisture / water over time. The minerals and other elements in the water lead to staining, which may graduate to corrosion and deterioration if left unmanaged.

It is important to identify the cause of water staining and STOP FURTHER DETERIORATION by the appropriate tradesperson.

Where water staining is active, a licensed plumber or appropriate trade must be consulted to identify the cause of the staining and to provide advice on any reparation works that may be required.

Replacement of any broken or damaged structures is advised in particular if the damage has caused secondary defects that have compromised the building structure or safety of any persons.

Conversely, where water staining is old and inactive, affected building materials may be repaired or replaced at client discretion only if the damage is cosmetic though.

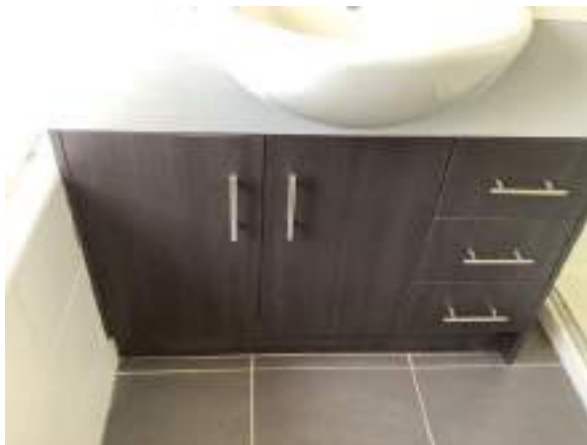
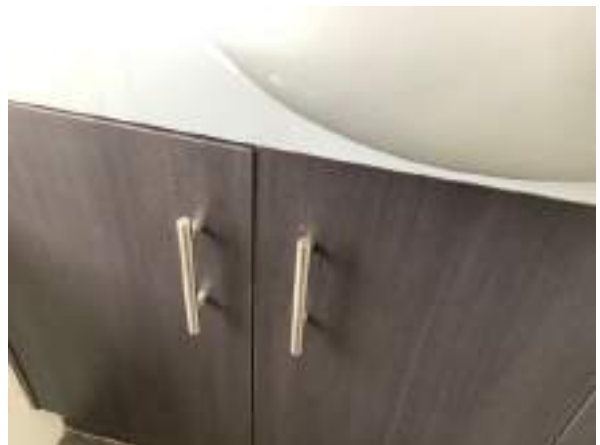
3.13

Location: Bathroom

Finding: Cabinetry - Loose hinges / Re-adjustment
 Several cupboard / wardrobe doors are not level and detract from the operational state of the cabinetry and doors.
 Upon further inspection, it was noted that the hinges to the cupboard doors have deteriorated or just need adjustment. This as a result over time that they have just come loose or deteriorated from their original fixing.

To improve operation of the affected doors, a general handyman / cabinetmaker/ carpenter may be appointed to replace the faulty hinges and/or adjust .

Such works should be completed at the discretion of the client, but we do recommend repairs so that there is no further damages to the existing cabinets or cupboards.

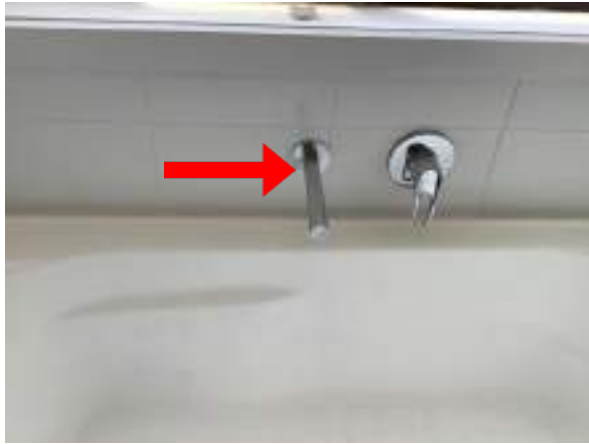
3.14

Location: Bathroom

Finding: Spout - Loose

The spout in this area has not been installed correctly, or has deteriorated with age, and is consequently loose. This spout being loose creates potential for water leaks and subsequent water damage to the surrounding area.

Where spouts are loose, a qualified plumber should be appointed to re-fix the plumbing fitting to prevent further secondary damages that may not be seen, creating water damage unseen.

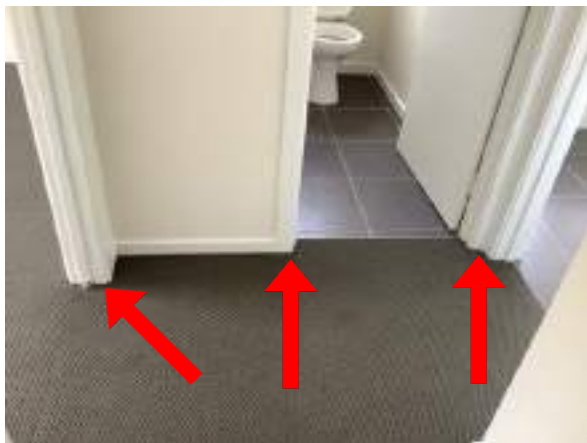
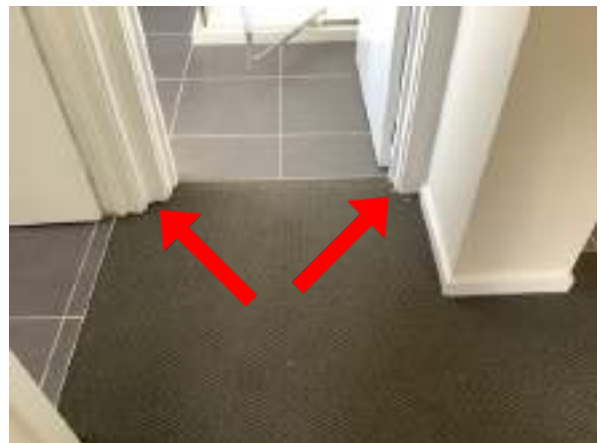
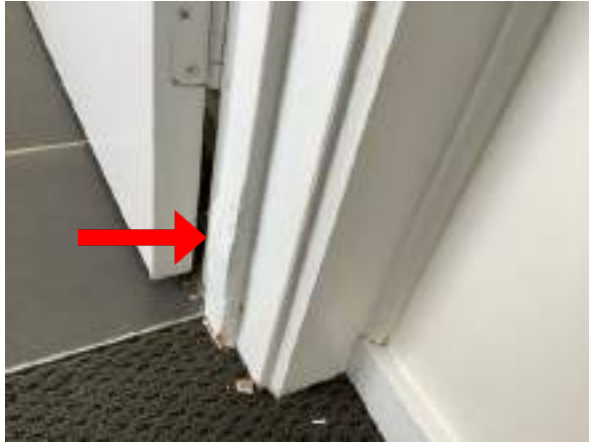
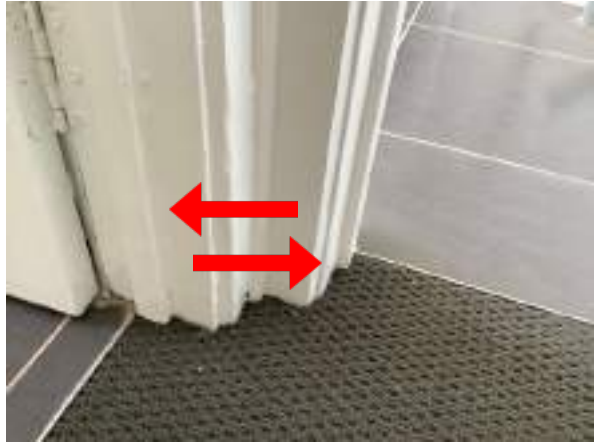
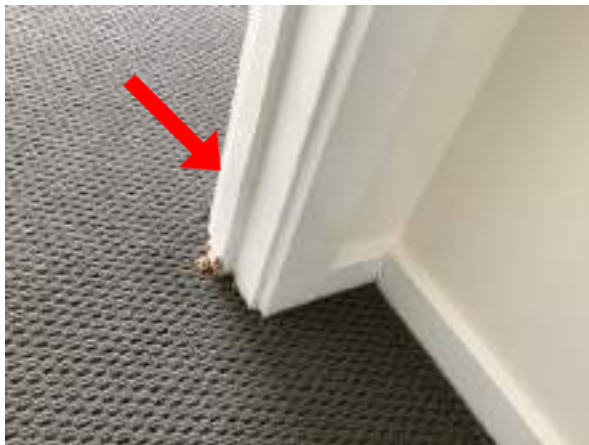
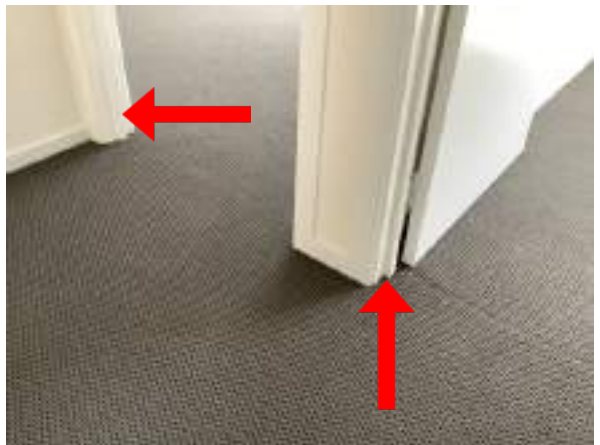
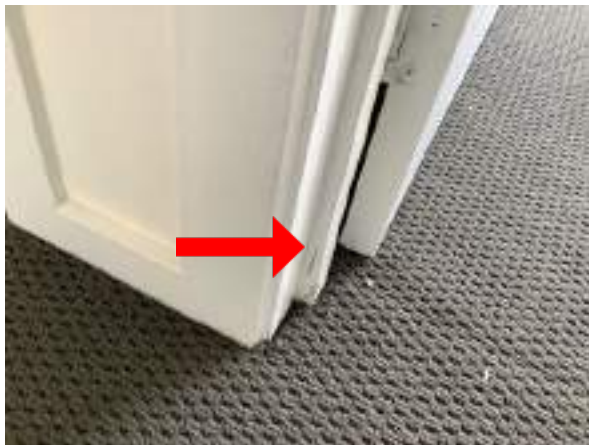
3.15

Location: Hallway 2

Finding: Water Staining - Damaged Materials.
Water staining was evident in this area or areas at the time of inspection.

Water staining indicates that surfaces have been exposed to excessive moisture / water over time. The minerals and other elements in the water lead to staining, which may graduate to corrosion and deterioration if left unmanaged.

It is important to identify the cause of water staining and STOP FURTHER DETERIORATION by the appropriate tradesperson.

Where water staining is active, a licensed plumber or appropriate trade must be consulted to identify the cause of the staining and to provide advice on any reparation works that may be required.

Replacement of any broken or damaged structures is advised in particular if the damage has caused secondary defects that have compromised the building structure or safety of any persons.

Conversely, where water staining is old and inactive, affected building materials may be repaired or replaced at client discretion only if the damage is cosmetic though.

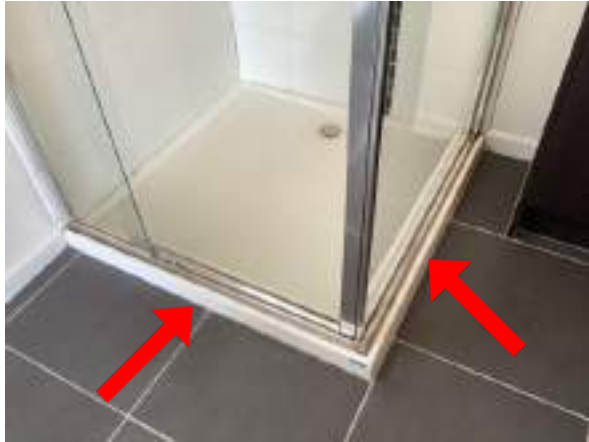
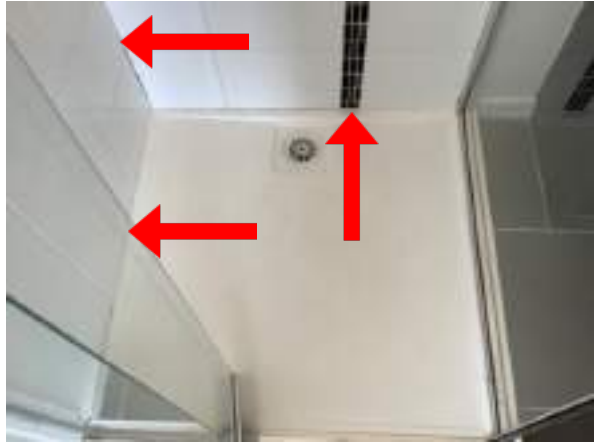
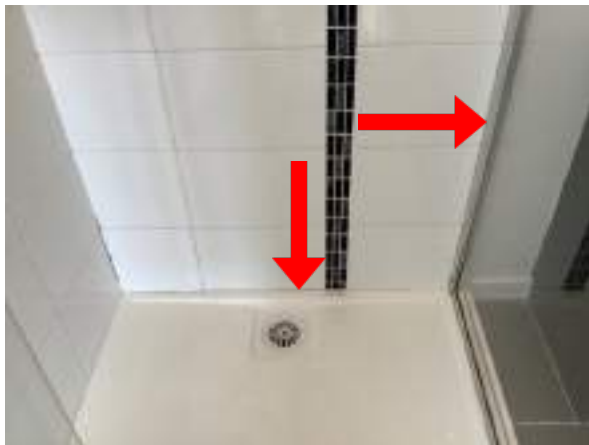
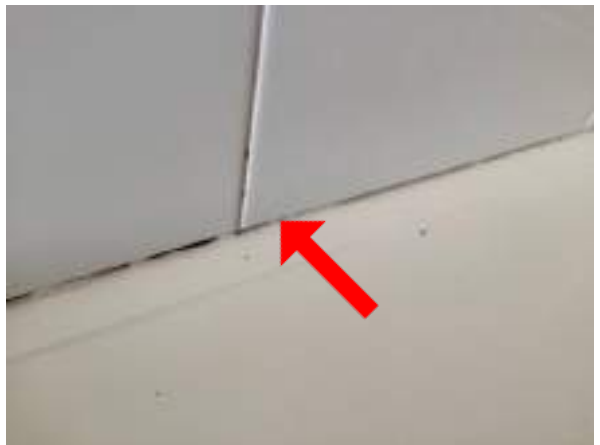
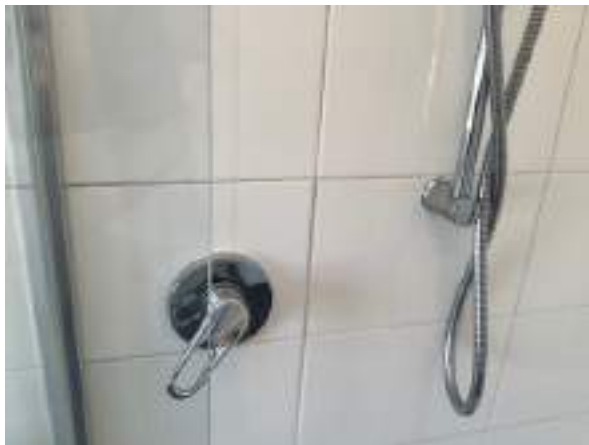
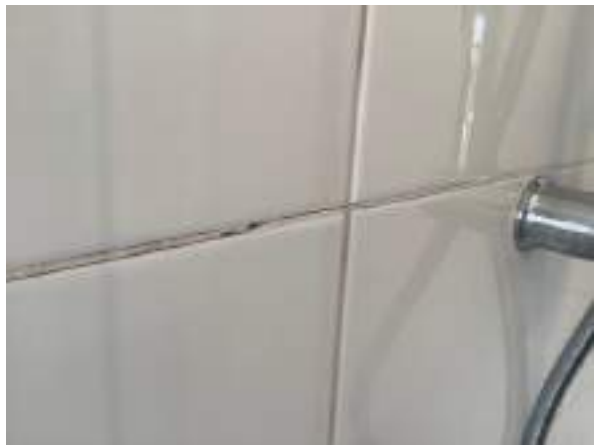
3.16

Location: Ensuite

Finding: Silicon / Caulking To All Wet Area Junctions and Tile Grouting - Missing or Damaged.
It was noted on inspection that sealant and/or tile grout is missing, damaged or inadequate to the tiled wet areas. This may include floor edges, kitchen benches/splashbacks, vanities, bath tub edges, shower areas to the floor and wall tiles, laundry's and all other areas subjected to water or moisture.

Sealant and/or tile grout where missing, damaged or inadequate to the tiled wet areas allows the water to penetrate into the walls and floors which can cause much damage, to the affect were the damage may become a secondary defect and create a conducive environment for termites and/or cause rotting to the timber studs, floor joists and bearers or plaster etc, especially in showers, baths, laundry and the like

Whilst in some of the areas there is sealant/silicon , it has become apparent that the sealant has deteriorated and/or is just missing.

Whilst in some of the tile mortar is perfect , it has become apparent that the tile mortar has deteriorated and/or is just missing in other areas.

A flexible sealant/silicon and tile mortar should be applied to affected areas to prevent any subsequent water damage that is likely to occur.

A sealant specialist, tiling contractor and/or registered builder should be appointed to assess any damage caused by water to the entire internal, sub-floor, walls etc of the building and clean, take off old sealant and tile mortar, then re-seal and re-mortar these works as soon as possible.

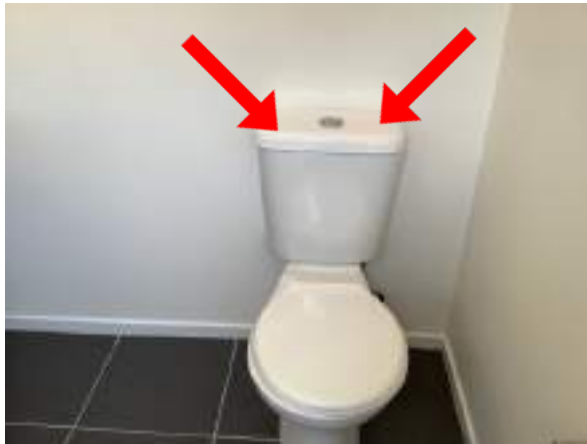
3.17

Location: Ensuite

Finding: Toilet Cistern - Loose to the wall
Installation of the cistern has been done to a substandard level or has just aged over time and has led to the cistern not being correctly attached to the adjoining wall.

Where cisterns are loose it is more susceptible to impact damage as well as creating potential for damage to the adjoining wall.

The cistern requires reattachment to the wall to prevent any further damage, sometimes it is as easy as a couple of dabs of silicon behind the cistern to stop the cistern moving as it is secure enough but just requires the shaking to stop or if the defect is greater then explained above works may be completed by a licensed plumber.

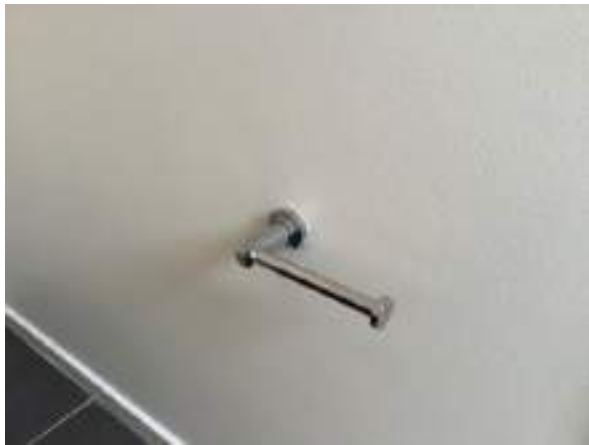
3.18

Location: Ensuite

Finding: Toilet roll holder - Loose

The toilet roll holder was found to be loose at the time of inspection. While not a major operational defect, function can deteriorate if the problem is left unmanaged.

It is advised that the homeowner performs remedial works to re-attach the toilet roll holder to its original fixing.

A general handyperson may be required to perform these works.

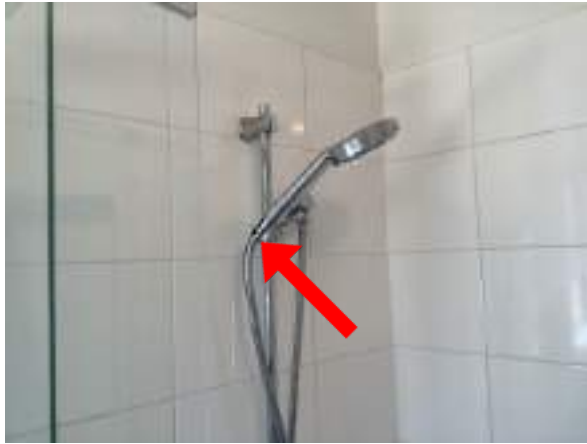
3.19

Location: Ensuite

Finding: Spout - Loose

The spout in this area has not been installed correctly, or has deteriorated with age, and is consequently loose. This spout being loose creates potential for water leaks and subsequent water damage to the surrounding area.

Where spouts are loose, a qualified plumber should be appointed to re-fix the plumbing fitting to prevent further secondary damages that may not be seen, creating water damage unseen.

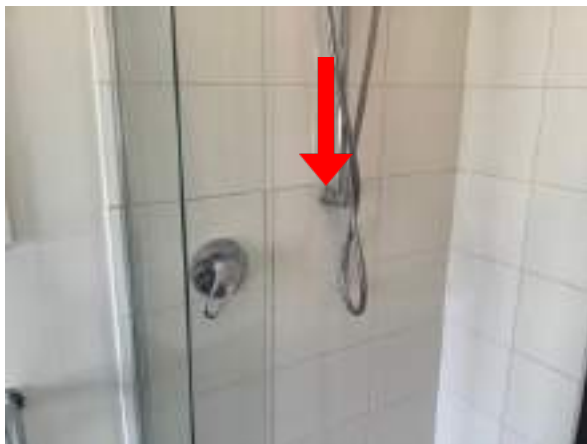
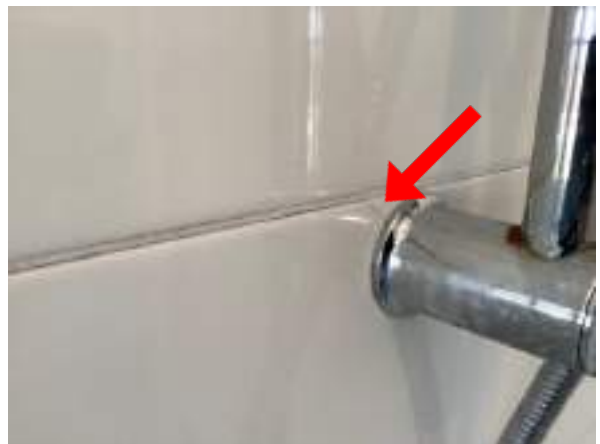
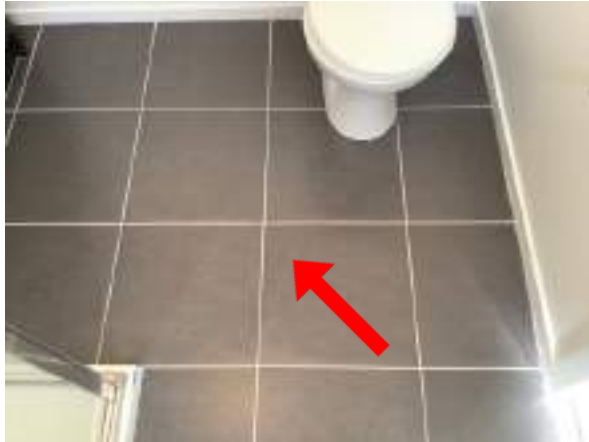
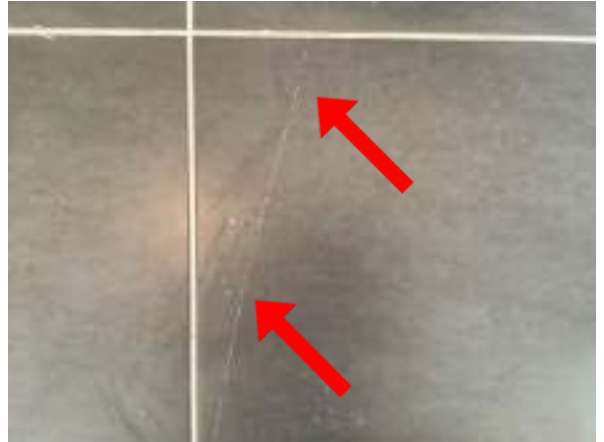
3.20

Location: Ensuite

Finding: Tiles - Cracked or damaged

Cracking was evident to the tiling at the time of inspection. While the cracking appears to be minor, these areas are frequently exposed to water, allowing potential for water penetration into adjoining sections of walls or flooring.

If left unmanaged, water penetration to these areas may lead to subsequent water damage, which is likely necessitate repair work to affected building elements.

What is important when tiles are cracking is to determine the cause of the cracking, which may be related to the subfloor structure, typical wear and tear and/or poor workmanship. The cause of the tiles cracking must be determined and repaired otherwise the same defect will occur.

Where water penetration has led to water damage, appointment of a relevant tradesperson may be required to repair damaged building elements.

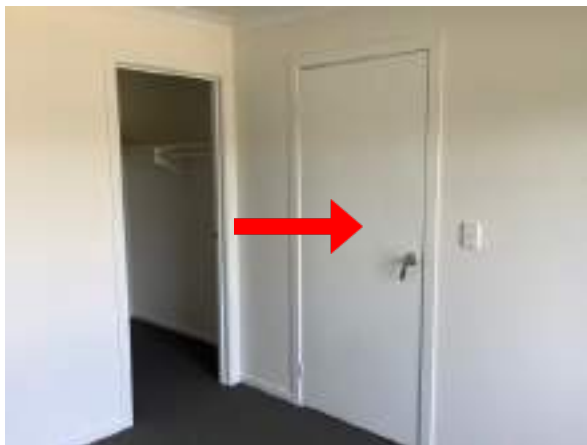
3.21

Location: Bedroom 1

For minor causes, a qualified carpenter or general handyperson should be appointed to perform minor rectification works at client discretion.

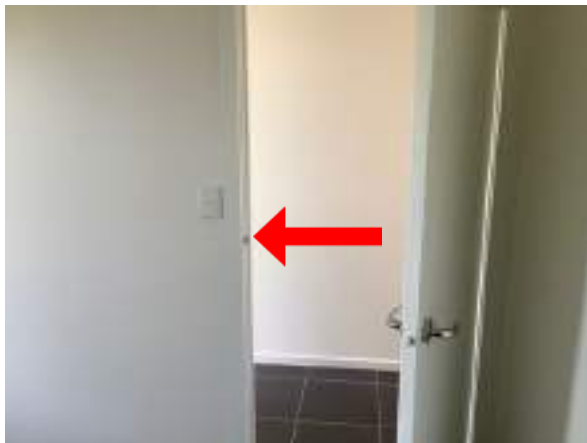
3.22

Location: Bedroom 2

If left unattended, further functional impairment is likely to occur.

Readjustment of the striker plate and/or hinges is recommended at client discretion.

A qualified carpenter or general handyperson may be appointed to perform rectification works as necessary, at client discretion.

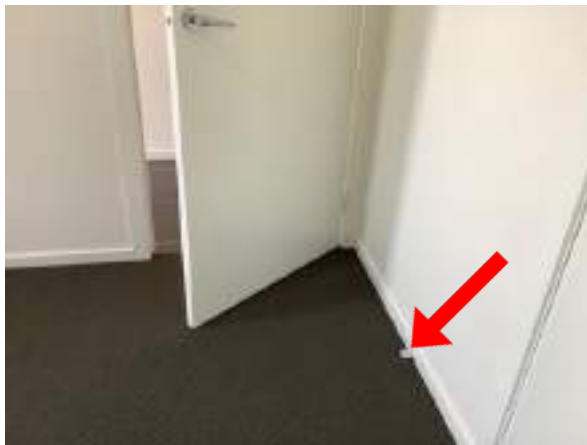
3.23

Location: Bedroom 2

The door stop is missing or is inadequate to stop the door handle from damaging the wall. Although some building elements may seem irrelevant or unnecessary, all building elements play a key role in the operation and function of the overall structure and its performance.

Re-installation or replacement of the door stop is advised as soon as possible to prevent any subsequent damage to the door or associated structures. A general handyman may be appointed to perform these works at client discretion.

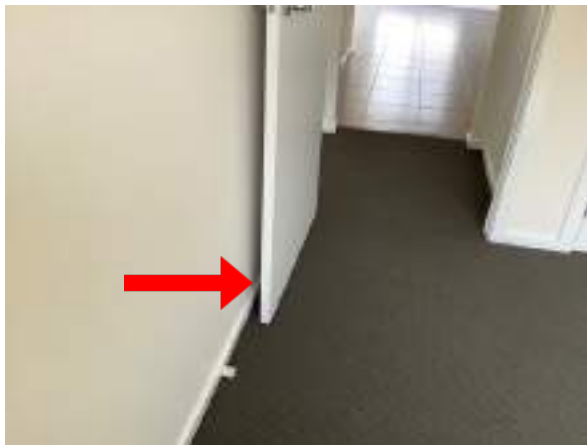
3.24

Location: Bedroom 3

The door stop is missing or is inadequate to stop the door handle from damaging the wall. Although some building elements may seem irrelevant or unnecessary, all building elements play a key role in the operation and function of the overall structure and its performance.

Re-installation or replacement of the door stop is advised as soon as possible to prevent any subsequent damage to the door or associated structures. A general handyman may be appointed to perform these works at client discretion.

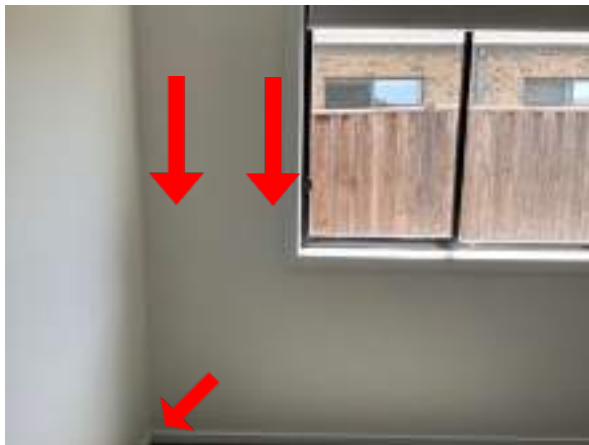
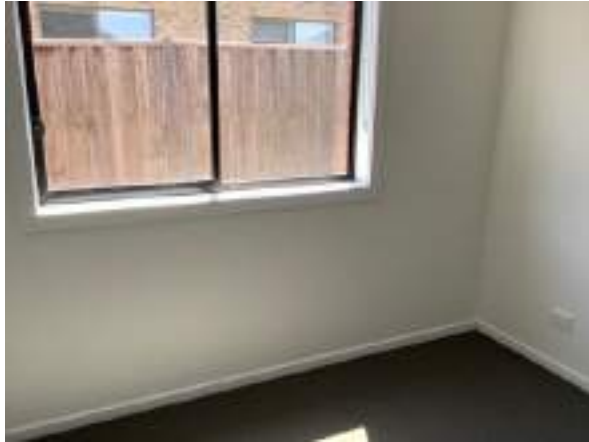
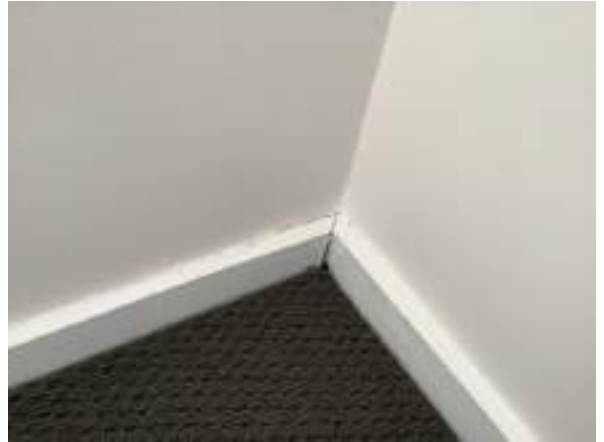
3.27

Location: Bedroom 4

Finding: Plaster & Timber Cracking - Damage Category 2 - Noticeable (up to 5mm)
Whilst we may have a photo of damaged paint, or a minor plaster cracking, etc, there may be many more paint/plaster defects and plaster cracking in other areas throughout the property.

Noticeable cracks are a common occurrence as a result of many primary defects. Such causes may include age, general wear and tear, expected building movement, general expansion/contraction of building materials in different weather conditions, and/or minor failings in the installation or application of building materials.

Noticeable cracks may result in minor sticking or jamming of associated doors and windows, which require easement. However, noticeable cracks are easily filled and repaired. A plasterer can be consulted to install an expansion joint at this point to allow for this movement during different weather conditions.

Monitoring of all cracking should be conducted frequently. Always contact a building inspector should cracks widen, lengthen, or become more numerous. Additionally, your building inspector should also be contacted if associated building elements such as doors and windows become more difficult to operate over time.

Relevant tradespeople, such as carpenters, painters and plasterers, should be appointed to perform remedial works, as deemed necessary.

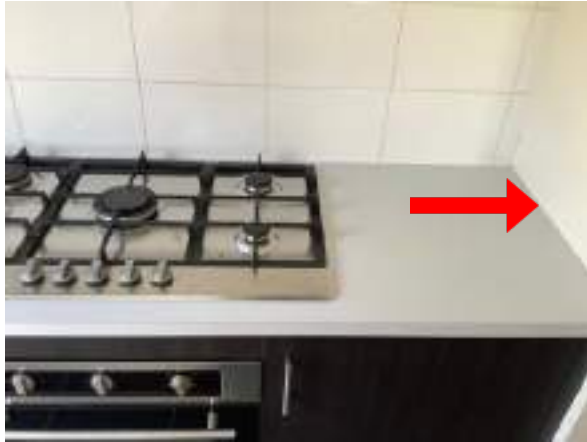
3.28

Location: Kitchen

Finding: Silicon / Caulking To All Wet Area Junctions and Tile Grouting - Missing or Damaged.
It was noted on inspection that sealant and/or tile grout is missing, damaged or inadequate to the tiled wet areas. This may include floor edges, kitchen benches/splashbacks, vanities, bath tub edges, shower areas to the floor and wall tiles, laundry's and all other areas subjected to water or moisture.

Sealant and/or tile grout where missing, damaged or inadequate to the tiled wet areas allows the water to penetrate into the walls and floors which can cause much damage, to the affect were the damage may become a secondary defect and create a conducive environment for termites and/or cause rotting to the timber studs, floor joists and bearers or plaster etc, especially in showers, baths, laundry and the like

Different materials and floor areas move at different rates, generally causing cracking to grout at this point.

Whilst in some of the areas there is sealant/silicon , it has become apparent that the sealant has deteriorated and/or is just missing.

Whilst in some of the tile mortar is perfect , it has become apparent that the tile mortar has deteriorated and/or is just missing in other areas.

A flexible sealant/silicon and tile mortar should be applied to affected areas to prevent any subsequent water damage that is likely to occur.

Regular maintenance and replacement of damaged or missing sealant and tile mortar is highly recommended to the wet areas, as this is a regular wear and tear defect. Sealant and grouting in areas that come into regular contact with water should be maintained for the long term care of the building in the areas required as water damage is one of the main defects in a building that causes the most damage and without sealant and tile grout always being perfect, secondary defects or secondary damages can start instantly.

A sealant specialist, tiling contractor and/or registered builder should be appointed to assess any damage caused by water to the entire internal, sub-floor, walls etc of the building and clean, take off old sealant and tile mortar, then re-seal and re-mortar these works as soon as possible.

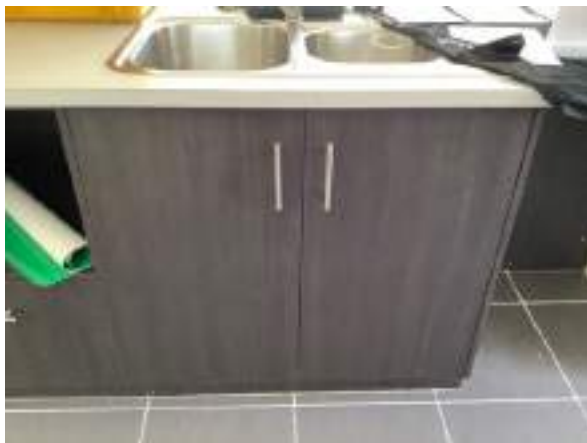
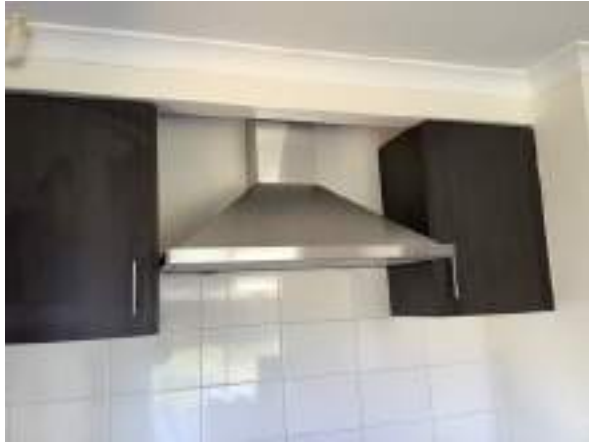
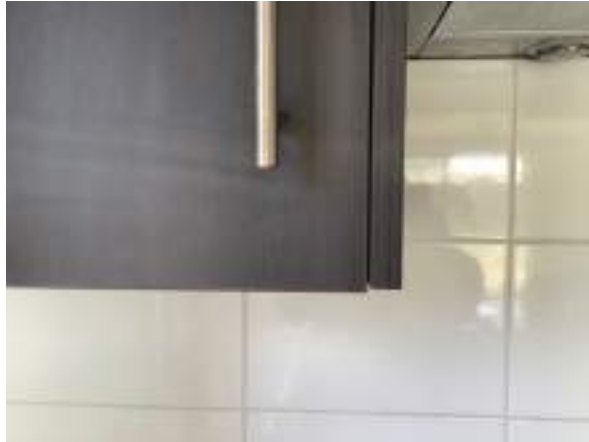
3.29

Location: Kitchen

Finding: Cabinetry - Loose hinges / Re-adjustment
Several cupboard / wardrobe doors are not level and detract from the operational state of the cabinetry and doors.
Upon further inspection, it was noted that the hinges to the cupboard doors have deteriorated or just need adjustment. This as a result over time that they have just come loose or deteriorated from their original fixing.

To improve operation of the affected doors, a general handyman / cabinetmaker/ carpenter may be appointed to replace the faulty hinges and/or adjust .

Such works should be completed at the discretion of the client, but we do recommend repairs so that there is no further damages to the existing cabinets or cupboards.
