Building-Termite-Electrical - Report - Previous Job

Inspection Date: 28 Jan 2020

Property Address: Building-Termite-Electrical Report

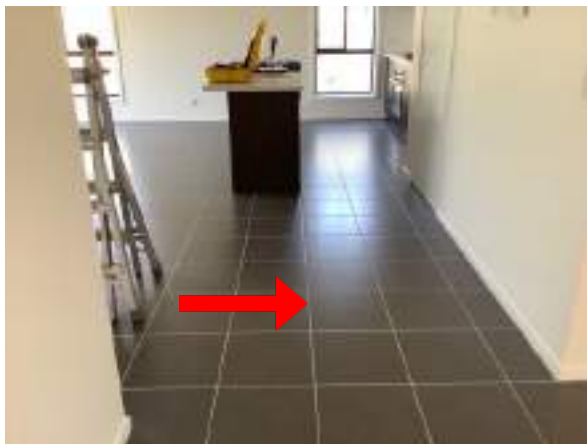
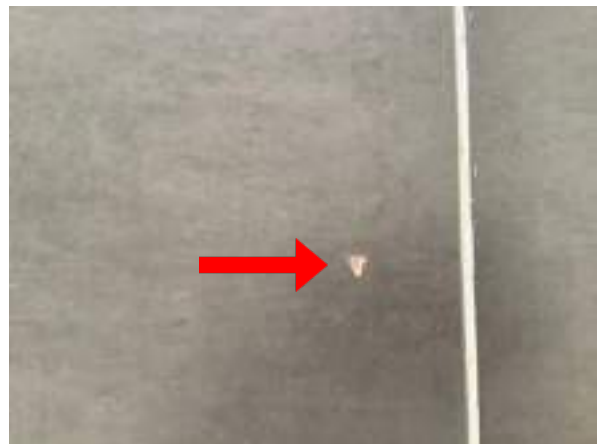
3.30

Location: Kitchen

Finding: Tiles - Cracked or damaged
Cracking was evident to the tiling at the time of inspection. While the cracking appears to be minor, these areas are frequently exposed to water, allowing potential for water penetration into adjoining sections of walls or flooring.

If left unmanaged, water penetration to these areas may lead to subsequent water damage, which is likely necessitate repair work to affected building elements.

What is important when tiles are cracking is to determine the cause of the cracking, which may be related to the subfloor structure, typical wear and tear and/or poor workmanship. The cause of the tiles cracking must be determined and repaired otherwise the same defect will occur.

A tiling contractor should be appointed to ensure that no further water damage occurs. The re-application of silicone and grouting throughout remaining tile work is also advised, to further protect the area against water penetration.

Where water penetration has led to water damage, appointment of a relevant tradesperson may be required to repair damaged building elements.

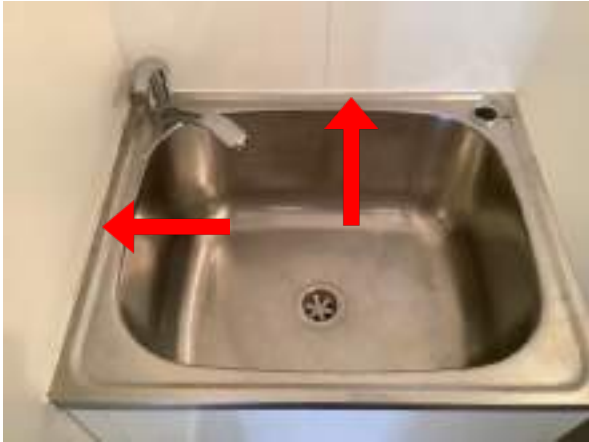
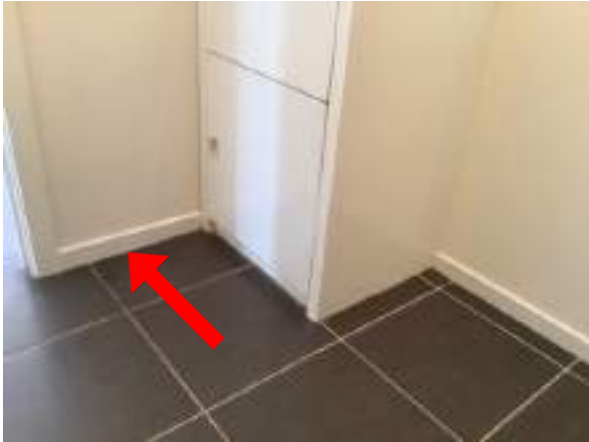
3.31

Location: Laundry

Finding: Silicon / Caulking To All Wet Area Junctions and Tile Grouting - Missing or Damaged.
It was noted on inspection that sealant and/or tile grout is missing, damaged or inadequate to the tiled wet areas. This may include floor edges, kitchen benches/splashbacks, vanities, bath tub edges, shower areas to the floor and wall tiles, laundry's and all other areas subjected to water or moisture.

Sealant and/or tile grout where missing, damaged or inadequate to the tiled wet areas allows the water to penetrate into the walls and floors which can cause much damage, to the affect were the damage may become a secondary defect and create a conducive environment for termites and/or cause rotting to the timber studs, floor joists and bearers or plaster etc, especially in showers, baths, laundry and the like

Different materials and floor areas move at different rates, generally causing cracking to grout at this point.

Whilst in some of the areas there is sealant/silicon , it has become apparent that the sealant has deteriorated and/or is just missing.

Whilst in some of the tile mortar is perfect , it has become apparent that the tile mortar has deteriorated and/or is just missing in other areas.

A flexible sealant/silicon and tile mortar should be applied to affected areas to prevent any subsequent water damage that is likely to occur.

Regular maintenance and replacement of damaged or missing sealant and tile mortar is highly recommended to the wet areas, as this is a regular wear and tear defect. Sealant and grouting in areas that come into regular contact with water should be maintained for the long term care of the building in the areas required as water damage is one of the main defects in a building that causes the most damage and without sealant and tile grout always being perfect, secondary defects or secondary damages can start instantly.

A sealant specialist, tiling contractor and/or registered builder should be appointed to assess any damage caused by water to the entire internal, sub-floor, walls etc of the building and clean, take off old sealant and tile mortar, then re-seal and re-mortar these works as soon as possible.

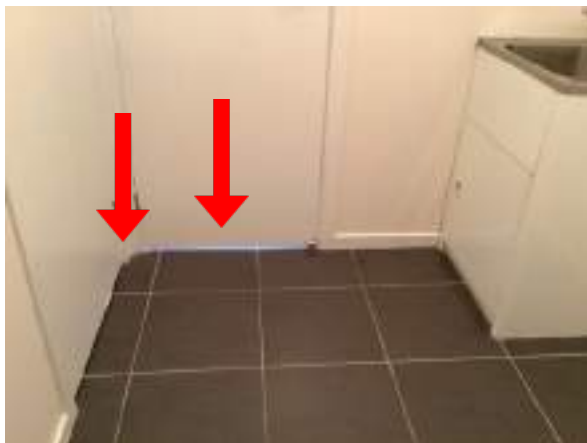
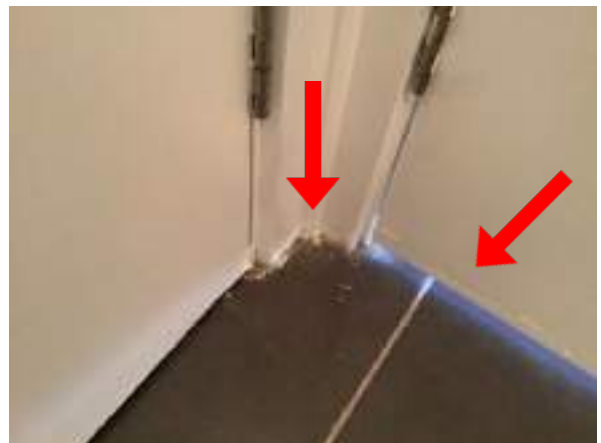
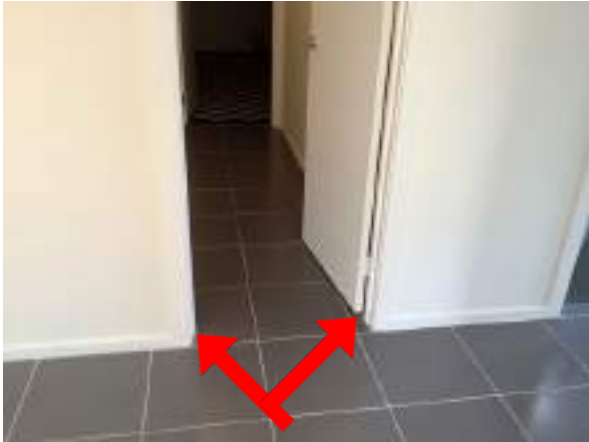
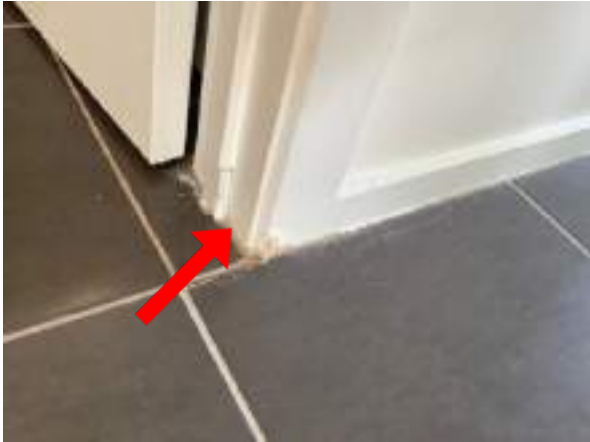
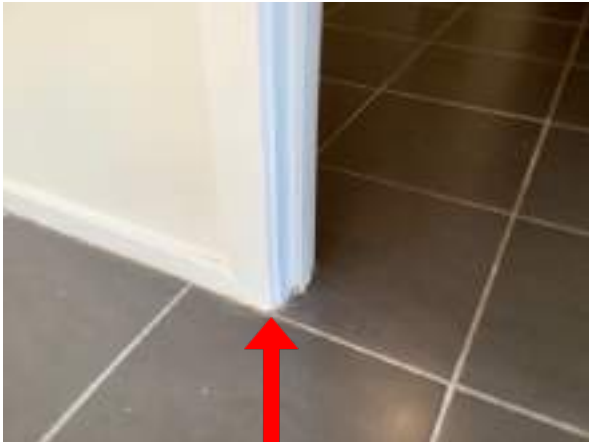
3.32

Location: Laundry

Finding: Water Staining - Damaged Materials.
Water staining was evident in this area or areas at the time of inspection.

Water staining indicates that surfaces have been exposed to excessive moisture / water over time. The minerals and other elements in the water lead to staining, which may graduate to corrosion and deterioration if left unmanaged.

Water staining can be indicative of more serious defects, such as plaster damage that has become detached from its fixings and become dangerous not just cosmetic, wood rot, mould, conducive environment for termites and damage to other types of building materials that are concealed or not concealed by other building elements.

It is important to identify the cause of water staining and STOP FURTHER DETERIORATION by the appropriate tradesperson.

Conversely, where water staining is old and inactive, affected building materials may be repaired or replaced at client discretion only if the damage is cosmetic though.

It is important to identify the correct professional to perform these works, pending on each situation on how minor or major it has become.

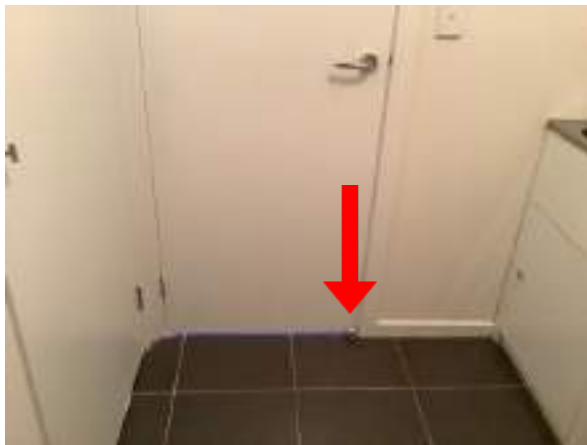
3.33

Location: Laundry

The door stop is missing or is inadequate to stop the door handle from damaging the wall. Although some building elements may seem irrelevant or unnecessary, all building elements play a key role in the operation and function of the overall structure and its performance.

Re-installation or replacement of the door stop is advised as soon as possible to prevent any subsequent damage to the door or associated structures. A general handyman may be appointed to perform these works at client discretion.

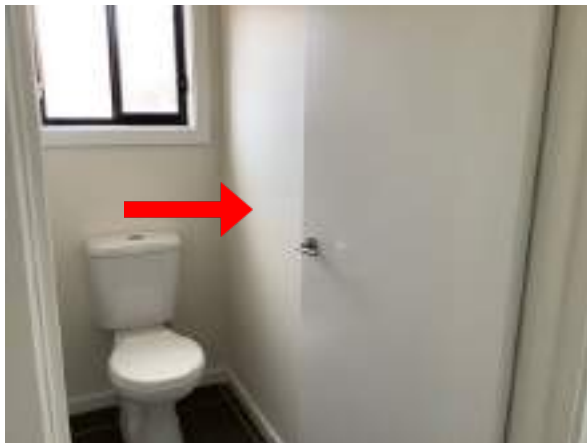
3.34

Location: Toilet

Relevant tradespeople, such as carpenters, painters and plasterers, should be appointed to perform remedial works, as deemed necessary.

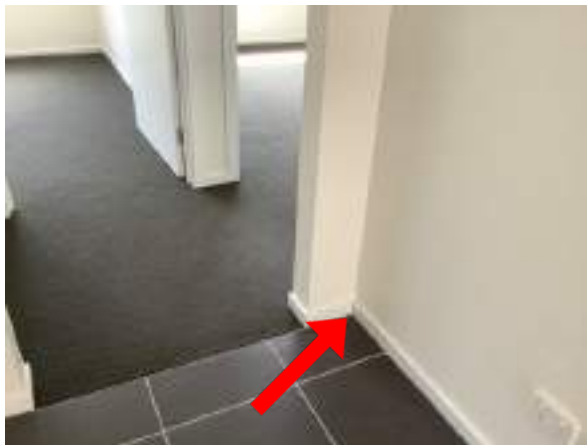
3.36

Location: Family Room

Relevant tradespeople, such as carpenters, painters and plasterers, should be appointed to perform remedial works, as deemed necessary.

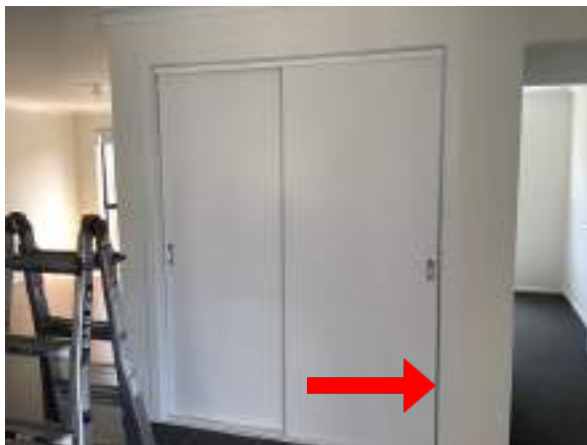
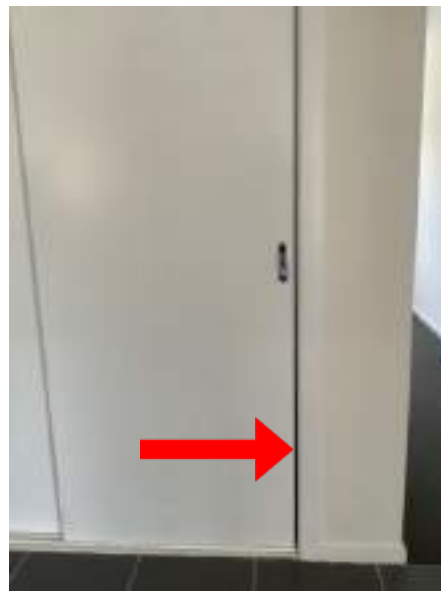
3.37

Location: Closets / Wardrobes

For minor causes, a qualified carpenter or general handyperson should be appointed to perform minor rectification works at client discretion.

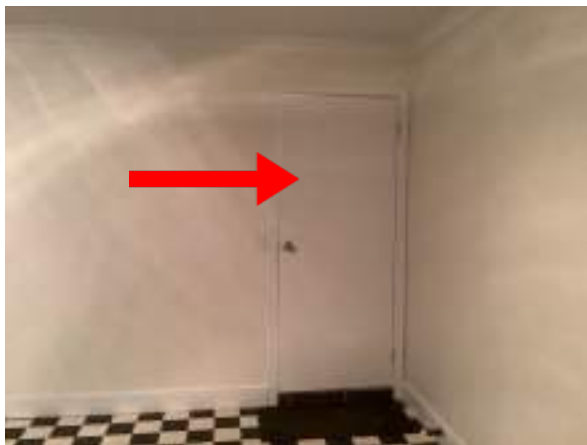
3.38

Location: Garage

For minor causes, a qualified carpenter or general handyperson should be appointed to perform minor rectification works at client discretion.

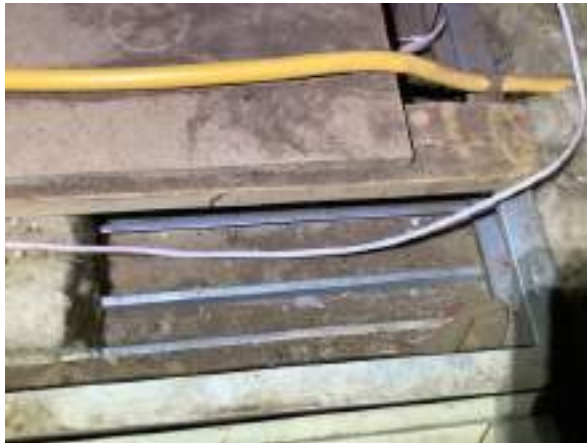
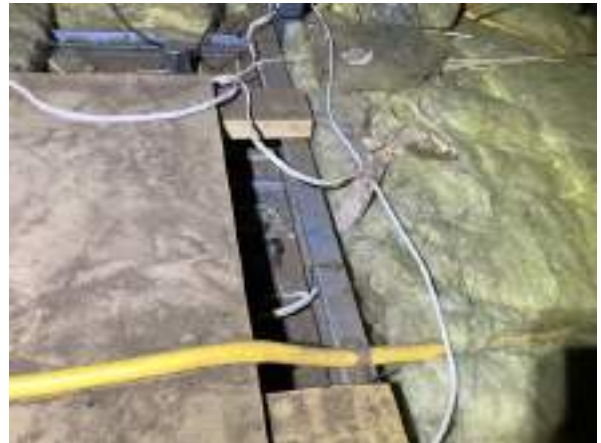
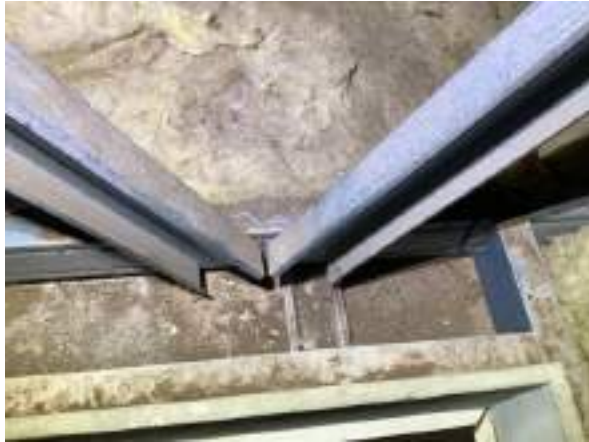
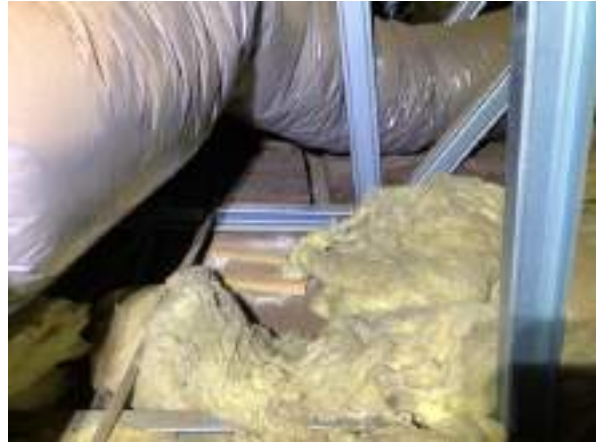
3.39

Location: Roof Space

Caution should be exercised when accessing the roof void. Do not attempt to stand on the framework to the underside of the trusses and be aware there is a potential for electric shock if contact is made with exposed or faulty electrical wiring.

Installation of adequate insulation is required according to Australian Standards and should be conducted as soon as possible.

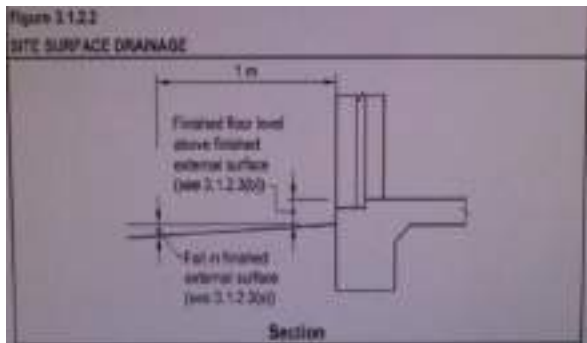
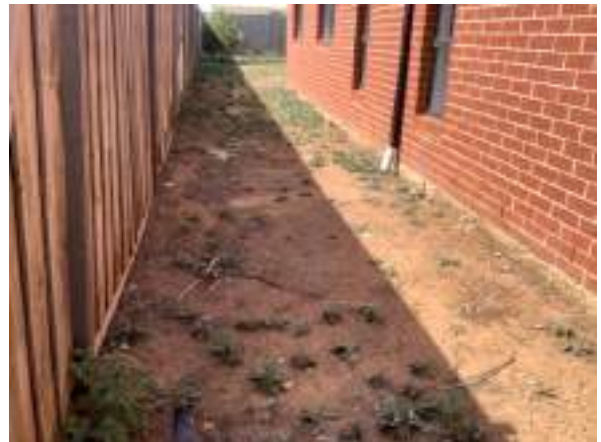
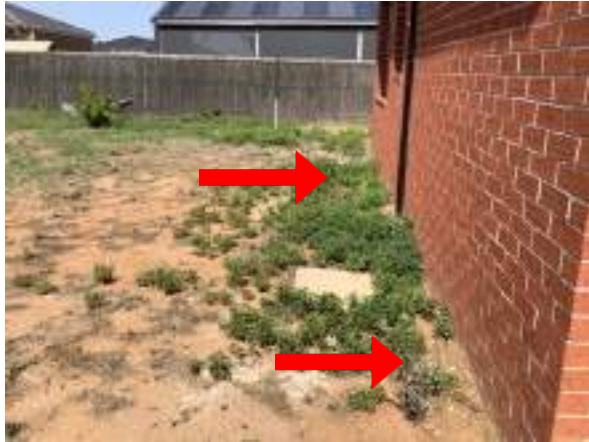
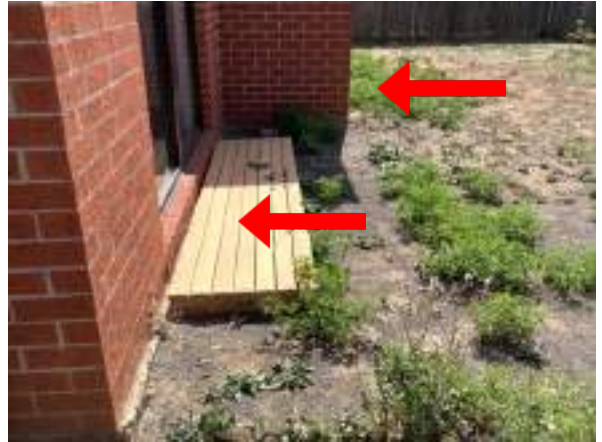
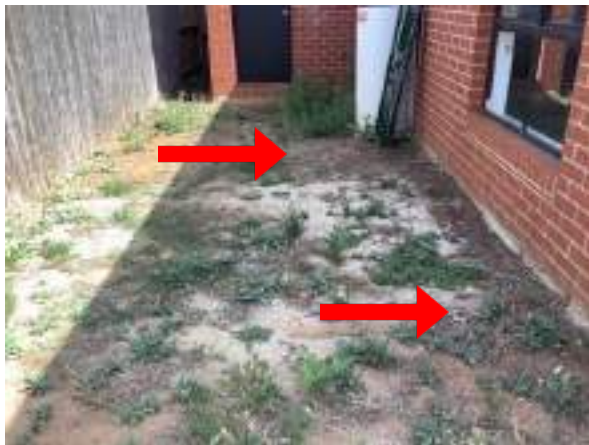
3.40

Location: Perimeter Of Building - Exterior

- (a) Slab-on-ground — finished ground level adjacent to buildings:
the external finished surface surrounding the slab must be drained to move surface water away from the building and graded to give a slope of not less than
- (i) 25 mm over the first 1 m from the building in low rainfall intensity areas for surfaces that are reasonably impermeable (such as concrete or clay paving) or
 - (ii) 50 mm over the first 1 m from the building in any other case.
- (b) Slab-on-ground — finished slab heights:
the height of the slab-on-ground above external finished surfaces must be not less than
- (i) 100 mm above the finished ground level in low rainfall intensity areas or sandy, well-drained areas; or
 - (ii) 50 mm above impermeable (paved or concreted areas) that slope away from the building in accordance with (a); or
 - (iii) 150 mm in any other case.

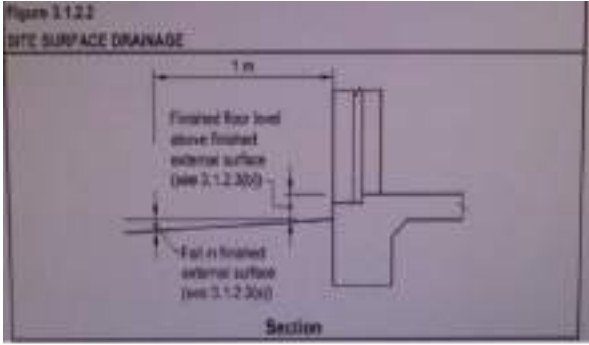
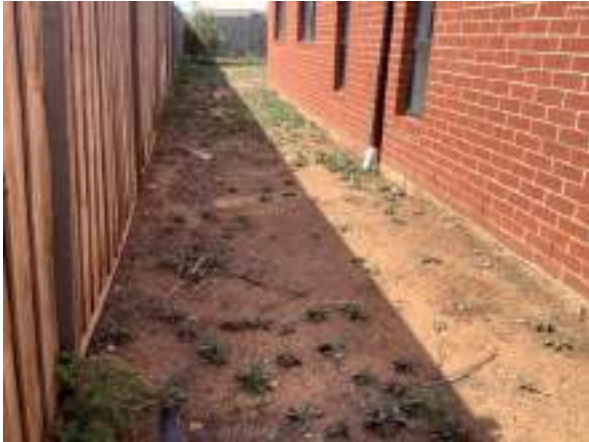
3.41

Location: Perimeter Of Building - Exterior

Please read the report carefully and Maintenance to all susceptible and conducive areas is a MUST to minimise the risk of termite and timber pest existence and timber damage.

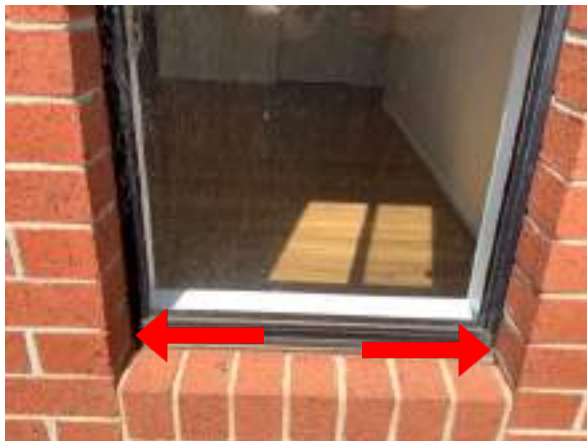
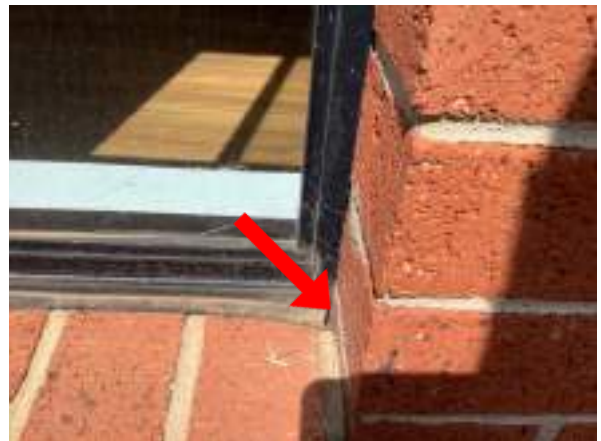
3.42

Location: Perimeter Of Building - Exterior

It is important to note once caulking these areas if water damage is noticeable to windows, timbers, etc, such as wood rott, it is imperative to engage the appropriate trades for replacement or repairs.

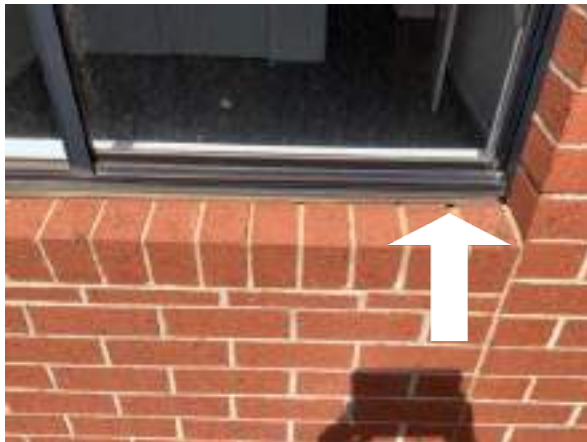
3.43

Location: Brickwork - All Areas

Finding: Brickwork - Deteriorated mortar

Mortar, or 'bedding', is the material which fills joins and intersections between bricks in masonry walls and structures. Sections of mortar in this brickwork were identified as having deteriorated, which is generally expected for a property of this age and condition.

Mortar may deteriorate as a result of age of building materials, minor movement of bricks, or frequent exposure to weathering. Mortar should be replaced to ensure that bricks remain in their intended location and to prevent gaps, which would allow water or moisture ingress and secondary damage as a result.

Mortar deterioration can be addressed by a bricklayer where areas of deterioration are localised and easily accessible. Alternatively, appointment of a registered builder is advised, to repoint large areas of decaying mortar. Where secondary structural defects have become evident, consultation with a structural engineer may be required.

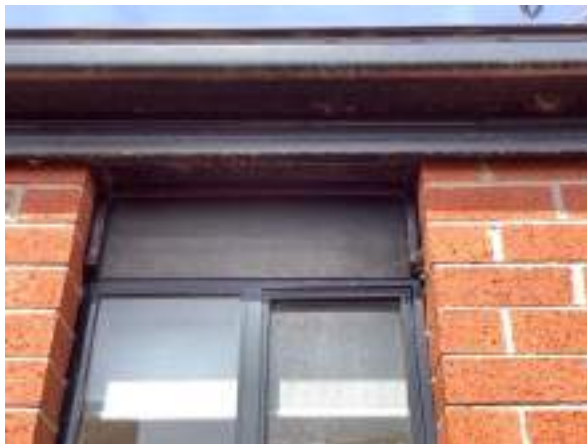
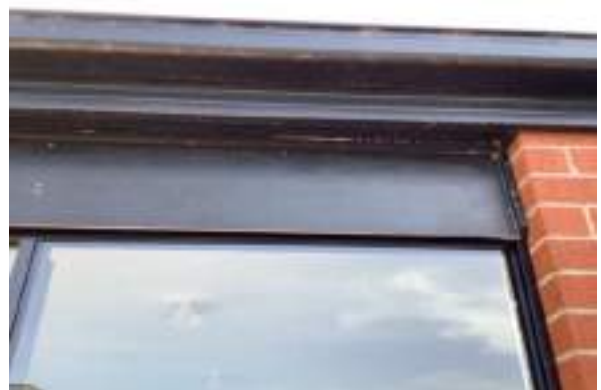
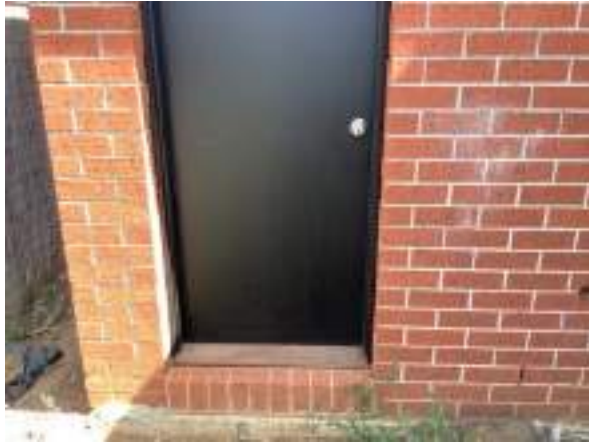
3.44

Location: Timber Work - All External Areas

Finding: Timber, exposed to weather / External painting deteriorated
 Much of the external paint work including but not limited to windows, fascias, guttering, veranda and other external fitments have been neglected and require attention to prepare and re paint.
 External timbers that are frequently exposed to harsh weather conditions require adequate protection (paint) in order to maintain their condition. Where timbers have not been painted or treated adequately, general deterioration is likely to occur at an accelerated rate.

Whilst incomplete or missing paint finish is generally an appearance defect, it can also lead to the development of secondary building defects over time. Incomplete areas of paint finish exposes the area to moisture, potentially accelerating the deterioration of underlying building materials.

Degraded paint finishes should be sanded back, filled, leveled and painted, as applicable. Where inadequate or missing paint protection has led to the deterioration of the associated building element, repair and/or replacement of this building element may be required.

If left unattended, replacement of these timbers is likely to be necessary in the short-term future. Adequate treatment of these timbers is required as soon as possible by a painting contractor should be appointed as soon as possible to perform necessary works to aid the appearance of the affected area and to ensure the area is protected against further deterioration. Alternatively, the homeowner following manufacturer instructions may perform these works.

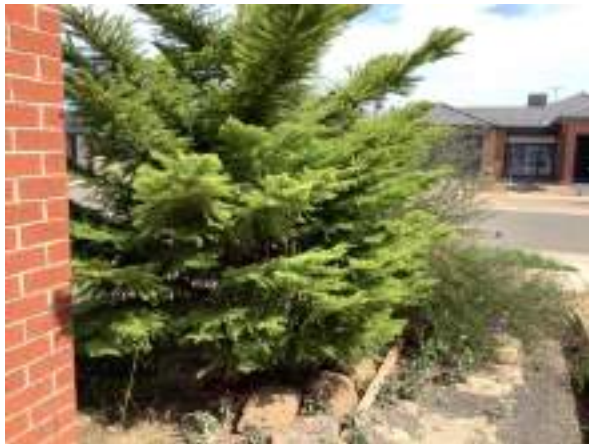
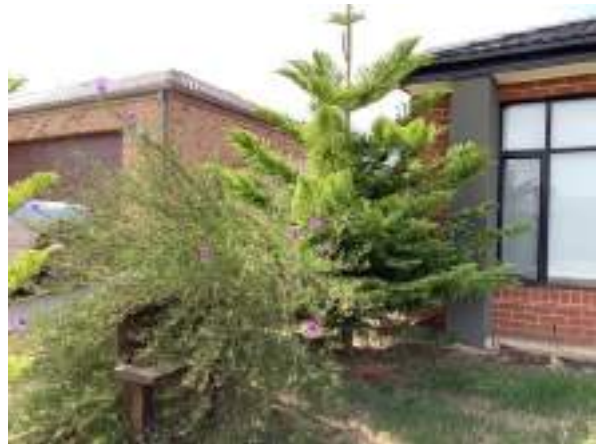
2.02

Location: Garden Areas - All Areas

Finding: Garden Plants - Overgrown .
PLEASE NOTICE THE ATTACHMENT PICTURES TO THIS DEFECT STATEMENT;

At the time of the inspection it was found that the plants are overgrown and close to the exterior building.

It is highly recommended that the plants be trimmed and/or moved away from the immediate area of the perimeter building...

As noted above, I can not stress how important it is to severely reduce the trees, vegetation, timber and other debris and all other items not only around the home but to the entire property as a matter of urgency.

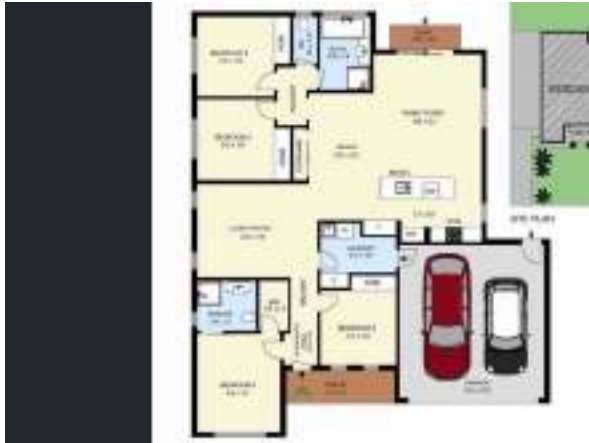
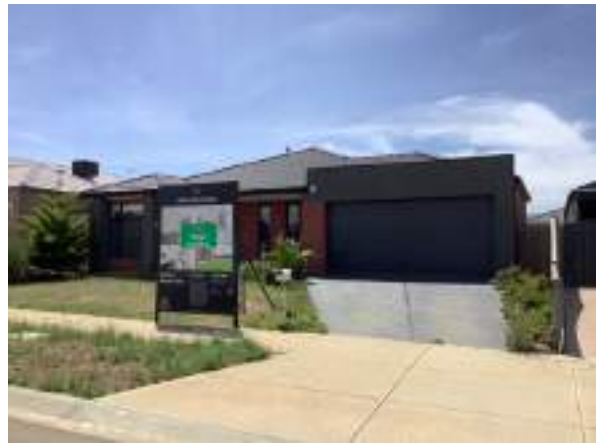
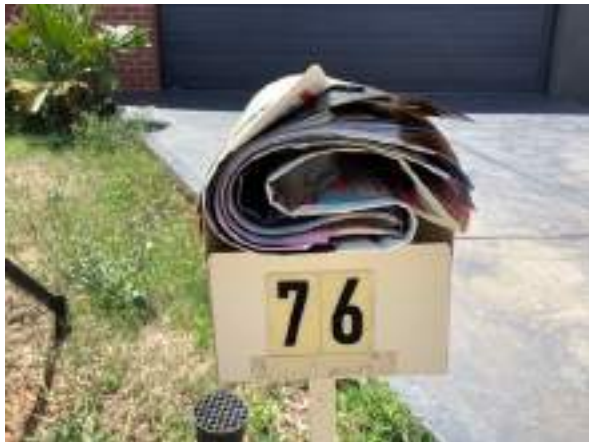
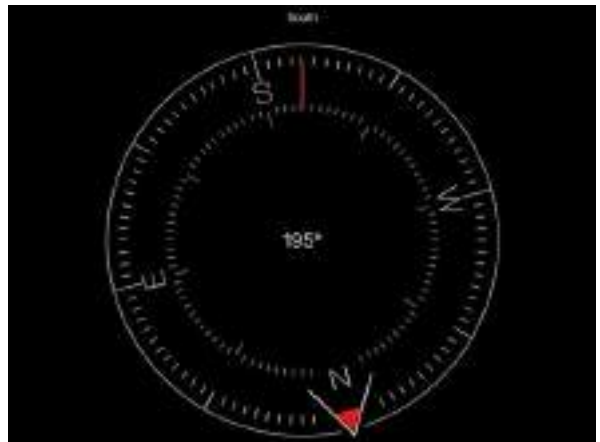
Location: The Site

Finding: General Site Photos & Compass
General site photos and other areas of interest are provided for your general reference.

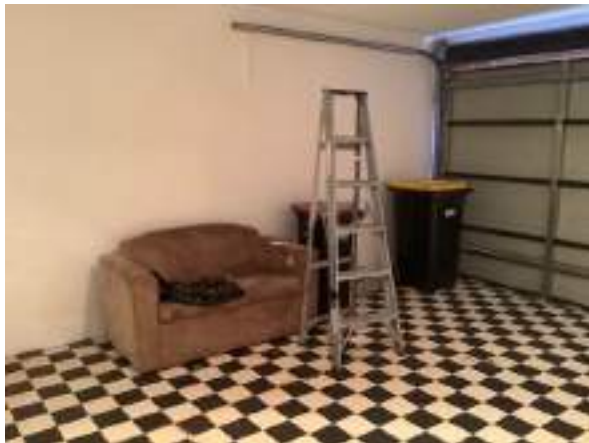
4.04

Location: The Site

Whilst we have taken many photos of the home and surroundings of the obstructions and limitations , we have just added a few photos in the report for you to understand the type of obstructions and limitations .

A re-inspection is recommended once the areas are made accessible.

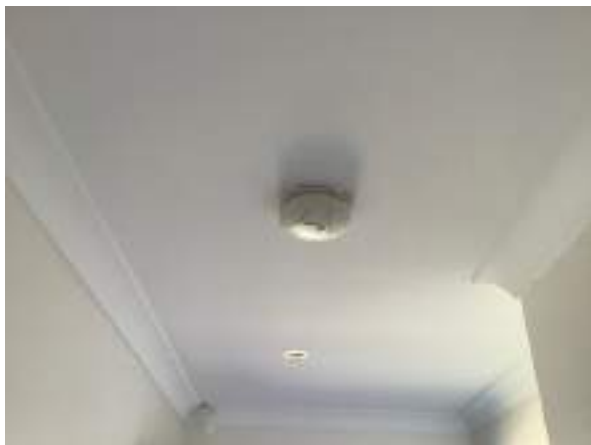
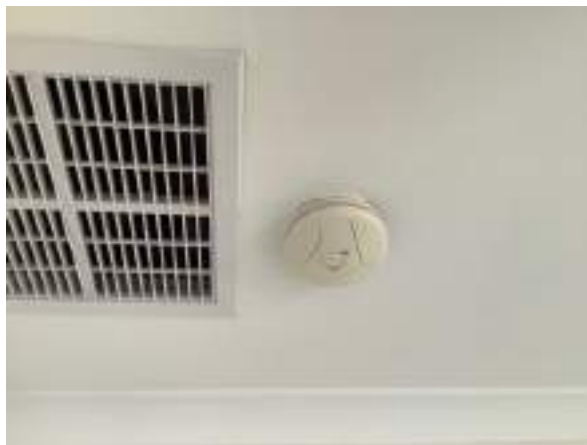
4.05

Location: The Site

Testing of smoke detectors is required monthly.

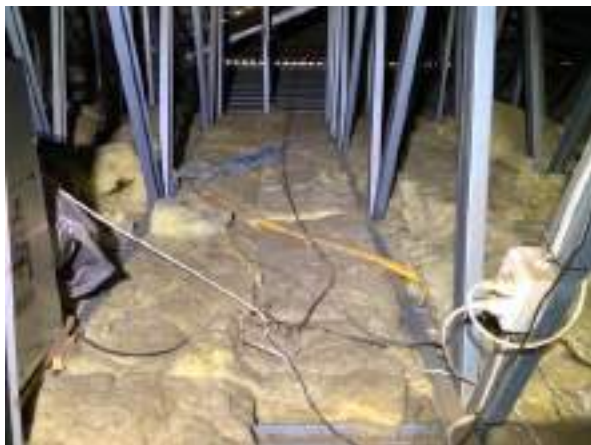
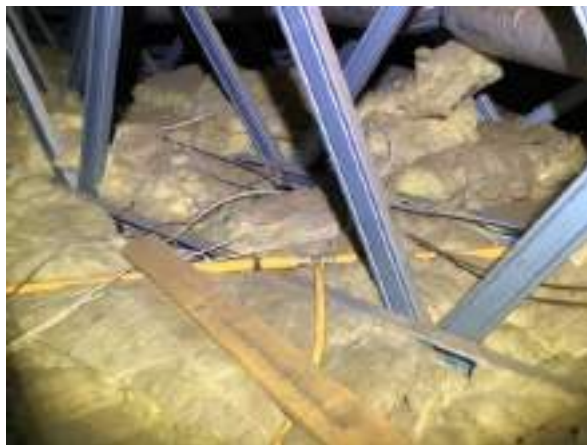
4.06

Location: Roof Space

The property is a very high risk for termites as the environments to the property are very conducive with many susceptible areas.

Please read the report carefully and Maintenance to all susceptible and conducive areas is a MUST to minimise the risk of termite and timber pest existence and timber damage.

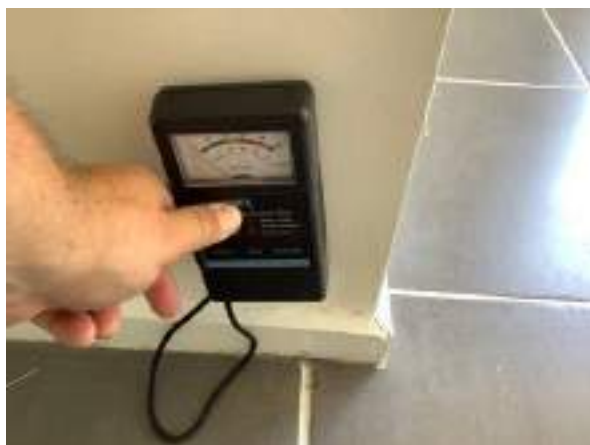
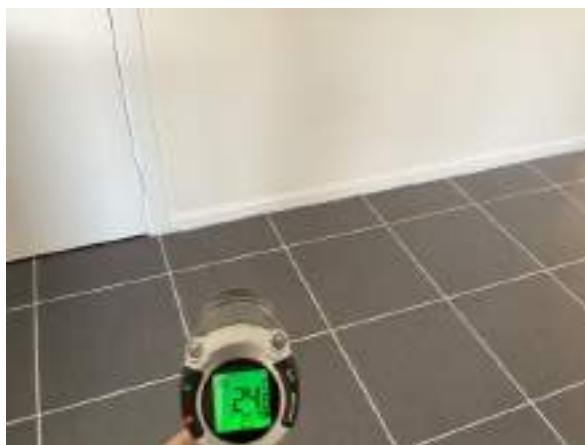
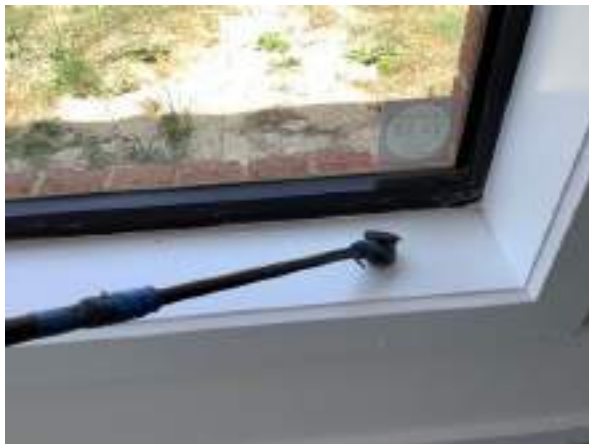
4.12

Location: The Site

As all areas are not able to be inspected due obstructions and limitations, we therefore can not rule out the possibility of concealed timber pest activity.

Wall paneling, wall paper, carpet and fixed cabinetry can obscure termite activity.
