Building & Termite, Timber, Asbestos Pest Report

Inspection Date: 15 Feb 2020

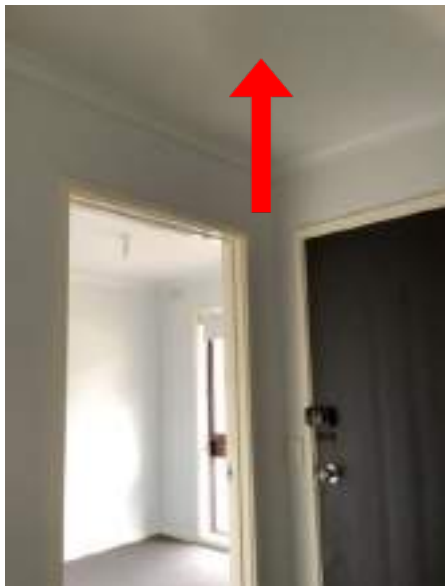
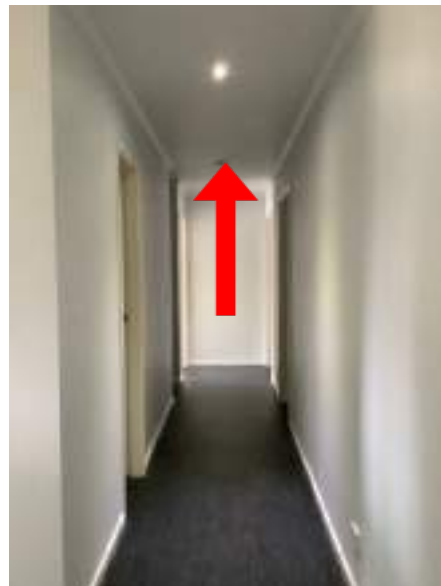
A qualified electrician is required do these works for hard wiring.

Upon completion a safety certificate is required to be supplied to the owner of the building.

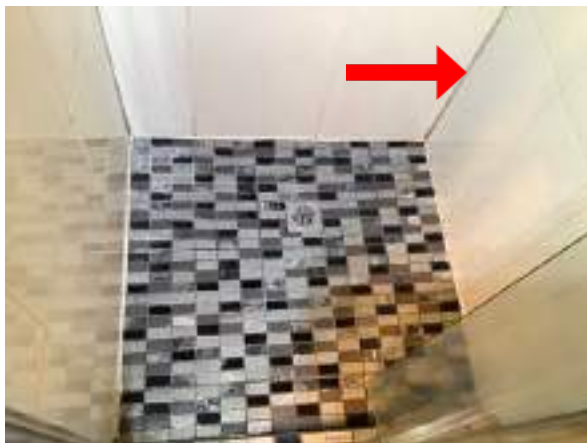
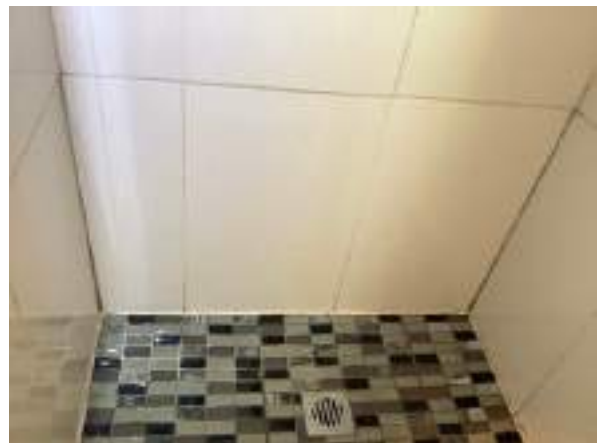
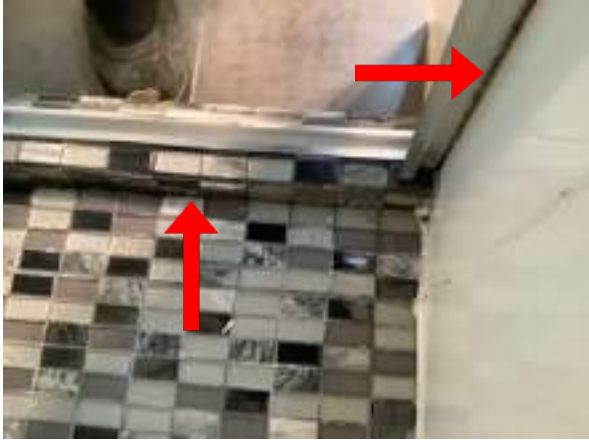
1.02

Location: Bathroom

Finally the cause or source of the mould MUST BE TAKEN CARE OF URGENTLY.

ALL AREAS should be checked carefully for this defect and attached are a few PHOTO
EXAMPLES as a GUIDE.

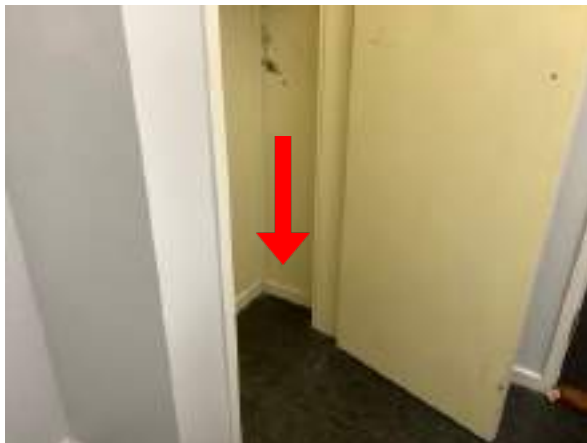
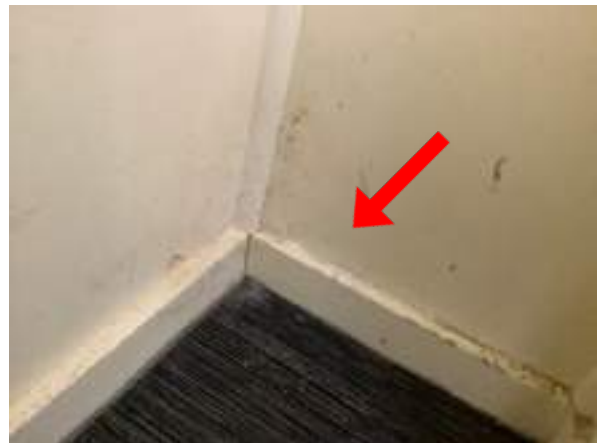
1.03

Location: Laundry

Finally the cause or source of the mould MUST BE TAKEN CARE OF URGENTLY.

ALL AREAS should be checked carefully for this defect and attached are a few PHOTO
EXAMPLES as a GUIDE.

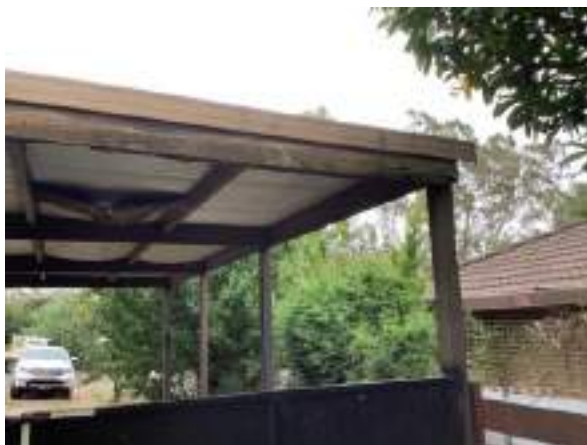
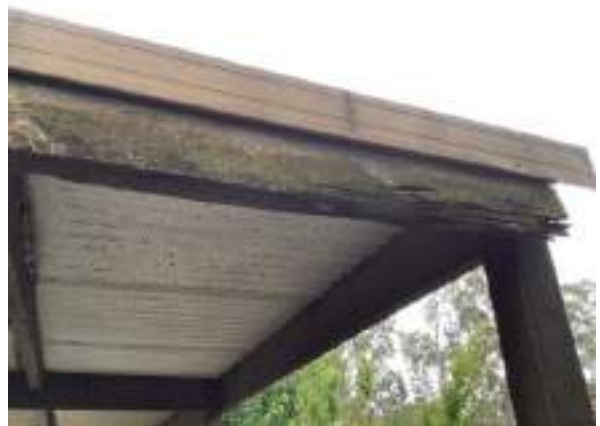
2.06

Location: Timber Work - All External Areas

The property is a very high risk for termites as the environments to the property are very conducive with many susceptible areas.

Please read the report carefully and Maintenance to all susceptible and conducive areas is a MUST to minimise the risk of termite and timber pest existence and timber damage.

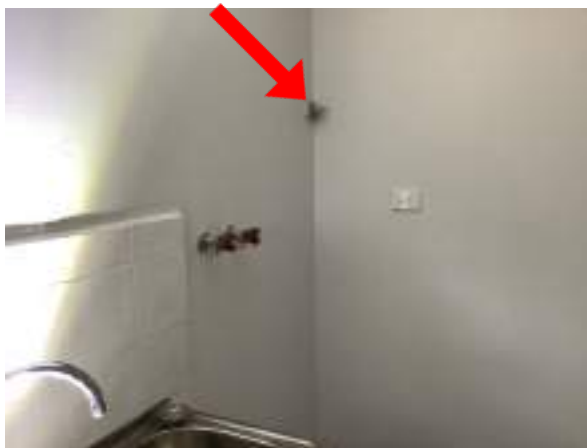
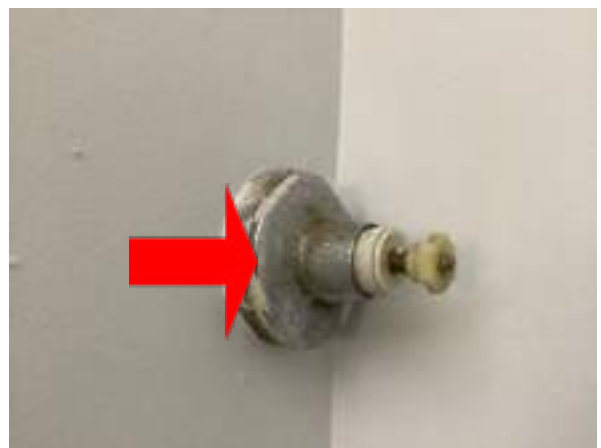
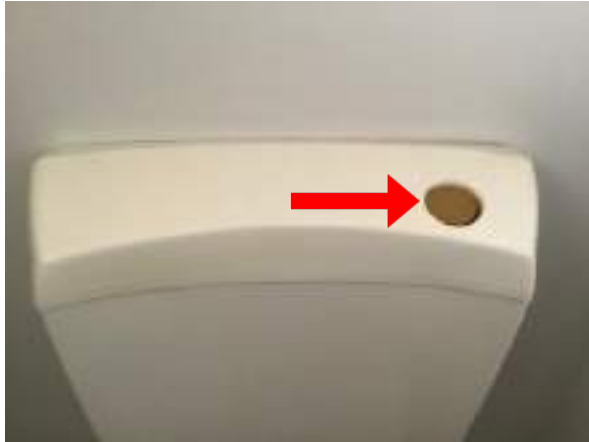
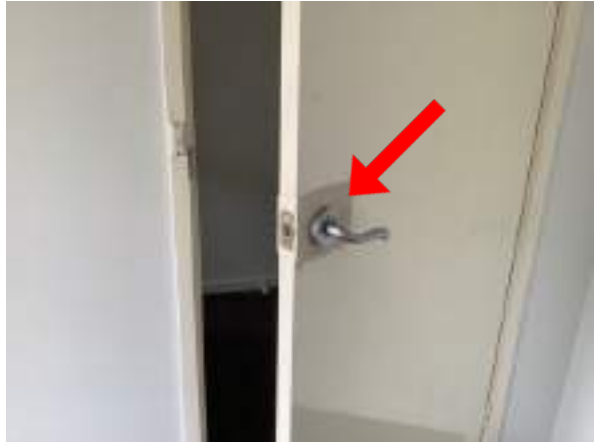
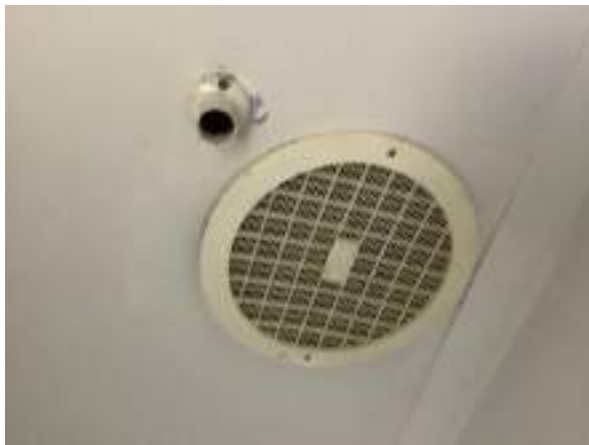
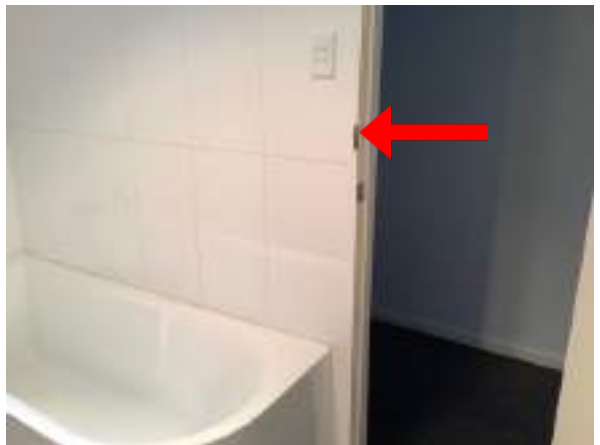
3.07

Items like cracked glass mirrors, cracked glass windows and windows not operation smoothly are defects that should be repaired by the appropriate trades.

It is IMPERATIVE that you engage registered and qualified trades and at the end of there works they must supply certificates, such as an electrical safety certificate, plumbing and gas certificate if the works are electrical or plumbing, but for items such as damaged door handles, painting an experienced carpenter or handyman can sometimes be engaged.

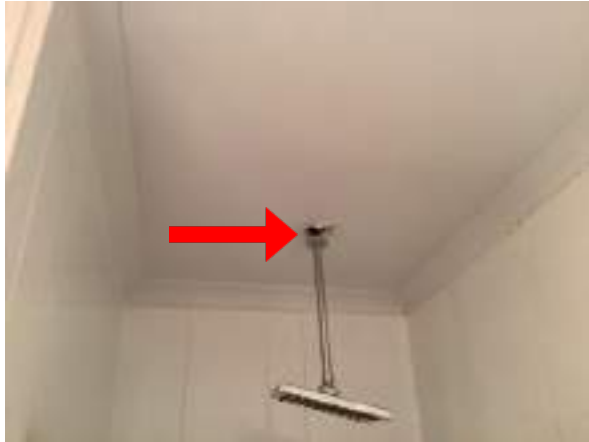
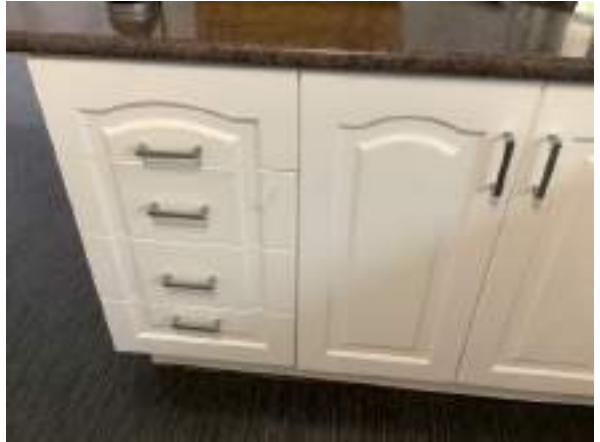
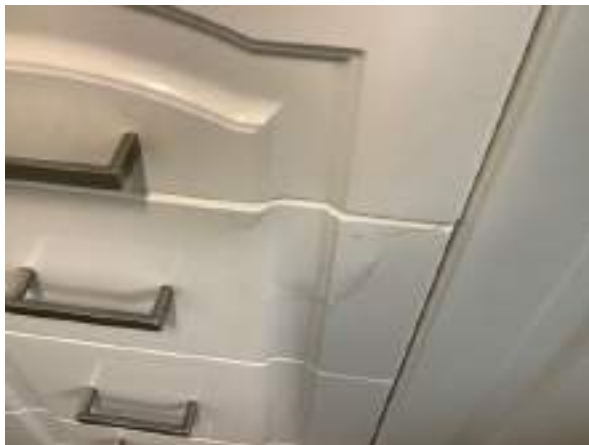
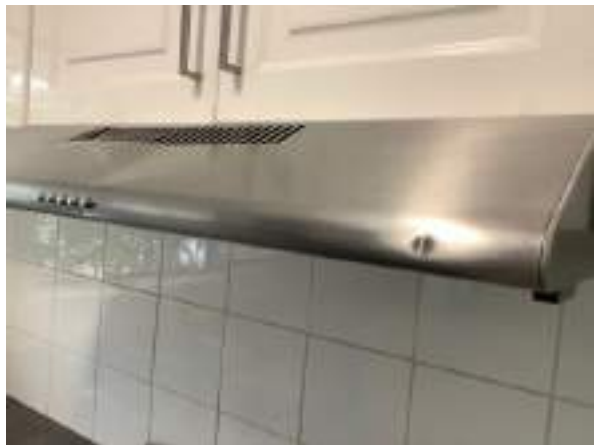
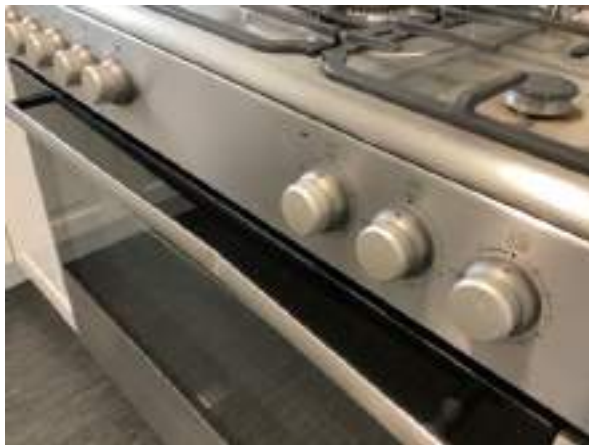
3.08

Location: All Areas - Various

These Defects are of Sub Standard Workmanship or Incomplete and not finished to a tradesmens like manner.

Unfinished and substandard building works are likely to degrade more quickly and may create potential for secondary defects to associated building elements and surrounding structures, also the workmanship is VERY displeasing to the eye.

Generally substandard repairs or installation are related to poor workmanship, the use of inappropriate materials, or a failure to complete installation to a suitable standard.

Where installation is substandard and/or incomplete, the client should contact the responsible trade to undertake rectification works, which are advised as soon as possible.

The appropriate tradesperson or specialist should be appointed to complete the various items for repair and organise the appropriate QUALIFIED trades to repair and complete the works to illiminate or reduce further deterioration / disfunction.

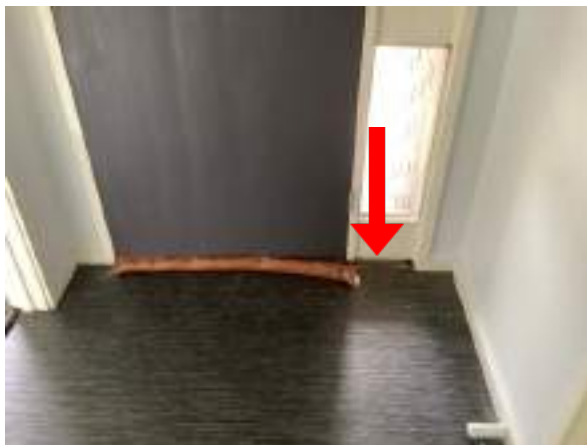
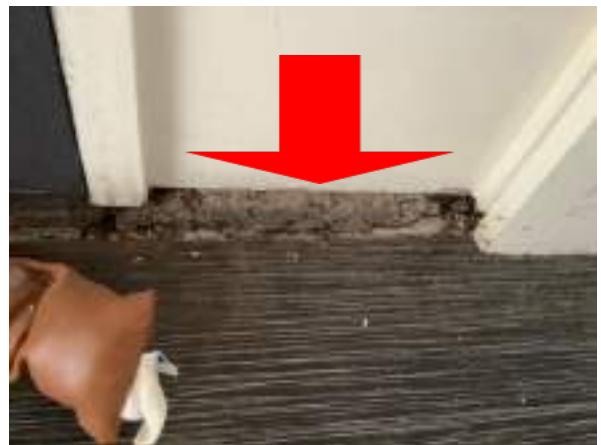
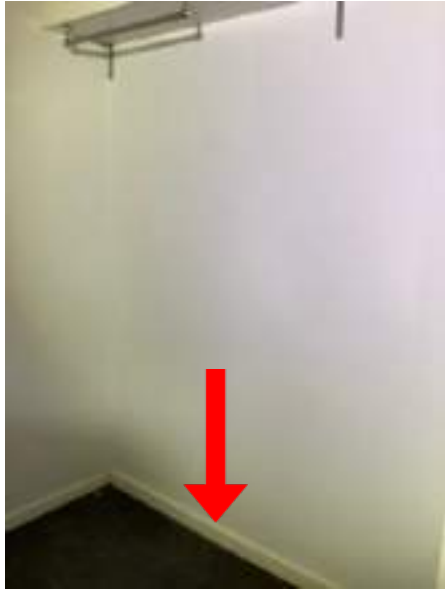
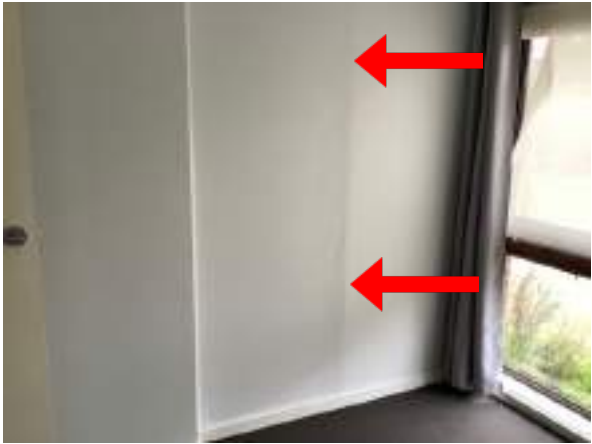
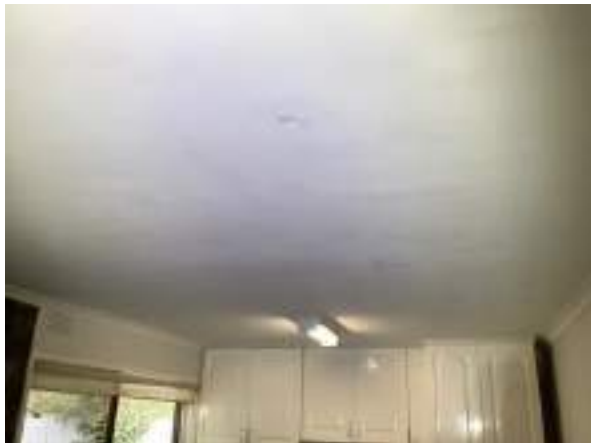
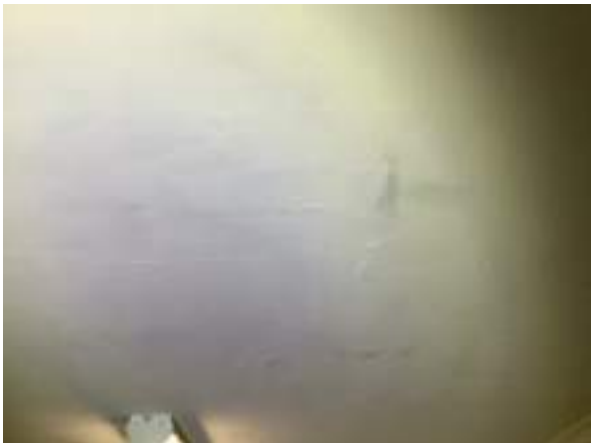
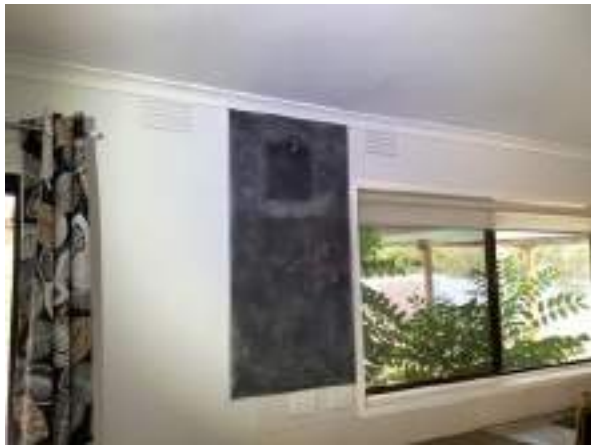
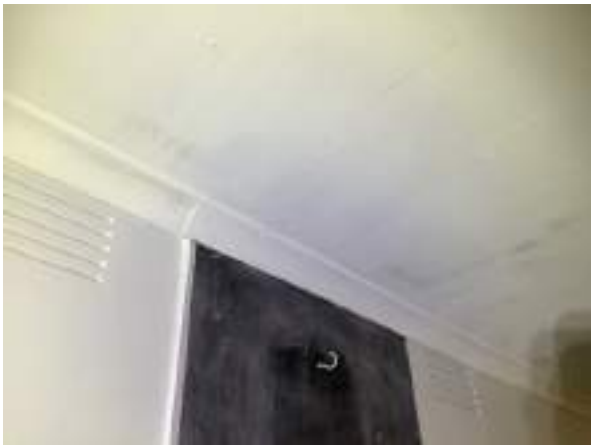
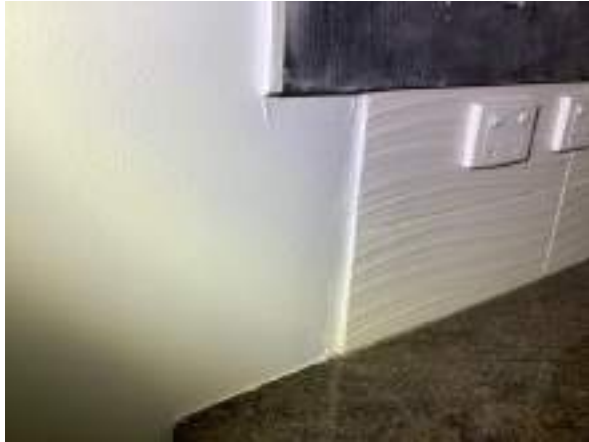
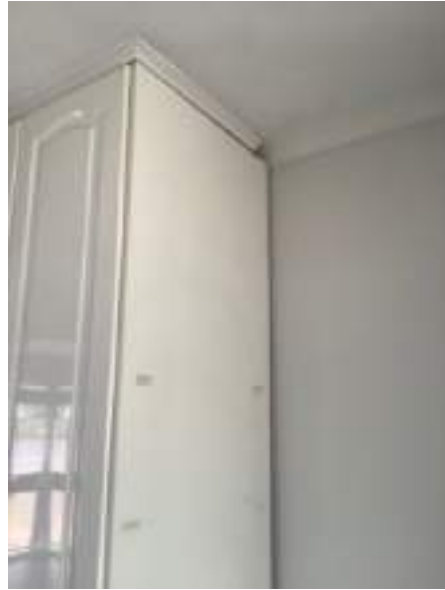
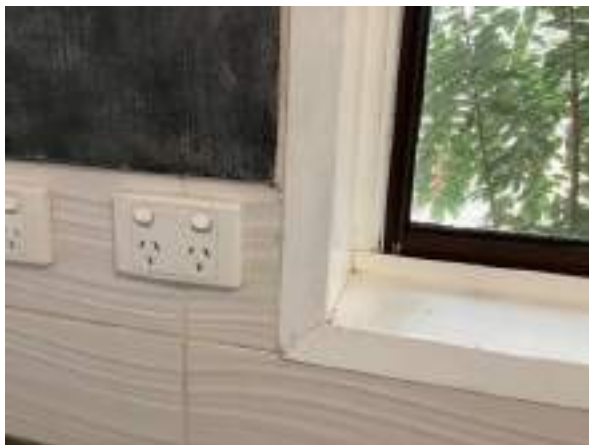
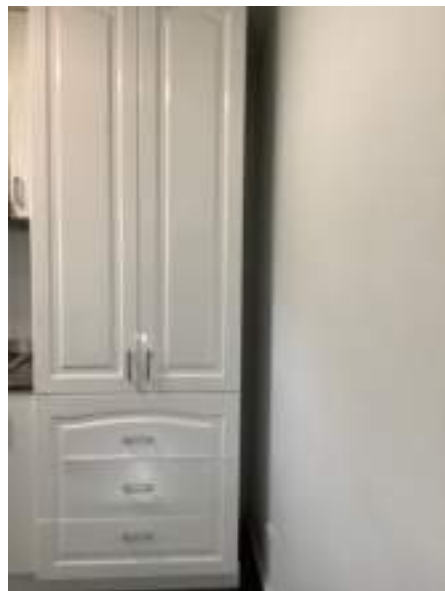
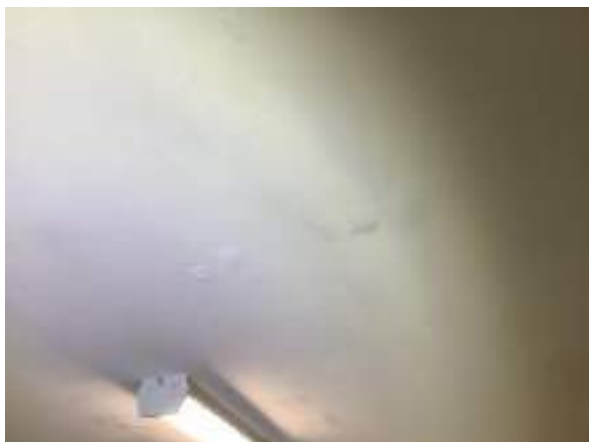
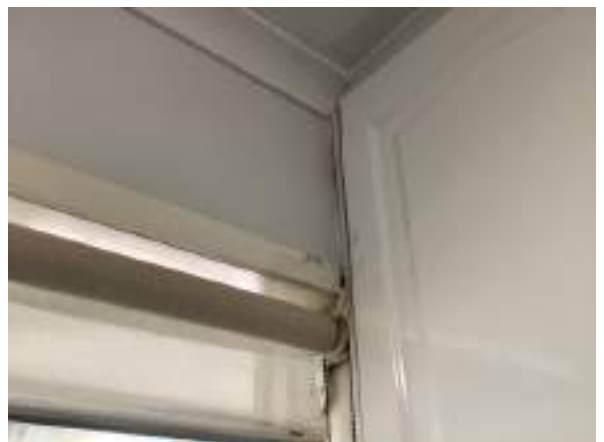
3.09

Location: Internal Areas

These Defects are of Sub Standard Workmanship or Incomplete and not finished to a tradesmens like manner.

There are areas that have been repaired as for example in bedroom 4 and the laundry and the toilet adjacent to bedroom 4. These areas appear to have repaired for some reason and the workmanship is substandard including the plasterwork and timber work.

It is unknown as to why these repairs have taken place, and may require further investigation at your discretion, possibly by a registered builder.

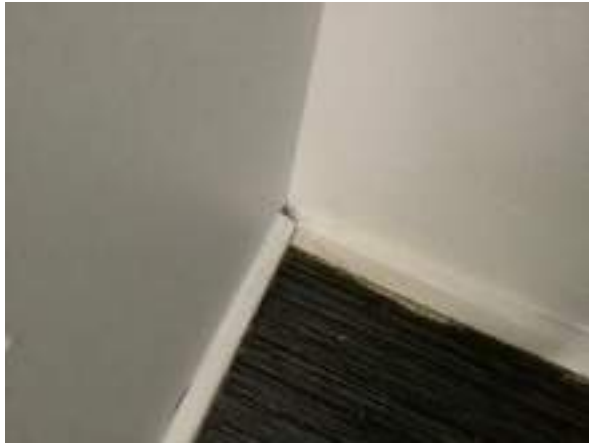
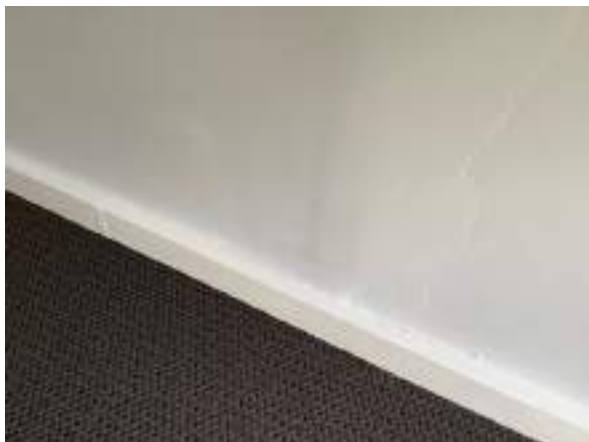
3.10

Location: Paint Internal Areas

Finding: Paint & Plaster Defects To Doors, Architraves, Walls & Ceilings, ETC.
It appears that the building has had a re paint or at least painted in areas.
There is the possibility that some or many cracks in the plaster or solid plaster may have been covered up and/or repaired, due to the selling of the home ?
There is always the possibility that the cracks in part or full will come back if the repairs have not been professionally done AND/OR the home has movement and/or subsidence continuing to the property.

Superficial scuff marks, damaged plaster, holes in walls,missing paint,sub-standard paint work were noted to the internal walls / ceilings and/or architraves as per the photos attached at the time of inspection.

While these minor defects are detracting from the overall appearance of the affected building element, they do not indicate any operational or structural damage.
This degree of surface damage is consistent with general damage, accidents, movement and wear and tear.

These type of minor defects are appearance cosmetics but they can also lead to the development of secondary building defects over time.

Incomplete areas of paint finish, holes in plaster, exposes the area to moisture, potentially accelerating the deterioration of underlying building materials especially in wet areas such as laundrys and bathrooms.

Superficial scuff marks, damaged plaster, holes in walls,missing paint,sub-standard paint work should be sanded back, filled, levelled and painted, as applicable. Where inadequate or missing protection has led to the deterioration of the associated building element, repair and/or replacement of this building element may be required.

A painting contractor,builder, plasterer and/or suitable handy person may be appointed to perform necessary works to aid the appearance of the affected area and to ensure the area is protected against further deterioration.

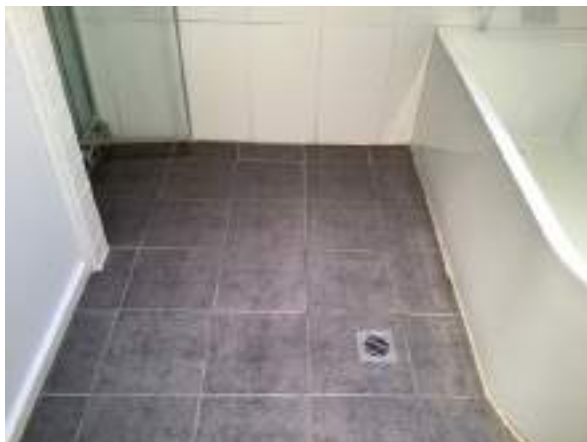
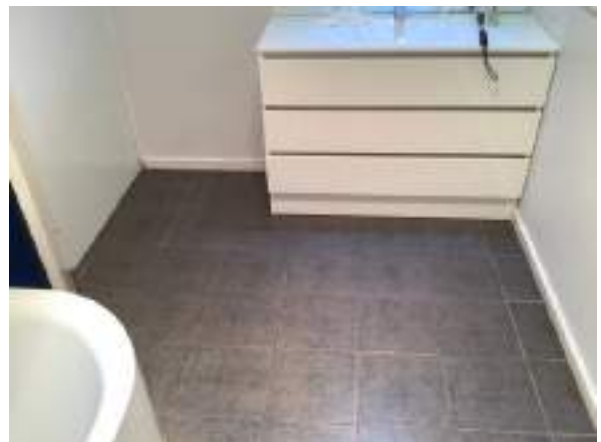
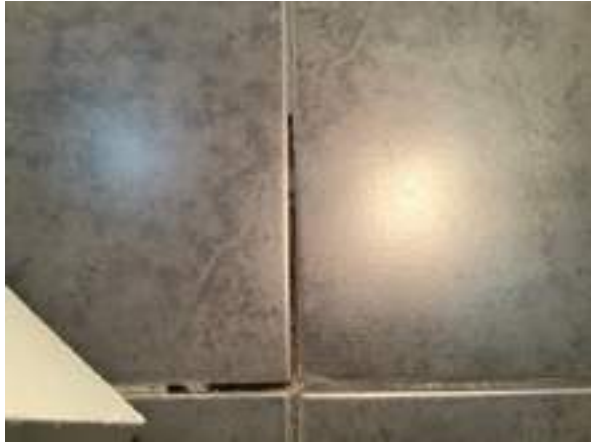
3.13

Location: Bathroom

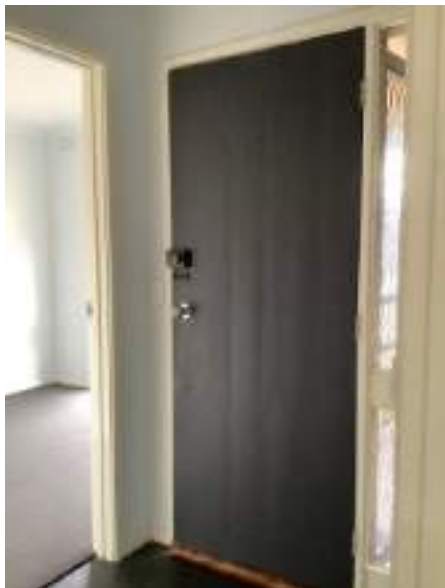
3.14

Location: Entry Hallway

This defect inhibits the functionality of the affected door as well as creating potential for secondary defects to associated building elements, such as damage to the floor covering.

A door that binds to flooring or to the associated door frame may have several causes, ranging from minor defects, such as poor installation of the door or deteriorated hinges, through to major structural issues, such as damage and/or subsidence (sinking) to subfloor structures.

For minor causes, a qualified carpenter or general handyperson should be appointed to perform minor rectification works at client discretion.

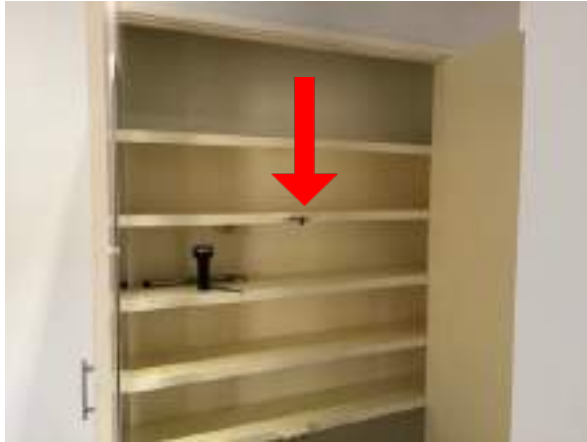
3.15

Location: Hallway

Finding: Door - Broken handle/latch

The door handle/latch in this area was found to be broken at the time of inspection. Replacement of the broken door handle is advised to improve the operational state of the associated door. A qualified carpenter or general handyman should be appointed to replace the door handle at the client's discretion.

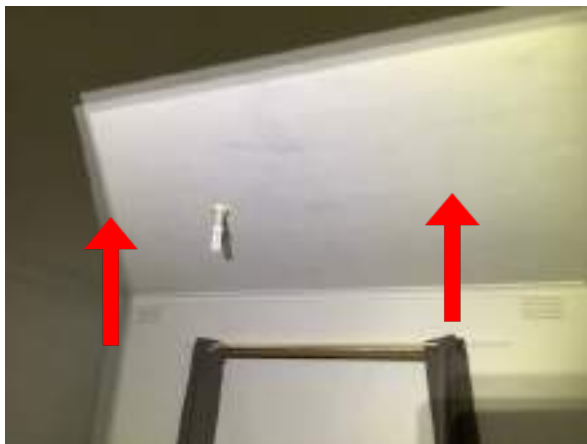
3.16

Location: Bedroom 2

Finding: Plaster & Timber Cracking - Damage Category 2 - Noticeable (up to 5mm)
Whilst we may have a photo of damaged paint, or a minor plaster cracking, etc, there may be many more paint/plaster defects and plaster cracking in other areas throughout the property.

Noticeable cracks are a common occurrence as a result of many primary defects. Such causes may include age, general wear and tear, expected building movement, general expansion/contraction of building materials in different weather conditions, and/or minor failings in the installation or application of building materials.

Noticeable cracks may result in minor sticking or jamming of associated doors and windows, which require easement. However, noticeable cracks are easily filled and repaired. A plasterer can be consulted to install an expansion joint at this point to allow for this movement during different weather conditions.

Monitoring of all cracking should be conducted frequently. Always contact a building inspector should cracks widen, lengthen, or become more numerous. Additionally, your building inspector should also be contacted if associated building elements such as doors and windows become more difficult to operate over time.

Relevant tradespeople, such as carpenters, painters and plasterers, should be appointed to perform remedial works, as deemed necessary.

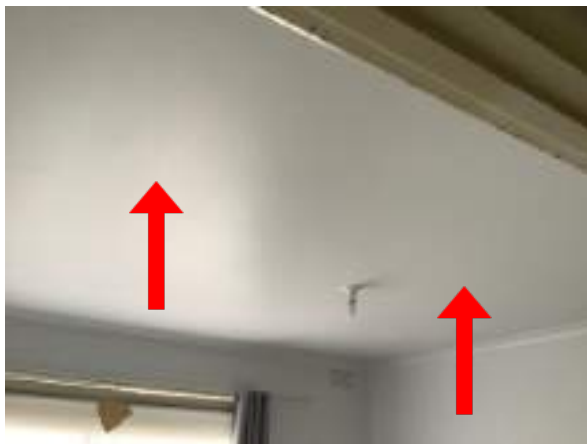
3.17

Location: Bedroom 3

Finding: Plaster & Timber Cracking - Damage Category 2 - Noticeable (up to 5mm)
Whilst we may have a photo of damaged paint, or a minor plaster cracking, etc, there may be many more paint/plaster defects and plaster cracking in other areas throughout the property.

Noticeable cracks are a common occurrence as a result of many primary defects. Such causes may include age, general wear and tear, expected building movement, general expansion/contraction of building materials in different weather conditions, and/or minor failings in the installation or application of building materials.

Noticeable cracks may result in minor sticking or jamming of associated doors and windows, which require easement. However, noticeable cracks are easily filled and repaired. A plasterer can be consulted to install an expansion joint at this point to allow for this movement during different weather conditions.

Monitoring of all cracking should be conducted frequently. Always contact a building inspector should cracks widen, lengthen, or become more numerous. Additionally, your building inspector should also be contacted if associated building elements such as doors and windows become more difficult to operate over time.

Relevant tradespeople, such as carpenters, painters and plasterers, should be appointed to perform remedial works, as deemed necessary.

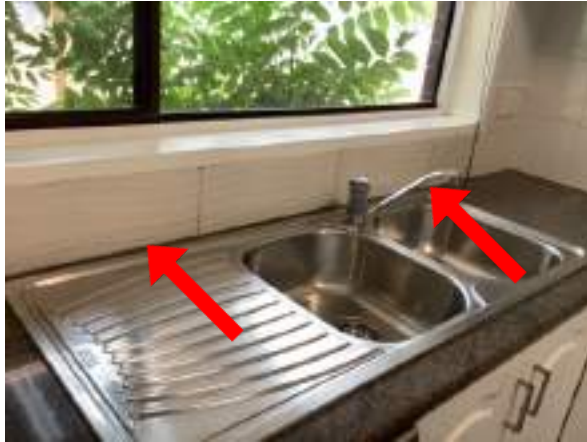
3.18

Location: Kitchen

Finding: Silicon / Caulking To All Wet Area Junctions and Tile Grouting - Missing or Damaged.
It was noted on inspection that sealant and/or tile grout is missing, damaged or inadequate to the tiled wet areas. This may include floor edges, kitchen benches/splashbacks, vanities, bath tub edges, shower areas to the floor and wall tiles, laundry's and all other areas subjected to water or moisture.

Sealant and/or tile grout where missing, damaged or inadequate to the tiled wet areas allows the water to penetrate into the walls and floors which can cause much damage, to the affect were the damage may become a secondary defect and create a conducive environment for termites and/or cause rotting to the timber studs, floor joists and bearers or plaster etc, especially in showers, baths, laundry and the like

Different materials and floor areas move at different rates, generally causing cracking to grout at this point.

Whilst in some of the areas there is sealant/silicon , it has become apparent that the sealant has deteriorated and/or is just missing.

Whilst in some of the tile mortar is perfect , it has become apparent that the tile mortar has deteriorated and/or is just missing in other areas.

A flexible sealant/silicon and tile mortar should be applied to affected areas to prevent any subsequent water damage that is likely to occur.

Regular maintenance and replacement of damaged or missing sealant and tile mortar is highly recommended to the wet areas, as this is a regular wear and tear defect. Sealant and grouting in areas that come into regular contact with water should be maintained for the long term care of the building in the areas required as water damage is one of the main defects in a building that causes the most damage and without sealant and tile grout always being perfect, secondary defects or secondary damages can start instantly.

A sealant specialist, tiling contractor and/or registered builder should be appointed to assess any damage caused by water to the entire internal, sub-floor, walls etc of the building and clean, take off old sealant and tile mortar, then re-seal and re-mortar these works as soon as possible.

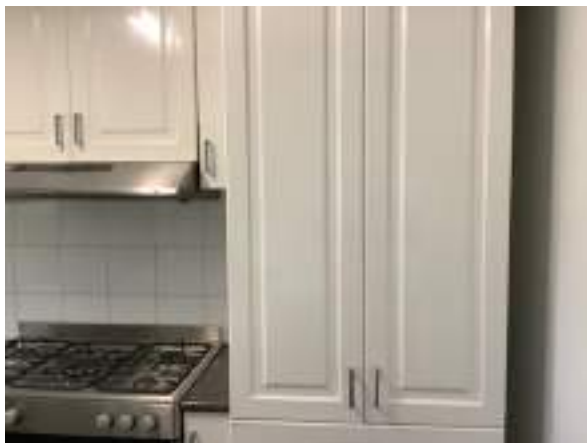
3.19

Location: Kitchen

Finding: Cabinetry - Loose hinges / Re-adjustment
Several cupboard / wardrobe doors are not level and detract from the operational state of the cabinetry and doors.
Upon further inspection, it was noted that the hinges to the cupboard doors have deteriorated or just need adjustment. This as a result over time that they have just come loose or deteriorated from their original fixing.

To improve operation of the affected doors, a general handyman / cabinetmaker/ carpenter may be appointed to replace the faulty hinges and/or adjust .

Such works should be completed at the discretion of the client, but we do recommend repairs so that there is no further damages to the existing cabinets or cupboards.

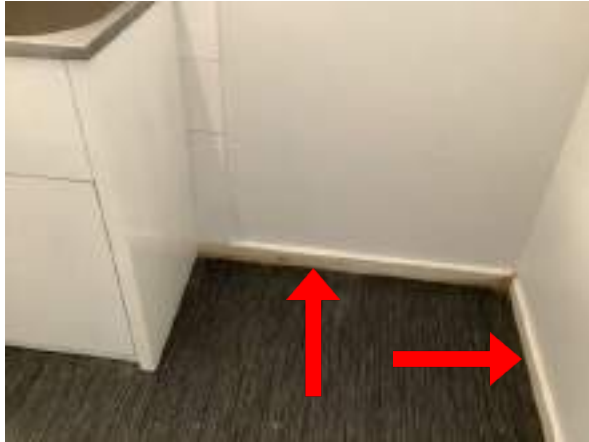
3.20

Location: Laundry

Finding: Silicon / Caulking To All Wet Area Junctions and Tile Grouting - Missing or Damaged.
It was noted on inspection that sealant and/or tile grout is missing, damaged or inadequate to the tiled wet areas. This may include floor edges, kitchen benches/splashbacks, vanities, bath tub edges, shower areas to the floor and wall tiles, laundry's and all other areas subjected to water or moisture.

Sealant and/or tile grout where missing, damaged or inadequate to the tiled wet areas allows the water to penetrate into the walls and floors which can cause much damage, to the affect were the damage may become a secondary defect and create a conducive environment for termites and/or cause rotting to the timber studs, floor joists and bearers or plaster etc, especially in showers, baths, laundry and the like

Different materials and floor areas move at different rates, generally causing cracking to grout at this point.

Whilst in some of the areas there is sealant/silicon , it has become apparent that the sealant has deteriorated and/or is just missing.

A flexible sealant/silicon and tile mortar should be applied to affected areas to prevent any subsequent water damage that is likely to occur.

Regular maintenance and replacement of damaged or missing sealant and tile mortar is highly recommended to the wet areas, as this is a regular wear and tear defect. Sealant and grouting in areas that come into regular contact with water should be maintained for the long term care of the building in the areas required as water damage is one of the main defects in a building that causes the most damage and without sealant and tile grout always being perfect, secondary defects or secondary damages can start instantly.

A sealant specialist, tiling contractor and/or registered builder should be appointed to assess any damage caused by water to the entire internal, sub-floor, walls etc of the building and clean, take off old sealant and tile mortar, then re-seal and re-mortar these works as soon as possible.

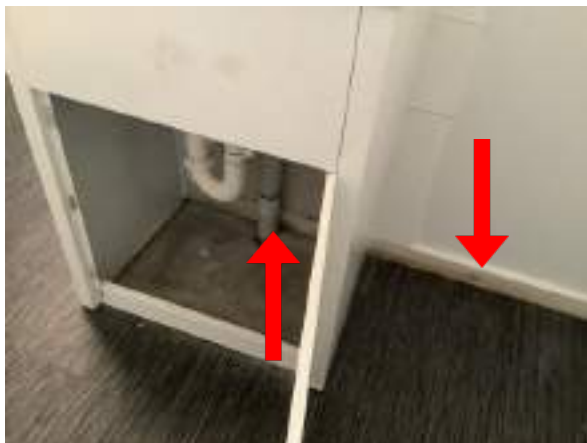
3.21

Location: Laundry

Finding: Water Staining - Damaged Materials.
Water staining was evident in this area or areas at the time of inspection.

Conversely, where water staining is old and inactive, affected building materials may be repaired or replaced at client discretion only if the damage is cosmetic though.

It is important to identify the correct professional to perform these works, pending on each situation on how minor or major it has become.

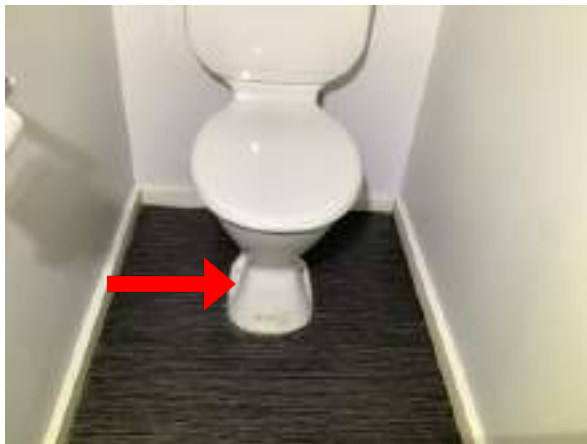
3.22

Location: Both Toilets

It is recommended that the toilet pan be refixed to the floor with concrete , fixing screws or silicone and/or a combination of two elements of fixing mentioned .

Works are to be carried out by a licensed plumbing contractor.

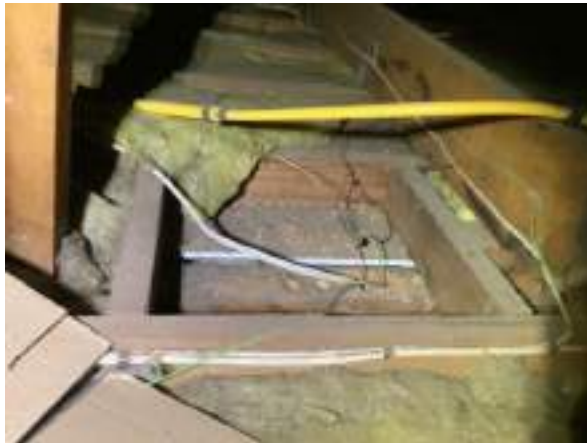
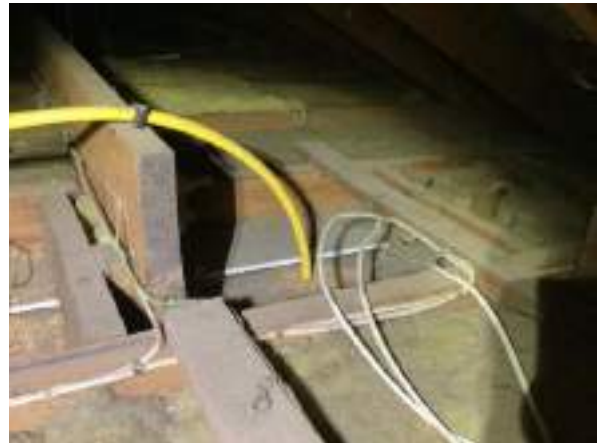
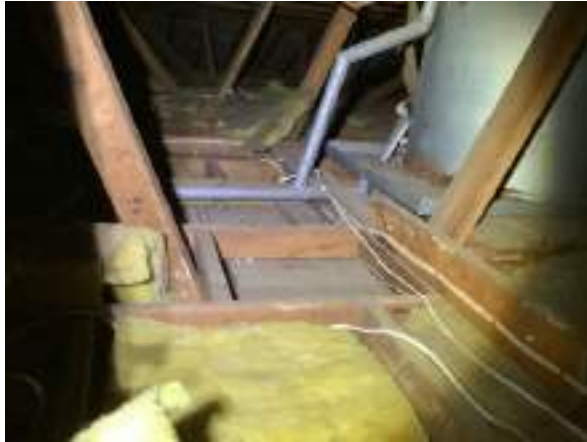
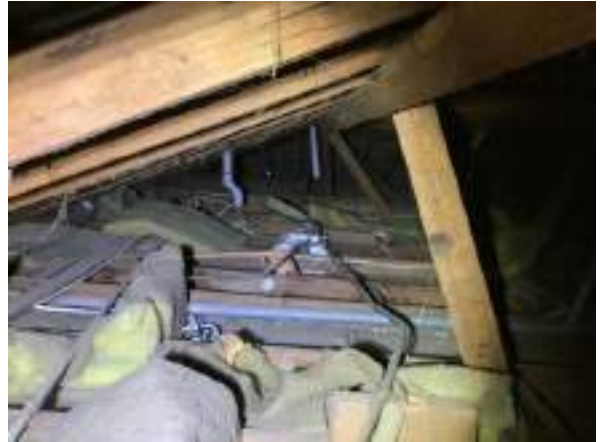
3.26

Location: Roof Space

Caution should be exercised when accessing the roof void. Do not attempt to stand on the framework to the underside of the trusses and be aware there is a potential for electric shock if contact is made with exposed or faulty electrical wiring.

Installation of adequate insulation is required according to Australian Standards and should be conducted as soon as possible.

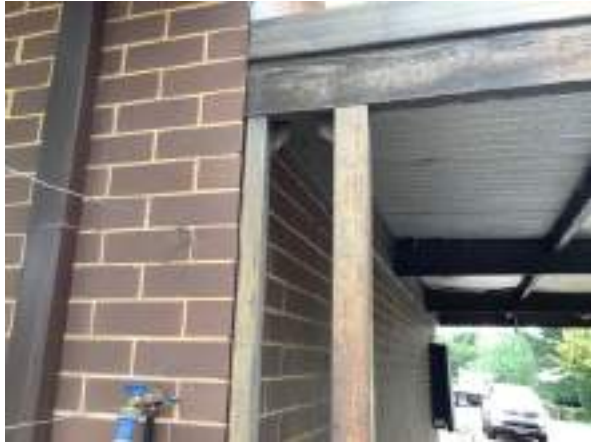
3.27

Location: External Areas

Rusting and corrosion should be managed by ideally removing or limiting the affected surface from exposure to moisture.

A registered builder may be appointed to replace any building elements that have been severely affected by rust or water damage.

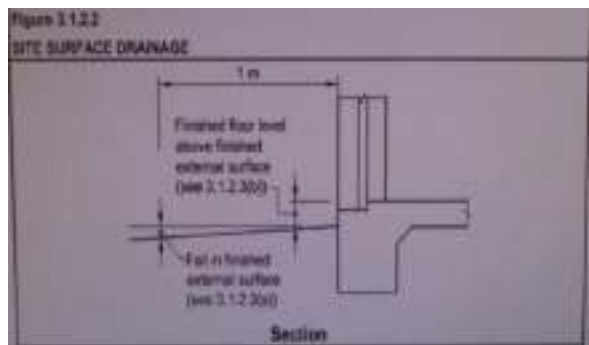
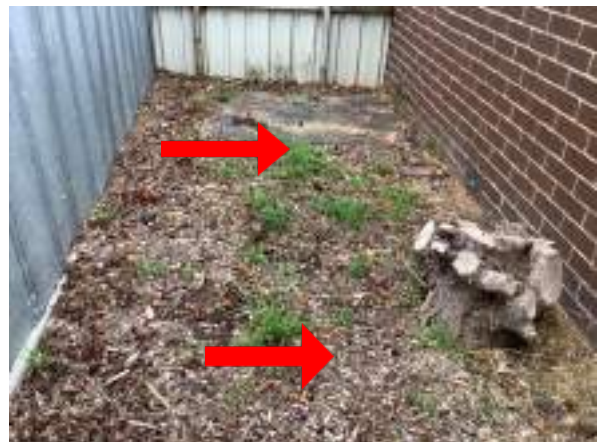
3.28

Location: Perimeter Of Building - Exterior

- (a) Slab-on-ground — finished ground level adjacent to buildings:
the external finished surface surrounding the slab must be drained to move surface water away from the building and graded to give a slope of not less than
- (i) 25 mm over the first 1 m from the building in low rainfall intensity areas for surfaces that are reasonably impermeable (such as concrete or clay paving) or
 - (ii) 50 mm over the first 1 m from the building in any other case.
- (b) Slab-on-ground — finished slab heights:
the height of the slab-on-ground above external finished surfaces must be not less than
- (i) 100 mm above the finished ground level in low rainfall intensity areas or sandy, well-drained areas; or
 - (ii) 50 mm above impermeable (paved or concreted areas) that slope away from the building in accordance with (a); or
 - (iii) 150 mm in any other case.

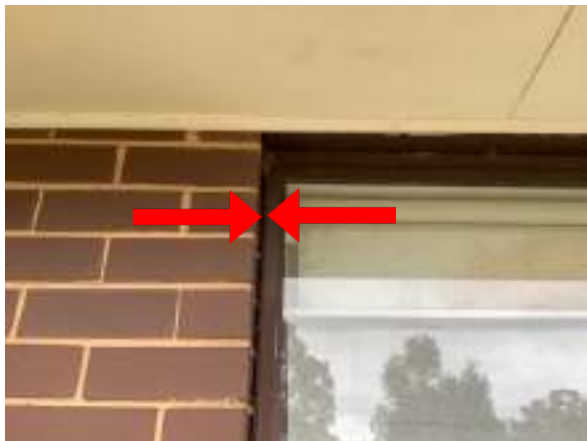
3.29

Location: Perimeter Of Building - Exterior

It is important to note once caulking these areas if water damage is noticeable to windows, timbers, etc, such as wood rott, it is imperative to engage the appropriate trades for replacement or repairs.

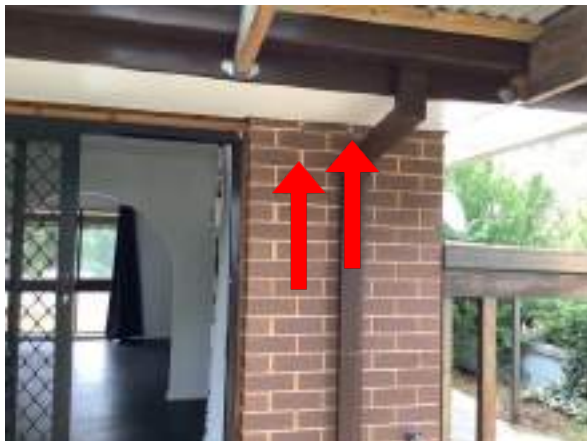
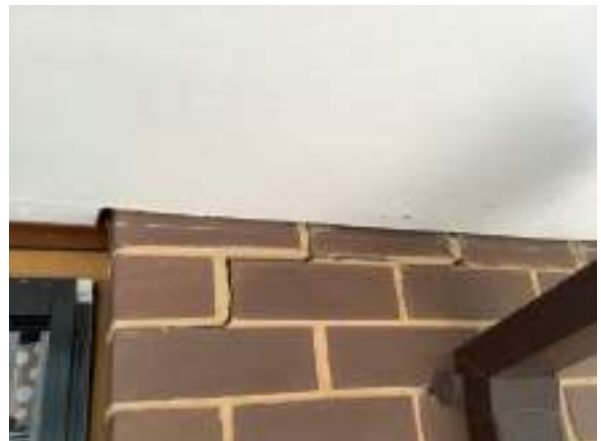
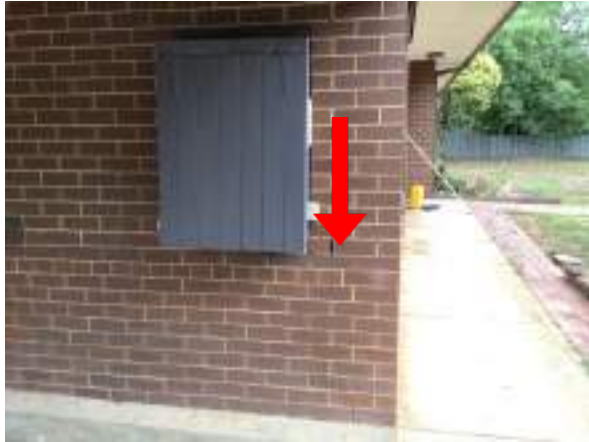
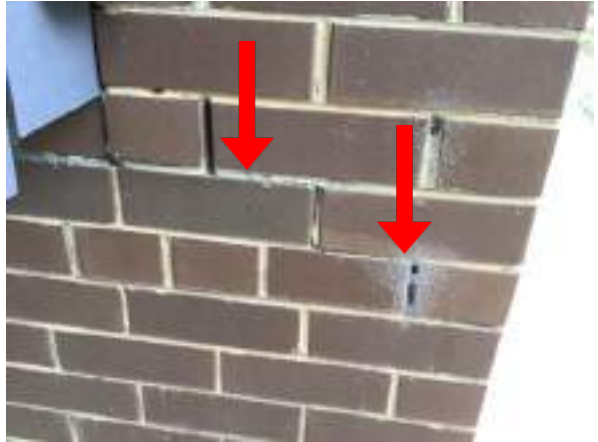
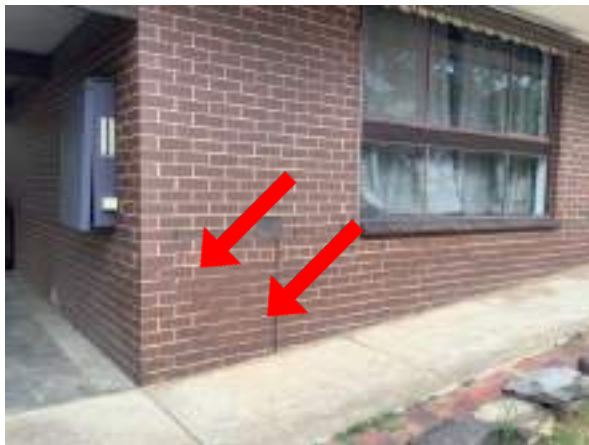
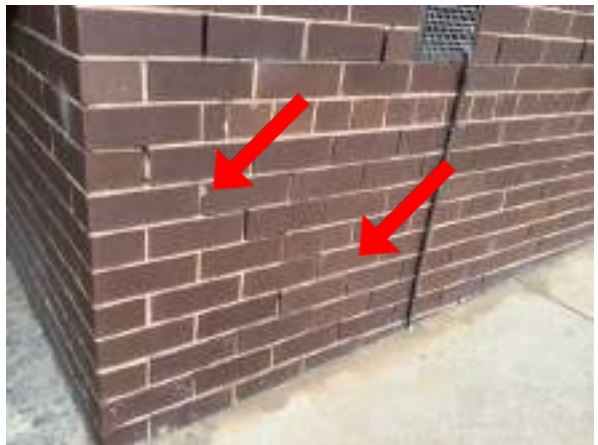
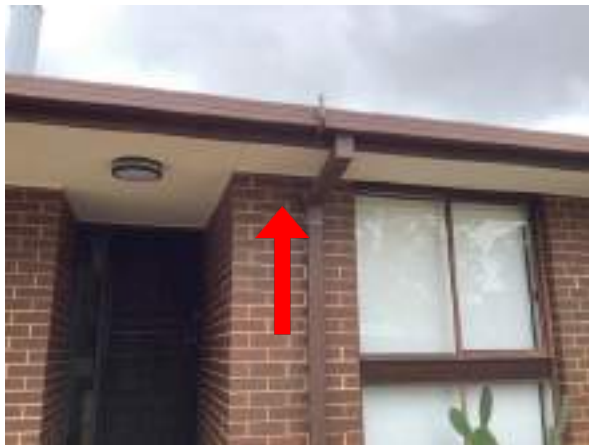
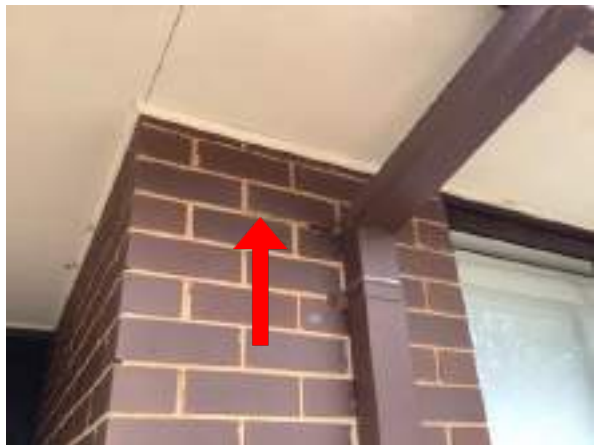
3.30

Location: Brickwork - All Areas

Always contact a building inspector should cracks widen lengthen or become more numerous.

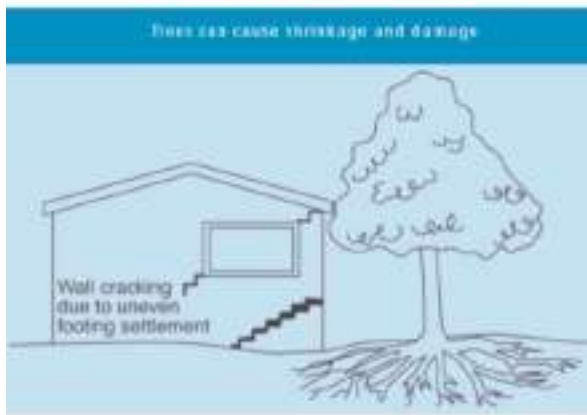
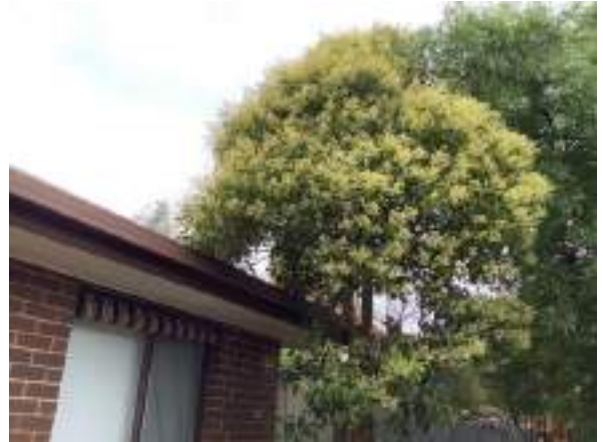
3.32

Location: Garden Areas - All Areas

Finding: Garden trees - Overhanging and filling gutters
PLEASE NOTICE THE ATTACHMENT PICTURES TO THIS DEFECT STATEMENT;
H = the height of the tree at its full potential height, not its height today.
D = the distance from the tree to the building at the trees full potential height.
D = varies pending on one tree to 4 trees or more.

Gutters are a critical part of the building's management of storm water and rain. It is therefore important that they be kept clear to prevent secondary damage to associated building elements, including exterior and interior walls, ceiling linings and any adjoining building elements. Where gutters are blocked, pooling of rainwater is likely to occur, fast-tracking rust and corrosion of the roof plumbing elements.

It is highly advised that all overhanging tree branches be removed as soon as possible to prevent any further damage. Repair and/or replacement of sections of damaged guttering may also be required where the extent of the damage necessitates.

Such works should be performed by the homeowner; however, appointment of a landscape contractor or an arborist may be required. Consultation with a licensed roof plumber is required where guttering has been damaged.
