Building & Termite, Timber, Asbestos Pest Report

Inspection Date: 15 Feb 2020

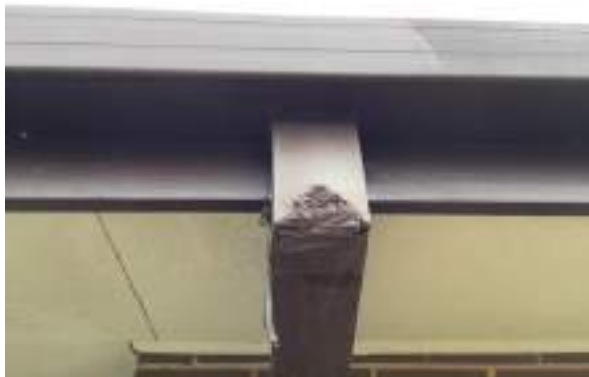
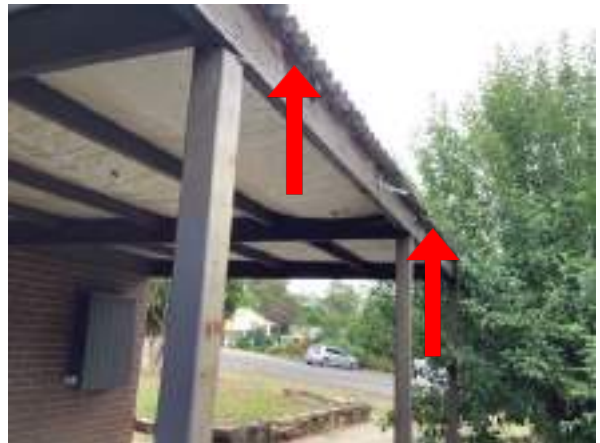
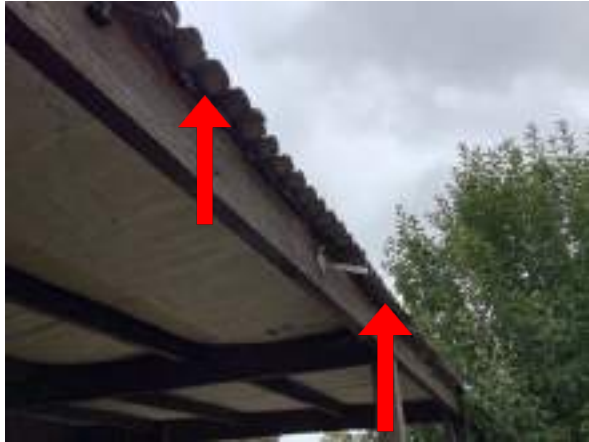
3.33

Location: Roof / Gutters / Downpipes - All Areas

Finding: Roof Sheetting, Flashing & Gutters - Rusted or Corroded

The roof plumbing has areas of rust and corrosion. It is suspected that this has been caused by blockages, resulting in pooling or standing water, that have prematurely rusted elements of the roof plumbing or sometimes just age combined with premature excess water is also a factor.

Rusted roof plumbing will generally develop holes and leaks that can affect other building elements with poor drainage of storm water. Poorly drained roof areas will also lead to damp conditions surrounding the base perimeter of the building which, if left unmanaged, can lead to a range of secondary building defects, such as timber rott to the roof framing, etc.

Repair and/or replacement of rusted roof plumbing is highly required in order to reinstate the roof drainage system to a fully operational level. To further maintain these areas, gutters should be cleaned frequently, allowing the avoidance of any partial blockages.

A licensed plumber or specialist roof restoration company should be appointed to undertake these works. It is advised that such works be completed as soon as possible to prevent any further damage and deterioration.

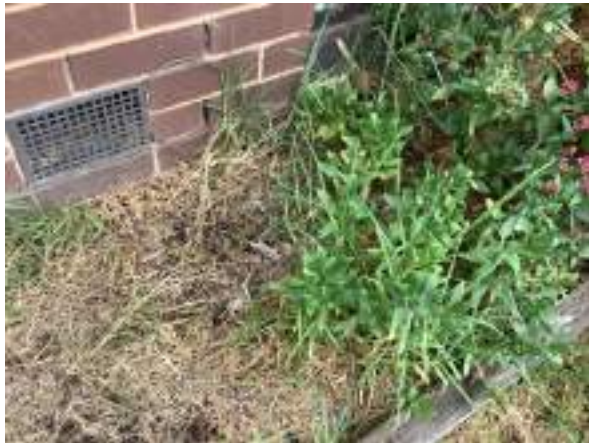
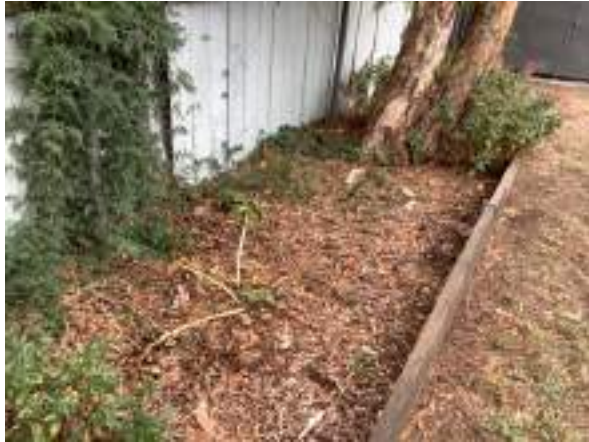
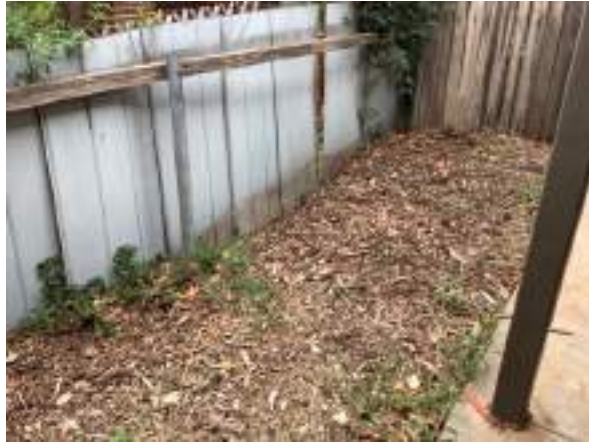
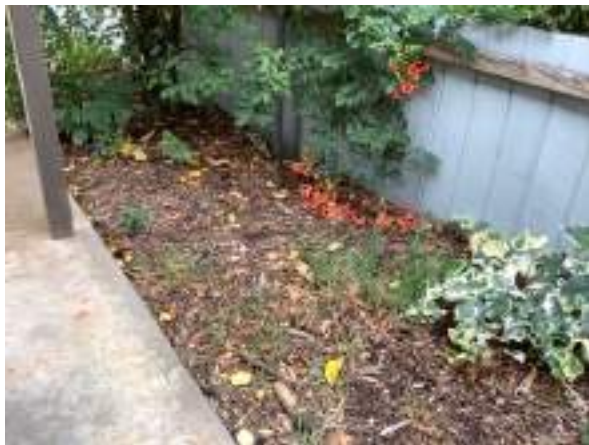
Finding: Garden Beds - Conditions Conducive to Termites
 Garden beds were found to be evident in areas of garden areas.
 These garden beds can include untreated timber, bark, excessive old vegetation and with a combination of moisture from watering hosing can make conditions very conducive to termite activity and termite ingress.
 It is always important to keep the garden beds as clean as possible and take out excess old bark from the trees, leaves and keep bark mulch to a minimum or better introduce rocks or some item that does not create an conducive environment for termites and hold excess moisture.

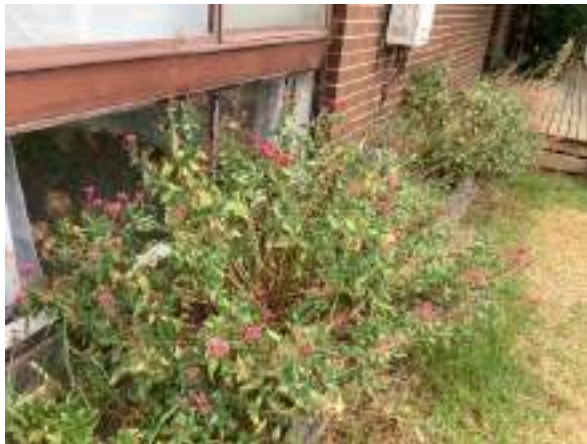
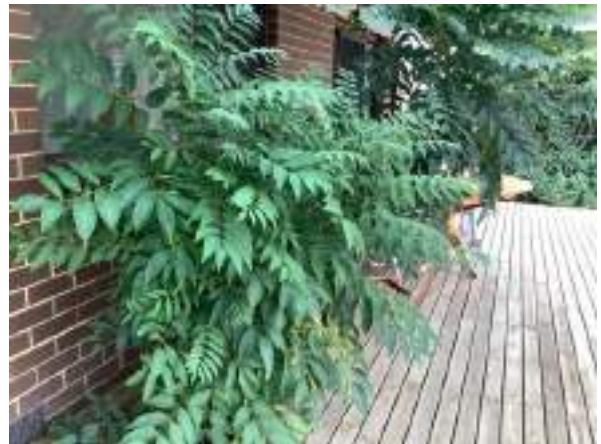
2.05

Location: Garden Areas - All Areas

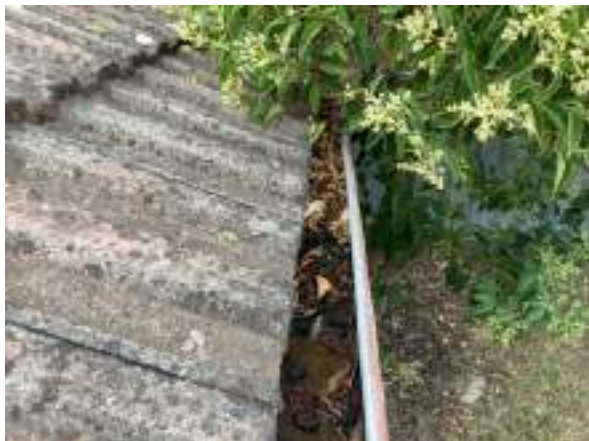
2.06

Location: Roof / Gutters / Downpipes - All Areas

Immediate clean up is required.

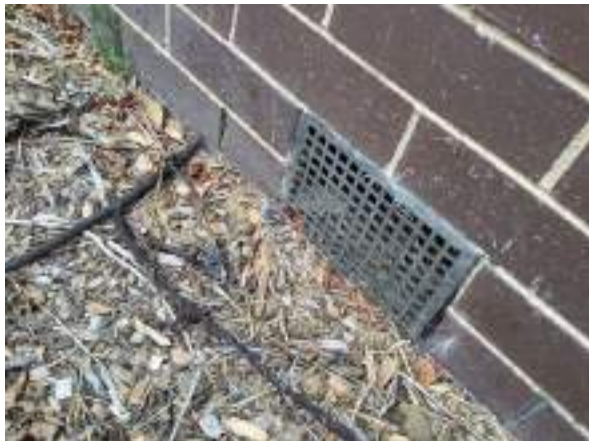
2.07

BRIDGING OR BREACHING OF TERMITE MANAGEMENT SYSTEMS AND INSPECTION ZONES

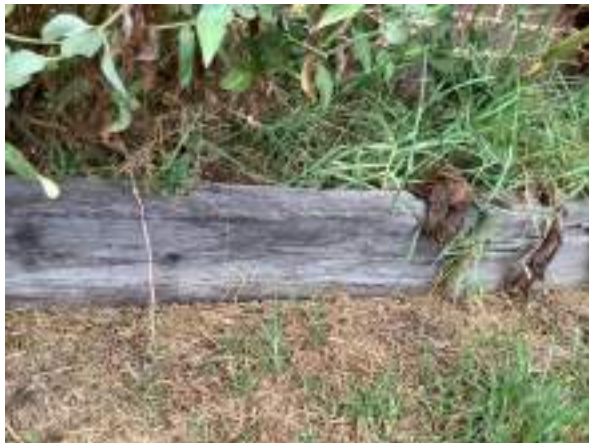
2.08

UNTREATED OR NON-DURABLE TIMBER USED IN A HAZARDOUS ENVIRONMENT

Remove untreated timber that is in direct contact with external grounds. Consider replacement with more durable materials i.e. treated timber or non timber elements.

Frequent pest inspections are advised to readily identify any termite activity in these areas.

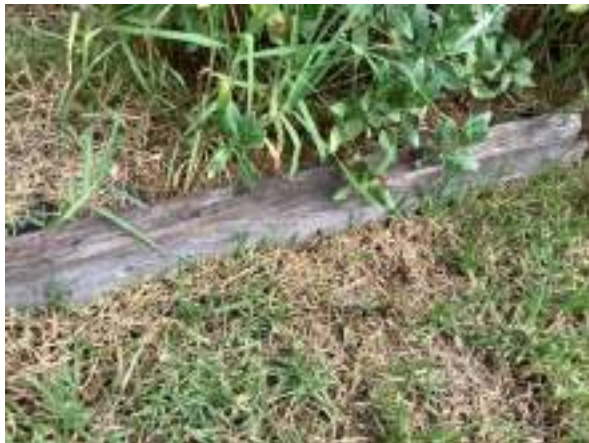
2.09

Location: Garden Areas - All Areas

Remove untreated timber that is in direct contact with external grounds. Consider replacement with more durable materials i.e. treated timber or non timber elements.

Frequent pest inspections are advised to readily identify any termite activity in these areas.

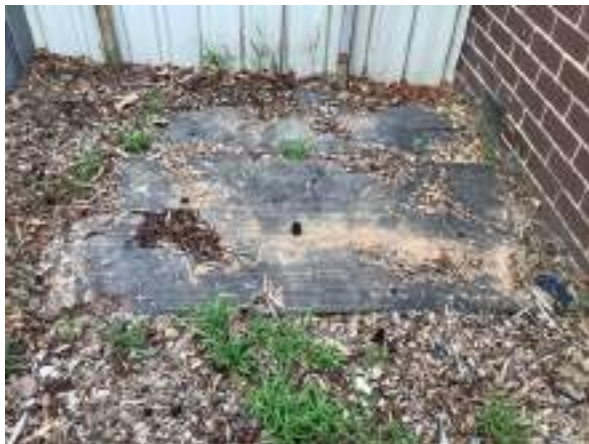
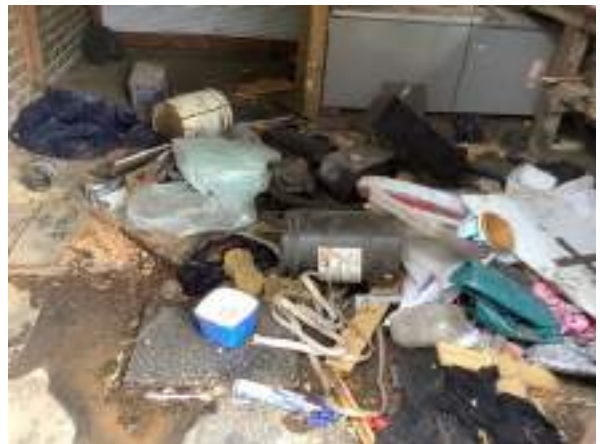
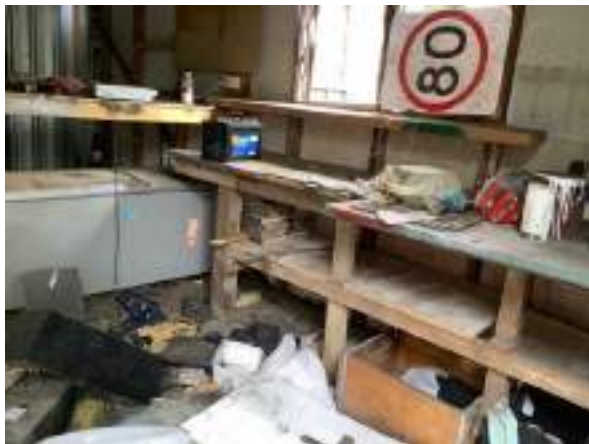
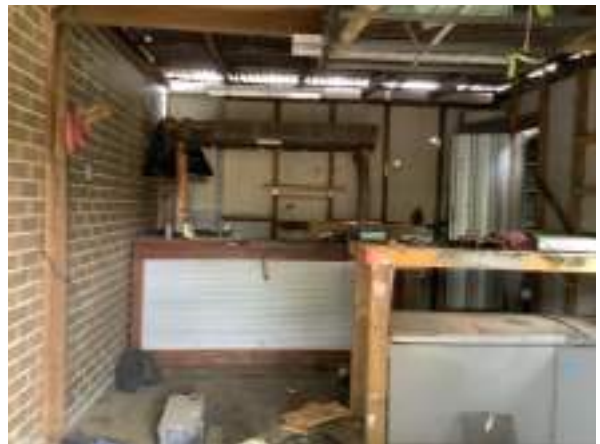
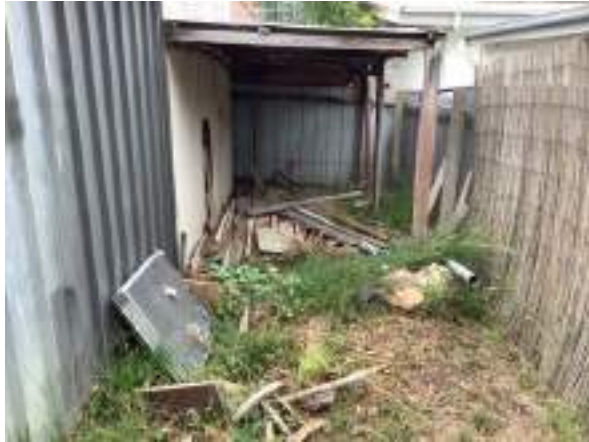
2.10

OTHER CONDITIONS CONDUCIVE TO TIMBER PEST ATTACK

It is highly recommended that any stored building materials or other materials be immediately removed from areas in which they may attract any termite / timber pest attack around the perimeter and/or sub floor areas of the dwelling and a re-inspection is carried out.

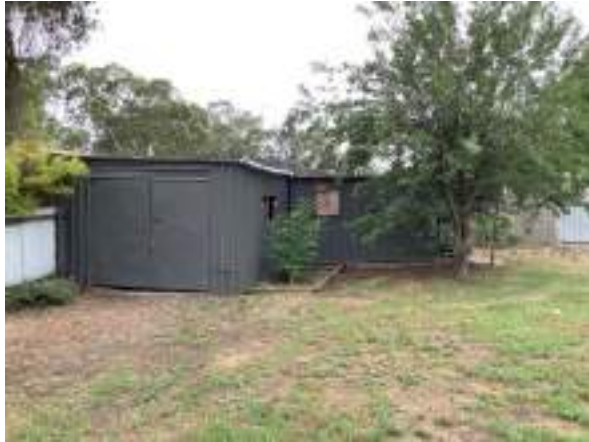
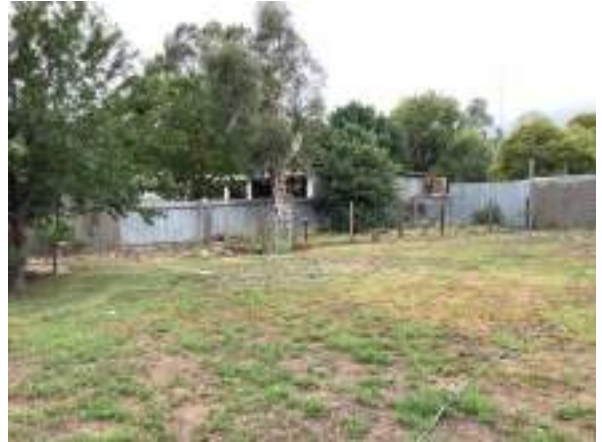
Location:	The Site
Finding:	General Site Photos & Compass General site photos and other areas of interest are provided for your general reference.

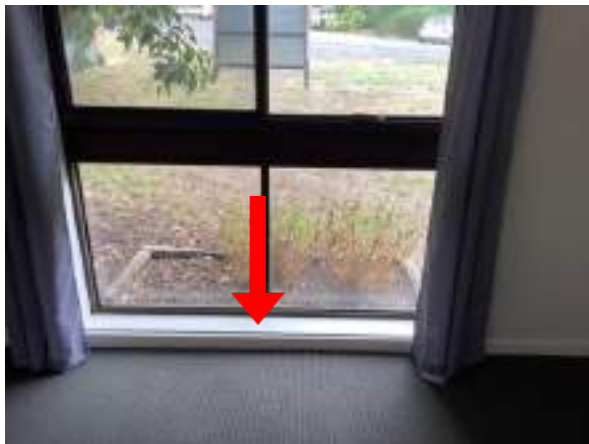
4.12

Location: Bedroom 2

Finding: Nail popping
Couple of nails are popping out in the window frame. This is generally due to timber shrinkage and is a minor repair. A handyman or carpenter can repair this item.

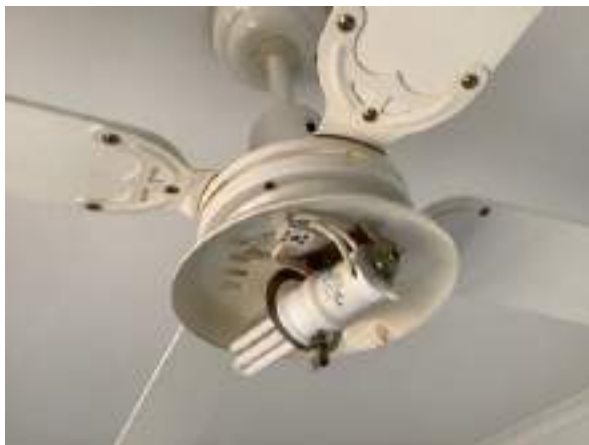
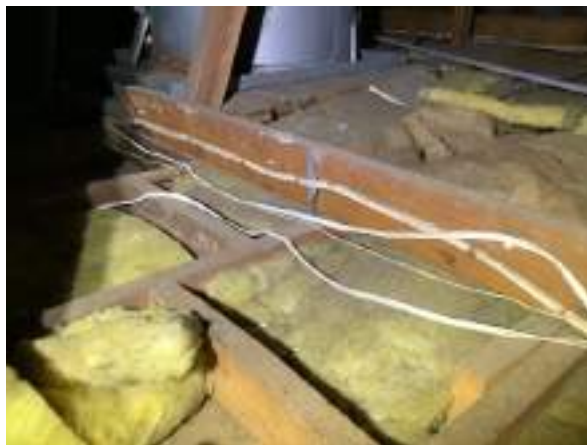
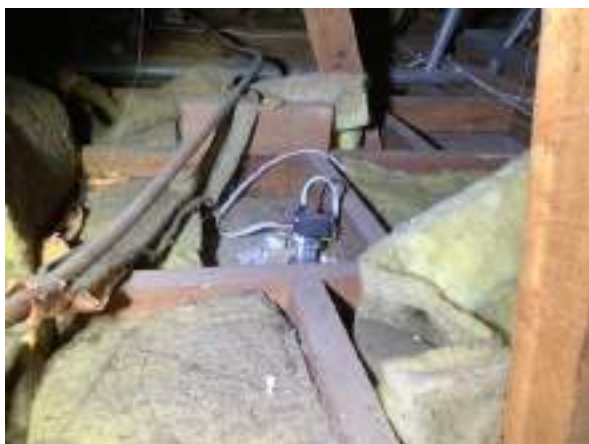
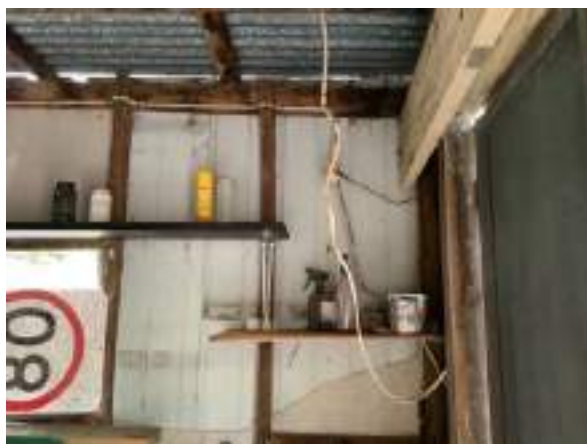
Finding: Electrical - Appears Defective.

I highly recommend that you engage a qualified electrician for a electrical inspection if you would like more information on the electrical.

Upon any electrical works the electrician must supply a safety certificate and also all works must comply with AS 3000.
