# Building/Termite/Electrical/ Asbestos/Digital Flooring

Inspection Date: 21 Jan 2020

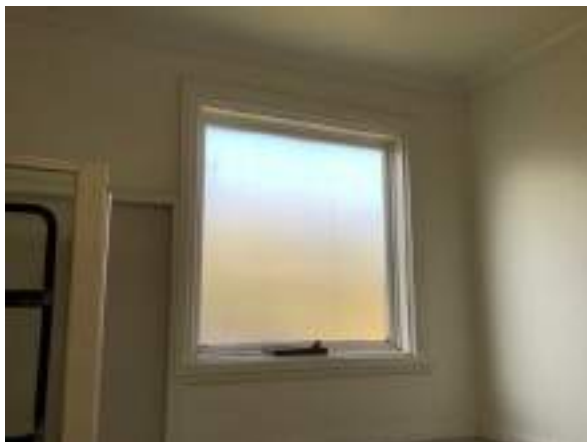
## 1.02

Location: Bathroom

Windows MUST function as a safety requirement and we HIGHLY RECOMMEND that you engage an appropriate professional as soon as possible to check all windows to the property.

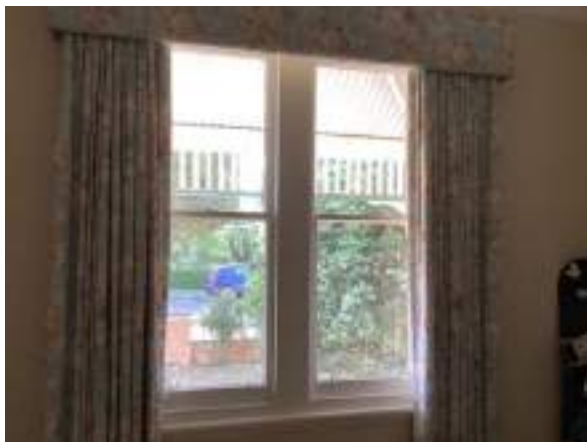
## 1.03

Location: Bedroom 3

Windows MUST function as a safety requirement and we HIGHLY RECOMMEND that you engage an appropriate professional as soon as possible to check all windows to the property.

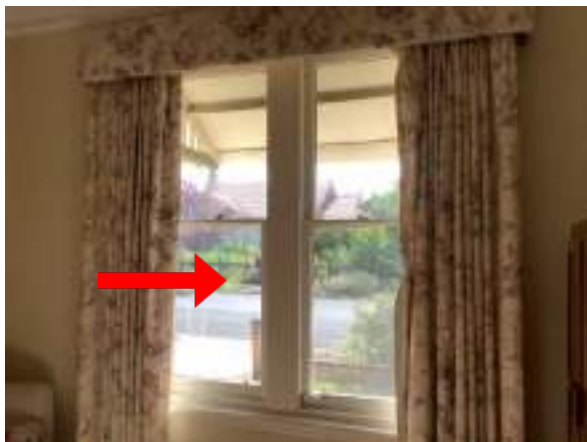
## 1.04

Location: Bedroom 1

Windows MUST function as a safety requirement and we HIGHLY RECOMMEND that you engage an appropriate professional as soon as possible to check all windows to the property.

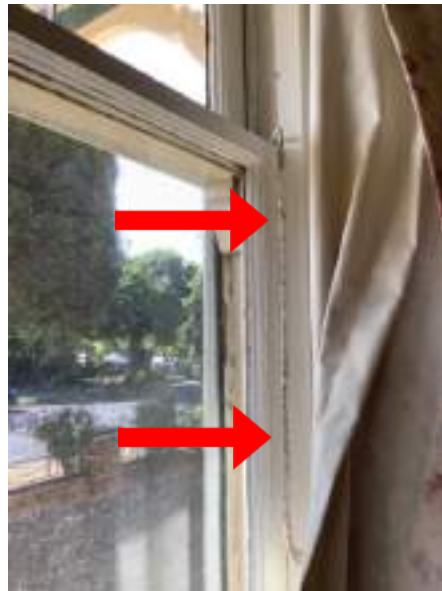
## 1.05

Location: Bedroom 1

Replacement of the handle /locks should be conducted as soon as possible. A general handy person, window manufacturer and/or service technician should be appointed to perform these works to improve the operational state of the affected window and improve the safety of the internal area.

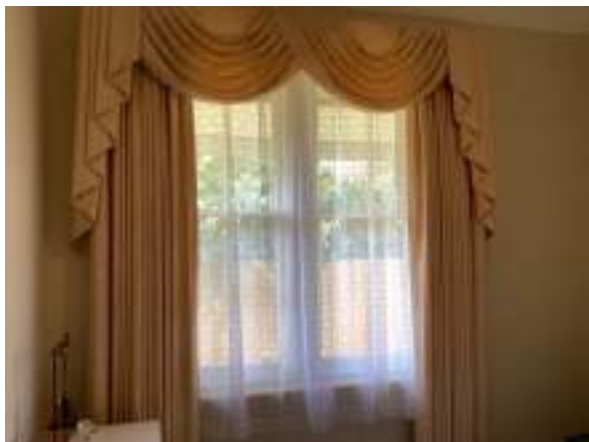
## 1.06

Location: Bedroom 2

Windows MUST function as a safety requirement and we HIGHLY RECOMMEND that you engage an appropriate professional as soon as possible to check all windows to the property.

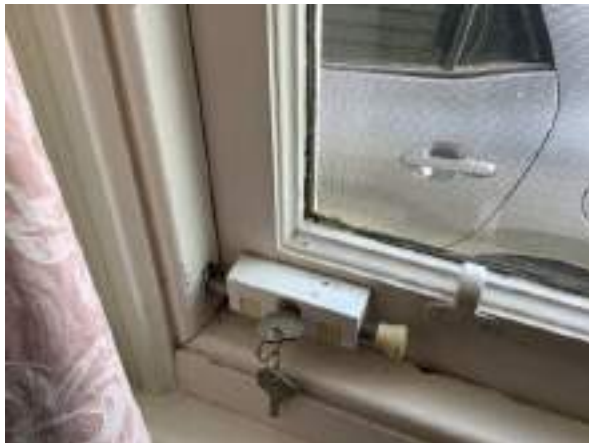
## 1.07

Location: Dining room

Replacement of the handle /locks should be conducted as soon as possible. A general handy person, window manufacturer and/or service technician should be appointed to perform these works to improve the operational state of the affected window and improve the safety of the internal area.

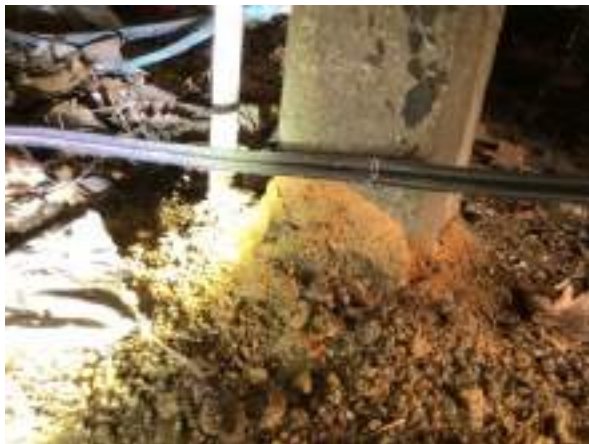
## 1.08

Location: Subfloor

Finally the cause or source of the mould MUST BE TAKEN CARE OF URGENTLY.

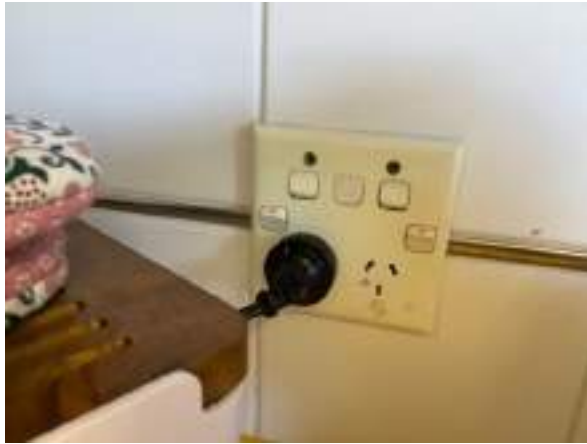
## 1.09

Location: Electrical - All Areas

Repair and/or replacement of the switches/power points is advised to ensure the fixture and it's associated structures are safe and fully operational. A licensed electrician should be appointed to repair/replace the light switches/power points as soon as possible.

Please engage a licensed electrician to further inspect the property for the repairs and replacements as required.

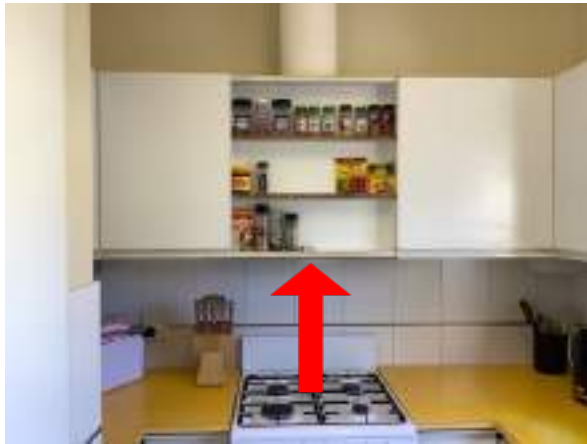
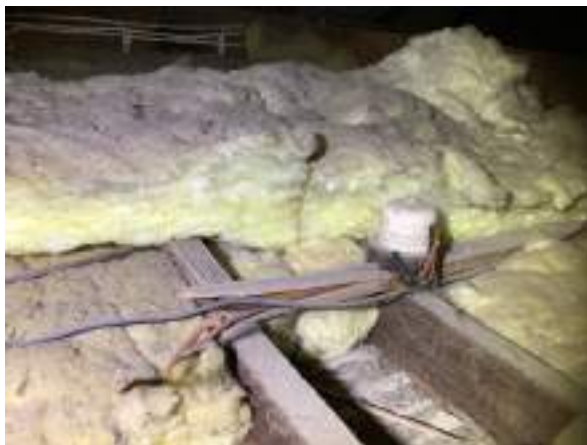
## 1.10

Location: Electrical - All Areas

-/// The kitchen make shift exhaust fan, does not comply with electrical safety standards and  
is a fire hazard.

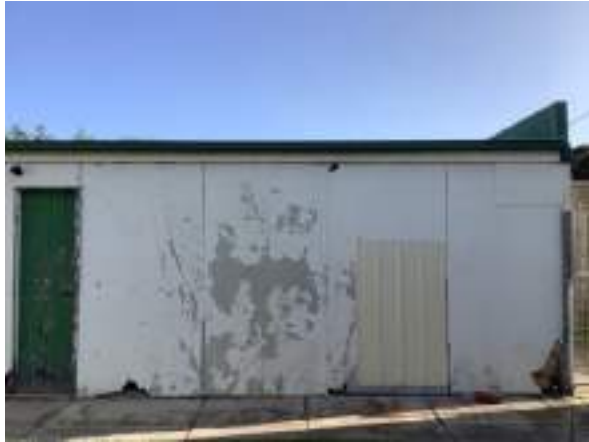
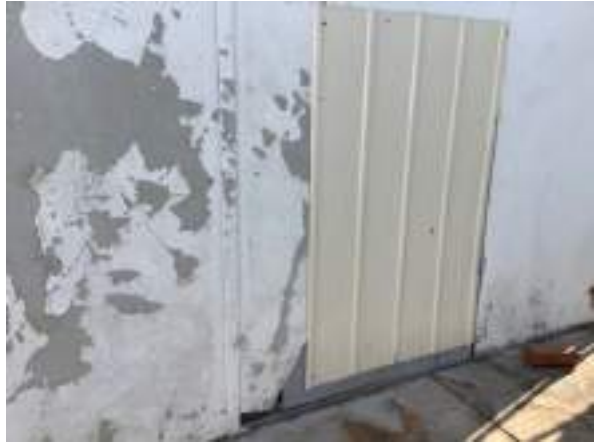
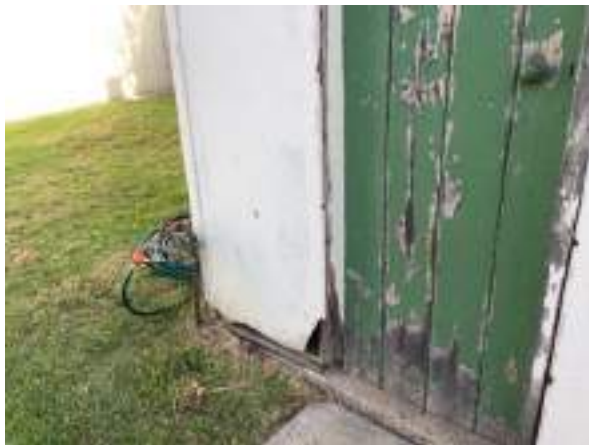
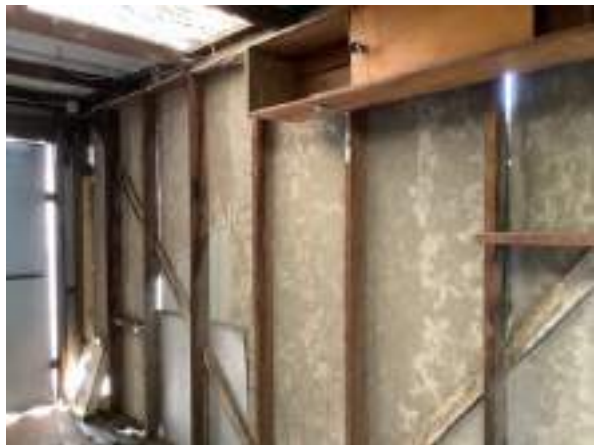
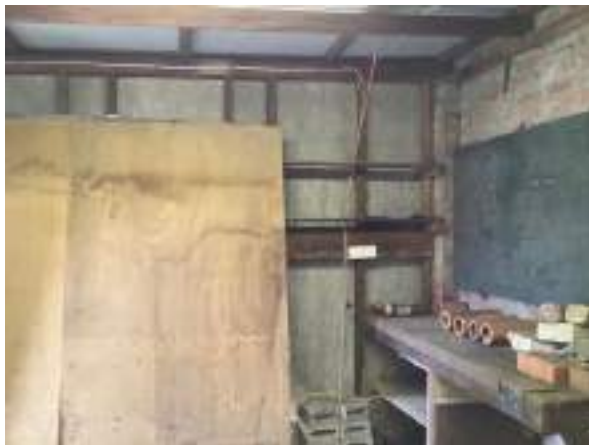
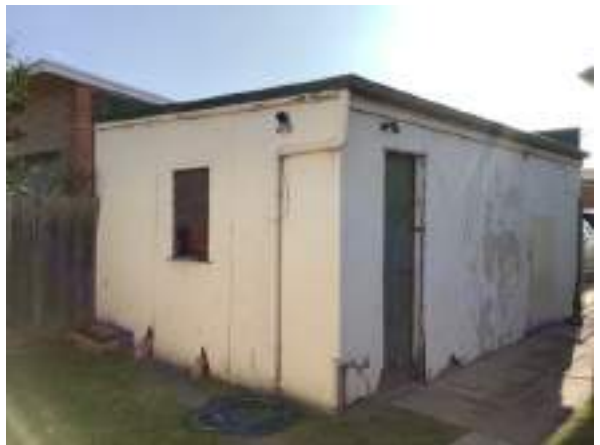
## 1.11

Location: Garage - Original

In the interim, the client is advised to act with caution, especially when considering any damage to building materials general wear and tear renovations extensions demolition and general maintenance activities due to the suspected presence of Asbestos.

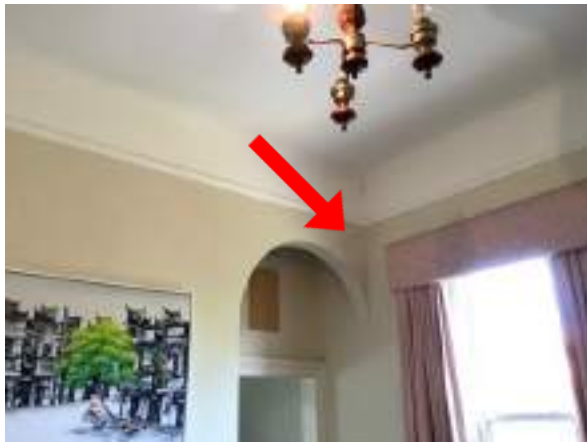
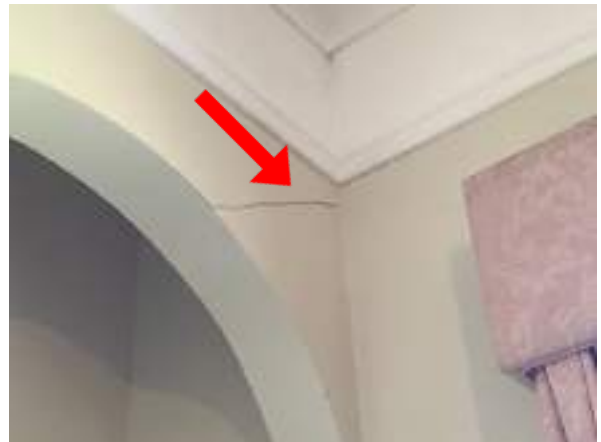
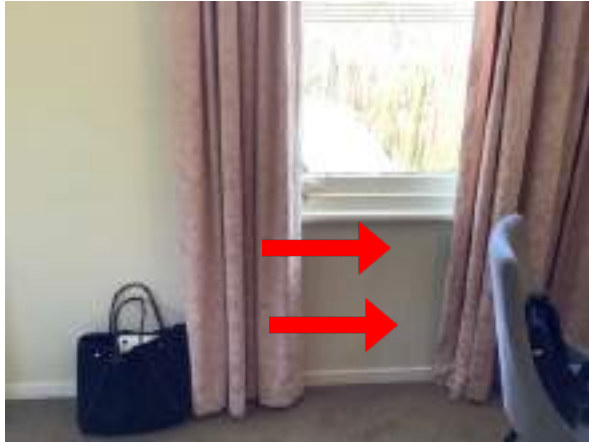
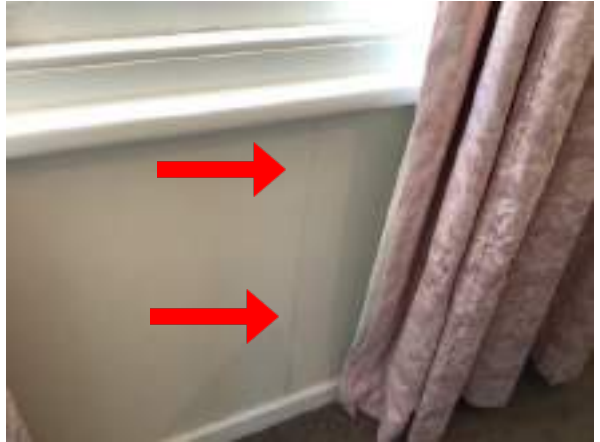
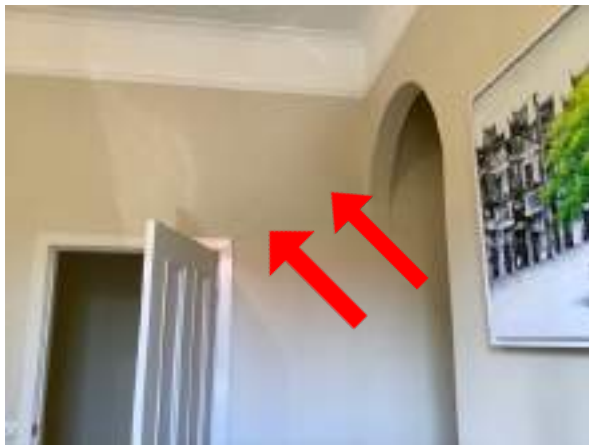
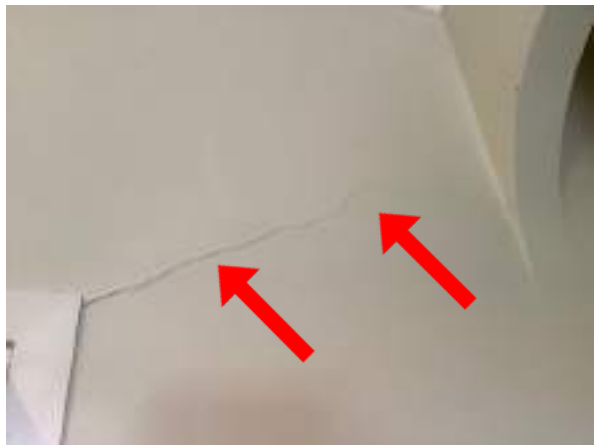
Finding: Plaster Cracking / Timber - Damage Category 3 - Repair Required (5mm-15mm or a grouping or cluster of cracks of 3mm or more)  
Whilst we may have a photo of damaged paint, or a minor plaster cracking, etc, there may be many more paint/plaster defects and plaster cracking in many more areas throughout the property.

Cracks of this type are likely to have been caused by minor, expected movement of building elements, but may also have a structural cause that is more significant. Cracking of this degree may result in doors and windows sticking or jamming, but may have more serious implications, such as fracturing service pipes. Weather tightness (the ability to resist rain and wind) is also often impaired, creating potential for the development of secondary defects.

A crack of this size may be repaired. However, these repairs may also include further works, such as easement of associated window and door frames that are jamming, as well as more extensive filling, sanding and/or repainting.

It is highly recommended to gain quotations on repair and restoration works that are required. Always contact your building inspector should cracks widen, lengthen or become more numerous.

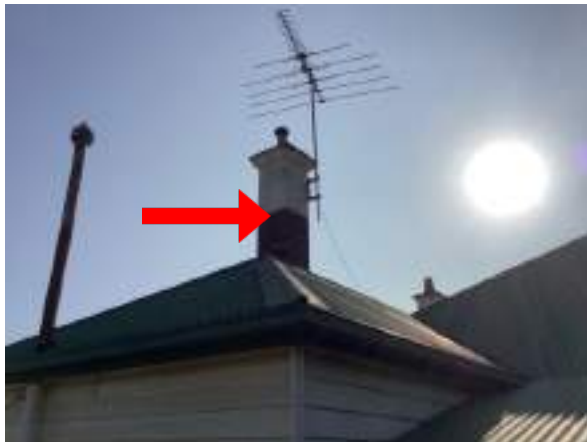
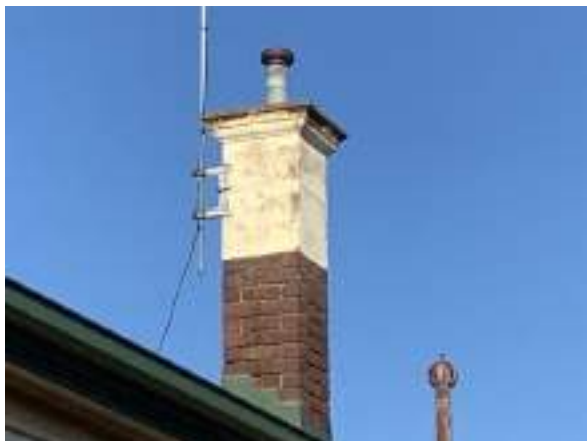
## 2.15

Finding: Brickwork - Deteriorated mortar  
Mortar, or 'bedding', is the material which fills joins and intersections between bricks in masonry walls and structures. Sections of mortar in this brickwork were identified as having deteriorated, which is generally expected for a property of this age and condition.

Mortar may deteriorate as a result of age of building materials, minor movement of bricks, or frequent exposure to weathering. Mortar should be replaced to ensure that bricks remain in their intended location and to prevent gaps, which would allow water or moisture ingress and secondary damage as a result.

Mortar deterioration can be addressed by a bricklayer where areas of deterioration are localised and easily accessible. Alternatively, appointment of a registered builder is advised, to repoint large areas of decaying mortar. Where secondary structural defects have become evident, consultation with a structural engineer may be required.

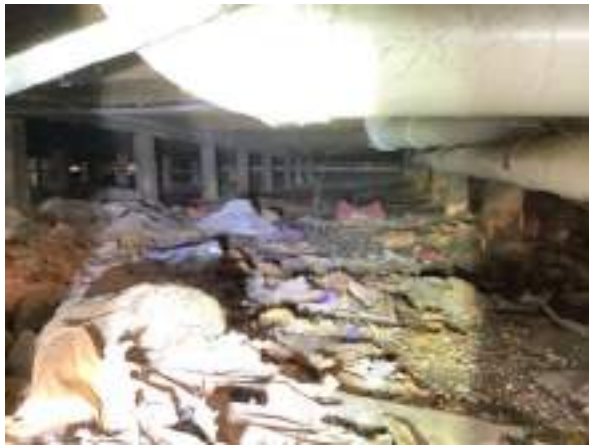
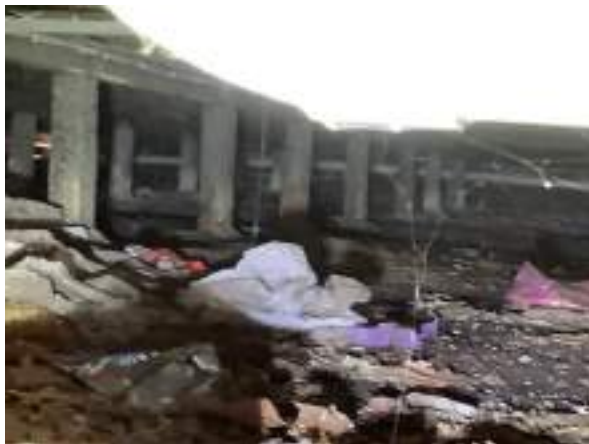
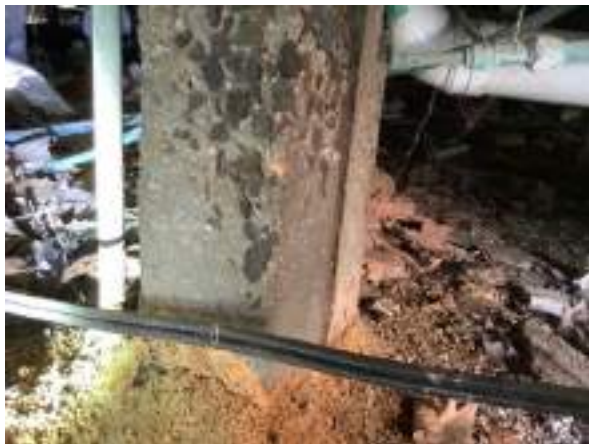
## 2.16

Finding: DAMP & WET LEAK  
WITHOUT FURTHER INVASIVE INVESTIGATIONS BY A PLUMBER, BUILDER AND OR  
STRUCTURAL ENGINEER AND SOMETIMES A GEOTECHNICAL ENGINEER, A COMPLETE  
ANALYSIS WILL NOT ALWAYS BE DETERMINED.

-----  
-----  
Damp (or structural damp) refers to the presence of unwanted moisture in the structure of a building, either as the result of intrusion from outside, or condensation from within the structure. Generally, structural damp is caused by rain penetration, rising damp, and leaks from plumbing pipes.

Unmanaged damp facilitates the formation and development of mould, fungi growth and wood rot, decaying associated building materials and compromising their structural integrity. Damage to finishes is also likely to occur, including lifting, bubbling, peeling and staining of paint, plaster and wallpaper.

Damp or wet conditions are generally a direct result of poor drainage an active leak or poor ventilation (or a combination of the three). Dry conditions should be maintained to prevent secondary building defects from developing.

If left unattended damp or wet conditions may have many consequences including the development of fungal decay and/or wood rot as well as providing an environment that may be conducive to termite or timber pest attack.

The first step in addressing damp is to diagnose the cause. The identified cause should be addressed first prior to repairing the appearance and other defects which have resulted from the rising damp. If the original cause is not resolved, further cases of damp are likely to ensue, resulting in secondary defects.

Consultation with a qualified plumber is advised immediately to identify the cause of damp and perform remedial works as required. Where excessive mould growth is present, further inspection by a specialist environmental health inspector should also be considered.

A qualified plumber should be appointed immediately to identify the cause of the excessive moisture in order to prevent further damage. The water leak should be resolved prior to any repairs of the damaged area which may require localised replacement of building materials

Once the cause is rectified further determinations may be required by a BUILDER AND OR STRUCTURAL ENGINEER AND SOMETIMES A GEOTECHNICAL ENGINEER.

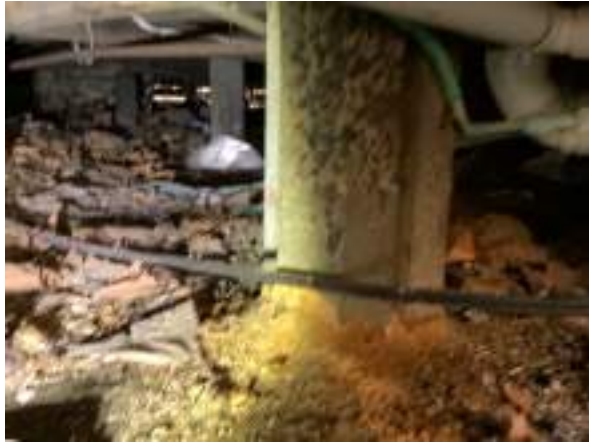
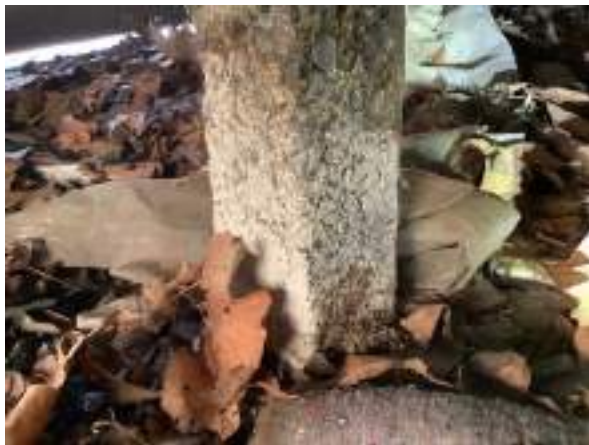
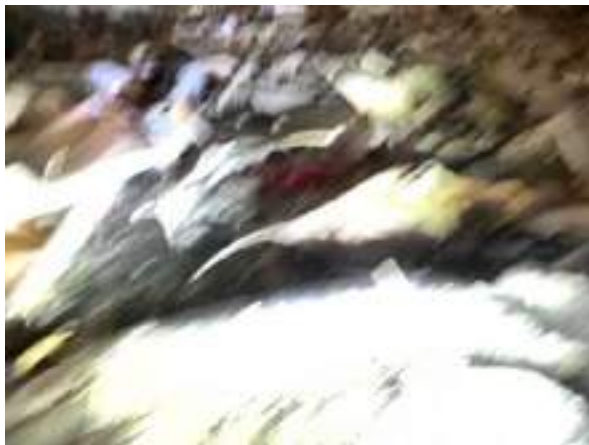
## 2.17

Rising damp is generally managed by the installation of a damp proof course during construction. A Damp Proof Course (DPC) is an impermeable barrier at the base of the wall above ground level. However, many 19th Century buildings have no damp course installed, or the materials have failed. The DPC may have been omitted as a consequence of poor workmanship, or it may have been bridged where materials built up against the side of the house allow moisture ingress above the DPC level.

The first step in addressing rising damp is to diagnose the cause. The identified cause should be addressed first before addressing the appearance and other defects which have resulted from the rising damp. If the original cause is not resolved, further cases of damp are likely to ensue, resulting in secondary defects.

Consultation with a PLUMBER, BUILDER AND OR STRUCTURAL ENGINEER AND SOMETIMES A GEOTECHNICAL ENGINEER, and also more then likely a structural engineer is advised immediately to identify the cause of the damp and perform remedial works as required.

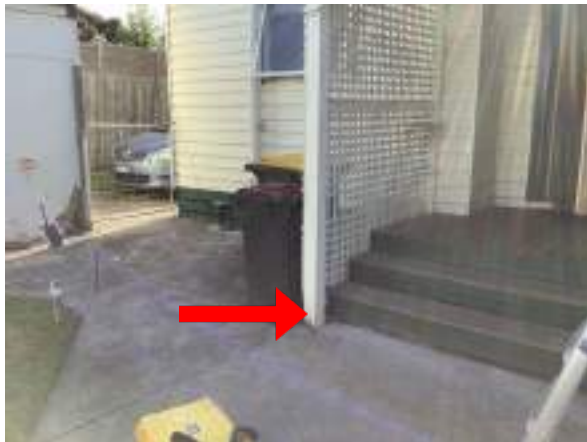
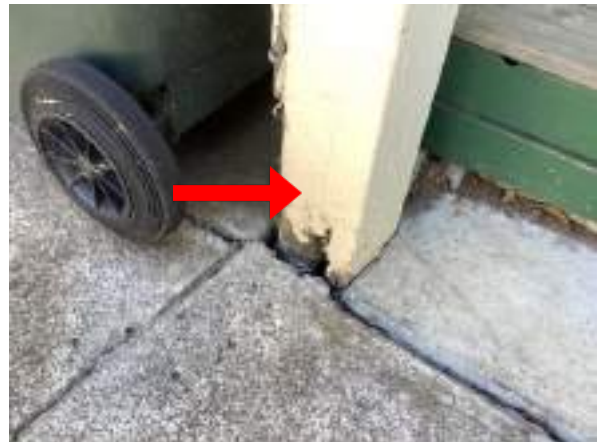
Finding: Wood Rot

This building element shows evidence of wood rot. Wood rot, also known as Fungal Decay, occurs when timbers and other cellulose building materials are exposed to damp conditions on an ongoing basis. This could be the result of exposure to weathering over a prolonged period of time, or the attraction of excessive moisture from other abutting building materials. Contributing factors also include poor air ventilation in the area.

Wood rot is often associated with general damp problems and is evidenced by a `musty` smell or mould and mildew occurring on surfaces. If left unmanaged, damp conditions can lead to further health problems and the decay of timbers will continue.

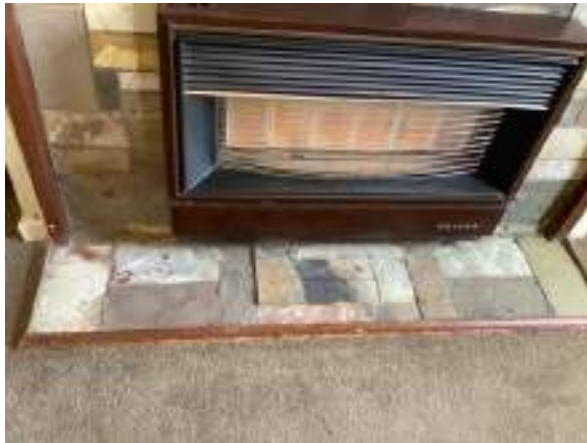
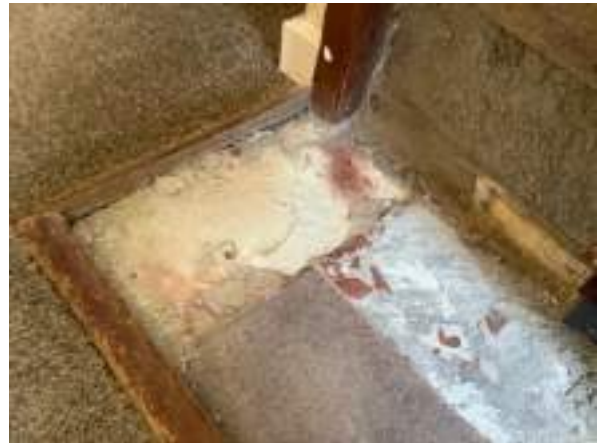
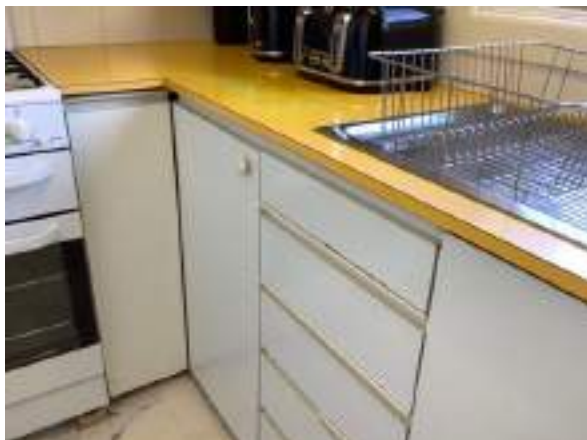
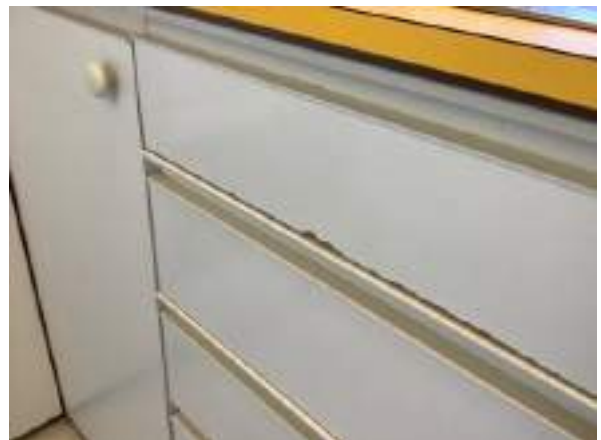
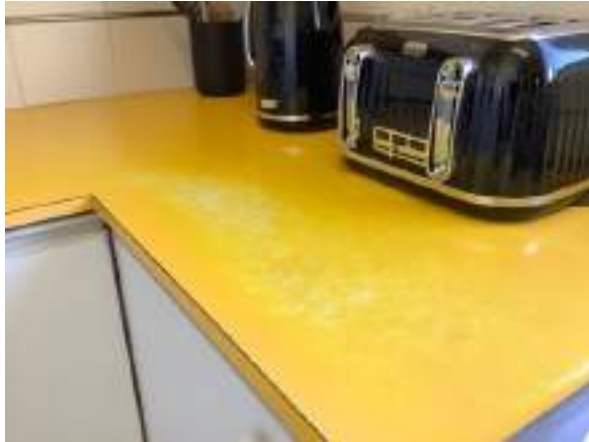
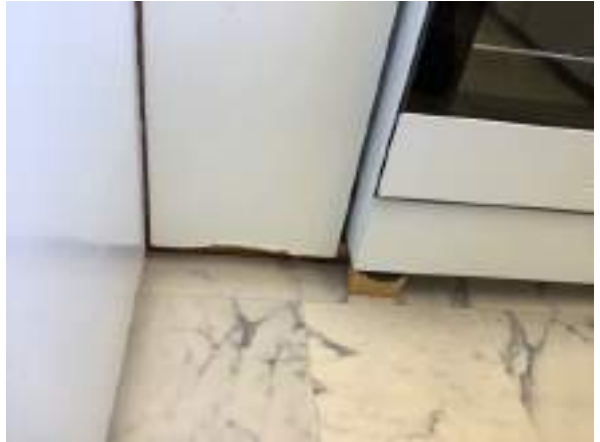
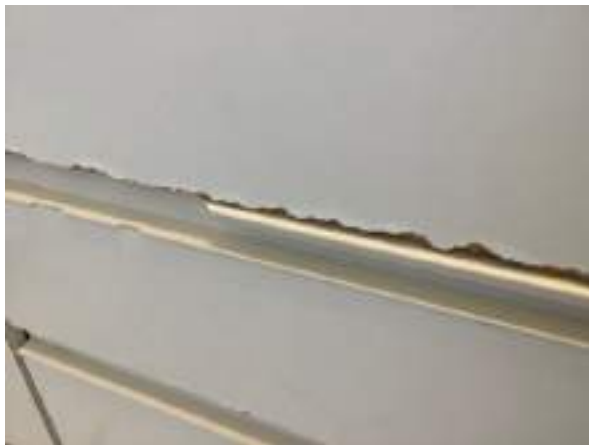
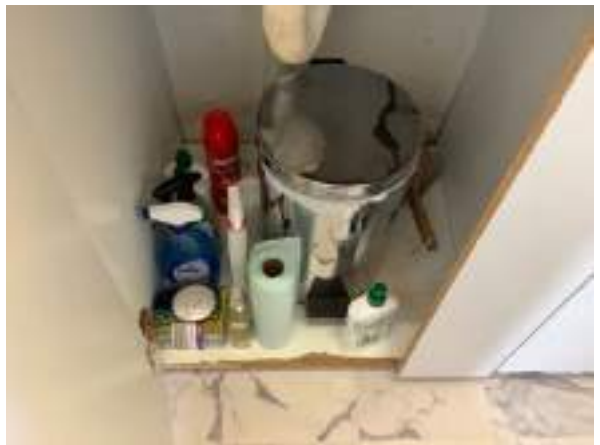
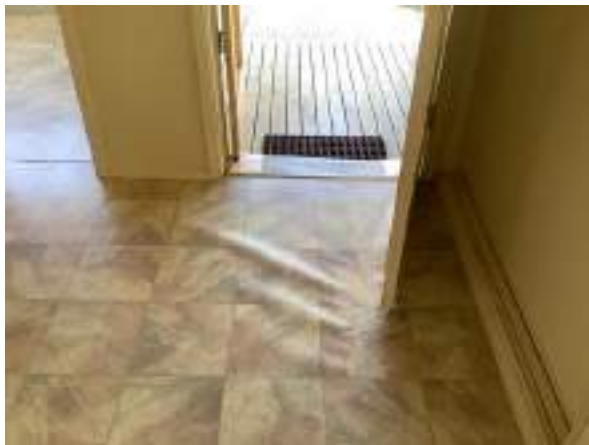
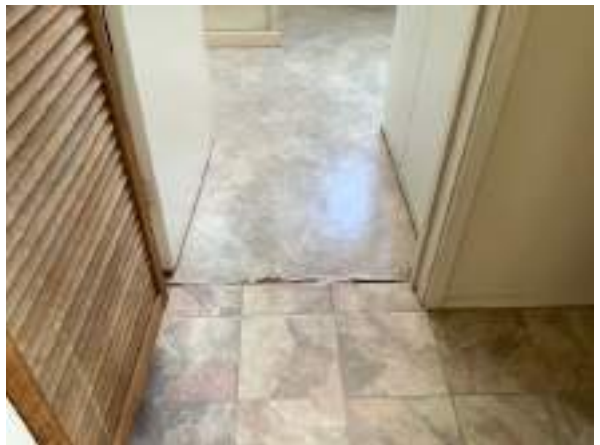
### 3.21

Pre-Purchase Inspections DO NOT require us to note in the reports Worn / Aged and/or Damaged materials and repairs are generally at the owners discretion.  
 Items like worn and damaged kitchens, door handles, damaged floor tiles, painting, etc, again is at the owners discretion.  
 Items like cracked glass mirrors, cracked glass windows and windows not operation smoothly are defects that should be repaired by the appropriate trades.

It is IMPERATIVE that you engage registered and qualified trades and at the end of there works they must supply certificates, such as an electrical safety certificate, plumbing and gas certificate if the works are electrical or plumbing, but for items such as damaged door handles, painting an experienced carpenter or handyman can sometimes be engaged.

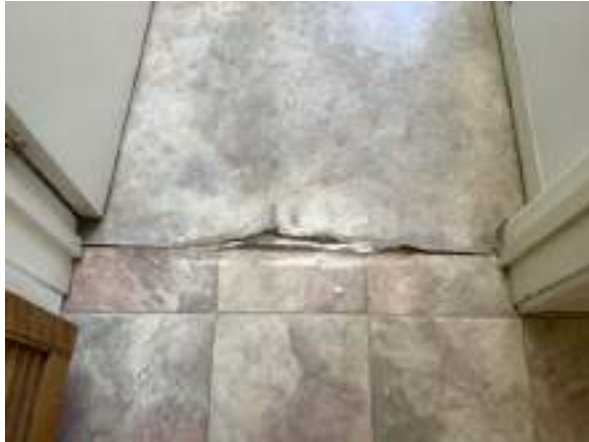
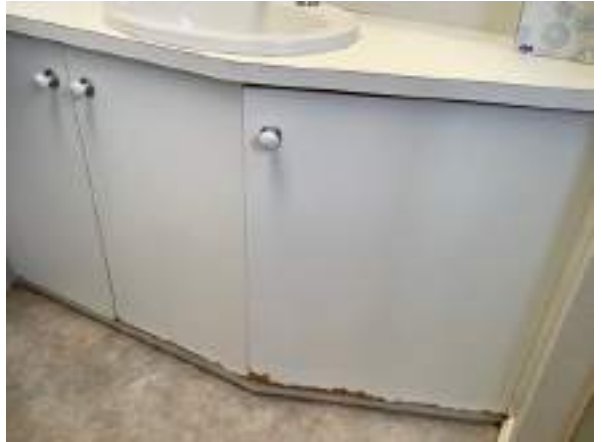
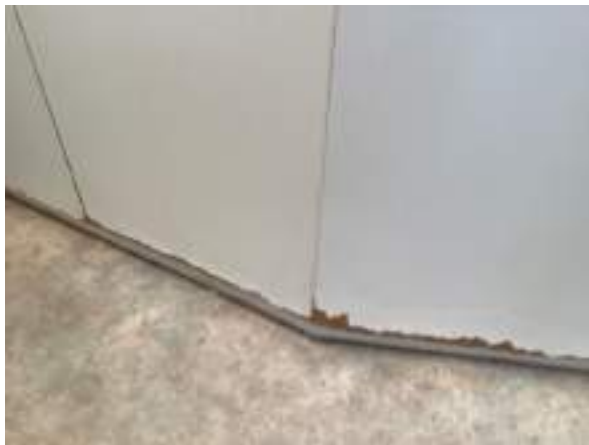
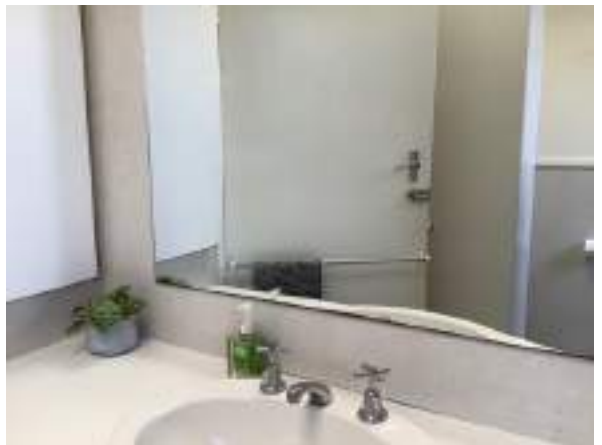
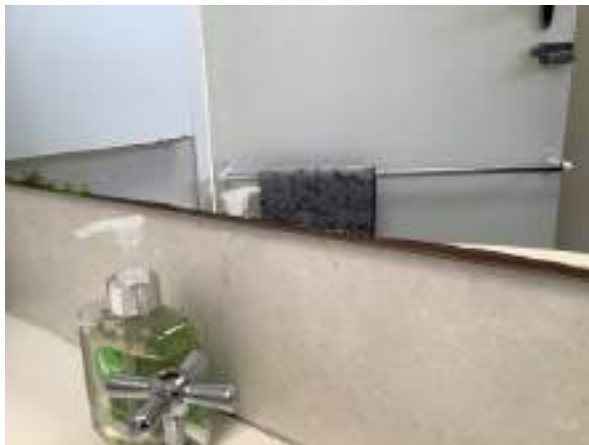
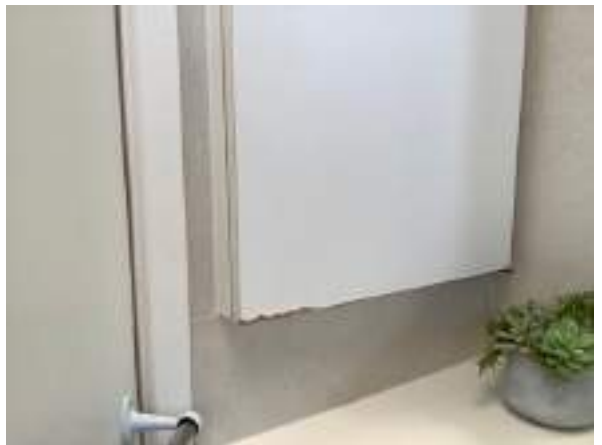
### 3.22

Location: All Areas - Various

These Defects are of Sub Standard Workmanship or Incomplete and not finished to a tradesmens like manner.

Unfinished and substandard building works are likely to degrade more quickly and may create potential for secondary defects to associated building elements and surrounding structures, also the workmanship is VERY displeasing to the eye.

Generally substandard repairs or installation are related to poor workmanship, the use of inappropriate materials, or a failure to complete installation to a suitable standard.

Where installation is substandard and/or incomplete, the client should contact the responsible trade to undertake rectification works, which are advised as soon as possible.

The appropriate tradesperson or specialist should be appointed to complete the various items for repair and organise the appropriate QUALIFIED trades to repair and complete the works to illiminate or reduce further deterioration / disfunction.

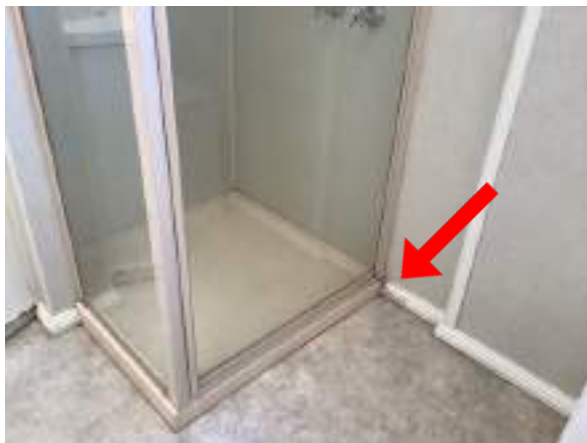
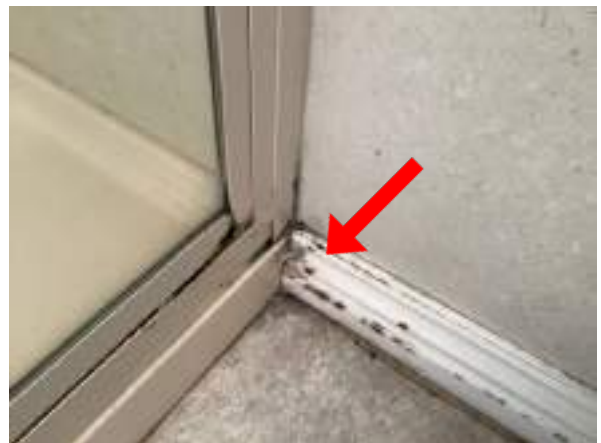
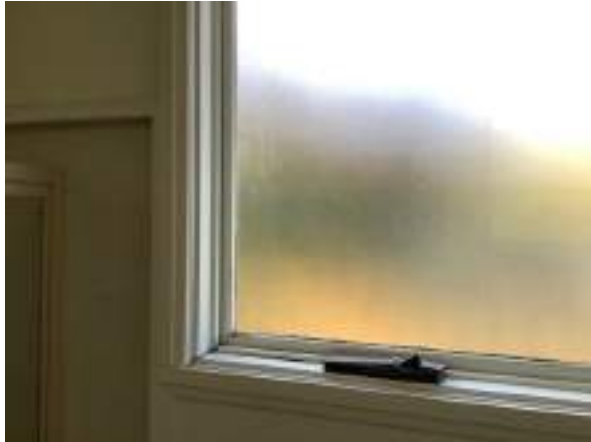
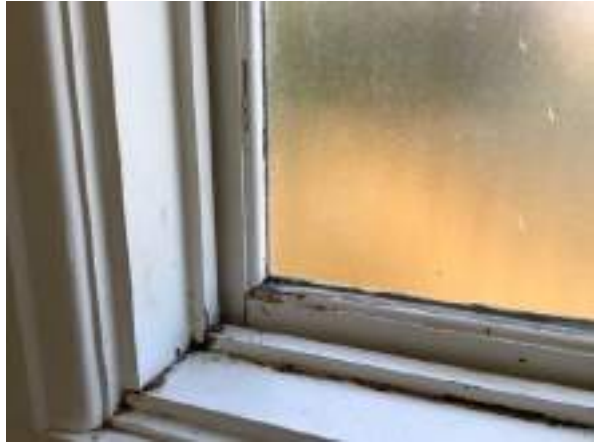
### 3.26

Location: Bathroom

For minor causes, a qualified carpenter or general handyperson should be appointed to perform minor rectification works at client discretion.

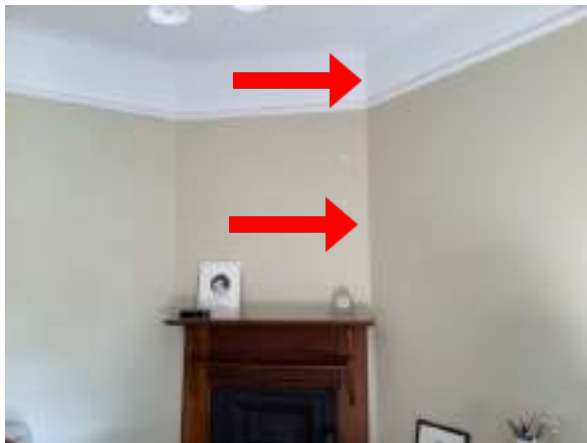
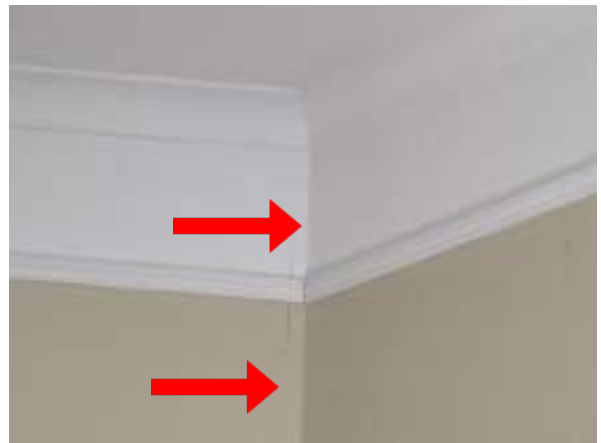
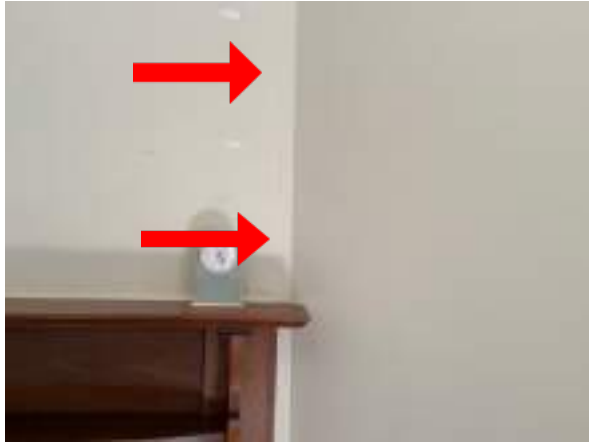
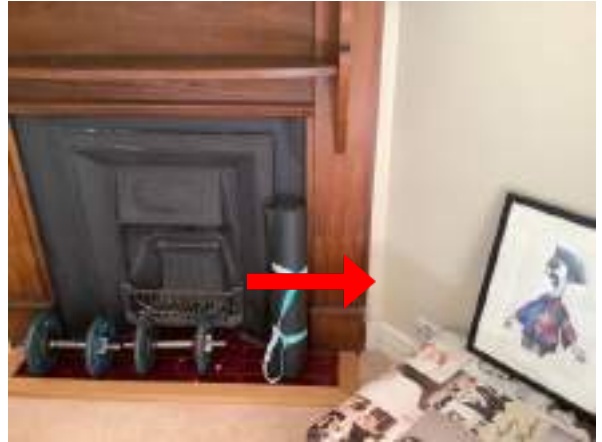
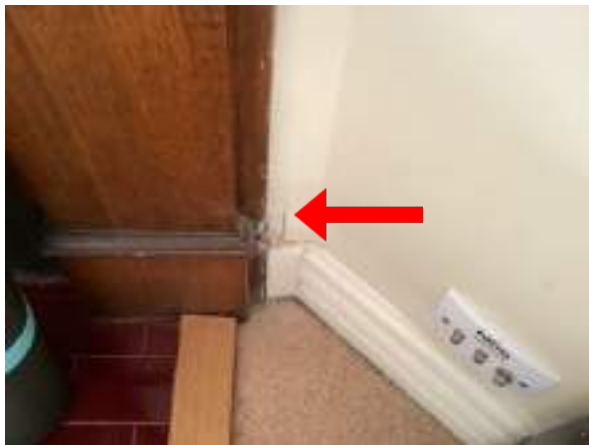
### 3.30

Location: Bedroom 1

Once the leak is repaired, consultation with relevant tradespeople, including plasterers and painters, is advised. Rectification works may include replacement of ceiling lining or minor repainting, depending on the extent of the damage.

Conversely, where water staining is old and inactive, affected building materials may be repaired or replaced at client discretion.

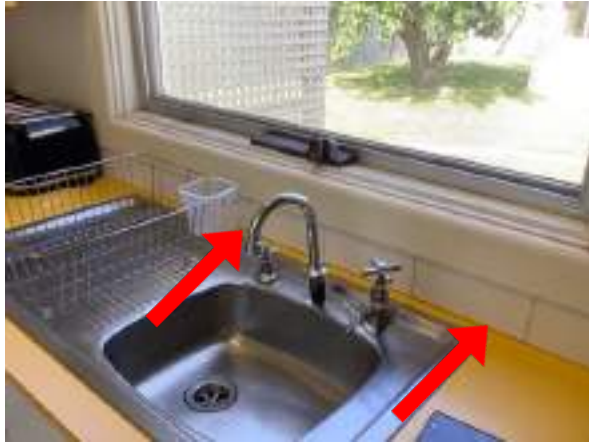
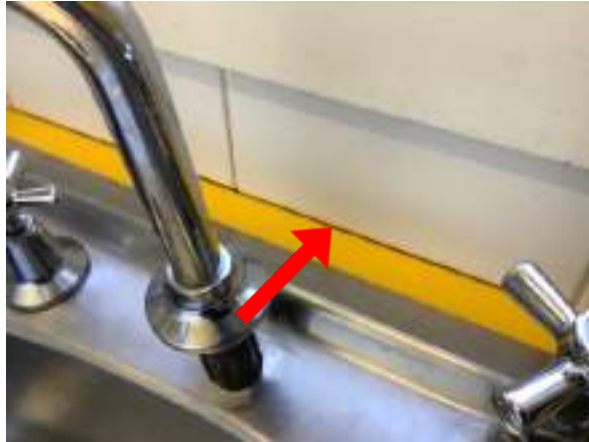
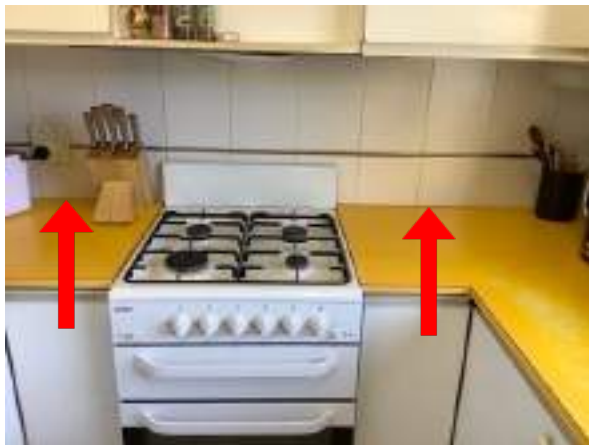
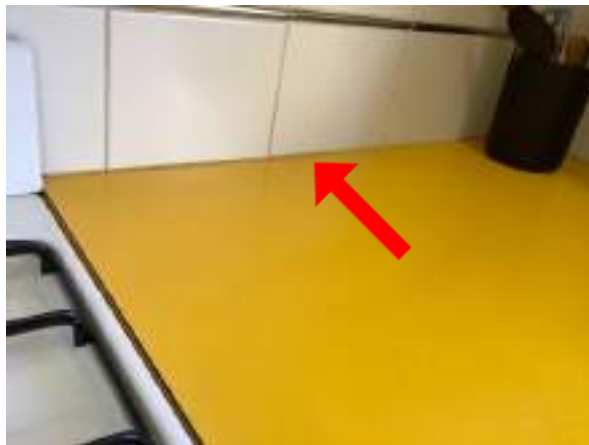
-----  
-----  
ALL AREAS should be checked carefully for this defect and attached are a few PHOTO  
EXAMPLES as a GUIDE.  
-----  
-----

A sealant specialist, tiling contractor and/or registered builder should be appointed to assess any damage caused by water to the entire internal, sub-floor, walls etc of the building and clean, take off old sealant and tile mortar, then re-seal and re-mortar these works as soon as possible.

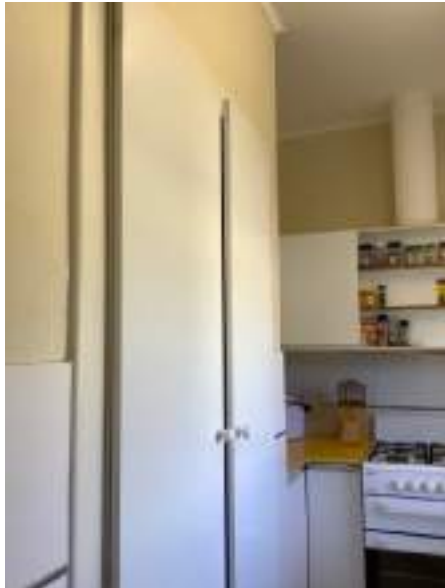
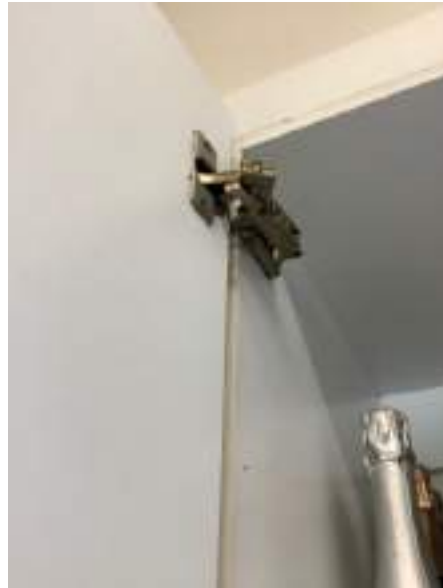
### 3.33

Location: Kitchen

Finding: Cabinetry - Loose hinges / Re-adjustment  
Several cupboard / wardrobe doors are not level and detract from the operational state of the cabinetry and doors.  
Upon further inspection, it was noted that the hinges to the cupboard doors have deteriorated or just need adjustment. This as a result over time that they have just come loose or deteriorated from their original fixing.

To improve operation of the affected doors, a general handyman / cabinetmaker/ carpenter may be appointed to replace the faulty hinges and/or adjust .

Such works should be completed at the discretion of the client, but we do recommend repairs so that there is no further damages to the existing cabinets or cupboards.

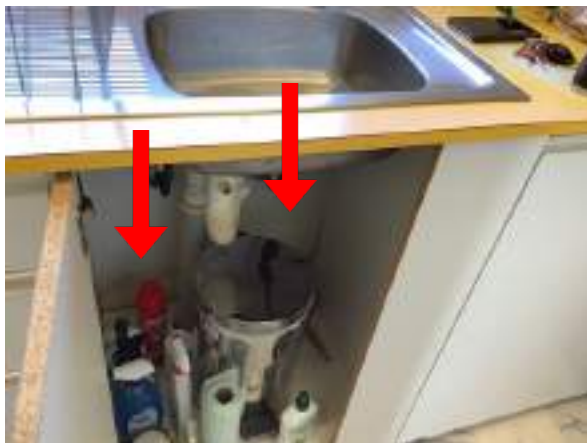
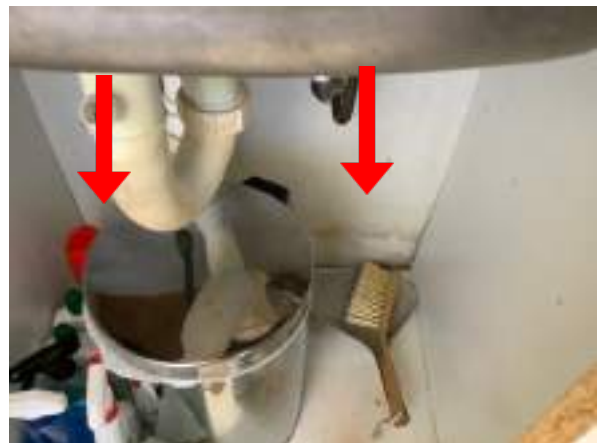
### 3.34

Location: Kitchen

Finding: Water Staining - Damaged Materials.  
Water staining was evident in this area or areas at the time of inspection.

Water staining indicates that surfaces have been exposed to excessive moisture / water over time. The minerals and other elements in the water lead to staining, which may graduate to corrosion and deterioration if left unmanaged.

It is important to identify the cause of water staining and STOP FURTHER DETERIORATION by the appropriate tradesperson.

Where water staining is active, a licensed plumber or appropriate trade must be consulted to identify the cause of the staining and to provide advice on any reparation works that may be required.

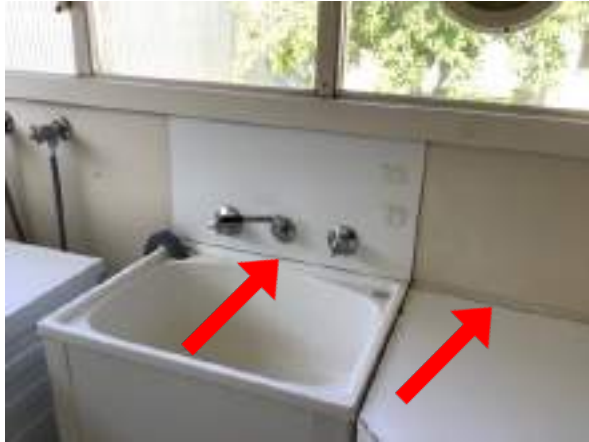
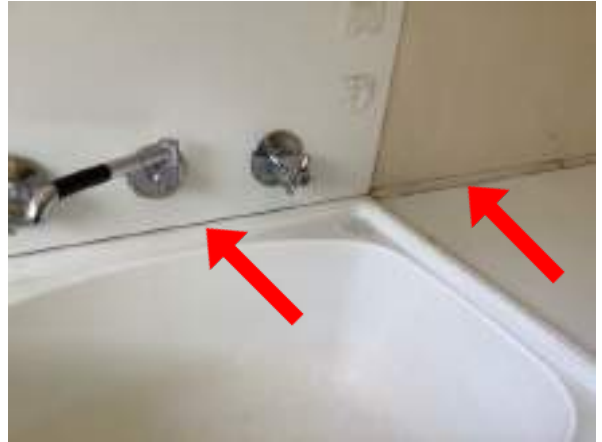
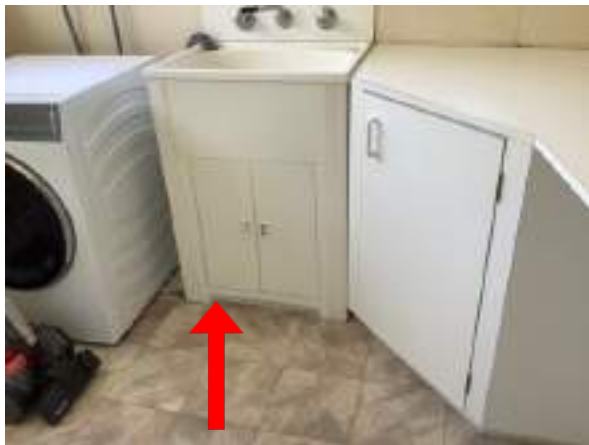
### 3.35

Location: Laundry

Finding: Silicon / Caulking To All Wet Area Junctions - Missing or Damaged.

It was noted on inspection that sealant and/or tile grout is missing, damaged or inadequate to the tiled wet areas. This may include floor edges, kitchen benches/splashbacks, vanities, bath tub edges, shower areas to the floor and wall tiles, laundry's and all other areas subjected to water or moisture.

Whilst in some of the areas there is sealant/silicon , it has become apparent that the sealant has deteriorated and/or is just missing.

Whilst in some of the tile mortar is perfect , it has become apparent that the tile mortar has deteriorated and/or is just missing in other areas.

A flexible sealant/silicon and tile mortar should be applied to affected areas to prevent any subsequent water damage that is likely to occur.

A sealant specialist, tiling contractor and/or registered builder should be appointed to assess any damage caused by water to the entire internal, sub-floor, walls etc of the building and clean, take off old sealant and tile mortar, then re-seal and re-mortar these works as soon as possible.
