# Building/Termite/Electrical/ Asbestos/Digital Flooring

Inspection Date: 21 Jan 2020

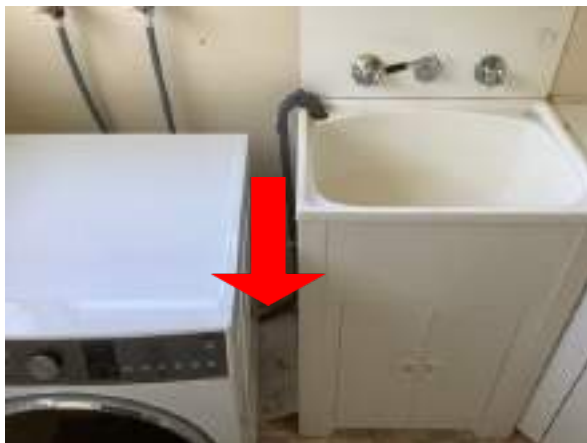
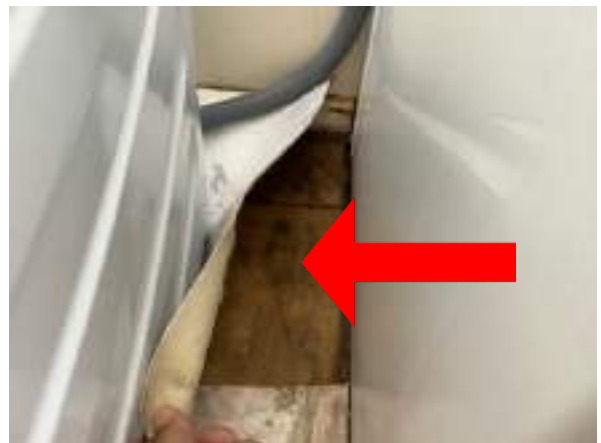
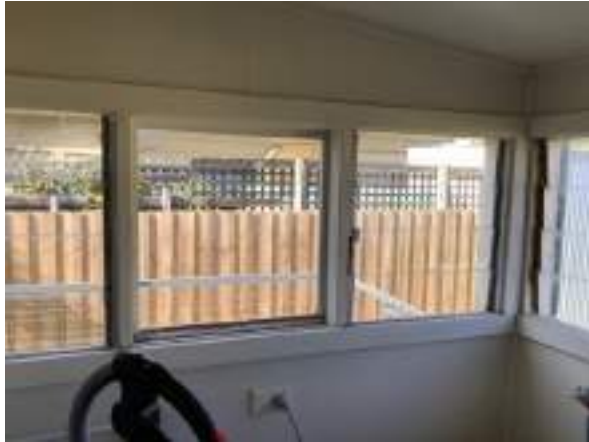
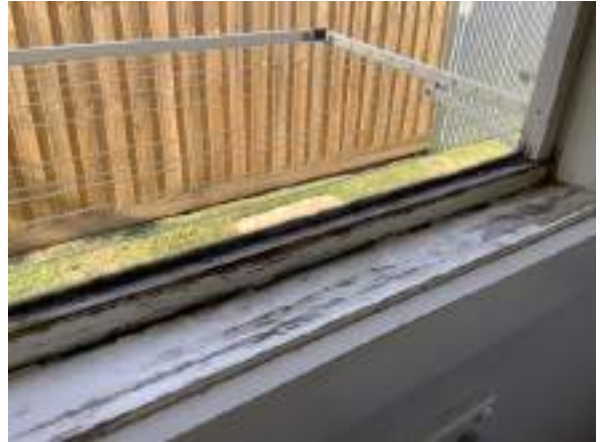
### 3.36

Location: Laundry

Finding: Water Staining - Damaged Materials.  
Water staining was evident in this area or areas at the time of inspection.

Water staining indicates that surfaces have been exposed to excessive moisture / water over time. The minerals and other elements in the water lead to staining, which may graduate to corrosion and deterioration if left unmanaged.

It is important to identify the cause of water staining and STOP FURTHER DETERIORATION by the appropriate tradesperson.

Where water staining is active, a licensed plumber or appropriate trade must be consulted to identify the cause of the staining and to provide advice on any reparation works that may be required.

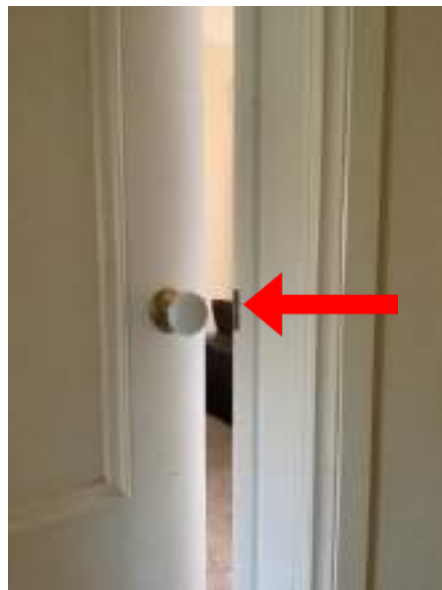
### 3.37

Location: Dining room

This is a common defect and is expected in a property of this age, whether being due to substandard installation or general deterioration of the door hardware and sometimes also the associated hinges

Readjustment of the striker plate and/or hinges is recommended at client discretion.

A qualified carpenter or general handyperson may be appointed to perform rectification works as necessary, at client discretion.  
If left unattended, further functional impairment is likely to occur.

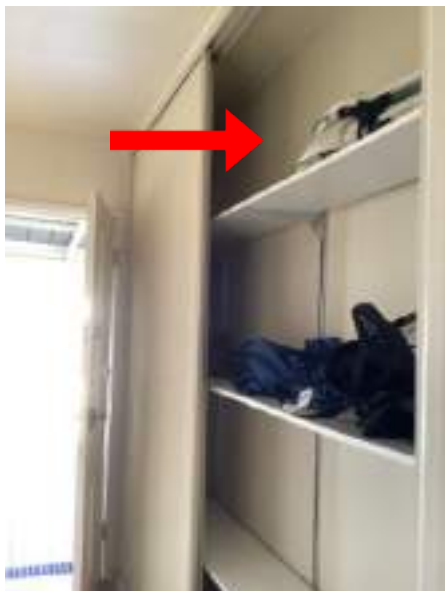
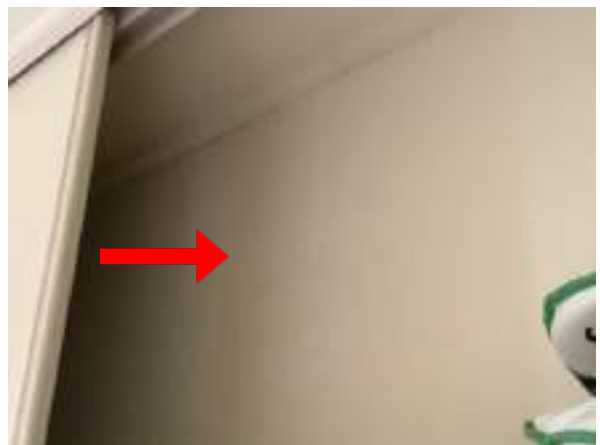
### 3.38

Location: Closets / Wardrobes

Finding: Water Staining - Damaged Materials.  
Water staining was evident in this area or areas at the time of inspection.

Water staining indicates that surfaces have been exposed to excessive moisture / water over time. The minerals and other elements in the water lead to staining, which may graduate to corrosion and deterioration if left unmanaged.

It is important to identify the cause of water staining and STOP FURTHER DETERIORATION by the appropriate tradesperson.

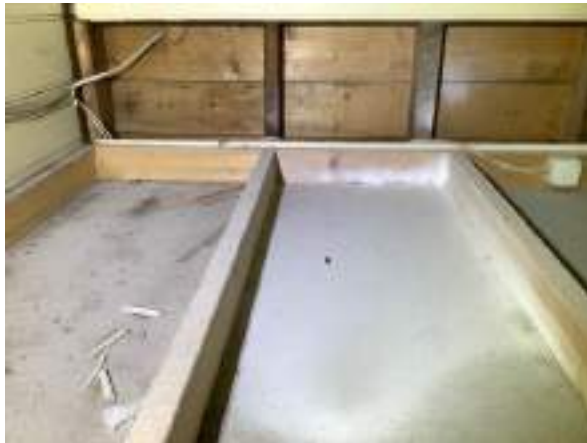
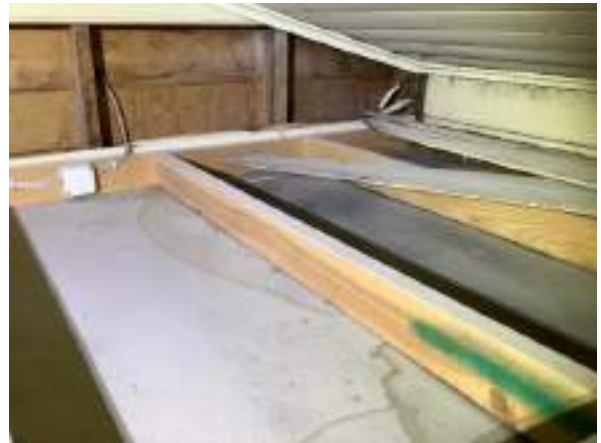
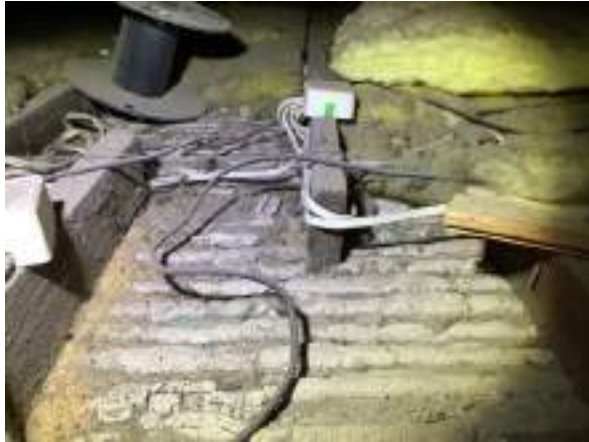
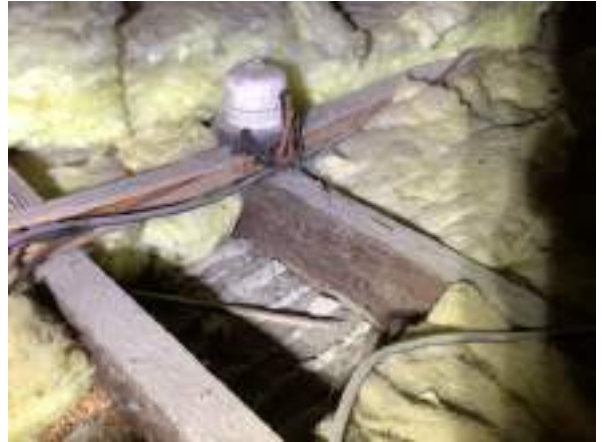
### 3.39

Location: Roof Space

Finding: Insulation - Inadequate / Missing

Installation of adequate insulation is required according to Australian Standards and should be conducted as soon as possible.

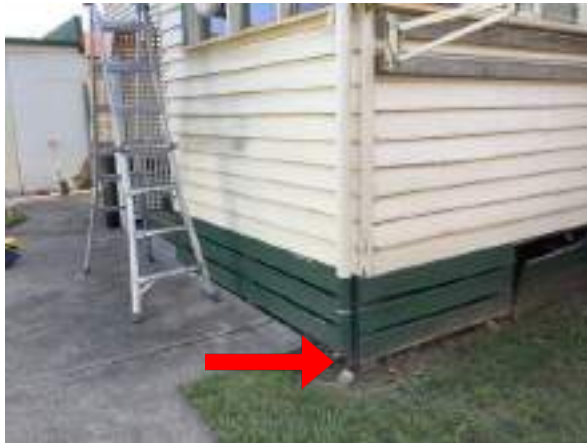
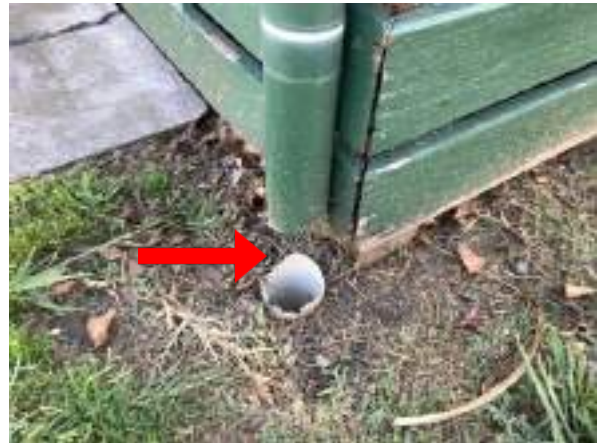
### 3.40

Location: External Areas

Finding: Stormwater drain - Not connected - Damaged.

If secondary damages have accrued we highly recommend that you engage a structural engineer and/or a registered builder for remedial works.

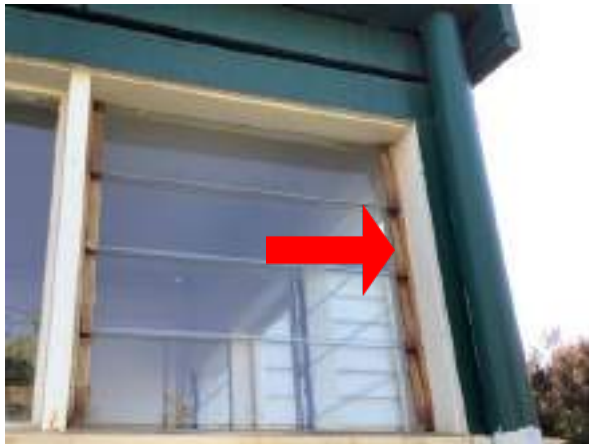
### 3.41

Location: External Areas

Finding: Rusted / Corroded - Building Materials

Rusting and corrosion should be managed by ideally removing or limiting the affected surface from exposure to moisture.

A registered builder may be appointed to replace any building elements that have been severely affected by rust or water damage.

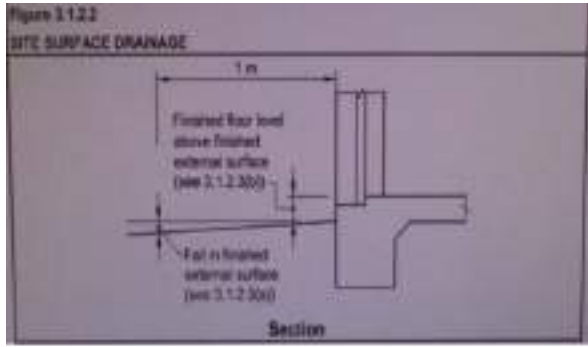
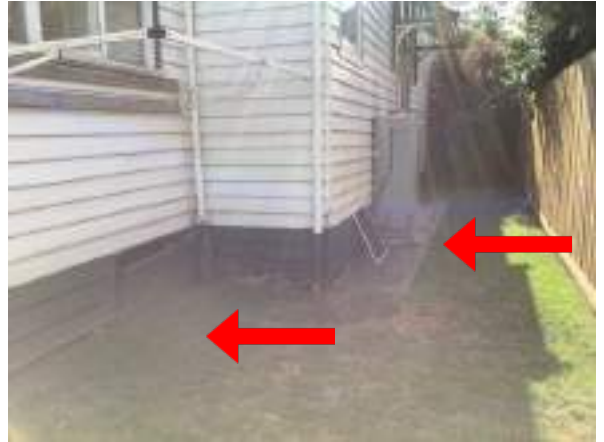
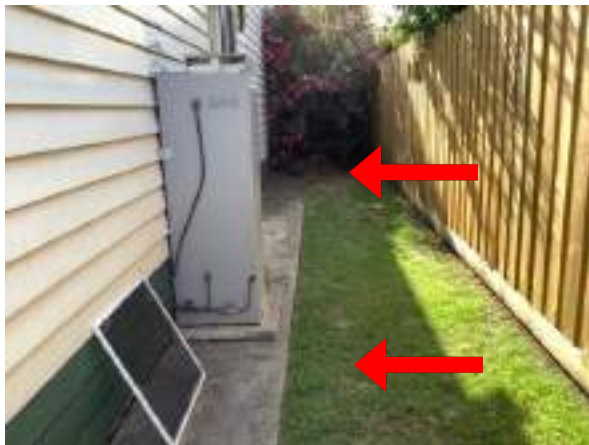
### 3.42

Location: Exterior - Perimeter Of Building

Please read the report carefully and Maintenance to all susceptible and conducive areas is a MUST to minimise the risk of termite and timber pest existence and timber damage.

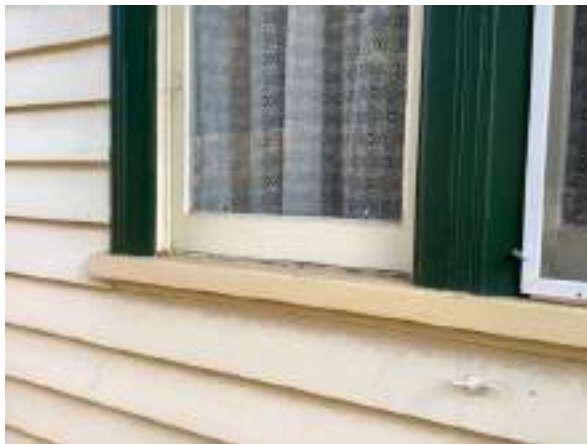
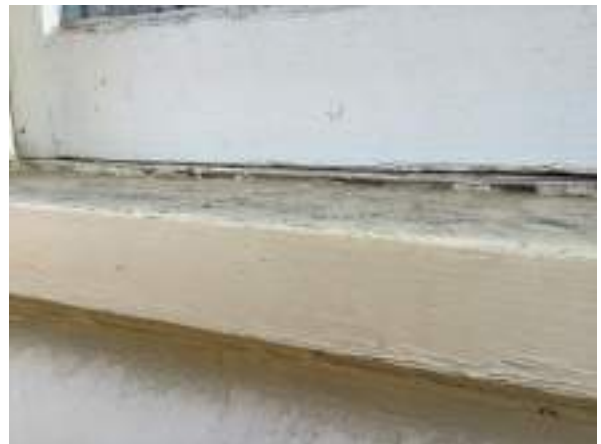
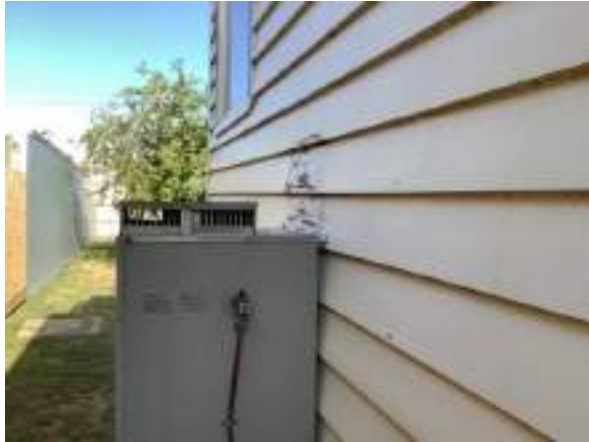
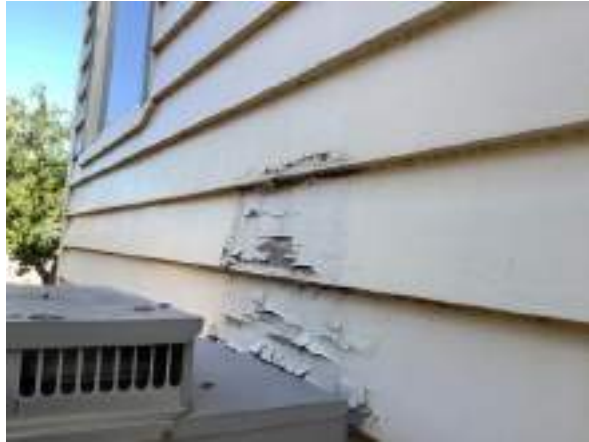
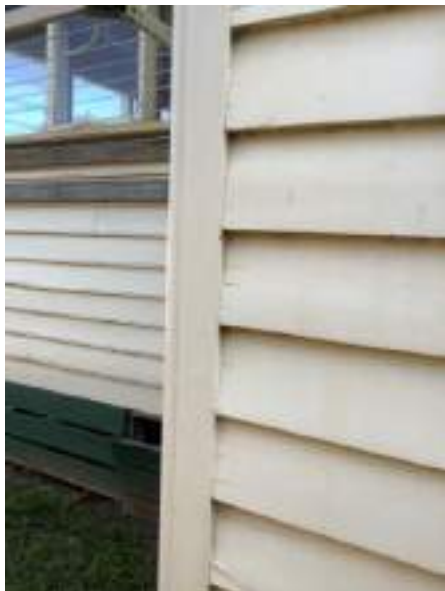
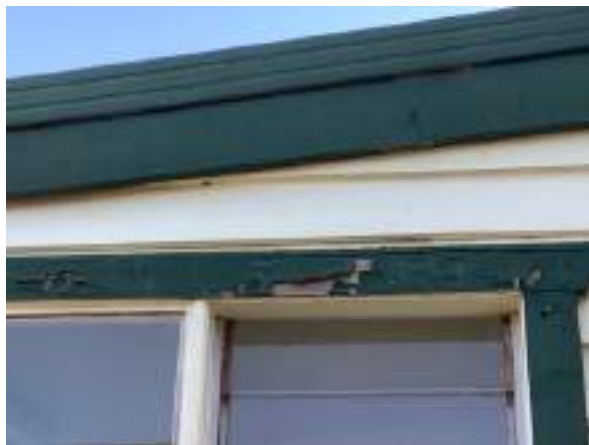
### 3.43

Location: External Timber Work

The property is a very high risk for termites as the environments to the property are very conducive with many susceptible areas.

Please read the report carefully and Maintenance to all susceptible and conducive areas is a MUST to minimise the risk of termite and timber pest existence and timber damage.

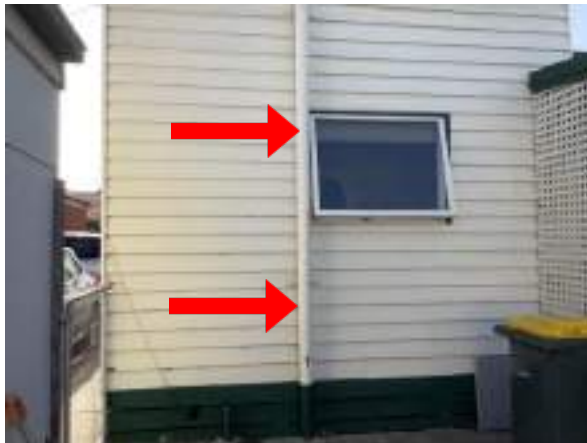
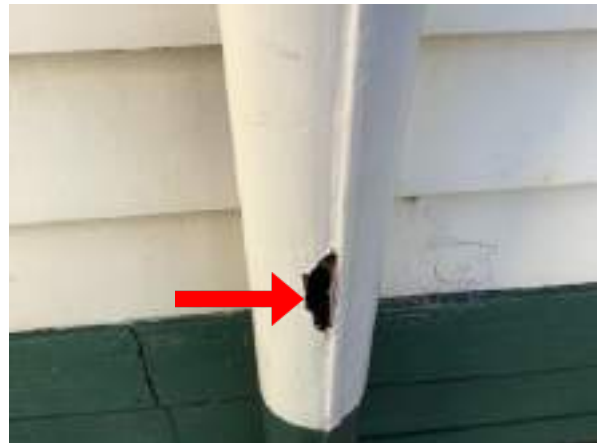
### 3.44

Location: All Exterior Roof Areas

A licensed plumber or specialist roof restoration company should be appointed to undertake these works. It is advised that such works be completed as soon as possible to prevent any further damage and deterioration.

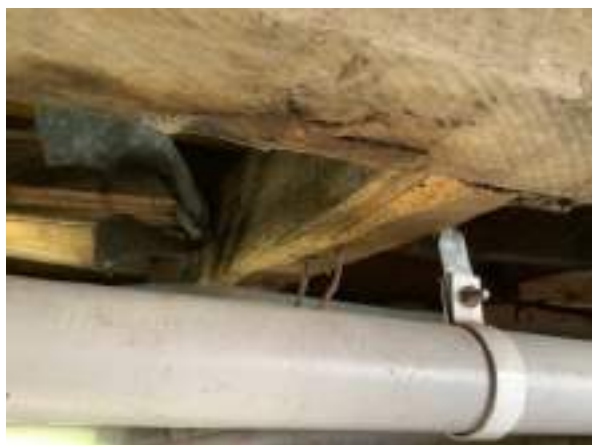
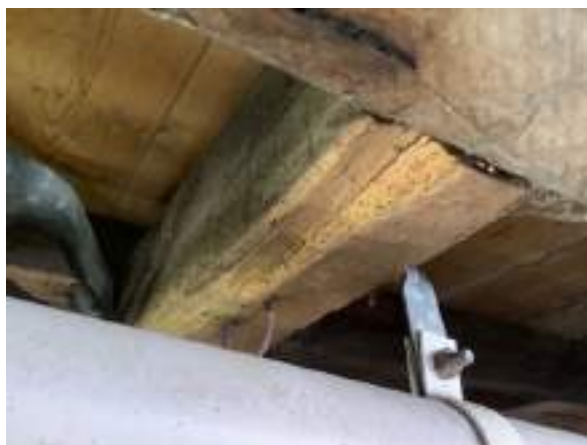
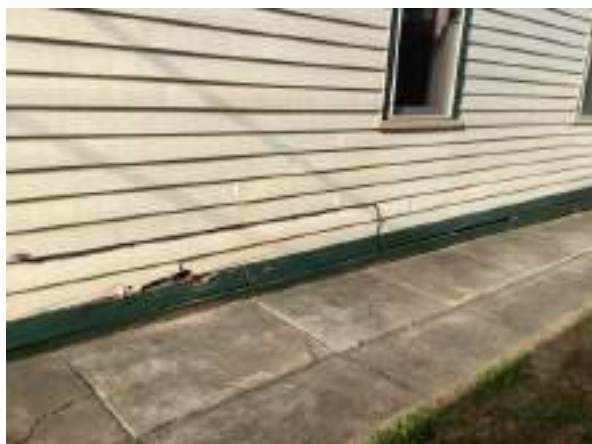
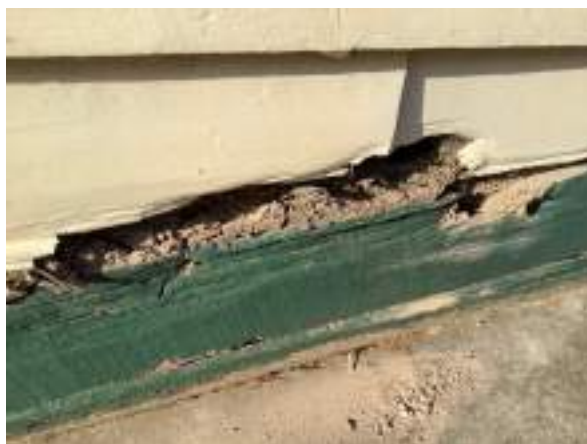
Finding: Timber Pest - Damage Identified.

It is suspected that timber pest activity is occurring or has occurred as there appears to be evidence of timber pest damage.

Despite no live termite or timber pest activity being identified, previous timber pest damage was found in these areas.

Such damage creates a potential safety hazard, and is likely to worsen and cause further damage to adjoining building materials.

If left unattended, this damage creates an unsafe environment and is likely to lead to the need for major structural works.

A building contractor should be appointed immediately to advise on options to prevent further damage and repair all affected building materials. Until such time, caution should be taken by all people coming into contact with these building elements and this area.

It is highly recommended that a Termite Chemical Barrier System and/or other suitable Termite Treatment with a preventative maintenance program be put in place.

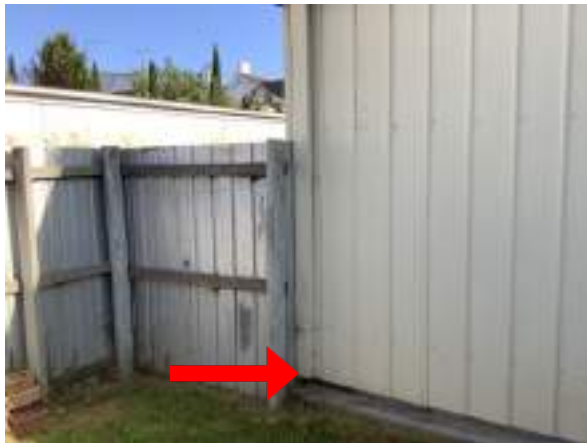
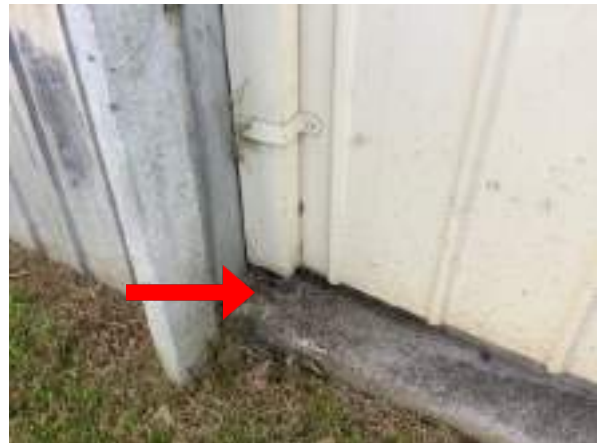
Finding: Stormwater drain - Not connected - Damaged.

Where roof plumbing doesn't drain adequately, the area at the base perimeter can become excessively damp, potentially creating an environment that is susceptible to rust and corrosion of surrounding building elements, as well as attracting termites and other pests.

This has the potential for foundation subsidence and/or secondary damages such as structural defects such as brick movement / cracking.

It is highly recommended that a plumber be appointed to further inspect the area and to install / repair adequate drainage equipment where necessary.

If secondary damages have accrued we highly recommend that you engage a structural engineer and/or a registered builder for remedial works.

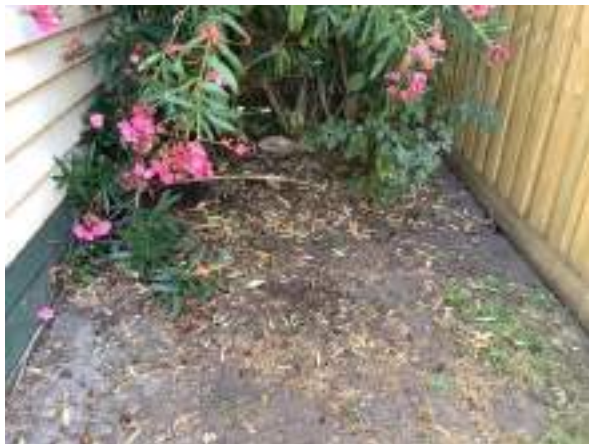
## 2.04

Location: All Garden Areas

Finding: Garden Beds - Conditions Conducive to Termites  
 Garden beds were found to be evident in areas of garden areas.  
 These garden beds can include untreated timber, bark, excessive old vegetation and with a combination of moisture from watering hosing can make conditions very conducive to termite activity and termite ingress.  
 It is always important to keep the garden beds as clean as possible and take out excess old bark from the trees, leaves and keep bark mulch to a minimum or better introduce rocks or some item that does not create an conducive environment for termites and hold excess moisture.

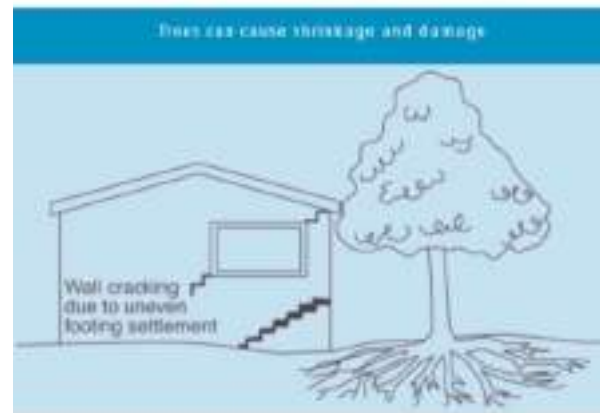
## 2.05

Location: All Garden Areas

At the time of the inspection it was found that the plants are overgrown and close to the exterior building.

It is highly recommended that the plants be trimmed and/or moved away from the immediate area of the perimeter building...

As noted above, I can not stress how important it is to severely reduce the trees, vegetation, timber and other debris and all other items not only around the home but to the entire property as a matter of urgency.

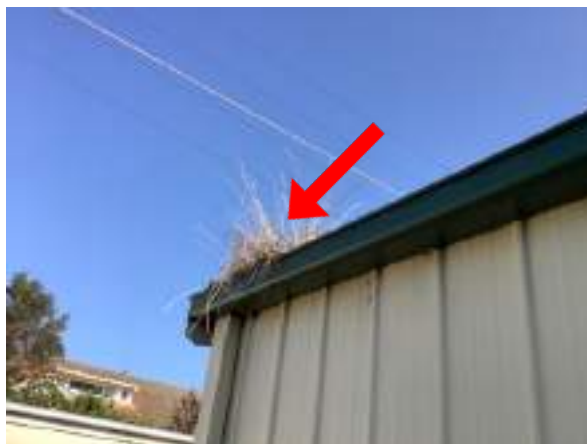
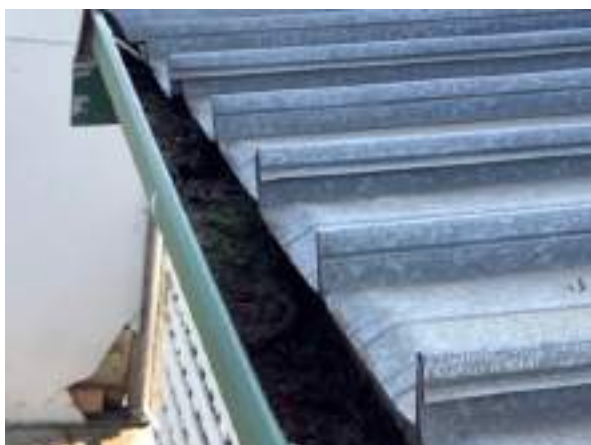
## 2.06

Location: All Exterior Roof Areas

Gutters are a critical part of the building's management of storm water and rain. It is therefore important that they be kept clear to prevent secondary damage to associated building elements, including exterior and interior walls, ceiling linings and any adjoining building elements. Where gutters are blocked, pooling of rainwater is likely to occur, fast-tracking rust and corrosion of the roof plumbing elements.

Unclean Gutters prevent building elements from operating as intended, detracting from the overall function of the affected building elements. Additionally, the lack of general maintenance may lead to the development of more significant defects, such as damage to surrounding building materials.

Blockages should be removed and addressed promptly, as they will lead to the development of secondary building defects. The blockage should be removed as the primary rectification works. Secondly, check for any secondary or concealed damage, and then attempt to address the cause of the blockage to prevent recurrence or any water damage to associated structures.

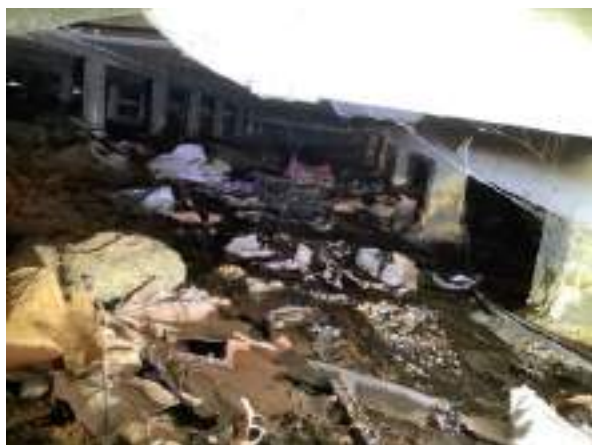
## 2.07

Location: Subfloor

Finding: Wet Areas, Moisture Present - Attract Termites.  
Excessive moisture can attract termites and produce conditions that promote termite attack fungal growth and wood decay as Termites are attracted to moisture.

Excessive moisture is generally caused by deteriorated inadequate or missing roof drainage leaking plumbing pipes or fixtures poorly plumbed HWS overflows or condenser units and poor site drainage.

It is highly recommended that all plumbing and drainage fixtures and fittings be maintained regularly in order to prevent excessive moisture being present in the external / internal property.

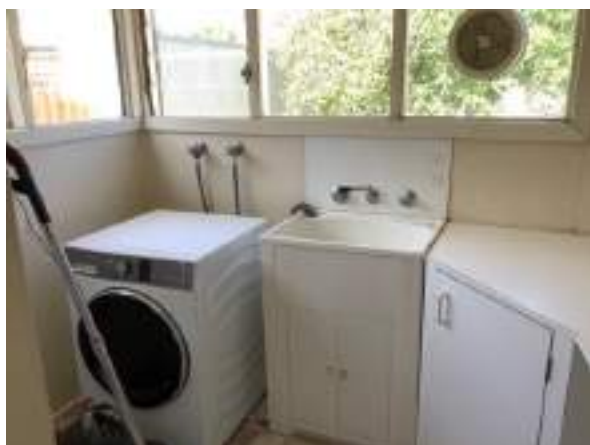
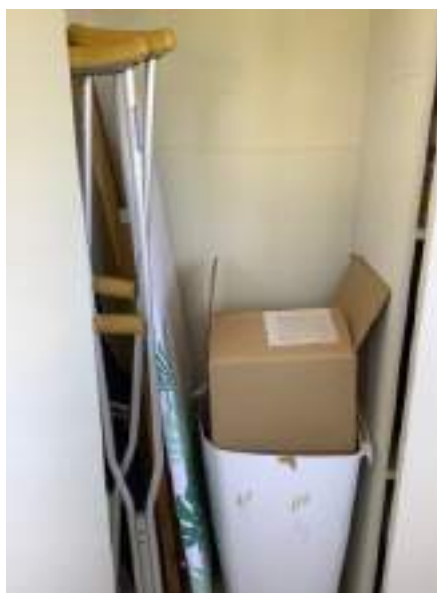
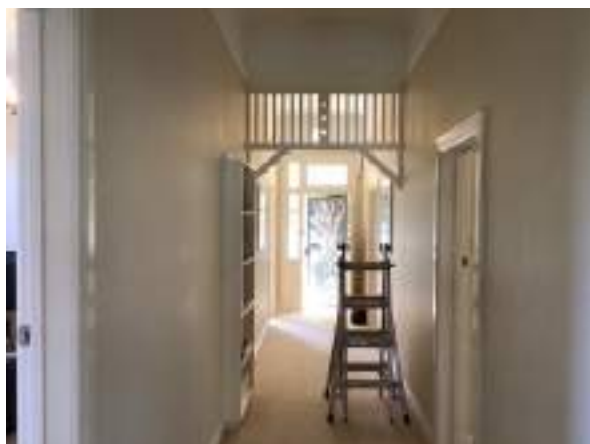
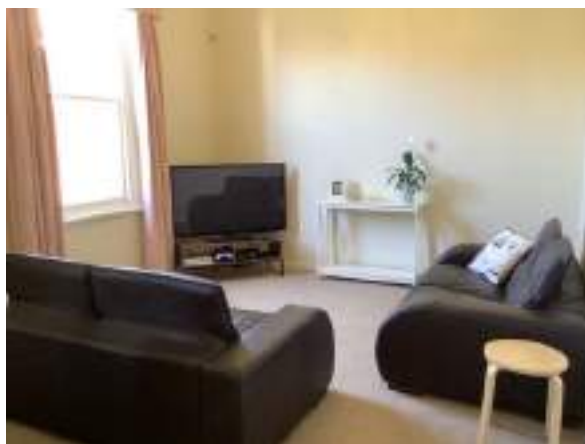
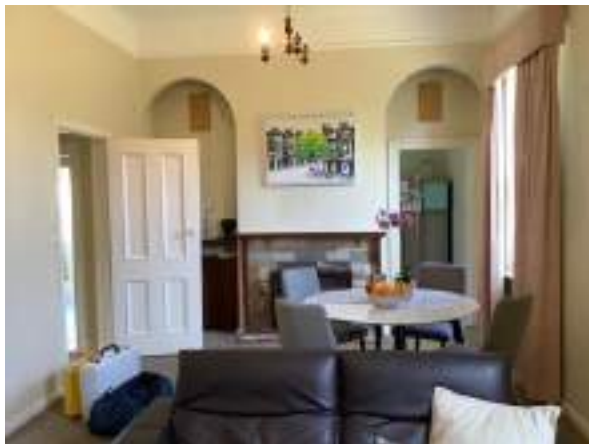
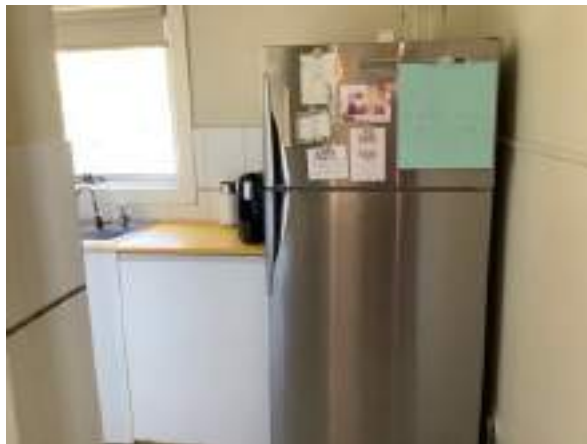
## 4.10

Location: The Site

Whilst we have taken many photos of the home and surroundings of the obstructions and limitations , we have just added a few photos in the report for you to understand the type of obstructions and limitations .

A re-inspection is recommended once the areas are made accessible.

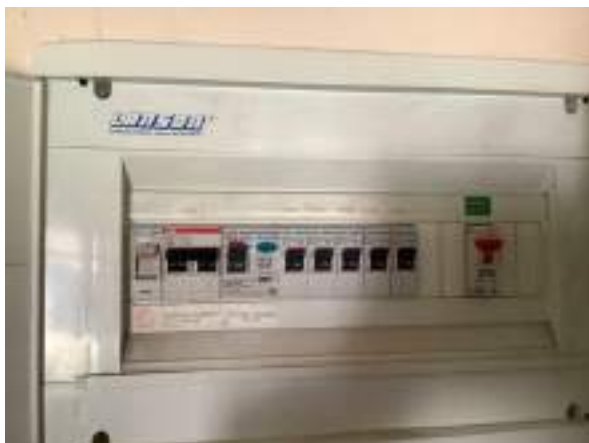
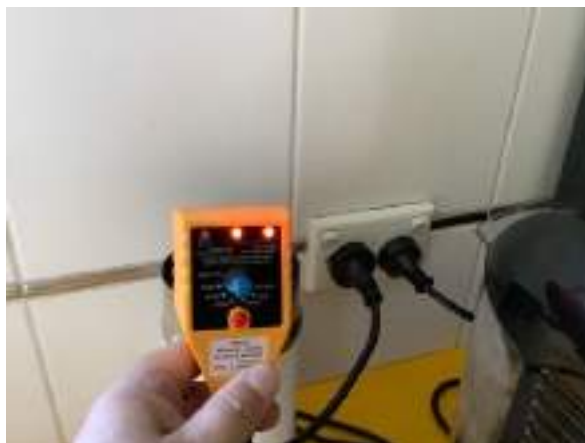
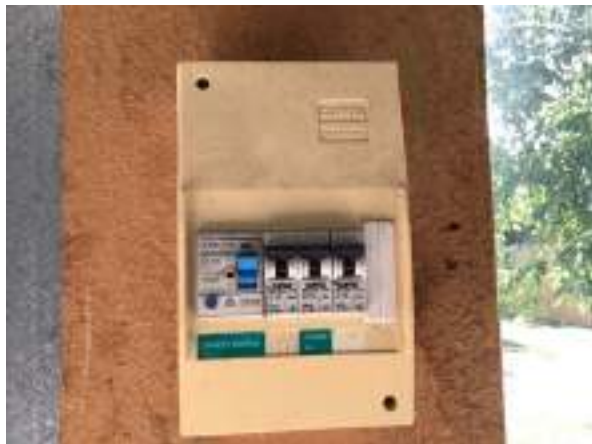
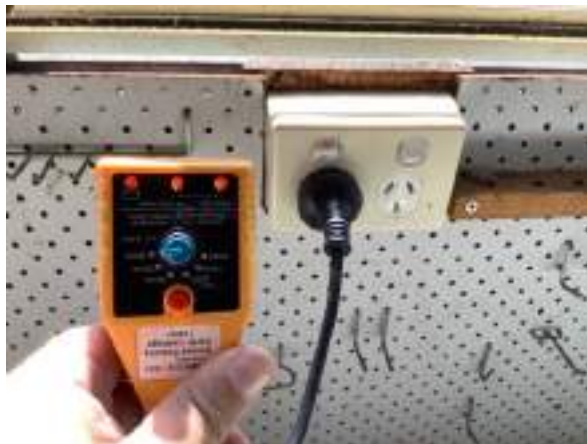
3/ Safety Switch test to trip the safety switch at less then 30 milli amps was performed.

These tests all passed the AS 3000 requirement and exceptance level.

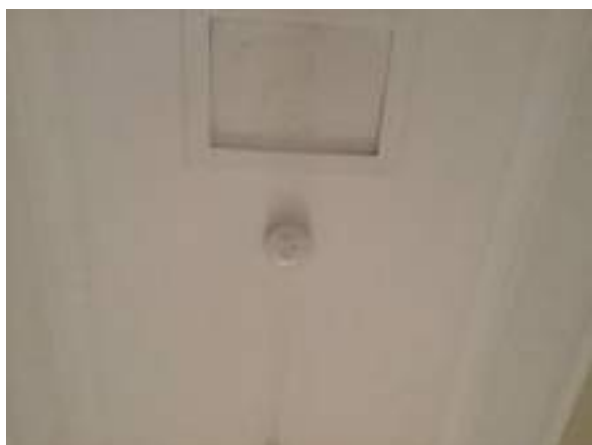
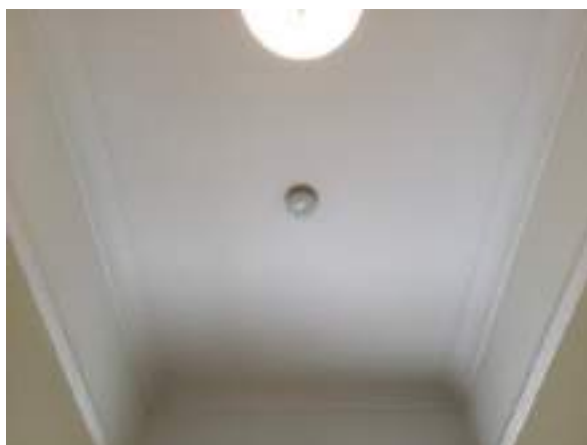
## 4.12

Location: The Site

Finding: Smoke Detectors Battery Replacement.  
This inspection DOES NOT test operation of smoke detectors .

Upon moving into a new property, it is highly recommended that the batteries to the smoke detectors all get replaced instantly.

Smoke detector batteries should be replaced every 12 months at a minimum.

It is highly recommended that replacement dates of the batteries be kept in a log book.

Testing of smoke detectors is required monthly.

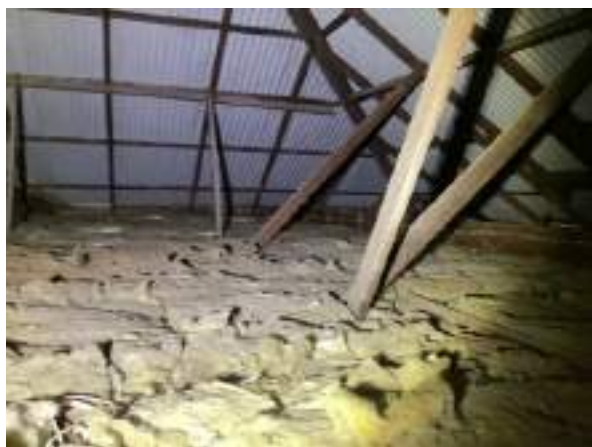
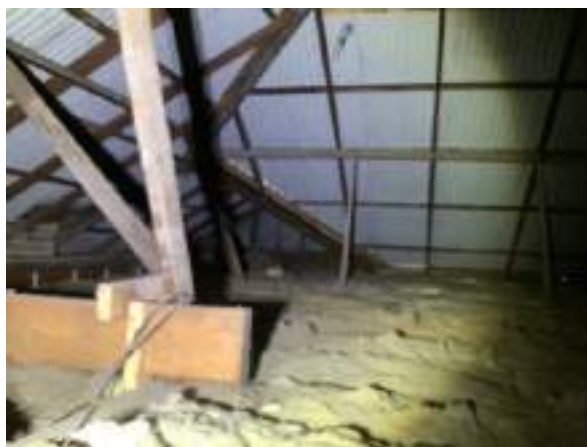
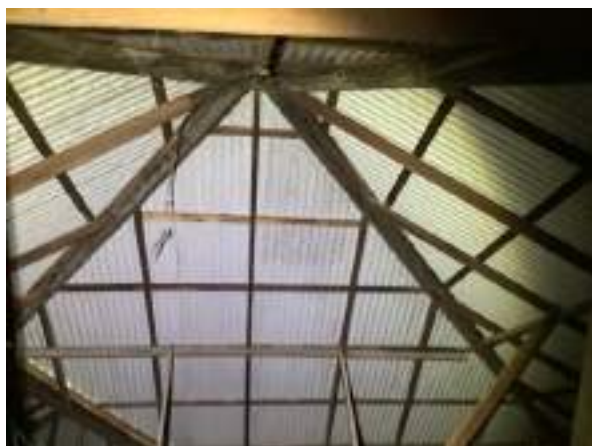
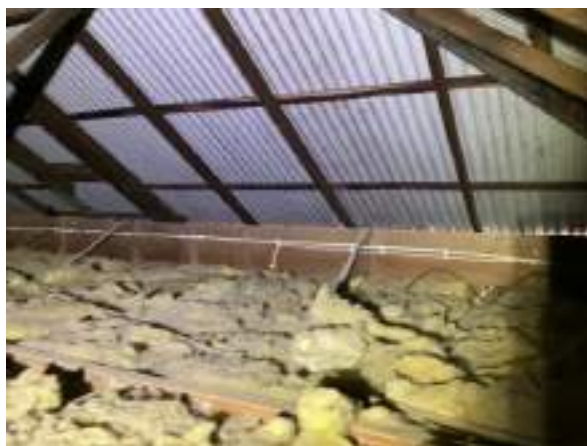
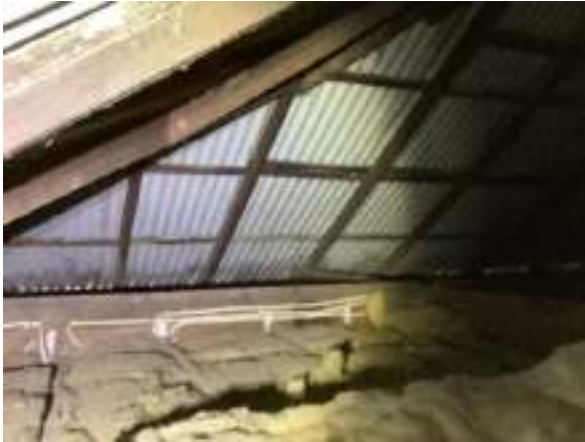
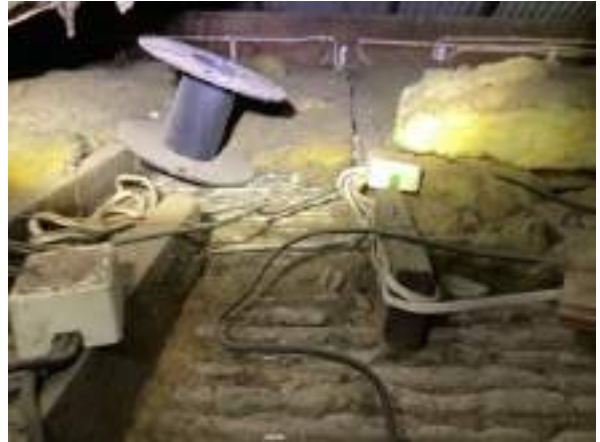
## 4.13

Location: Roof Space

These obstructions can hide an array of defects, without removing the insulation it is impossible to rule out termite activity and/or termite damage and other undetectable issues.

The property is a very high risk for termites as the environments to the property are very conducive with many susceptible areas.

Please read the report carefully and Maintenance to all susceptible and conducive areas is a MUST to minimise the risk of termite and timber pest existence and timber damage.

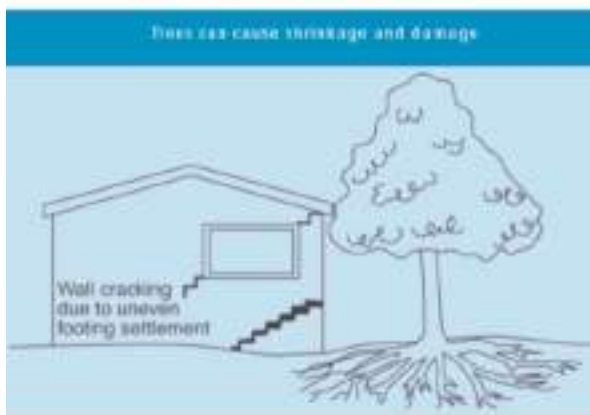
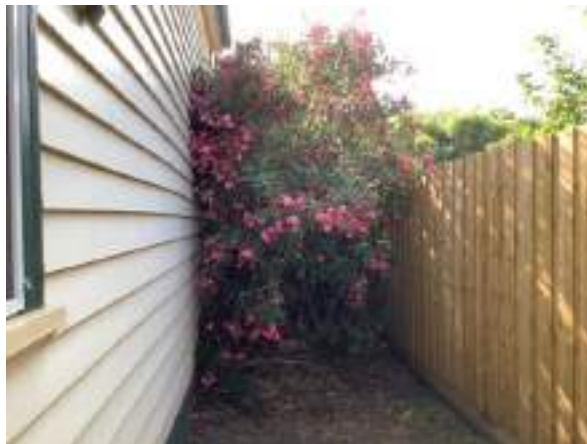
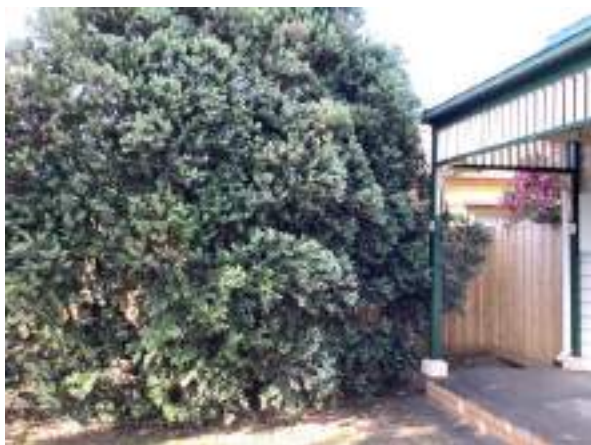
## 4.14

Location: All Garden Areas

Finding: Garden trees and vegetation - Close to building.  
Trees and other vegetation can have a significant local effect on drying of soils. Over a number of years, especially during drought conditions, adjacent trees and vegetation may draw excessive moisture from the soils. The opposite may also occur, where swelling of the soil results when the trees decline or are removed.

As the cumulative moisture deficient is reversed, the surface level around the tree (and adjoining subfloor or concrete slab) will rise and expand laterally. This is often damaging to buildings unless the foundations have been strengthened or designed to cope with the effect.

Subsidence can have complex and varying causes, which will influence the required remedial works. It is advised to begin by consulting a structural engineer to determine the required scope of works. This generally includes some form of underpinning, as well as addressing the underlying cause. Consultation with a geotechnical engineer may also be necessary.

A registered builder specialising in re-stumping / structural damage such as major brick cracking would then generally carry out works as advised by an Engineer and/or Geotechnical Engineer.

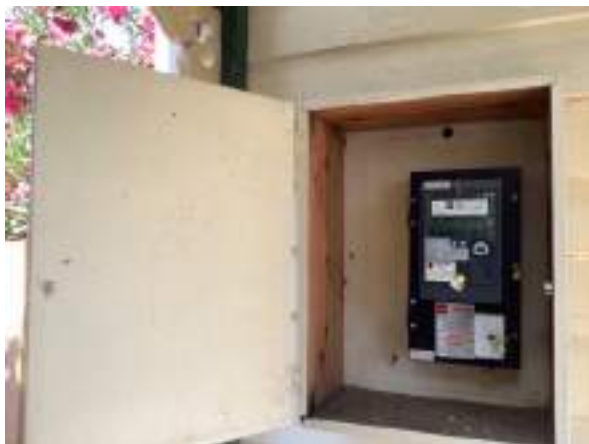
## 4.17

Location:	The Site
Finding:	<p>Termite Management System - NO evidence of installation</p> <p>The application of a post-construction chemical termite barrier and/or baiting stations or the like is highly recommended for all properties, particularly if live termite activity has been found on the site previously. Such barriers are highly effective in preventing termite attack on any timber building elements throughout the property.</p> <p>A durable notice should be placed in the switchboard unit to indicate current termite barriers.</p> <p>At the time of inspection, it appeared as though no termite management system has been installed, with no evidence to suggest preventative works taking place.</p> <p>The client may consider gaining further advice from a pest controller as to the costs and procedures involved with this application. It is recommended that obtaining such advice be a short-term priority.</p>
