## **New Construction-Handover Report (Luxury Town House)**

Inspection Date: 26 Mar 2020

Property Address: CBD Area

Report Type: New Home Construction

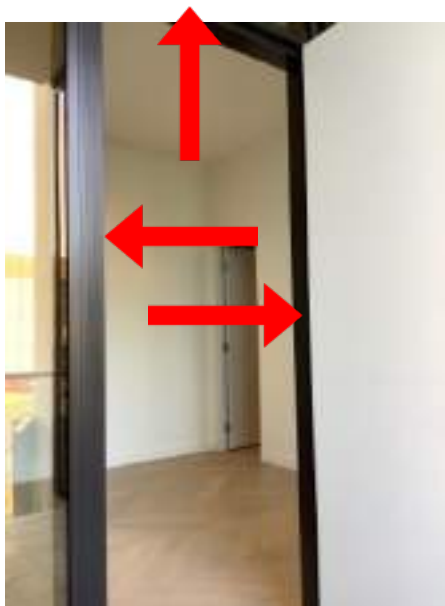
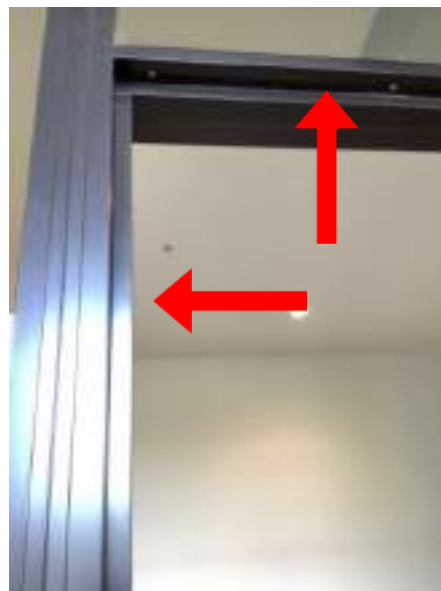
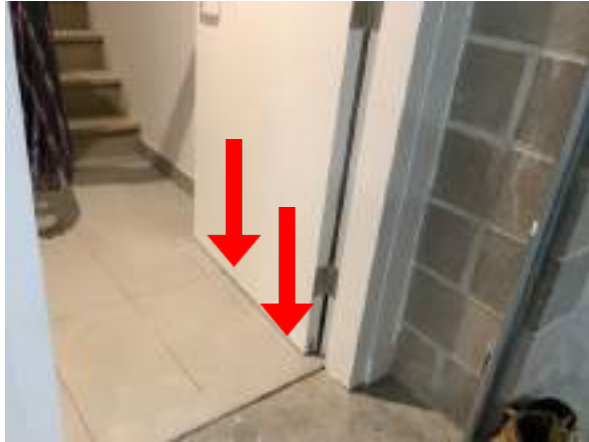
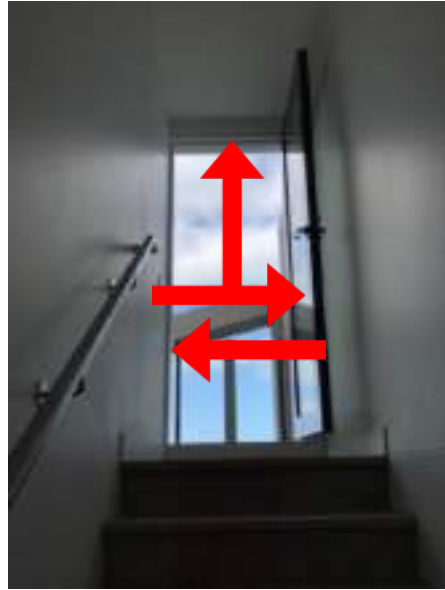
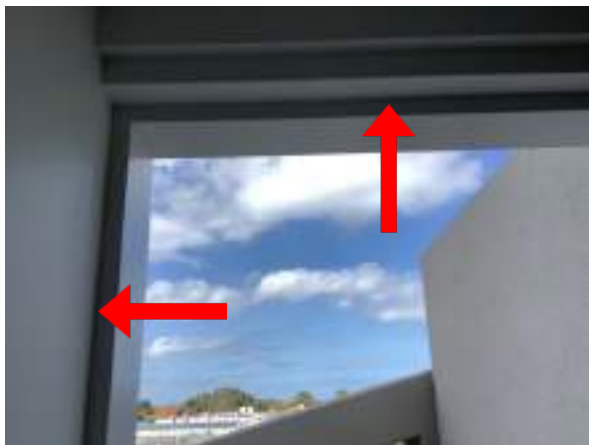
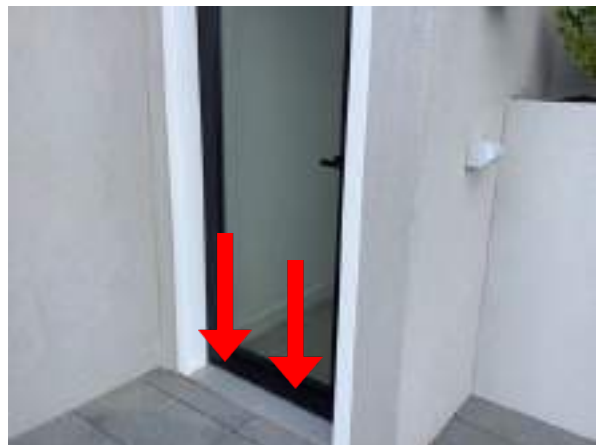
Finding: Doors (external) - Gaps and / or seals defective  
The photos attached are just a guide to the type of repairs required and are NOT all the defects related to this topic on the property.  
All interior rooms should be checked carefully to identify any further defects of the same type.

This requirement is inclusive of the garage to house entry door which must have full weather seals fitted to comply with the BCA part 3.12.3.3.

Seals required to the 3 sides of the door frame and a bottom seal to the door as well.

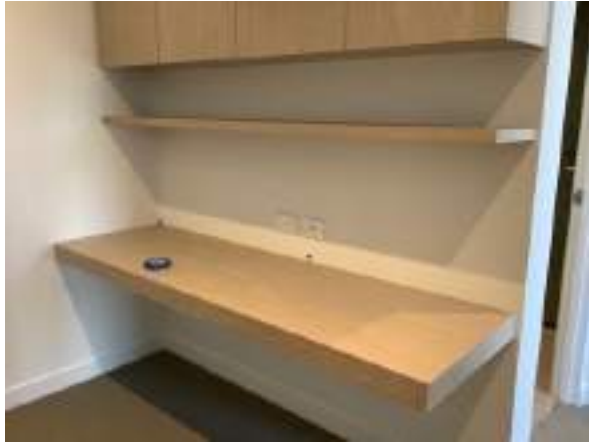
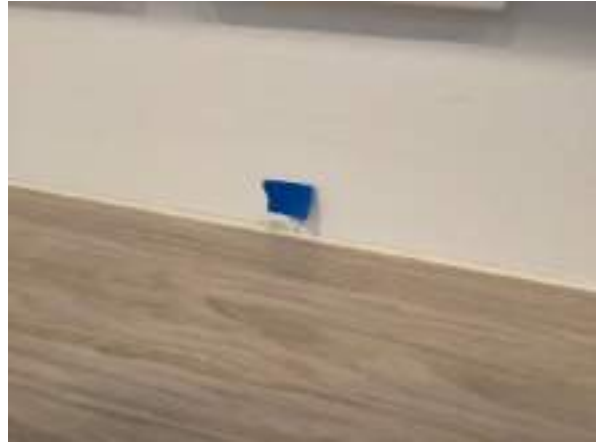
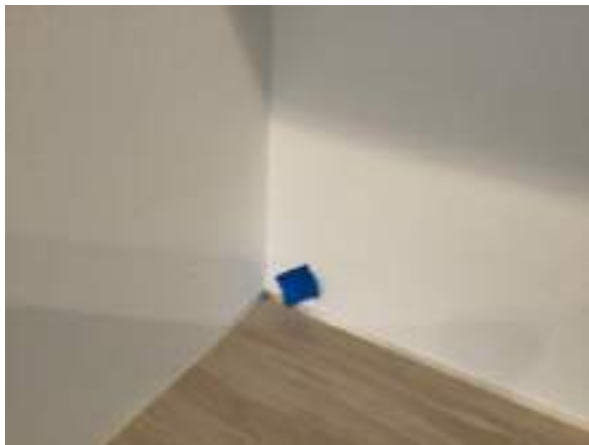
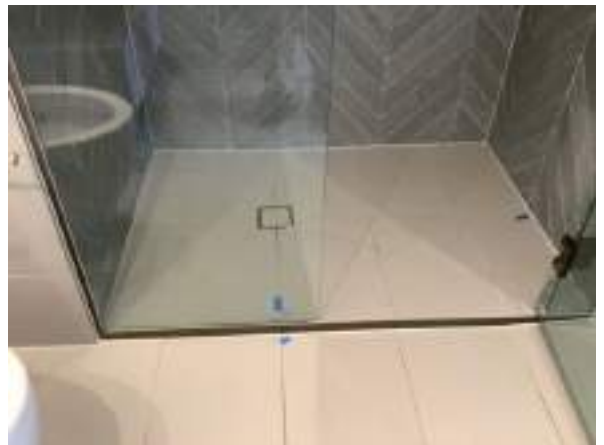
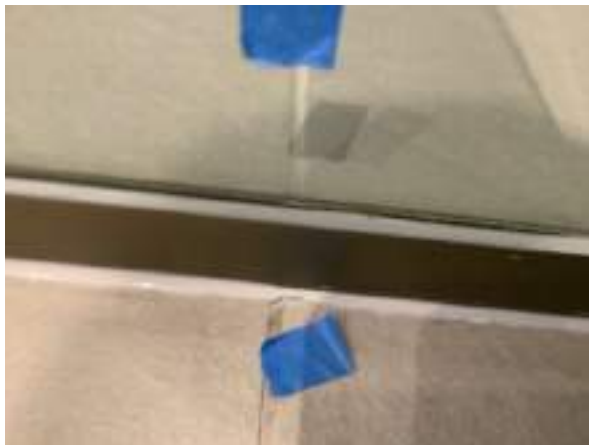
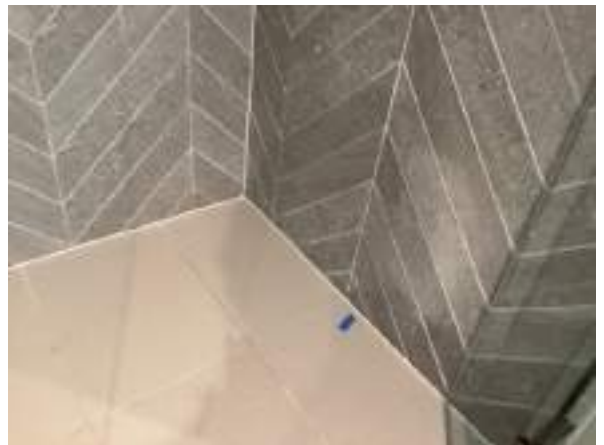
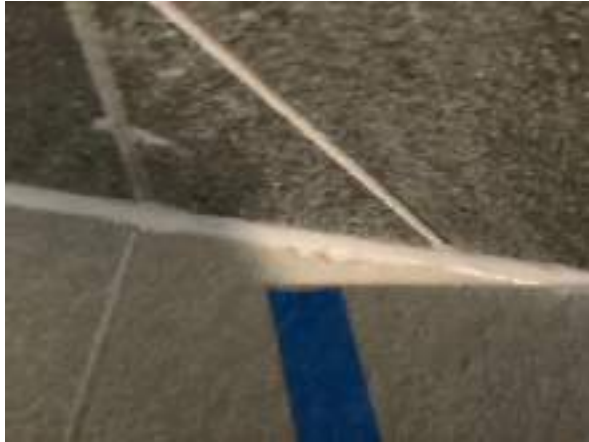
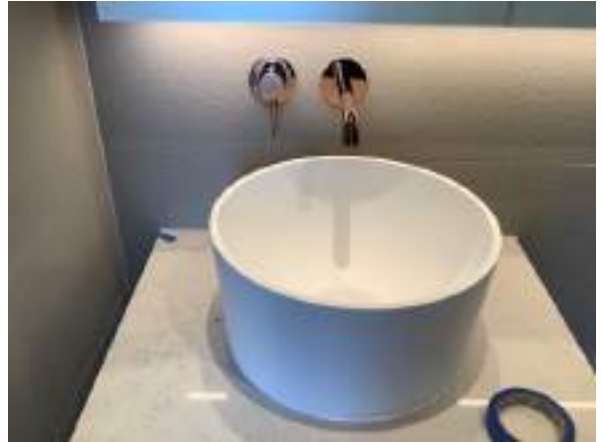
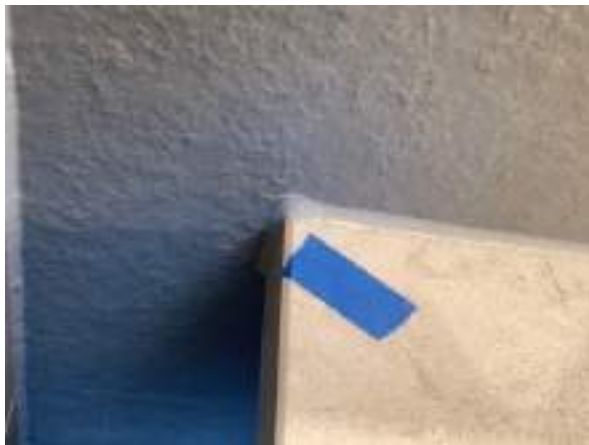
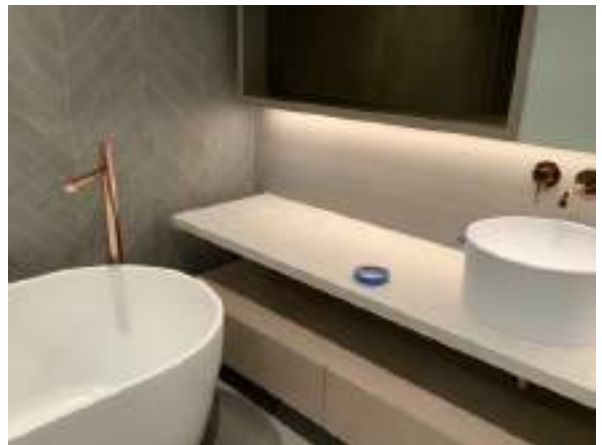
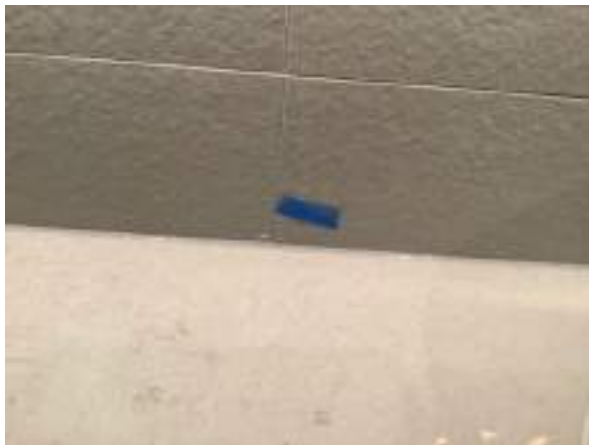
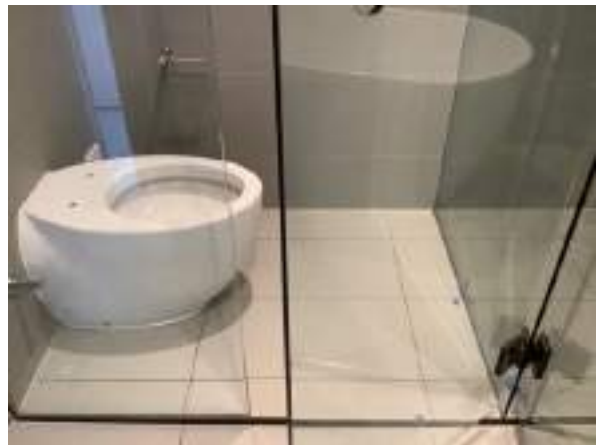
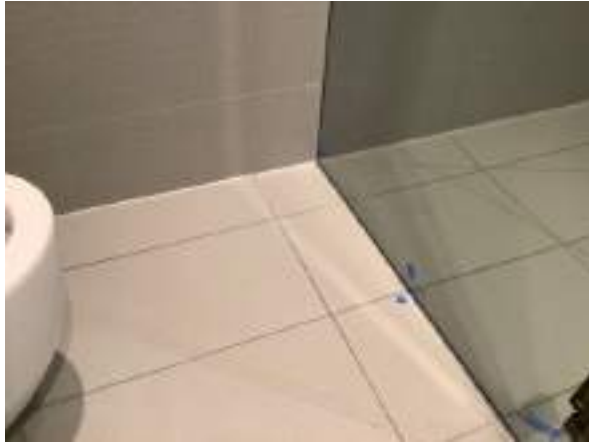
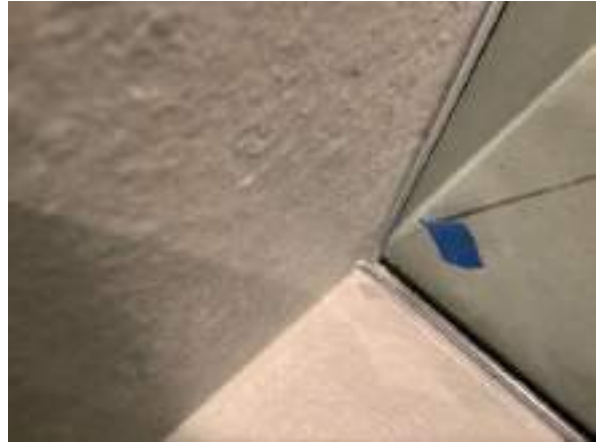
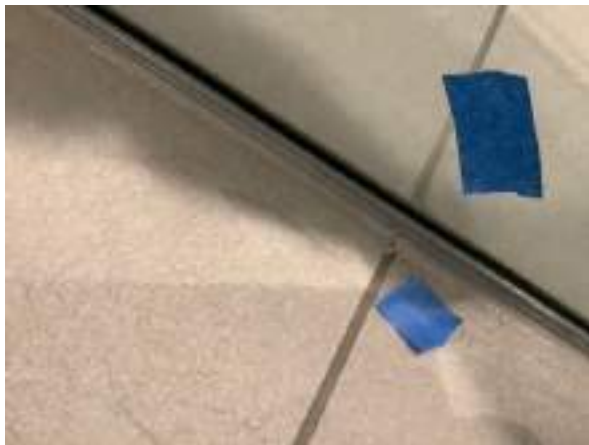
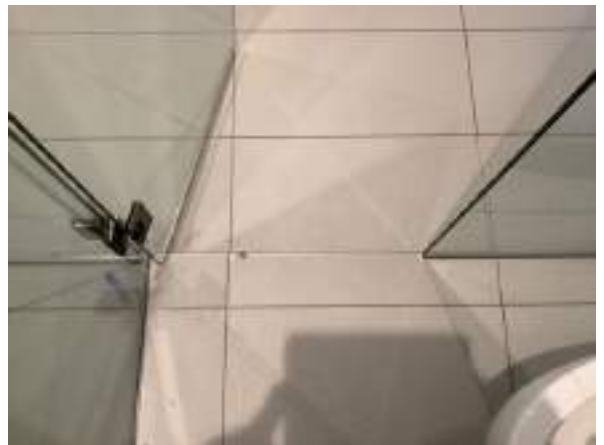
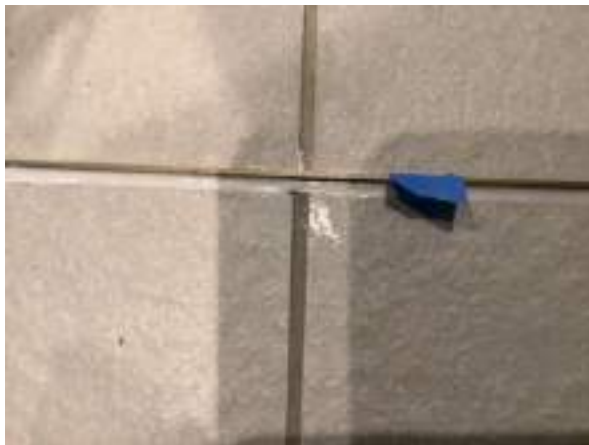
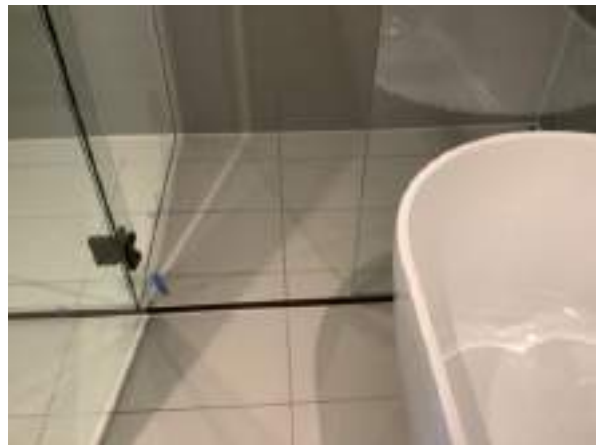
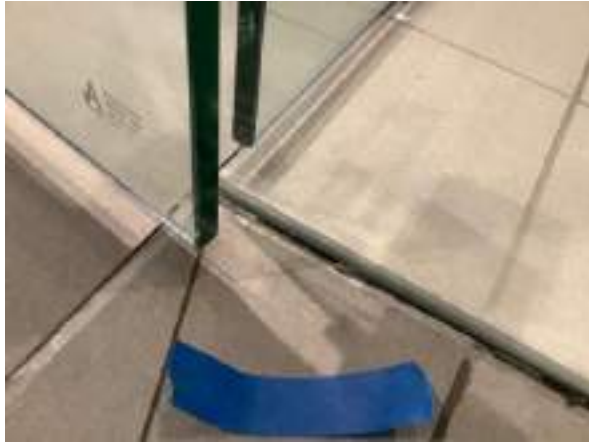
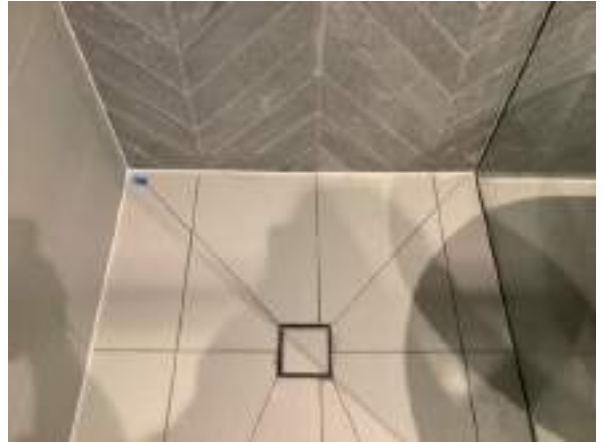
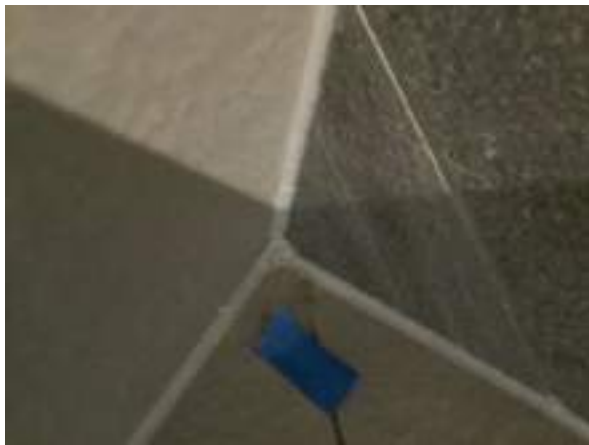
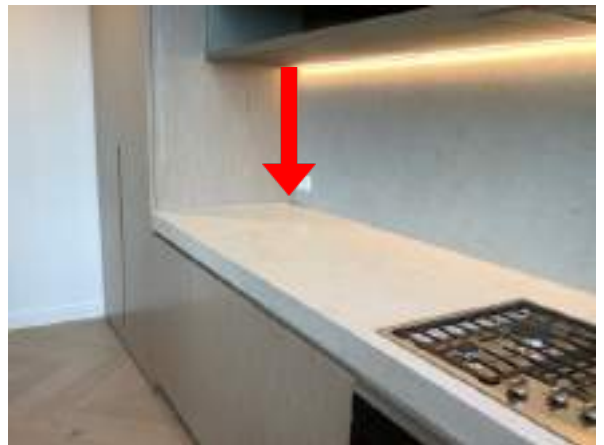
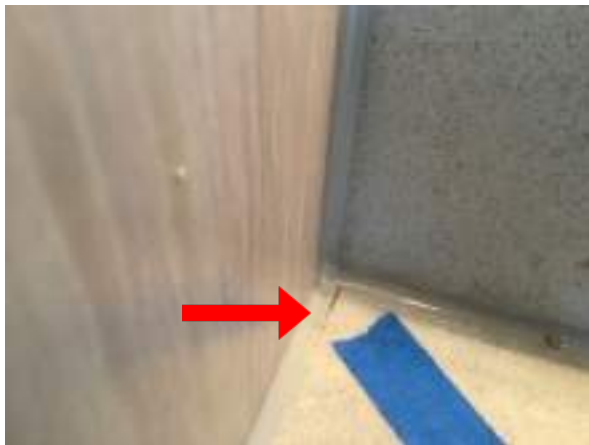
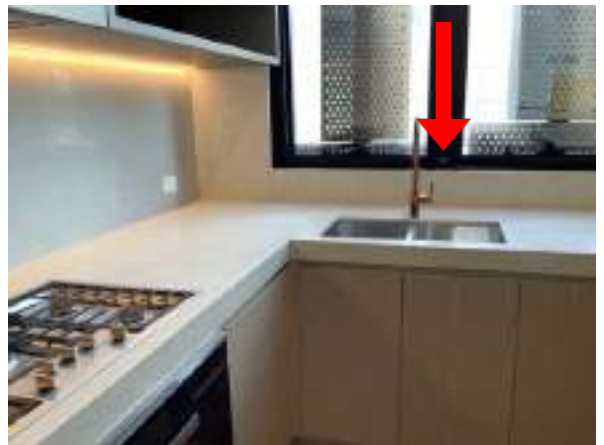
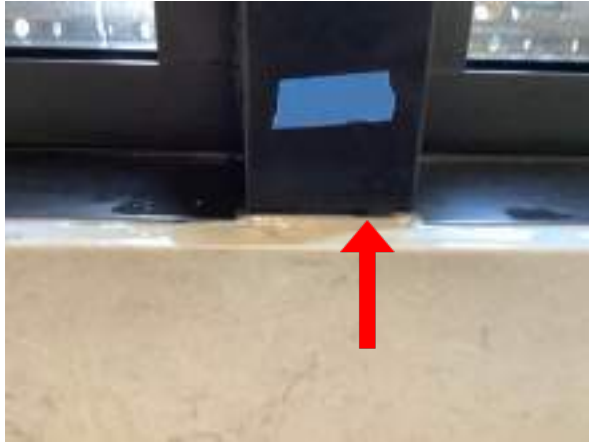
Location: Sealant / Caulking - All Areas

Finding: Sealant / Caulking - Wet Areas & Junctions.  
The photos attached are just a guide to the type of repairs required and are NOT all the defects related to this topic on the property.  
All areas to the entire property should be checked carefully to identify any further defects of the same type.

Defective Caulking To Cabinetry, Bench Tops, Tile Junctions, Cabinetry/Plaster Junctions, Etc.

It was noted on inspection that sealant is missing, inadequate and/or not completed to a tradesmens like finish.

Where required, junctions between bench tops and adjoining surfaces are defective if they are not sealed with a suitable flexible sealant of matching or agreed colour.

Seals around items such as sinks, hand basins or the like are defective if the joint leaks or they are not installed in accordance with the manufacturer's installation requirements.

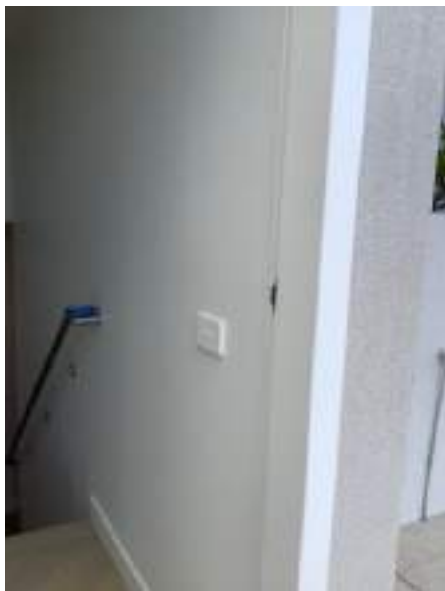
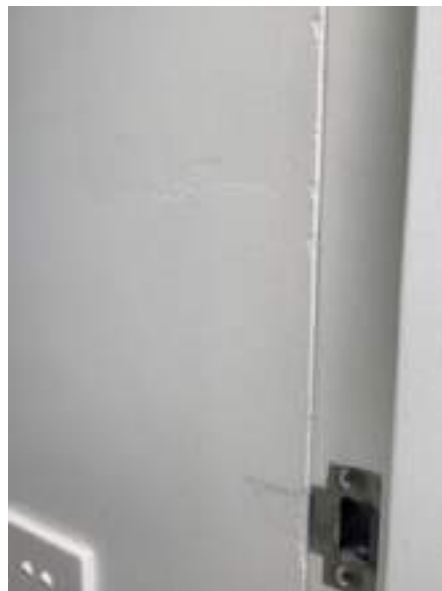
Location: Painting - All Areas

Finding: Painting - Defective (AS2311)

Areas were identified where the surface finish of the painting was found to be defective. This includes areas of minor blemishes, missing painting, over-painting, paint runs, sags , lack of paint and/or wrinkling of paint finish.

Paintwork is defective if the application results in excessive over-painting of fittings, trims, skirtings, architraves, glazing and other finished edges.

I HIGHLY RECOMMEND that the painter inspects ALL rooms and ALL areas of the building carefully to all the timber work including the skirting, architraves and doors.

I HIGHLY RECOMMEND that the painter inspects ALL rooms and ALL areas of the building carefully to all the walls and ceilings as the paint does not meet the Australian Standards and Standards and Tolerances.

All plaster work and plaster patching along with all the sanding and preparation to all the areas for repair to the plaster and timber work will require to be completed first and then the paint work.

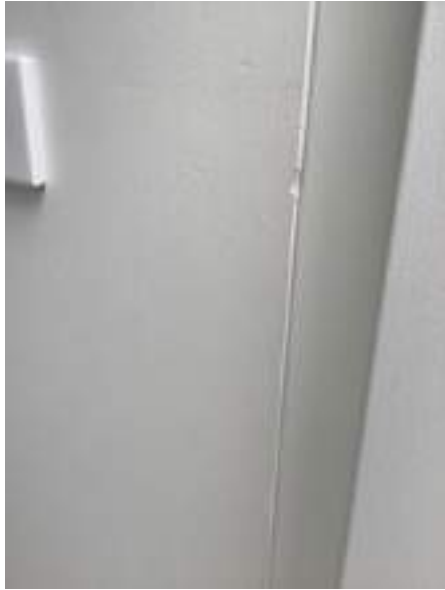
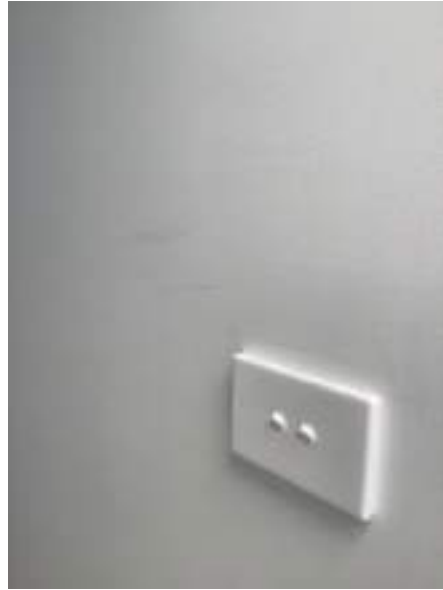
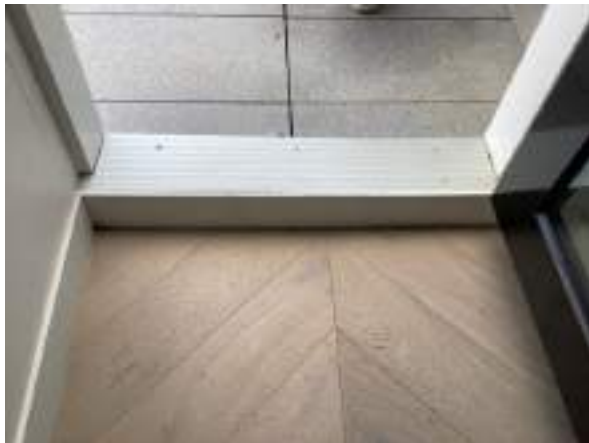
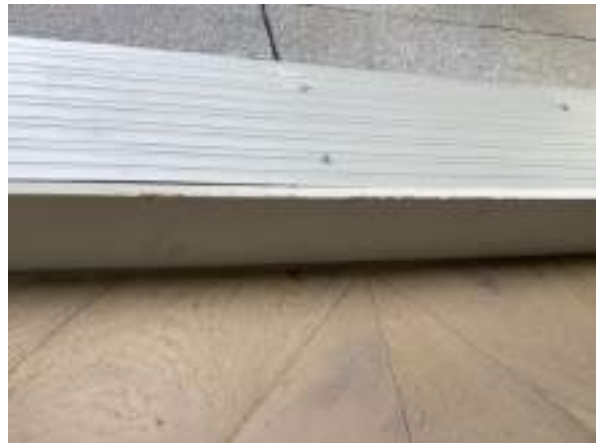
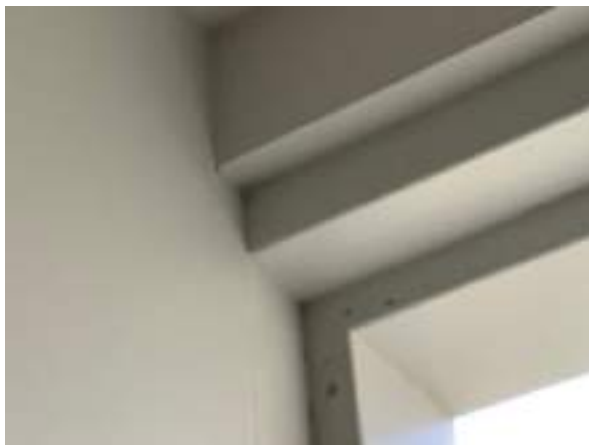
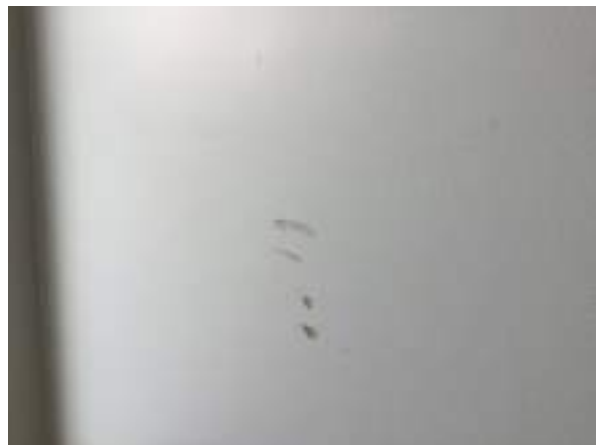
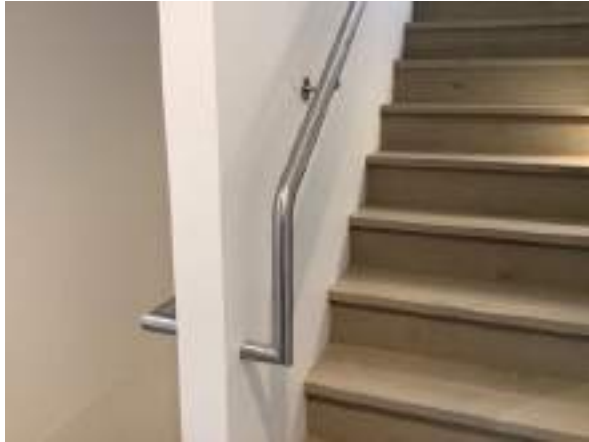
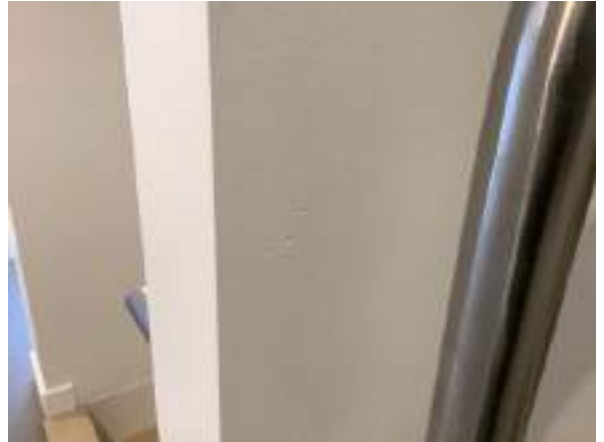
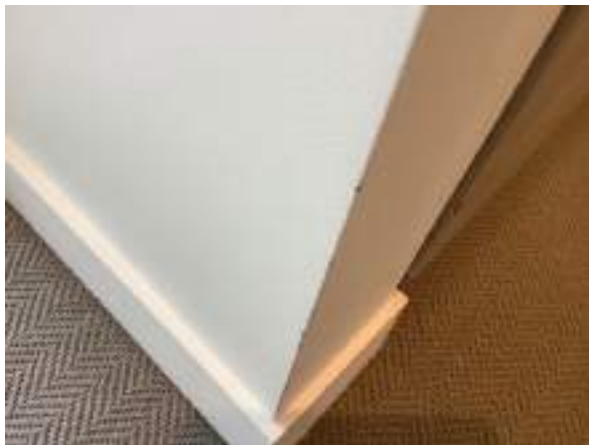
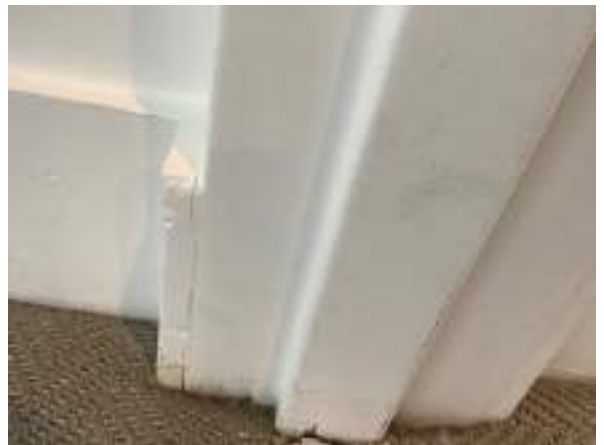
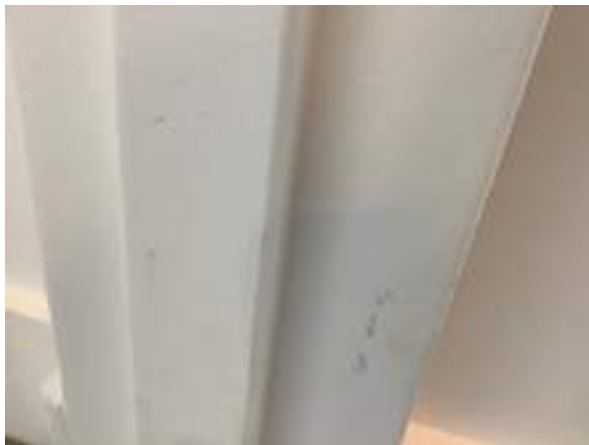
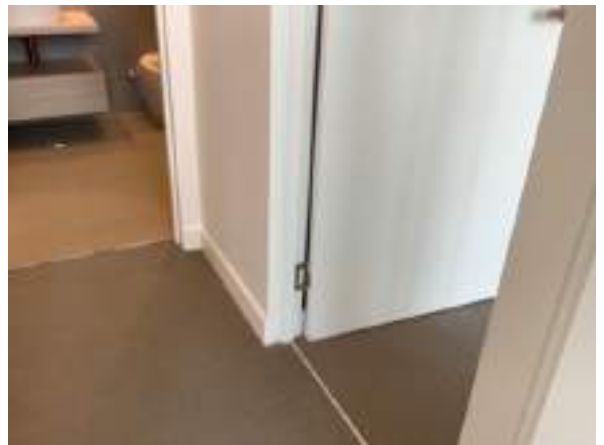
## Non Compliant 2.04

Location: Painting - All Areas  
 Finding: Paint finish excessive over painting - defective

Areas were identified where the surface finish and junctions of the painting is defective. This includes areas of excessive over painting of fittings, trims, skirtings, architraves, windows, cornices, junctions of colour changes and / or other finished edges and junctions.

Any irregularity in the surface and junctions which is visible from a normal viewing position is considered a defect.

Paintwork is defective if the application results in excessive over-painting of fittings, trims, skirtings, architraves, glazing and other finished edges.

I HIGHLY RECOMMEND that the painter inspects ALL rooms and ALL areas of the building carefully to all the timber work, walls and ceilings as the paint junctions do not meet the Australian Standards and Standards and Tolerances.

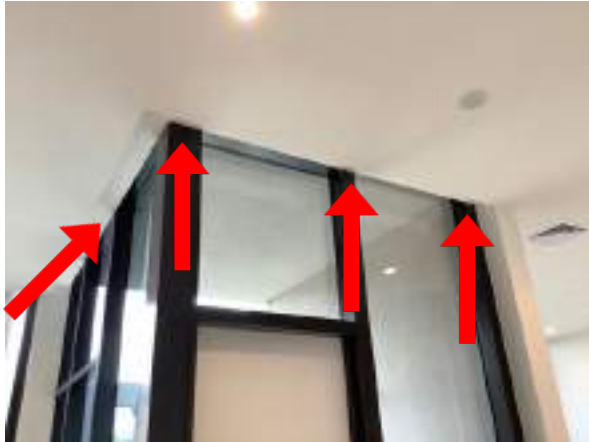
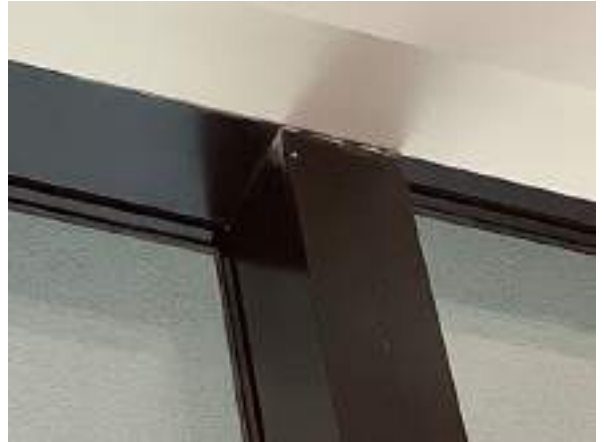
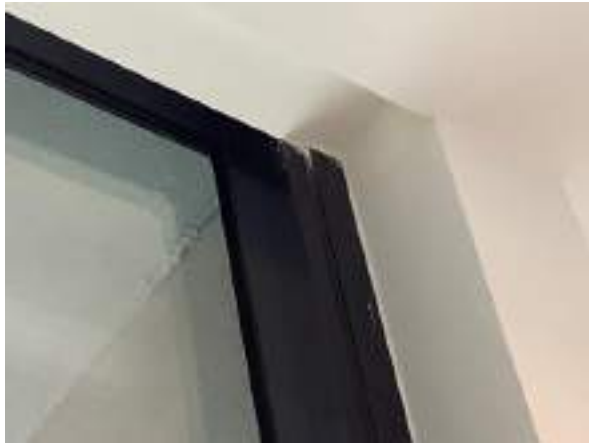
## Non Compliant 2.05

Location: Cleaning - All Areas

Finding: Cleaning Defective - Floors, Tiles, Glass, Bathroom fittings and fixtures, Etc  
I have ONLY taken LIMITED photos of this defect and attached are LIMITED photos of this defect in SOME AREAS ONLY.  
All AREAS to the entire property should be checked CAREFULLY to identify any further defects that are the same, as this defect is in other areas of the property.

It was identified that the cleanliness and degree of finish for fixtures and fittings is substandard. Fittings and fixtures including sinks and bathtubs are required to be as new prior to handover. Evidence of damage marks scuffs and dirt need to be removed where present.

The Building Commission's, Guide to Standards and Tolerances clause 18.09 Cleaning, states- 'Owners are entitled to expect that the building site and works are clean and tidy on completion. Building works are defective where windows are not clean, floors are not swept, mopped or vacuumed as appropriate, tiles, sinks, basins, troughs, baths, etc. are not cleaned and shelving, drawers and cupboards ready for use.'

Once the cleaners have properly completed all of this work, all of the glazing, mirrors, cupboards, baths, shower bases, shower screens, floor coverings, walls, stairs, garage floor, fixtures and fitting etc, should all be thoroughly checked again for any scratches and damage which may have occurred, prior to handover proceeding.

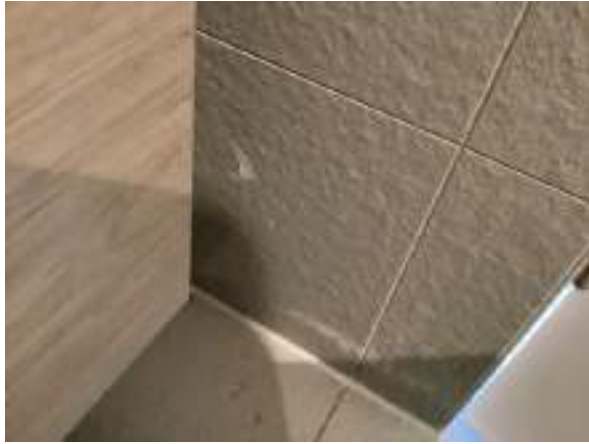
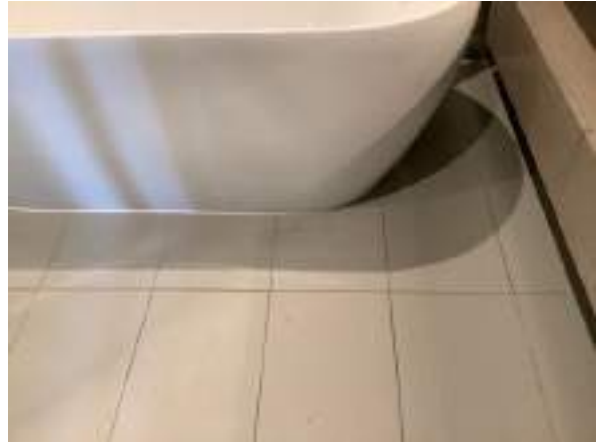
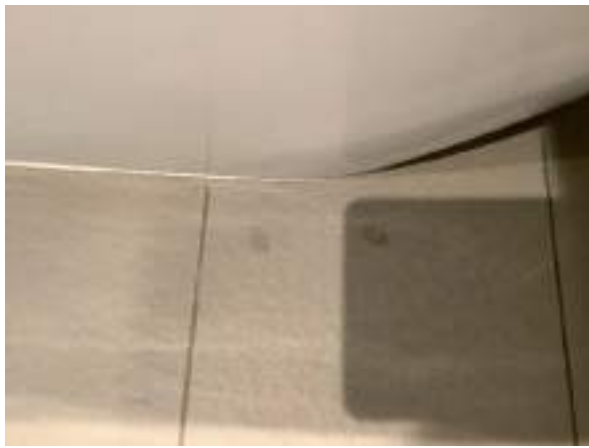
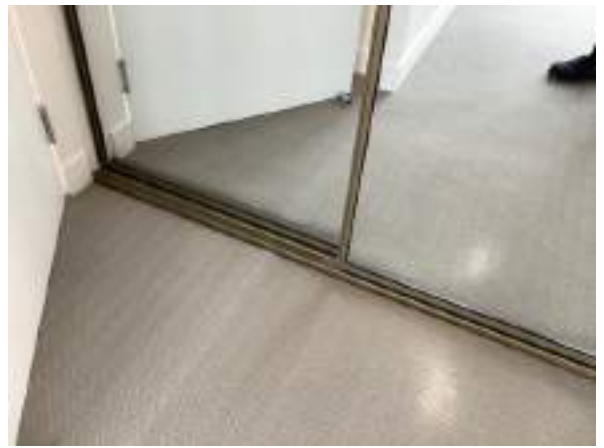
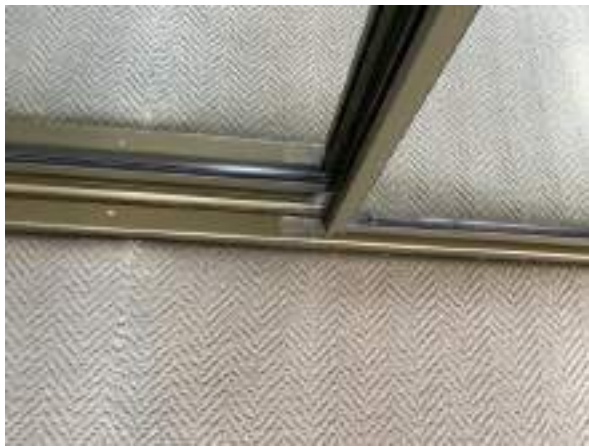
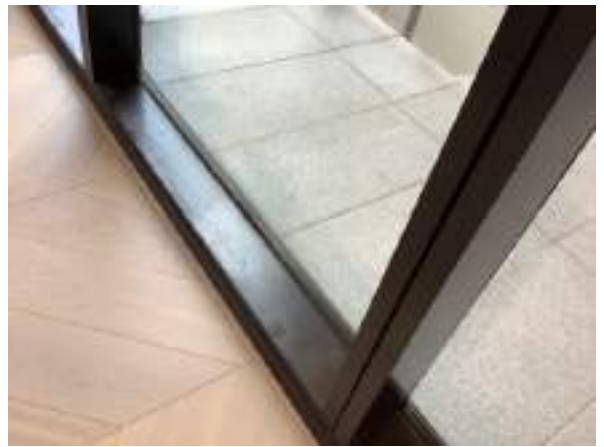
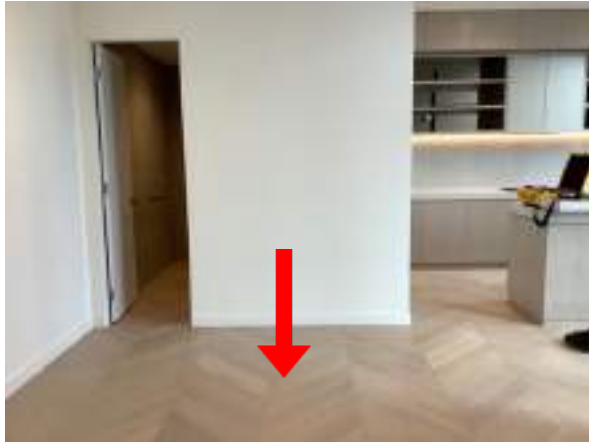
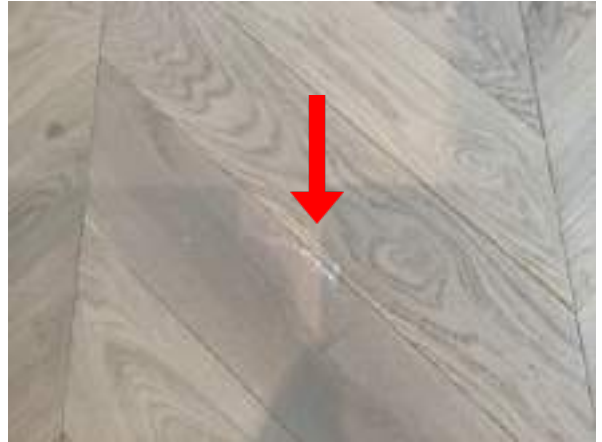
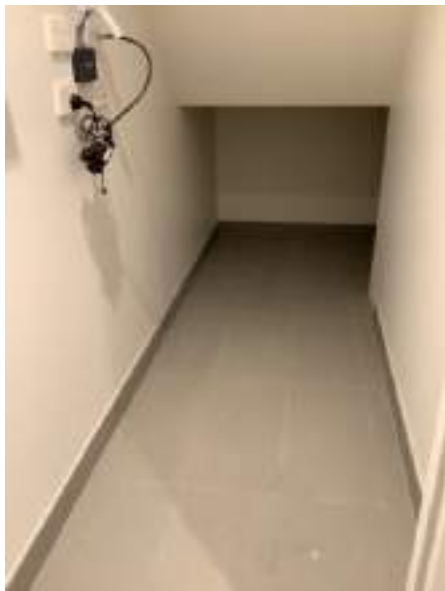
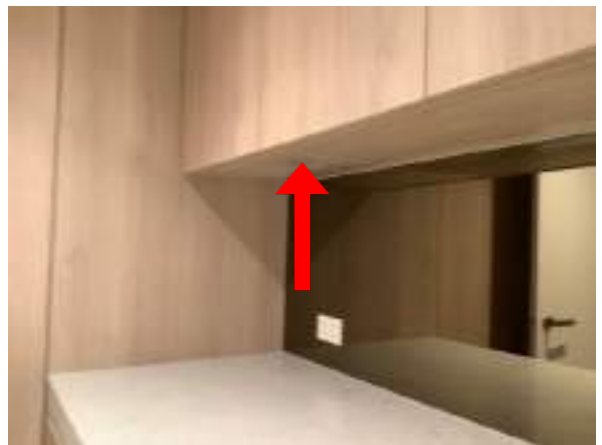
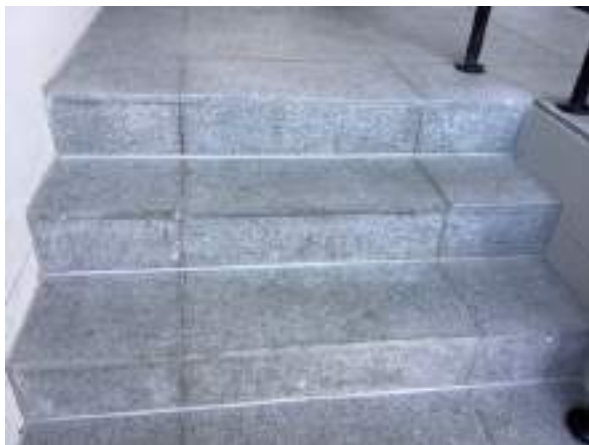
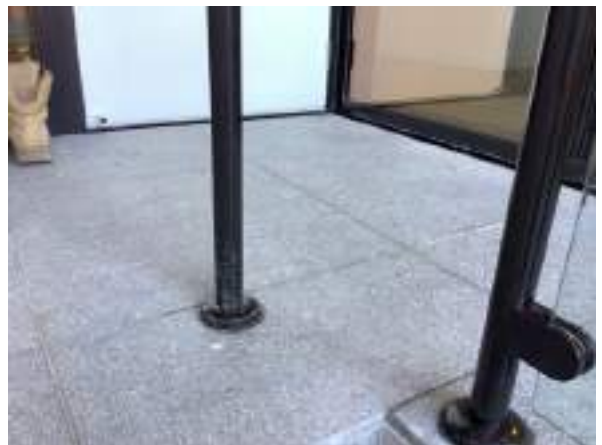
## Non Compliant 2.06

Location: Damages/ Faults - Internal

Finding: Damages/ Faults - Appliances / Fittings / Tiles, Etc  
All areas to the entire property should be checked carefully to identify any further defects of the same type.

It is identified that damage or faults affecting tiles, appliances and / or fittings supplied as part of the building contract have occurred. Where this is due to the builder's workmanship or damage occurring during construction it is considered a defect with respect to Standards and Tolerances - 18.02.
