Practical Completion Report (Final)

Inspection Date: 5 Feb 2020

Company Name: Master Property Inspections

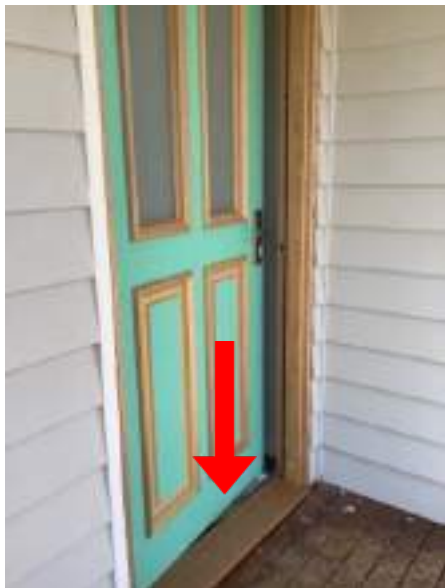
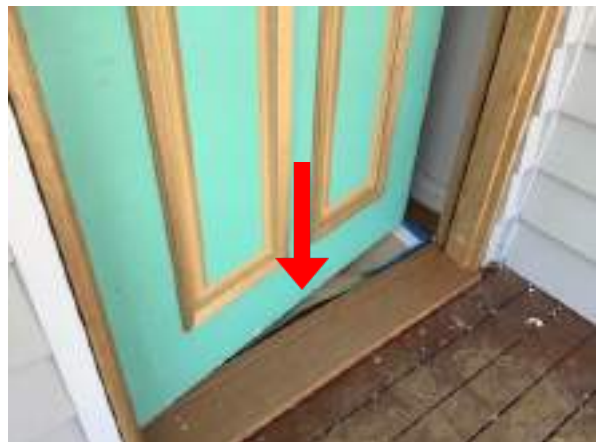
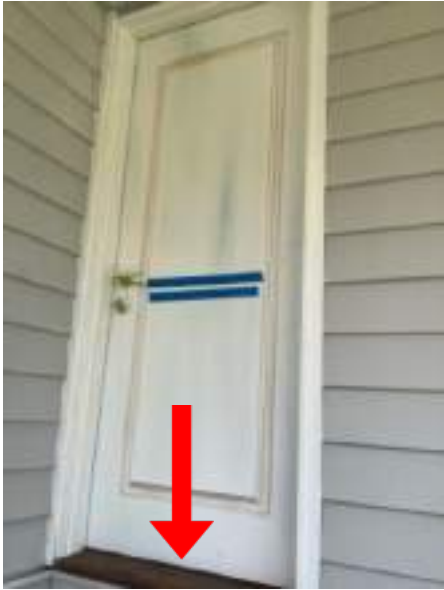
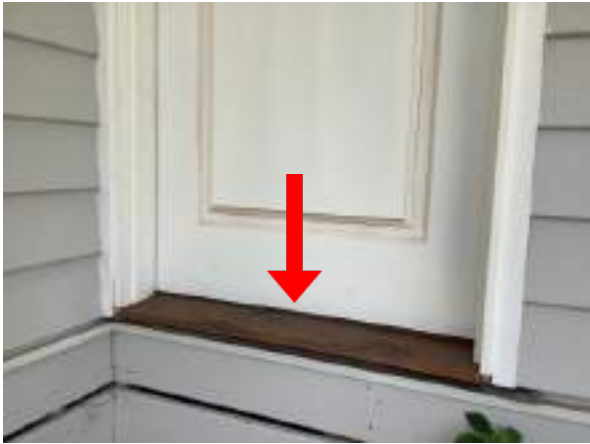
Finding: Doors (external) - Gaps and / or seals defective
The photos attached are just a guide to the type of repairs required and are NOT all the defects related to this topic on the property.
All interior rooms should be checked carefully to identify any further defects of the same type.

This requirement is inclusive of the garage to house entry door which must have full weather seals fitted to comply with the BCA part 3.12.3.3.

Seals required to the 3 sides of the door frame and a bottom seal to the door as well.

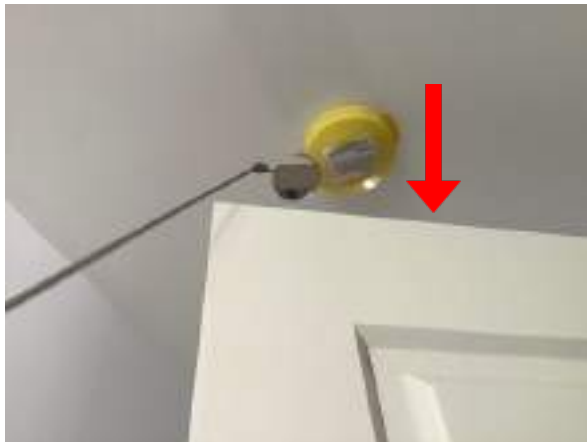
2.02

Finding: Doors Paint-Tops & Bottoms Not sealed (AS2688)
 I have ONLY taken LIMITED photos of this defect and attached are LIMITED photos of this defect in SOME AREAS ONLY.
 All AREAS to the entire property should be checked CAREFULLY to identify any further defects that are the same, as this defect is in other areas of the property.

The paint finish is missing to the tops and bottoms of the doors.

It was found at the time of inspection that the doors have not been adequately sealed.

Tops and bottoms of all external and internal doors must be sealed to uphold manufacturer warranty conditions and to comply with Section 8.06 of the Guide to Standards and Tolerances, 2015.

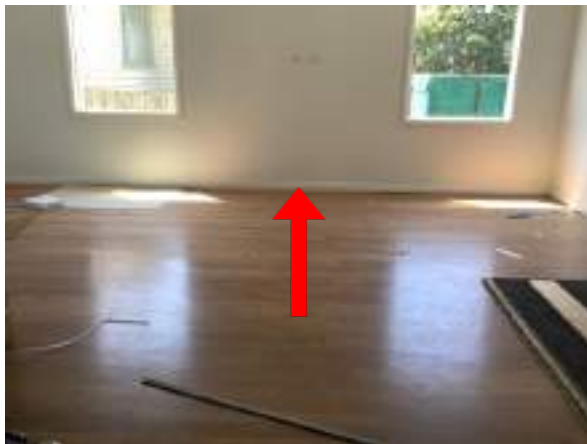
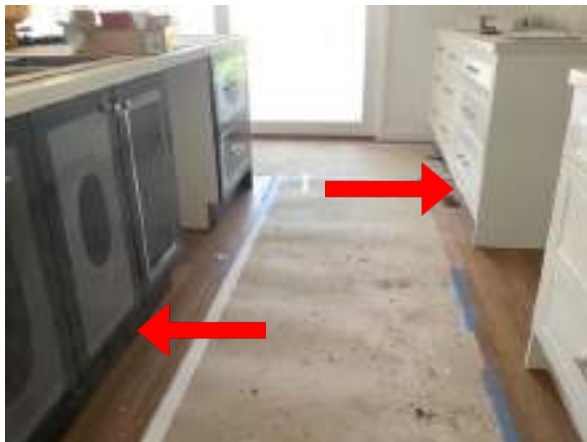
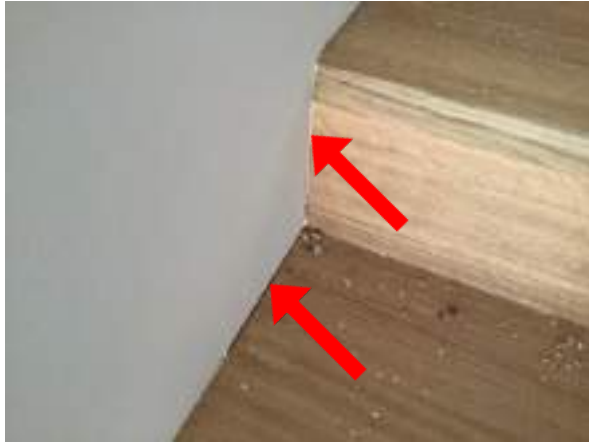
2.04

Finding: Sealant / Caulking - Missing Floor Areas.
Caulking / Silicon - Missing, Required To Bottom Of Skirtings, Door Frames, Entrances, Kitchens, Toilets, Garages or Similar To Protect Skirtings & Timbers From Moisture & Water Damage.

It was noted on inspection that sealant and/or caulking is not to the bottom of all the skirtings, where the skirting is on top of the timber flooring or floor tiles.

Garages in particular are subjected to sometimes high levels of incoming water through incoming rain and/or hosing and/or moisture, which is all very typical and it is very common to identify swollen skirtings in these type of areas.

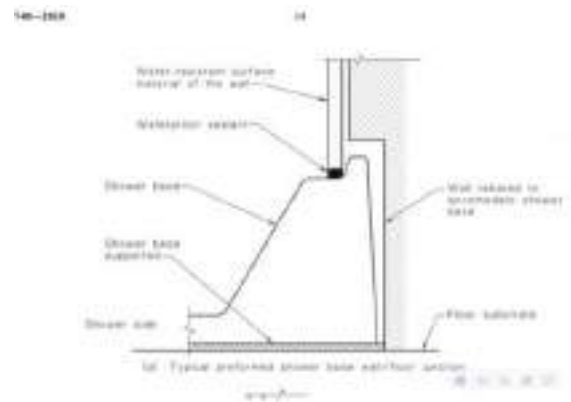
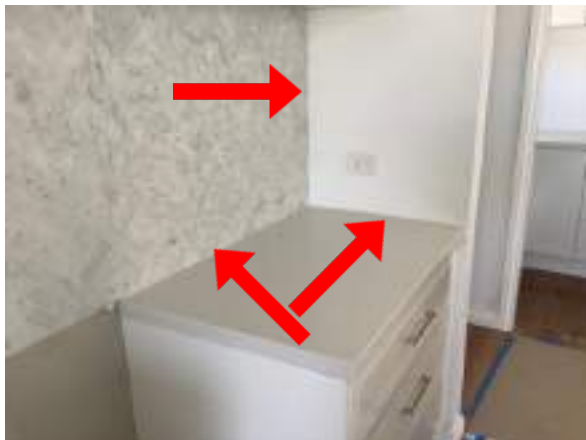
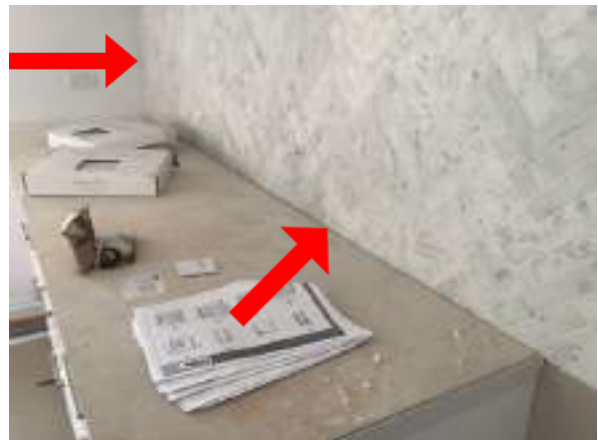
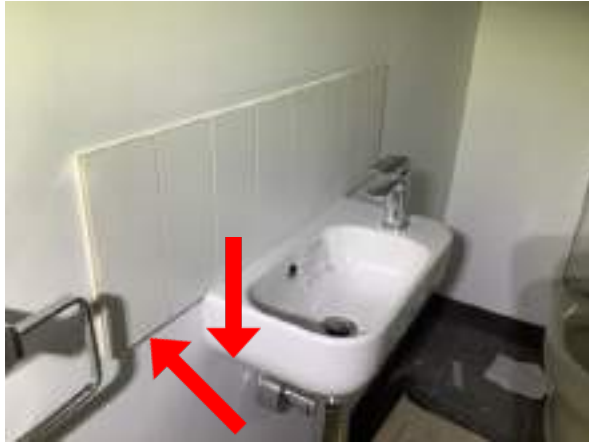
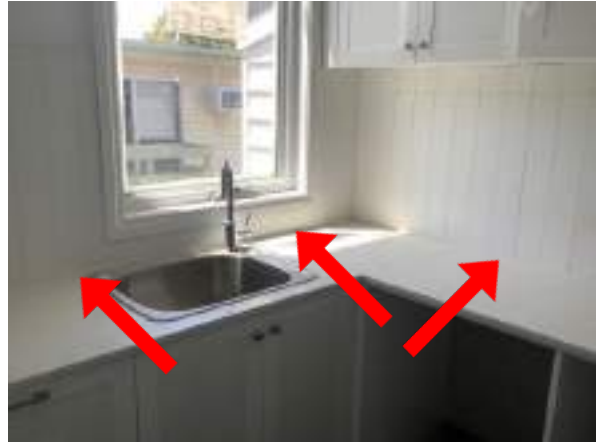
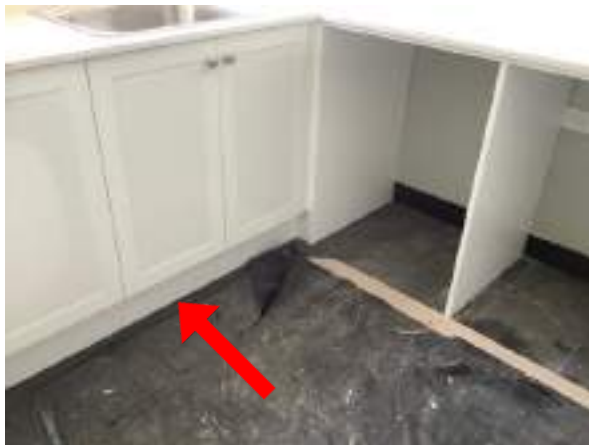
2.05

Defective Caulking To Cabinetry, Bench Tops, Tile Junctions, Cabinetry/Plaster Junctions, Etc.

It was noted on inspection that sealant is missing, inadequate and/or not completed to a tradesmens like finish.

Where required, junctions between bench tops and adjoining surfaces are defective if they are not sealed with a suitable flexible sealant of matching or agreed colour.

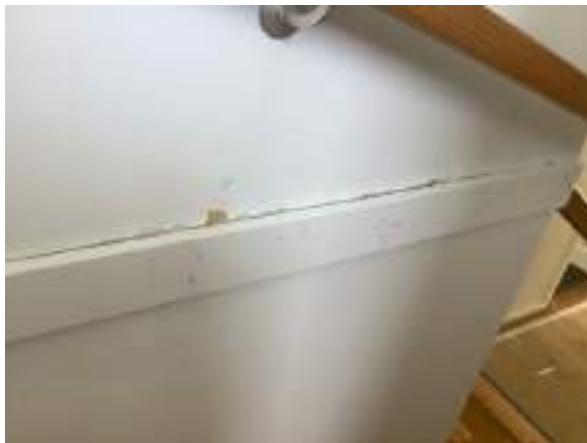
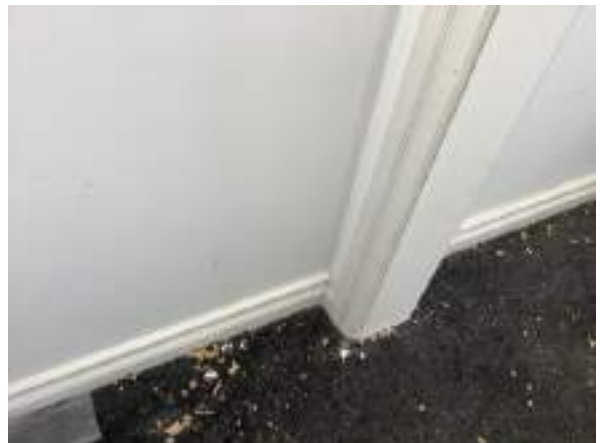
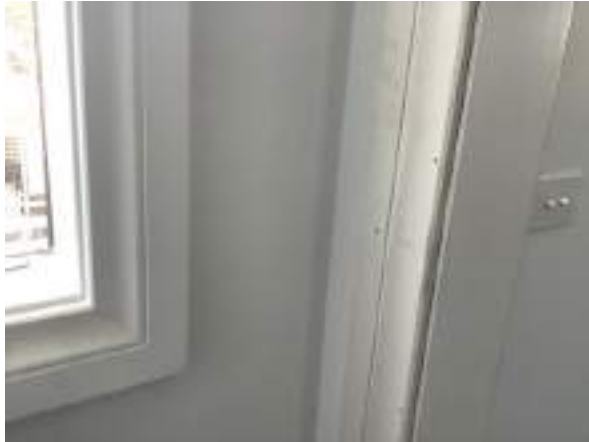
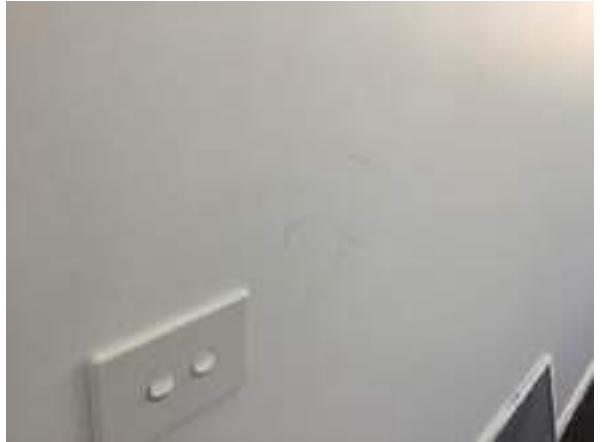
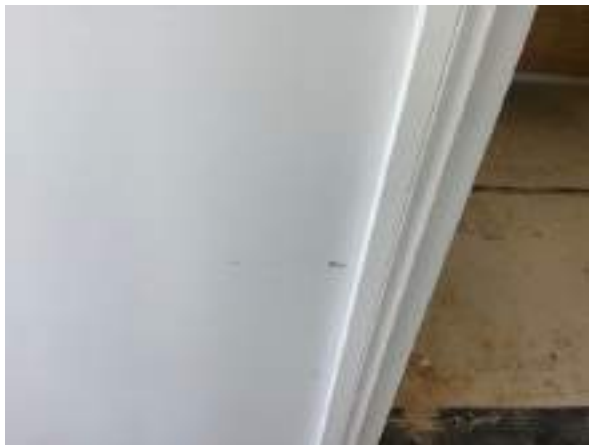
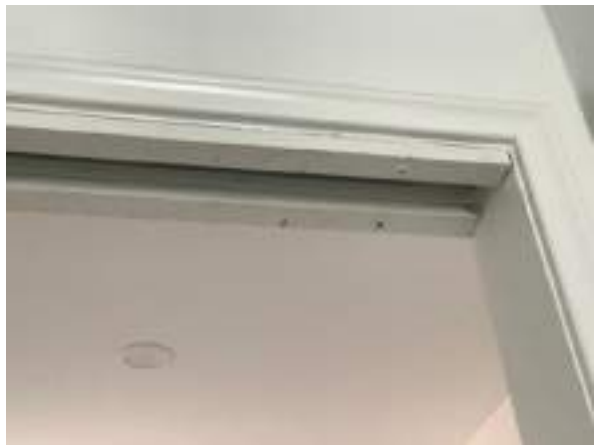
2.06

Location: Painting - All Areas

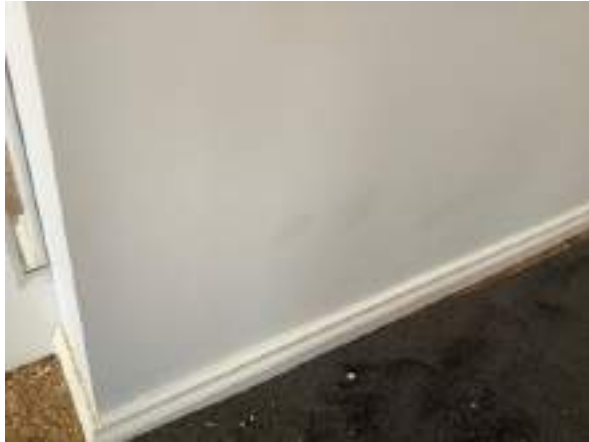
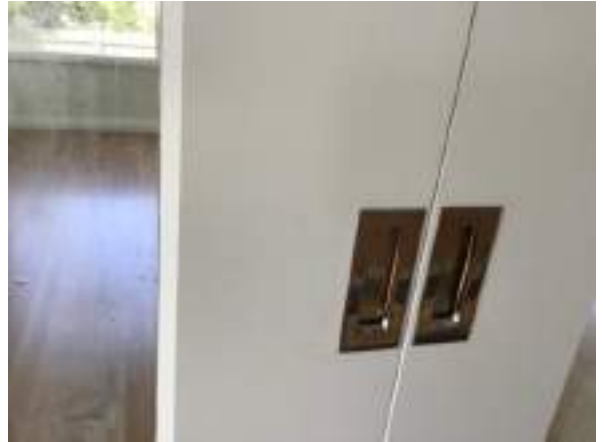
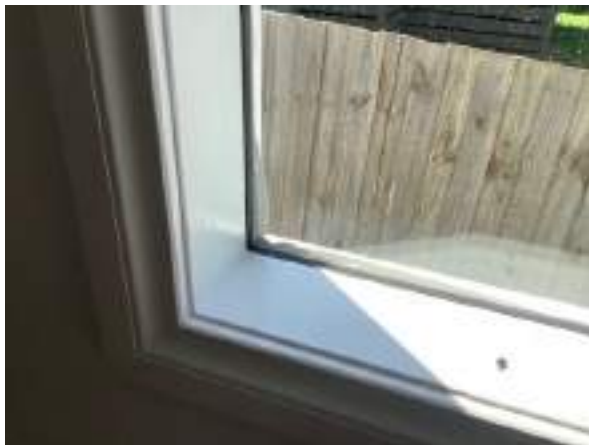
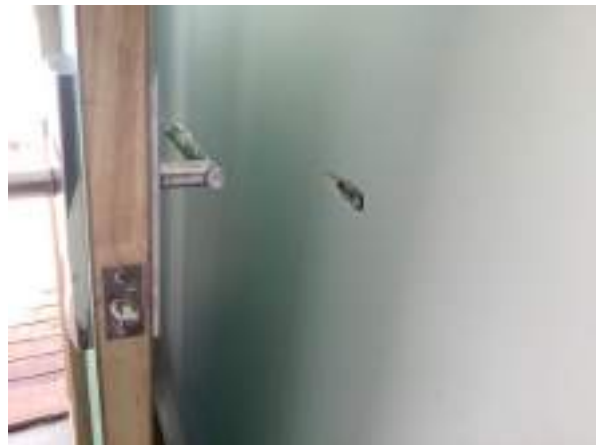
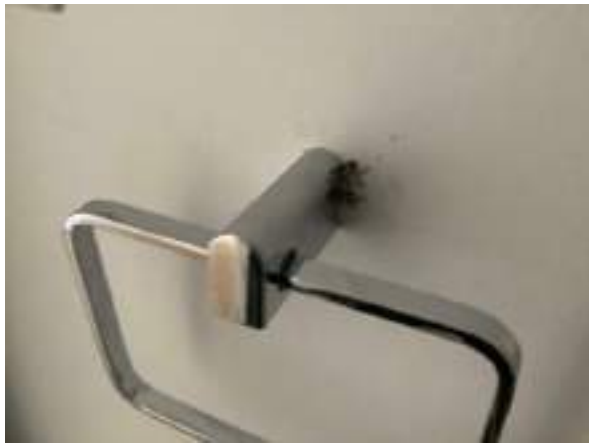
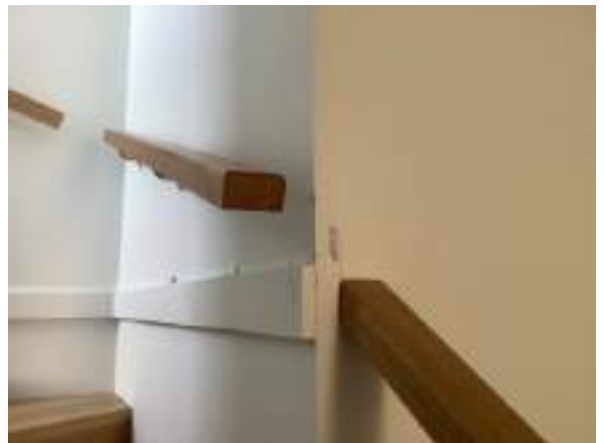
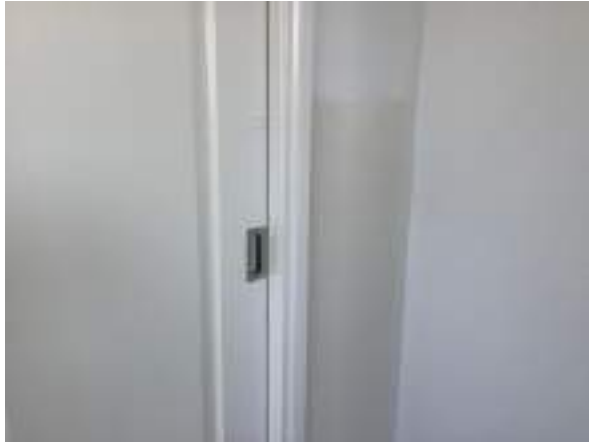
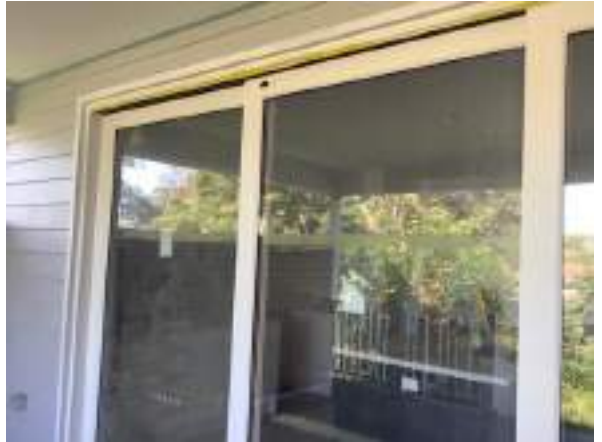
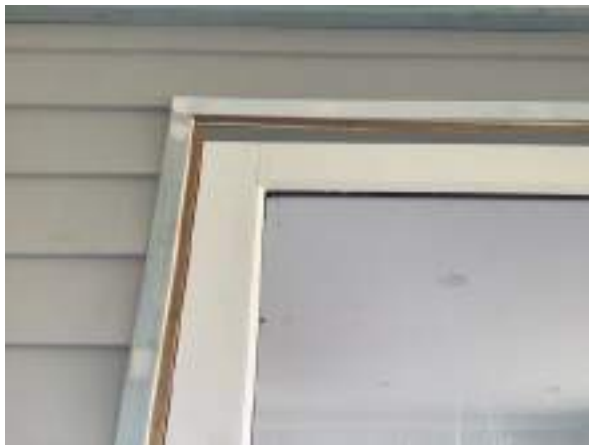
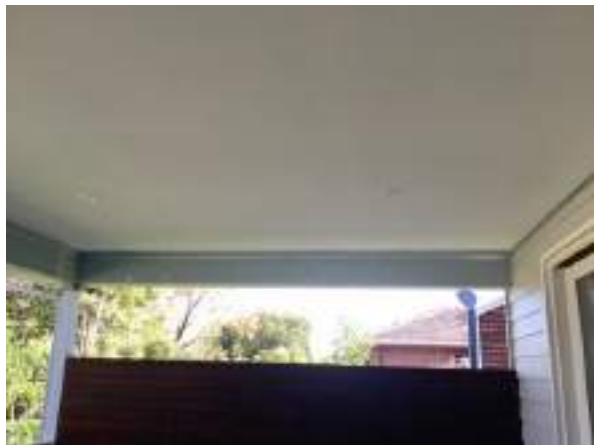
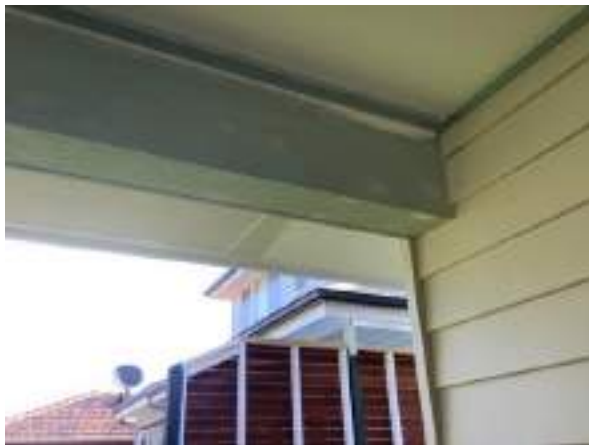
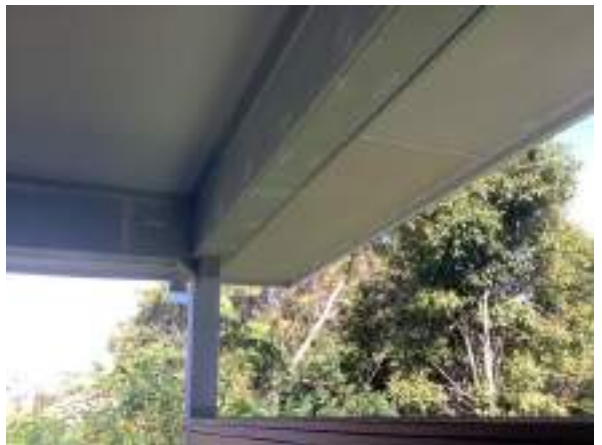
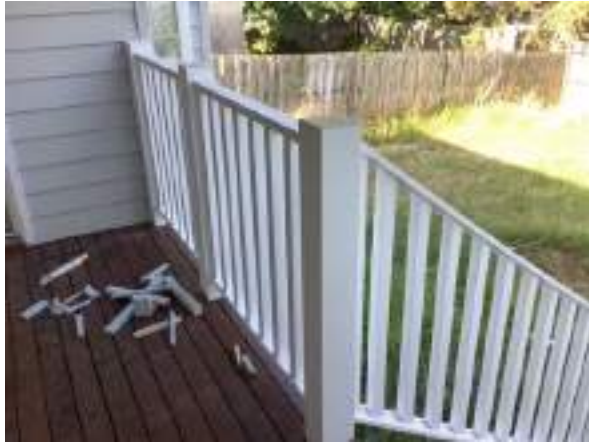
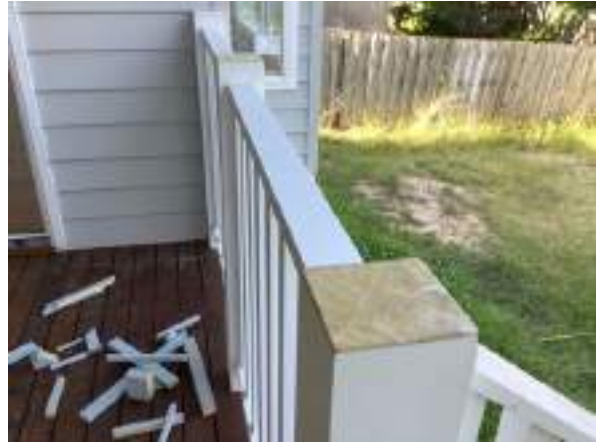
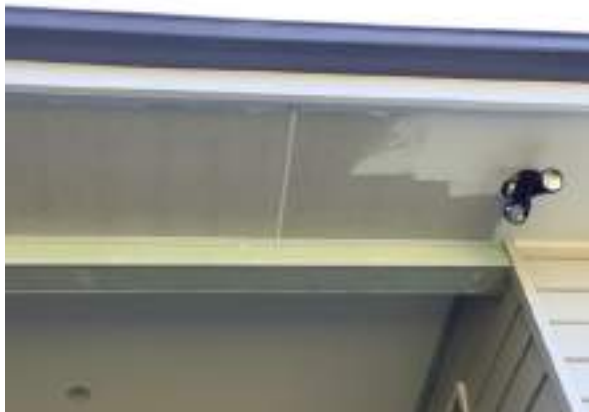
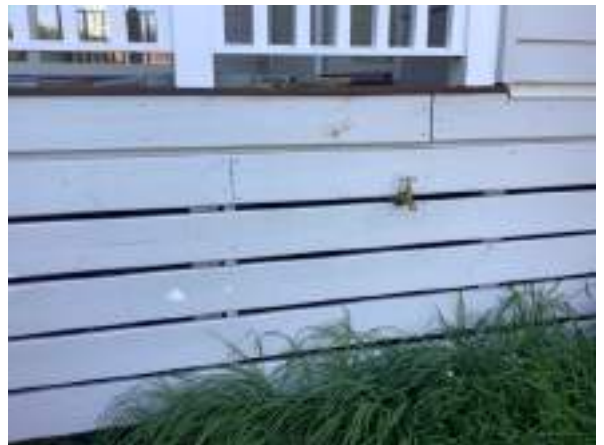
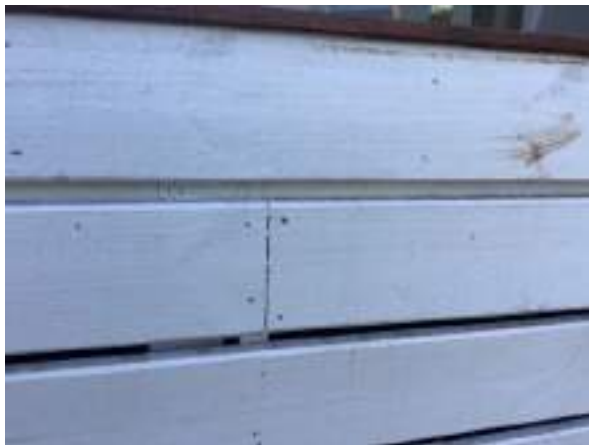
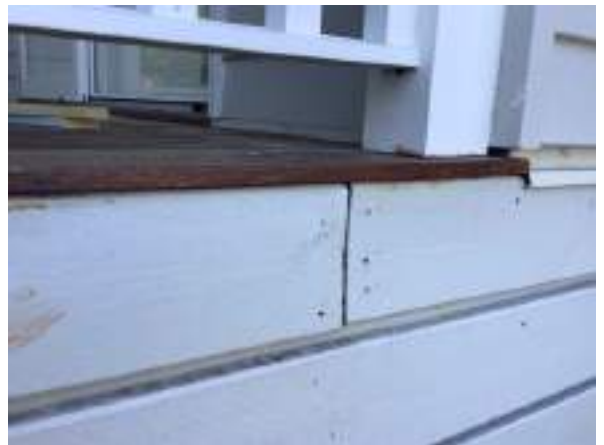
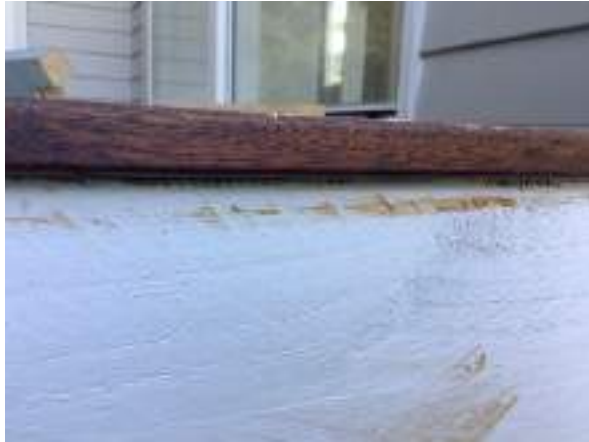
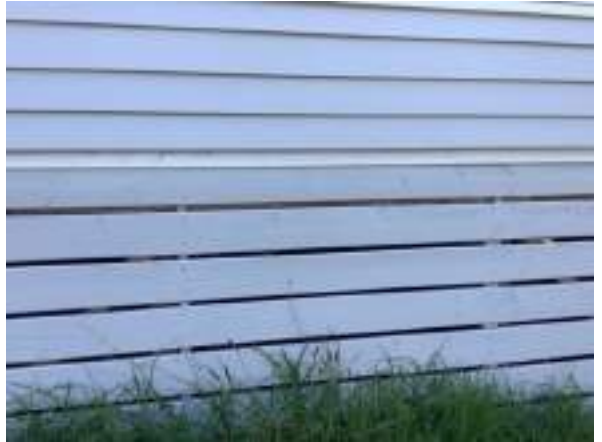
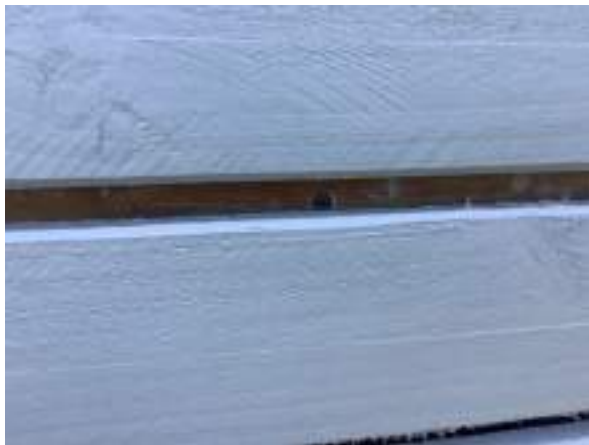
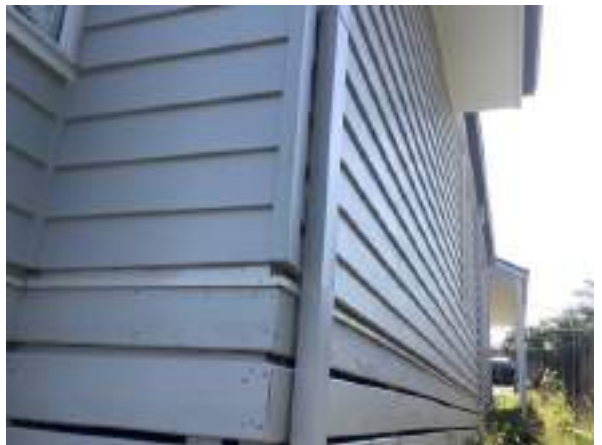
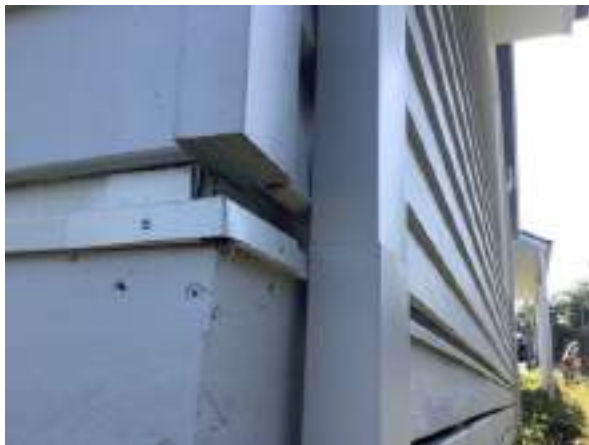
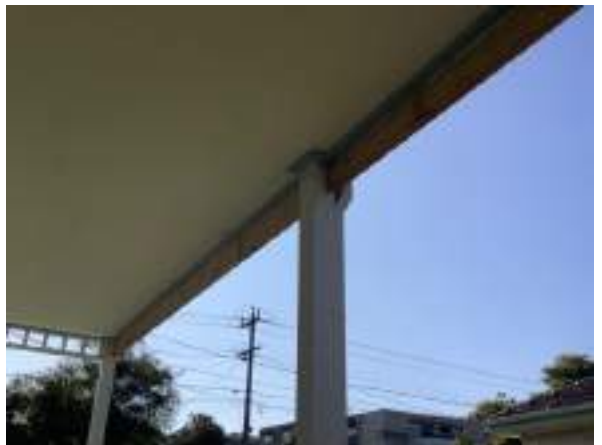
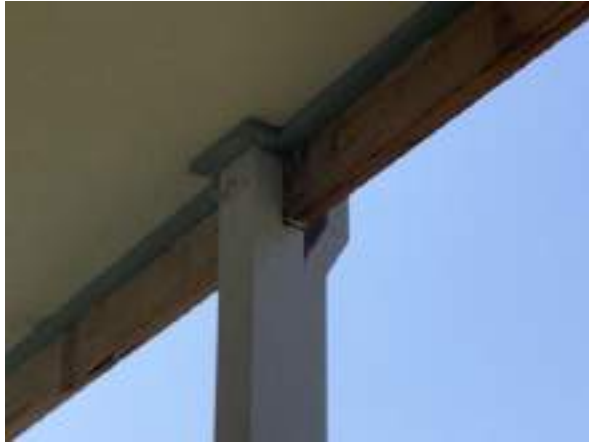
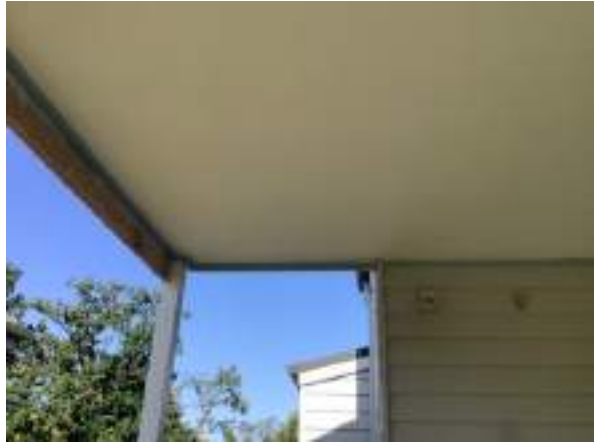
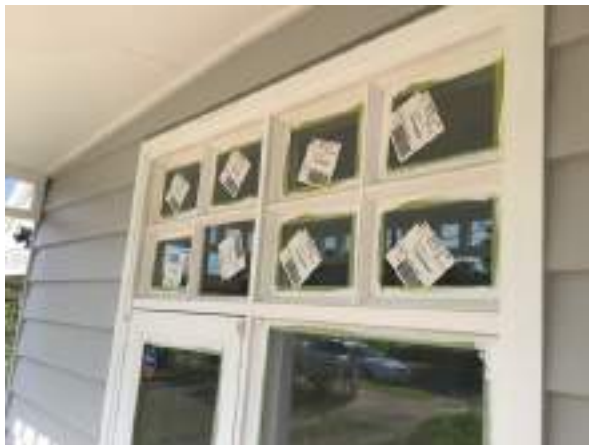
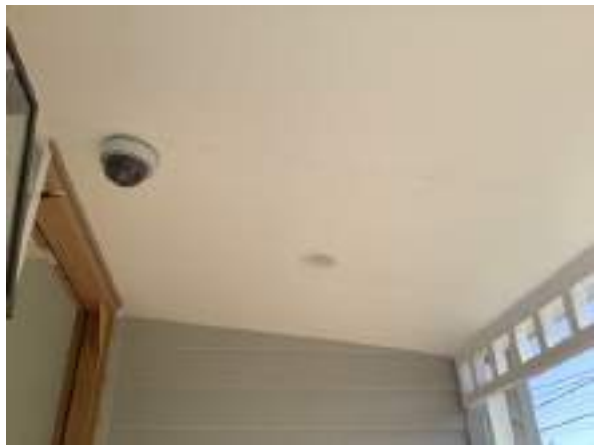
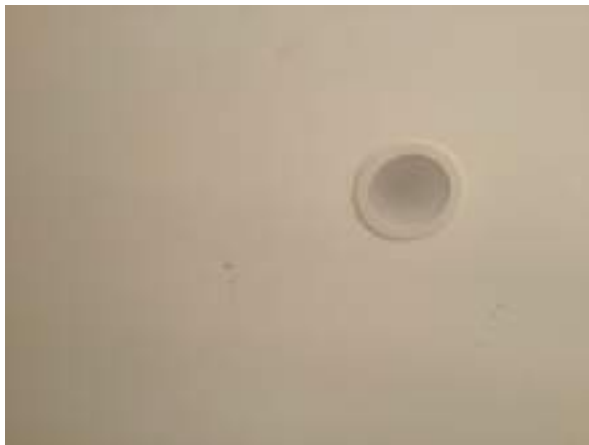
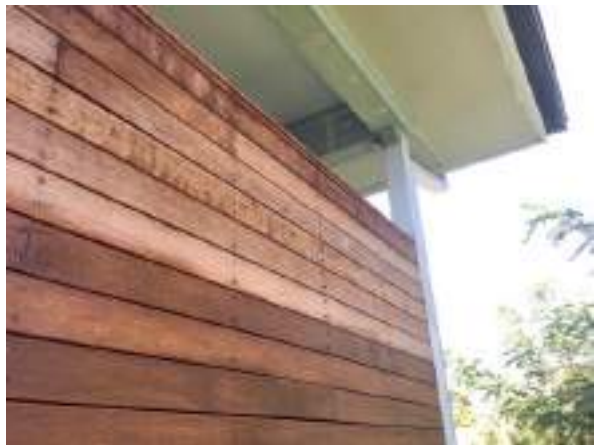
2.07

Location: Painting - All Areas

Finding: Paint Surface Finish - Incomplete/Starved/Defective.

The paint finish in these areas was identified as being incomplete/starved/defective.

Paintwork is defective if the application has blemishes such as paint runs, paint sags, wrinkling, dust, bare or starved painted areas, colour variations, surface cracks, irregular and coarse brush marks, sanding marks, blistering, non-uniformity of gloss level and other irregularities in the surface that are visible from a normal viewing position.

Paintwork is defective if the application results in excessive over-painting of fittings, trims, skirtings, architraves, glazing and other finished edges.

Whilst incomplete or missing paint finish is generally an appearance defect, it can also lead to the development of secondary building defects over time. Incomplete areas of paint finish exposes the area to moisture, potentially accelerating the deterioration of underlying building materials.

Incomplete paint finishes should be sanded back, filled, levelled and painted as applicable. Where inadequate or missing paint protection has led to the deterioration of the associated building element, repair and/or replacement of this building element may be required.

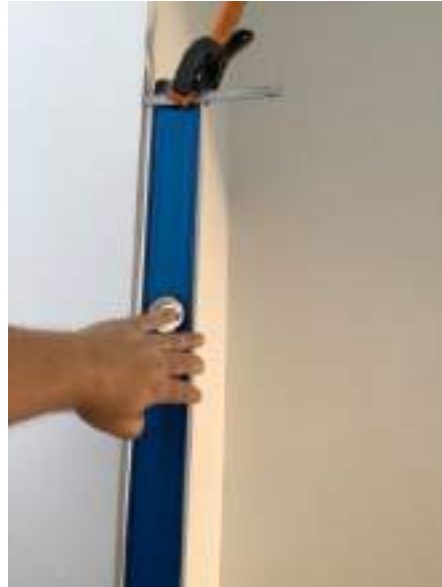
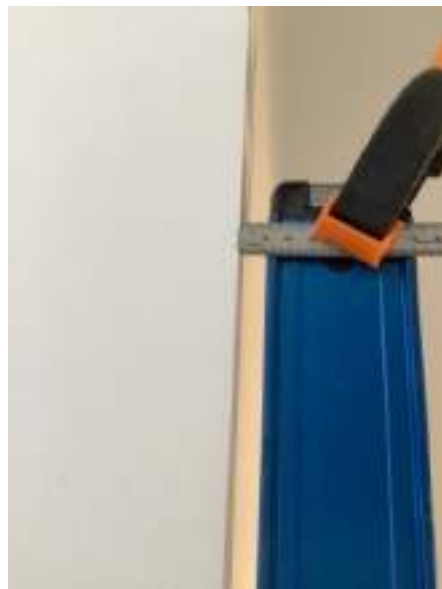
2.08

Location: Plaster - All Areas

Finding: Plaster wall surfaces - Vertical / Horizontal Defective to plaster and/or framing.
It is important to mention, that this property had serious vertical and horizontal walls that were considerably out of level. I supplied my client a postcompletion pre-paint inspection report if you would like more information.
No re-inspection was performed at the clients request. It is obvious that not all the areas have been repaired as the staircase is still quite out of level and there is a possibility that other areas of the home are still out of level as well and I recommend further investigation into this matter to identify all walls that are vertically and horizontally out of level.

It is observed that the wall frame/s are defective as there is a deviation from a vertical or straight plumb line which exceeds 4mm within any 2m of height / length.

This is commonly referred to as a bow in the frame material and/or defective workman. Any bow in excess of 4mm as identified exceeds the allowable Standards and Tolerances and is considered defective.

This deviation from the verticality / horizontal or plumbness of the wall is a defect with reference to Standards and Tolerances 9.10.

Frames are defective if they deviate from plane (horizontal or vertical bow) by more than 4 mm in any 2 m length of wall.

A registered builder should be appointed to assess the defect and perform rectification works as necessary.

Considerable re working of the plaster to rectify this defect in the areas specified is required.

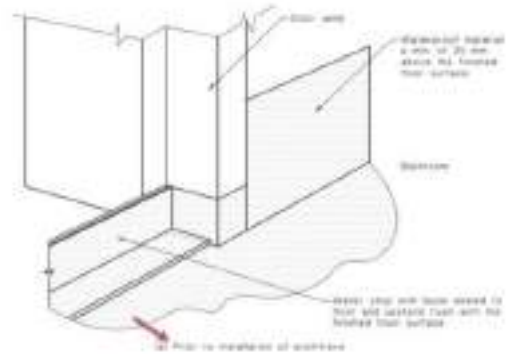
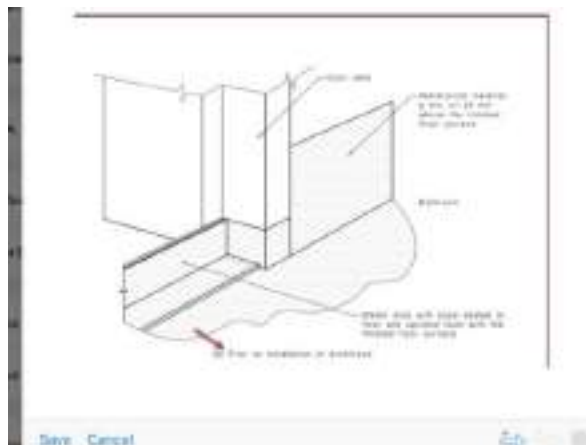
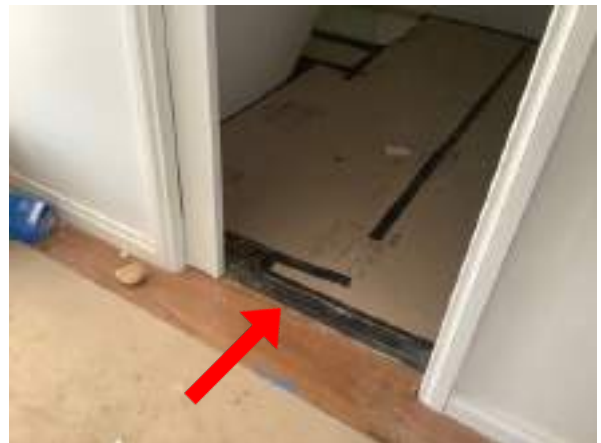
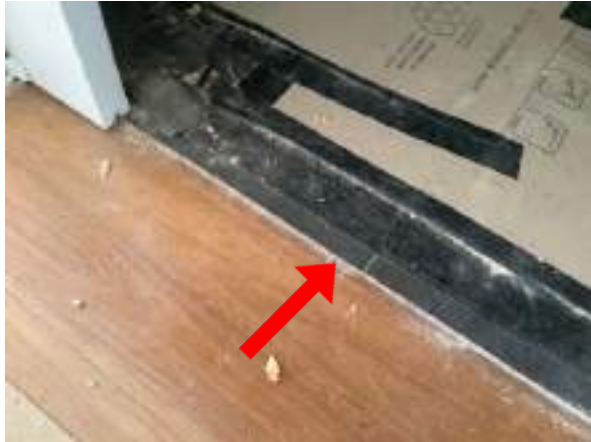
2.09

Waterproofed areas must be sealed to all perimeters.

The end of the tiles appears not to have the water stop at the end of the tiles.

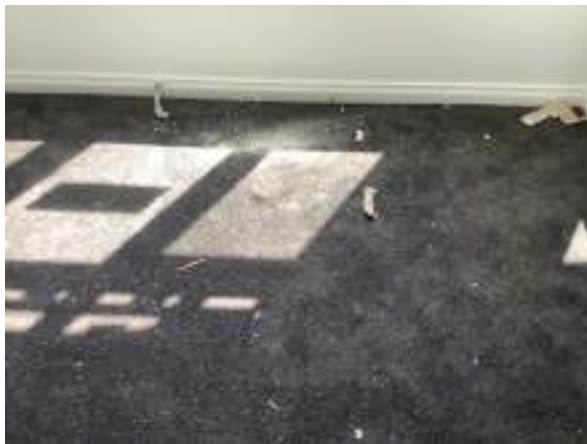
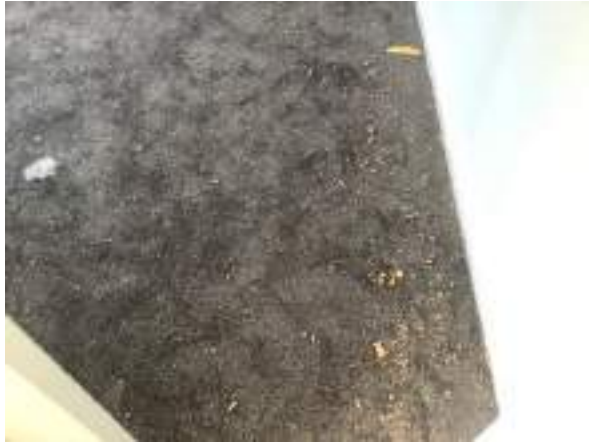
2.10

Location: Cleaning - All Areas

The Building Commission's, Guide to Standards and Tolerances clause 18.09 Cleaning, states- 'Owners are entitled to expect that the building site and works are clean and tidy on completion. Building works are defective where windows are not clean, floors are not swept, mopped or vacuumed as appropriate, tiles, sinks, basins, troughs, baths, etc. are not cleaned and shelving, drawers and cupboards ready for use.'

Once the cleaners have properly completed all of this work, all of the glazing, mirrors, cupboards, baths, shower bases, shower screens, floor coverings, walls, stairs, garage floor, fixtures and fitting etc, should all be thoroughly checked again for any scratches and damage which may have occurred, prior to handover proceeding.

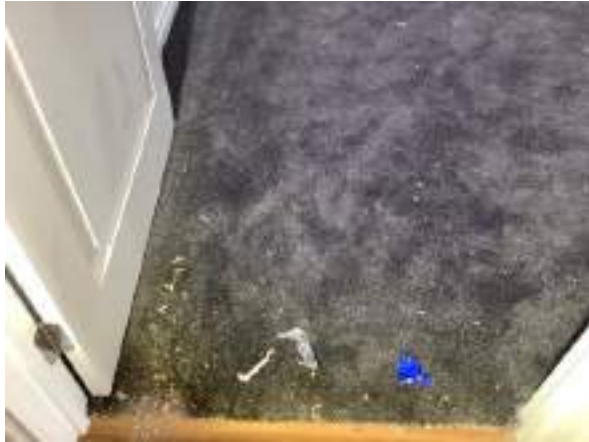
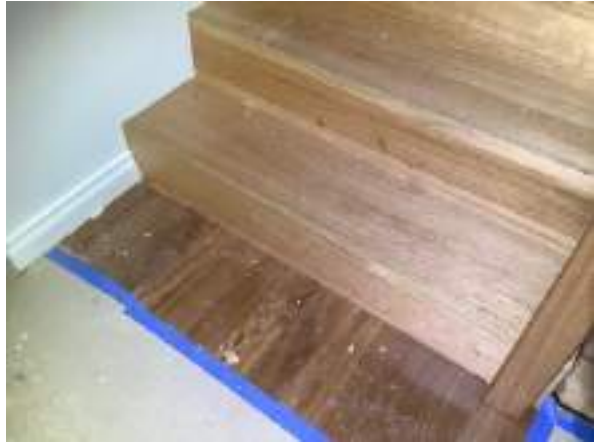
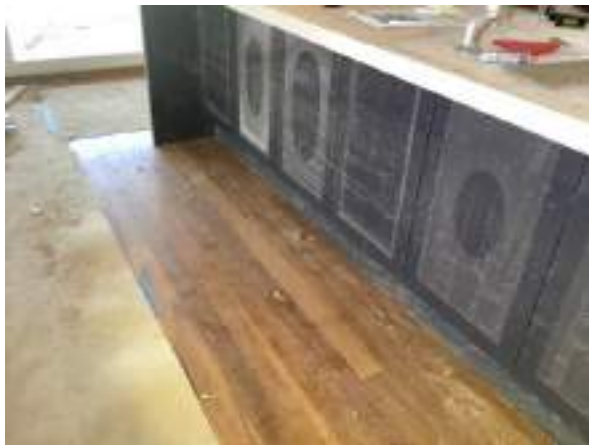
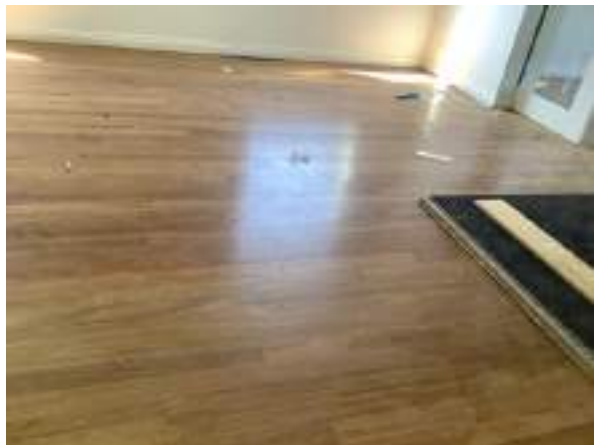
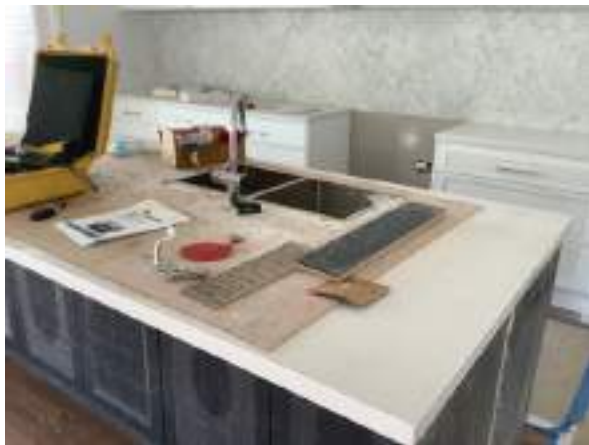
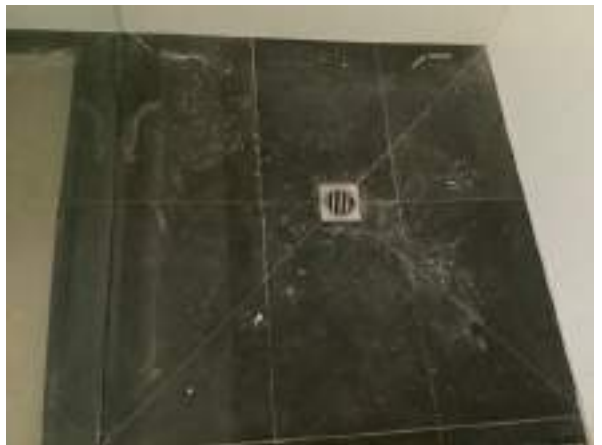
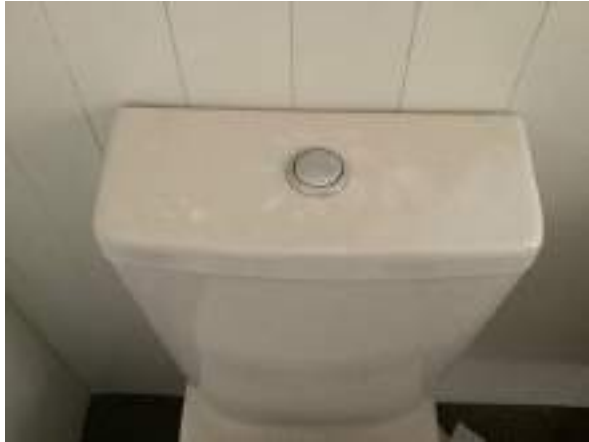
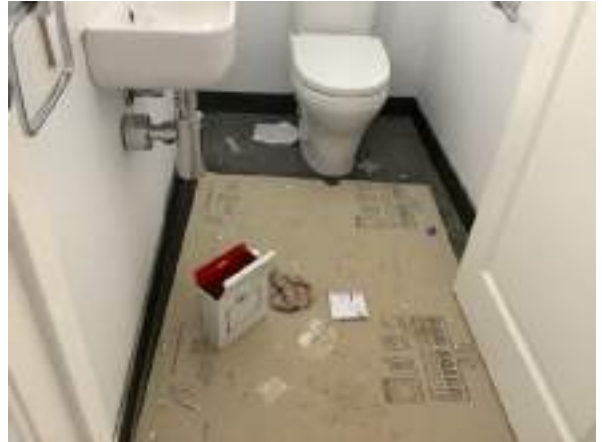
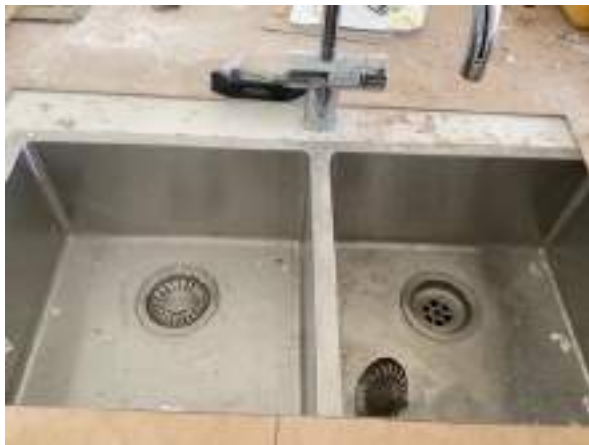
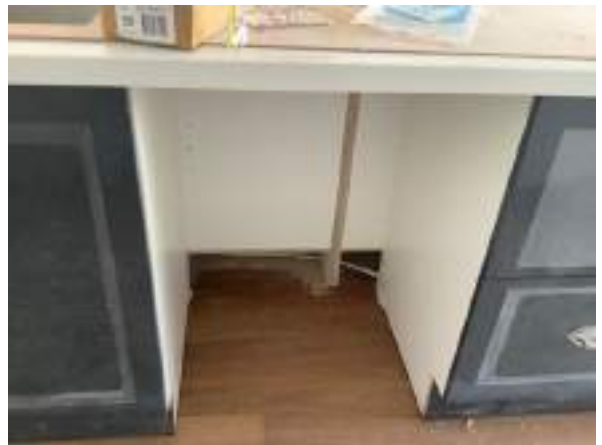
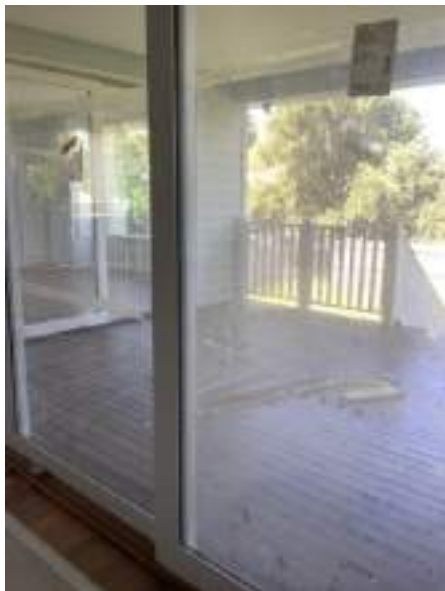
2.11

Location: Cleaning - All Areas

Finding: Cleaning - debris on site at handover
It was observed that builder's debris was present on site at handover. This is a defect with reference to Standards and Tolerances.

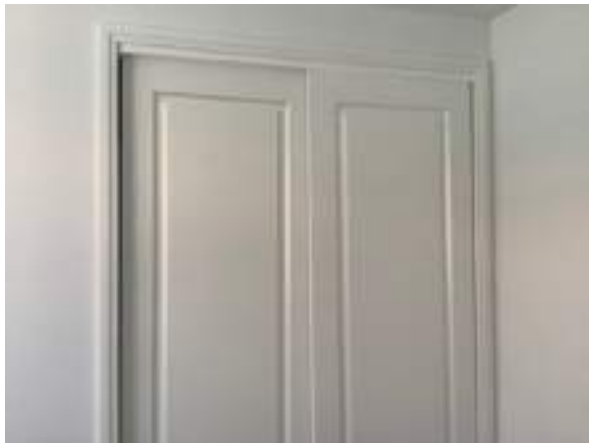
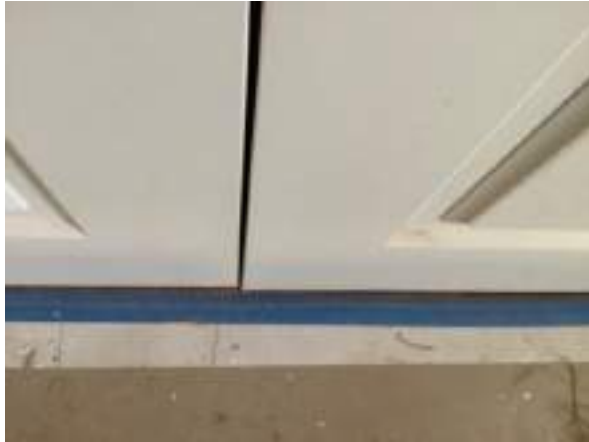
2.14

Location: Door Defects - All Areas

Finding: Door operation - binding and jamming - defective
Binding and/or jamming of this door is evident during standard operation. This defect inhibits the functionality of the affected door as well as creating potential for secondary defects to associated building elements, such as damage to the floor covering.

A door that binds to flooring or to the associated door frame may have several causes, ranging from minor defects, such as poor installation of the door or deteriorated hinges, through to major structural issues, such as damage to subfloor structures.

Where the operation of the door is not as intended by the manufacturer it is considered defective with reference to Standards and Tolerances

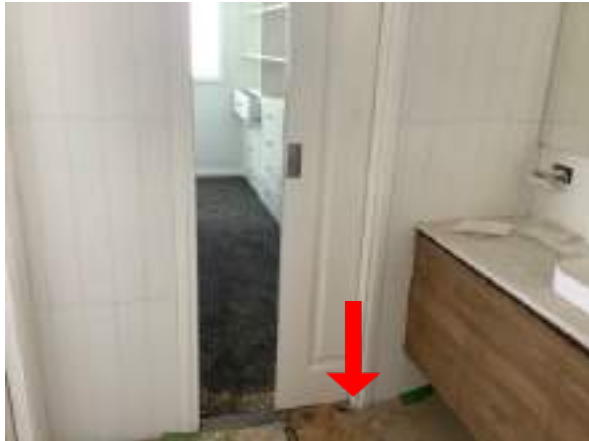
Location: Door Defects - All Areas

Finding: Cavity doors - missing guides
The cavity doors require the guides to be adjusted, also some guides are missing, All areas are to be checked for installation or repair and adjustment.

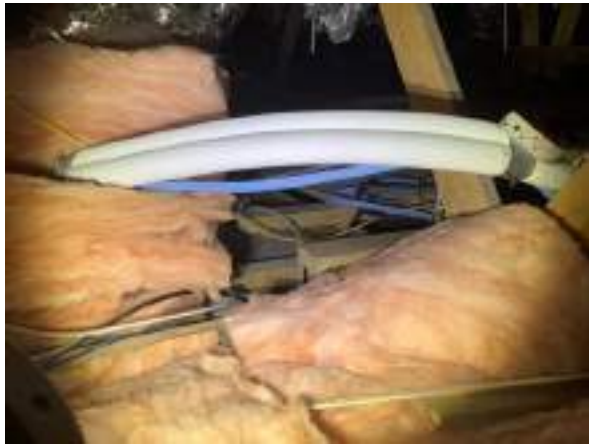
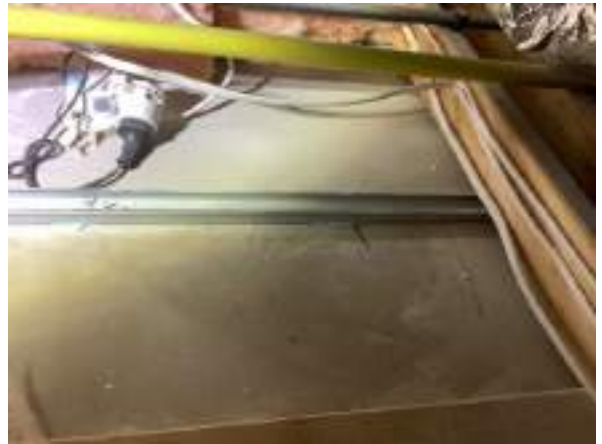
2.22

Location: Roof Space - All Areas

Sustainability Victoria's Energy Smart Housing Manual warns that 'if ends and edges of batts are not snugly fitted then up to 5% of the ceiling area will not be properly covered, which would lose up to 50% of the potential insulation benefit.'

The present insulation must be rectified so that it is fitted around the light fittings correctly as required by Australian Standard AS/NZs 3000:2007 Wiring Rules to achieve the required R-value and across the entire ceiling area.

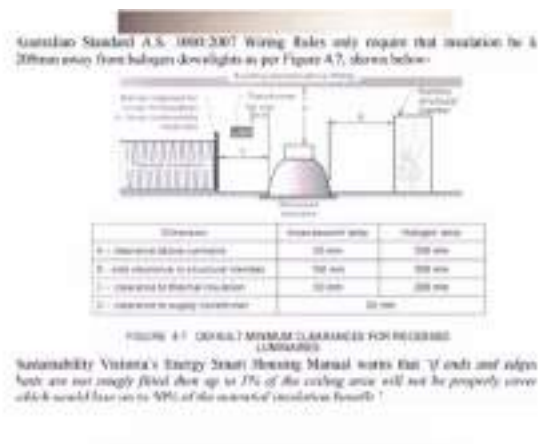
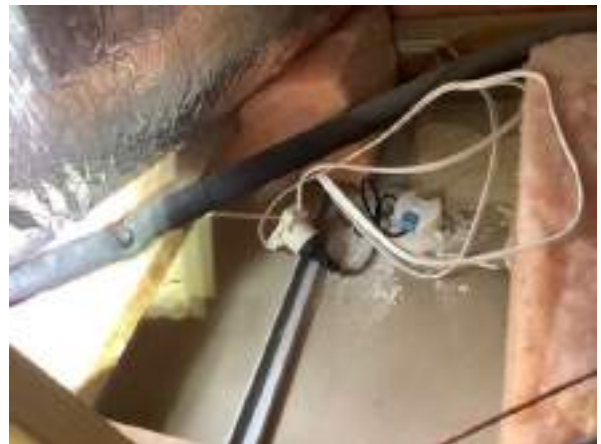
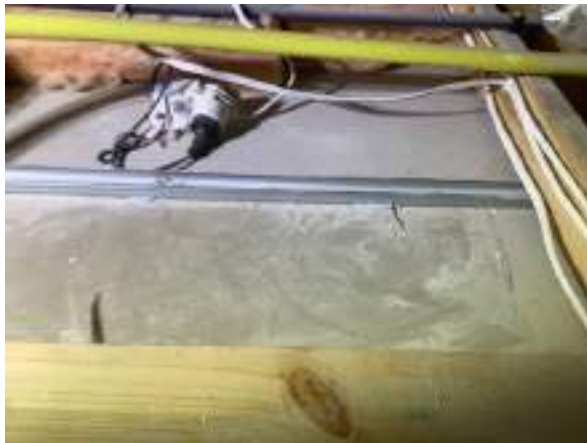
2.23

Location: Roof Space - All Areas

Finding: Light missing, above the proposed heater area in the roof and light switch missing next to manhole - Non-compliant (AS5601)
The roof space area where the heater installation is required must have a light switch within the manhole area and a light above the heater as this is a safety requirement .

The gas appliance fitted in the roof space was found to be non-compliant with contemporary building regulations.

The relevant Australian Standard A.S. 5601 – 2004 Gas Installations, clause 5.3.11 Appliances in Roof Spaces, requires that 'The location of the appliance is to allow access for lighting and servicing' and defines access as 'Access can be gained without hazard or undue difficulty for inspection, repair, renewal or operational purposes.'

The access to the location of this unit must be rectified to allow for the required access to light & service it.

The builder must perform rectification works as necessary to meet ALL these requirements prior to final handover.
