Practical Completion Report (Final)

Inspection Date: 5 Feb 2020

Company Name: Master Property Inspections

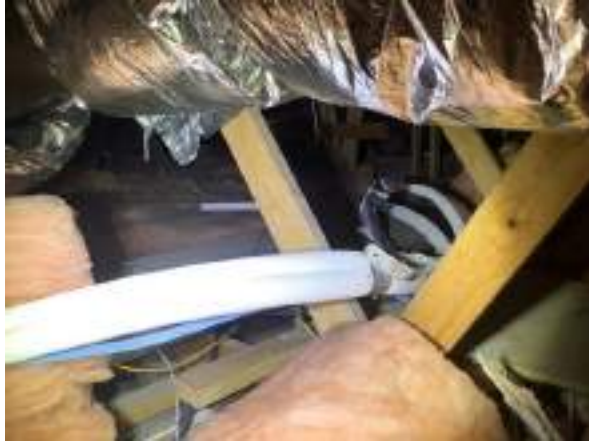
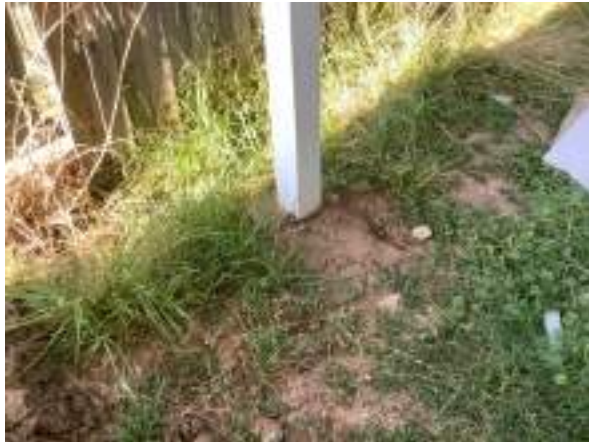
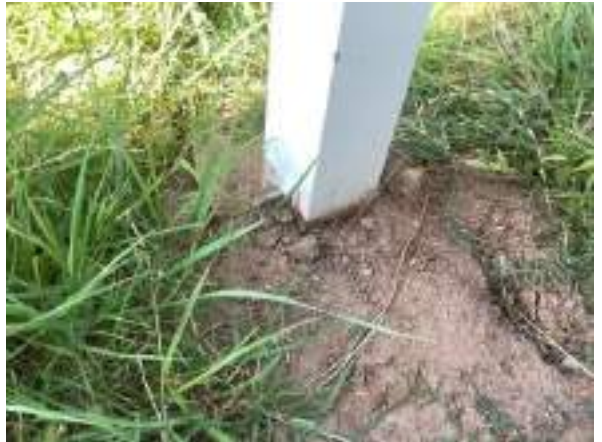
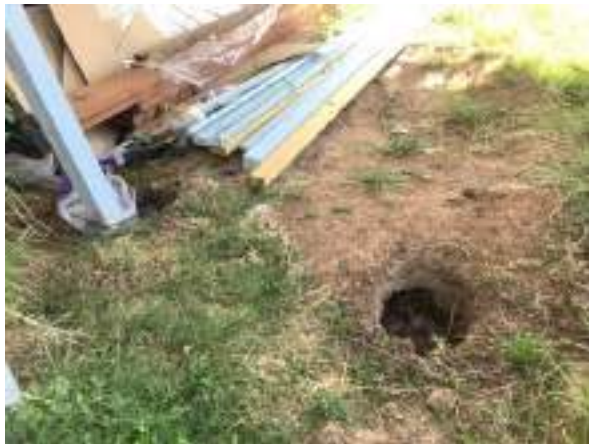
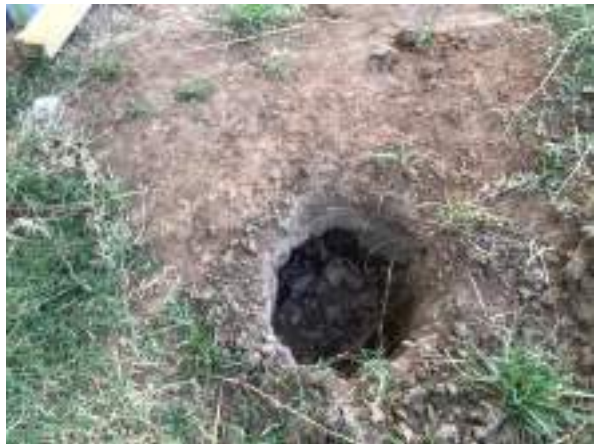
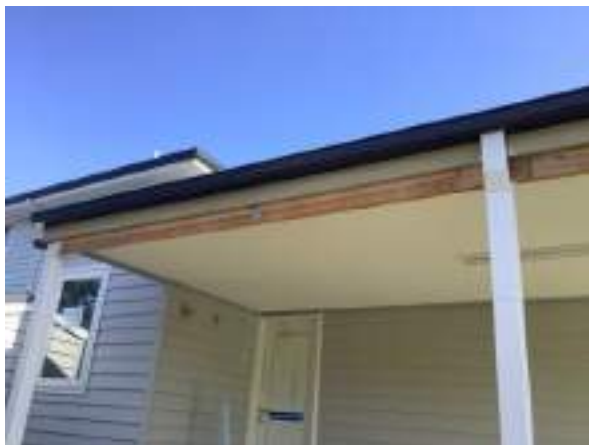
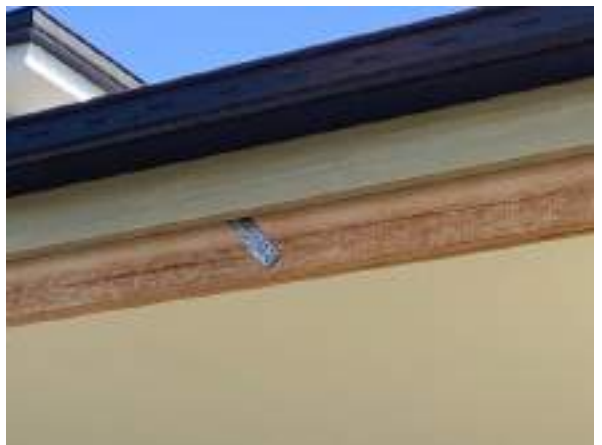
2.24

Location: External-Unfinished/Defective Works

Finding: External - Unfinished/Defective Works - Additional Photos

All these photos are added in to demonstrate DEFECTIVE / SUB STANDARD and/or INCOMPLETE WORKS and they are all required to be rectified as they are ALL not satisfactory for Handover as per the DOMESTIC BUILDING CONTRACT ACT 1995 as stated above.

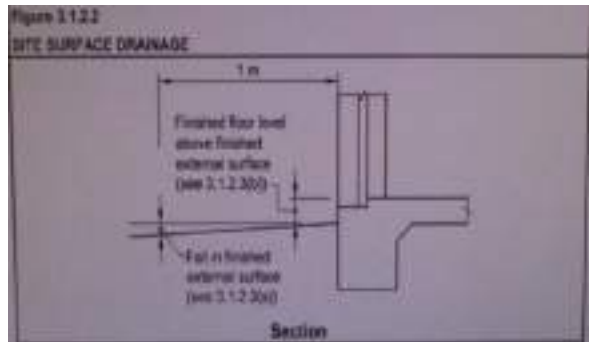
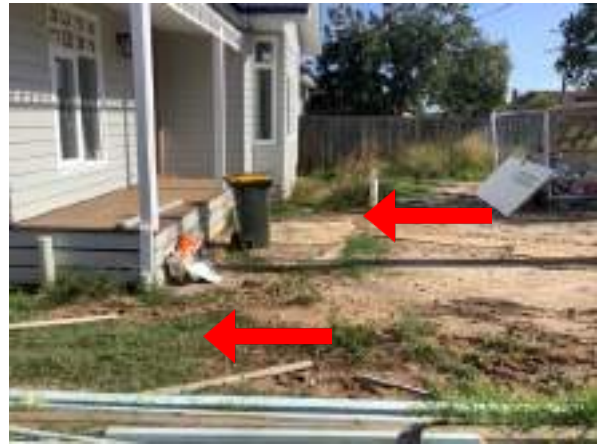
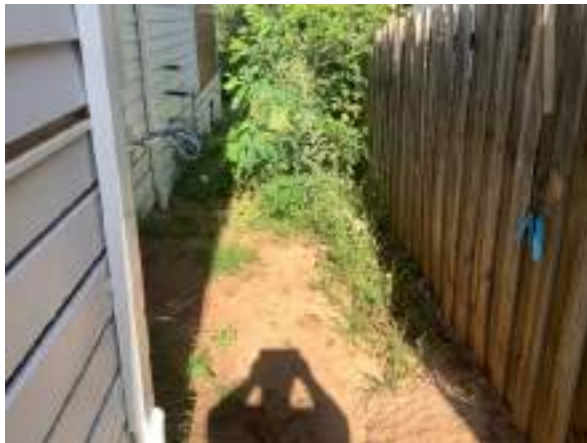
2.25

Location: Drainage - Exterior

Finding: Drainage - Fall Ground Perimeter Building - Inadequate Fall (AS2870)
Fall Ground Perimeter Building - Inadequate Fall (AS2870)

Water pooling near foundations and footings is a serious concern with the potential to adversely impact on the longevity of the dwelling. The Building Code of Australia (BCA) outlines that the soil must be graded away from the dwelling at a minimum of 50mm over 1m (1:50 fall).

At the time of inspection, it was noted that drainage in these areas is poor, and likely to result in the pooling of water around footings and foundations. Slab and footing movement is often caused by a failure to design and construct in accordance with Australian Standards. Such movement is likely to cause major secondary defects in the long-term.

The soil levels around several footings need to be adjusted to ensure that footings and foundations are protected from excessive moisture.

To be compliant, finished ground levels (FGLs) must fall away from slab and footing construction by a minimum 50mm over the first 1 metre. This fall is designed to promote site drainage away from foundations to minimise susceptibility to erosion.

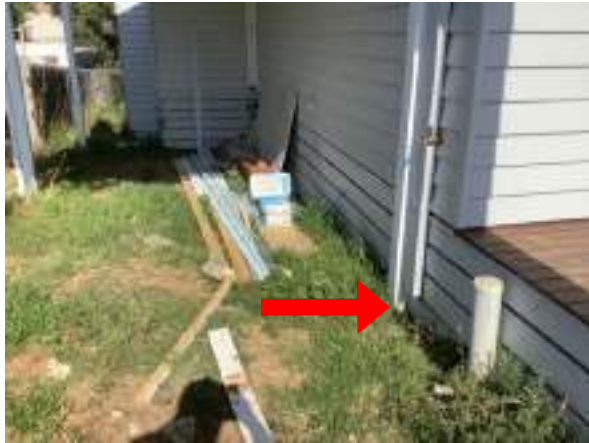
2.26

Location: Plumbing - All Areas

Finding: Plumbing work - Appears Defective

An instance of potentially defective plumbing work was identified. Whilst we are not licensed plumbers it appears that work which is not compliant with the relevant plumbing regulations and or the contract documents has occurred. The area of suspected non-compliance or poor workmanship should be referred to the builder and or the Building Surveyor or Certifier. The builder is required to provide a Certificate of Compliance when required by the relevant regulations.

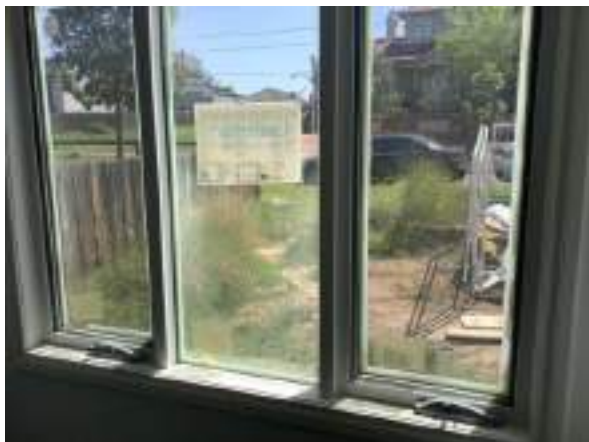
3.27

Several windows throughout the property were jammed and difficult to operate at the time of the inspection. Windows provide ventilation to the adjoining area and should be at a fully operational level to ensure user comfort. Restricted function of the window may also pose as a potential safety hazard if required for emergency egress from the building.

Generally, factors such as general age of the building element and a lack of maintenance are the usual causes for this type of defect.

The windows may have several causes, ranging from minor defects as outlined above through to major structural issues, such as damage and/or subsidence (sinking) to subfloor structures.

For minor causes of repair, replacement where window hardware or frame may be required, as well as minor repairs and cleaning a carpenter, registered builder, window specialist/ company or general handy person will be required to repair the affected windows.

Windows MUST function as a safety requirement and we HIGHLY RECOMMEND that you engage an appropriate professional as soon as possible to check all windows to the property.

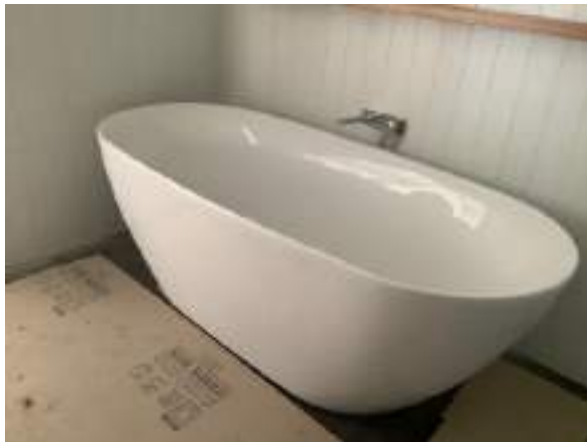
4.28

Finding: Bath Tub Loose

The bath tub is just sitting in location and loose, they may be the possibility it is not connected and requires further investigation.

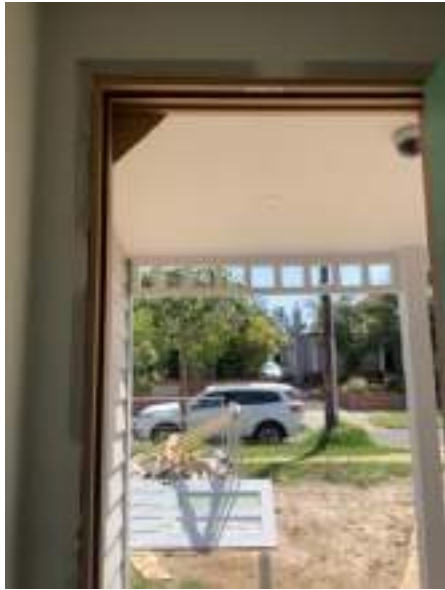
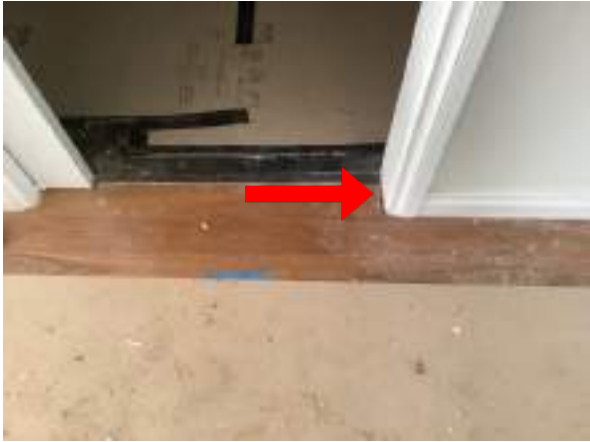
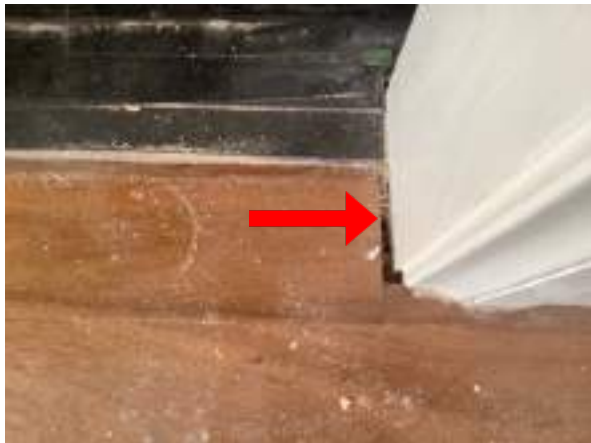
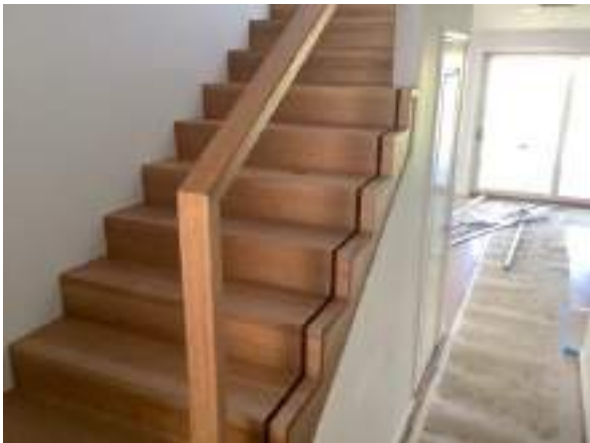
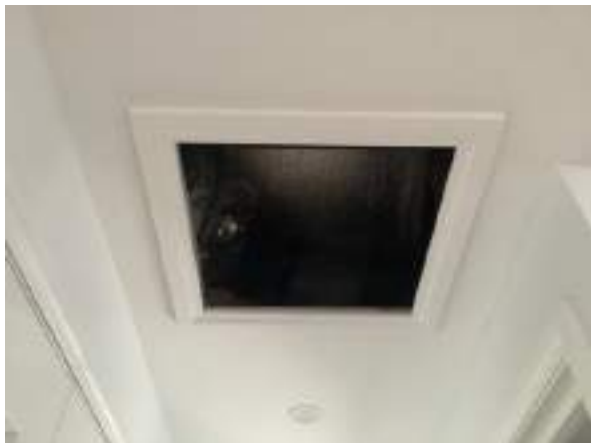
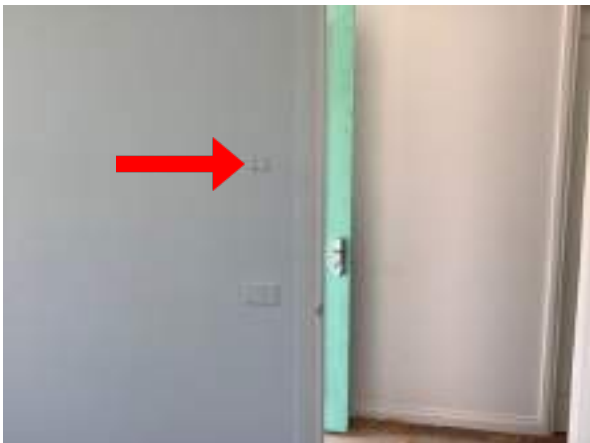
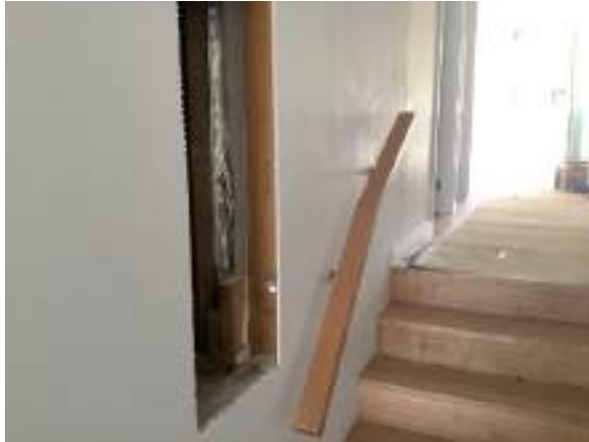
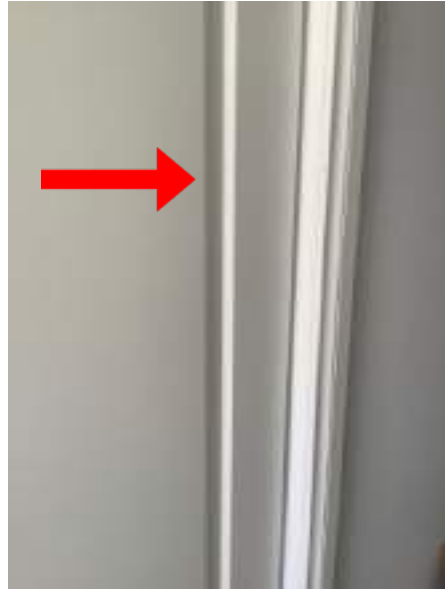
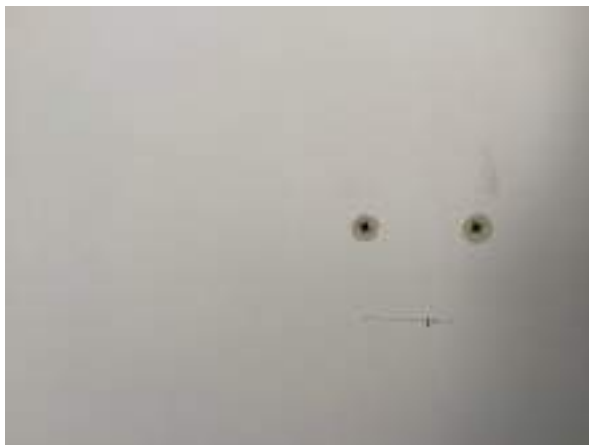
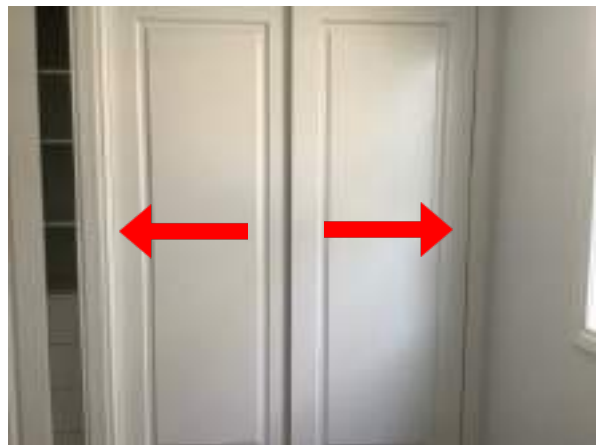
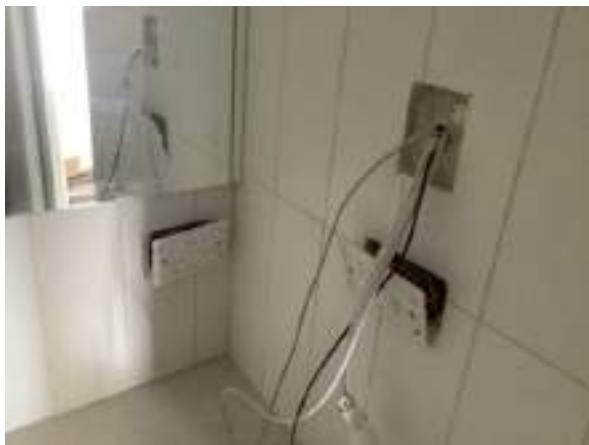
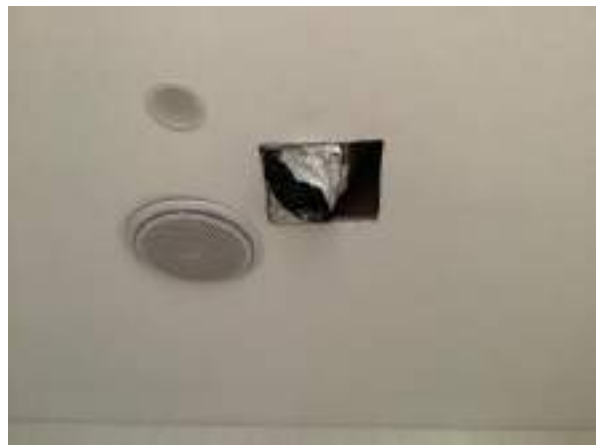
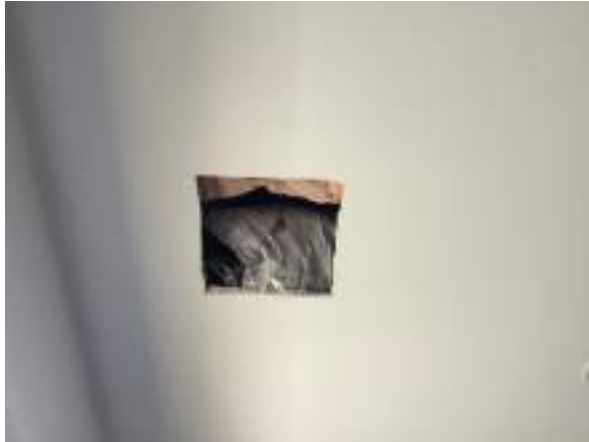
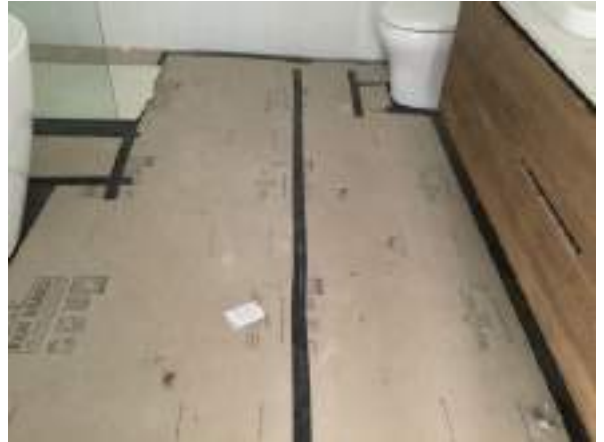
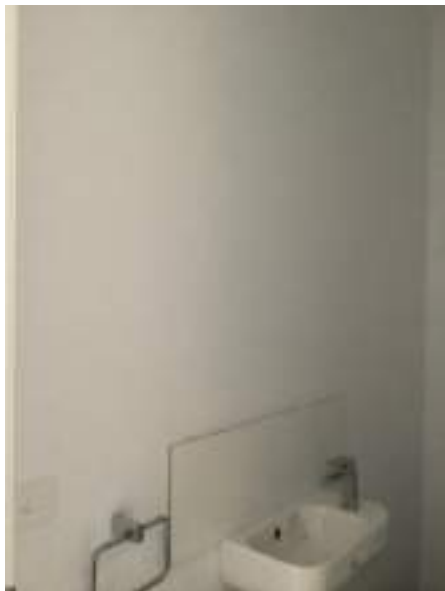
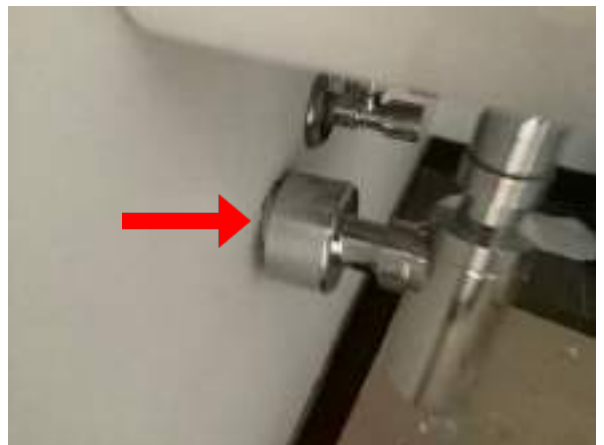
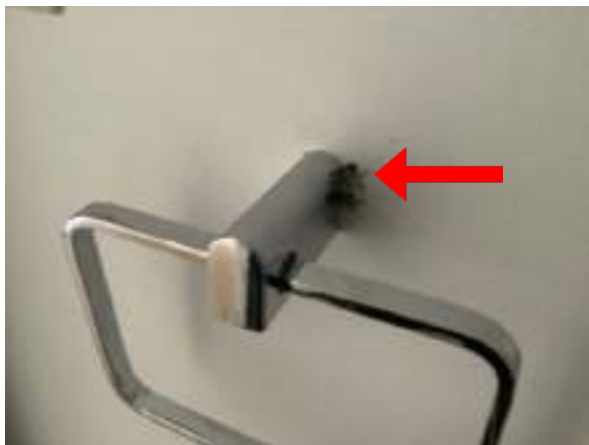
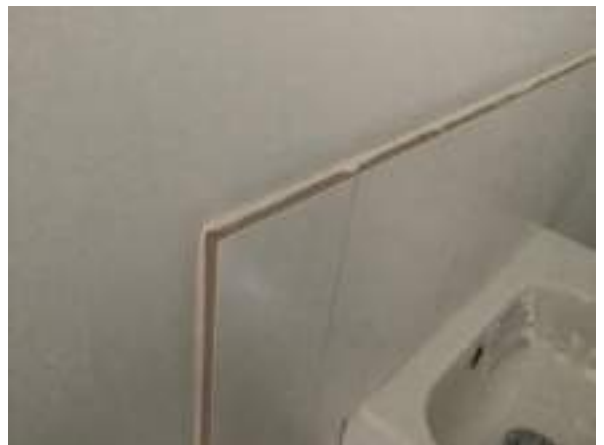
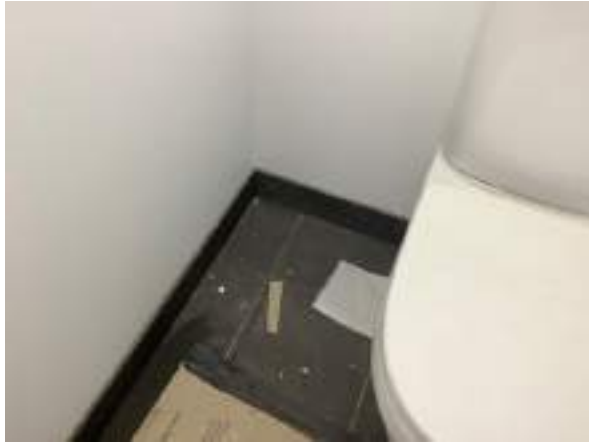
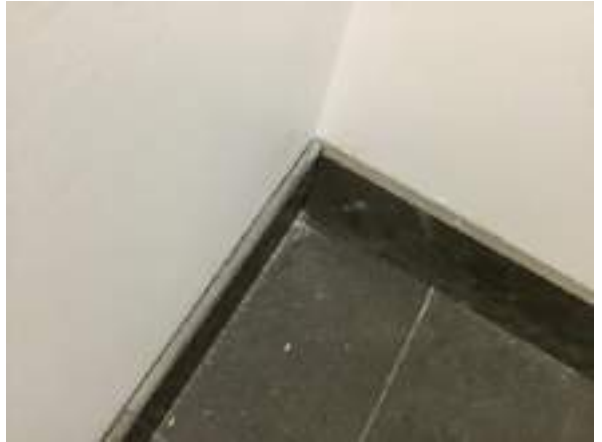
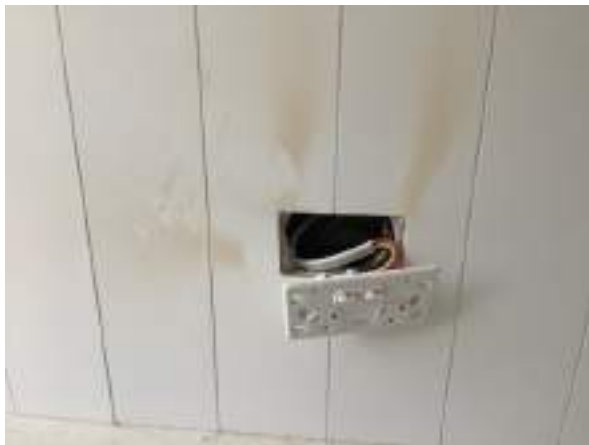
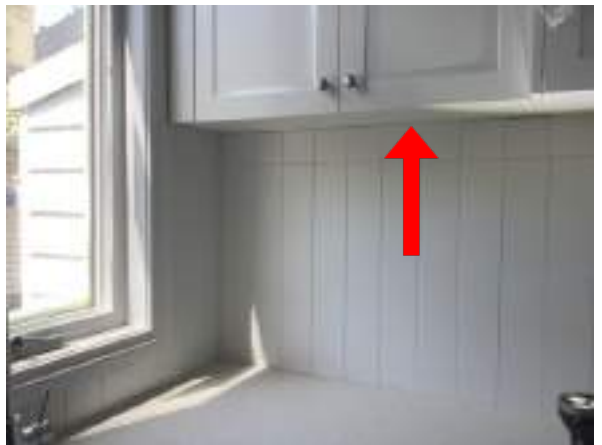
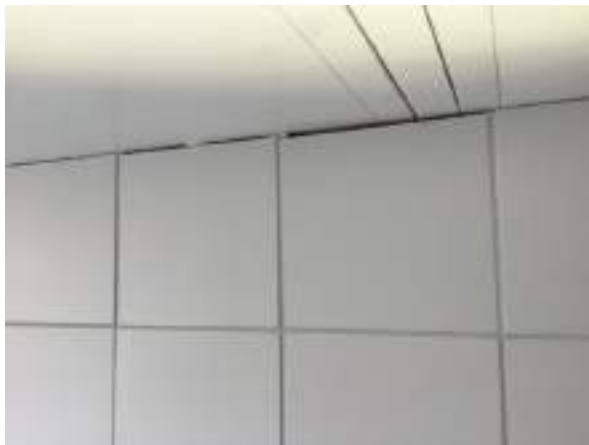
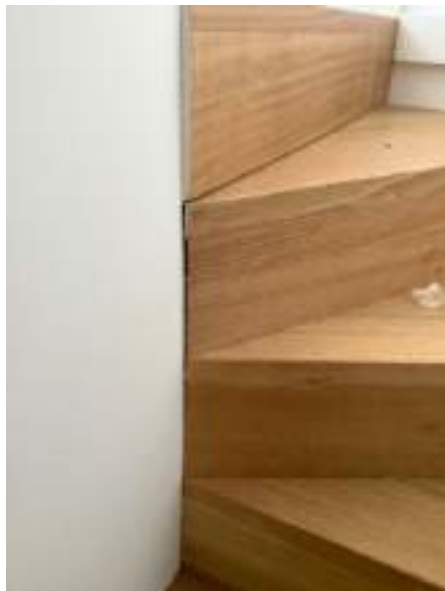
4.29

Location: Internal-Unfinished/Defective Works

Finding: Internal - Unfinished/Defective Works - Additional Photos

It is very important to note, that this house is not completed in all areas as the builder has gone into bankruptcy. So I am not inspecting a complete home. Generally we put incomplete works and works that are not completed to a tradesman's light finish, so this defect statement is a generalisation only, it is not to be used for specifics in the contract for the answers to note what has not been completed as per the contract, this is generally only more so defects, but for this report defects as not complete.

All these photos are added in to demonstrate DEFECTIVE / SUB STANDARD and/or INCOMPLETE WORKS and they are all required to be rectified as they are ALL not satisfactory for Handover as per the DOMESTIC BUILDING CONTRACT ACT 1995 as stated above.

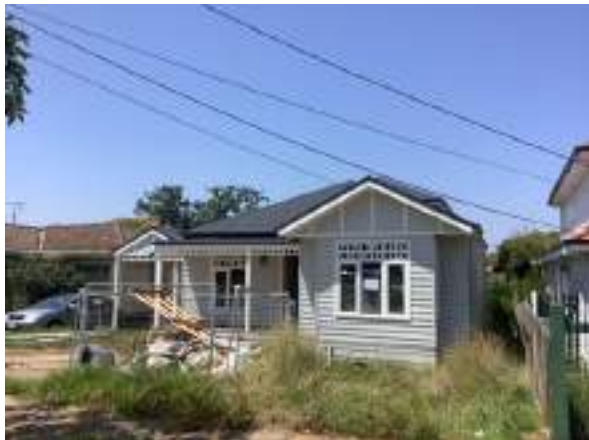
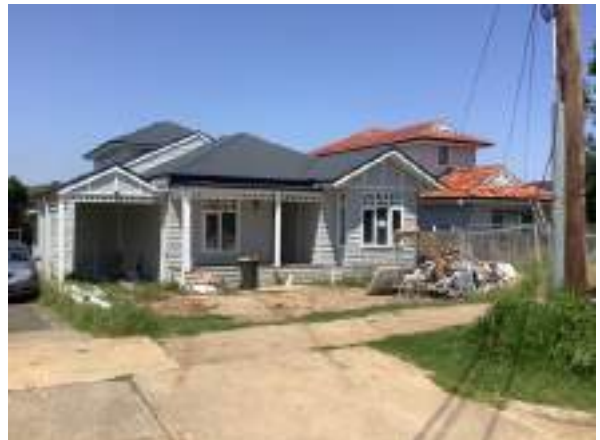
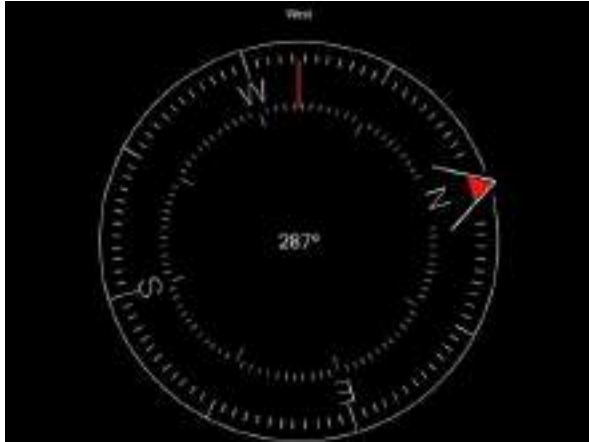
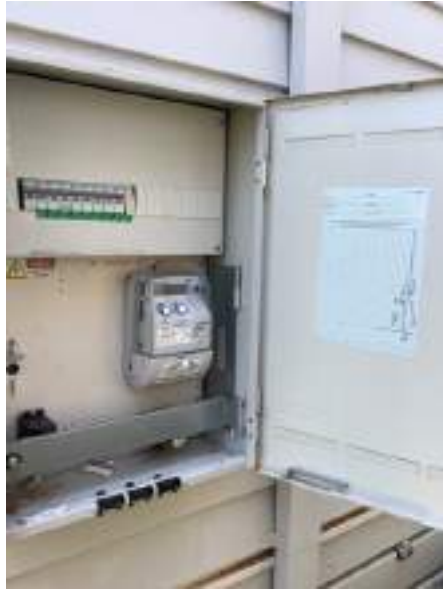
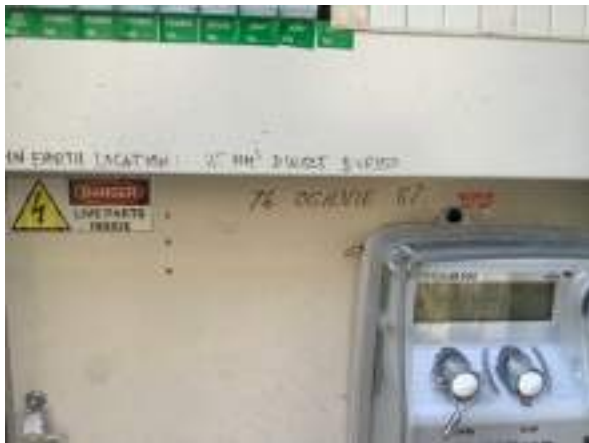
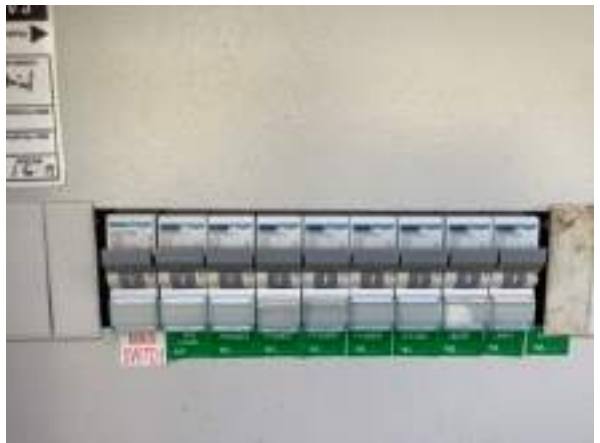
5.30

Location:	Site Photos & Areas Of Interest.
Finding:	Site Photos. Additional photos are provided for your general reference.

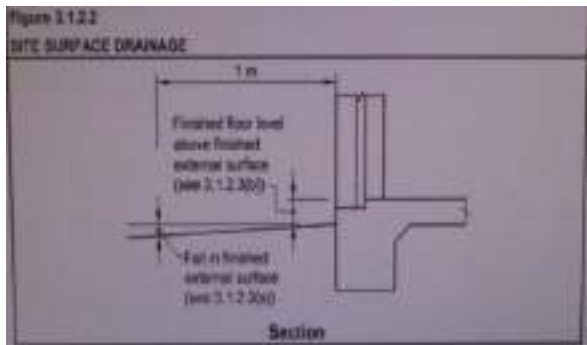
Location: Drainage - Exterior

Finding: Drainage - Owners Responsibility - Foundation and Site Drainage Maintenance
Foundation movement caused by activities not documented at the time of the contract any variations or which have been undertaken by the owner have been identified.
This may include paving landscaping planting trees and drainage works after the site is handed over. The builder is not responsible for foundation movements caused by the owners failure to maintain drainage systems after the site is handed over to the owner.

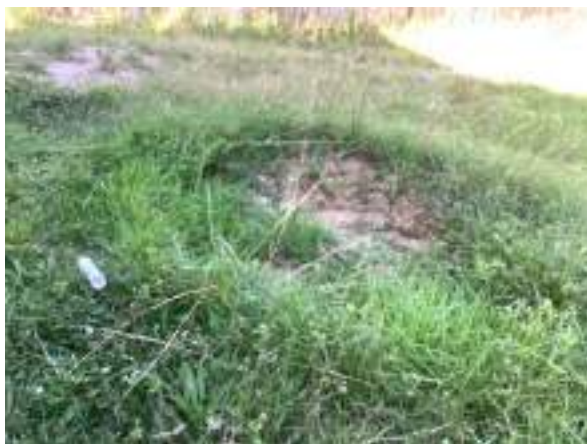
5.34

Location: Exterior Ground

Finding: Holes - Safety Hazard
The exterior ground around the perimeter of the home has various paint holes and is quite a safety hazard
