Pre-Plaster Report.

Inspection Date: 5 Feb 2020

Company Name: Master Property Inspections

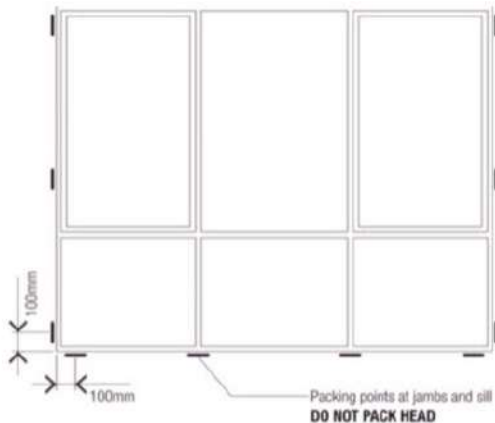
Location: Sample Only - Must Check & Repair Entire Building

As per AS-2047-1999 and the defect clause is below.

In this case the defect in discussion is the sides of the window and the bottom of the window DO NOT have a sufficient gap if any to allow for movement and compression of the frame.

ALL WINDOWS with no or insufficient gaps, also as per manufacturers standards is packing to the sides and bottom of the windows as well, must be reworked to allow a recommended of at least 15mm to 20mm of packing.

The gap shall be sealed with suitable flexible mouldings or flexible caulking to resist water penetration, or other weatherproofing methods shall be used.

All AREAS to the entire property should be checked CAREFULLY to identify any further defects that are the same as this defect.

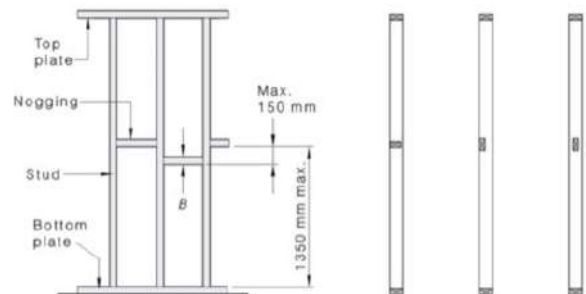
FIGURE 6.6 NOGGING

Finding: Noggings - Defective Installation - Missing - Taken Out For Tradespersons Requirements. We refer the builder to AS 1684.2, clause 6.2.1.5 which calls for all noggings to be installed to comply with the Australian Standards. That is into all stud openings, staggered no greater than 150 mm with no opening exceeding 1350 mm in total.

All AREAS to the entire property should be checked CAREFULLY to identify any further defects that are the same as this defect.

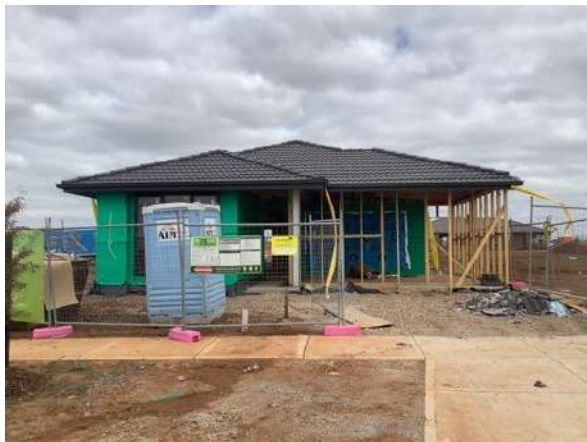
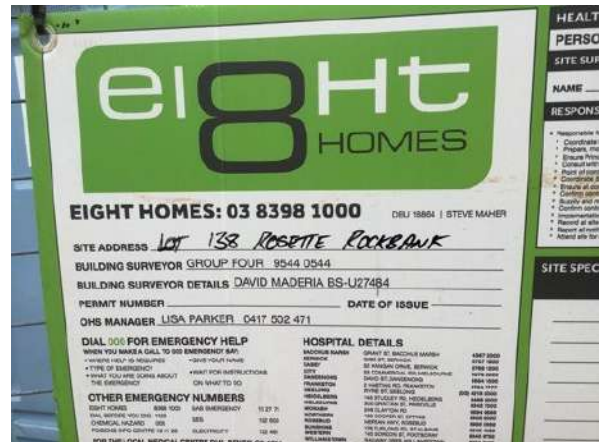
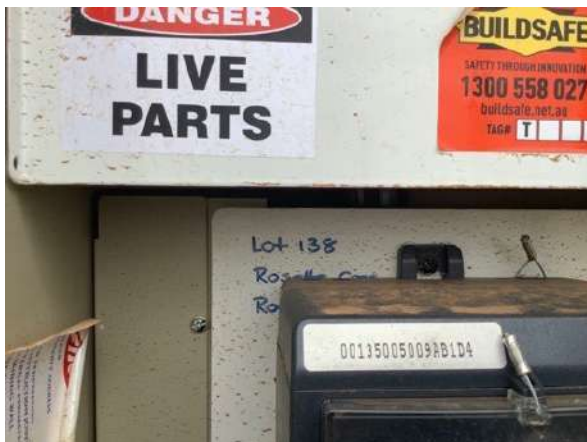
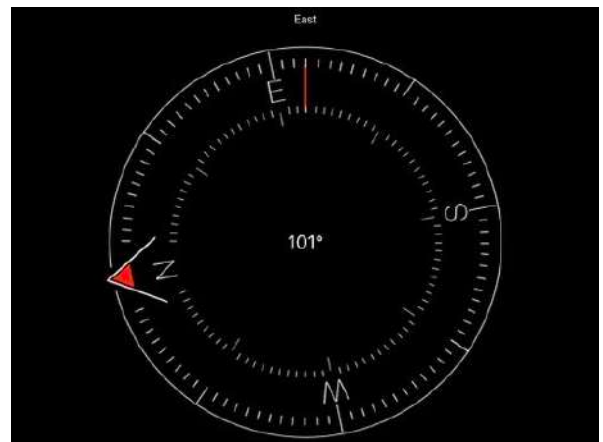
Location: The Site

Finding: Site Photos
Additional photos are provided for your general reference.
