## Pre-Pour Concrete Slab Report

Inspection Date: 25 Mar 2020

Property Address: Greenvale Area, Vic

Report Type: New Home Construction

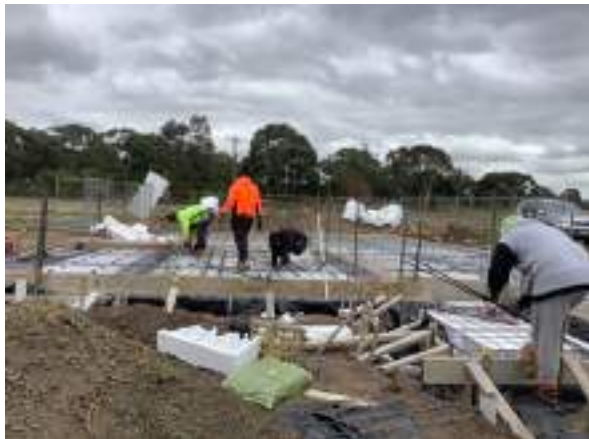
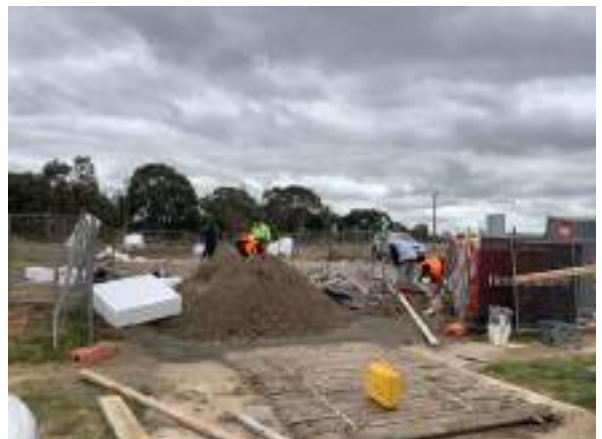
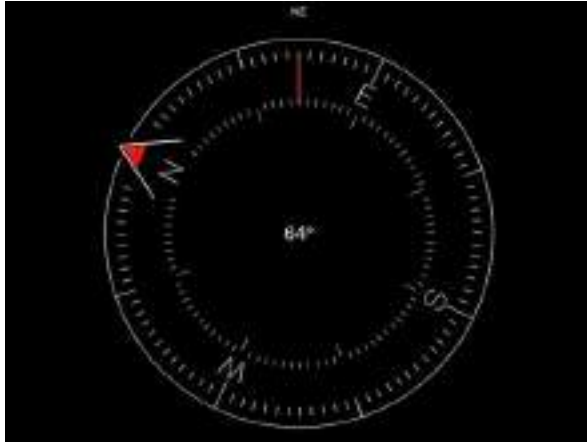
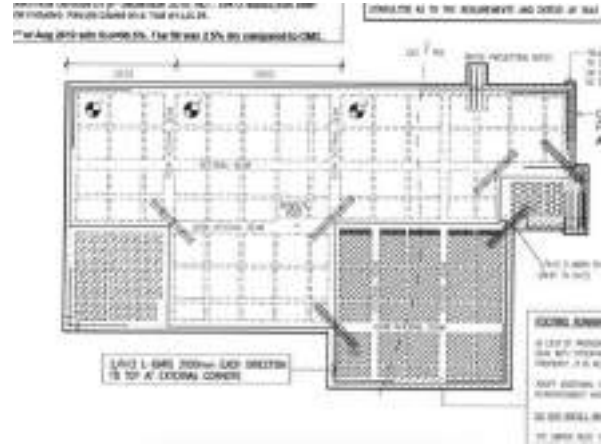
## For Your Information 5.11

Location: General Site Photos

Finding: Site Photos.  
Additional photos are provided for your general reference.
