Termite, Timber Pest Report.

Inspection Date: 15 Feb 2020

Property Address: Northern Rural Area, Vic

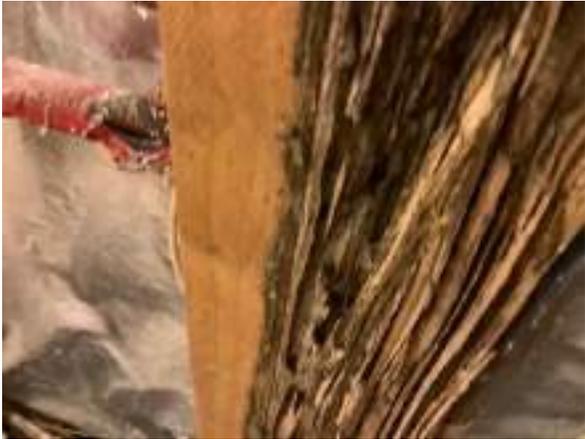
1.03

Location: Roof Space

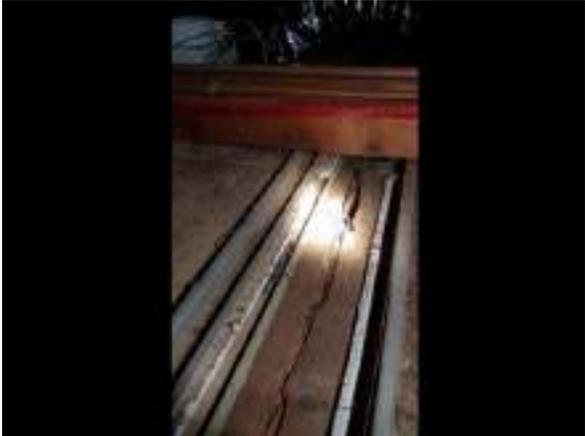
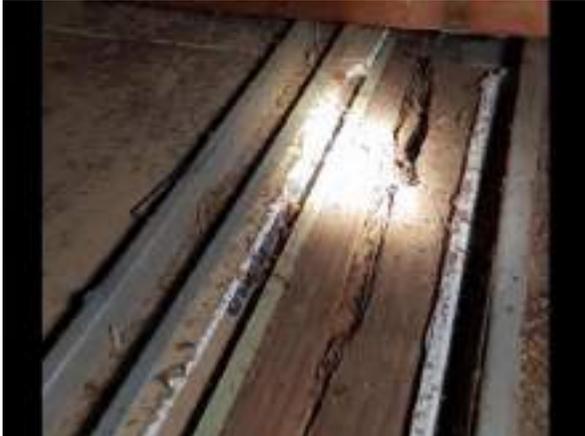
1.04

The property is a EXTREMELY high risk for termites as the environments to the property are very conducive with many susceptible areas.
I can not stress how important it is to severely reduce and keep clean the trees, vegetation, timber and/or all other debri and all other items not only around the home but to the entire property as a matter of urgency to reduce the very high risk for termite activity and to keep the environment as low risk as possible for a conducive and susceptible area or areas for termites and timber pests.
It is impossible to identify all areas for termites, timber pest and timber pest damage.

Please read the report carefully and Maintenance to all susceptible and conducive areas is a MUST to minimise the risk of termite and timber pest existence and timber damage.

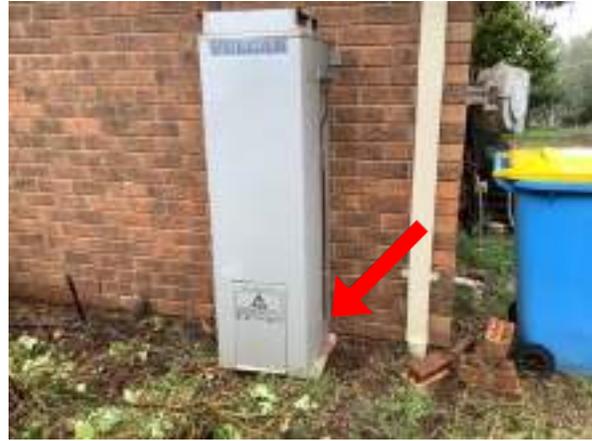
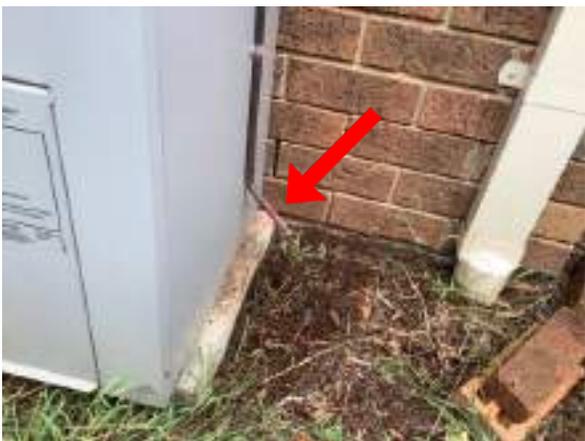
2.13

Location: Garden Areas - All Areas

Please read the report carefully and Maintenace to all susceptible and conducive areas is a MUST to minimise the risk of termite and timber pest existence and timber damage.

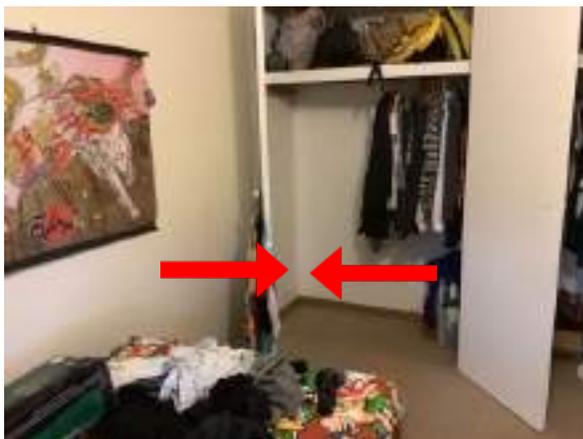
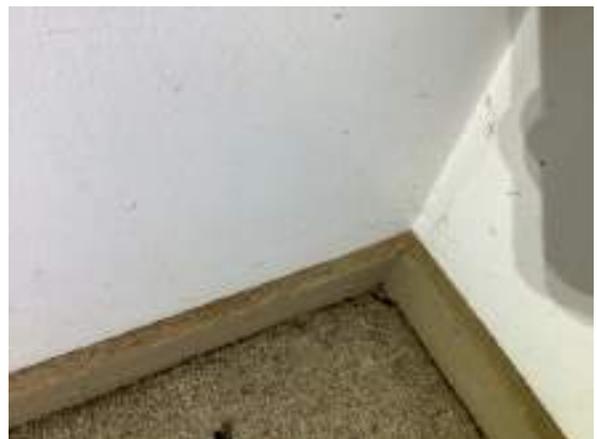
2.16

BRIDGING OR BREACHING OF TERMITE MANAGEMENT SYSTEMS AND INSPECTION ZONES

It is highly recommended that any stored building materials or other materials be immediately removed from areas in which they may attract any termite / timber pest attack around the perimeter and/or sub floor areas of the dwelling and a re-inspection is carried out.

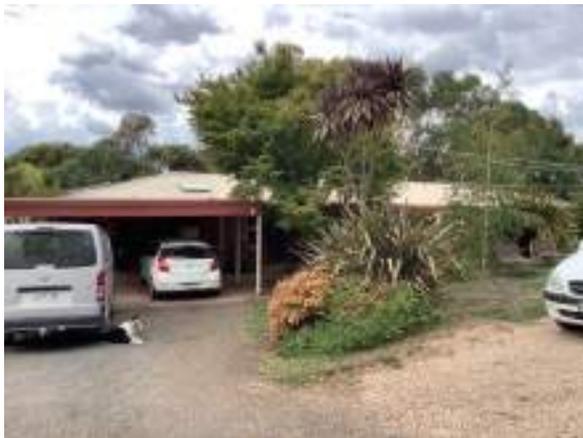
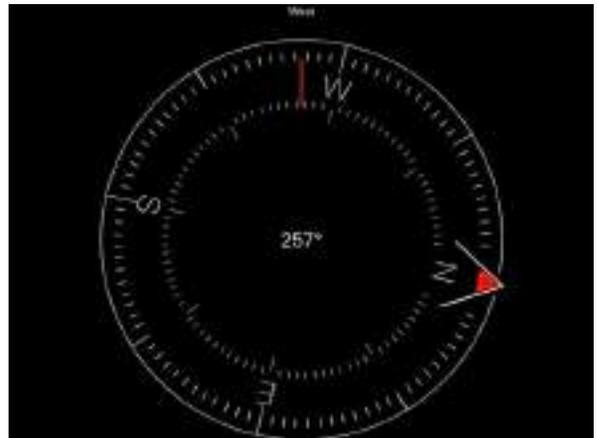
4.20

Location: The Site

At the time of inspection, it appeared as though no termite management system has been installed, with no evidence to suggest preventative works taking place.

The client may consider gaining further advice from a pest controller as to the costs and procedures involved with this application. It is recommended that obtaining such advice be a short-term priority.

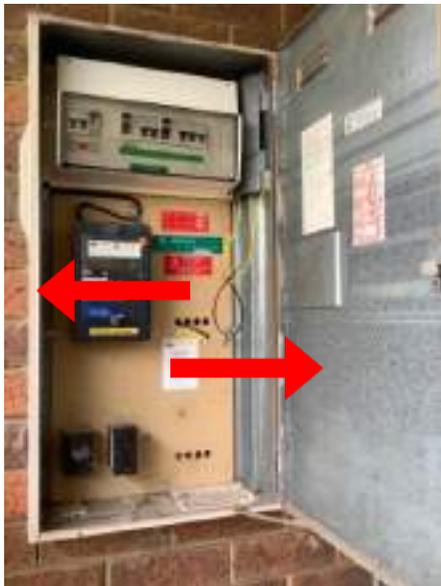
4.21

Location: The Site

A re-inspection is recommended once the areas are made accessible.

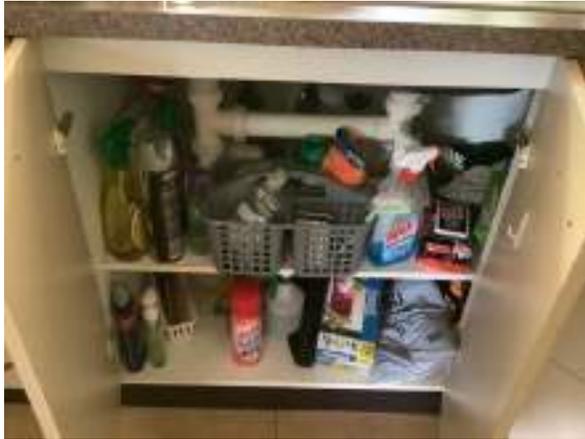
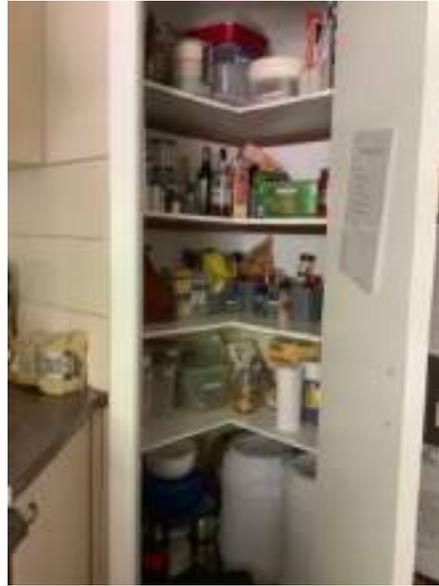
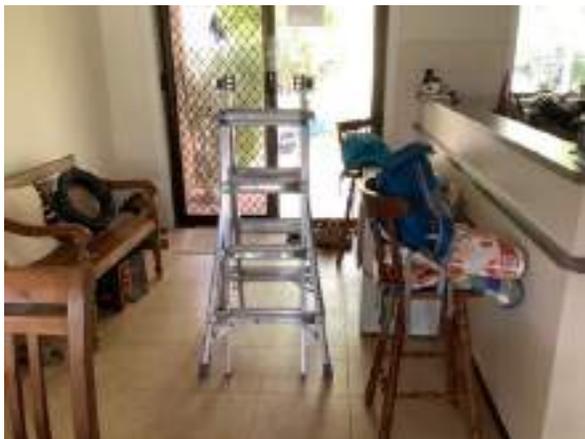
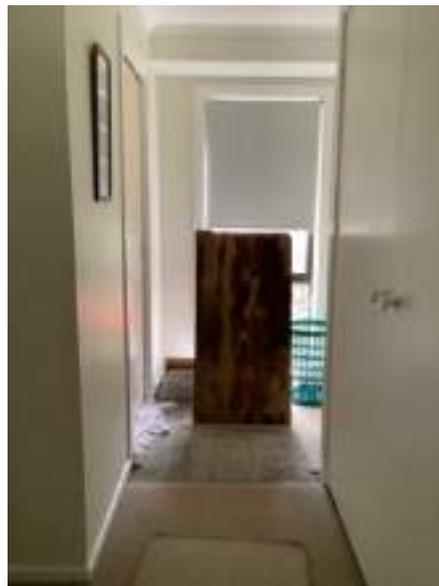
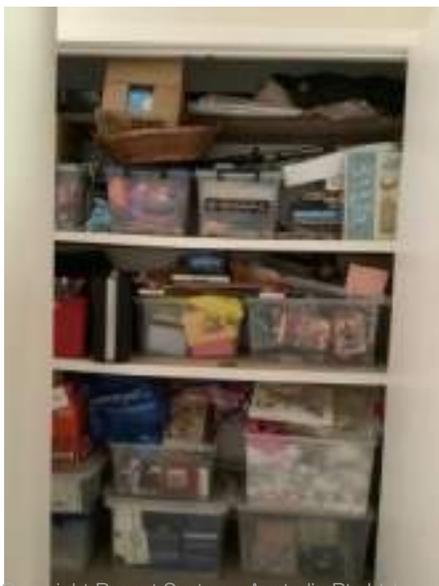
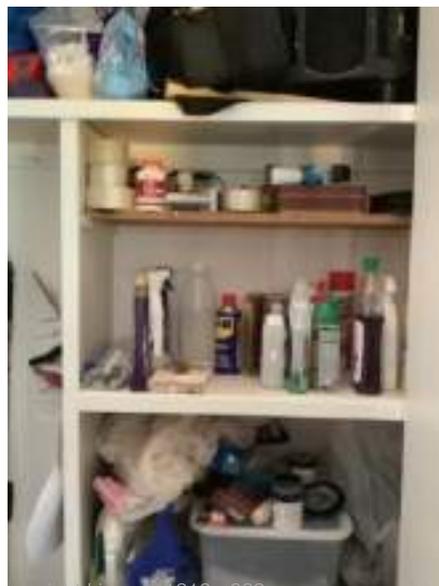
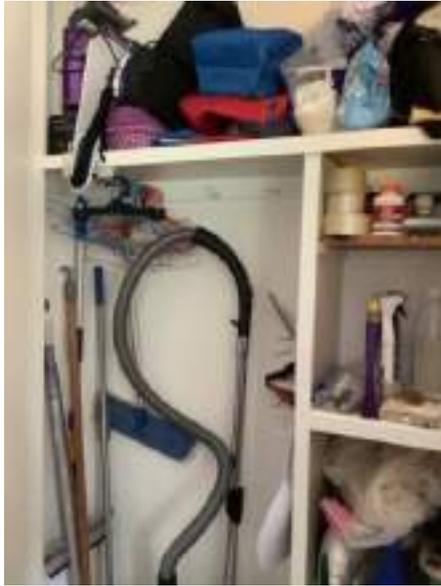
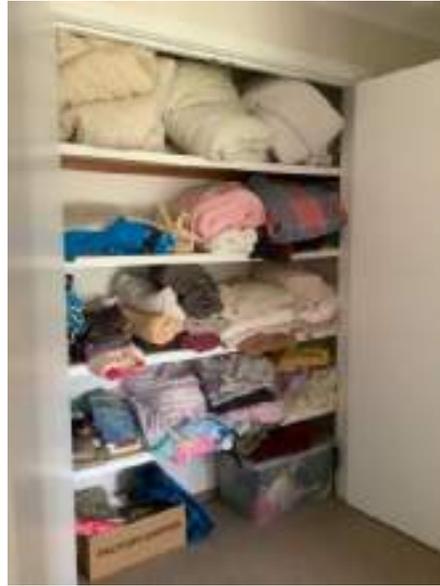
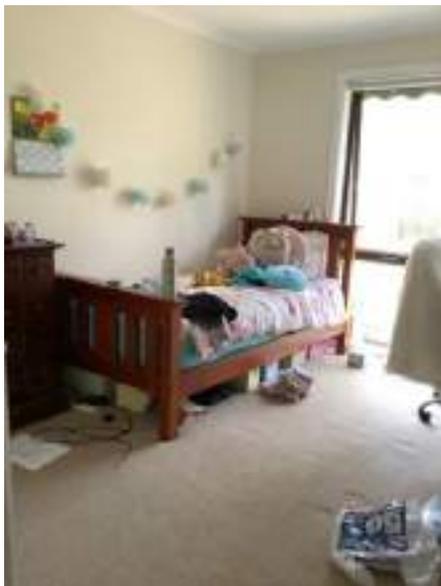
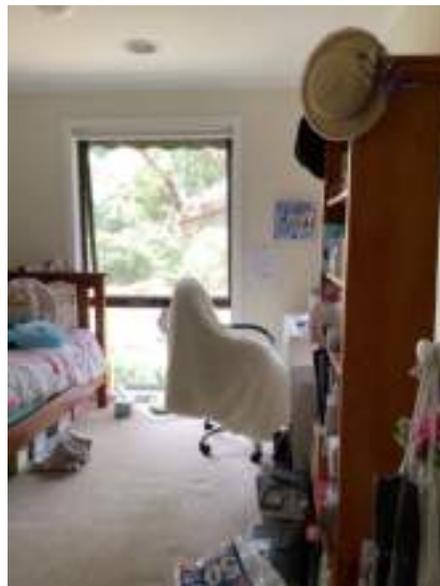
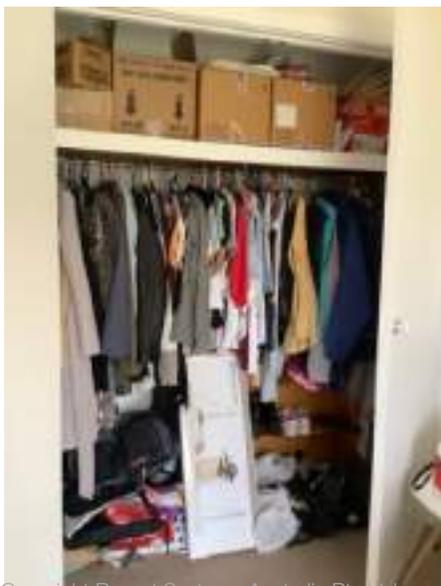
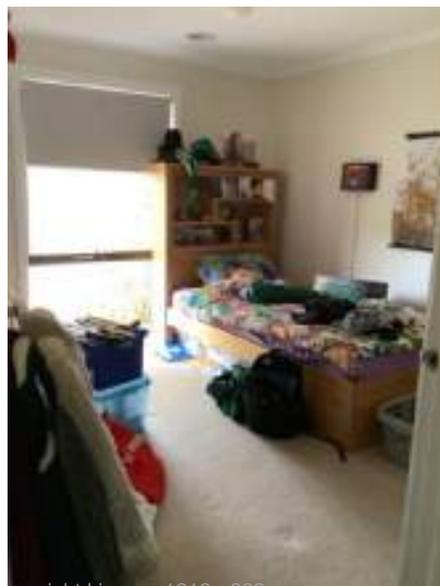
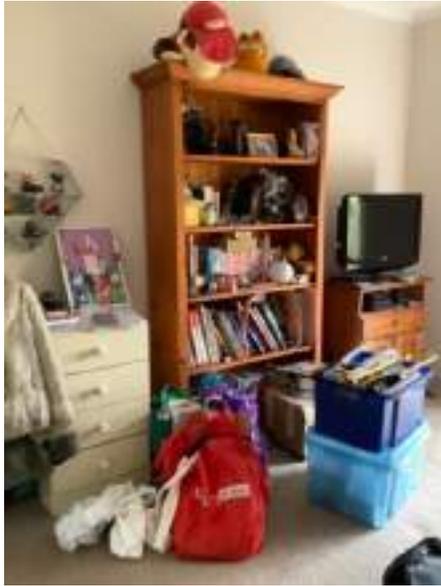
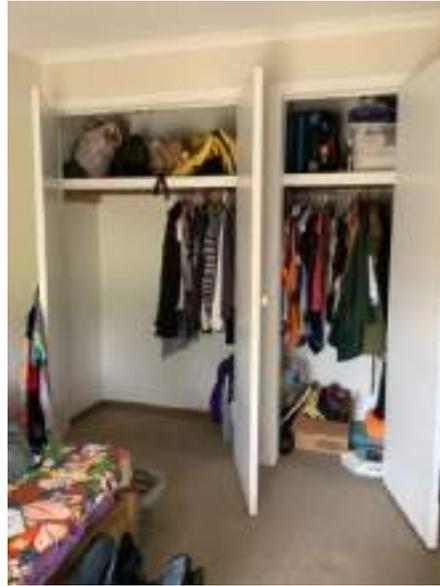
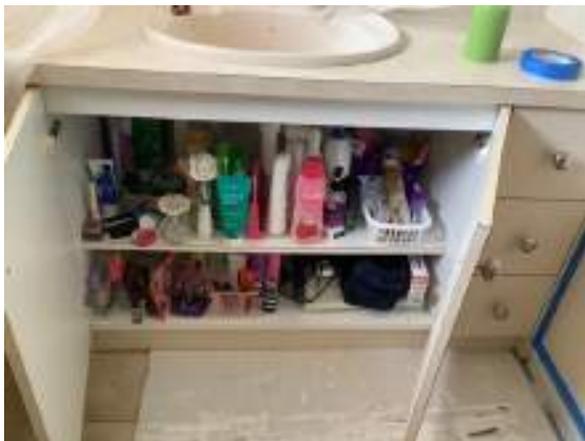
These obstructions can hide an array of defects such as minor defects , major defects , safety hazards , termite activity and conducive environments for termites but not limited to.

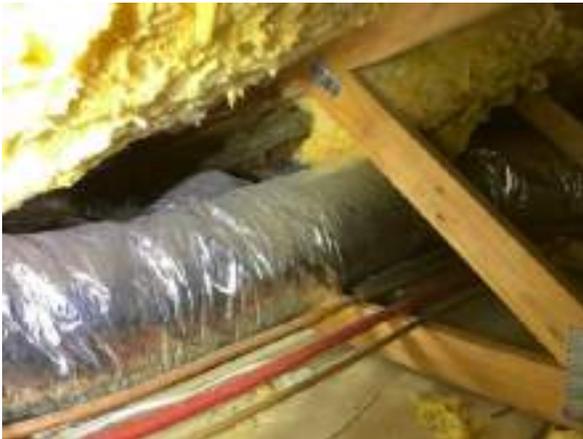
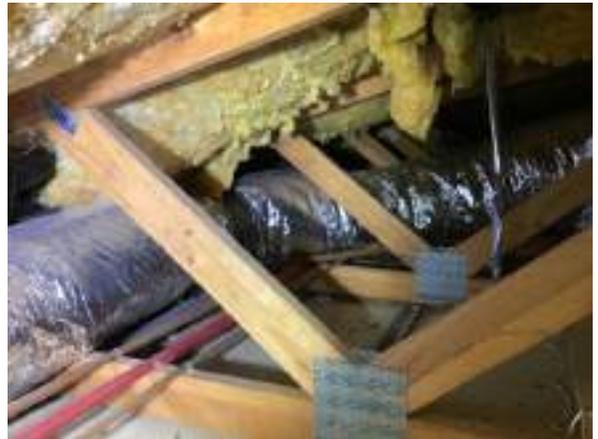
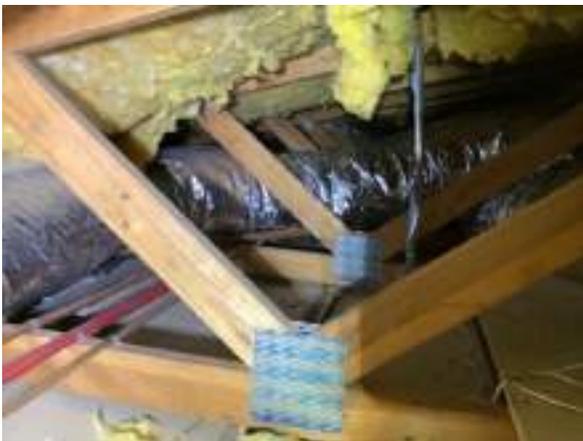
4.22

Location: Roof Space

Height 3.6 m ladder max on a ladder.

By not inspecting the roof space area there can hide an array of defects, without inspection to the roof void area it is impossible to rule out termite activity and/or termite damage and other undetectable issues .
