## Vendors Report

Inspection Date: 8 Apr 2020

Report Type: Property Inspection Report

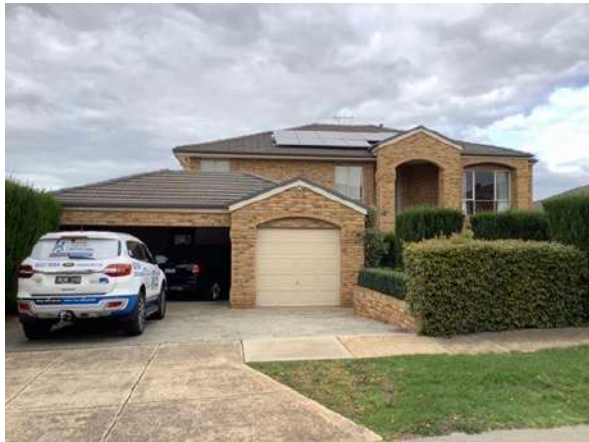
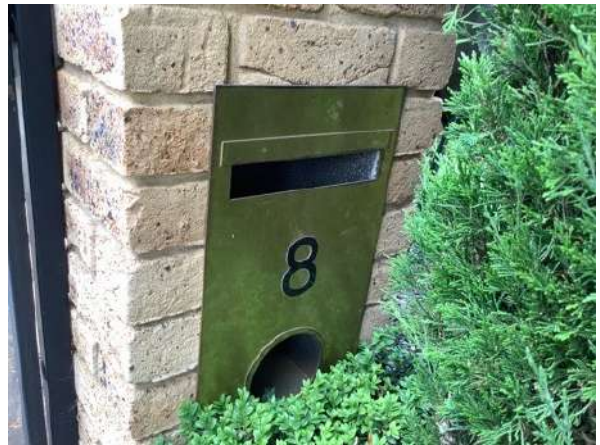
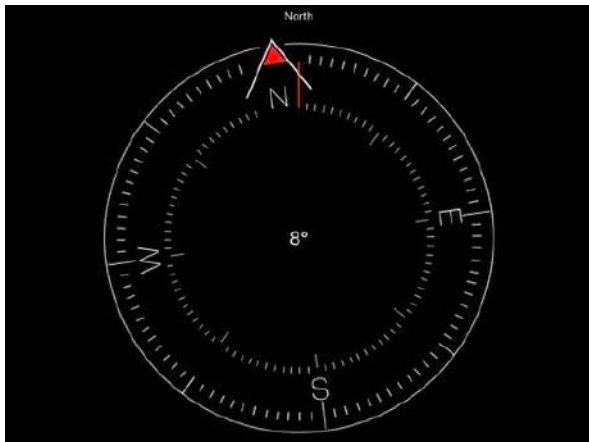
### Observation 4.07

Location: The Site  
Finding: General Site Photos & Compass  
General site photos and other areas of interest are provided for your general reference.
