Building, Electrical, Digital Floor Assessment & Termite, Timber Pest Report

Inspection Date: 14 Apr 2020

Property Address: Prahran Area, Melbourne

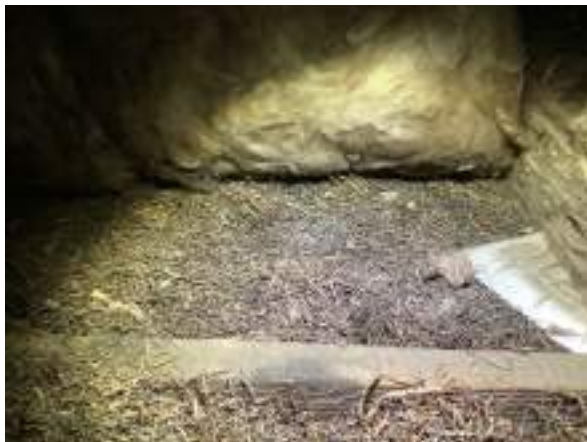
Serious Safety Hazard 1.03

Location: Roof Space

Finding: Insulation - Under insulation batts

There is the old original insulation under the insulation batts, this particular type of insulation may be a fire hazard and further investigation into this product is highly recommended. You make seek further advice from an insulation installer or a registered builder to determine if the product is required to be taken out.

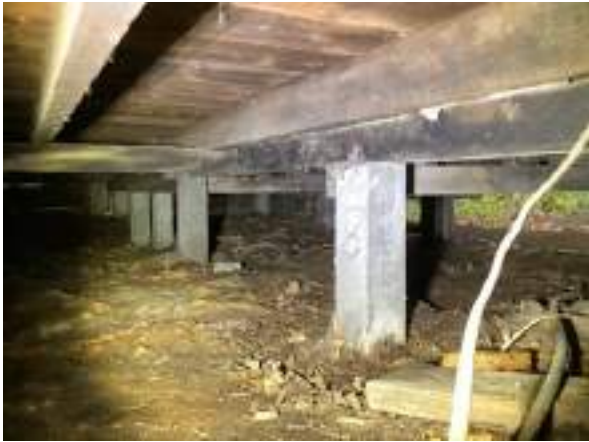
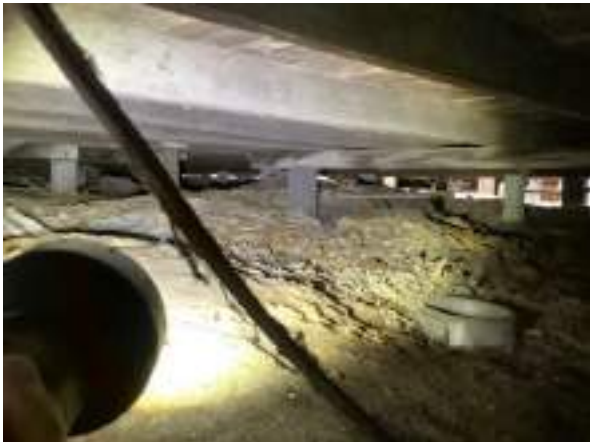
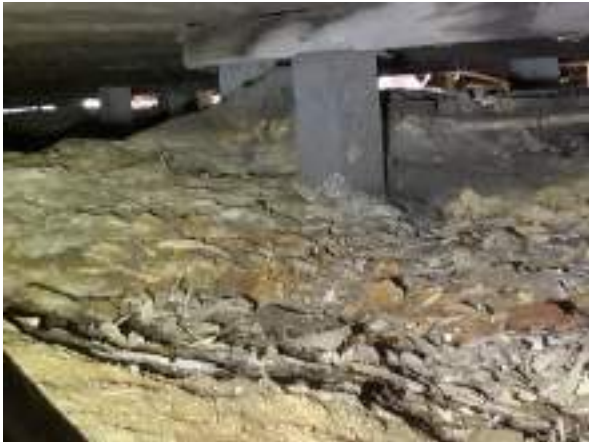
Serious Safety Hazard 1.05

Location: Subfloor

It is important to determine the cause of mould not just to get rid of mould.

Finally the cause or source of the mould MUST BE TAKEN CARE OF URGENTLY.

ALL AREAS should be checked carefully for this defect and attached are a few PHOTO EXAMPLES as a GUIDE.

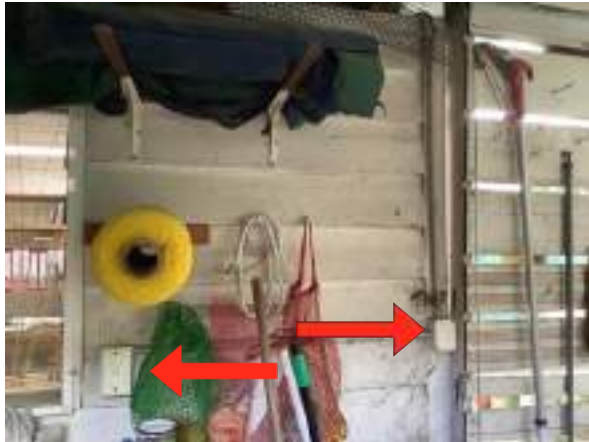
Serious Safety Hazard 1.09

Location: Rear Storage Area

Electrical defects stated in this report below are only items that we have visually noticed in this brief inspection and are of importance for repair and are of a SAFETY CONCERN which require a qualified electrician for repairs.

A Certificate of Electrical Safety is required for all electrical works and repairs performed to this property.

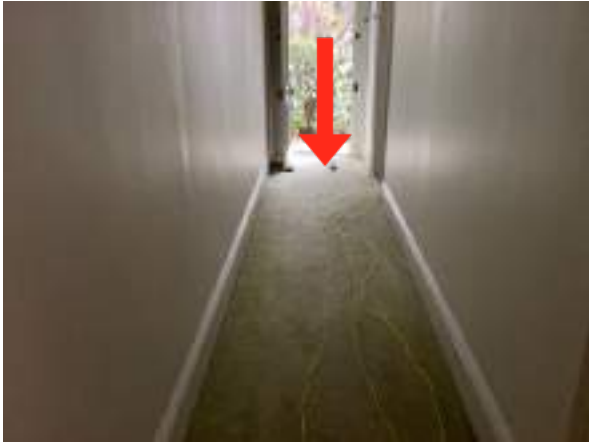
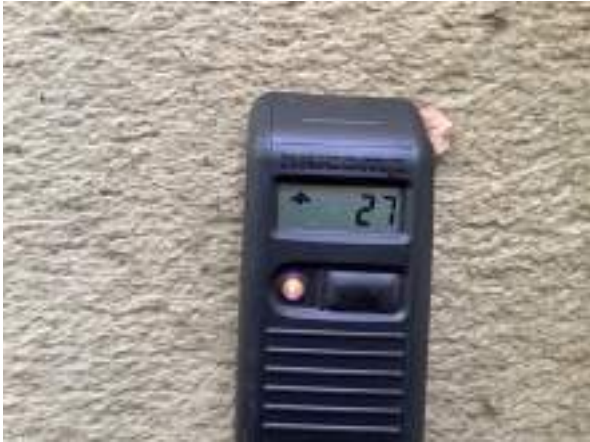
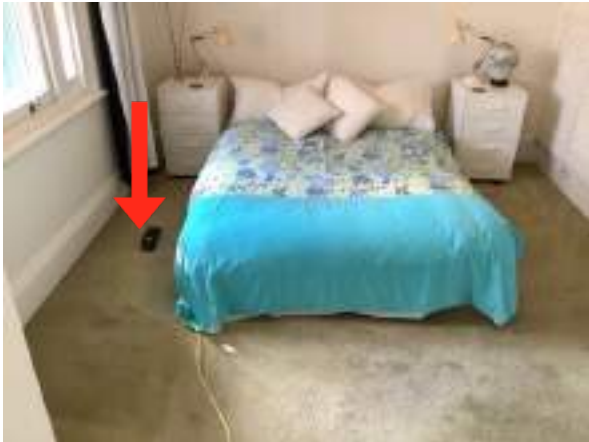
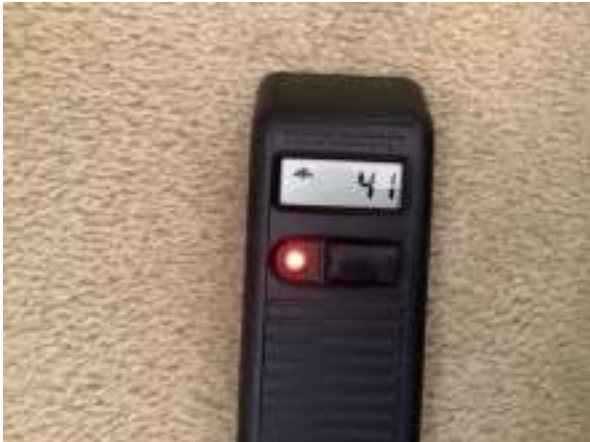
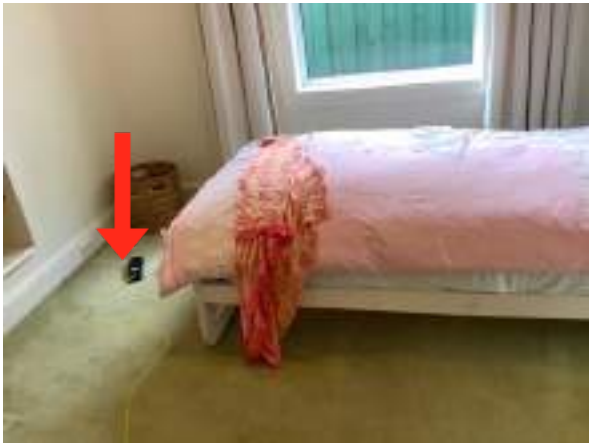
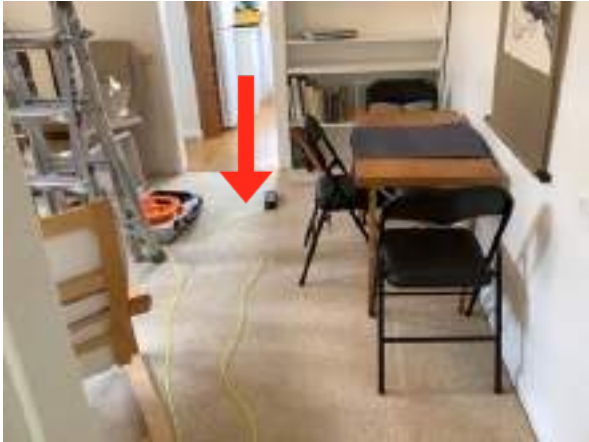
Major Defect 2.10

IMPORTANT TO NOTE : It will be important to note that the likely hood of cracking and movement to plaster, floor and wall tiles, doors requiring re-working, windows requiring re-working, kitchen cupboards, etc will be high once the home is jacked up and re-leveled to the correct height, the amount of repairs can be nothing to many areas. There will more then likely be the repairs of plaster, paint and the other repair concerns mentioned.

A Registered Builder who is experienced in flooring, stumps and re-stumping would then generally carry out works or be associated with re-stumpers as advised by a Structural Engineer and/or a geotechnical engineer, if required.

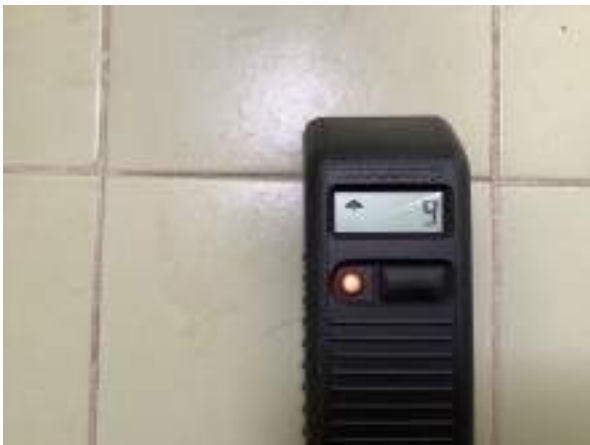
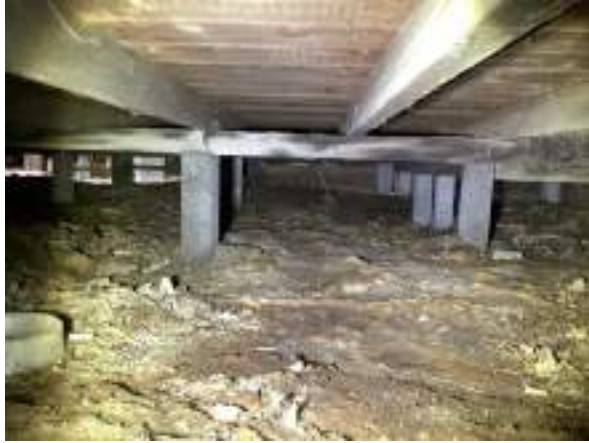
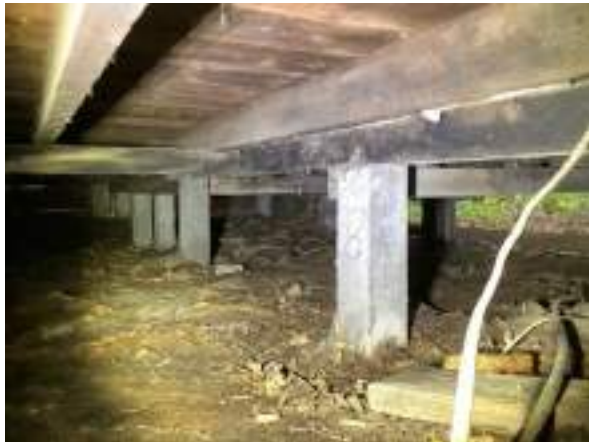
Major Defect 2.11

Location: Subfloor

It is important to note that the subfloor timbers may also be structurally compromised in areas. A registered builder will need to perform further invasive investigations.

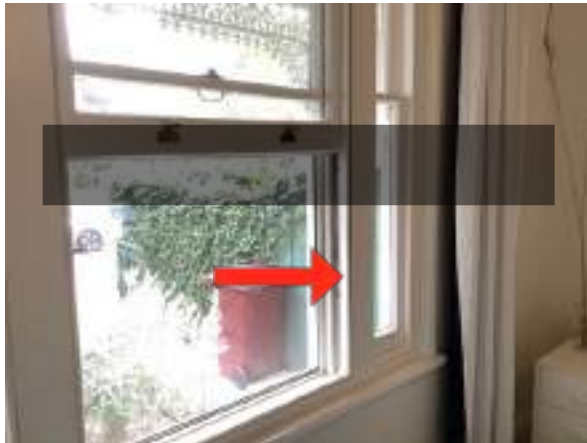
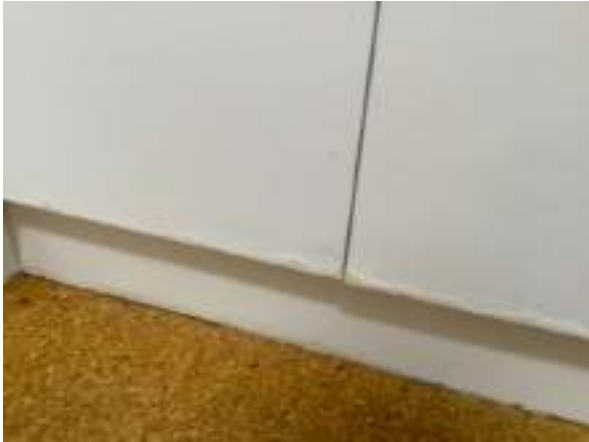
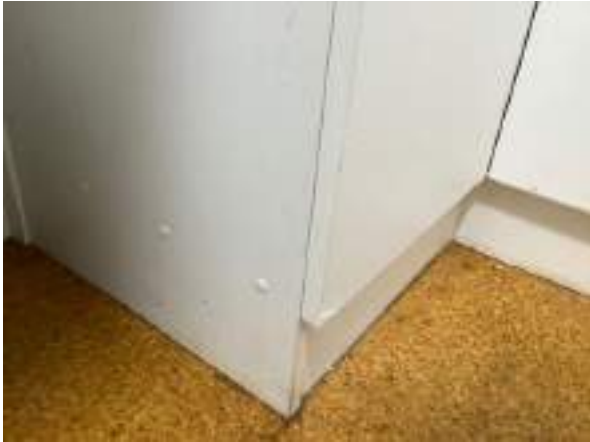
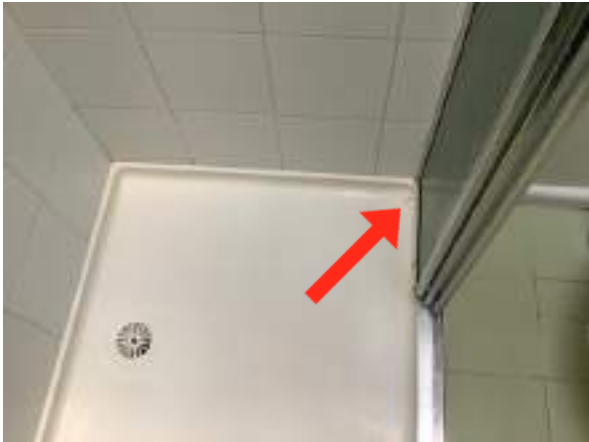
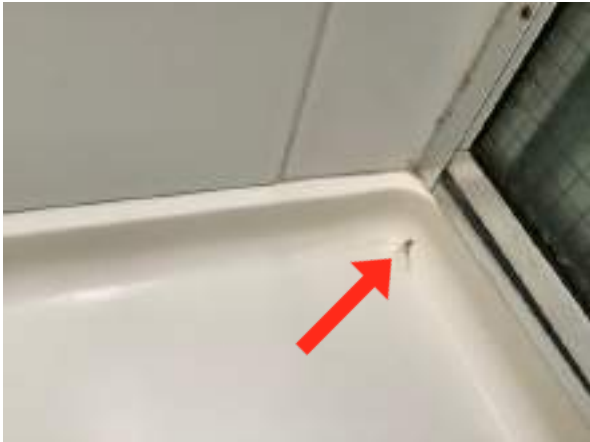
Minor Defect 3.12

Items like cracked glass mirrors, cracked glass windows and windows not operation smoothly are defects that should be repaired by the appropriate trades.

It is IMPERATIVE that you engage registered and qualified trades and at the end of there works they must supply certificates, such as an electrical safety certificate, plumbing and gas certificate if the works are electrical or plumbing, but for items such as damaged door handles, painting an experienced carpenter or handyman can sometimes be engaged.

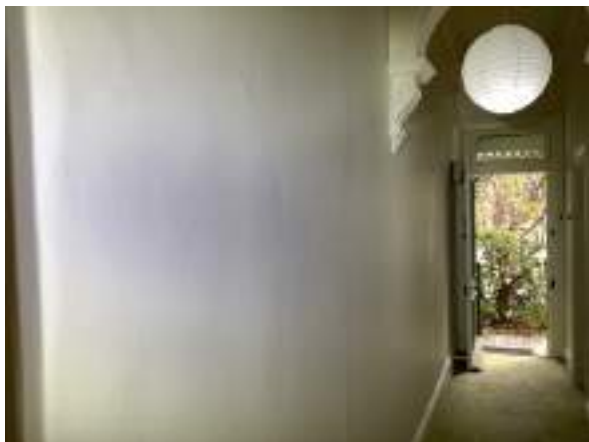
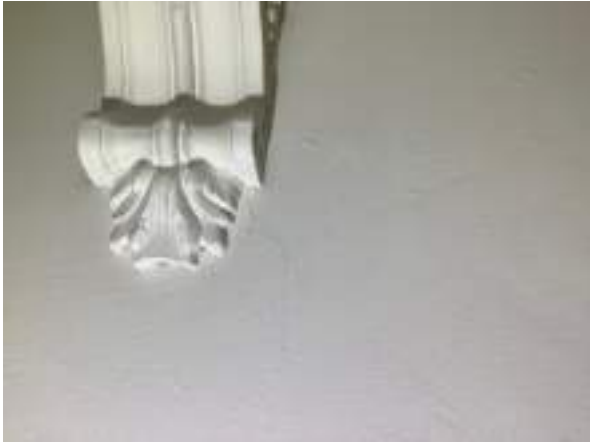
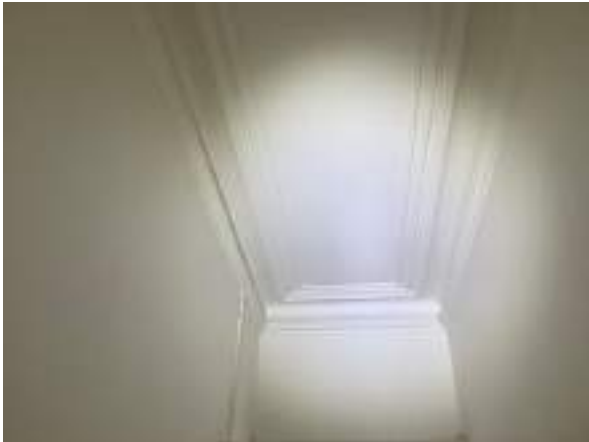
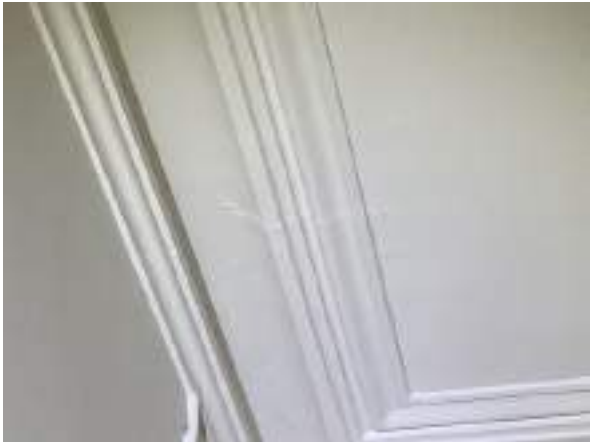
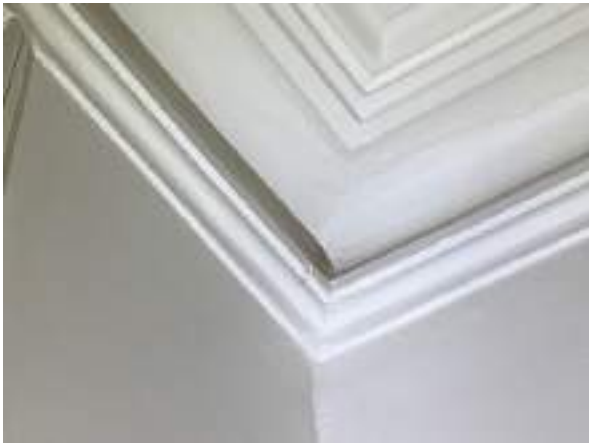
Minor Defect 3.13

Location: All Areas - Various

Finishes to (lath and plaster walls & hair line plaster walls or ceilings) generally have many imperfections.

Ultimately an experienced professional can generally put you on the right direction before spending a lot of money on repairing (lath and plaster walls & hair line plaster walls or ceilings)

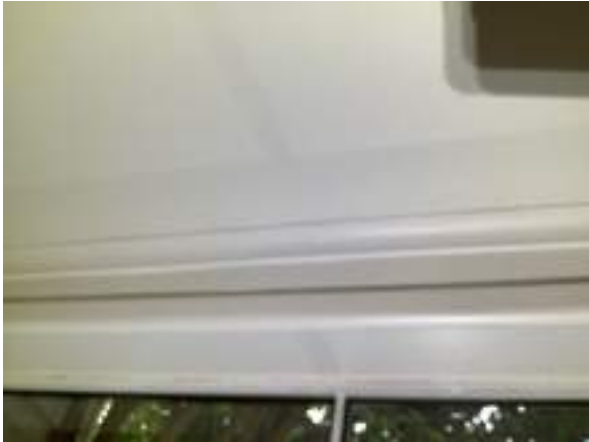
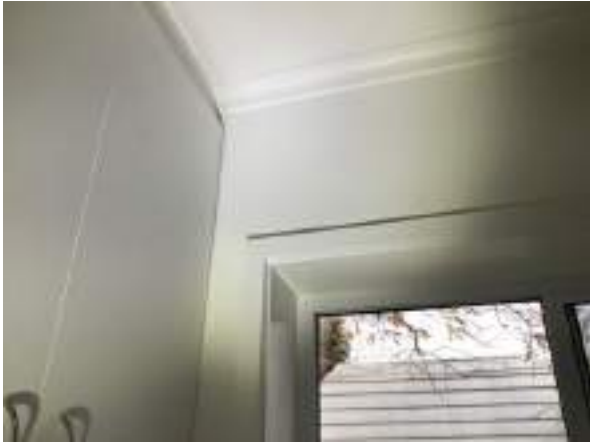
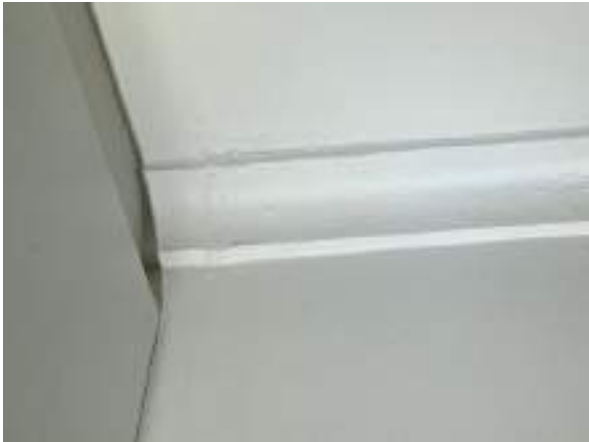
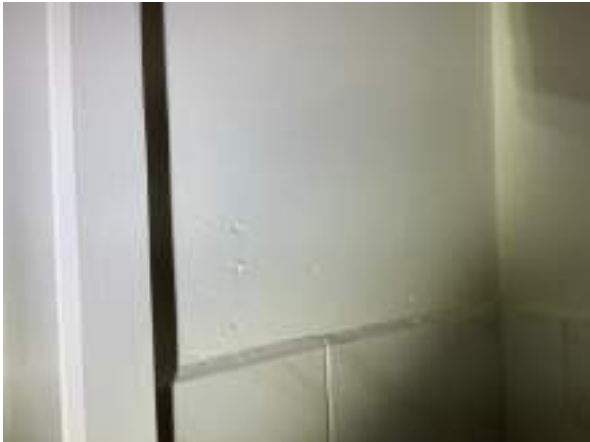
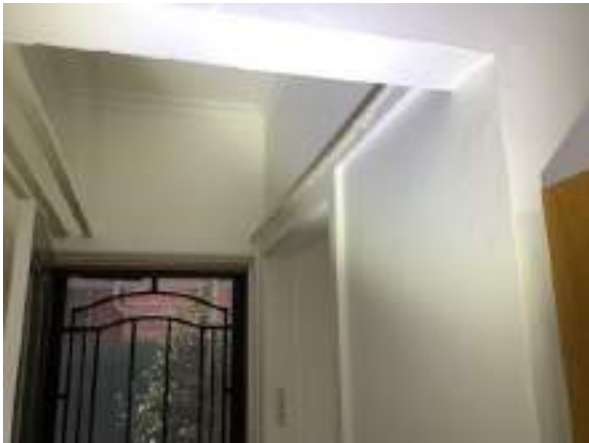
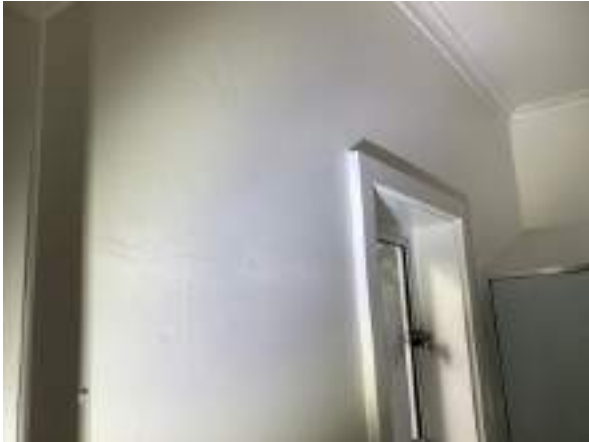
Minor Defect 3.15

Location: Plaster Internal Areas

Finding: Plaster & Timber Cracking - Damage Category 2 - Noticeable (up to 5mm)
Front bedroom

Noticeable cracks are a common occurrence as a result of many primary defects. Such causes may include age, general wear and tear, expected building movement, general expansion/contraction of building materials in different weather conditions, and/or minor failings in the installation or application of building materials.

Noticeable cracks may result in minor sticking or jamming of associated doors and windows, which require easement. However, noticeable cracks are easily filled and repaired. A plasterer can be consulted to install an expansion joint at this point to allow for this movement during different weather conditions.

Relevant tradespeople, such as carpenters, painters and plasterers, should be appointed to perform remedial works, as deemed necessary.

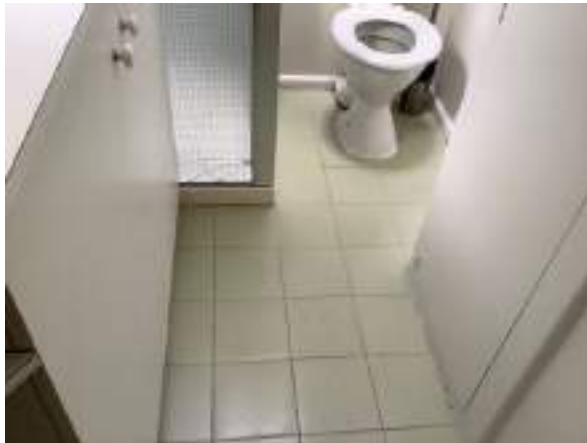
Minor Defect 3.18

Location: Bathroom

Sections of paint in this area was found to have bubbled and deteriorated. Paint bubbling is generally an indication of excessive moisture in the area, that is currently hidden by the painted surface.

The presence of excessive moisture can have major implications on associated building elements if left unattended. While only seemingly minor at this stage, the damage cannot be determined due to the paint obstructing any further inspection of the damage.

It is highly advised that the affected paint be cleaned to allow a further, more invasive inspection by a licensed plumber. Failure to act on this defect may necessitate major works in the future.

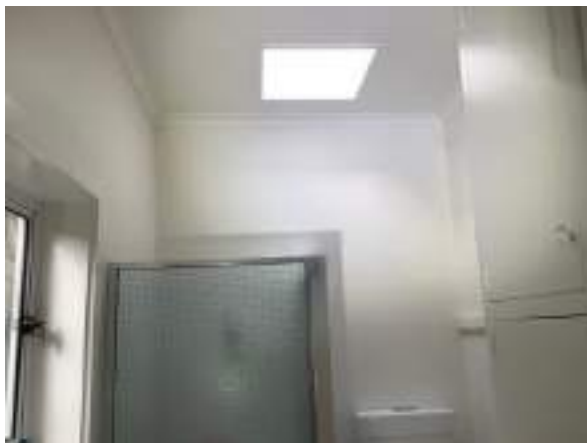
Minor Defect 3.19

Location: Bathroom

Drummy tiles may also be contributed to tiles cracking and what is important is to determine the cause of the cracking, which may be related to the subfloor structure, typical wear and tear and/or poor workmanship

Such defects are generally caused by physical or moisture damage to the area. Drummy tiled areas may also be a direct result of poor workmanship during the construction process.

Tiled areas may swell and shrink with changes in air humidity if the area has sustained moisture damage.

Any exposure to moisture is capable of causing tiled areas to become drummy and/or cracked over a prolonged period of time. Drummy tiled areas generally require removal and replacement of affected tiles, with adequate sealant and grouting.

Specialist trades are available for these types of services. A registered builder may be required to undertake works if damage is extensive or if secondary building defects have resulted. Otherwise, it is advised that a tiling contractor be appointed to perform works as necessary. Immediate action is recommended to ensure that no further damage is sustained in the affected area.

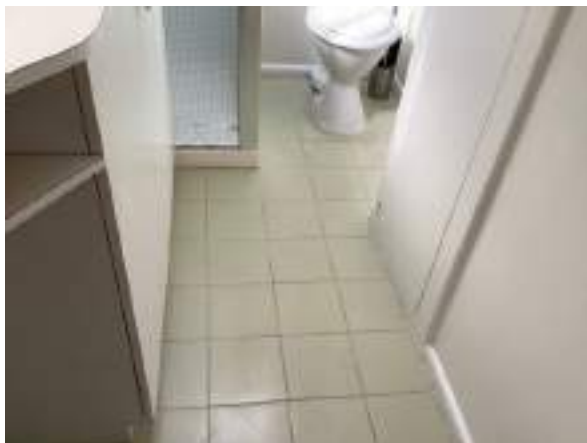
Minor Defect 3.20

Location: Bathroom

Finding: Toilet Cistern - Loose to the wall
Installation of the cistern has been done to a substandard level or has just aged over time and has led to the cistern not being correctly attached to the adjoining wall.

Where cisterns are loose it is more susceptible to impact damage as well as creating potential for damage to the adjoining wall.

The cistern requires reattachment to the wall to prevent any further damage, sometimes it is as easy as a couple of dabs of silicon behind the cistern to stop the cistern moving as it is secure enough but just requires the shaking to stop or if the defect is greater then explained above works may be completed by a licensed plumber.

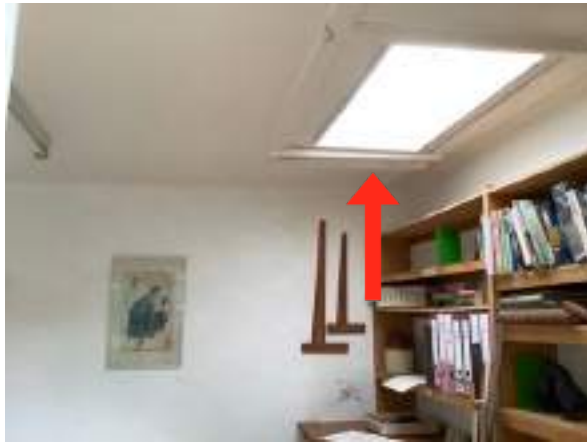
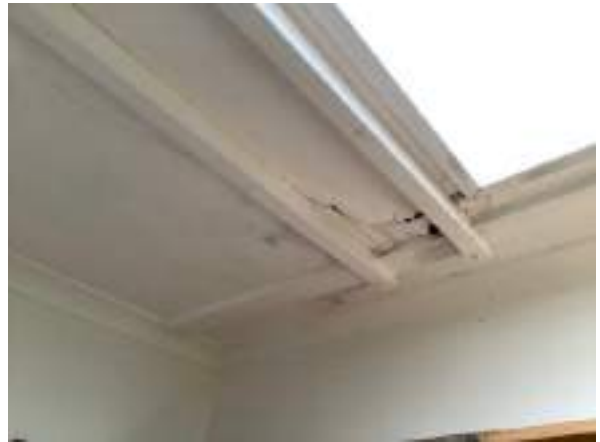
Once the leak is repaired, consultation with relevant tradespeople, including plasterers and painters, is advised. Rectification works may include replacement of ceiling lining or minor repainting, depending on the extent of the damage.

Conversely, where water staining is old and inactive, affected building materials may be repaired or replaced at client discretion.

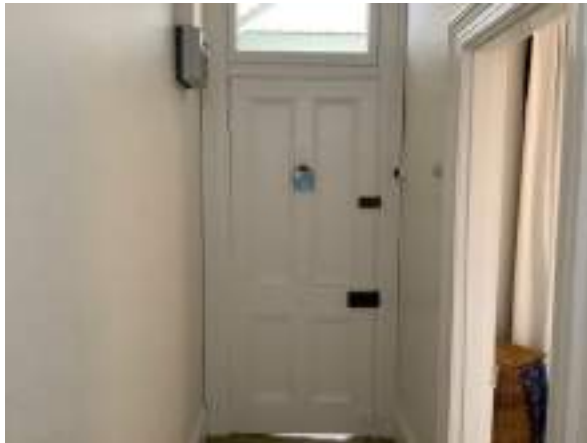
Minor Defect 3.32

Location: Entry, Bedroom 2
Finding: Door - Binding / Jamming / Out Of Level

This defect inhibits the functionality of the affected door as well as creating potential for secondary defects to associated building elements, such as damage to the floor covering.

A door that binds to flooring or to the associated door frame may have several causes, ranging from minor defects, such as poor installation of the door or deteriorated hinges, through to major structural issues, such as damage and/or subsidence (sinking) to subfloor structures.

For minor causes, a qualified carpenter or general handyperson should be appointed to perform minor rectification works at client discretion.

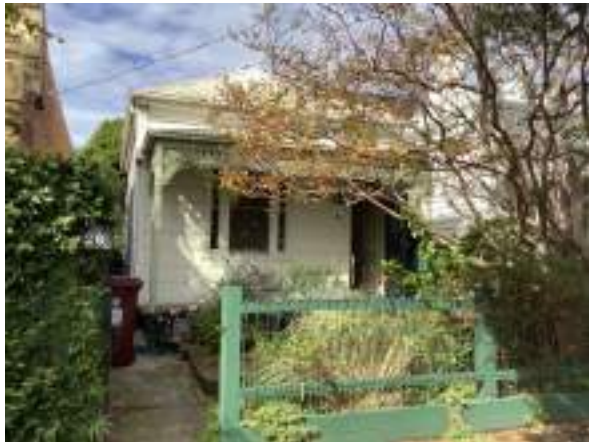
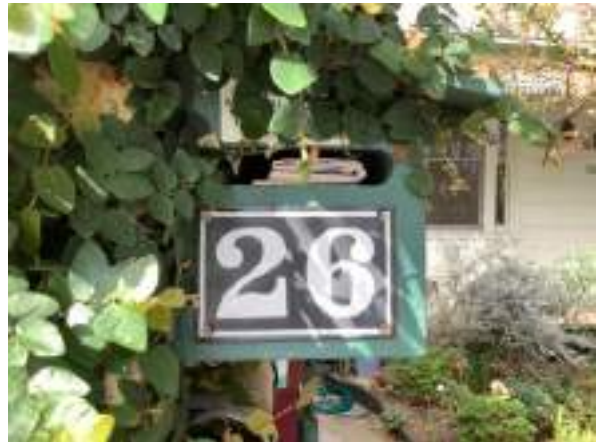
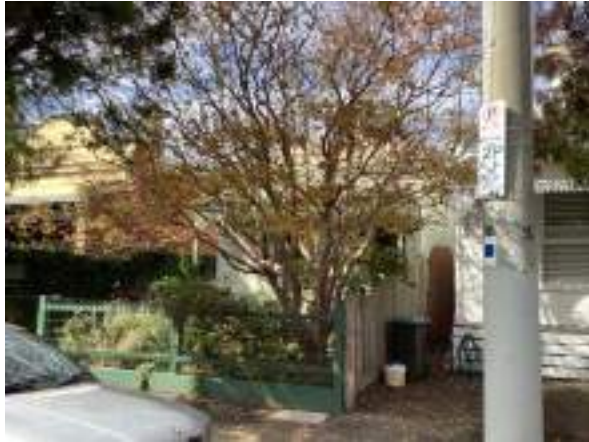
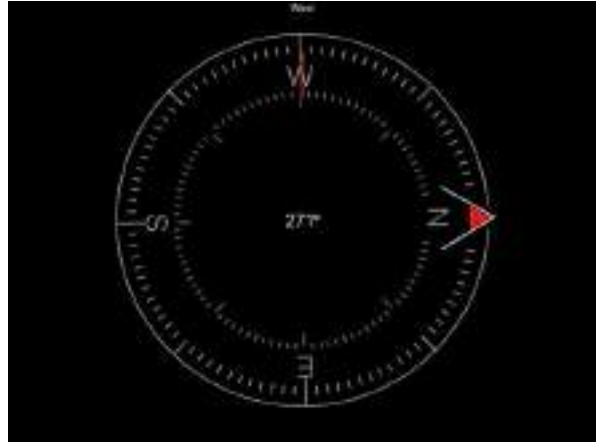
Location: The Site

Finding: General Site Photos & Compass
General site photos and other areas of interest are provided for your general reference.

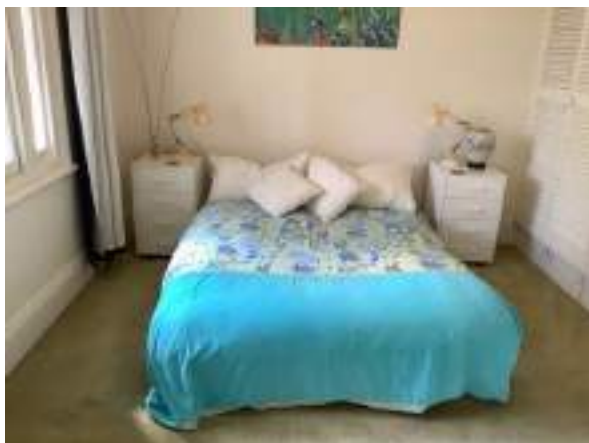
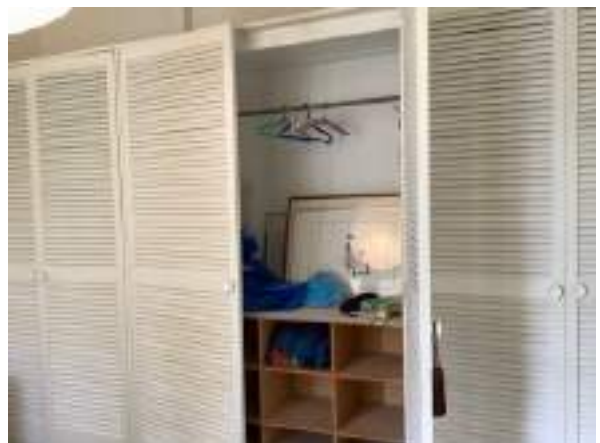
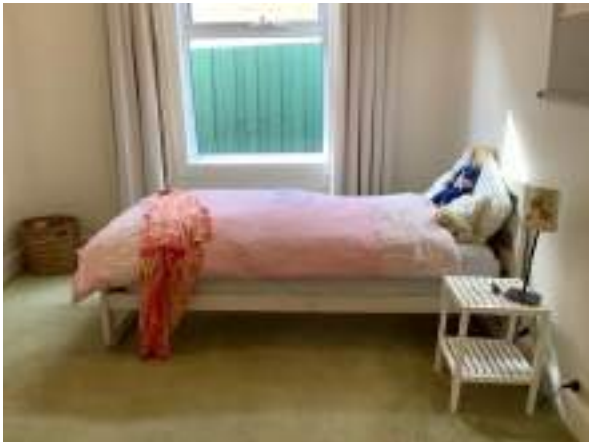
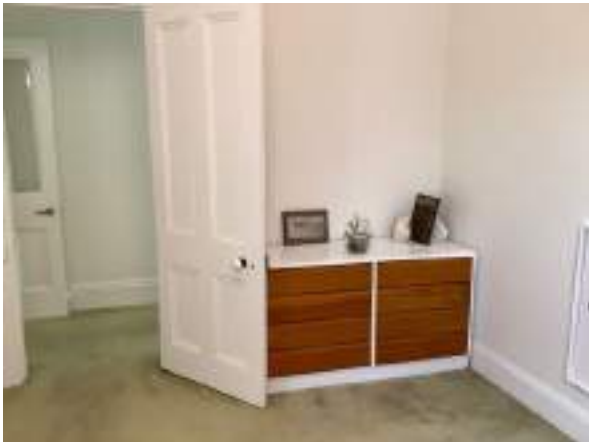
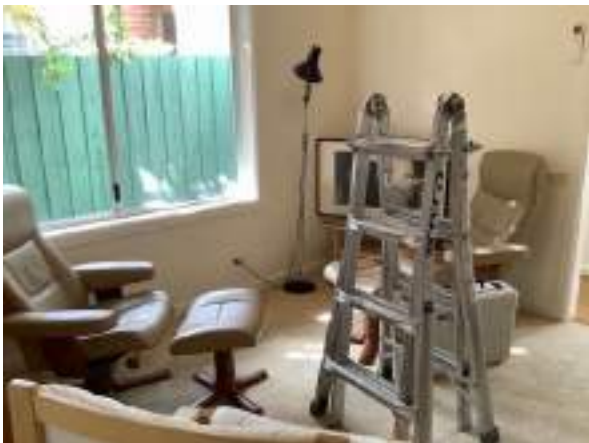
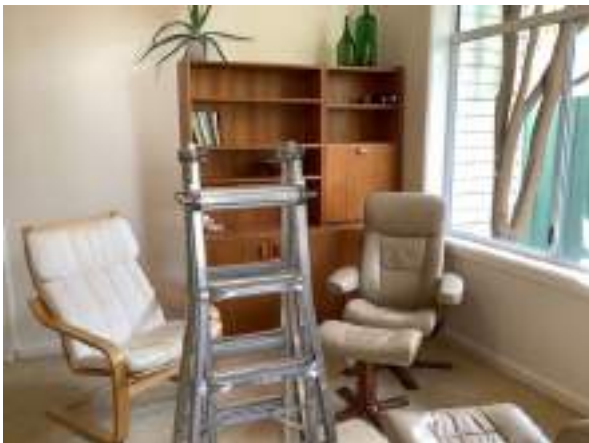
For your information 4.34

Location: The Site

Finding: Additional Photos - Obstructions and Limitations
These photographs are an indication of the obstructions and limitations which impeded full inspection of the property at the time of inspection.
These obstructions can hide an array of defects such as minor defects , major defects , safety hazards , termite activity and conducive environments for termites but not limited to.

Whilst we have taken many photos of the home and surroundings of the obstructions and limitations , we have just added a few photos in the report for you to understand the type of obstructions and limitations .

A re-inspection is recommended once the areas are made accessible.

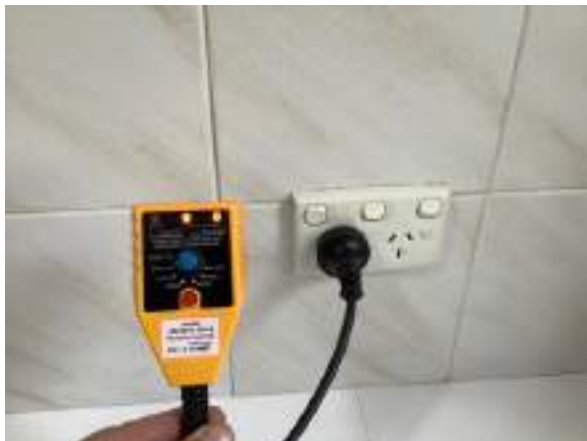
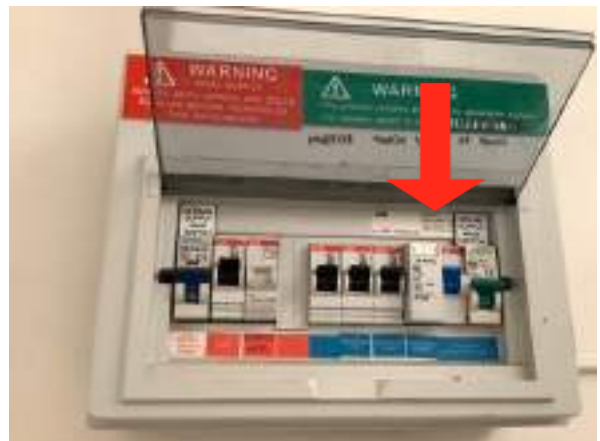
3/ Safety Switch test to trip the safety switch at less then 30 milli amps was performed.

These tests all passed the AS 3000 requirement and exceptance level.

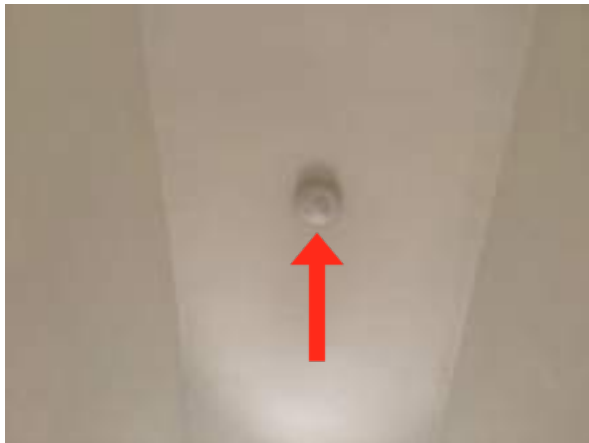
For your information 4.36

Location: The Site

Finding: Smoke Detectors Battery Replacement.
This inspection DOES NOT test operation of smoke detectors .

Upon moving into a new property, it is highly recommended that the batteries to the smoke detectors all get replaced instantly.

Smoke detector batteries should be replaced every 12 months at a minimum.

It is highly recommended that replacement dates of the batteries be kept in a log book.

Testing of smoke detectors is required monthly.

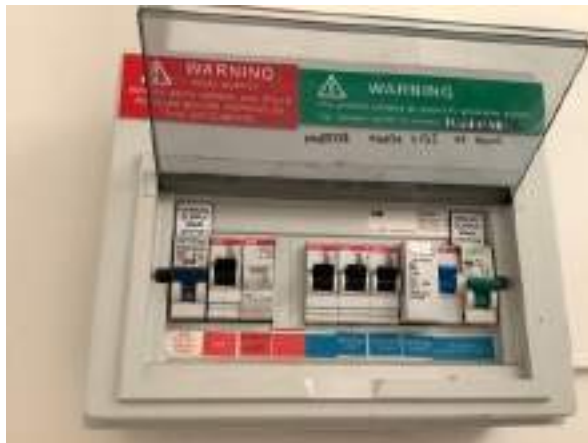
Finding: Electrical - A further Electrical Invasive Inspection recommended.
As we perform a VISUAL ELECTRICAL DEFECT INSPECTION.

It is highly recommended that an invasive electrical inspection take place by a qualified electrician as our inspection is Visual ONLY.

For example we highly recommend that further tests to determine that the main earthing system and the earthing to all metal fittings such as lights etc are all connected.

Upon any Electrical Installation or repairs a certificate of Electrical safety for prescribed or non-prescribed electrical installation work must be given to the owner of the building.
(Electricity safety act 1998, Electricity safety (Installations) Regulations 2009)

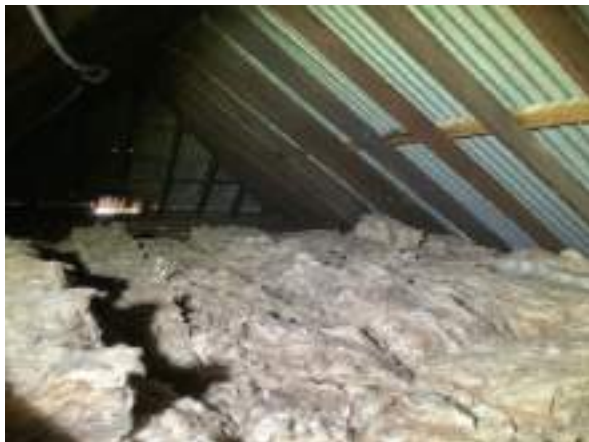
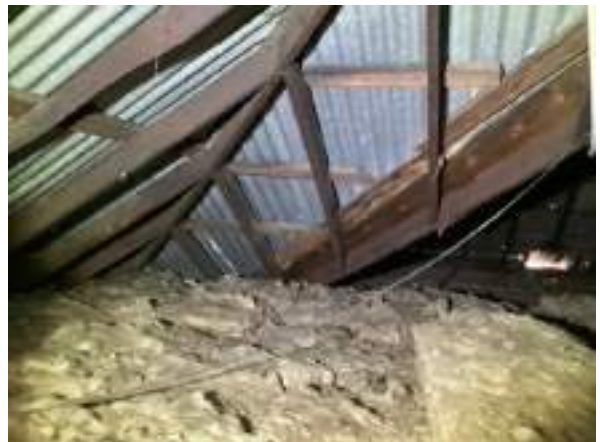
These obstructions can hide an array of defects, without removing the insulation it is impossible to rule out termite activity and/or termite damage and other undetectable issues.

The property is a very high risk for termites as the environments to the property are very conducive with many susceptible areas.

Please read the report carefully and Maintenance to all susceptible and conducive areas is a MUST to minimise the risk of termite and timber pest existence and timber damage.

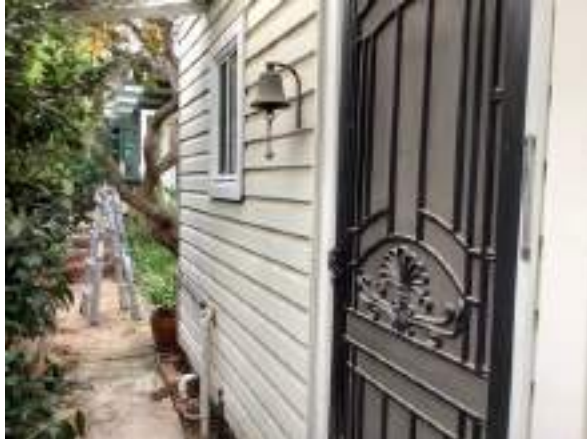
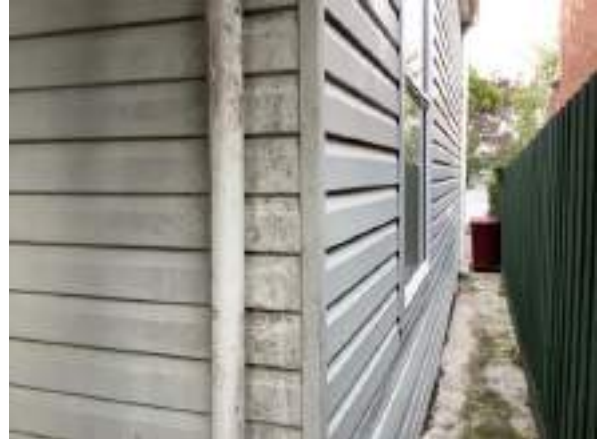
For your information 4.41

Location: Perimeter Of Building - Exterior

Finding: Cladding Over weatherboards.
There is cladding over the timber weatherboards. This was a fashion in the day and it is unknown the quality of the weatherboards underneath the cladding.

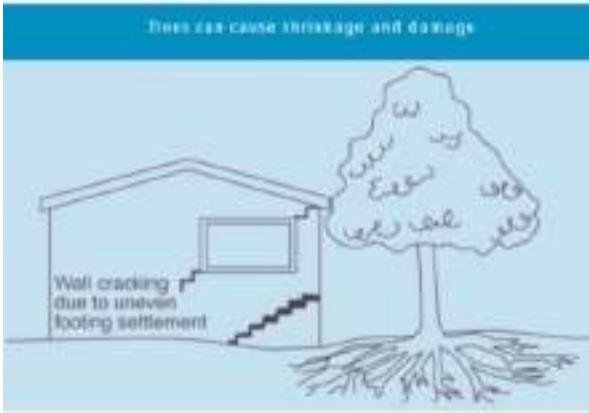
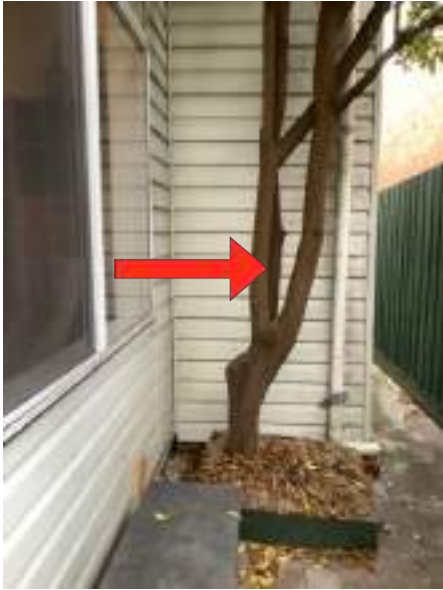
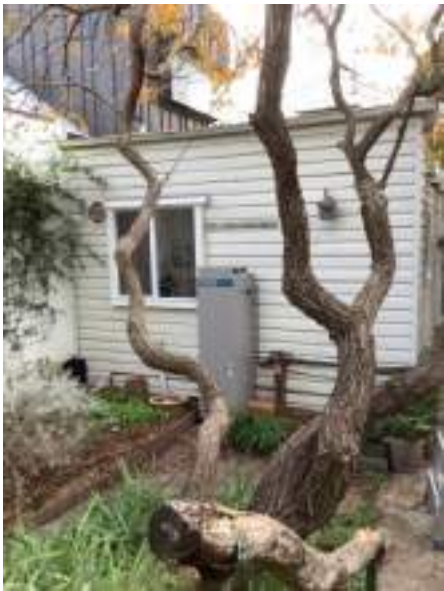
For your information 4.42

Location: Garden Areas - All Areas

Finding: Garden trees and vegetation - Close to building.
PLEASE NOTICE THE ATTACHMENT PICTURES TO THIS DEFECT STATEMENT;
H = the height of the tree at its full potential height, not its height today.
D = the distance from the tree to the building at the trees full potential height.
D = varies pending on one tree to 4 trees or more.

Trees and other vegetation can have a significant local effect on drying of soils. Over a number of years, especially during drought conditions, adjacent trees and vegetation may draw excessive moisture from the soils. The opposite may also occur, where swelling of the soil results when the trees decline or are removed.

As the cumulative moisture deficient is reversed, the surface level around the tree (and adjoining subfloor or concrete slab) will rise and expand laterally. This is often damaging to buildings unless the foundations have been strengthened or designed to cope with the effect.

Subsidence can have complex and varying causes, which will influence the required remedial works. It is advised to begin by consulting a structural engineer to determine the required scope of works. This generally includes some form of underpinning, as well as addressing the underlying cause. Consultation with a geotechnical engineer may also be necessary.

A registered builder specialising in re-stumping / structural damage such as major brick cracking would then generally carry out works as advised by an Engineer and/or Geotechnical Engineer.

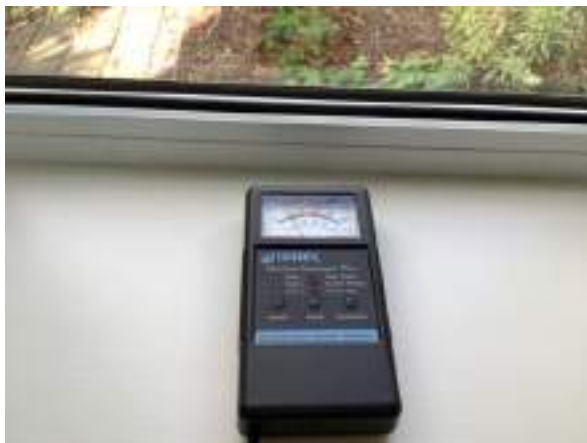
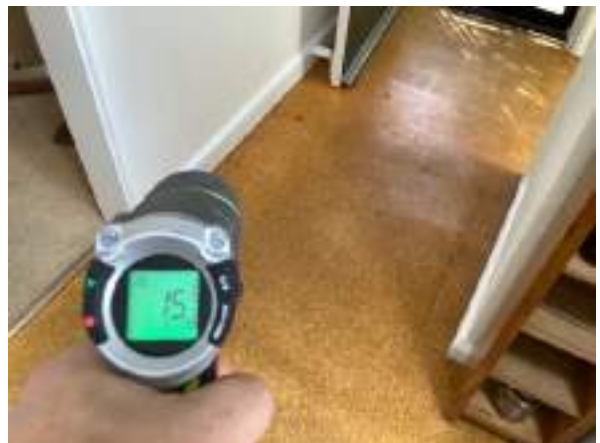
As all areas are not able to be inspected due obstructions and limitations, we therefore can not rule out the possibility of concealed timber pest activity.

Wall paneling, wall paper, carpet and fixed cabinetry can obscure termite activity.

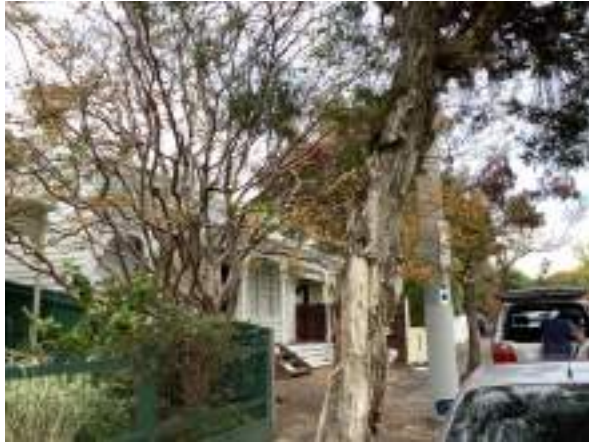
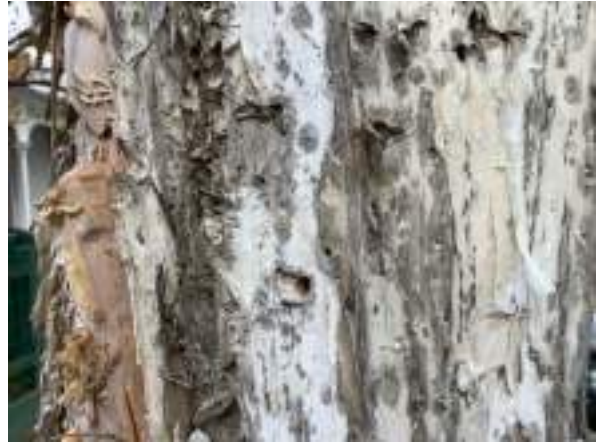
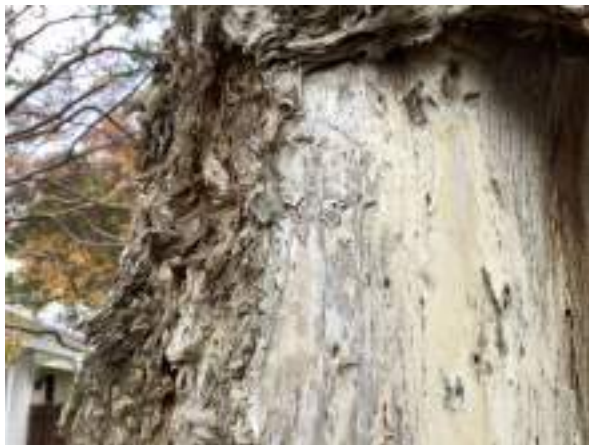
Finding: Timber Pest - Damage Identified.

It is suspected that timber pest activity is occurring or has occurred as there appears to be evidence of timber pest damage.

Despite no live termite or timber pest activity being identified, previous timber pest damage was found in these areas.

Such damage creates a potential safety hazard, and is likely to worsen and cause further damage to adjoining building materials.

If left unattended, this damage creates an unsafe environment and is likely to lead to the need for major structural works.

A building contractor should be appointed immediately to advise on options to prevent further damage and repair all affected building materials. Until such time, caution should be taken by all people coming into contact with these building elements and this area.

The application of a post-construction chemical termite barrier or other termite / timber pest treatments is highly recommended for all properties, particularly if live termite activity has been found on the site previously. Such barriers are highly effective in preventing termite attack on any timber building elements throughout the property.

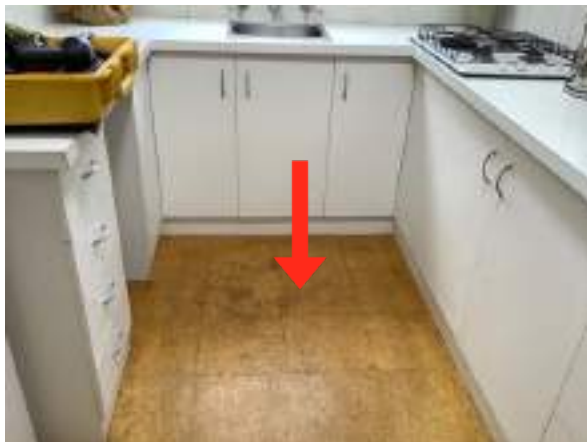
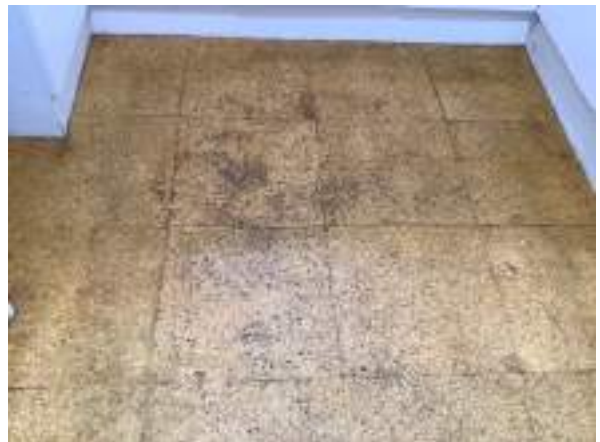
Finding: Wet Areas, Moisture Present - Attract Termites.
Excessive moisture can attract termites and produce conditions that promote termite attack fungal growth and wood decay as Termites are attracted to moisture.

Excessive moisture is generally caused by deteriorated inadequate or missing roof drainage leaking plumbing pipes or fixtures poorly plumbed HWS overflows or condenser units and poor site drainage.

It is highly recommended that all plumbing and drainage fixtures and fittings be maintained regularly in order to prevent excessive moisture being present in the external / internal property.

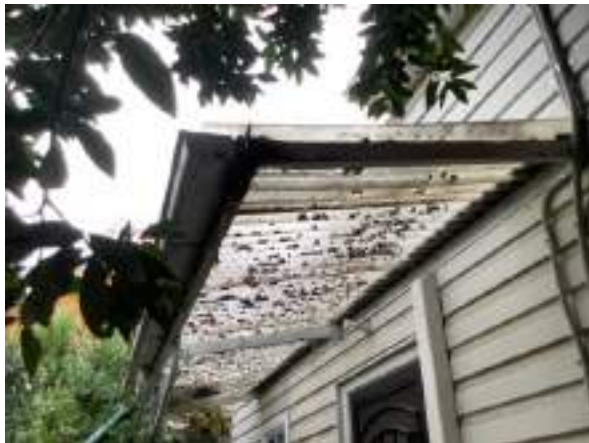
Item 2.05

Location: External Areas

Finding: Wet Areas, Moisture Present - Attract Termites.
Excessive moisture can attract termites and produce conditions that promote termite attack fungal growth and wood decay as Termites are attracted to moisture.

Excessive moisture is generally caused by deteriorated inadequate or missing roof drainage leaking plumbing pipes or fixtures poorly plumbed HWS overflows or condenser units and poor site drainage.

It is highly recommended that all plumbing and drainage fixtures and fittings be maintained regularly in order to prevent excessive moisture being present in the external / internal property.

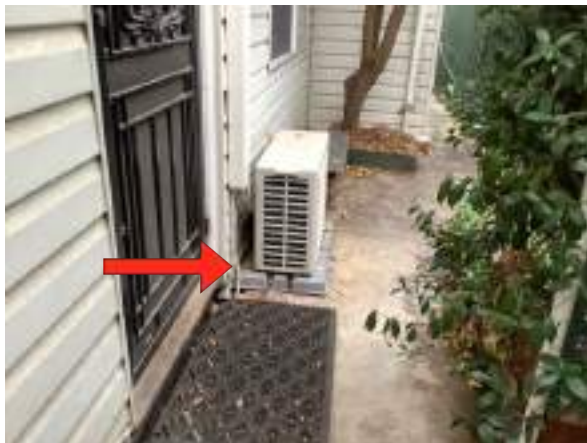
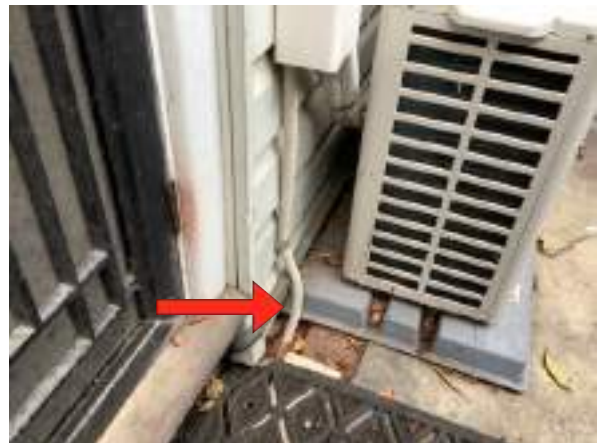
Item 2.07

Location: Perimeter Of Building - Exterior

Finding: Air conditioner - Disconnected overflow

The Air Conditioner (A/C) overflow was found to be disconnected from storm water draining and is creating excessive moisture in the surrounding area.

Such leaking creates an environment which is conducive to an array of defects, including water damage to associated building elements and the attraction of termite or timber pest infestation.

This excessive water creates a much more conducive environment for termites as well.

It is highly recommended that a licensed plumber be appointed to connect the A/C overflow in order to prevent such an environment from being created.

These minor works should be carried out as soon as possible.
