Building, Electrical, Digital Floor Assessment & Termite, Timber Pest Report

Inspection Date: 14 Apr 2020

Property Address: Prahran Area, Melbourne

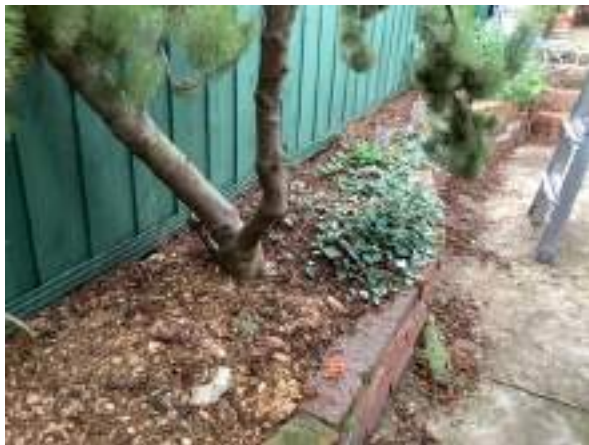
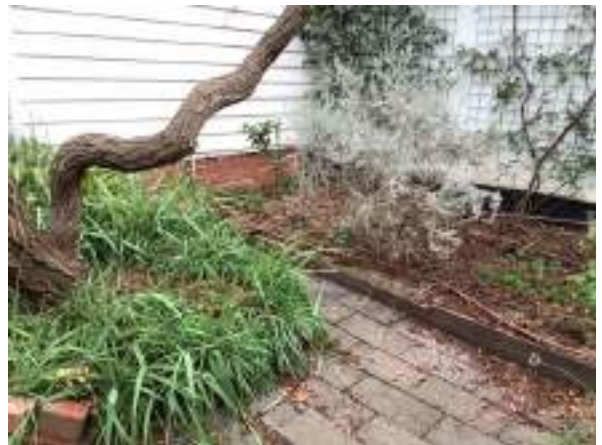
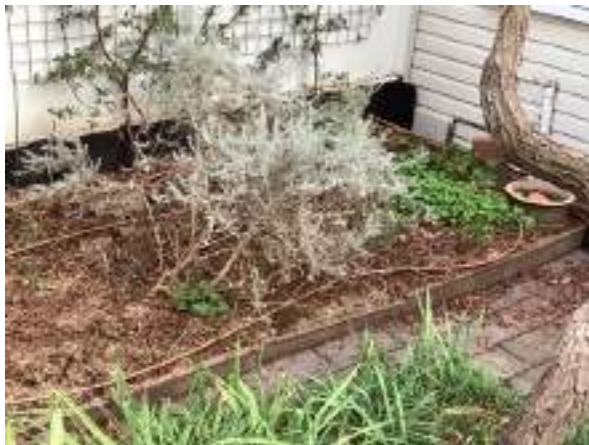
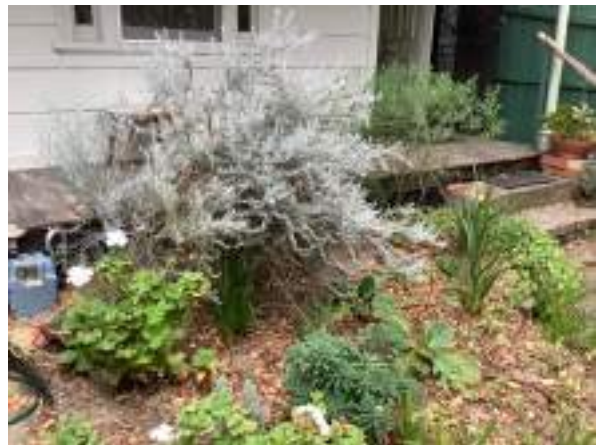
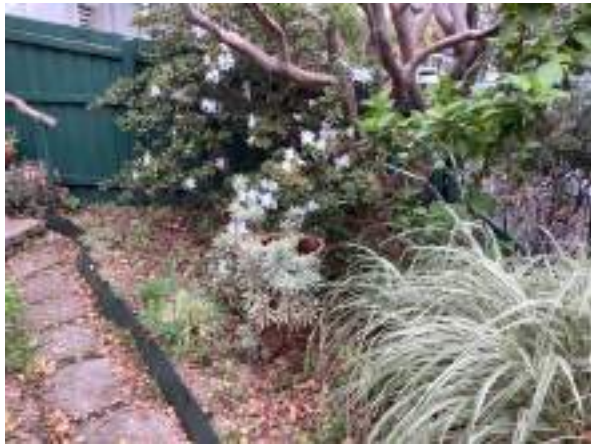
Item 2.08

Location: Garden Areas - All Areas

Finding: Garden Beds - Conditions Conducive to Termites
Garden beds were found to be evident in areas of garden areas. These garden beds can include untreated timber, bark, excessive old vegetation and with a combination of moisture from watering hosing can make conditions very conducive to termite activity and termite ingress.
It is always important to keep the garden beds as clean as possible and take out excess old bark from the trees, leaves and keep bark mulch to a minimum or better introduce rocks or some item that does not create an conducive environment for termites and hold excess moisture.

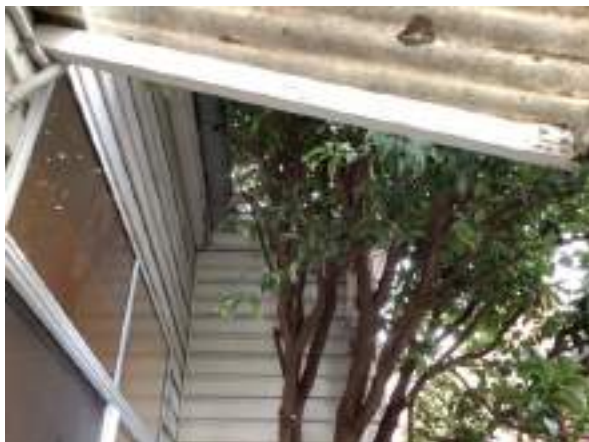
Item 2.09

Location: Roof Areas & Stormwater

Finding: Gutters - Requiring Clean Up And Removal Of Vegetation.
Gutters are a critical part of the building's management of storm water and rain. It is therefore important that they be kept clear to prevent secondary damage to associated building elements, including exterior and interior walls, ceiling linings and any adjoining building elements. Where gutters are blocked, pooling of rainwater is likely to occur, fast-tracking rust and corrosion of the roof plumbing elements.

Unclean Gutters prevent building elements from operating as intended, detracting from the overall function of the affected building elements. Additionally, the lack of general maintenance may lead to the development of more significant defects, such as damage to surrounding building materials.

Blockages should be removed and addressed promptly, as they will lead to the development of secondary building defects. The blockage should be removed as the primary rectification works. Secondly, check for any secondary or concealed damage, and then attempt to address the cause of the blockage to prevent recurrence or any water damage to associated structures.

Immediate clean up is required.

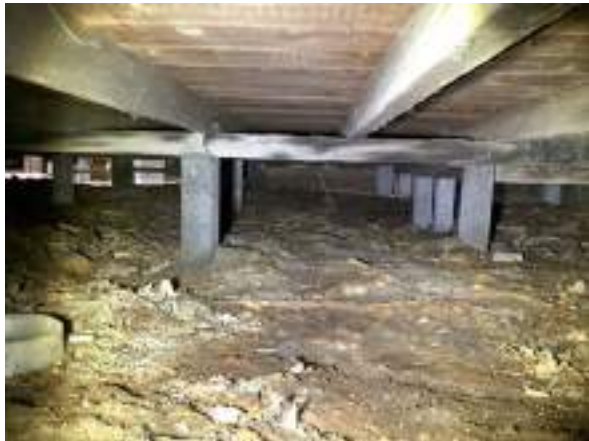
Item 2.10

Location: Subfloor

Finding: Wet Areas, Moisture Present - Attract Termites.
Excessive moisture can attract termites and produce conditions that promote termite attack fungal growth and wood decay as Termites are attracted to moisture.

Excessive moisture is generally caused by deteriorated inadequate or missing roof drainage leaking plumbing pipes or fixtures poorly plumbed HWS overflows or condenser units and poor site drainage.

It is highly recommended that all plumbing and drainage fixtures and fittings be maintained regularly in order to prevent excessive moisture being present in the external / internal property.

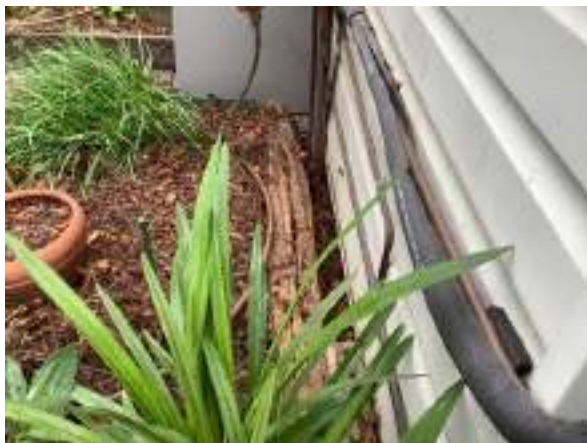
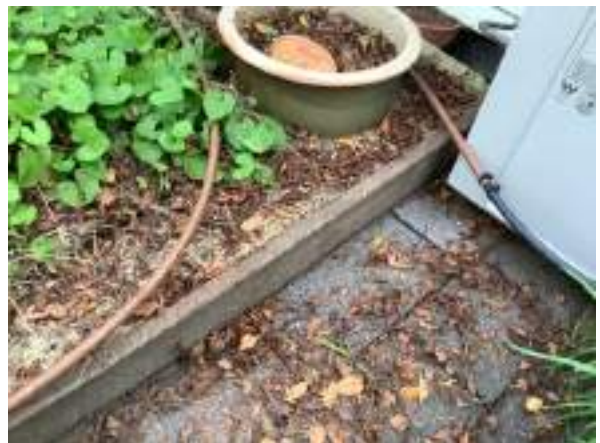
UNTREATED OR NON-DURABLE TIMBER USED IN A HAZARDOUS ENVIRONMENT

Remove untreated timber that is in direct contact with external grounds. Consider replacement with more durable materials i.e. treated timber or non timber elements.

Frequent pest inspections are advised to readily identify any termite activity in these areas.
