Post Pour Concrete Slab Report

Inspection Date: 9 Apr 2020

Property Address: Rockbank Area - Melbourne

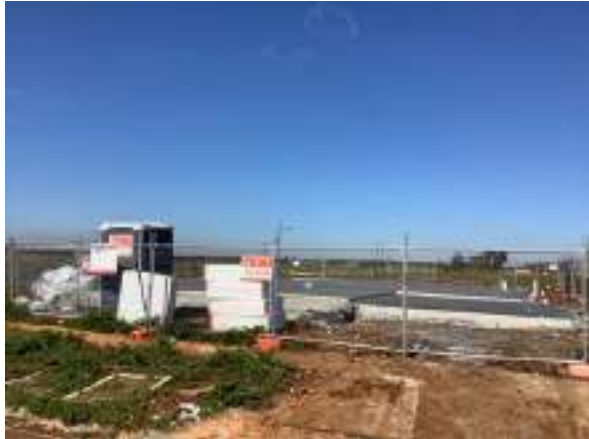
For Your Information 5.11

Location: For Your Information
Finding: Re-Inspection - Recommended
We highly recommend that a Re-Inspection to inspect the rectified defects are performed prior to further works commencing.

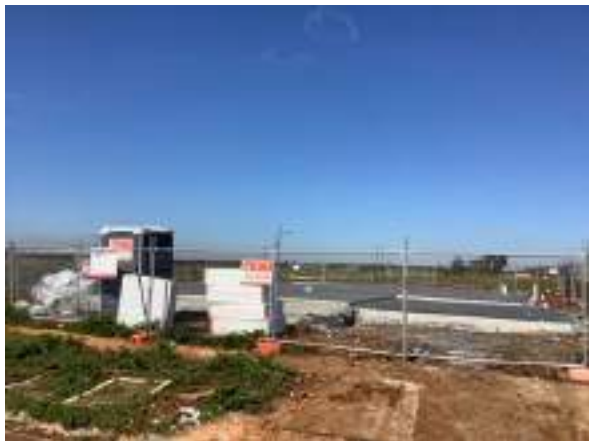
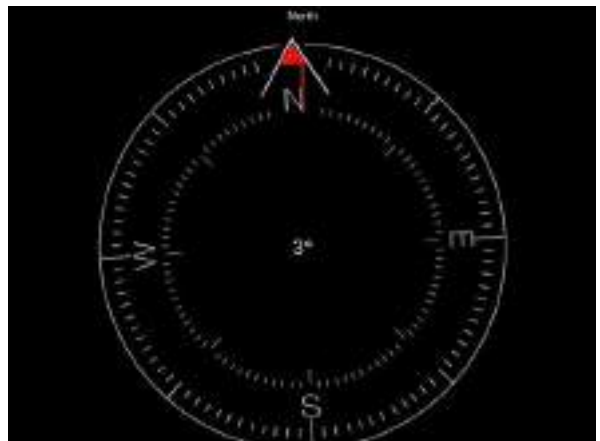
For Your Information 5.12

Location: General Site Photos.
Finding: Site Photos
General site photos are provided for your general reference.

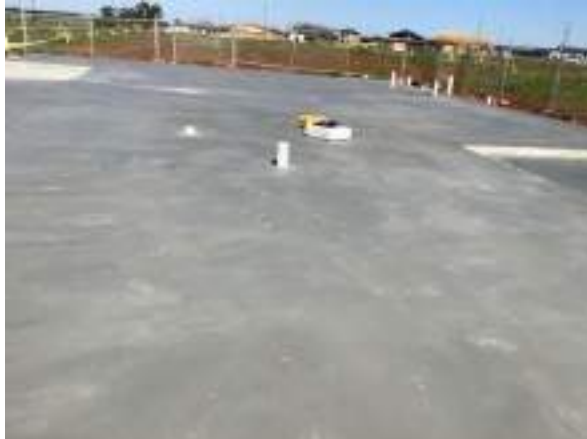
For Your Information 5.13

Location: Post Pour Slab - All Areas

Finding: Concrete Surface Finish - Acceptable
Additional photos are provided for your general reference to show that the concrete surface finish is acceptable and well within Standards & Tolerances 2015.
