Termite & Timber Pest Report

Inspection Date: 31 Jan 2020

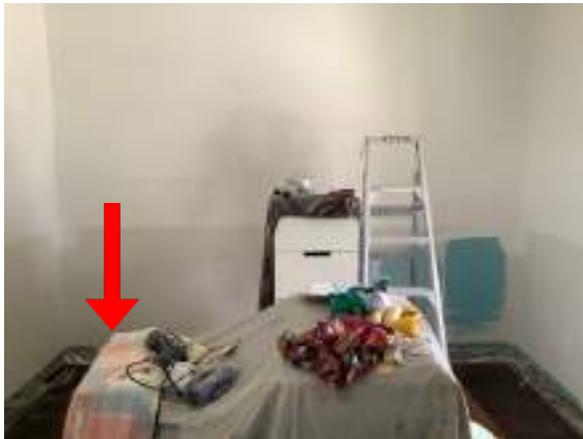
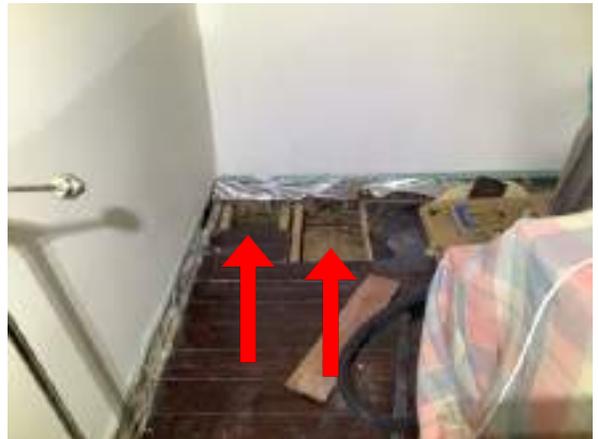
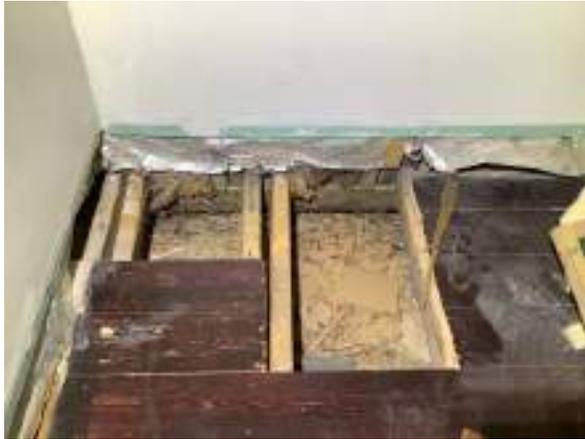
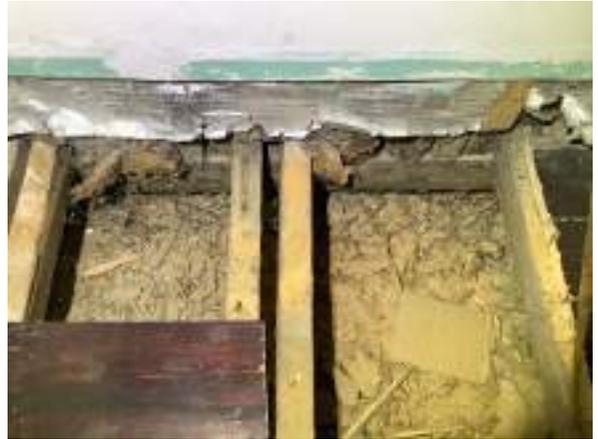
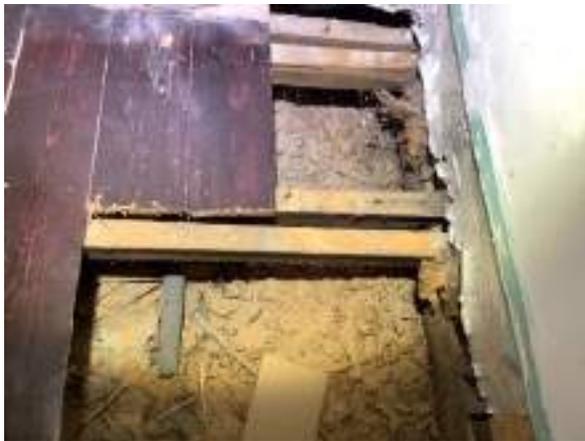
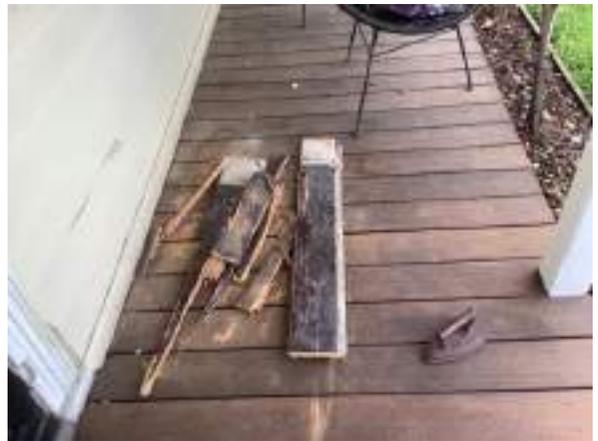
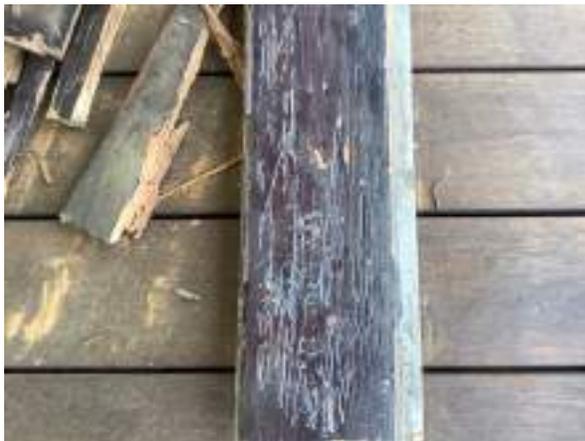
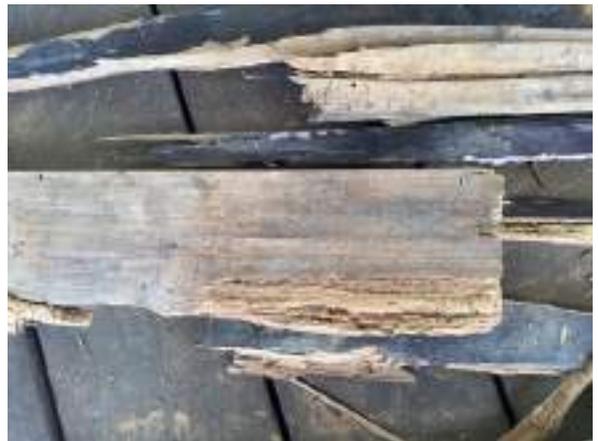
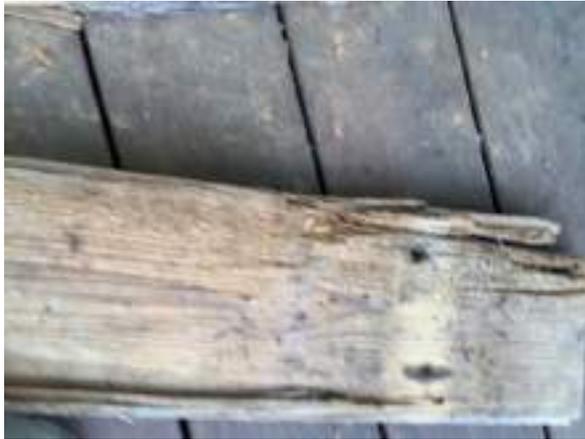
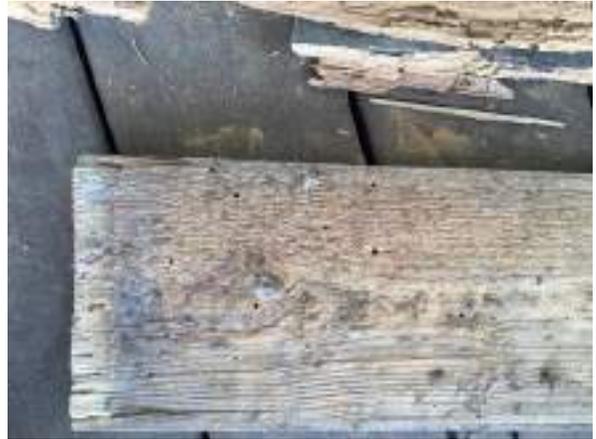
It is impossible to identify all areas for termites, timber pest and timber pest damage.

Please read the report carefully and Maintenance to all susceptible and conducive areas is a MUST to minimise the risk of termite and timber pest existence and timber damage.

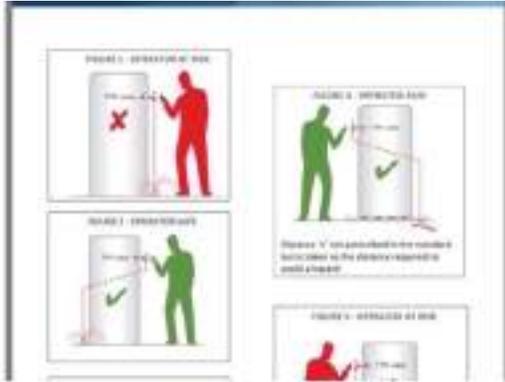
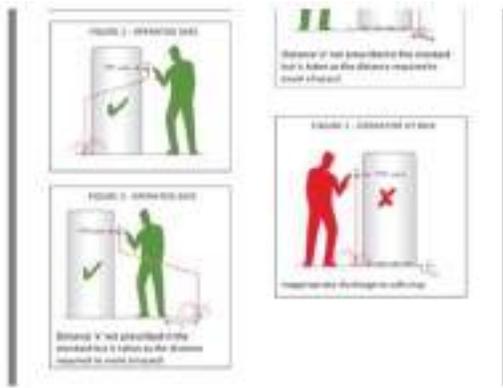
Technical Solution Sheet 6.09 6: Hot Water Plumbing

Temperature Pressure Relief (TPR) Valve Drain Lines

It is highly recommended that a licensed plumber be appointed to connect the HWS overflow in order to prevent such an environment from being created. These minor works should be carried out as soon as possible.

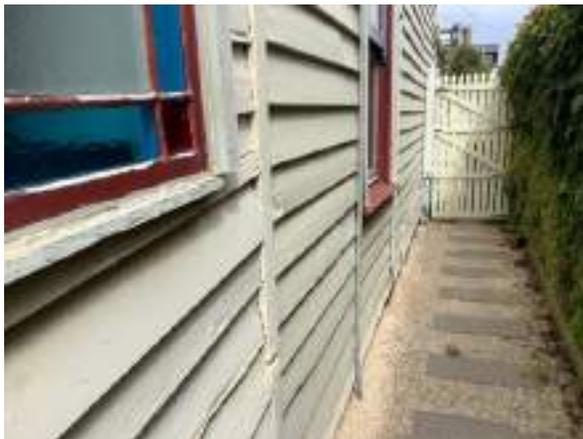
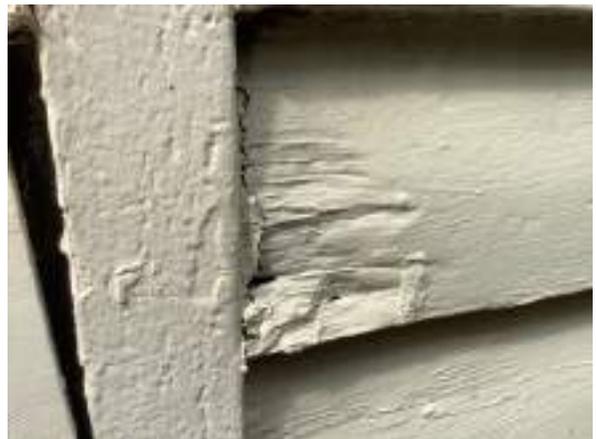
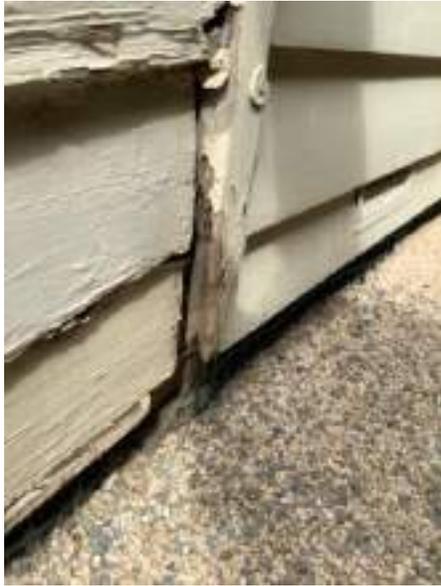
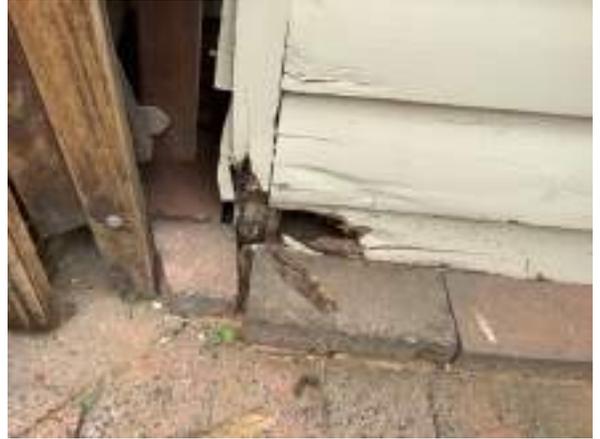
The property is a very high risk for termites as the environments to the property are very conducive with many susceptible areas.

Please read the report carefully and Maintenance to all susceptible and conducive areas is a MUST to minimise the risk of termite and timber pest existence and timber damage.

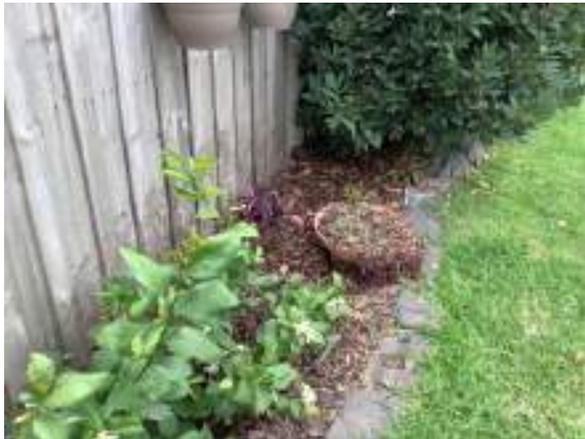
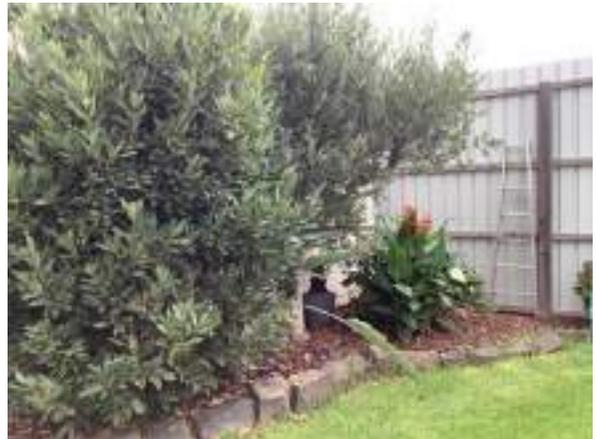
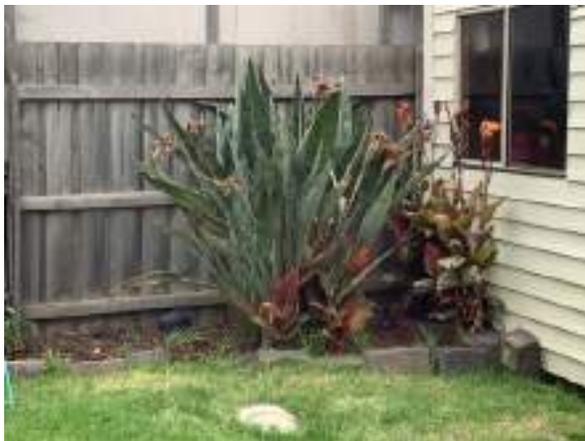
Finding: Garden Beds - Conditions Conducive to Termites
Garden beds were found to be evident in areas of garden areas. These garden beds can include untreated timber, bark, excessive old vegetation and with a combination of moisture from watering hosing can make conditions very conducive to termite activity and termite ingress. It is always important to keep the garden beds as clean as possible and take out excess old bark from the trees, leaves and keep bark mulch to a minimum or better introduce rocks or some item that does not create an conducive environment for termites and hold excess moisture.

ALL AREAS should be checked carefully for this defect and attached are a few PHOTO EXAMPLES as a GUIDE.

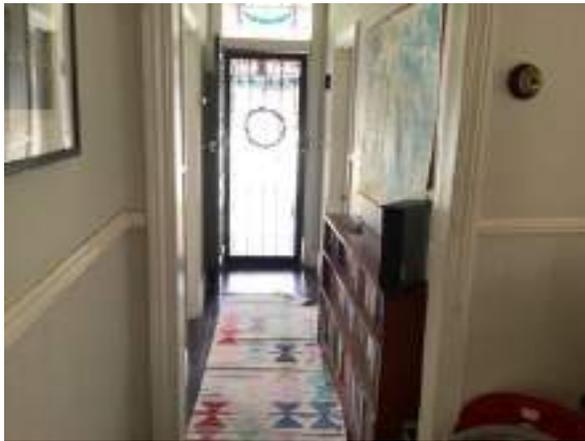
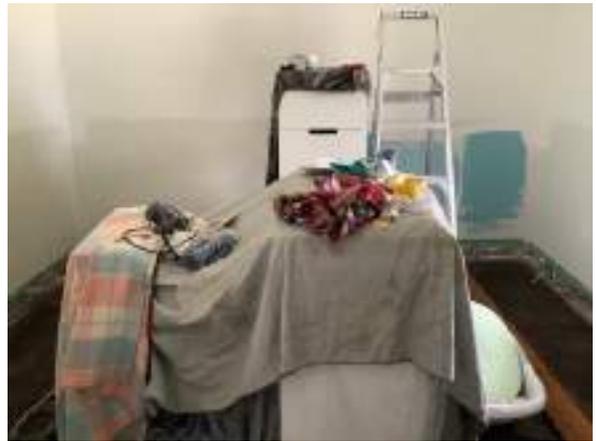
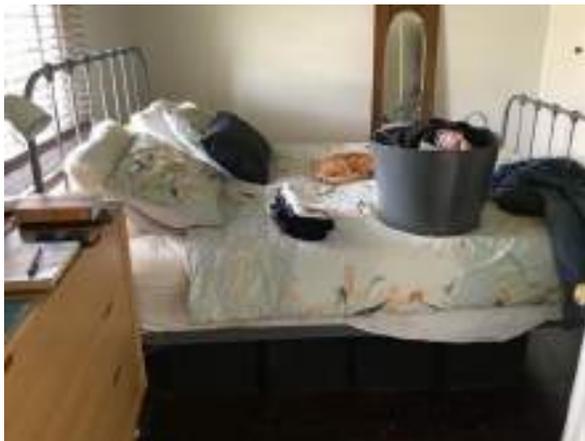
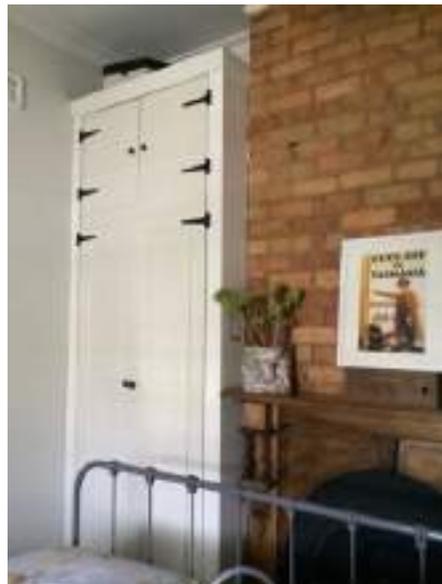
Whilst we have taken many photos of the home and surroundings of the obstructions and limitations , we have just added a few photos in the report for you to understand the type of obstructions and limitations .

A re-inspection is recommended once the areas are made accessible.

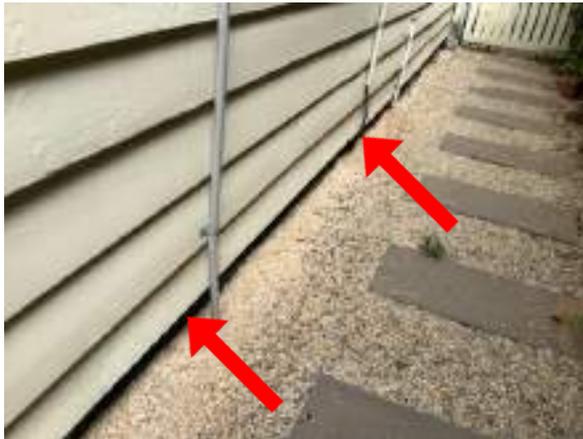
Height 3.6 m ladder max on a ladder.

By not inspecting the sub floor area there can hide an array of defects, without inspection to the roof void area it is impossible to rule out termite activity and/or termite damage and other undetectable issues .

Re-Inspection is HIGHLY RECOMMENDED once the man hole is made larger, if possible.
