## Termite / Timber Pest Report

Inspection Date: 30 Mar 2020

Property Address: Bundoora Area

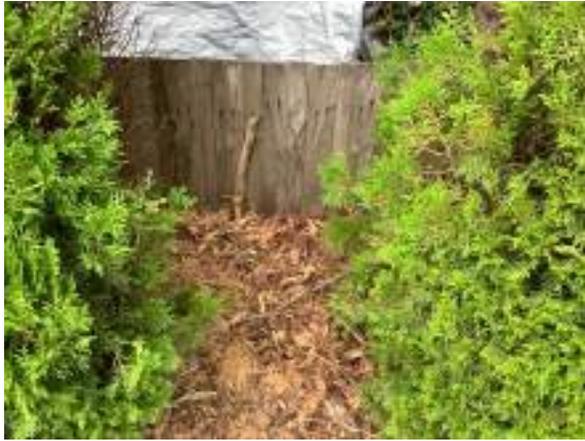
## Conditions conducive to timber pest attack 2.08

Location: Garden Areas - All Areas

Please read the report carefully and Maintenance to all susceptible and conducive areas is a MUST to minimise the risk of termite and timber pest existence and timber damage.

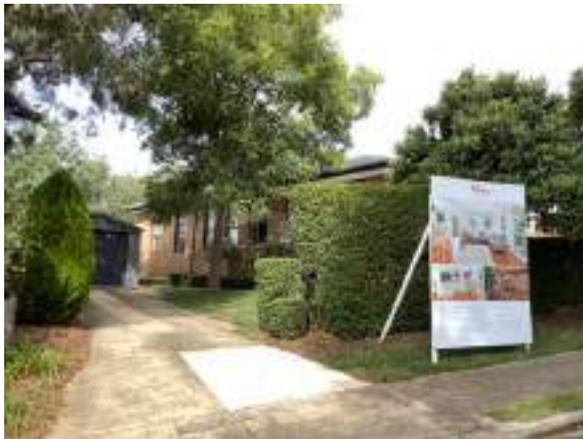
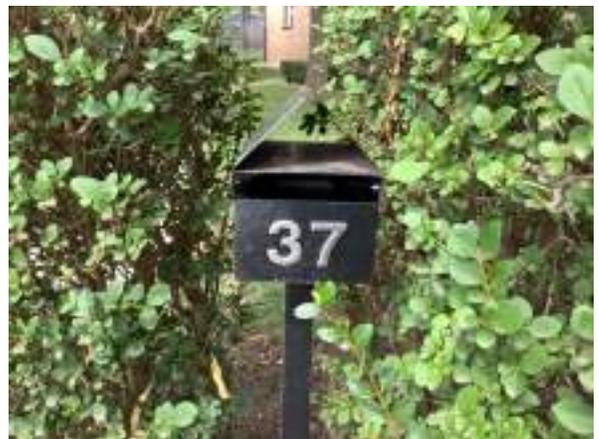
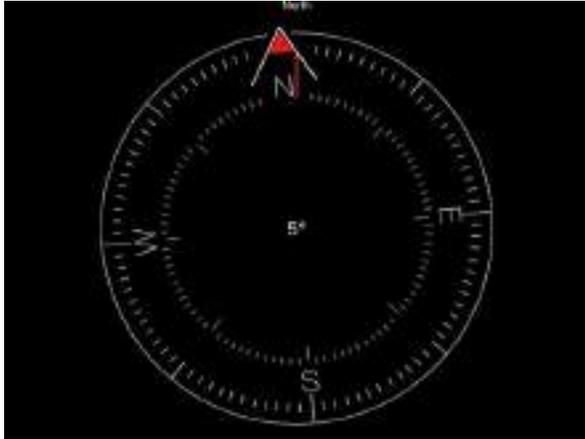
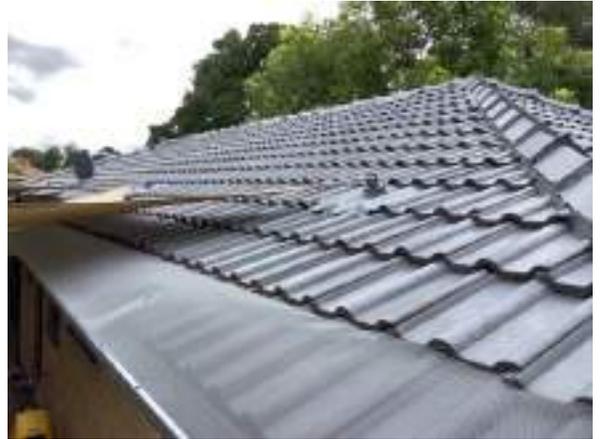
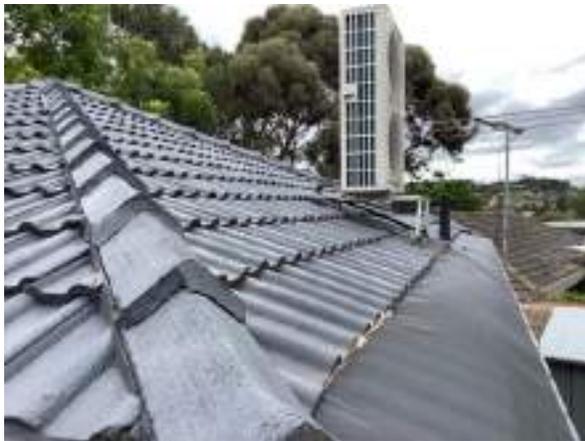
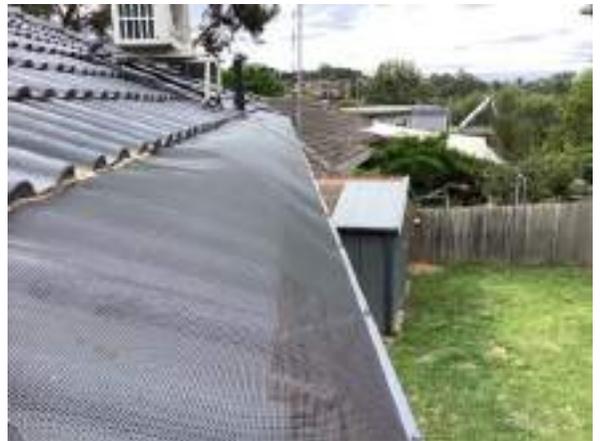
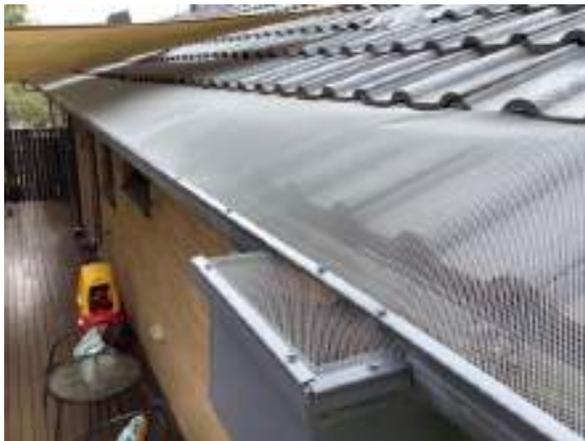
#### For your information 4.12

Location: The Site  
Finding: General Site Photos & Compass  
General site photos and other areas of interest are provided for your general reference.

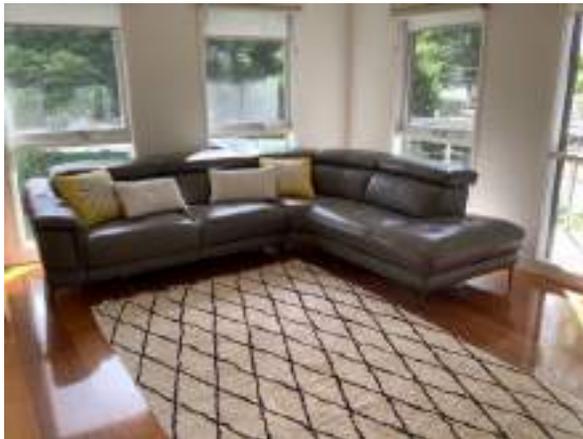
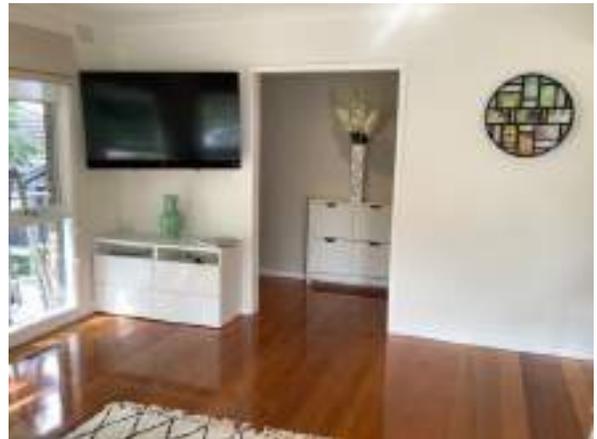
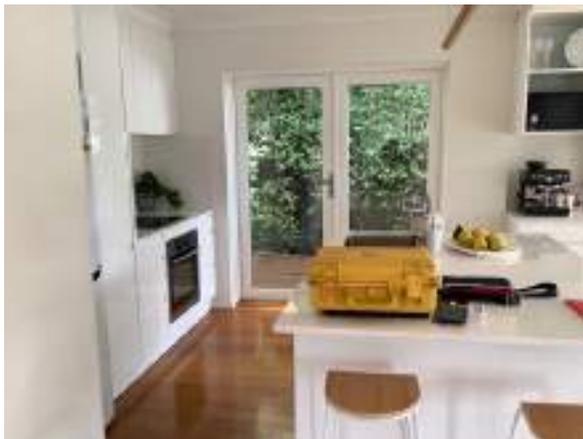
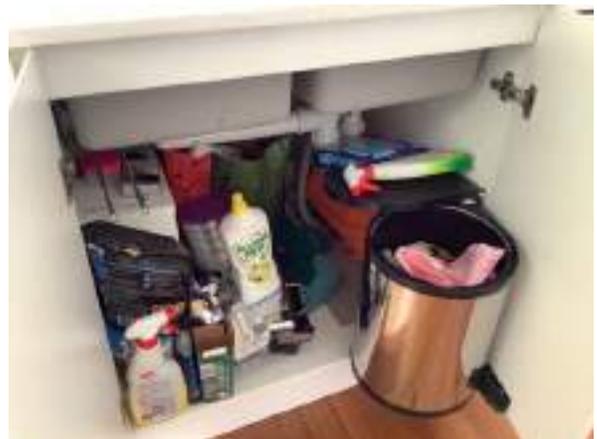
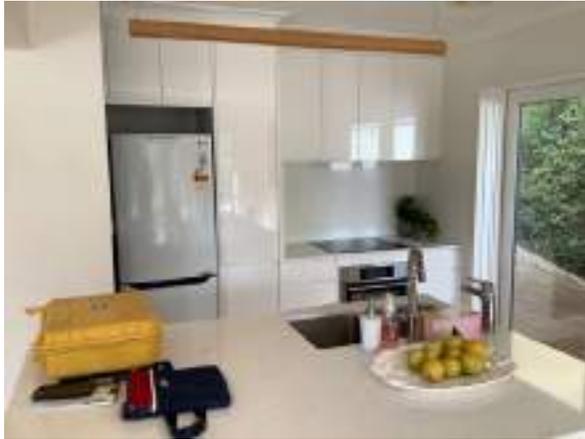
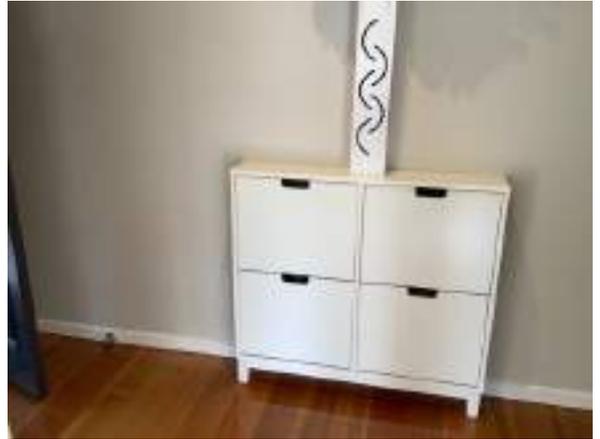
## For your information 4.14

Location: The Site

Whilst we have taken many photos of the home and surroundings of the obstructions and limitations , we have just added a few photos in the report for you to understand the type of obstructions and limitations .

A re-inspection is recommended once the areas are made accessible.

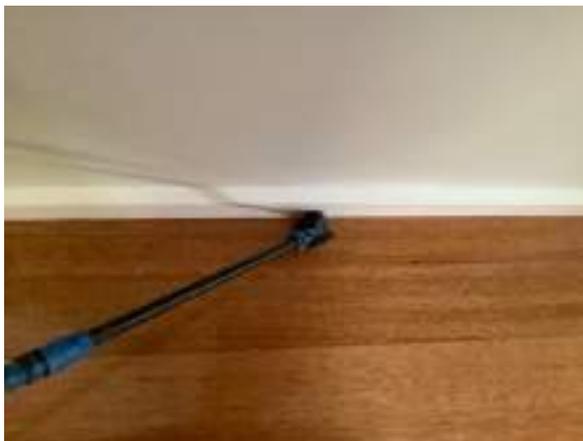
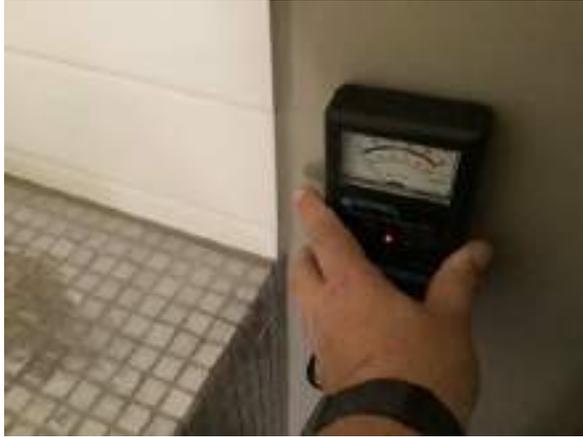
## For your information 4.15

Location: The Site

As all areas are not able to be inspected due obstructions and limitations, we therefore can not rule out the possibility of concealed timber pest activity.

Wall paneling, wall paper, carpet and fixed cabinetry can obscure termite activity.
