Asbestos Sampling Report

Inspection Date: 30 Apr 2020

Property Address: Nothern Country Area

Report Type: Asbestos Inspection and Condition Report

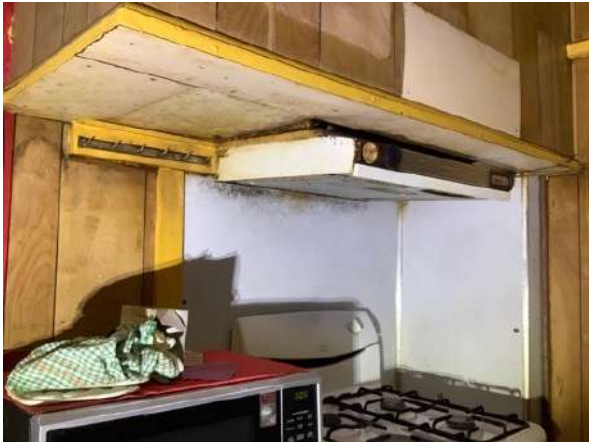
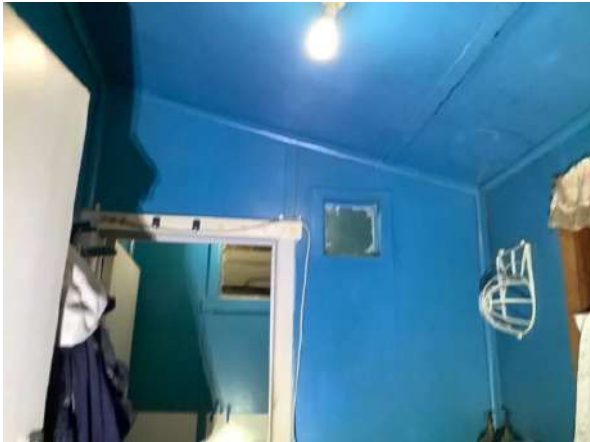
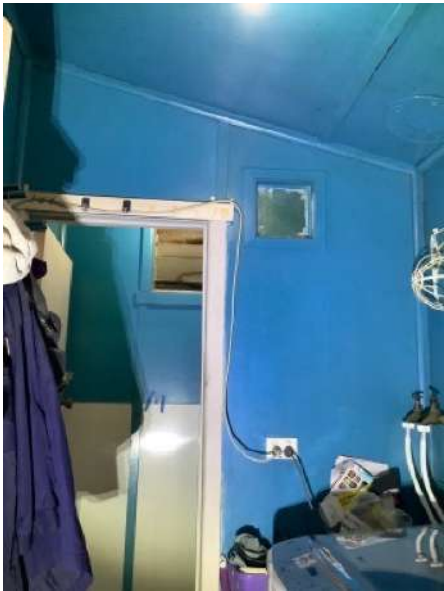
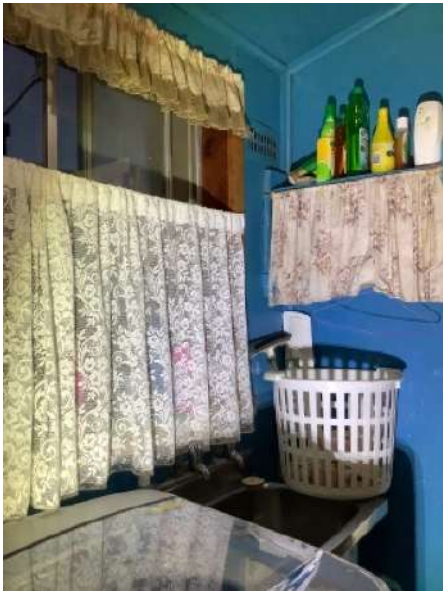
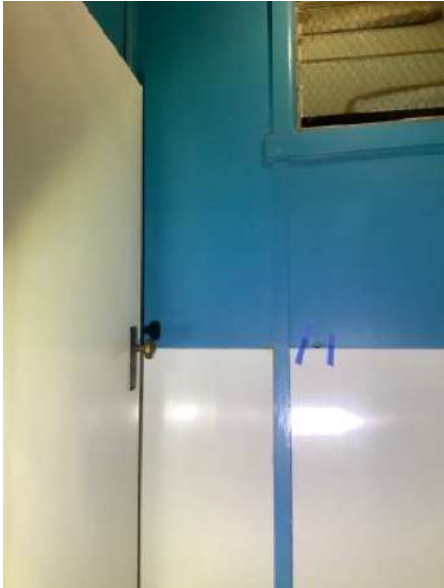
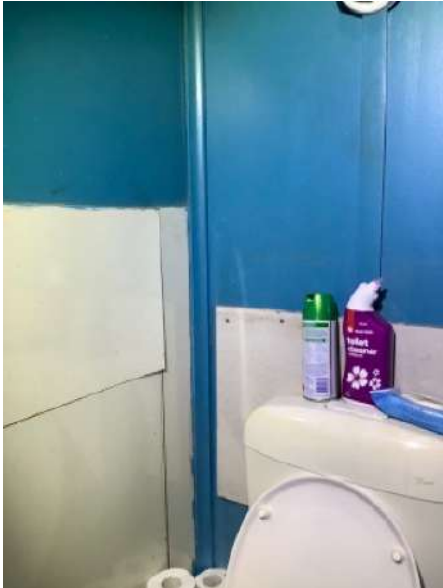
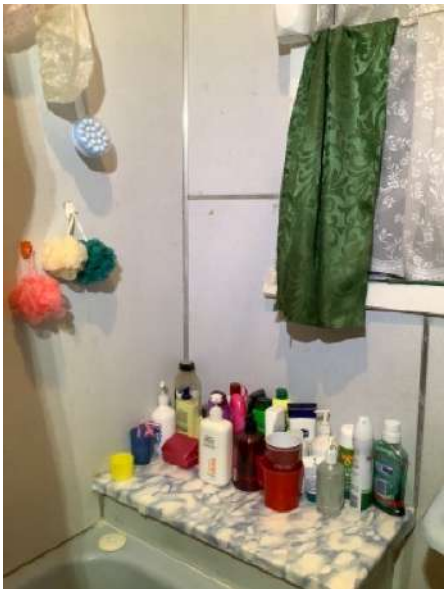
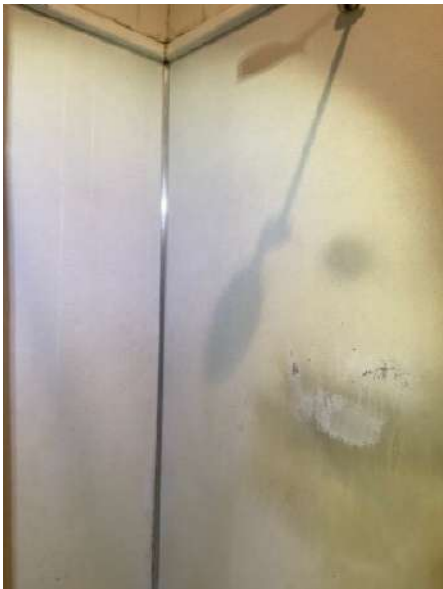
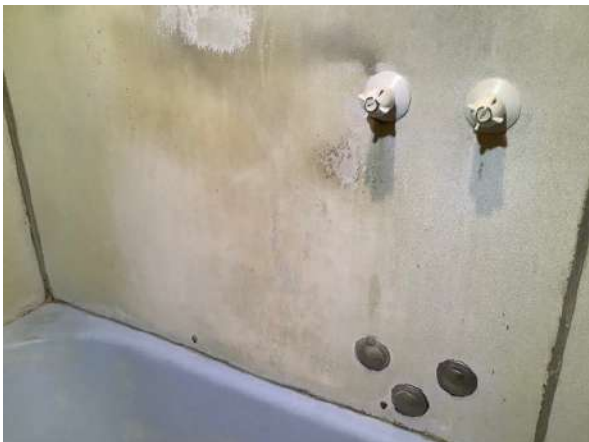
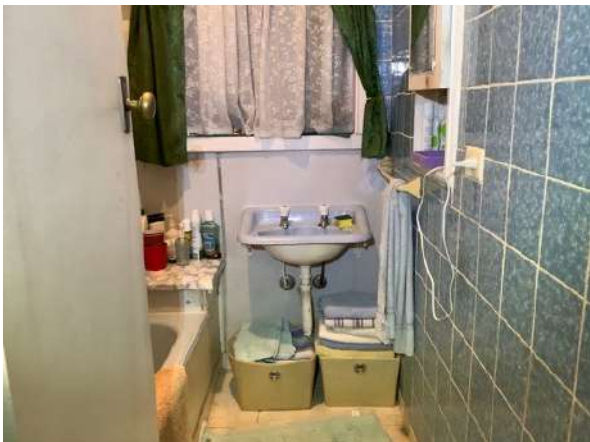
These photographs are an indication of the obstructions and limitations which impeded full inspection of the property at the time of inspection. These obstructions can hide an array of defects and should be removed to allow full inspection to be carried out.

A re-inspection is recommended once the areas are made accessible, if you require a further detailed inspection and report, which we do recommend.

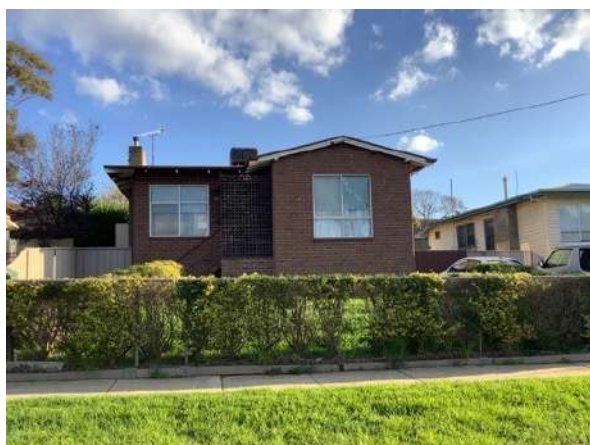
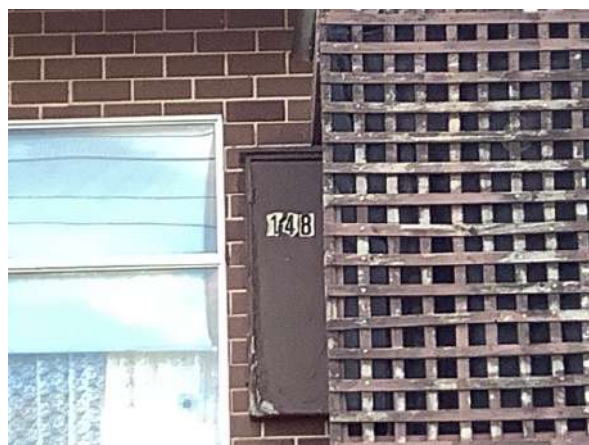
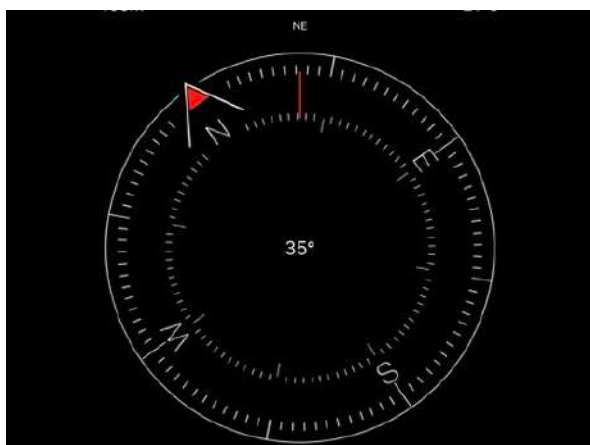
Location: The Site

Finding: Site Photos Added
Additional photos are provided for your general reference.

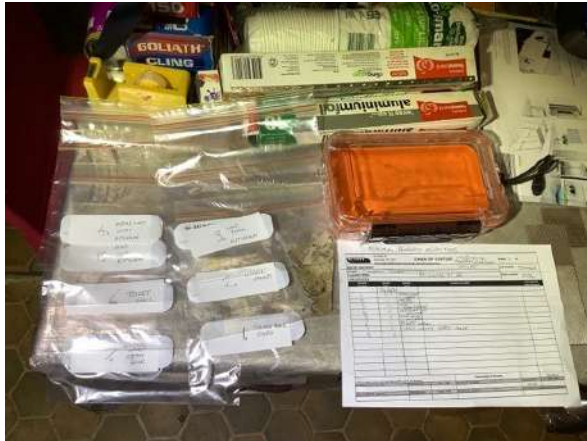
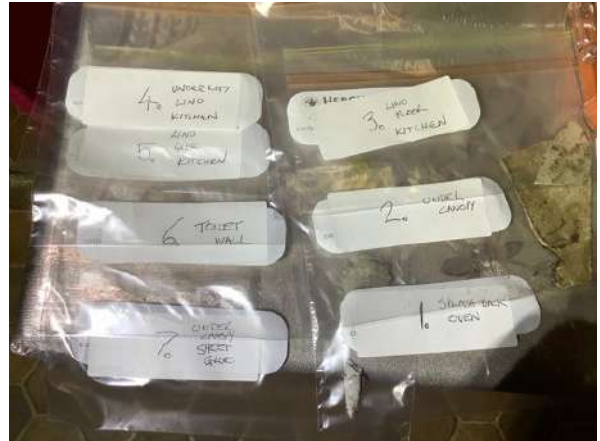
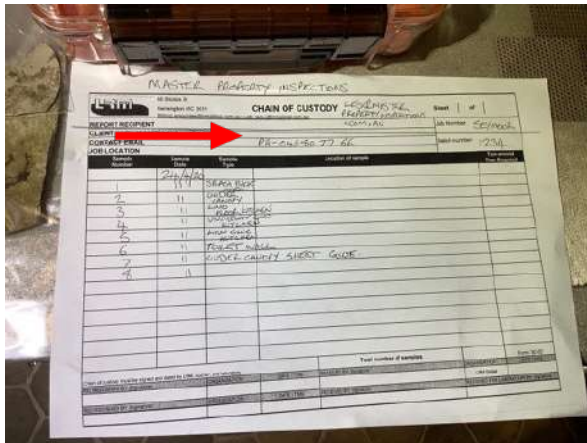
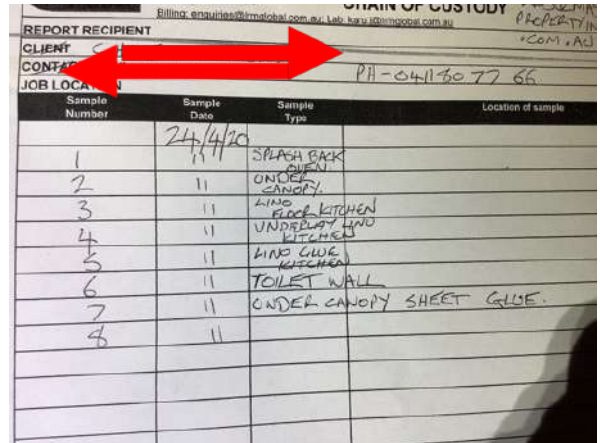
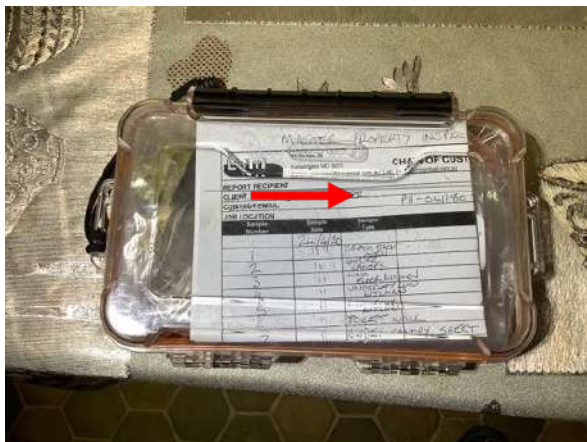
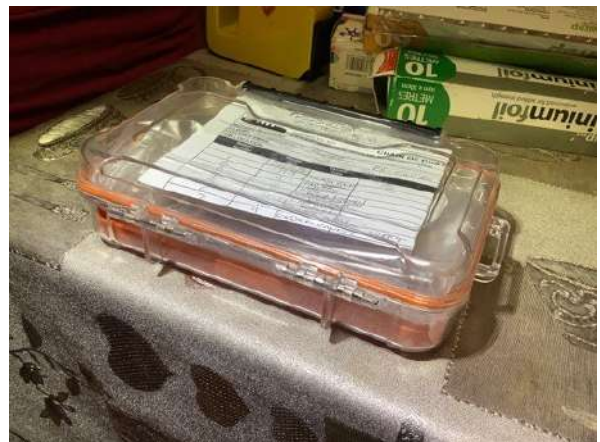
Location: The Site

Finding: Copy of Chain Of Custody & Materials To Be Taken Away - For Your Information
Copy of Chain Of Custody and Asbestos in sealed bags and container, to be taken away for laboratory results.
