Bathroom & Toilet Renovation Report

Inspection Date: 8 May 2020

Property Address: Airport West Area

Report Type: New Home Construction

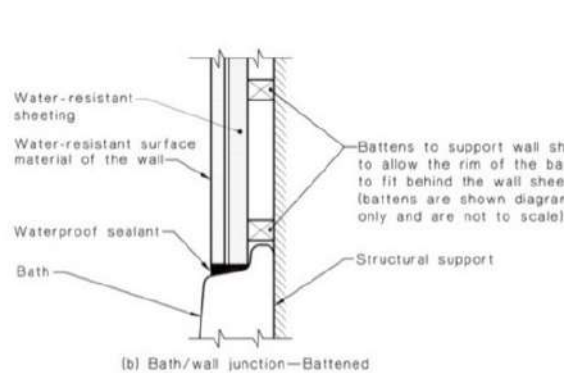
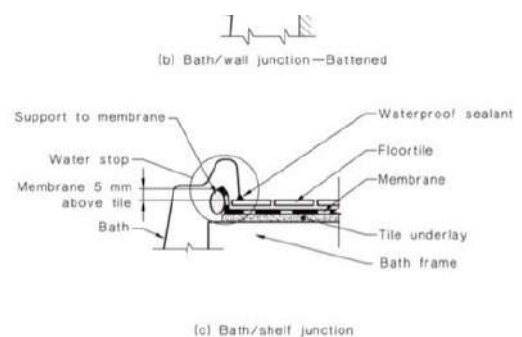
FIGURE 3.2 TYPICAL BATH JUNCTIONS

Defective Caulking To Cabinetry, Bench Tops, Tile Junctions, Cabinetry/Plaster Junctions, Etc.

It was noted on inspection that sealant is missing, inadequate and/or not completed to a tradesmens like finish.

Where required, junctions between bench tops and adjoining surfaces are defective if they are not sealed with a suitable flexible sealant of matching or agreed colour.

Seals around items such as sinks, hand basins or the like are defective if the joint leaks or they are not installed in accordance with the manufacturer's installation requirements.

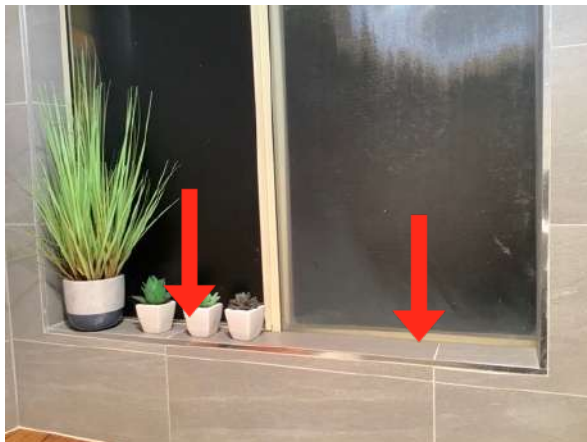
The tiles to the base of the existing window should be flush with the base of the window frame, which is typical of normal for every installation of this type. In this particular case the height of the tiles far exceeds the height of the window sill, in fact you cannot visually see the bottom of the window.

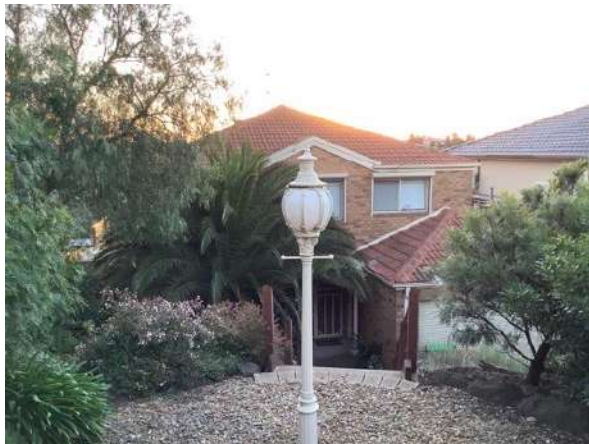
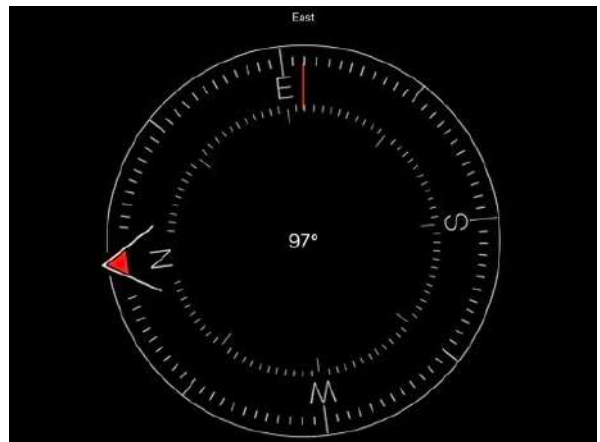
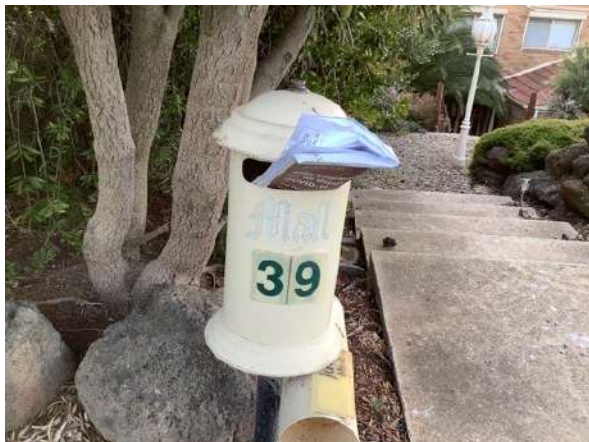
For Your Information 5.20

Location: Site Photos & Areas Of Interest.
Finding: Site Photos.
Additional photos are provided for your general reference.
