Building, Electrical, Asbestos & Termite, Timber Pest Report.

Inspection Date: 29 May 2020

Property Address: Ivanhoe Area

Report Type: Property and Timber Pest Report

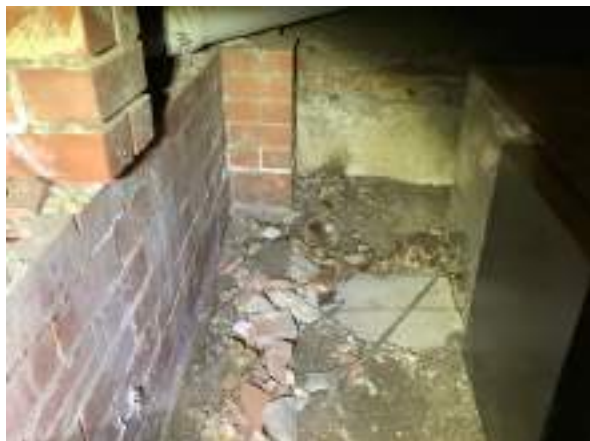
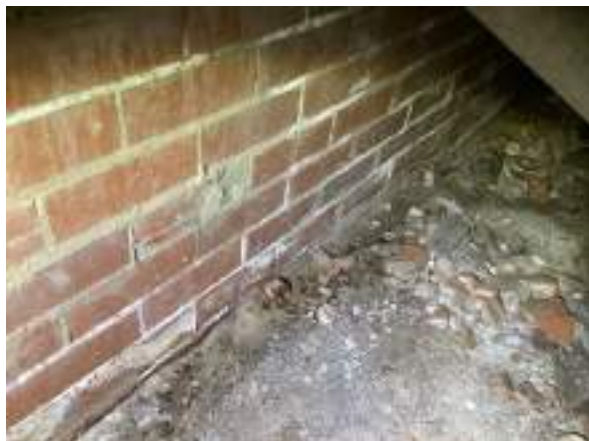
Serious Safety Hazard 1.05

Location: Subfloor

Finally the cause or source of the mould MUST BE TAKEN CARE OF URGENTLY.

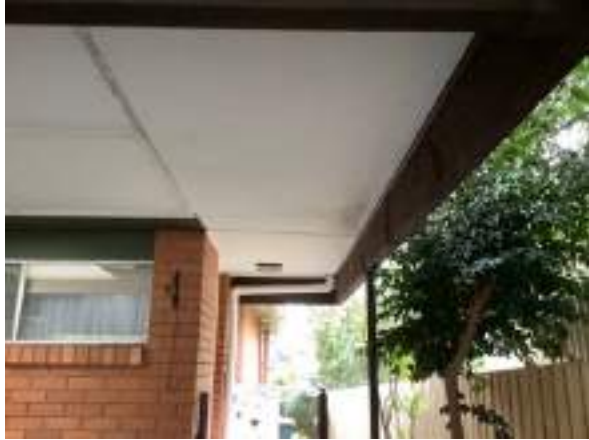
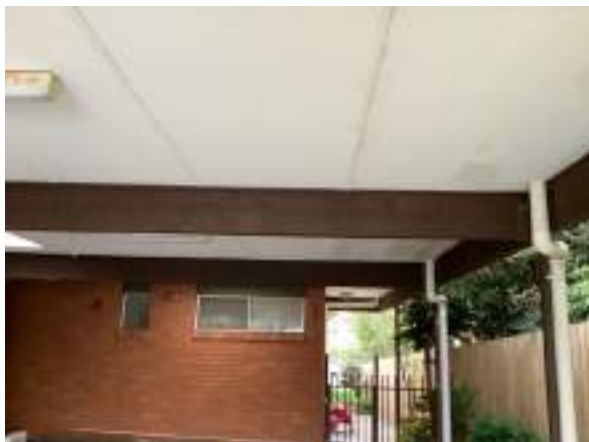
Major Defect 2.07

The damage to the eave sheeting in this area detracts from the appearance of the structure, as well as potentially compromising the structural integrity of the roofing area.

Where eaves show moderate to severe damage, remedial works may be required. Where water damage is suspected as being the underlying cause, appointment of a licensed plumber is advised as a matter of urgency to identify the source of the water leak.

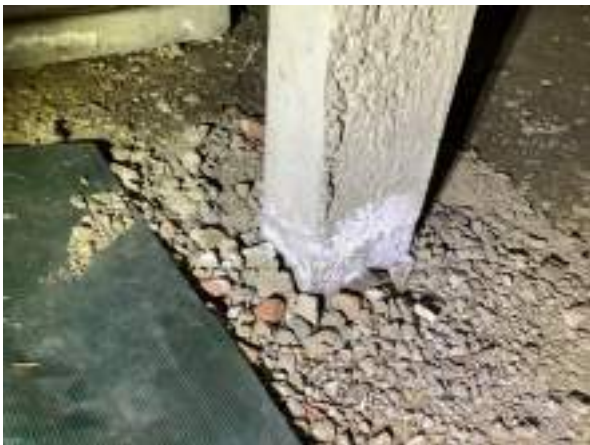
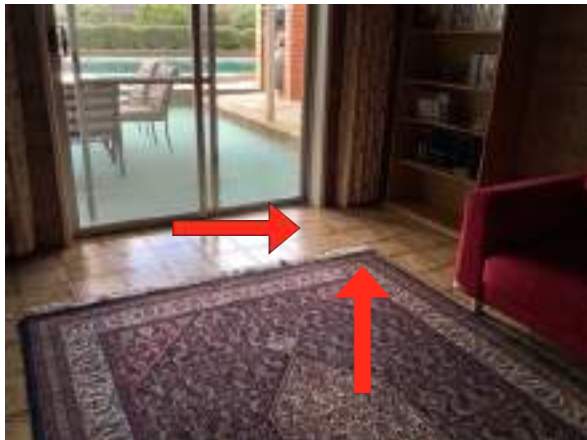
Minor Defect 3.09

If left unmanaged, water penetration to these areas may lead to subsequent water damage, which is likely necessitate repair work to affected building elements.

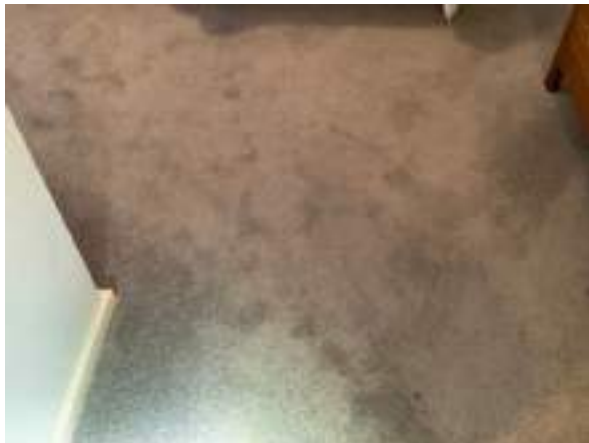
Minor Defect 3.10

Location: Floor Levels - All Areas

The client is advised to seek quotations for required repairs from a Registered Builder specialising in re-stumping. The potential resolution may range from packing gaps in subfloor structures through to replacement of subfloors stumps and refixing of flooring.

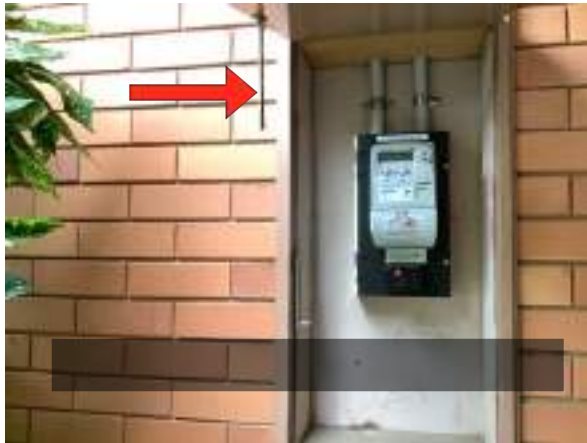
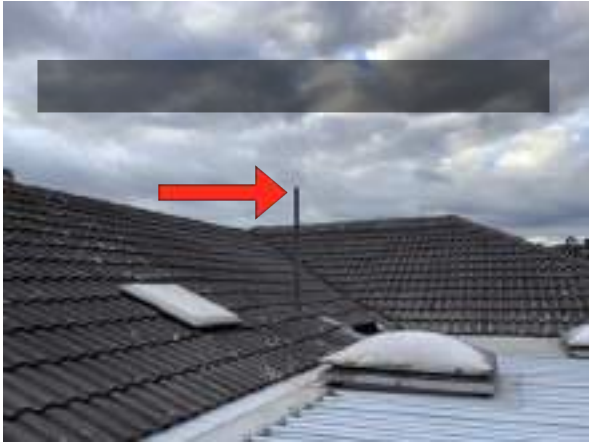
Minor Defect 3.11

Location: All Areas - Various

Items like cracked glass mirrors, cracked glass windows and windows not operation smoothly are defects that should be repaired by the appropriate trades.

It is IMPERATIVE that you engage registered and qualified trades and at the end of there works they must supply certificates, such as an electrical safety certificate, plumbing and gas certificate if the works are electrical or plumbing, but for items such as damaged door handles, painting an experienced carpenter or handyman can sometimes be engaged.

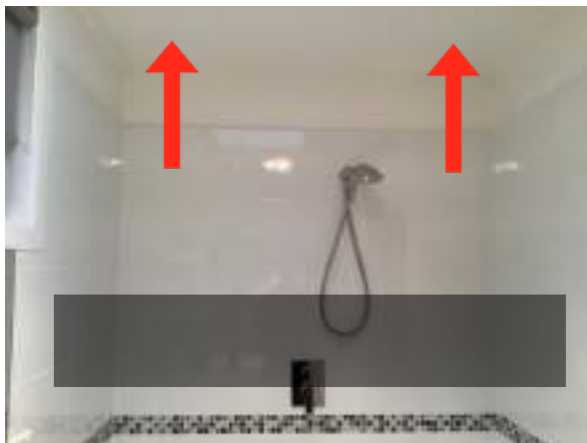
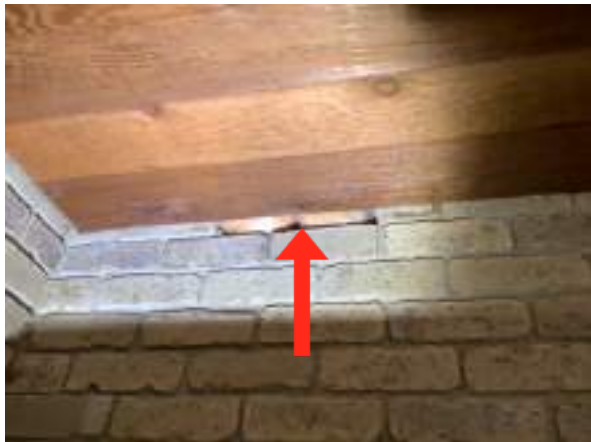
Minor Defect 3.12

Location: All Areas - Various

Where installation is substandard and/or incomplete, the client should contact the responsible trade to undertake rectification works, which are advised as soon as possible.

The appropriate tradesperson or specialist should be appointed to complete the various items for repair and organise the appropriate QUALIFIED trades to repair and complete the works to illiminate or reduce further deterioration / disfunction.

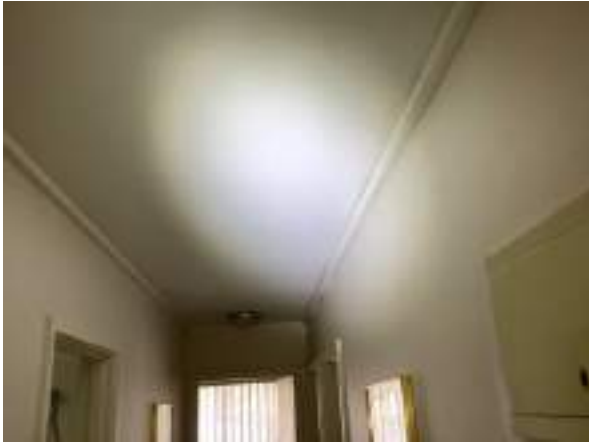
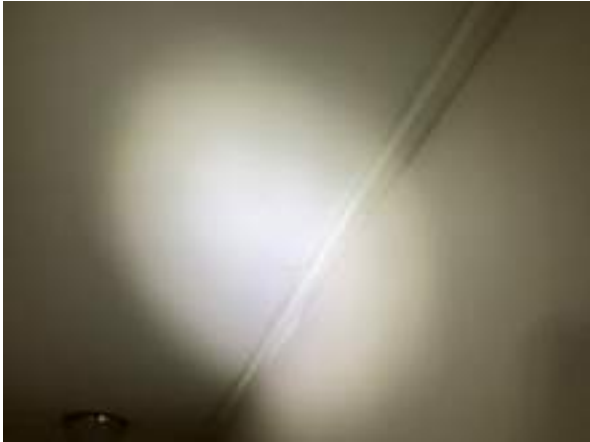
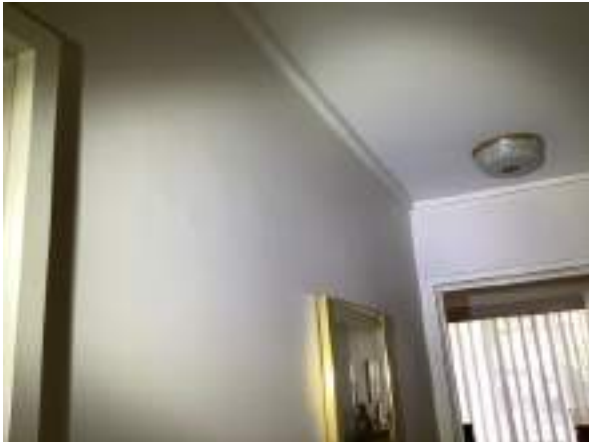
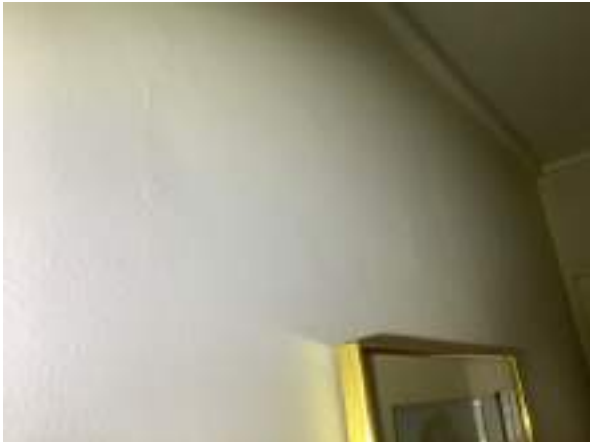
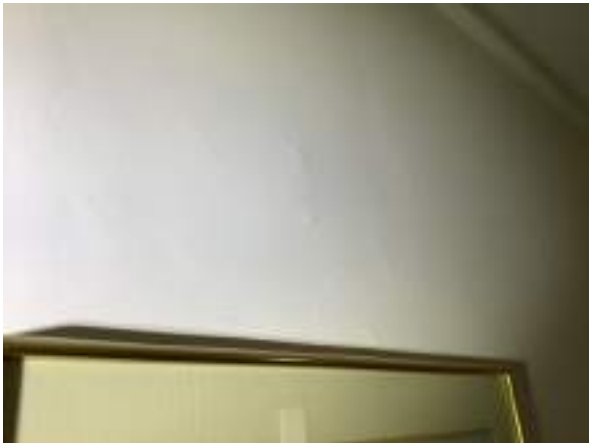
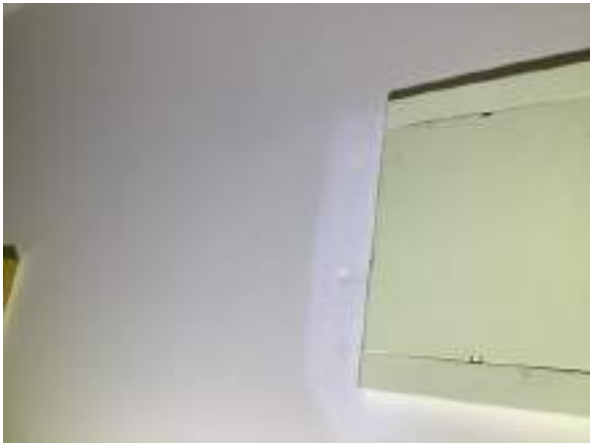
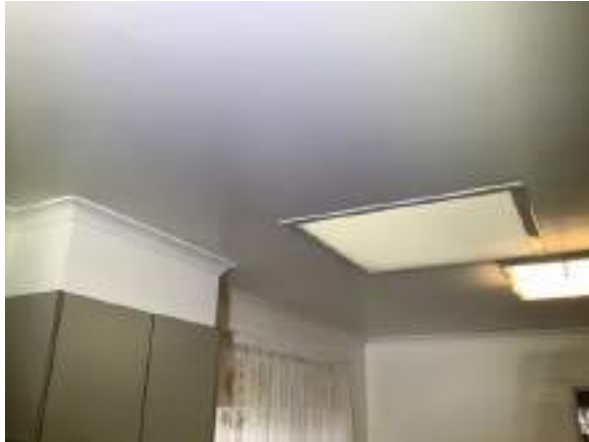
Wet areas are the main areas that MUST have SUFFICIENT paint coverage to the walls, ceilings and timber work as moisture can deteriorate the areas.

A painting contractor,builder, plasterer and/or suitable handy person may be appointed to perform necessary works to aid the appearance of the affected area and to ensure the area is protected against further deterioration.

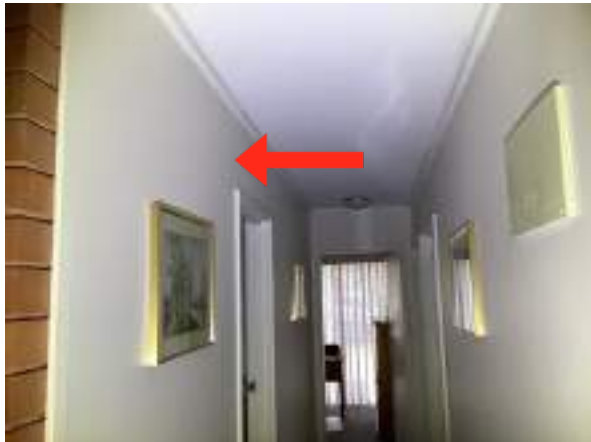
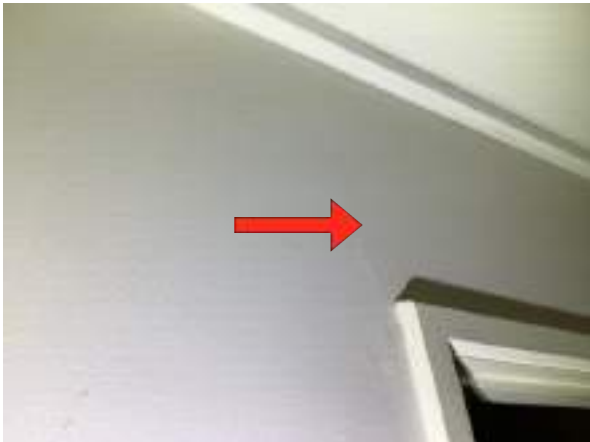
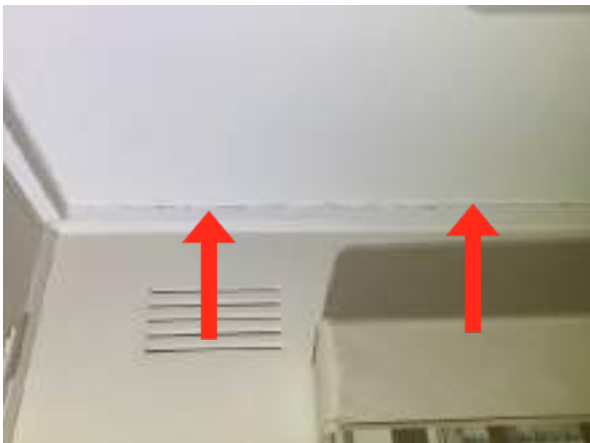
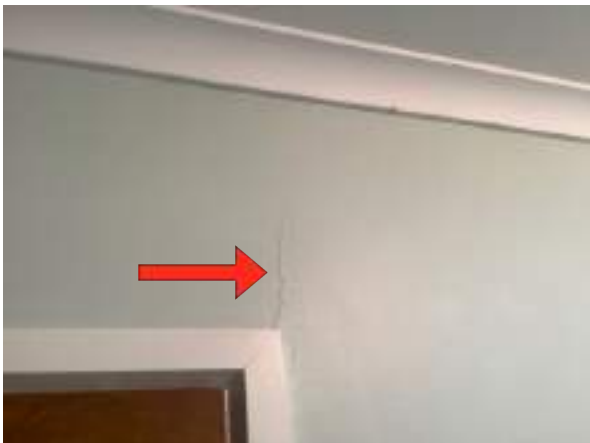
Minor Defect 3.14

Location: Entry, Hallway, Various Bedrooms, Main Bedroom

Finding: Plaster & Timber Cracking - Damage Category 1 - Fine (up to 1mm)

Although fine cracks are quite noticeable, they are often only considered to be an appearance defect, and usually do not indicate any structural damage. Generally, the cause of a fine crack is indicative of a separation between building materials and finishes (e.g. paint, plaster, etc.) along joins.

Cracking of this nature can generally be repaired with minor sanding, filling and/or repainting. Such works should be performed by a qualified painter or a general handyman.

Monitoring of all cracking should be conducted frequently. Always contact a building inspector should cracks widen, lengthen, or become more numerous.

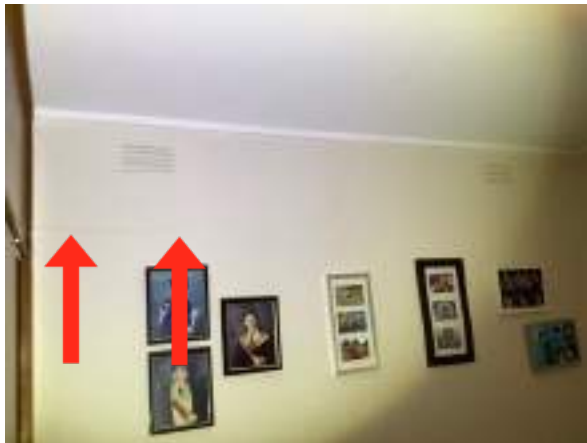
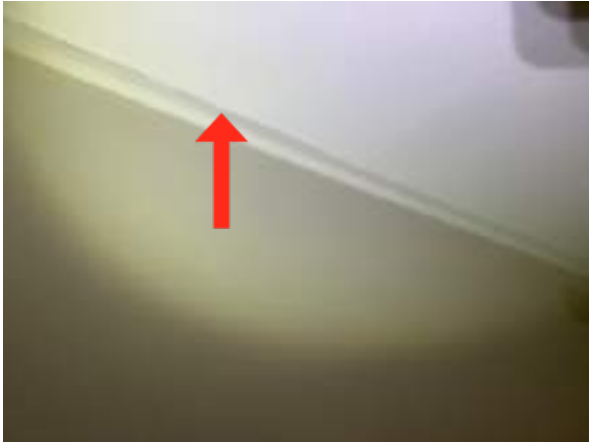
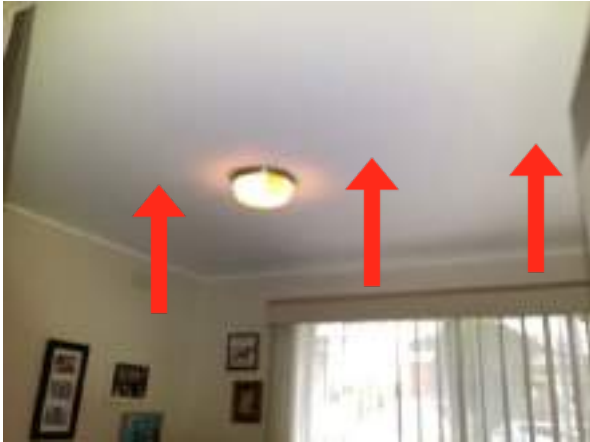
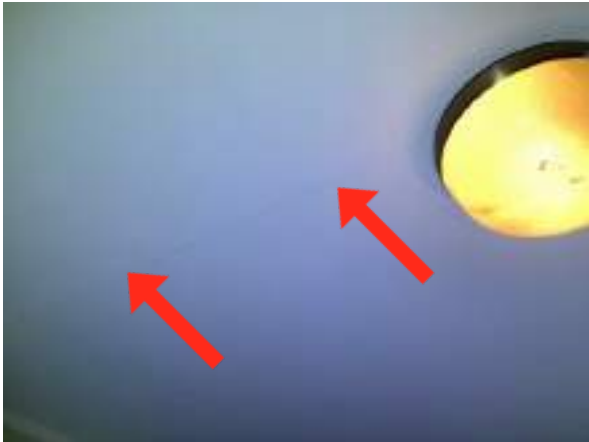
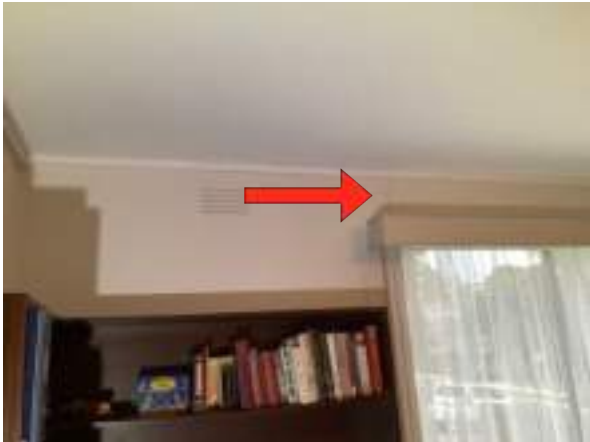
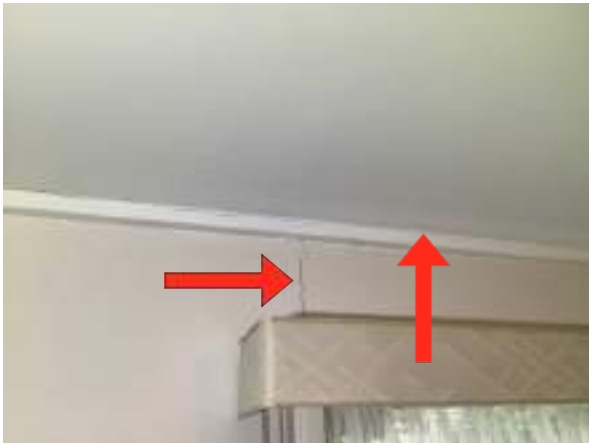
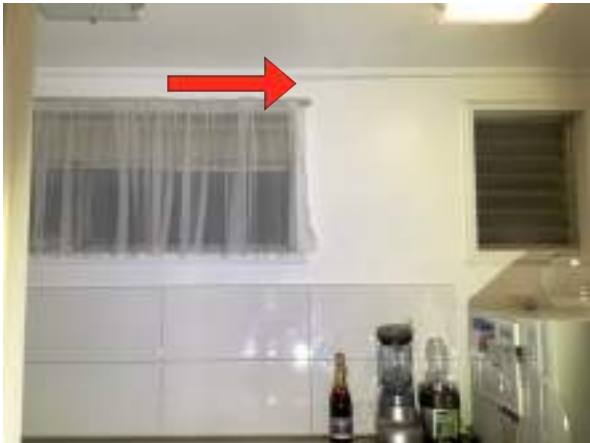
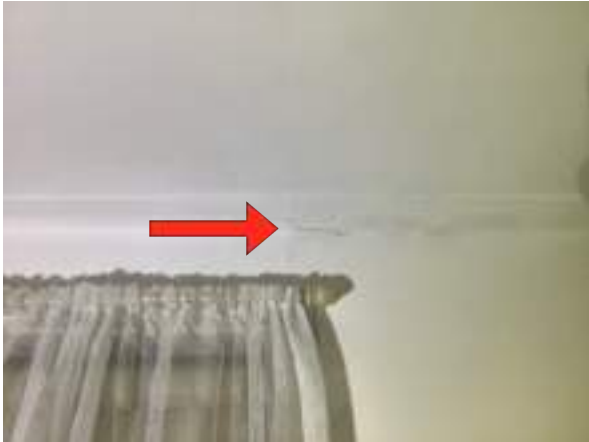
Minor Defect 3.15

Location: Front Bedroom East Side, Front Bedroom East Side, Laundry

Finding: Plaster & Timber Cracking - Damage Category 2 - Noticeable (up to 5mm)
Whilst we may have a photo of damaged paint, or a minor plaster cracking, etc, there may be many more paint/plaster defects and plaster cracking in other areas throughout the property.

Noticeable cracks are a common occurrence as a result of many primary defects. Such causes may include age, general wear and tear, expected building movement, general expansion/contraction of building materials in different weather conditions, and/or minor failings in the installation or application of building materials.

Noticeable cracks may result in minor sticking or jamming of associated doors and windows, which require easement. However, noticeable cracks are easily filled and repaired. A plasterer can be consulted to install an expansion joint at this point to allow for this movement during different weather conditions.

Monitoring of all cracking should be conducted frequently. Always contact a building inspector should cracks widen, lengthen, or become more numerous. Additionally, your building inspector should also be contacted if associated building elements such as doors and windows become more difficult to operate over time.

Relevant tradespeople, such as carpenters, painters and plasterers, should be appointed to perform remedial works, as deemed necessary.

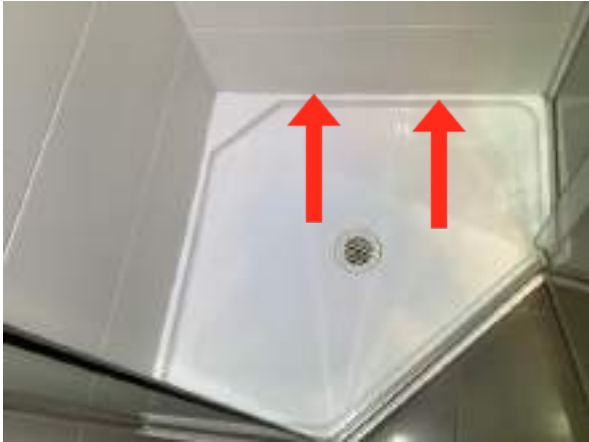
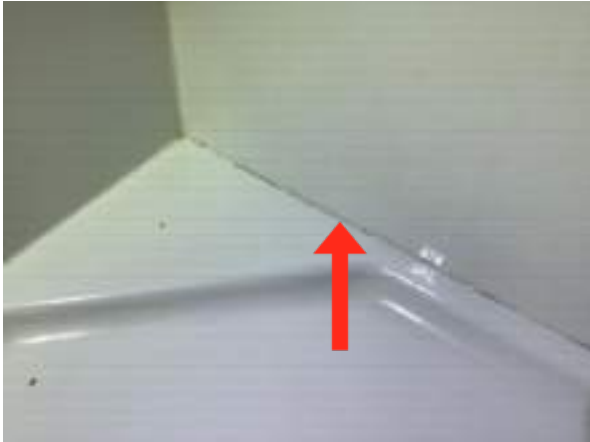
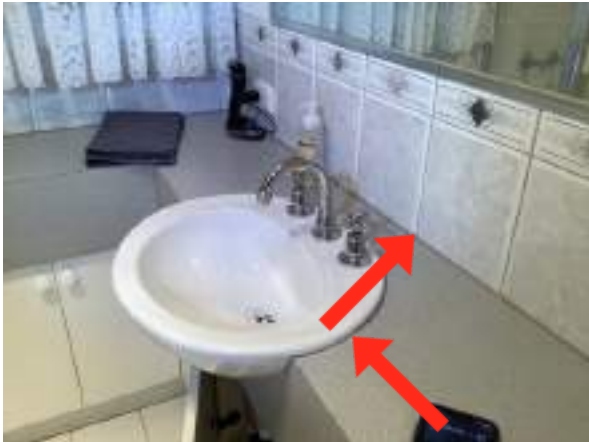
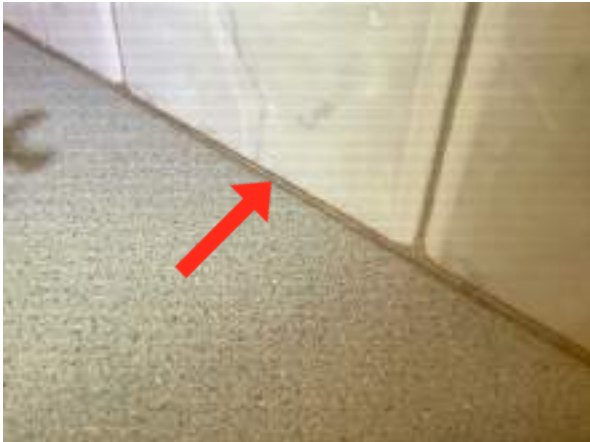
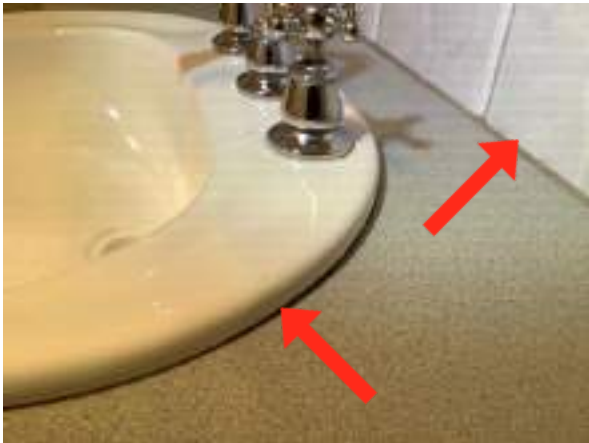
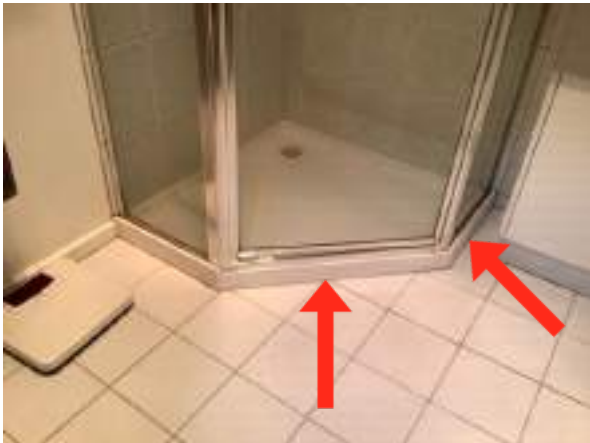
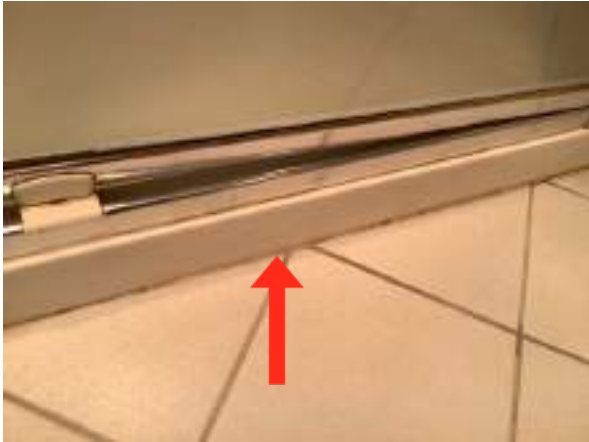
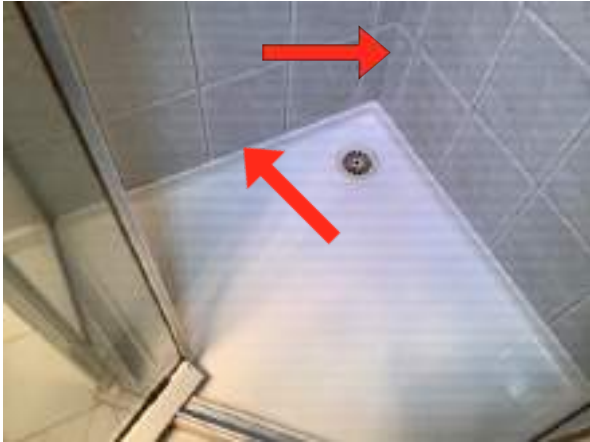
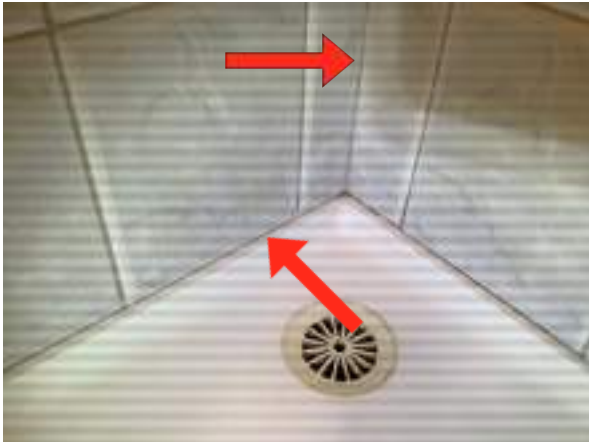
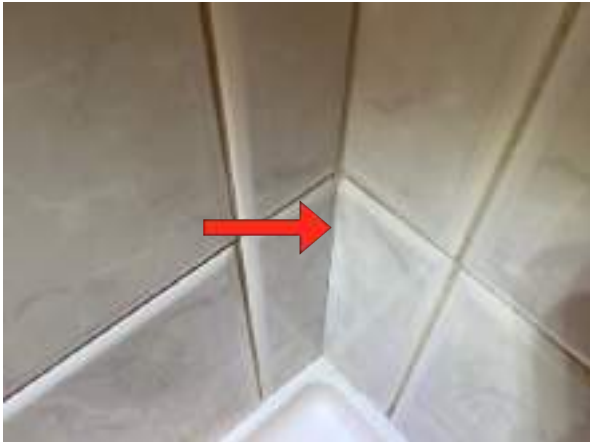
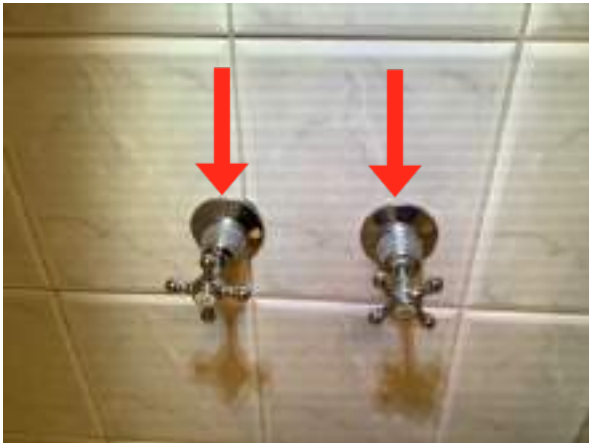
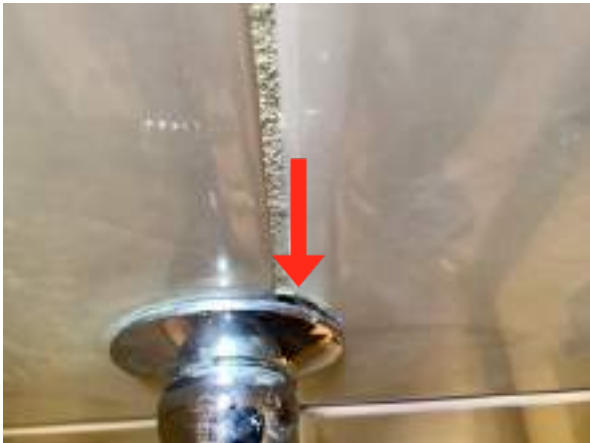
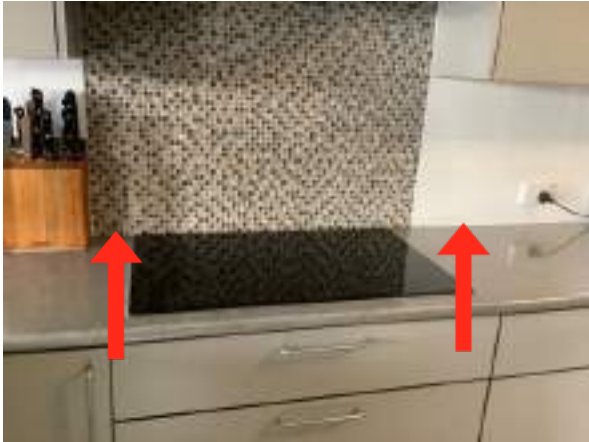
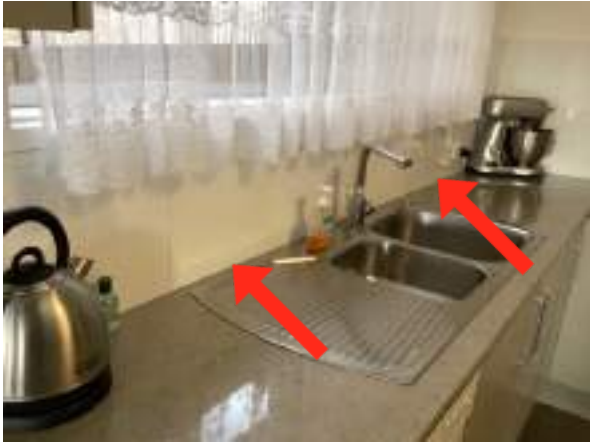
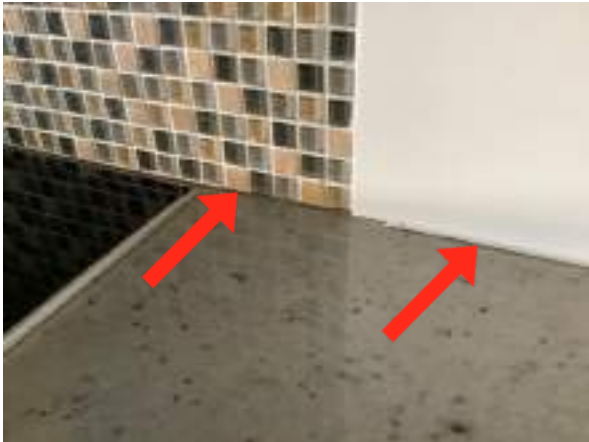
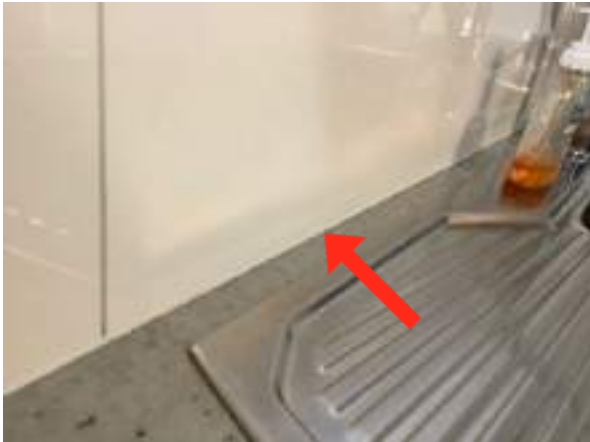
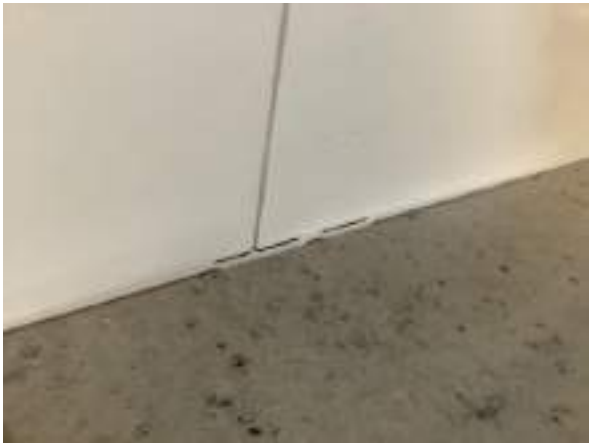
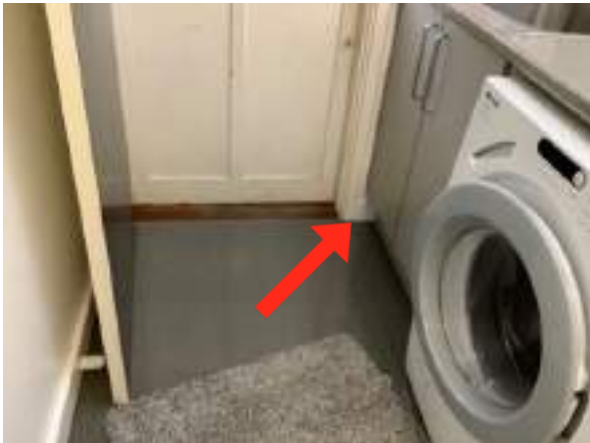
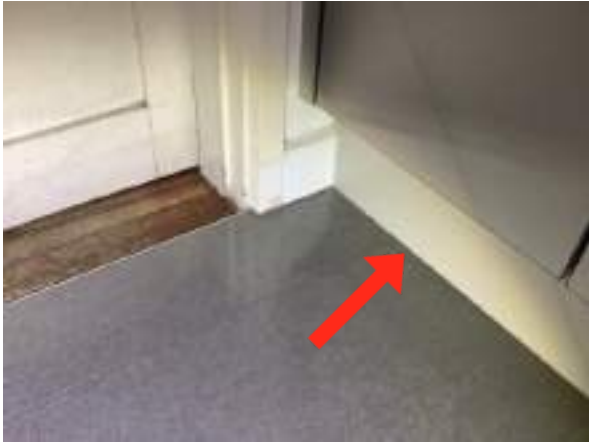
Minor Defect 3.16

Location: Bathroom, Ensuite, Kitchen, Laundry

Finding: Silicon / Caulking To All Wet Area Junctions and Tile Grouting - Missing or Damaged - Internal Areas

It was noted on inspection that sealant and/or tile grout is missing, damaged or inadequate to the tiled wet areas. This may include floor edges, kitchen benches/splashbacks, vanities, bath tub edges, shower areas to the floor and wall tiles, laundry's and all other areas subjected to water or moisture.

Sealant and/or tile grout where missing, damaged or inadequate to the tiled wet areas allows the water to penetrate into the walls and floors which can cause much damage, to the affect were the damage may become a secondary defect and create a conducive environment for termites and/or cause rotting to the timber studs, floor joists and bearers or plaster etc, especially in showers, baths, laundry and the like

Different materials and floor areas move at different rates, generally causing cracking to grout at this point.

Whilst in some of the areas there is sealant/silicon , it has become apparent that the sealant has deteriorated and/or is just missing.

Whilst in some of the tile mortar is perfect , it has become apparent that the tile mortar has deteriorated and/or is just missing in other areas.

A flexible sealant/silicon and tile mortar should be applied to affected areas to prevent any subsequent water damage that is likely to occur.

Regular maintenance and replacement of damaged or missing sealant and tile mortar is highly recommended to the wet areas, as this is a regular wear and tear defect. Sealant and grouting in areas that come into regular contact with water should be maintained for the long term care of the building in the areas required as water damage is one of the main defects in a building that causes the most damage and without sealant and tile grout always being perfect, secondary defects or secondary damages can start instantly.

A sealant specialist, tiling contractor and/or registered builder should be appointed to assess any damage caused by water to the entire internal, sub-floor, walls etc of the building and clean, take off old sealant and tile mortar, then re-seal and re-mortar these works as soon as possible.

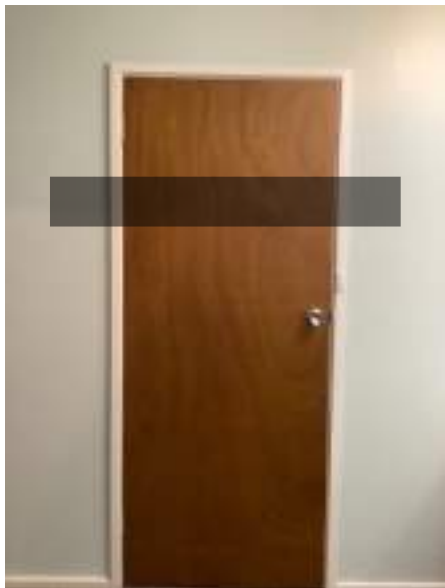
Minor Defect 3.17

Location: Doors - Internal Areas

This defect inhibits the functionality of the affected door as well as creating potential for secondary defects to associated building elements, such as damage to the floor covering.

A door that binds to flooring or to the associated door frame may have several causes, ranging from minor defects, such as poor installation of the door or deteriorated hinges, through to major structural issues, such as damage and/or subsidence (sinking) to subfloor structures.

For minor causes, a qualified carpenter or general handyperson should be appointed to perform minor rectification works at client discretion.

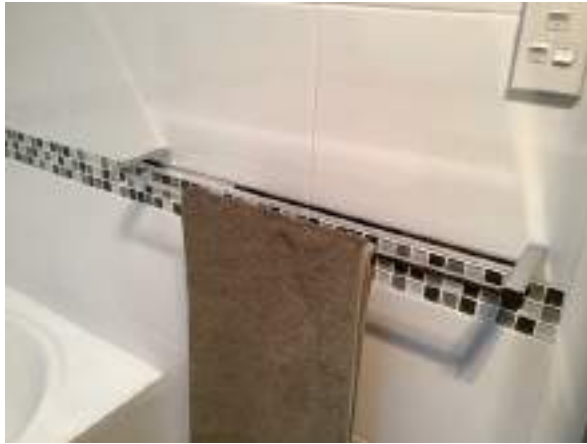
Minor Defect 3.18

Location: Bathroom

Finding: Towel Rail - Loose

The Towel Rail was found to be loose at the time of inspection. While not a major operational defect, function can deteriorate and cause further damage to the plaster/tiles if the problem is left unmanaged.

It is advised that the homeowner performs remedial works to re-attach the towel rail to its original fixing.

A general handyperson may be required to perform these works.

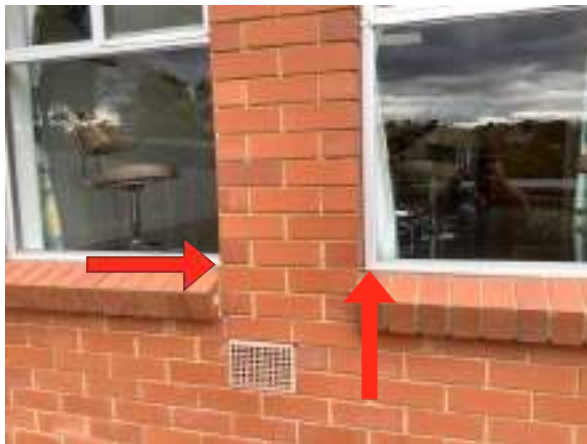
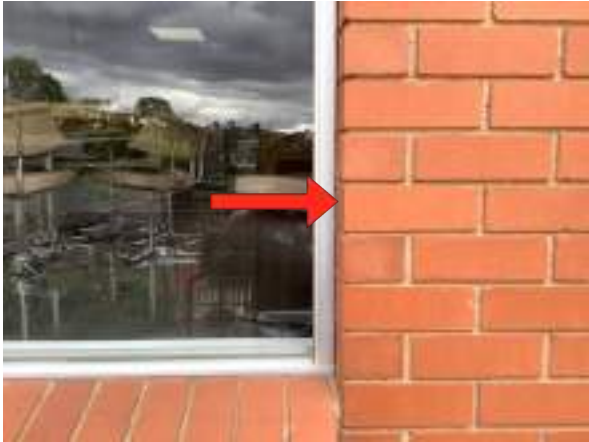
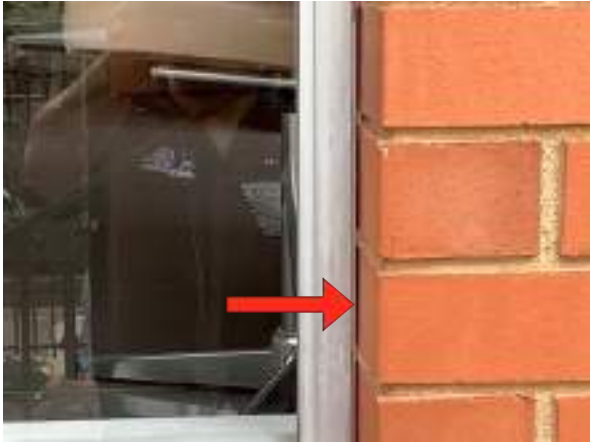
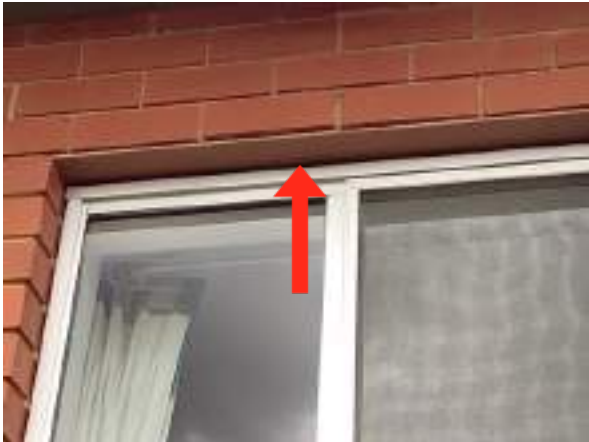
Minor Defect 3.20

Finding: Water Leaking & Water Ingress - External Areas

Water leaks were found to be present to the exterior sides, tops and or bottoms of the windows and/or doors and other areas as per the photos attached, such as brick expansion joints and timber and cement sheet junctions above windows , eaves and other areas.

Leaks are generally caused by deterioration of silicon or rubber seals or sometimes just defective workmanship when no caulking as ever been used .

With gaps like these that can be only a few millimeters to be exposed to weather conditions, can cause wood rott internally to the walls create a conducive environment for termites or possibly cause secondary defects the have the potential for structural damage the can be seen or in the walls internally.

Such leaking creates damp conditions in the affected area, causing potential for water pooling and subsequent water damage if left unattended. These conditions may also attract termite attack as already mentioned above, particularly if the area is subject to minimal levels of sun throughout daylight hours.

It is highly advised that a licensed plumber, handyman, builder be appointed to rectify any water leaks that may be present.

It is important to note once caulking these areas if water damage is noticeable to windows, timbers, etc, such as wood rott, it is imperative to engage the appropriate trades for replacement or repairs.

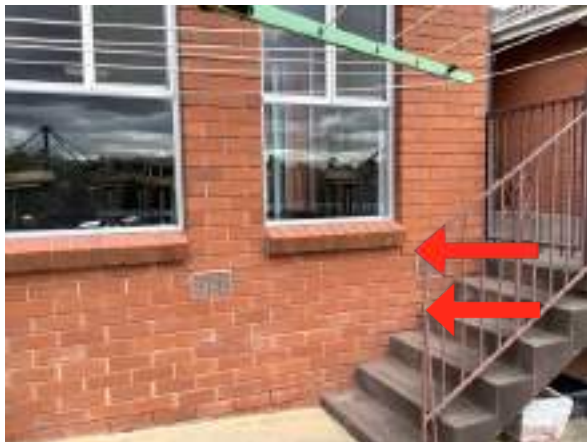
Minor Defect 3.21

Location: Brickwork

Finding: Brickwork / Masonary - Step cracking and minor cracking
There are several cracks and/or step cracking evident throughout the exterior of the property . These cracks are commonly less than 5mm in width.

Although fine cracks are quite noticeable, they are often only considered to be an appearance defect and usually do not indicate any structural damage most of the time. Generally, the cause of a fine crack is indicative of a separation between brickwork and mortar throughout the structure, but single bricks may also show cracks of this nature.

Step cracking, which is similar to other forms of cracking, has a variety of possible causes. However, the most common is the subsidence of adjacent footings.

Step cracking is a relatively common defect, and is most likely to occur adjacent to windows, doors and other openings. Mortar failure in the gaps between affected bricks indicates the stresses and tensions affecting the wall.

Cracking of this nature can generally be repaired with minor filling and should be conducted by a qualified bricklayer and/or registered builder.

Where step cracking is extensive or severe, the client is advised to consult a structural engineer.

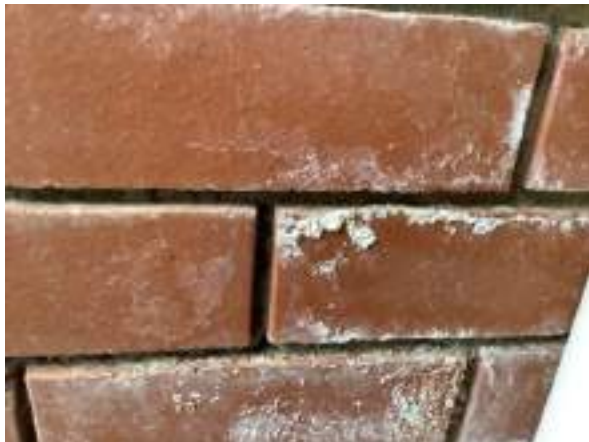
Minor Defect 3.22

Location: Brickwork

It is typically seen as white salt deposits on the surfaces of concrete pavement or mortar between bricks or tiles. While detracting from the overall appearance of the affected area, efflorescence is not likely to develop into secondary damage if left unmanaged.

Generally, soluble salt deposits can be removed by dry brushing with a stiff-bristled brush. Repeated dry brushing is an ideal treatment for eliminating this forming of efflorescence. A cleaning contractor or general handy person may be appointed to perform these works at the discretion of the client.

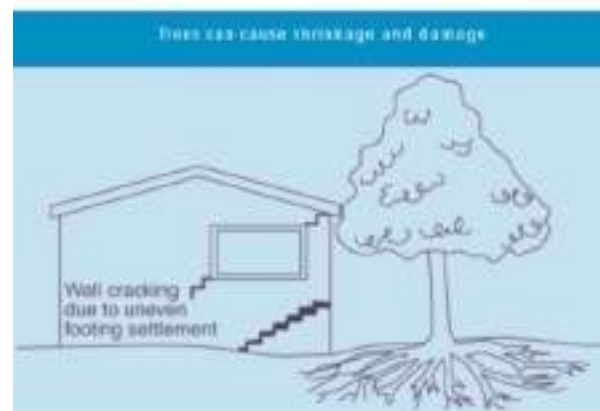
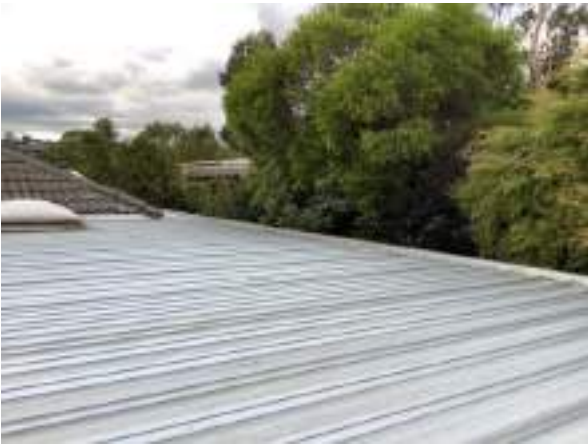
Minor Defect 3.23

Location: Garden Areas - All Areas

Finding: Garden trees - Overhanging and filling gutters
PLEASE NOTICE THE ATTACHMENT PICTURES TO THIS DEFECT STATEMENT;
H = the height of the tree at its full potential height, not its height today.
D = the distance from the tree to the building at the trees full potential height.
D = varies pending on one tree to 4 trees or more.

Gutters are a critical part of the building's management of storm water and rain. It is therefore important that they be kept clear to prevent secondary damage to associated building elements, including exterior and interior walls, ceiling linings and any adjoining building elements. Where gutters are blocked, pooling of rainwater is likely to occur, fast-tracking rust and corrosion of the roof plumbing elements.

It is highly advised that all overhanging tree branches be removed as soon as possible to prevent any further damage. Repair and/or replacement of sections of damaged guttering may also be required where the extent of the damage necessitates.

Such works should be performed by the homeowner; however, appointment of a landscape contractor or an arborist may be required. Consultation with a licensed roof plumber is required where guttering has been damaged.

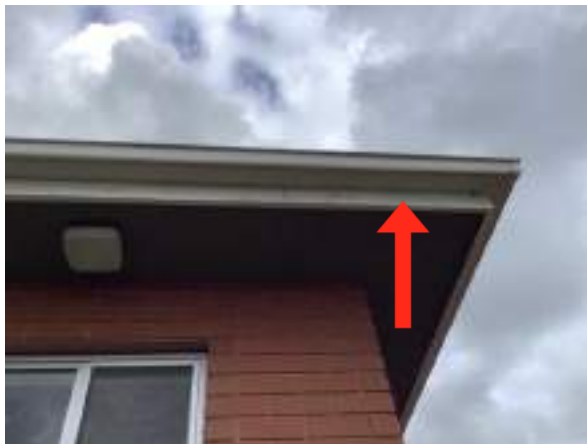
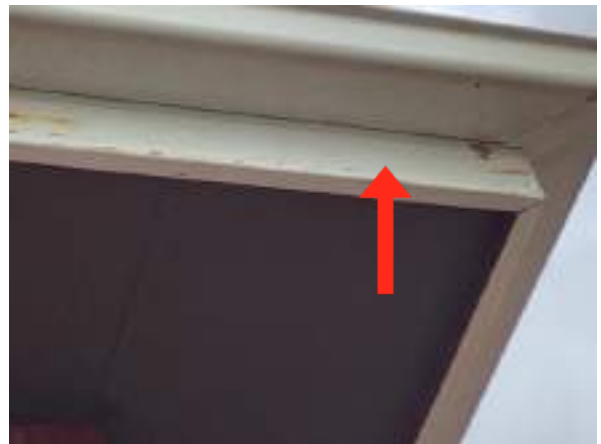
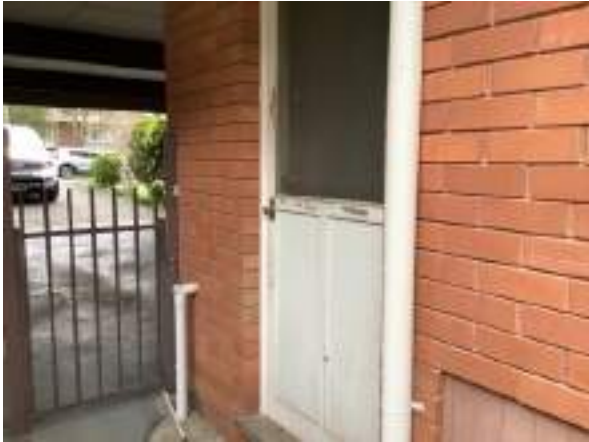
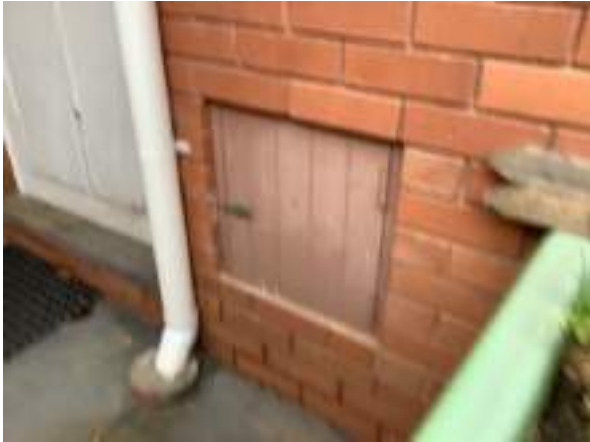
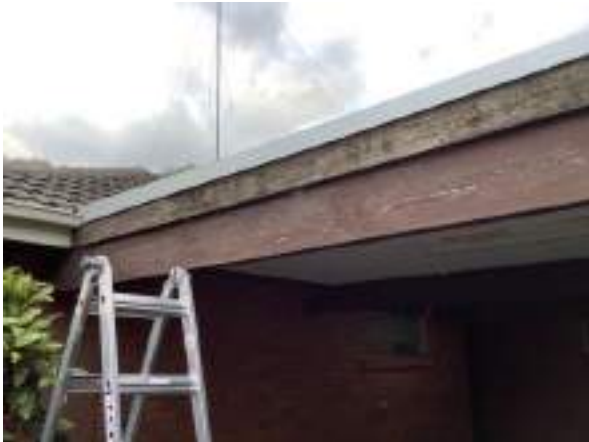
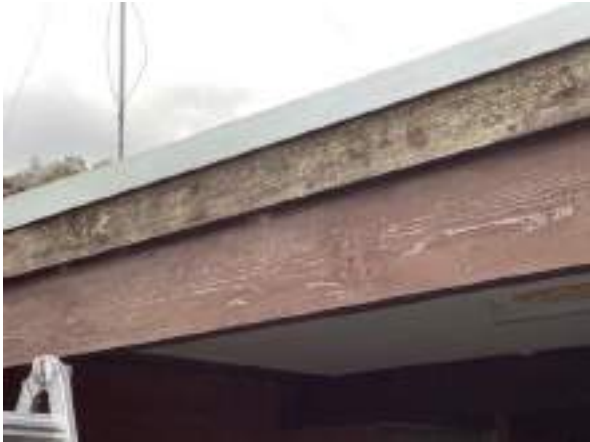
Minor Defect 3.24

Location: Timber Work - All External Areas

Finding: Timber, exposed to weather / External painting deteriorated
Much of the external paint work including but not limited to windows, fascias, guttering, veranda and other external fitments have been neglected and require attention to prepare and re paint.
External timbers that are frequently exposed to harsh weather conditions require adequate protection (paint) in order to maintain their condition. Where timbers have not been painted or treated adequately, general deterioration is likely to occur at an accelerated rate.

Whilst incomplete or missing paint finish is generally an appearance defect, it can also lead to the development of secondary building defects over time. Incomplete areas of paint finish exposes the area to moisture, potentially accelerating the deterioration of underlying building materials.

Degraded paint finishes should be sanded back, filled, leveled and painted, as applicable. Where inadequate or missing paint protection has led to the deterioration of the associated building element, repair and/or replacement of this building element may be required.

If left unattended, replacement of these timbers is likely to be necessary in the short-term future. Adequate treatment of these timbers is required as soon as possible by a painting contractor should be appointed as soon as possible to perform necessary works to aid the appearance of the affected area and to ensure the area is protected against further deterioration. Alternatively, the homeowner following manufacturer instructions may perform these works.

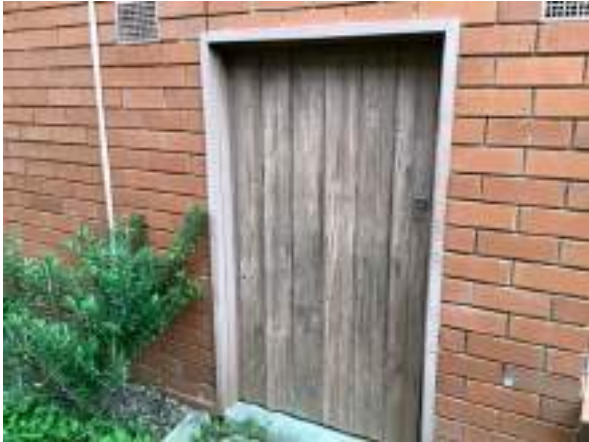
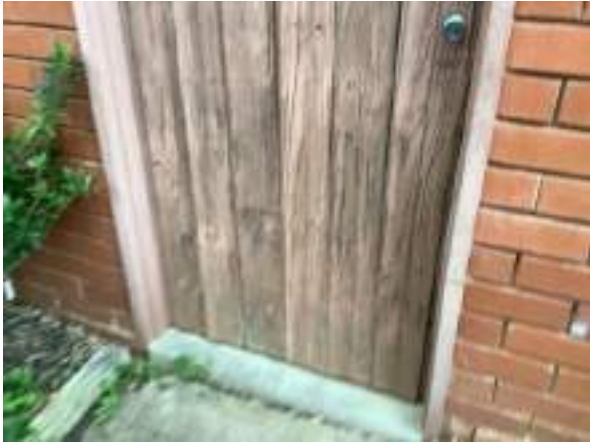
Minor Defect 3.25

Location: Timber Work - All External Areas

Finding: Wood Rot

This building element shows evidence of wood rot. Wood rot, also known as Fungal Decay, occurs when timbers and other cellulose building materials are exposed to damp conditions on an ongoing basis. This could be the result of exposure to weathering over a prolonged period of time, or the attraction of excessive moisture from other abutting building materials. Contributing factors also include poor air ventilation in the area.

Wood rot is often associated with general damp problems and is evidenced by a 'musty' smell or mould and mildew occurring on surfaces. If left unmanaged, damp conditions can lead to further health problems and the decay of timbers will continue.

A qualified plumber / builder may be appointed to assess the cause of excessive moisture and to provide advice on any remedial works as required.

A qualified carpenter and/or registered builder may also be required to replace affected building materials.
