Building, Electrical, Asbestos & Termite, Timber Pest Report.

Inspection Date: 29 May 2020

Property Address: Ivanhoe Area

Report Type: Property and Timber Pest Report

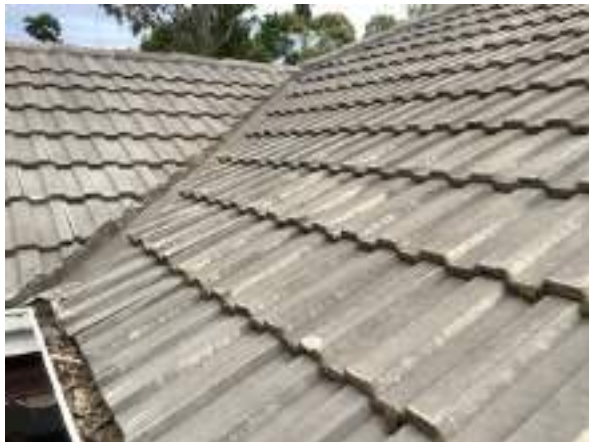
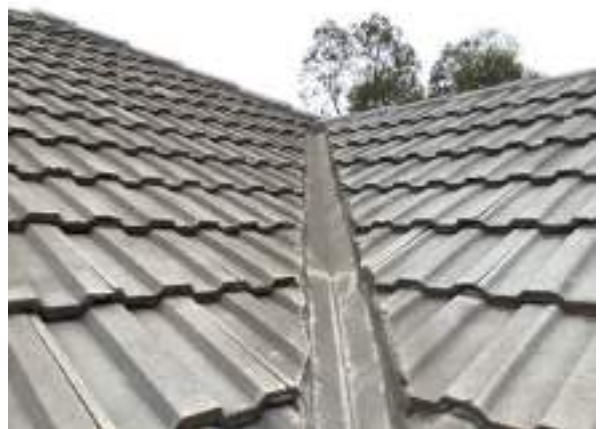
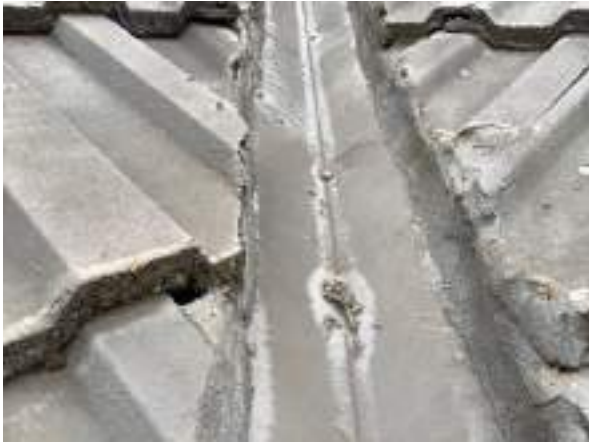
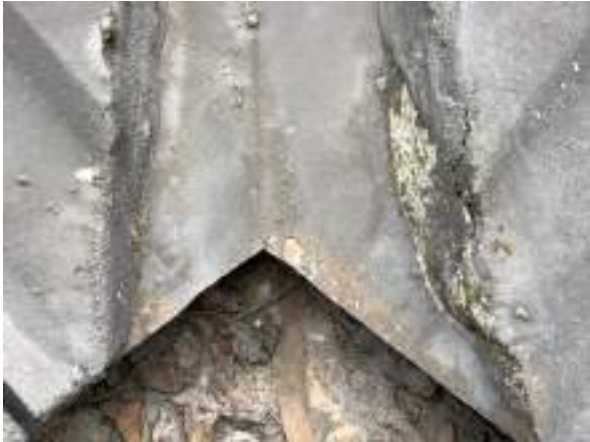
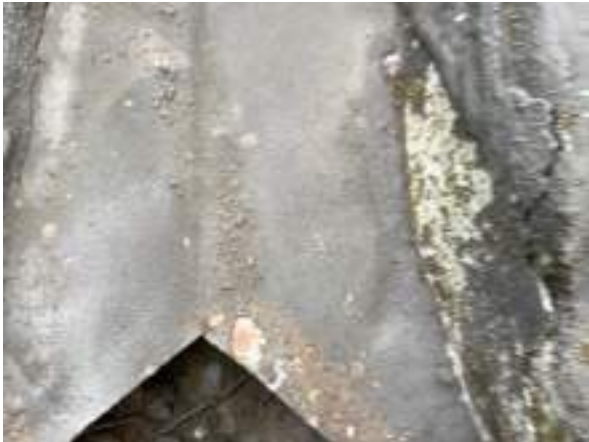
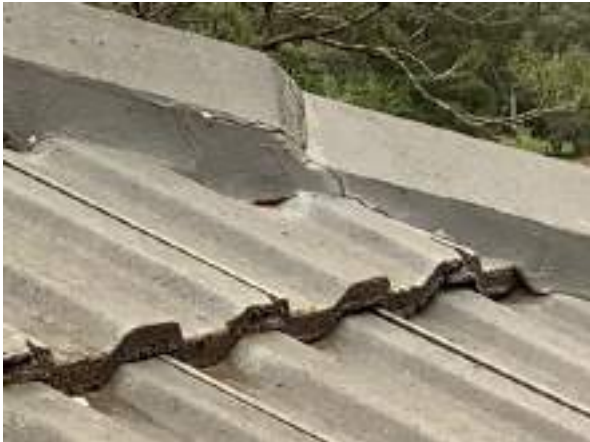
Minor Defect 3.26

Location: Roof Areas & Stormwater

Remedial works are likely to increase the longevity of the exterior roofing structure.

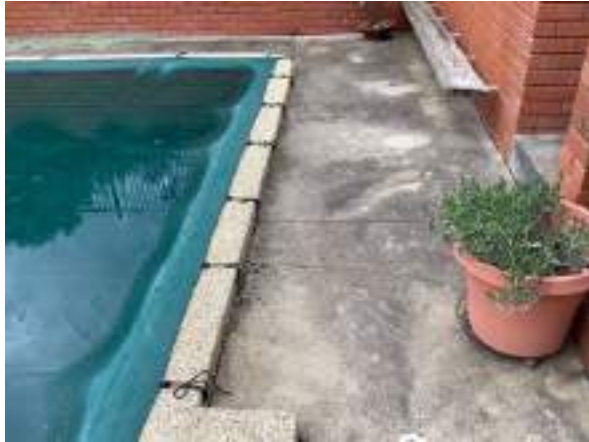
Minor Defect 3.27

Location: Concrete - All Areas

Relevant tradespeople, such as carpenters, painters and plasterers, should be appointed to perform remedial works, as deemed necessary.

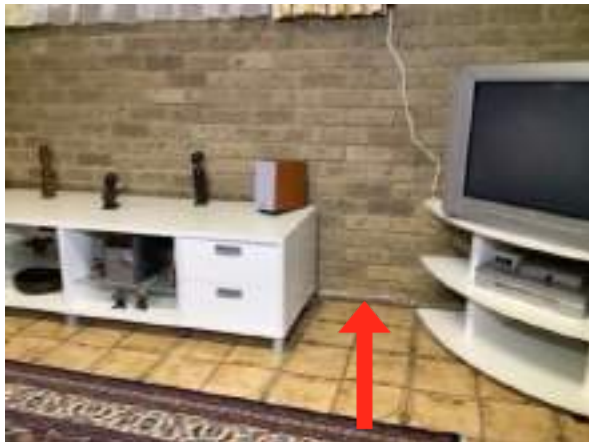
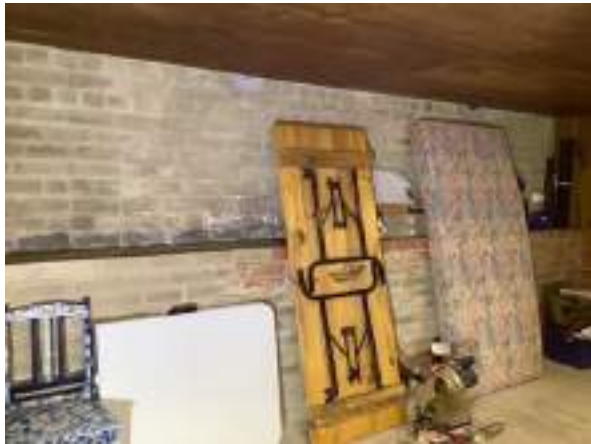
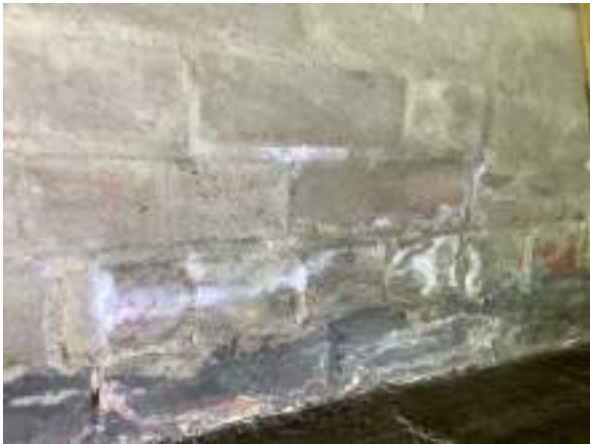
Minor Defect 3.28

Location: Downstairs rumpus Room

It is typically seen as white salt deposits on the surfaces of concrete pavement or mortar between bricks or tiles. While detracting from the overall appearance of the affected area, efflorescence is not likely to develop into secondary damage if left unmanaged.

Generally, soluble salt deposits can be removed by dry brushing with a stiff-bristled brush. Repeated dry brushing is an ideal treatment for eliminating this forming of efflorescence. A cleaning contractor or general handy person may be appointed to perform these works at the discretion of the client.

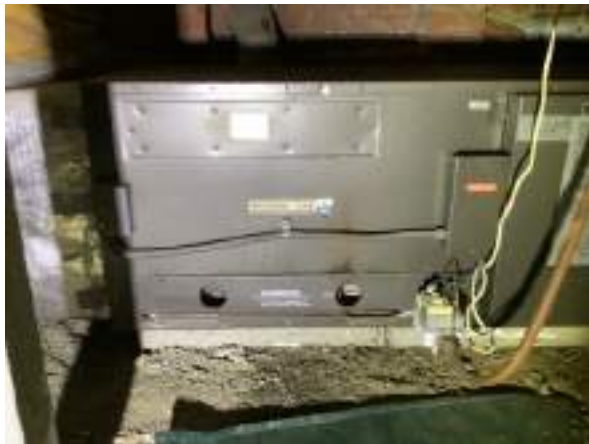
For your information 4.31

Location: For Your Information
Finding: Gas & Electrical Appliances - Inspection & Servicing
For you information

It is highly recommended that a registered plumber is required to inspect all the gas appliances and the gas Installation for defective workmanship and for carbon monoxide leaks and/or gas leaks.

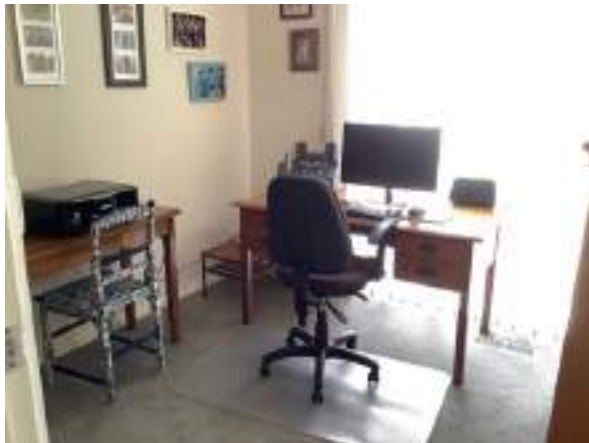
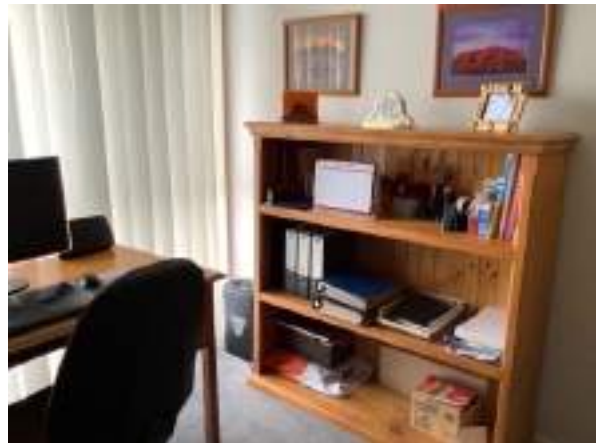
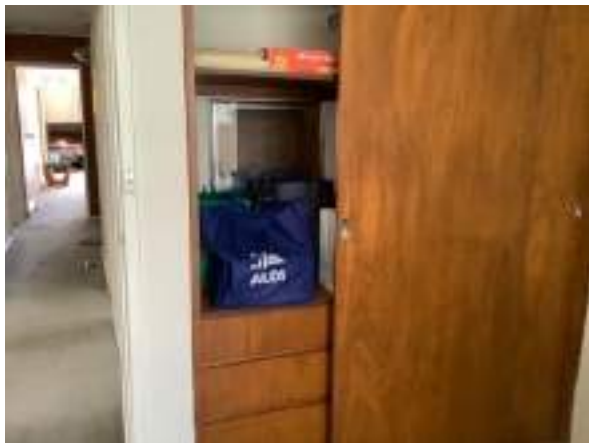
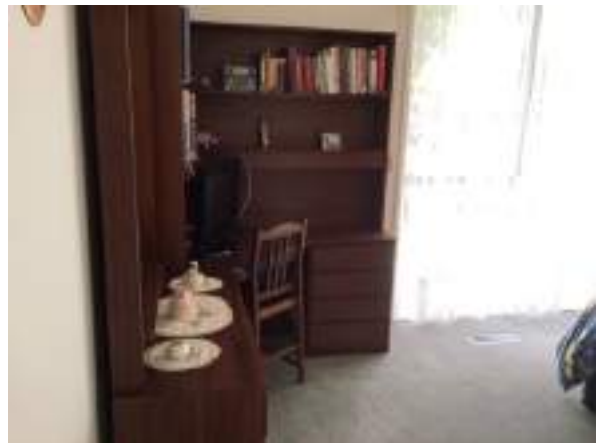
For your information 4.32

Location: For Your Information

Whilst we have taken many photos of the home and surroundings of the obstructions and limitations , we have just added a few photos in the report for you to understand the type of obstructions and limitations .

A re-inspection is recommended once the areas are made accessible.

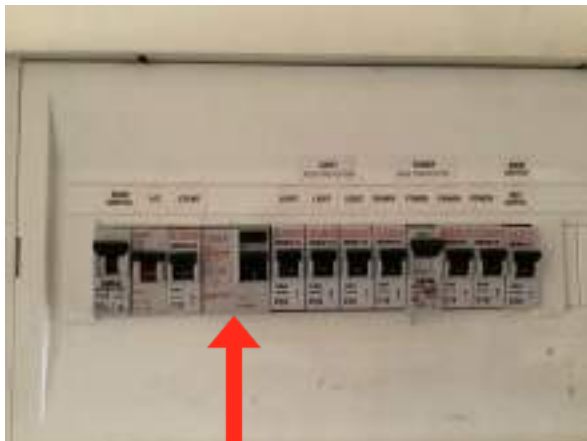
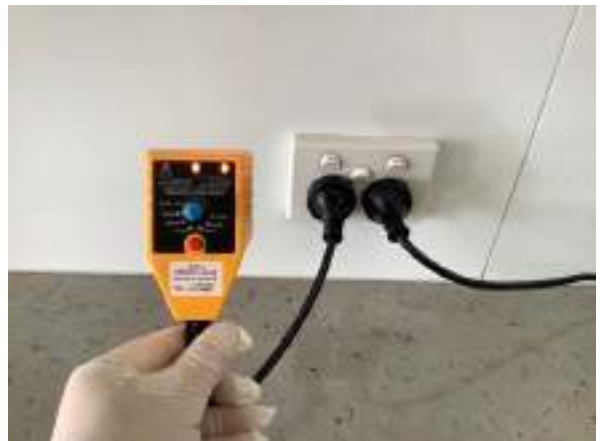
For your information 4.35

3/ Safety Switch test to trip the safety switch at less then 30 milli amps was performed.

These tests all passed the AS 3000 requirement and exceptance level.

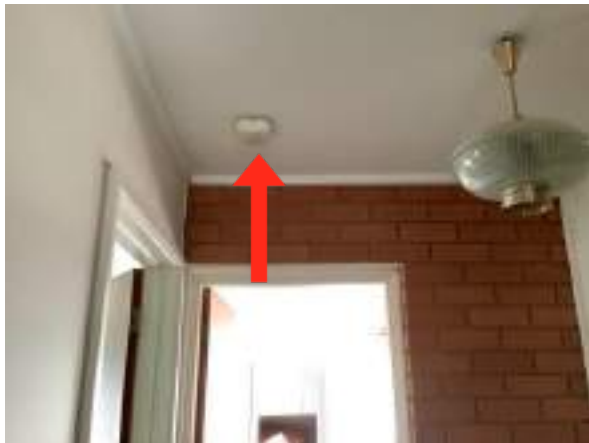
For your information 4.36

Finding: Smoke Detectors Battery Replacement.
This inspection DOES NOT test operation of smoke detectors .

Upon moving into a new property, it is highly recommended that the batteries to the smoke detectors all get replaced instantly.

Smoke detector batteries should be replaced every 12 months at a minimum.

It is highly recommended that replacement dates of the batteries be kept in a log book.

Testing of smoke detectors is required monthly.

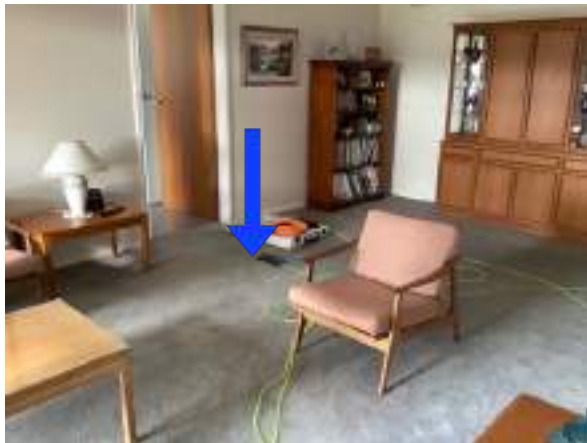
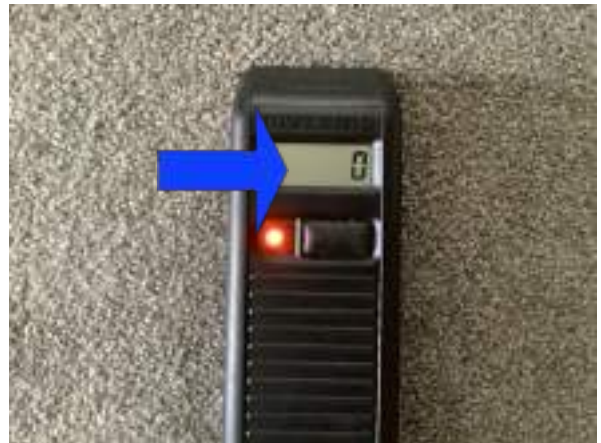
For your information 4.37

Location: Floor Levels - All Areas
Finding: Flooring - Within Levels Of Acceptance.
LIQUID DIGITAL ELECTRONIC FLOOR LEVELLING

At the time of the inspection it appears that the subfloor structure flooring is within standards and tolerances.

We advise that the flooring be closely monitored to identify any movement over time. Where flooring remains relatively unchanged for an extended period of time (i.e. several months or seasons) it is likely that the flooring is relatively stable, however unexpected movement of the foundations of the property can happen at any time.

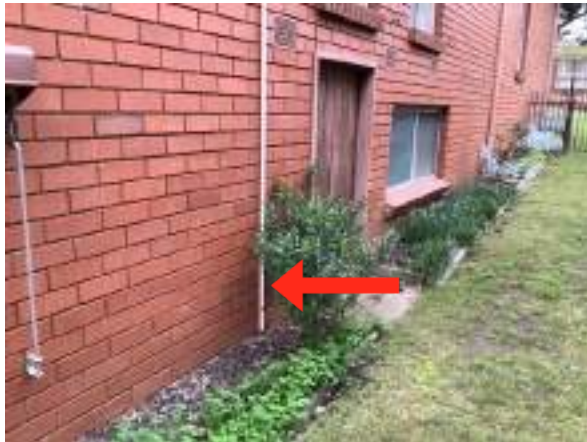
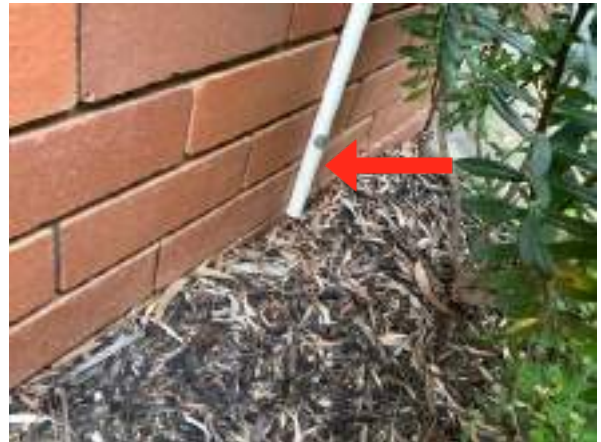
This excessive water creates a much more conducive environment for termites as well.

These minor works should be carried out as soon as possible.

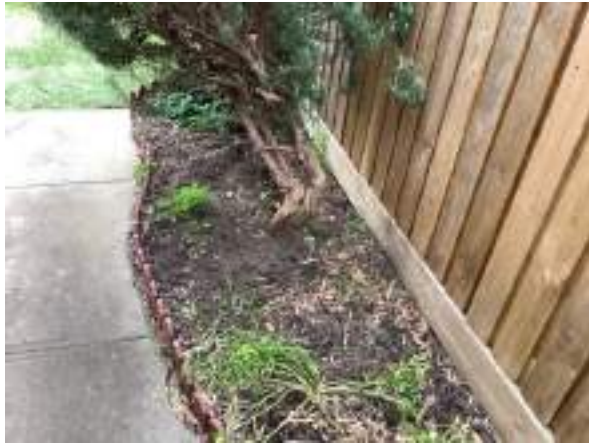
Item 2.03

Location: Garden Areas - All Areas

Finding: Garden Beds - Conditions Conducive to Termites
Garden beds were found to be evident in areas of garden areas.
These garden beds can include untreated timber, bark, excessive old vegetation and with a combination of moisture from watering hosing can make conditions very conducive to termite activity and termite ingress.
It is always important to keep the garden beds as clean as possible and take out excess old bark from the trees, leaves and keep bark mulch to a minimum or better introduce rocks or some item that does not create an conducive environment for termites and hold excess moisture.

ALL AREAS should be checked carefully for this defect and attached are a few PHOTO EXAMPLES as a GUIDE.

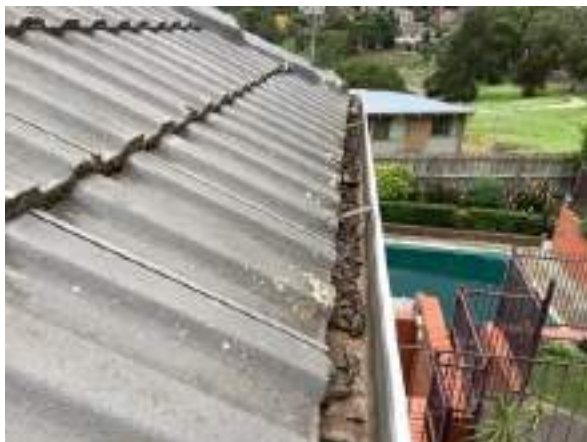
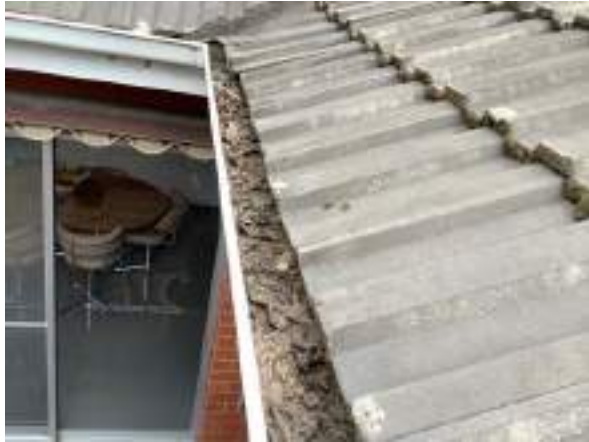
Item 2.04

Location: Roof Areas & Stormwater

Immediate clean up is required.

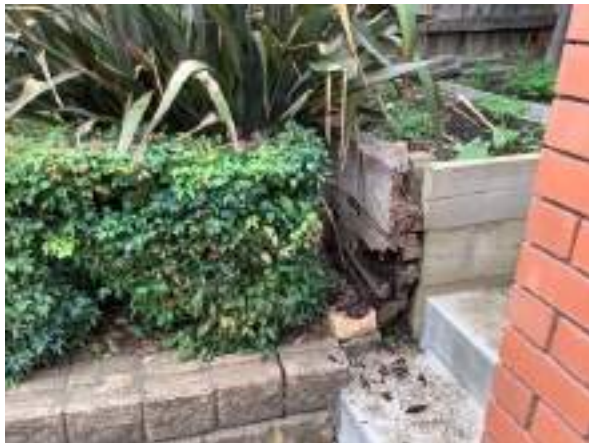
UNTREATED OR NON-DURABLE TIMBER USED IN A HAZARDOUS ENVIRONMENT

Any timbers in direct ground contact provide opportunity for concealed termite entry and are likely to be subject to premature rot and decay as the soil retains moisture or damp conditions against the timbers.

When met with excessive moisture timber begins to decay and develop wood rot. Any timbers that are in direct contact with external grounds especially if left untreated or non-durable also provide ingress for subterranean termites into that particular element.

Remove untreated timber that is in direct contact with external grounds. Consider replacement with more durable materials i.e. treated timber or non timber elements.

Frequent pest inspections are advised to readily identify any termite activity in these areas.

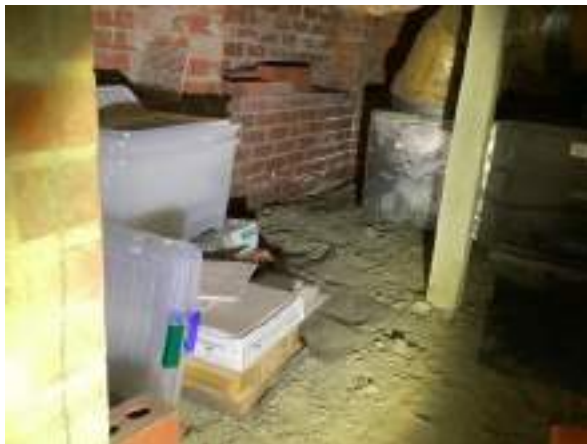
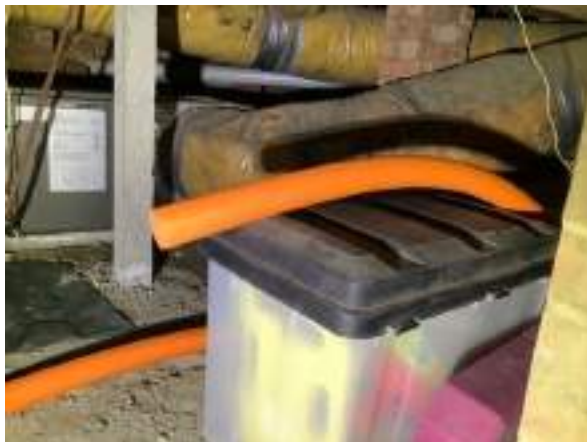
Item 2.06

Finding: Stored Timbers / Debris / Items - All Areas, Subfloor space or exterior external areas.
The storing of timbers / debris / items in the subfloor space or around the external property increases the risk of termite activity being present, as they are likely to come into contact with weather conditions or excessive moisture where wood rot is likely to develop on timbers that are not treated, or where debris or items are stored

It is highly recommended that any stored timbers / debris or items be immediately removed from areas

It is highly recommended that any stored building materials or other materials be immediately removed from areas in which they may attract any termite / timber pest attack around the perimeter and/or sub floor areas of the dwelling and a re-inspection is carried out.

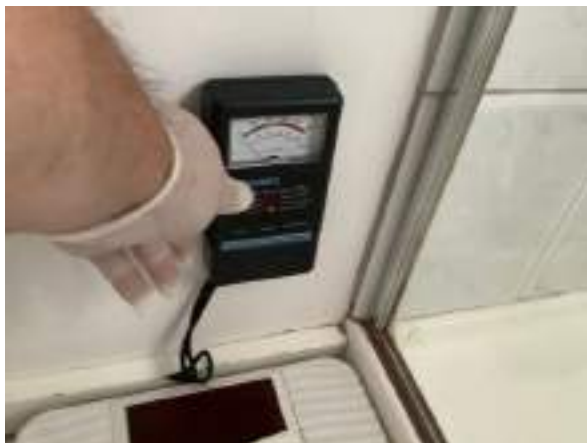
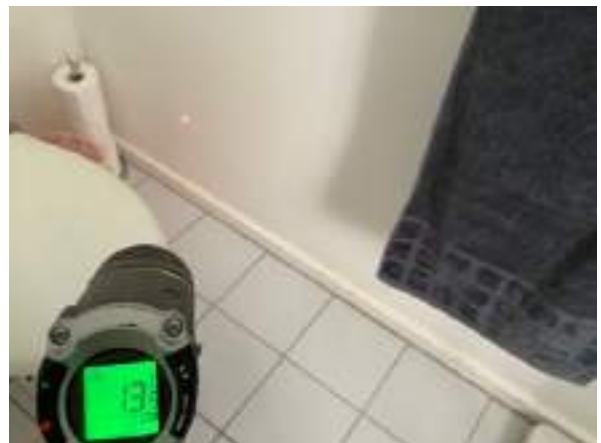
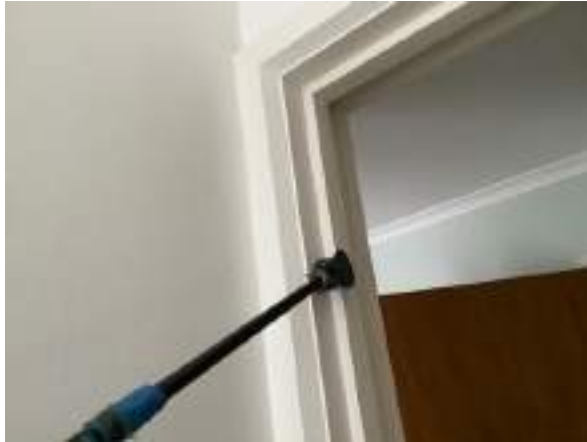
Finding: Identification Procedures Designed To Help identify Termite Activity
All areas accessible of the dwelling are checked with particular attention paid to the wet areas which were closely assessed to check for excessive levels of moisture and temperature anomalies.

The moisture content variation was quite low and within the acceptable range of 5% to 20%.

At the time of the inspection there was evidence of termite (timber pest) visually accessible timber damage caused by termites and timber pest.

As all areas are not able to be inspected due obstructions and limitations, we therefore can not rule out the possibility of concealed timber pest activity.
