## Warranty Claim Report

Inspection Date: 7 May 2020

Property Address: Eastern Area Victoria

Report Type: New Home Construction

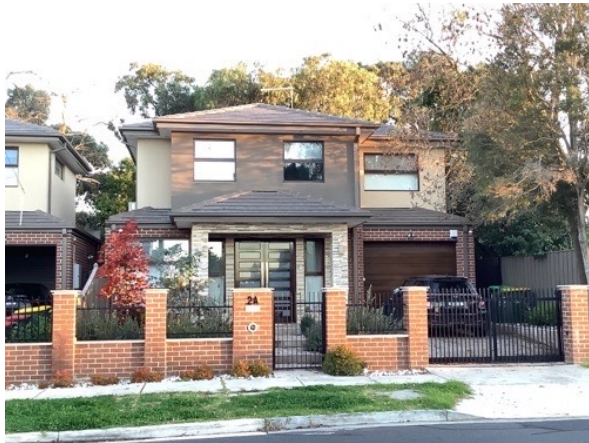
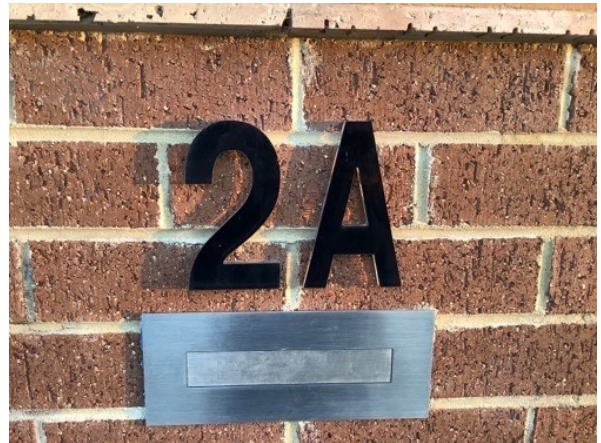
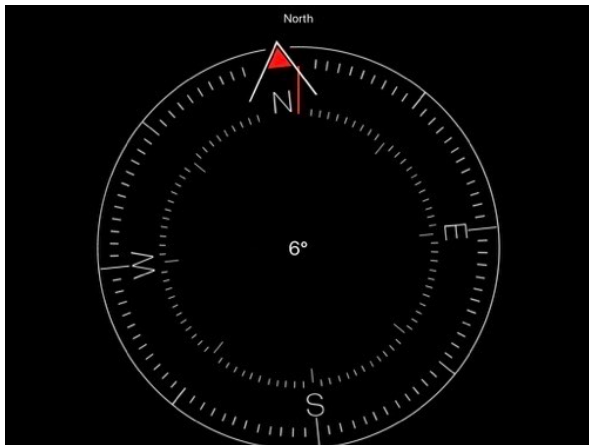
Location: For Your Information

Finding: General Site Photos & Compass  
General site photos and other areas of interest are provided for your general reference.
