New Construction Lock Up Report

Inspection Date: 23 Jun 2020

Property Address: Rockbank Area

Report Type: New Home Construction

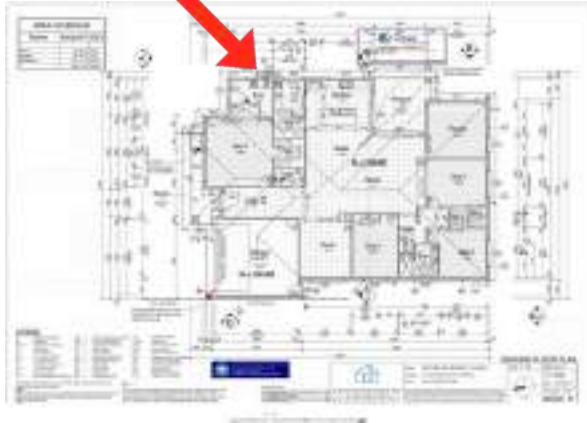
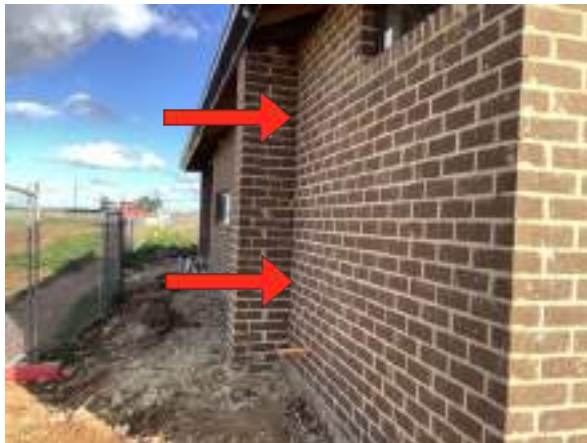
Finding: ARTICULATION JOINTS - Missing - Inadequate .

Articulation joints locations depend on many factors such as the windows, doors, garage openings, sliding door openings, slab foundations and so on.

Masonry work is considered to be defective if articulation and movement control joints have not been provided for as required.

Where appropriate, articulation joints shall be used in masonry walls to limit the potential cracking or distress that may be caused by footing movement.

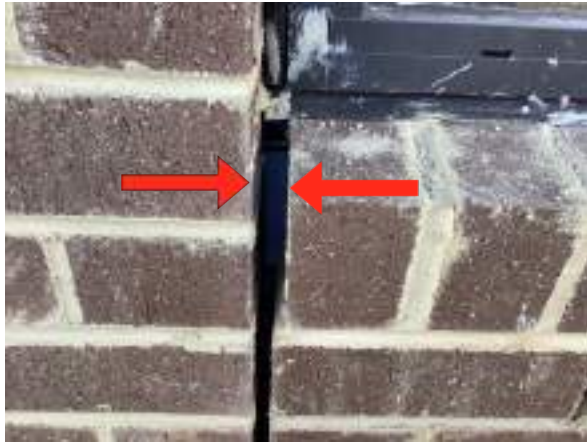
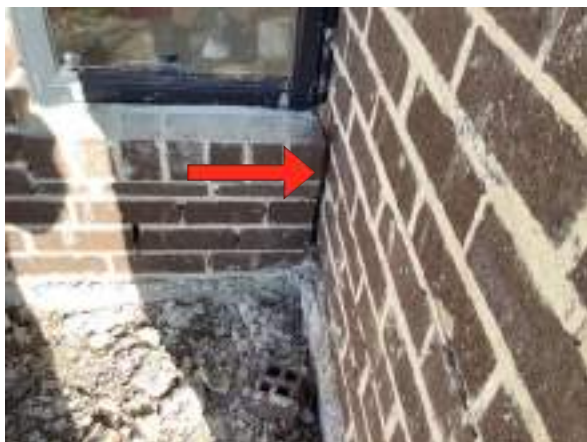
Non Compliant 2.02

Location: Articulation Joints - Exterior Perimeter Of Building

Finding: Articulation joints - Width defective .(AS3700)
To comply with AS3700 all articulation joints must be a minimum gap of 10mm wide and a max gap of 15mm.

The joints also must be sealed to maintain the integrity of weatherproofness, acoustic and fire isolation.

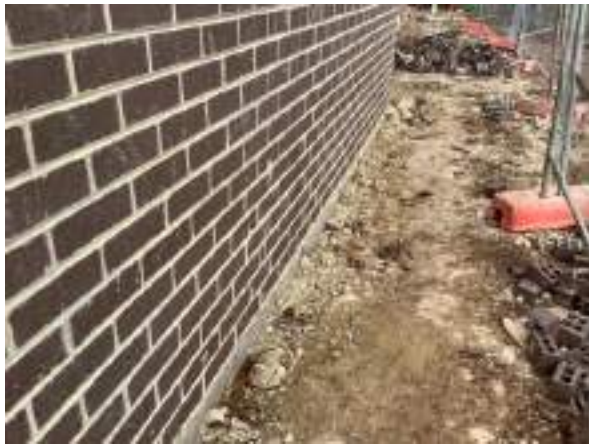
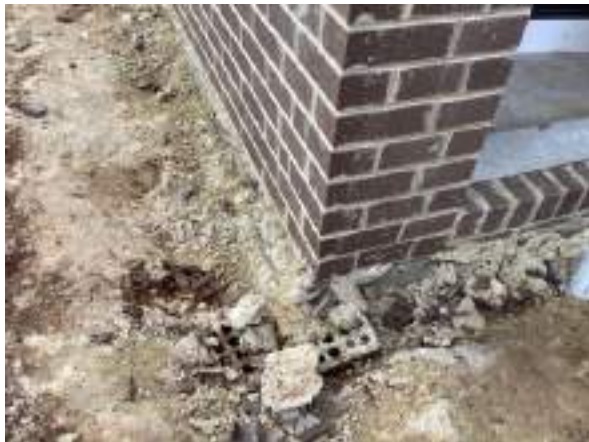
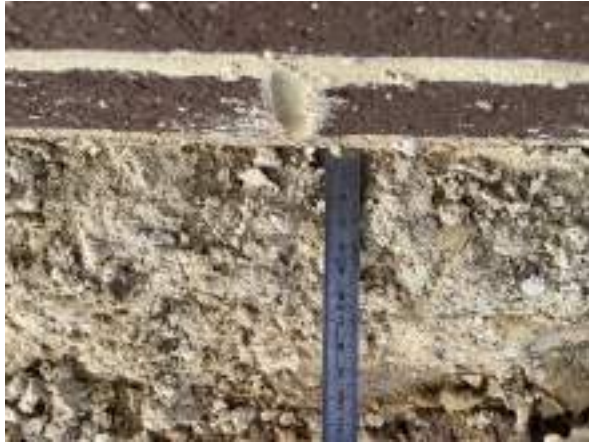
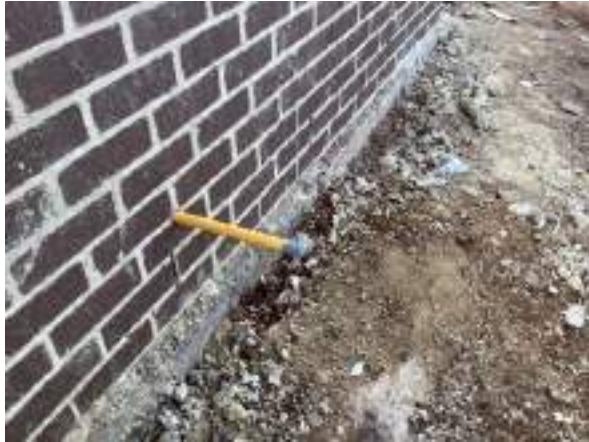
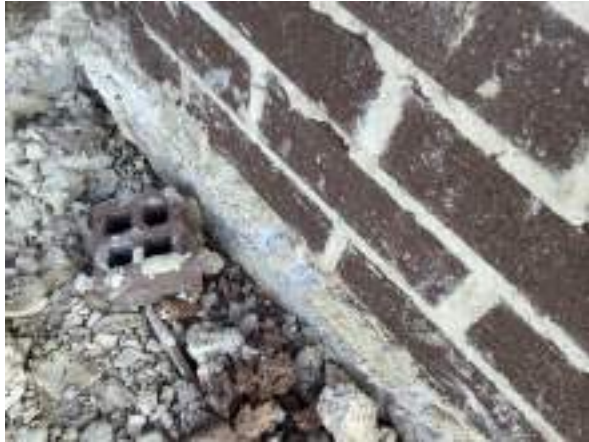
It was observed that there are areas where the edge of the slab protrudes past the document finished dimension of the slab. There are many areas to the total perimeter of the home that have EXCESSIVE concrete slab .

The current overhang will affect any concrete pavement of hard material landscaping such as pavers and as such the overhang needs to be cut back.

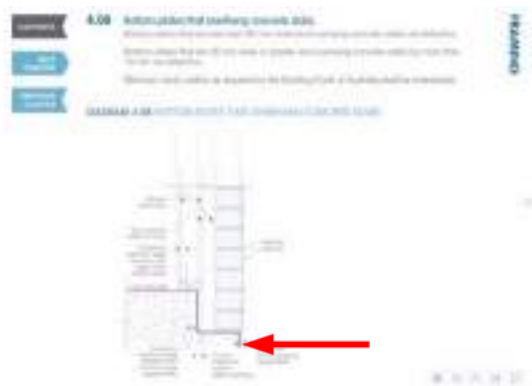
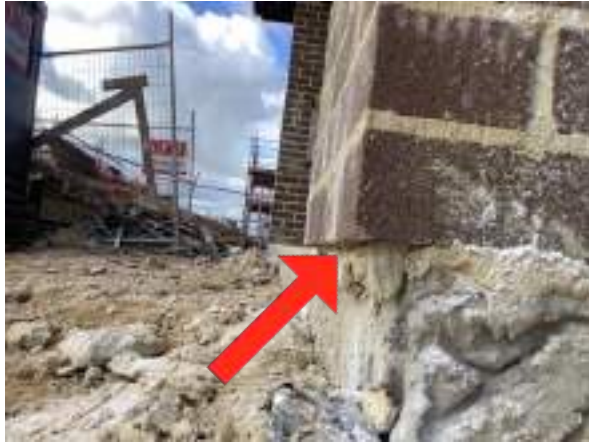
Non Compliant 2.05

Location: Brick Work - Exterior Perimeter Of Building

Finding: Brick/Wall Overhang On Slab.
 I have ONLY taken LIMITED photos of this defect and attached are LIMITED photos of this defect in SOME AREAS ONLY.
 All AREAS to the entire property should be checked CAREFULLY to identify any further defects that are the same, as this defect is in other areas of the property.

At the time of the inspection it was found that the brickwork is overhanging the slab by more than 15 mm.

Standards and Tolerances 2015 - Diagram 4.08 states that the maximum overhang of the brick work is 15 mm.

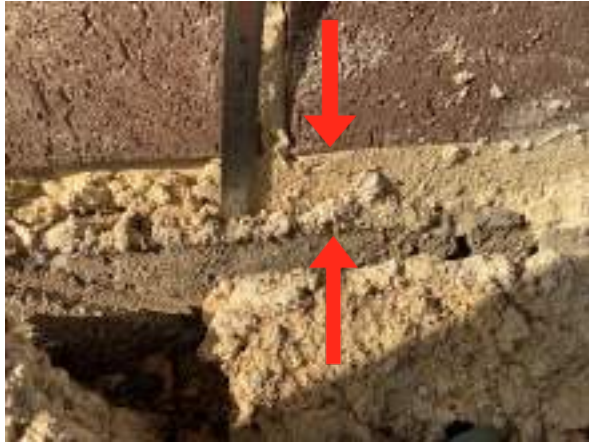
Non Compliant 2.06

Location: Brick Work - Exterior Perimeter Of Building

Finding: Brick Base bed joints (exposed)- defective
It was observed that the exposed base bed joint is defective. Exposed base bed joints in masonry walls which are above the finished ground level are considered to be defective if they exceed 20mm in thickness which is the allowable Standards and Tolerances.

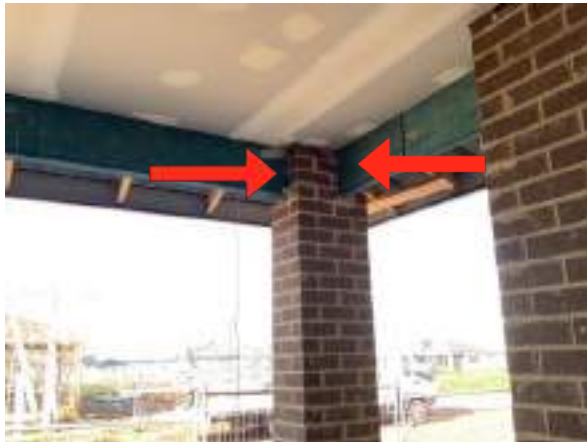
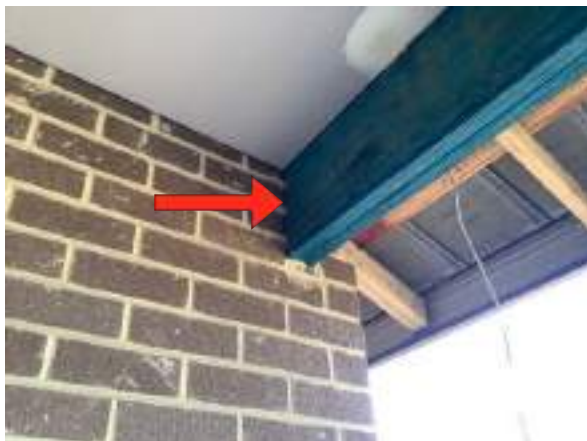
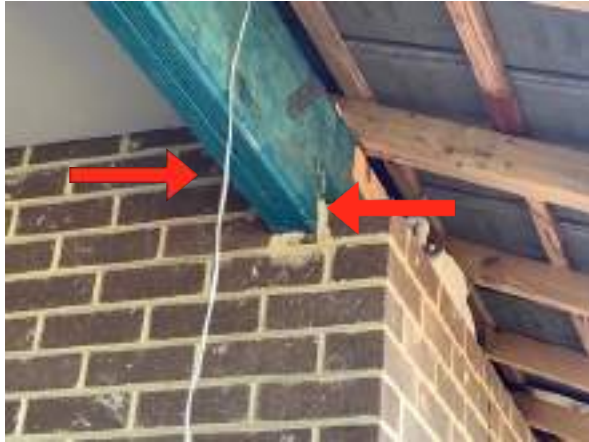
Non Compliant 2.07

Location: Brick Work - Exterior Perimeter Of Building

Part 3.3.1.10 Shrinkage Allowance for Timber Framing of the BCA requires that 'In masonry veneer walls a gap must be left between the timber frame and the top of the masonry wall, including window sills ect, to allow for settlement of the timber framing caused by timber shrinkage.

The Australian Standard AS 1684.2 Timber Framed Construction and Masonry standard call for a clear gap of 8-10mm to be left to allow for expansion and contraction of timber beams due to varying moisture content.

The bricklayer needs to rework these junctions to achieve the 8mm minimum gap.

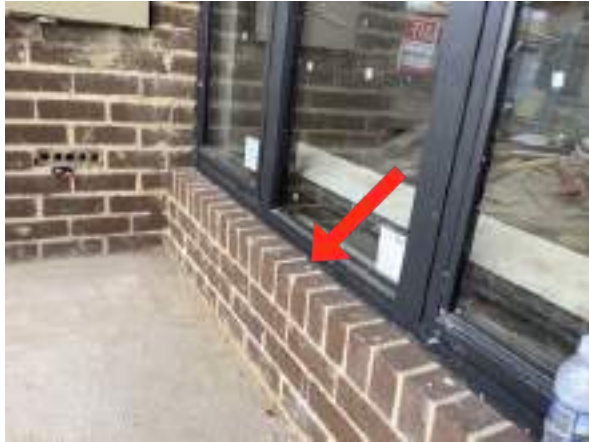
Non Compliant 2.08

Location: Brick Work - Exterior Perimeter Of Building

Finding: Brick Pipe penetrations (walls) - defective
Examples of pipe penetrations or plumbing holes which are penetrating external walls being defective were identified. Generally this means that the penetrations have not been finished neatly grouted as appropriate or kept to the smallest practicable size.

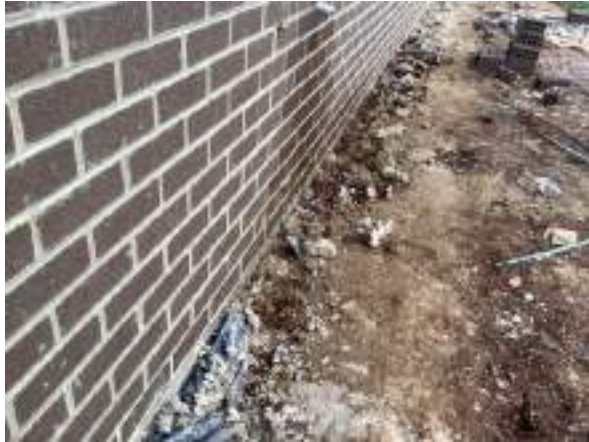
Non Compliant 2.10

Location: Concrete Slab - Perimeter To All Areas

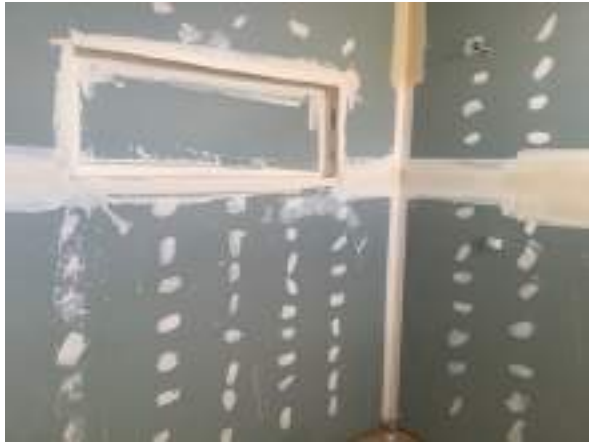
Finding: Waterproofing not completed
At the time of inspection the waterproofing was not completed, this can be done with the pre-paint inspection which consists of plaster checking vertically and diagonally, waterproofing and timber fixing
