Commercial Report-Commercial Building Report-Public Areas (Balcony & Carpark)

Inspection Date: 19 Jul 2020

Property Address: Ascot Vale Area

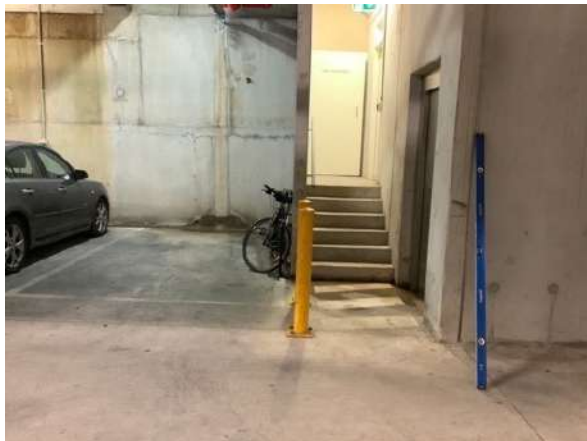
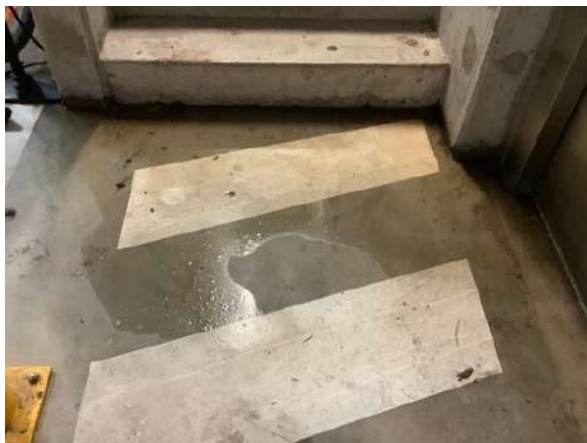
Safety Hazard 1.01

Finding: Drainage - Inadequate
Water is pooling near the steps area into the building. This is defective workmanship as the falls in the concrete, must allow the water to run away from this area.
This is a slip hazard that **MUST** be attended to.

The question as to why water is ingressing into this area is of a concern as well as water ingress via concrete and the concrete areas has the potential to damage the associated building materials and the concrete as outlined in more detail in this report.

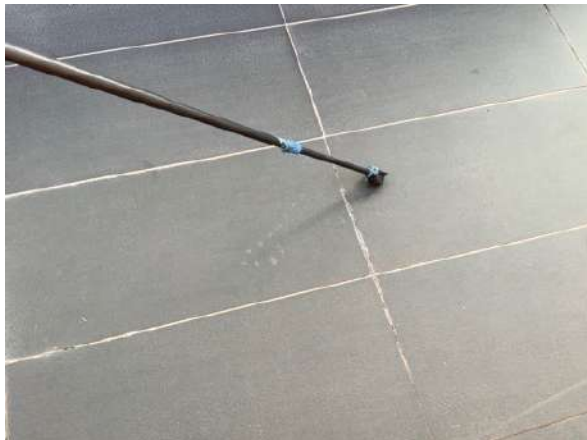
Major Defect 2.02

Drummy tiles may also be contributed to tiles cracking and what is important is to determine the cause of the cracking, which may be related to the subfloor structure, typical wear and tear and/or poor workmanship

Such defects are generally caused by physical or moisture damage to the area. Drummy tiled areas may also be a direct result of poor workmanship during the construction process.

ALL AREAS should be checked carefully for this defect and attached are a few PHOTO EXAMPLES as a GUIDE.

The cause of the tiles cracking must be determined and repaired otherwise the same defect will occur.

Any exposure to moisture is capable of causing tiled areas to become drummy and/or cracked over a prolonged period of time. Drummy tiled areas generally require removal and replacement of affected tiles, with adequate sealant and grouting.

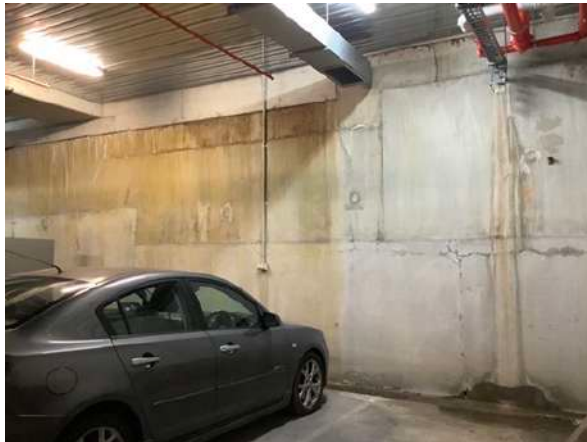
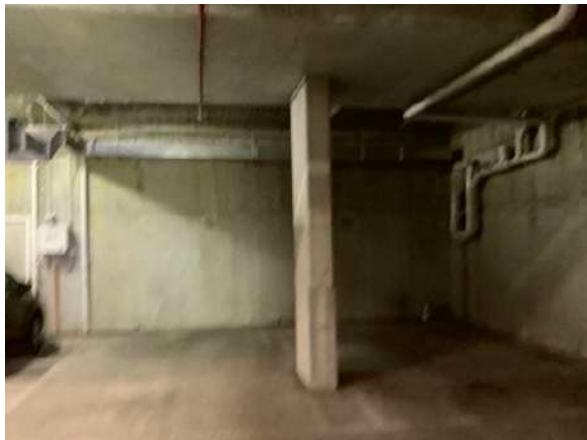
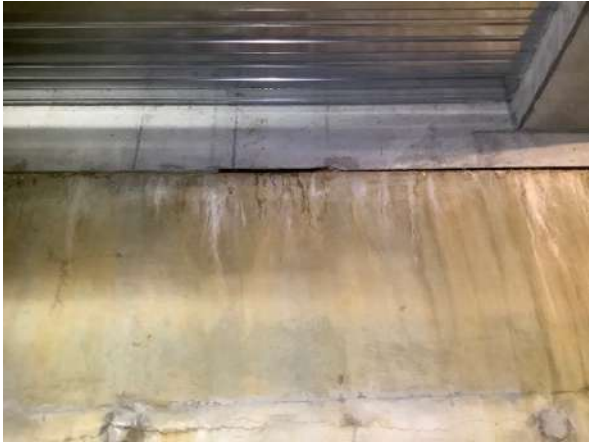
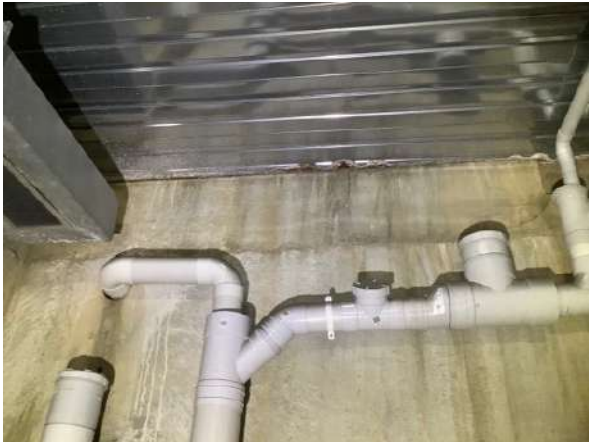
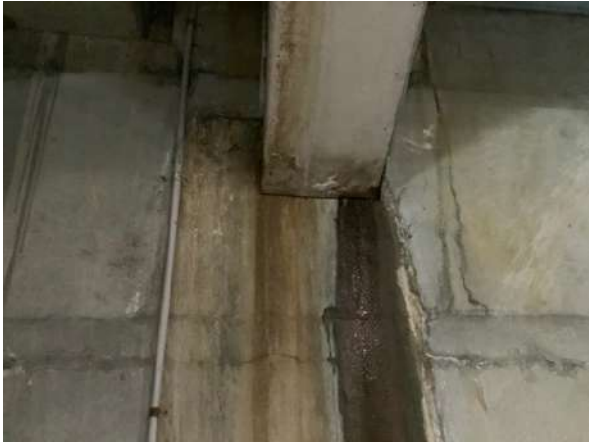
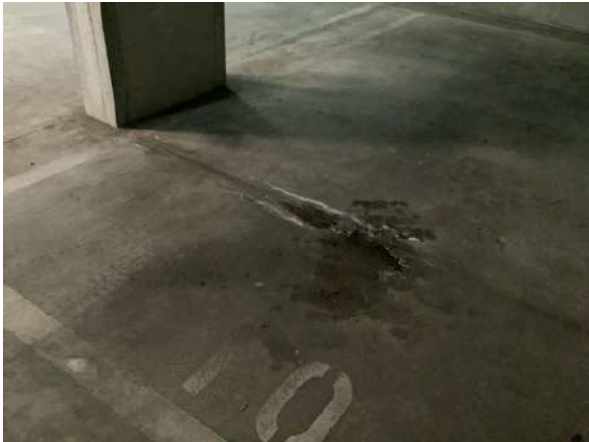
Ultimately, the cause of the concrete cancer (e.g. poor water proofing) must also be addressed, otherwise the problem is likely to recur. Treatment of concrete cancer can be expensive and, left unmanaged, the problem is likely to worsen over time, potentially leading to the development of major structural defects or safety hazards.

In some instances, repairs are possible; however, repair works will generally involve extensive works, including removal of affected concrete and the treatment or replacement of any exposed steel. Some injection of resins or special mortars may also be possible, however this depends on the size and extent of consequent damage.

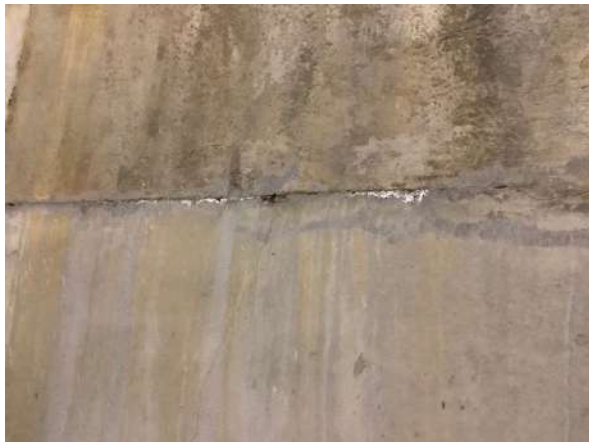
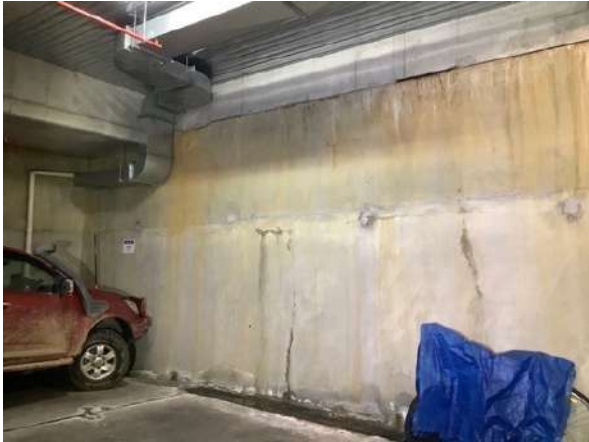
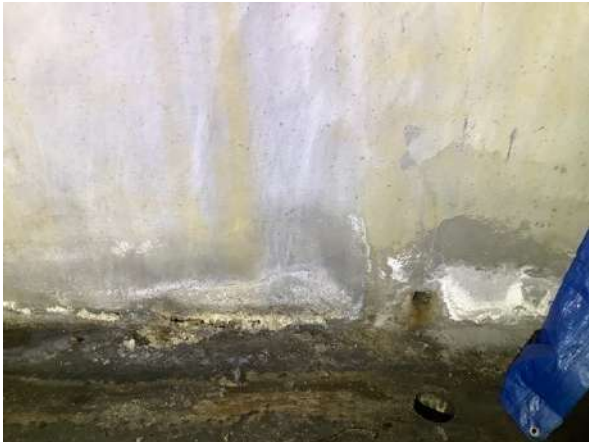
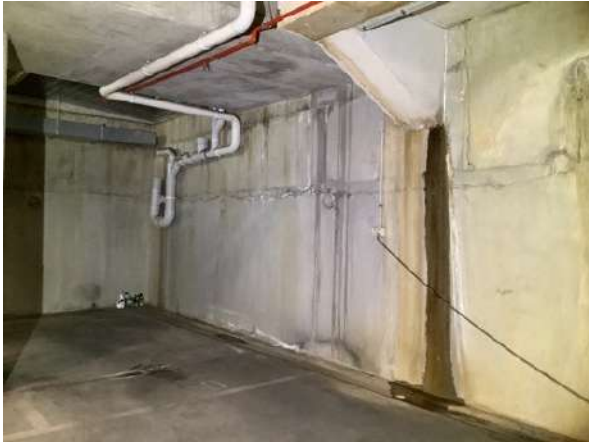
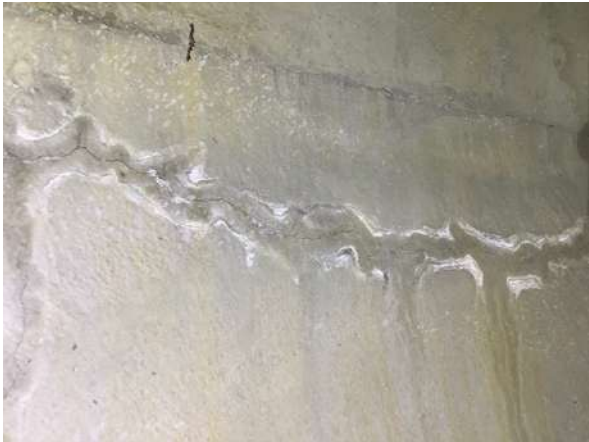
Major Defect 2.06

Location: Carpark & Surrounding Areas

It is important to note that unless the cause / source is determined and repaired efflorescence will return.

A cleaning contractor should be appointed who is experienced in this field of works.

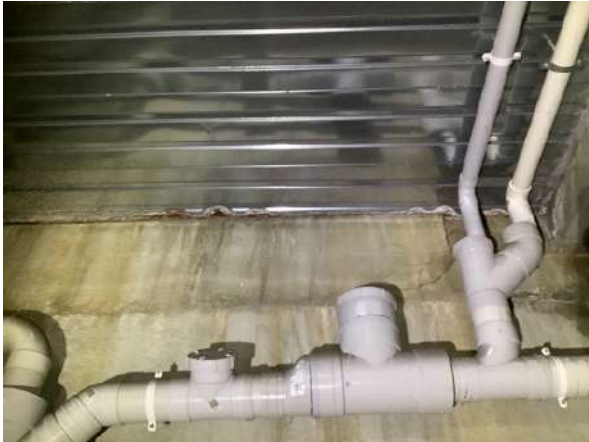
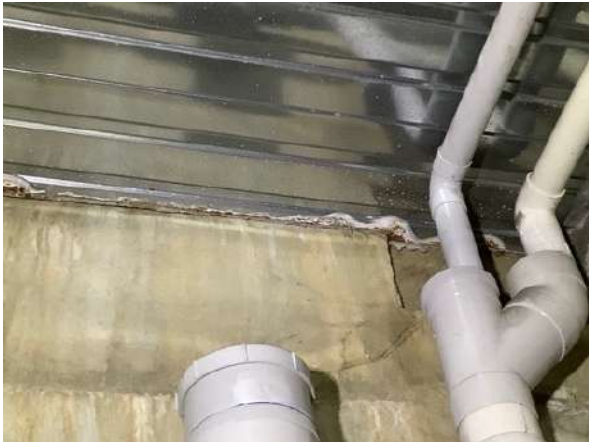
Major Defect 2.07

Location: Carpark & Surrounding Areas

Rusting and corrosion should be managed by ideally removing or limiting the affected surface from exposure to moisture.

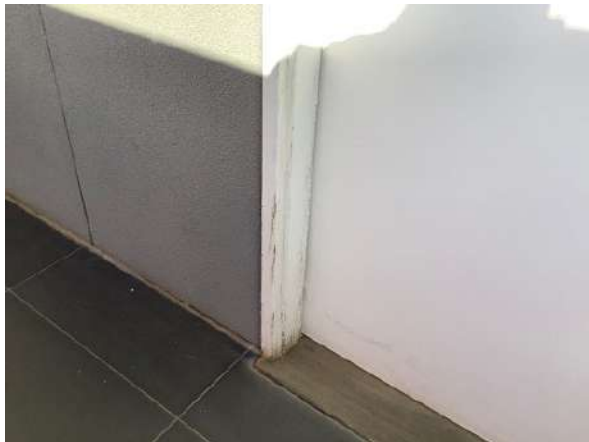
Minor Defect 3.08

Finding: Timber, exposed to weather / External painting deteriorated
Whilst incomplete or missing paint finish is generally an appearance defect, it can also lead to the development of secondary building defects over time. Incomplete areas of paint finish exposes the area to moisture, potentially accelerating the deterioration of underlying building materials.

Degraded paint finishes should be sanded back, filled, leveled and painted, as applicable. Where inadequate or missing paint protection has led to the deterioration of the associated building element, repair and/or replacement of this building element may be required.

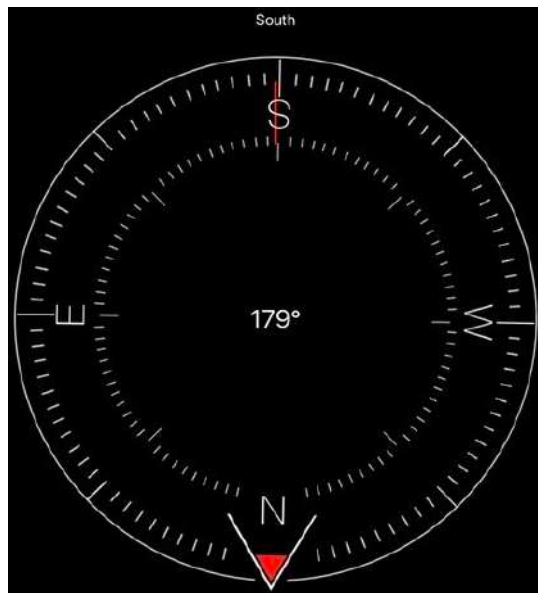
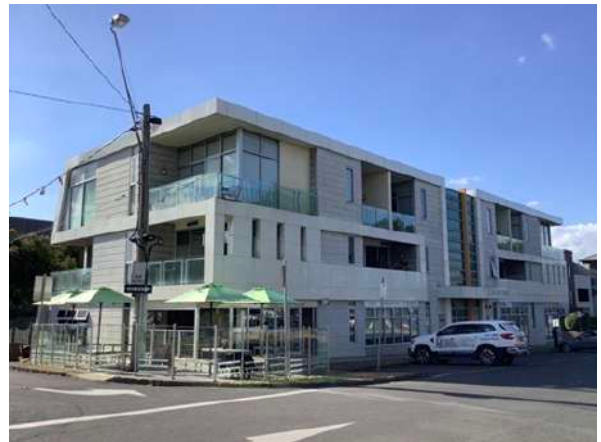
Location: For Your Information

Finding: General Site Photos
General site photos and other areas of interest are provided for your general reference.

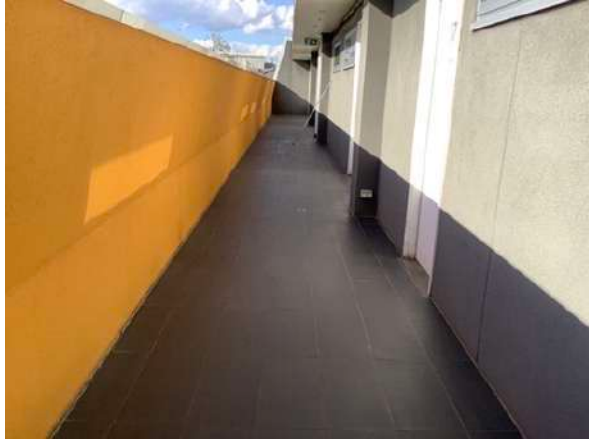
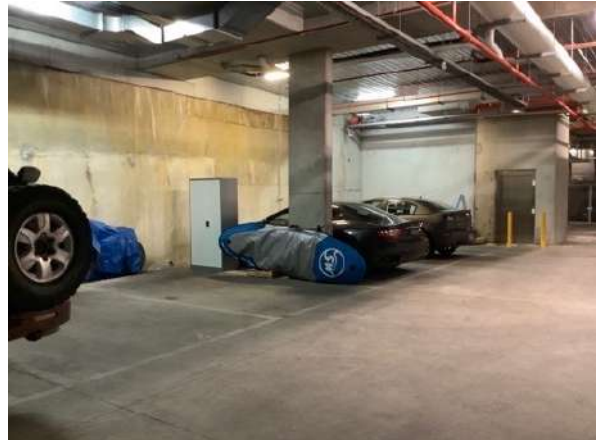
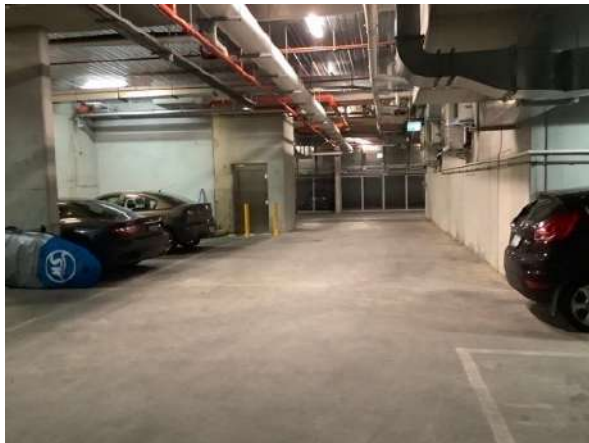
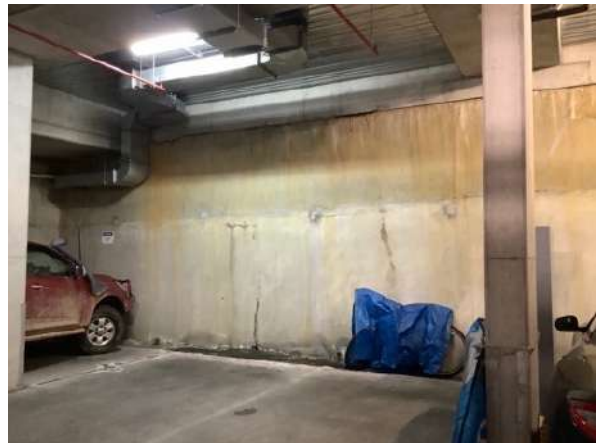
Observation 4.11

Finding: Areas Of Concern - Balcony Walkway & Carpark Areas
Areas Of Concern-General site photos and other areas of interest are provided for your general reference.

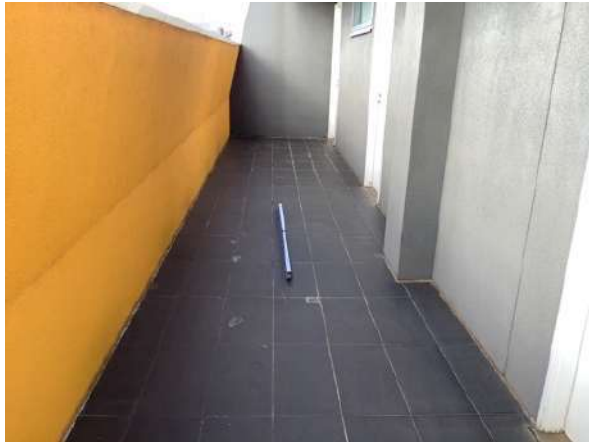
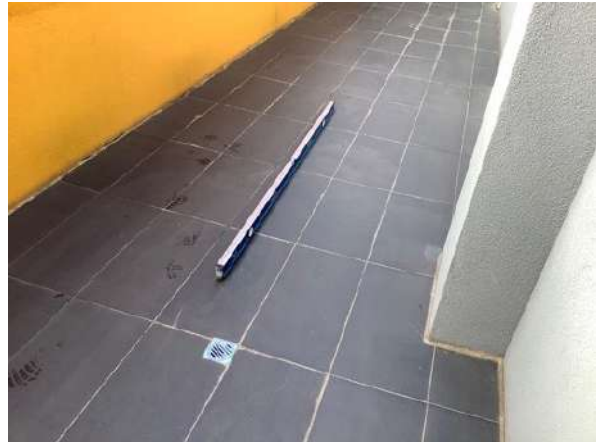
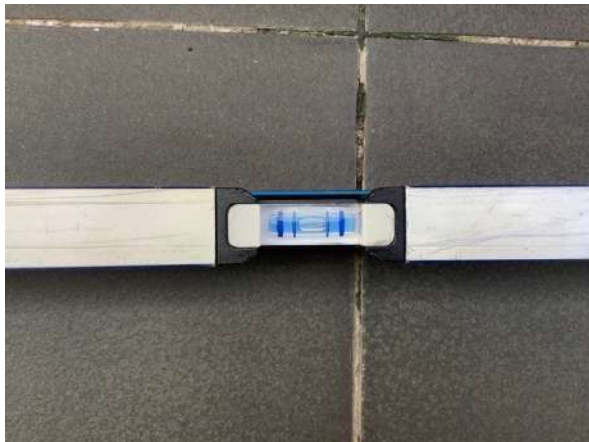
In all cases, tiles may require diagonal cutting in the area around the waste to achieve the required falls, sufficient drainage and to ensure lipping is kept within the guidelines of AS 3958.1.

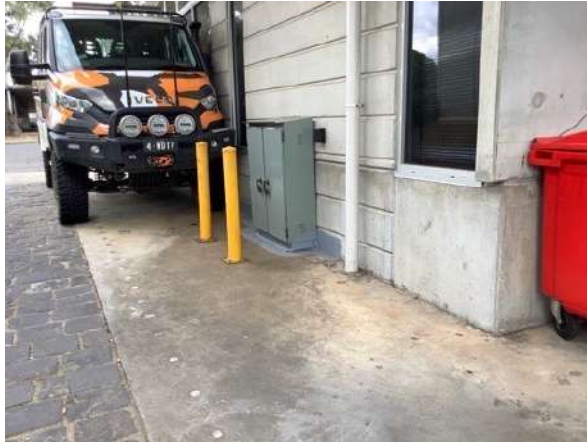
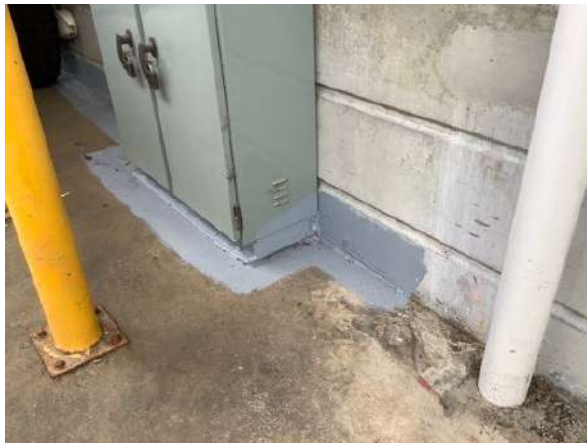
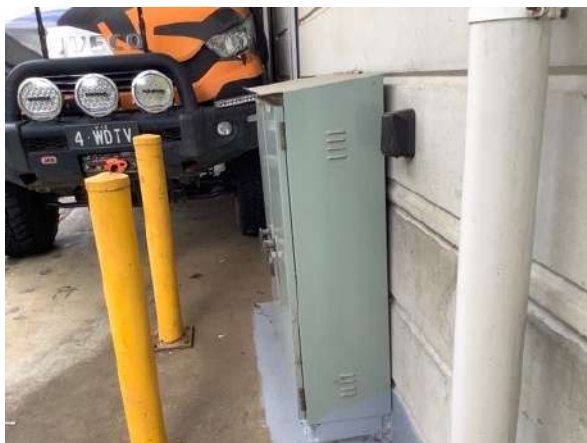
Observation 4.15

Finding: Area Of Repair

It appears as though works to this area in relation to stopping or reducing water ingress into the carpark has taken place. Whilst this may help this area of the carpark, it is not the overwhelming concern to the water and moisture ingress into the areas of concern.

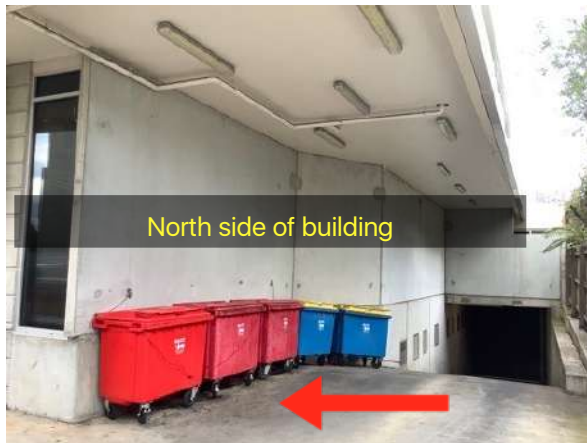
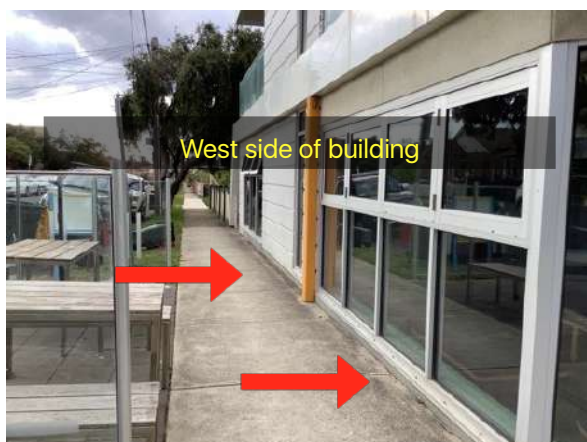
Observation 4.16

Location: Perimeter Of Building - Exterior
Finding: Areas where water is seeping through
XXXXXX
