Dilapidation Inspection Report

Inspection Date: 24 Mar 2020

Property Address: Northern Area

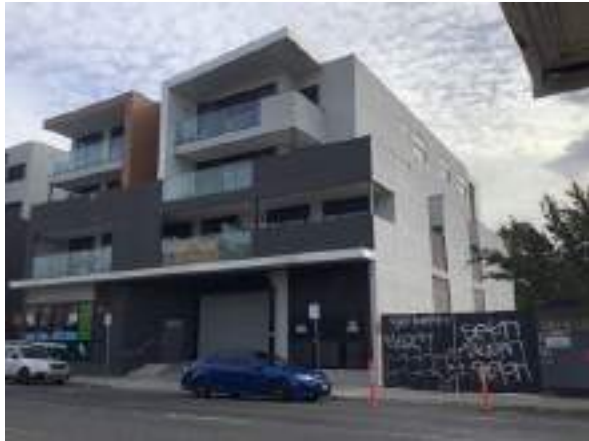
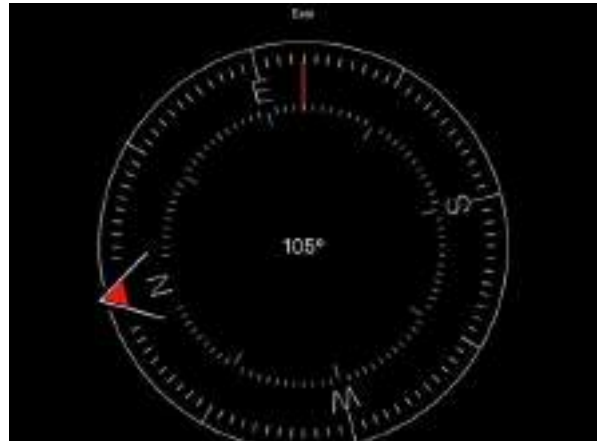
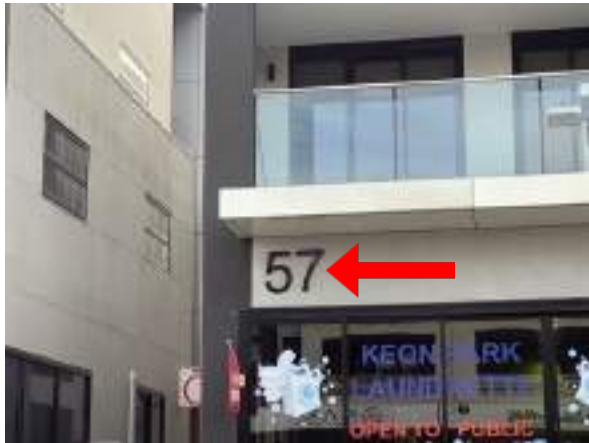
For your information 4.01

Location: The Site
Finding: Site Photos.
Site photos & Additional photos are provided for your general reference.

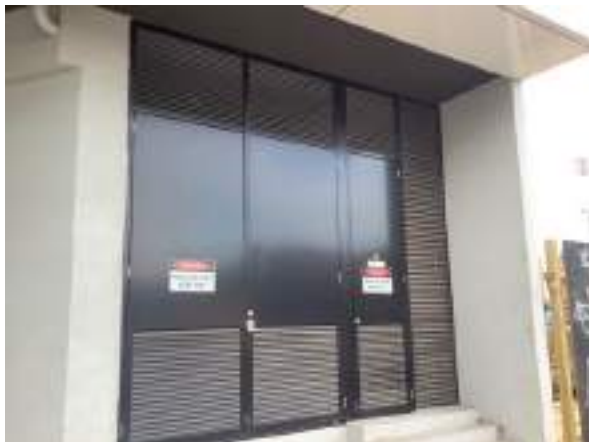
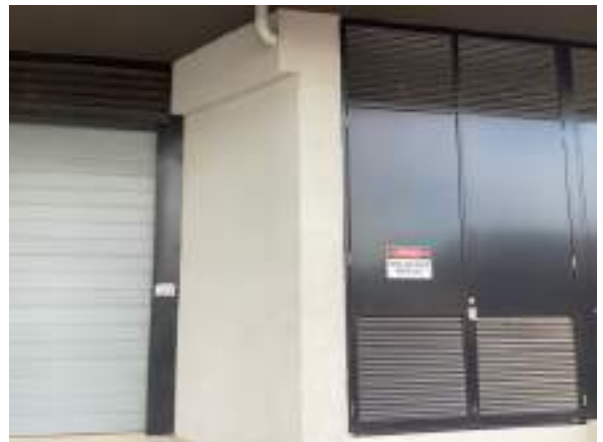
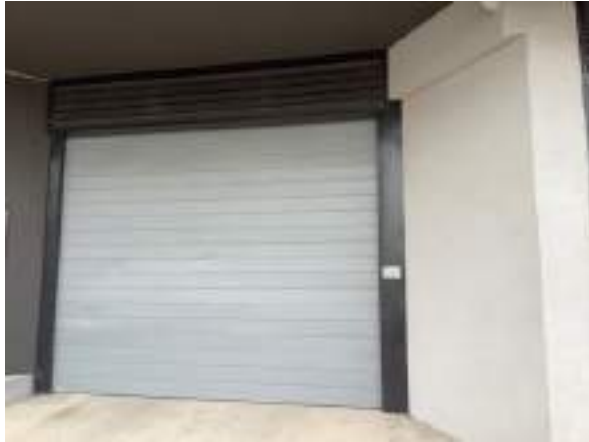
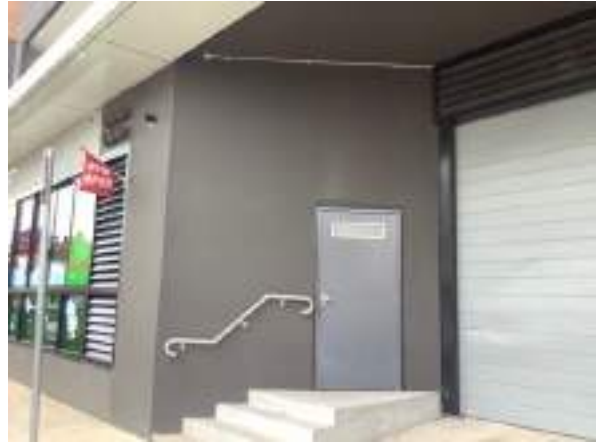
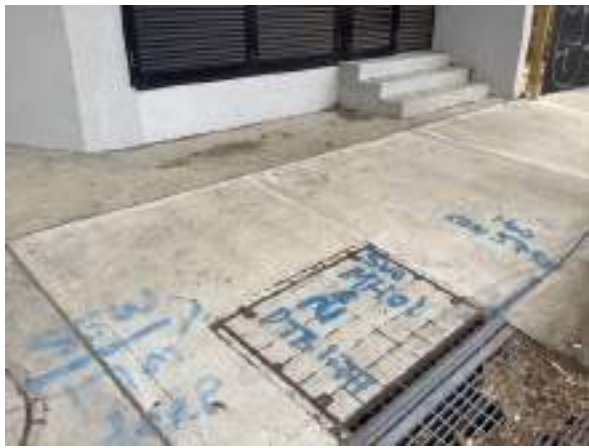
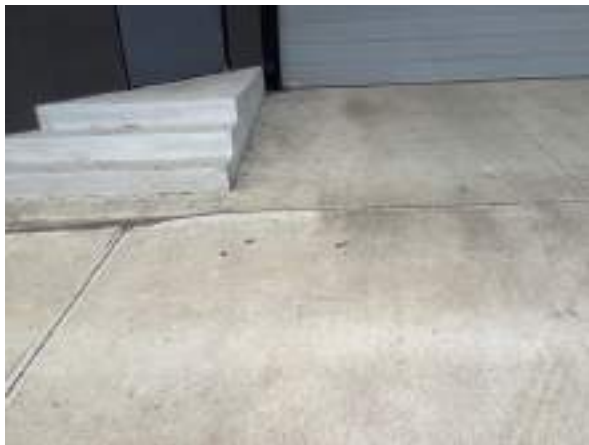
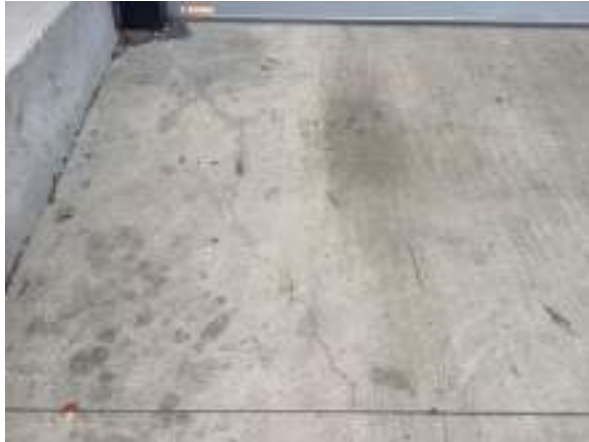
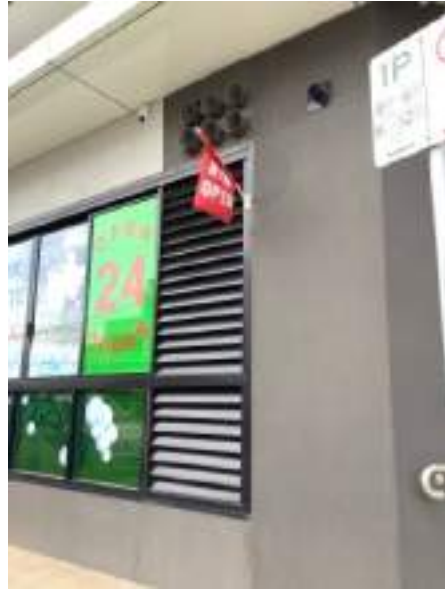
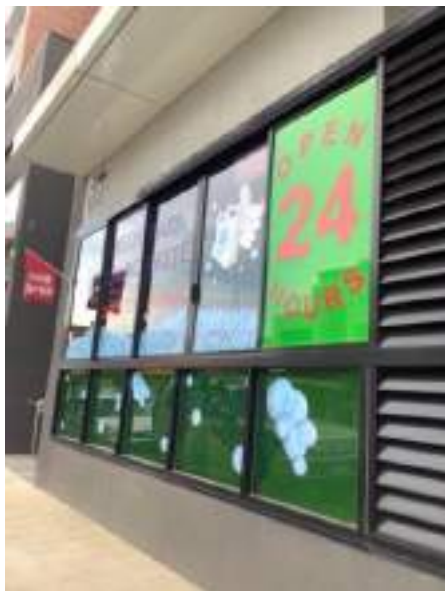
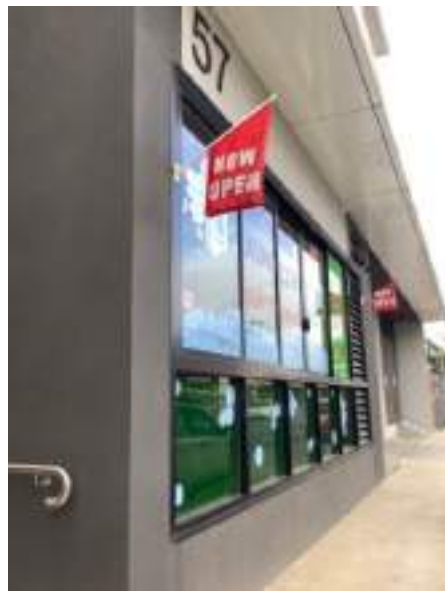
For your information 4.03

Location: Exterior East Side
Finding: For Your Information
Lower story, for your information.

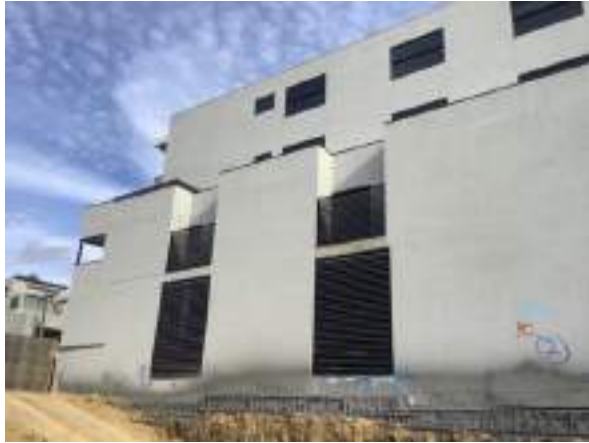
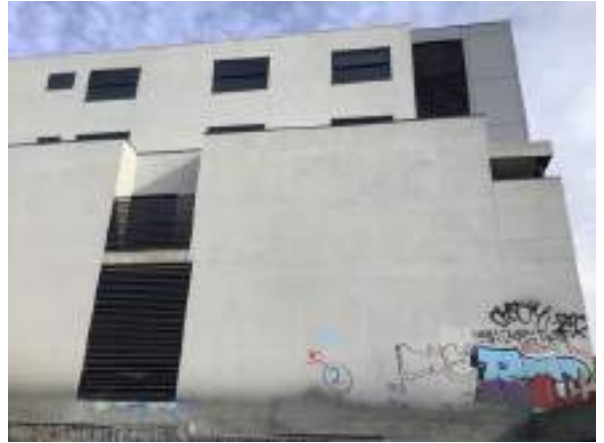
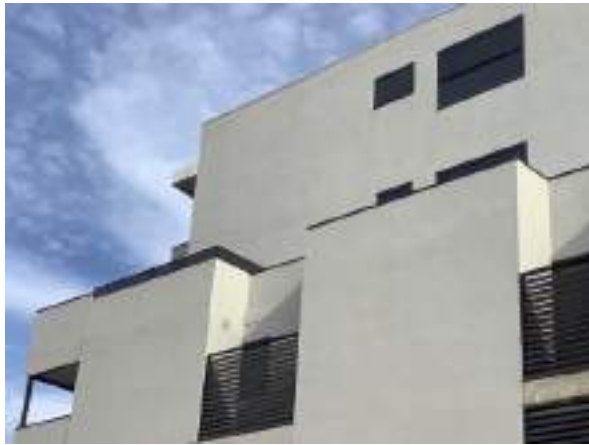
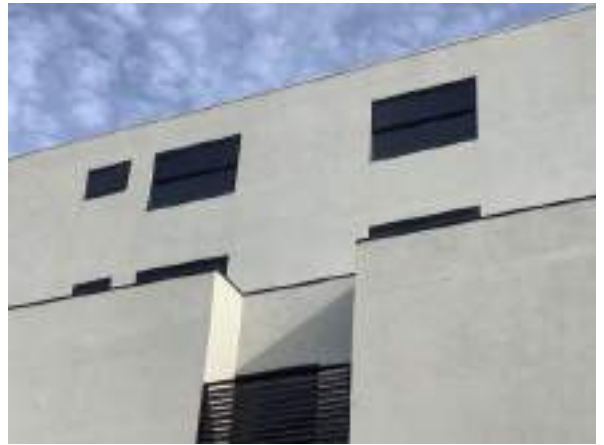
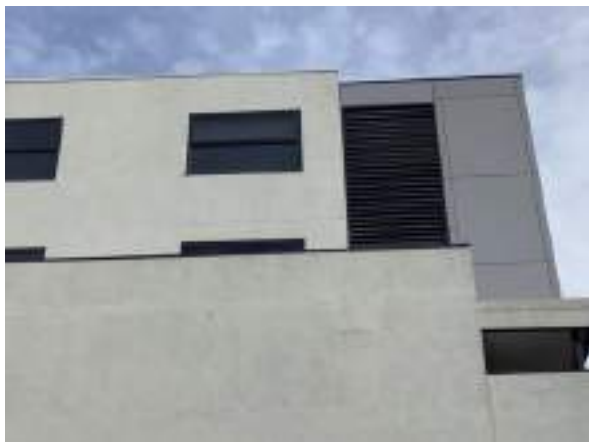
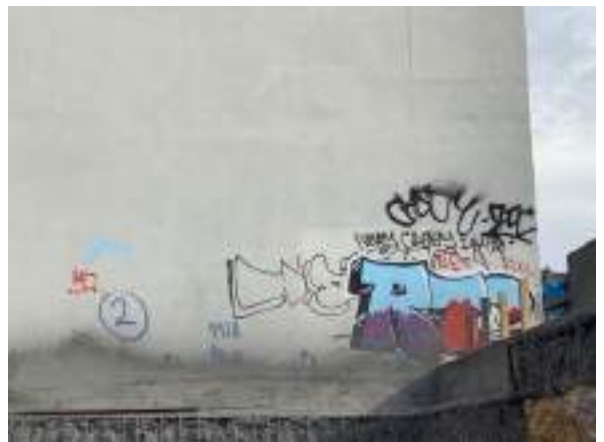
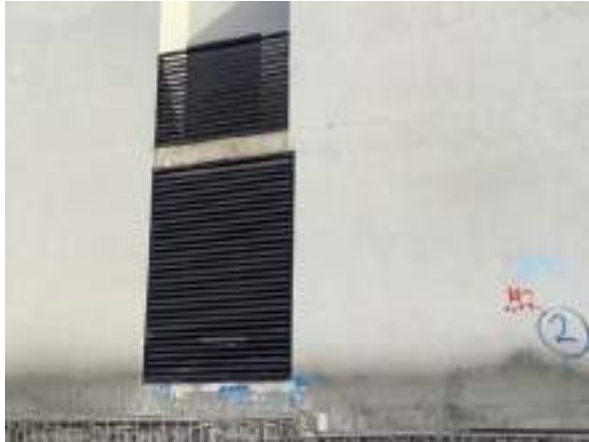
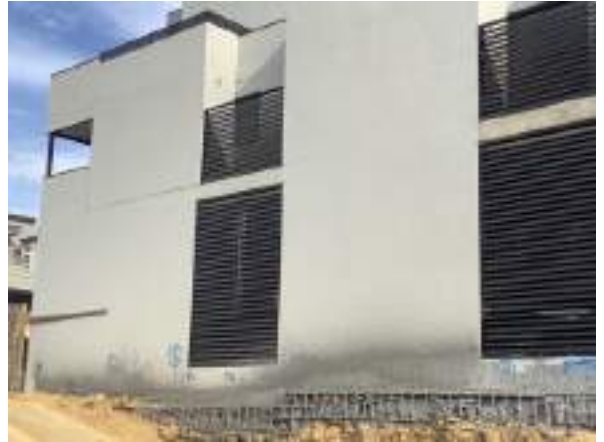
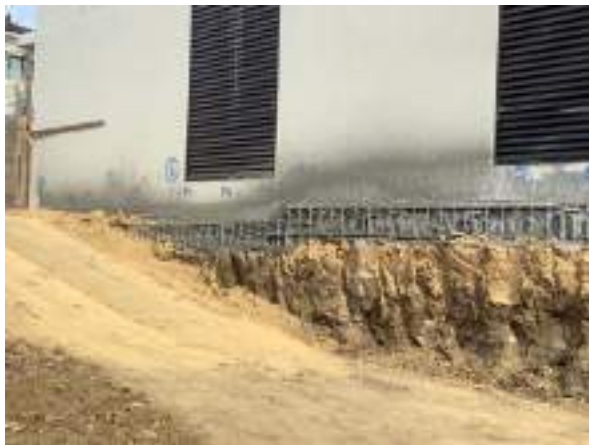
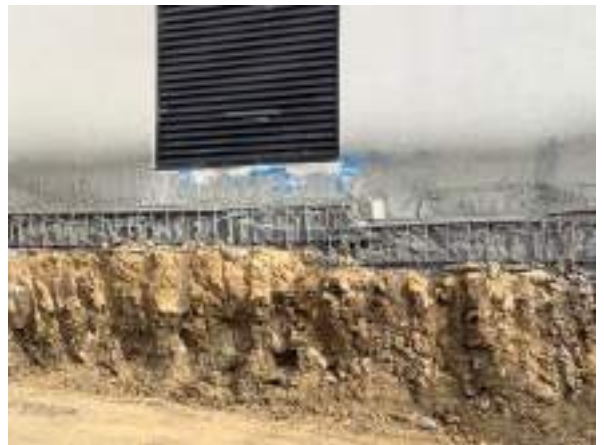
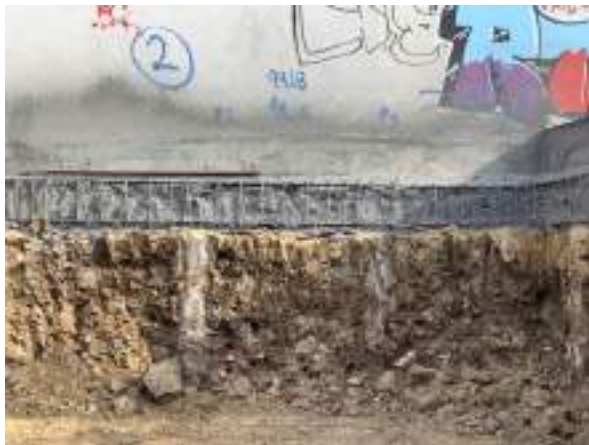
For your information 4.04

Location: Exterior North Side
Finding: For Your Information
Site Photos

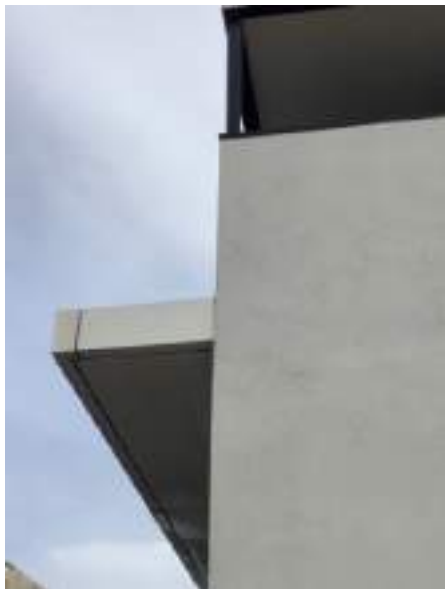
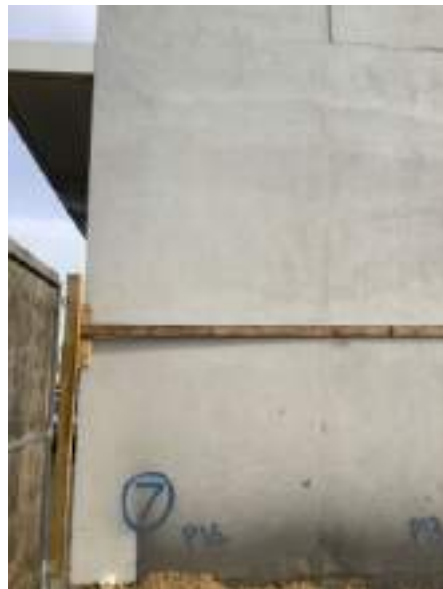
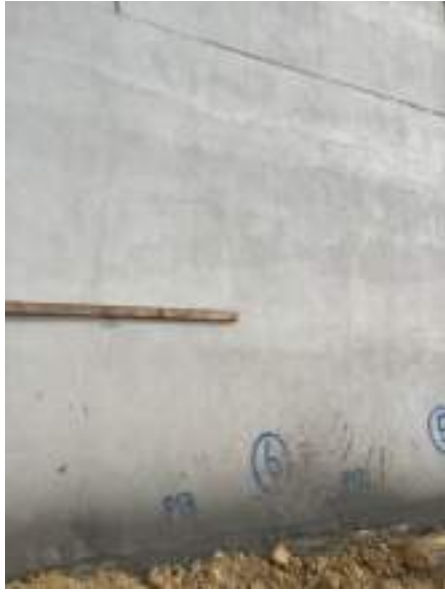
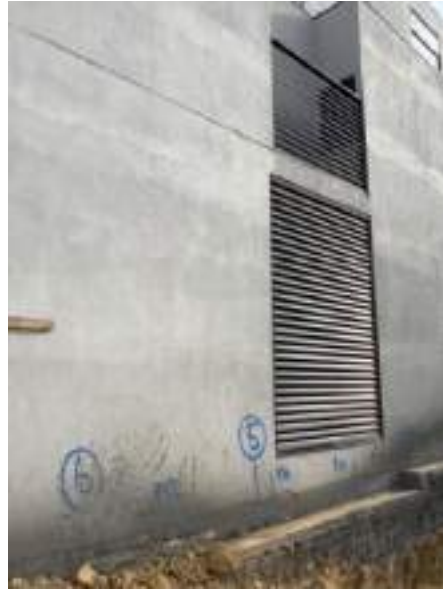
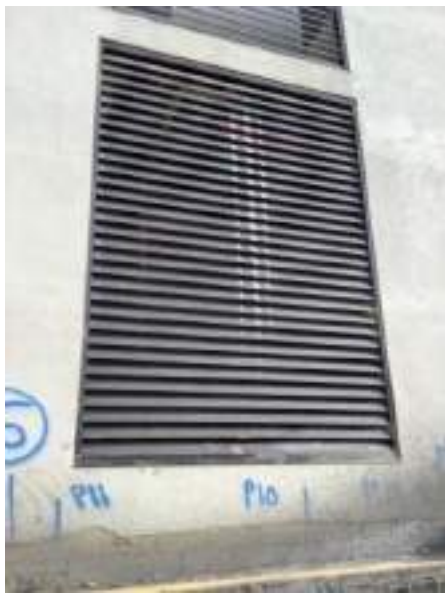
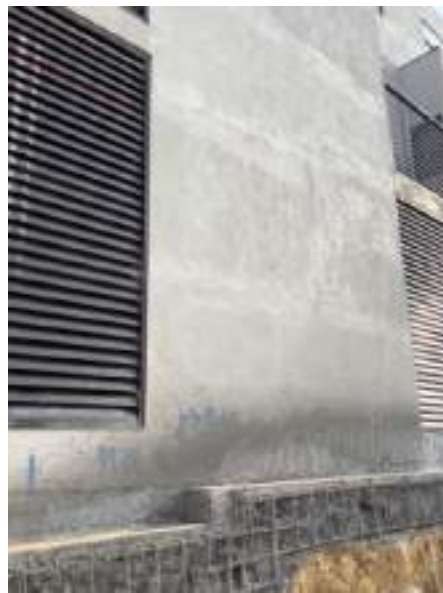
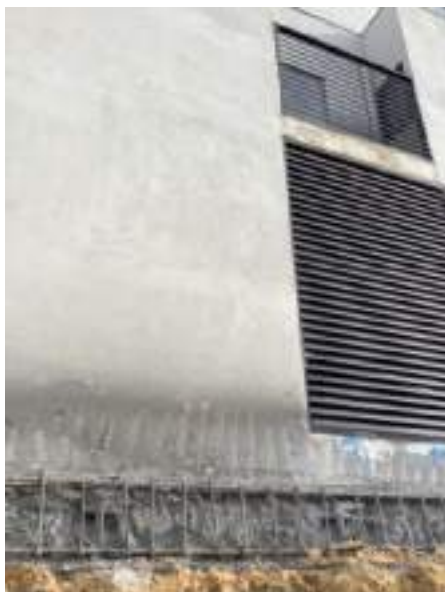
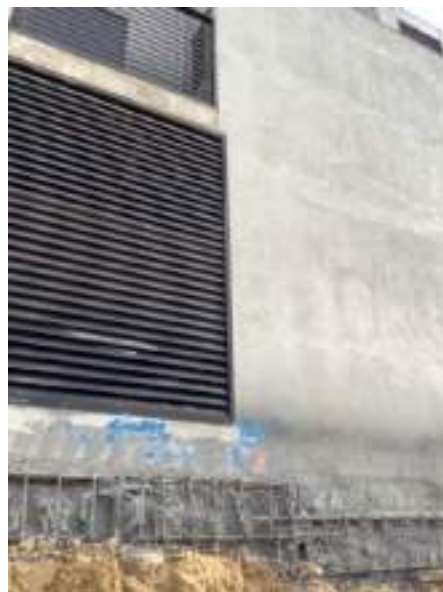
For your information 4.07

Location: Exterior North Side
Finding: For Your Information Site Photos

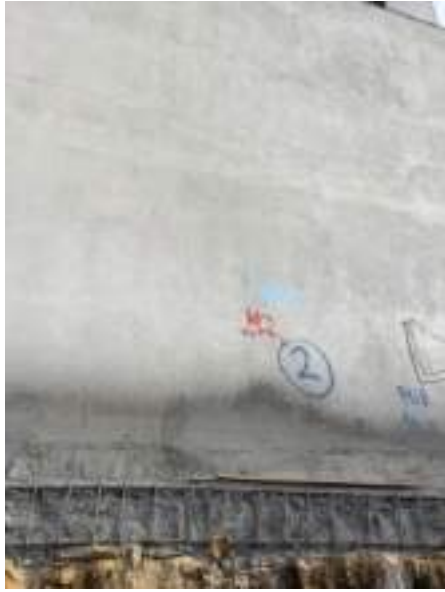
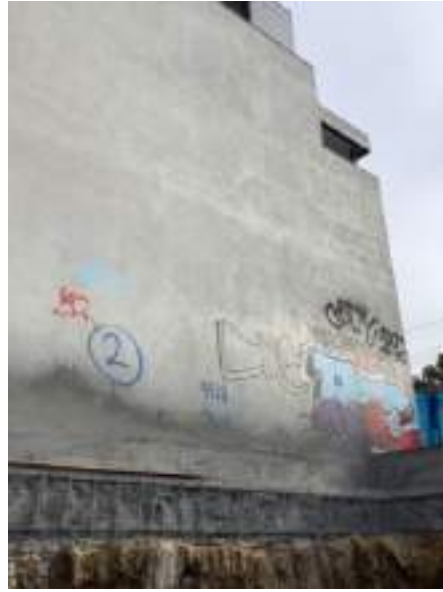
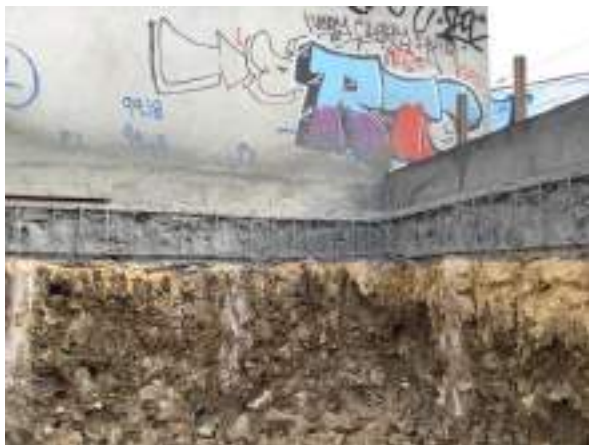
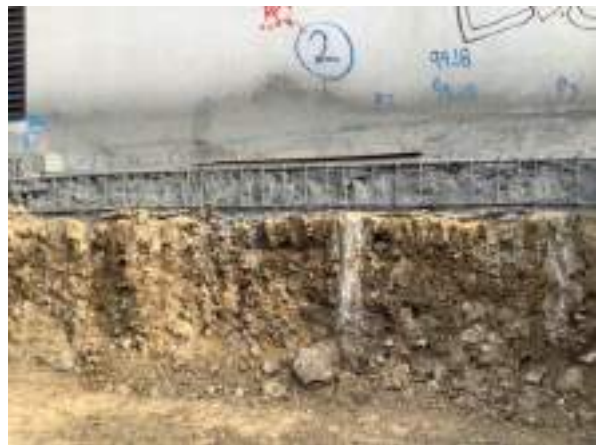
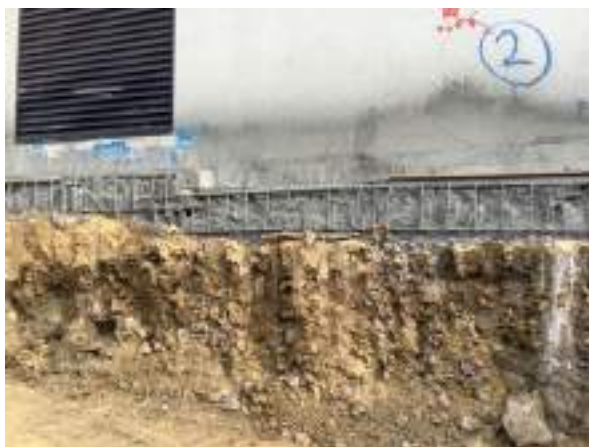
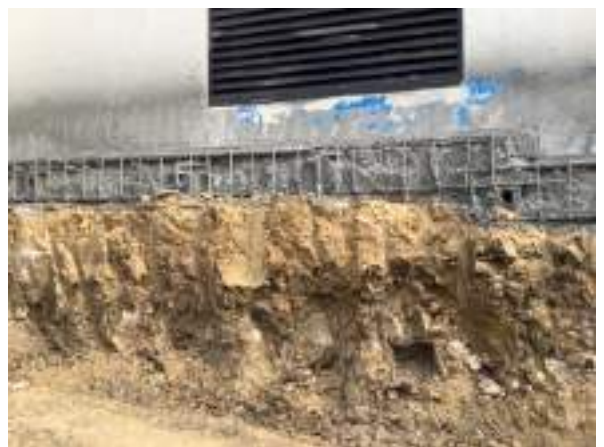
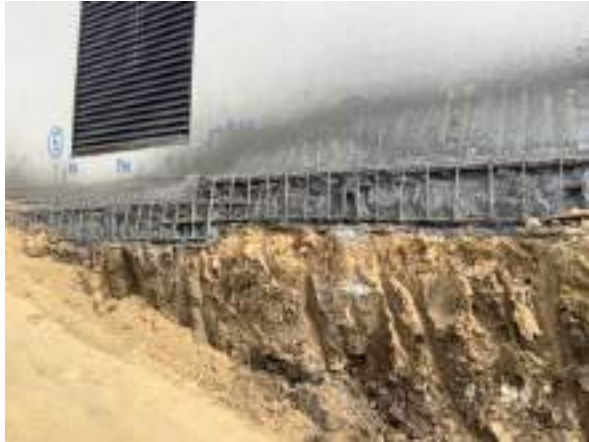
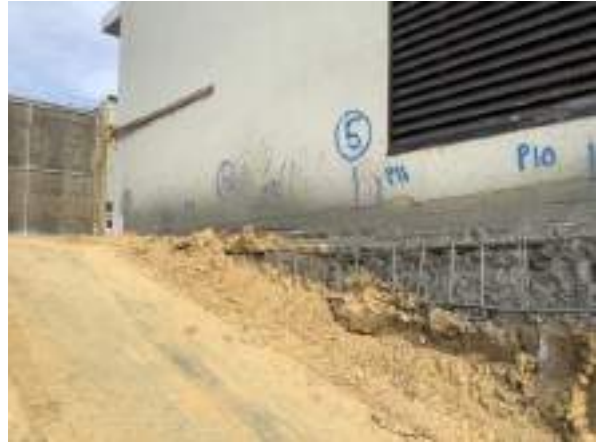
Finding: For Your Information
Site Photos of cracks which have already been noted with arrows, These are just additional photos from a different angle.

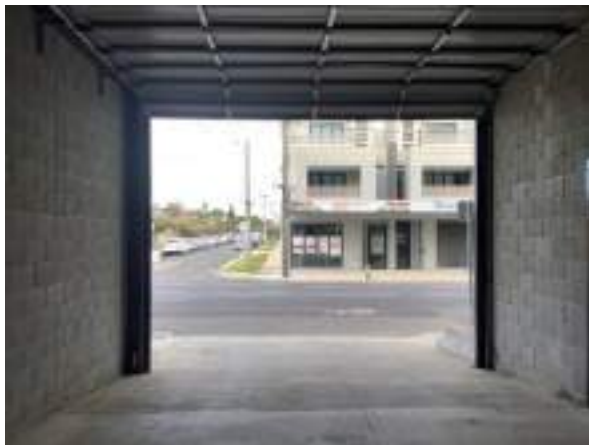
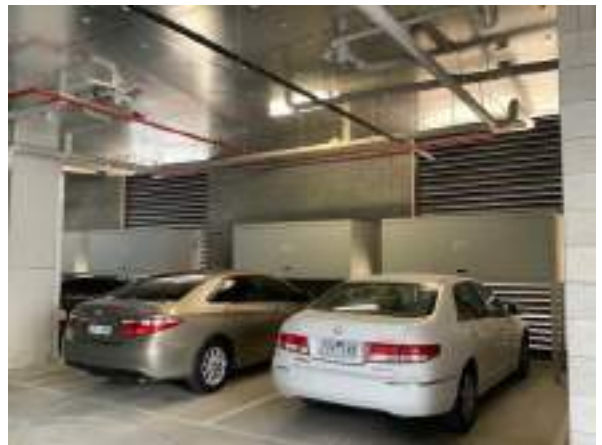
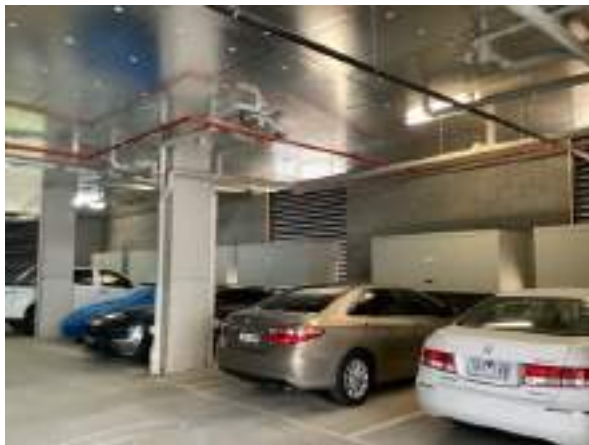
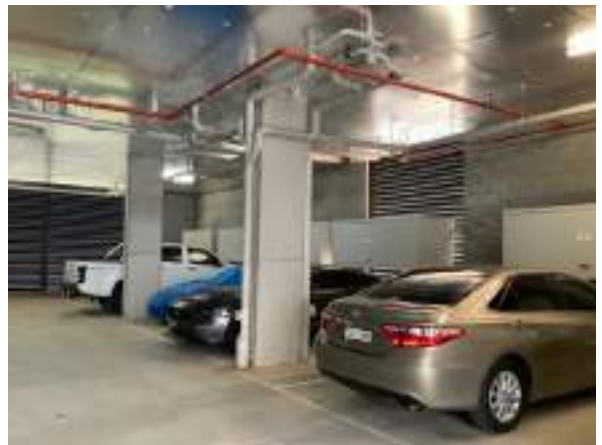
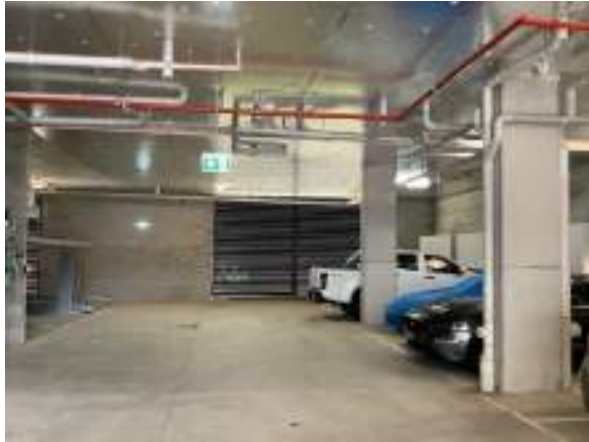
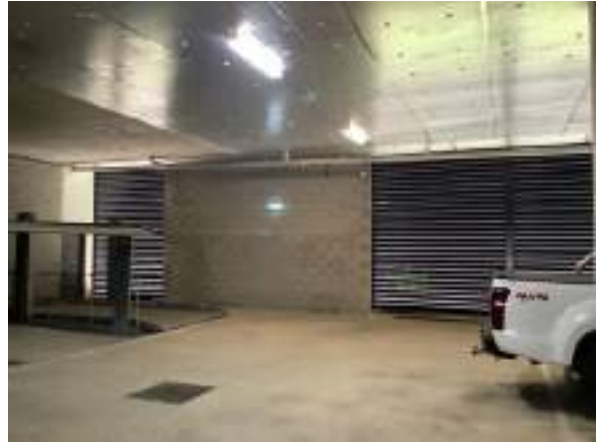
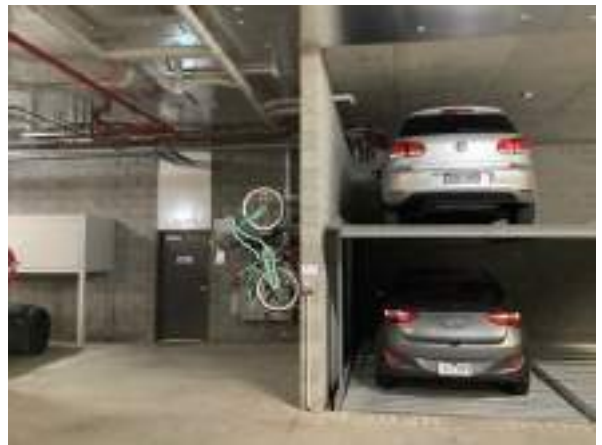
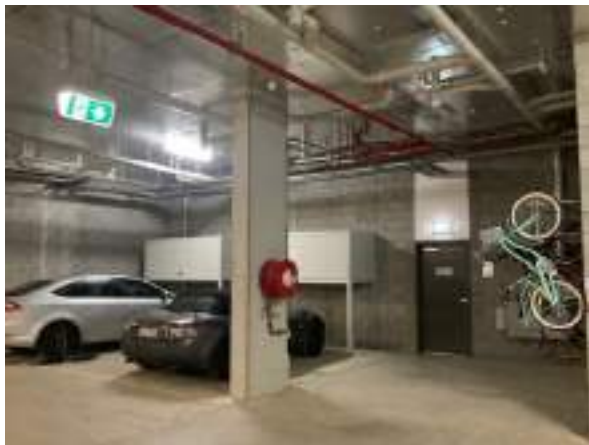
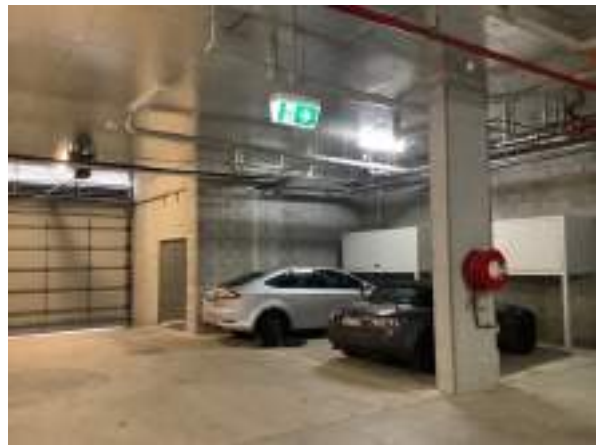
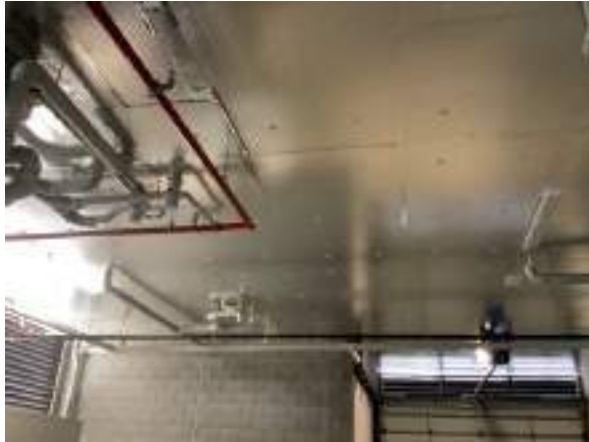
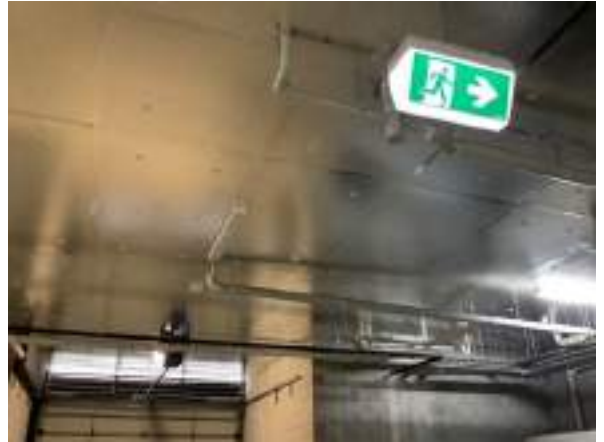
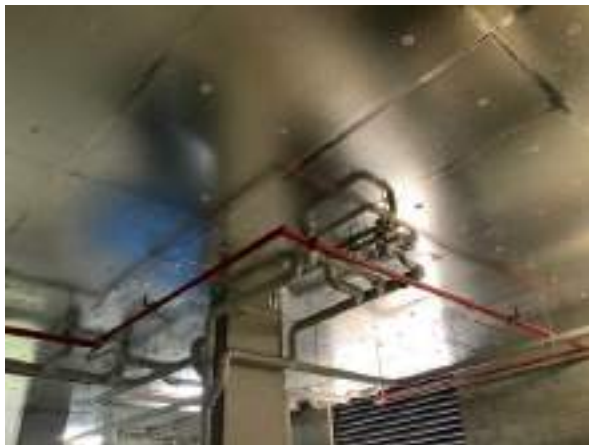
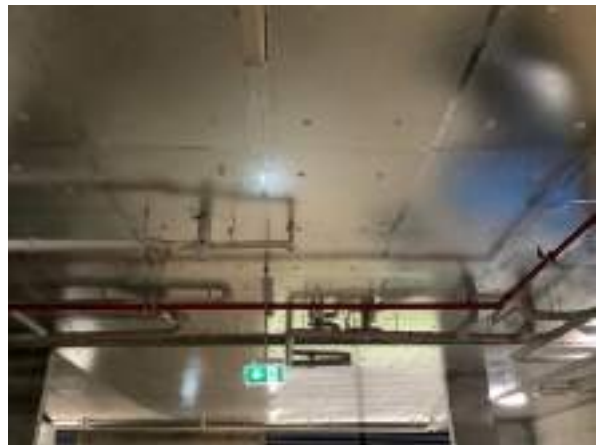
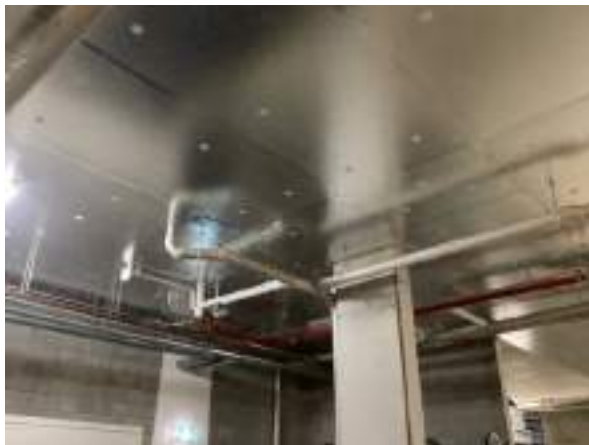
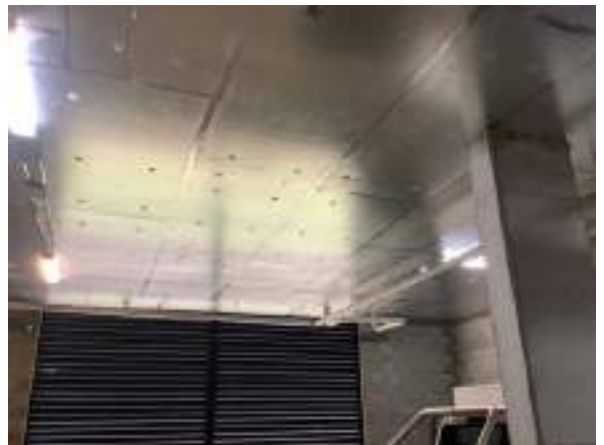
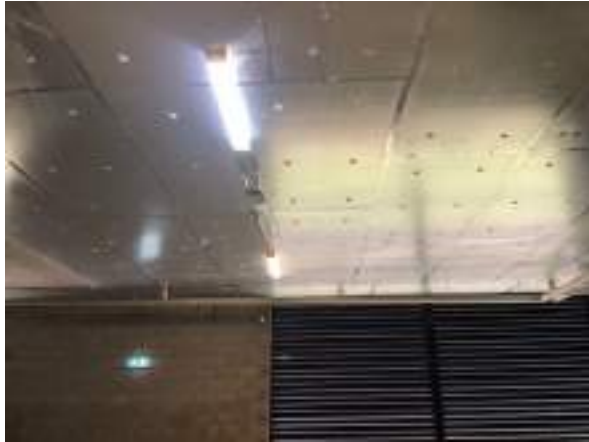
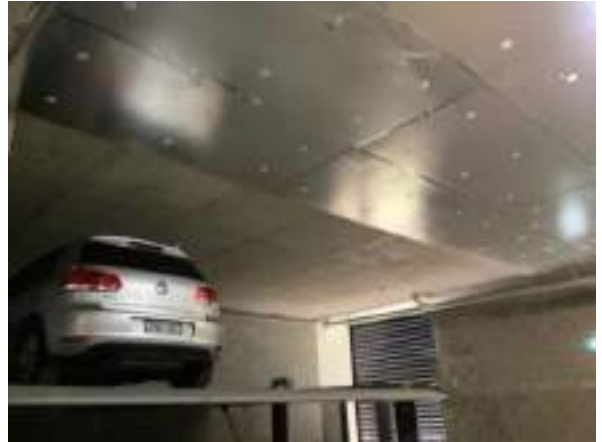
For your information 4.08

Location: Car Park
Finding: For Your Information
Carpark, adjacent to work site.

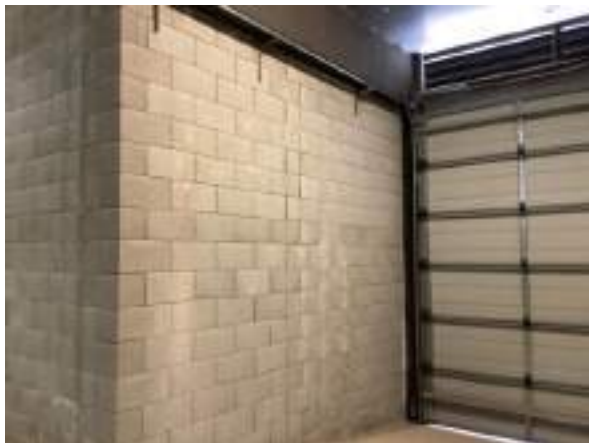
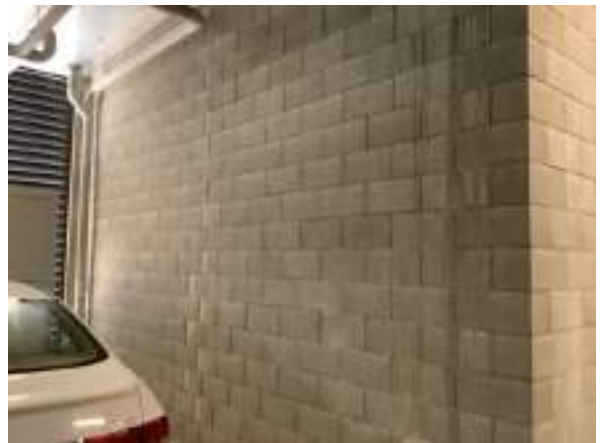
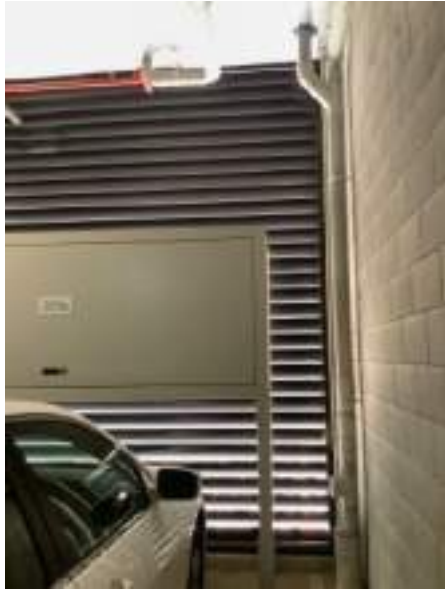
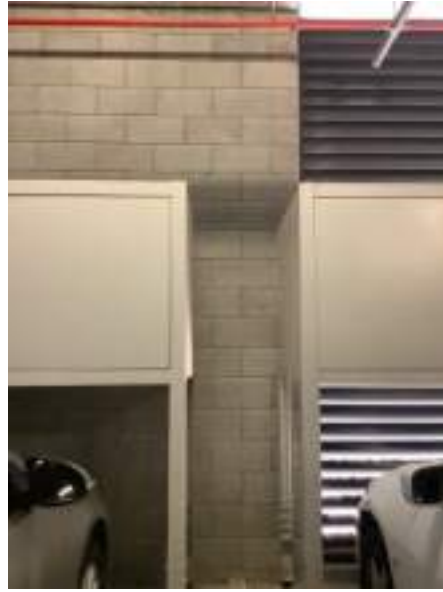
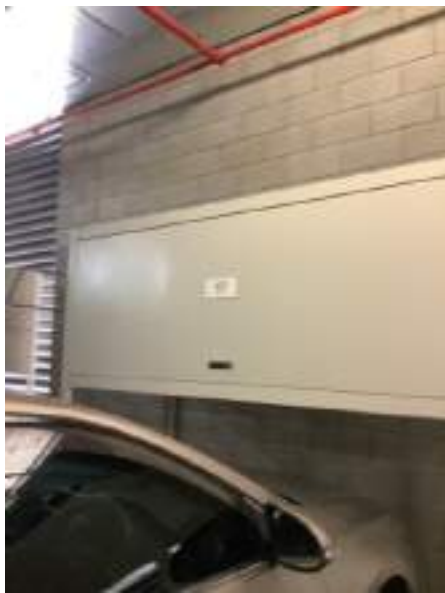
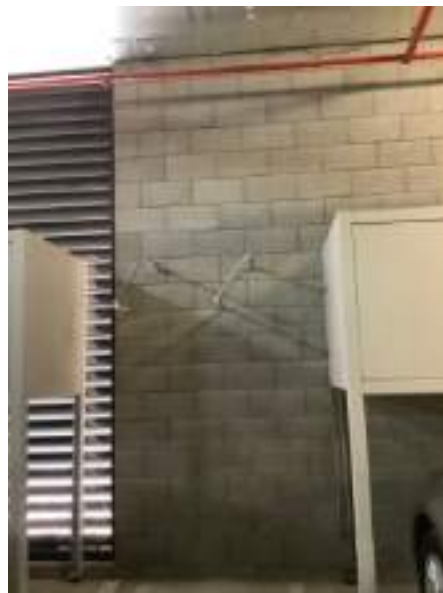
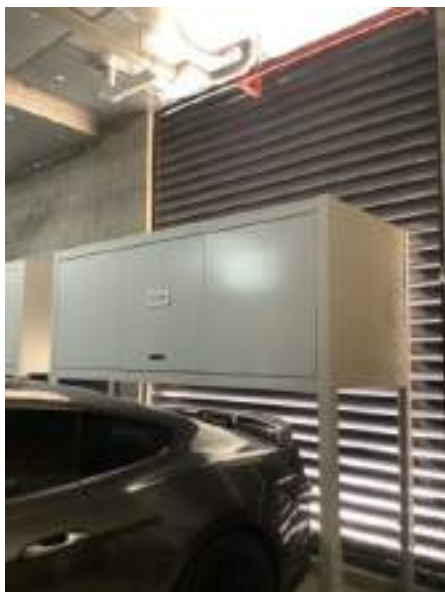
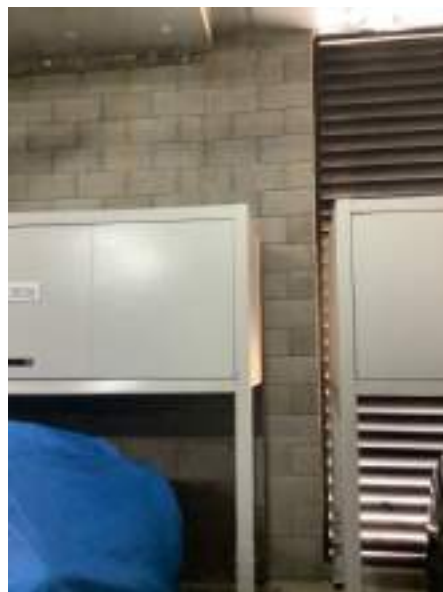
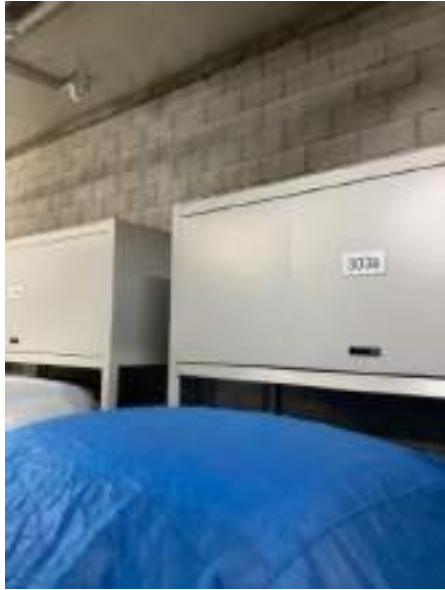
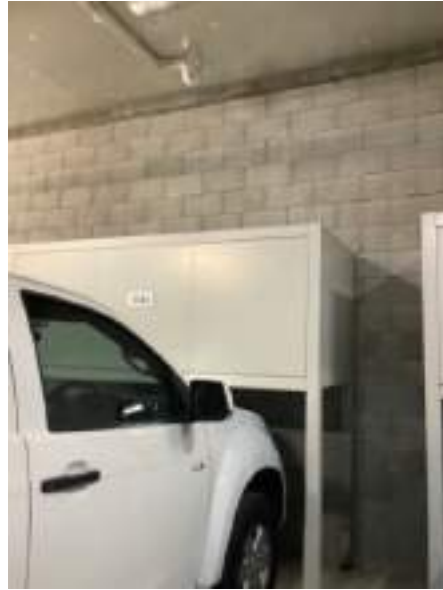
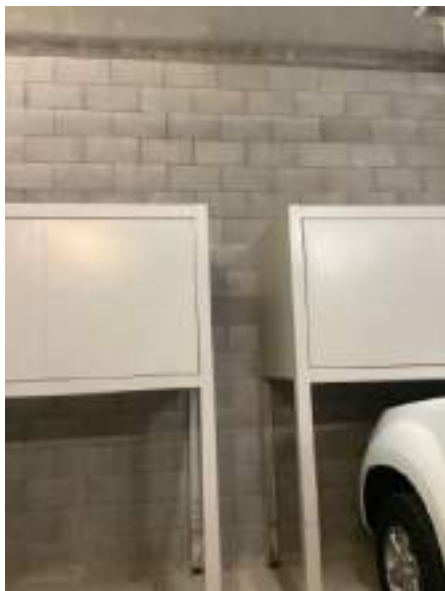
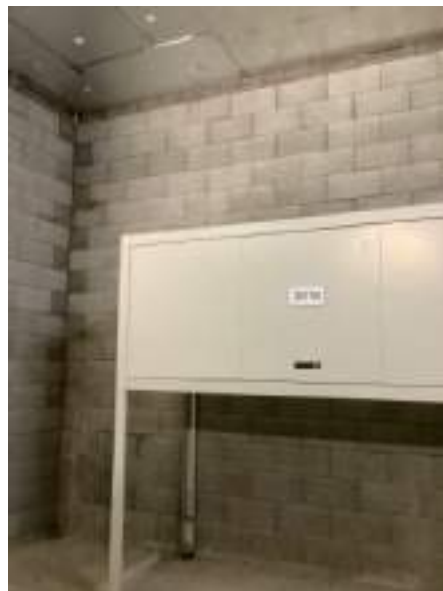
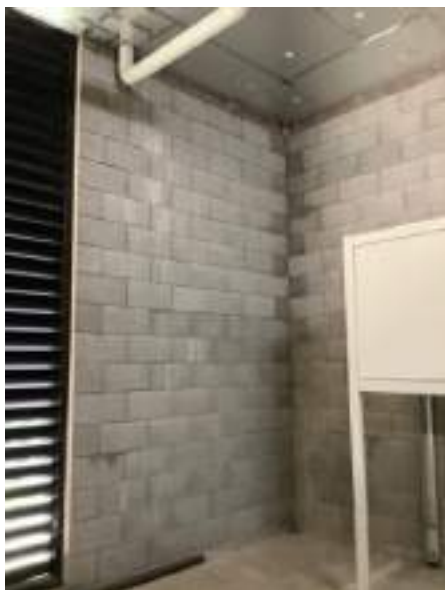
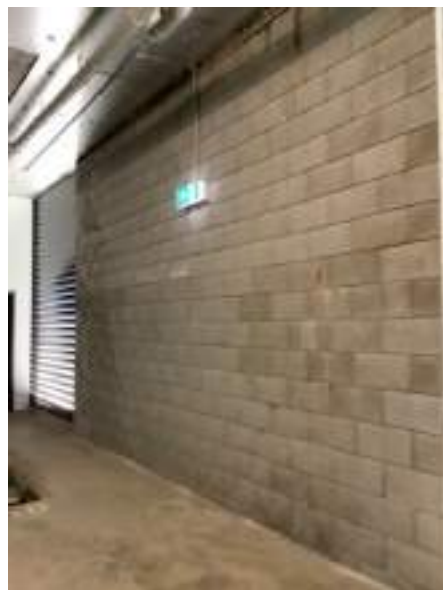
For your information 4.09

Location: Car Park
Finding: For your Information
Walls

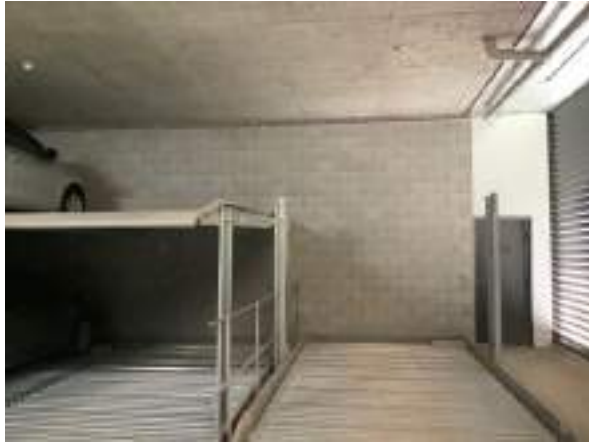
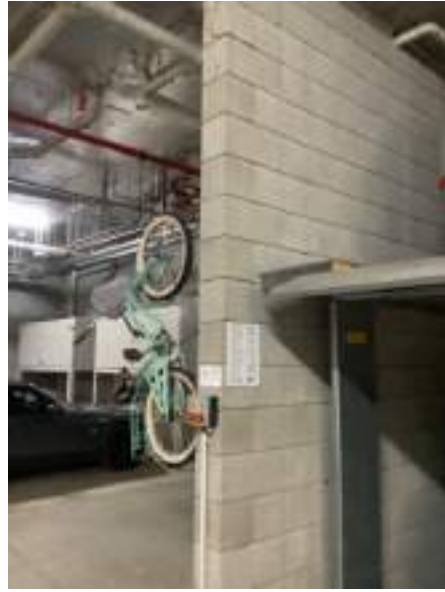
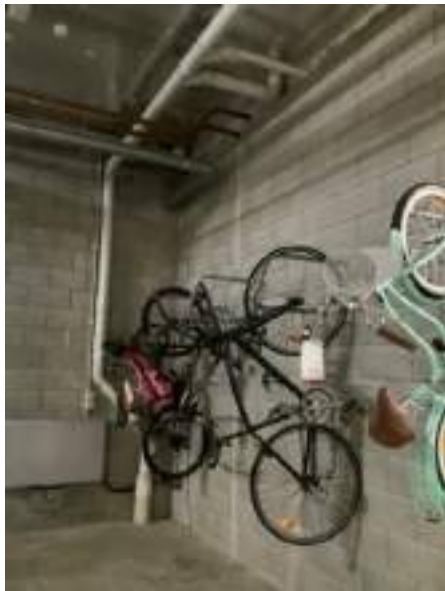
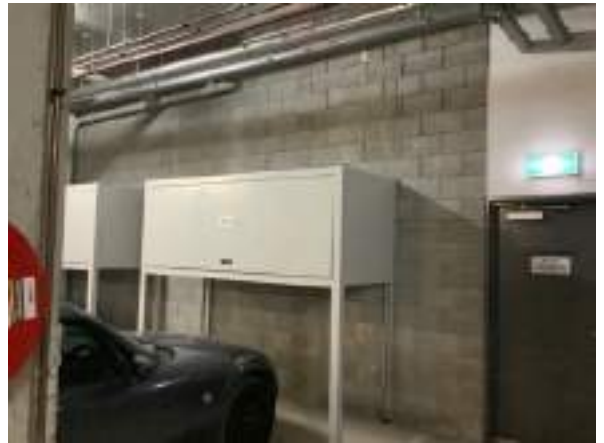
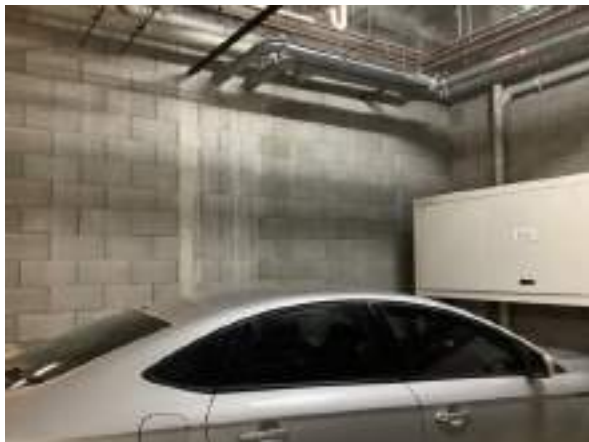
For your information 4.10

Location: Car Park
Finding: Concrete Flooring
For your information, minimum typical cracking.

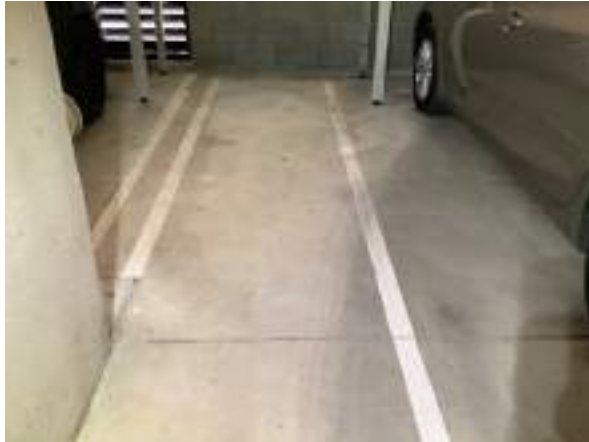
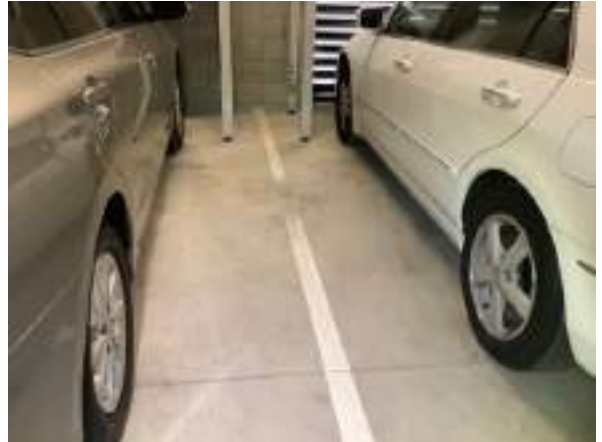
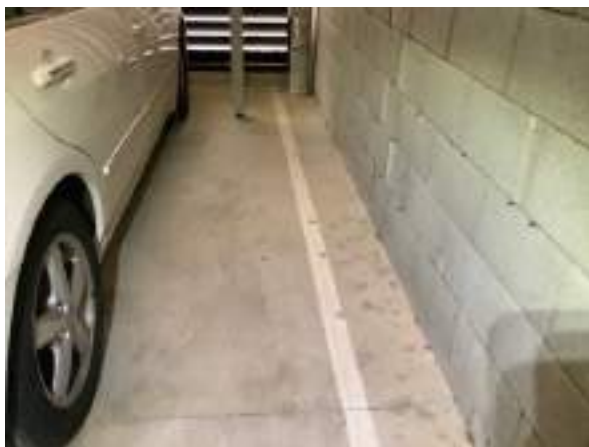
For your information 4.11

Location: Car Park
Finding: For your information
Concrete Pillars

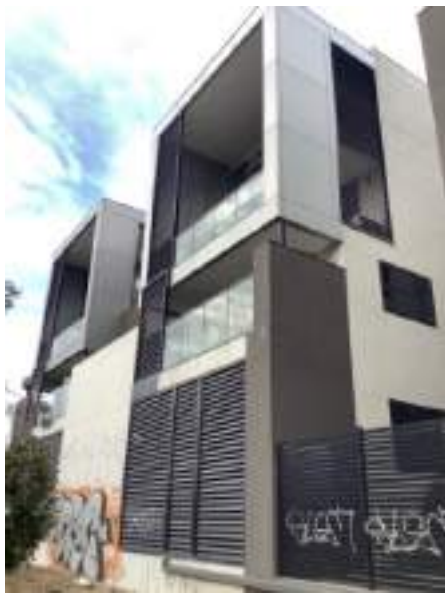
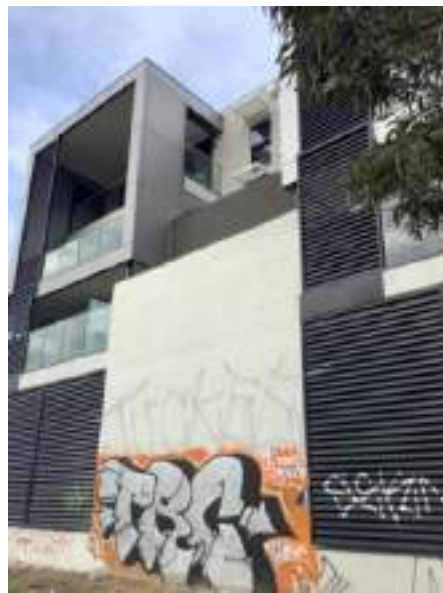
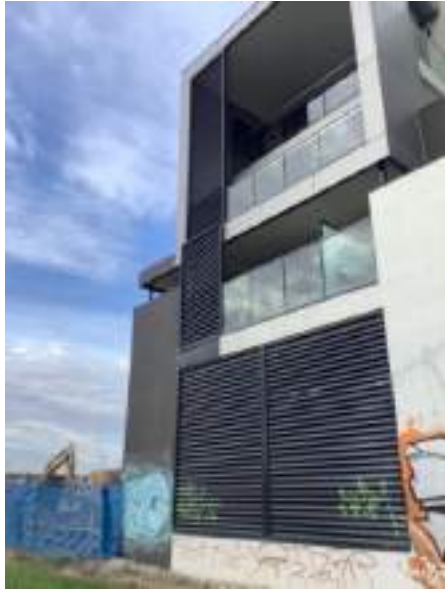
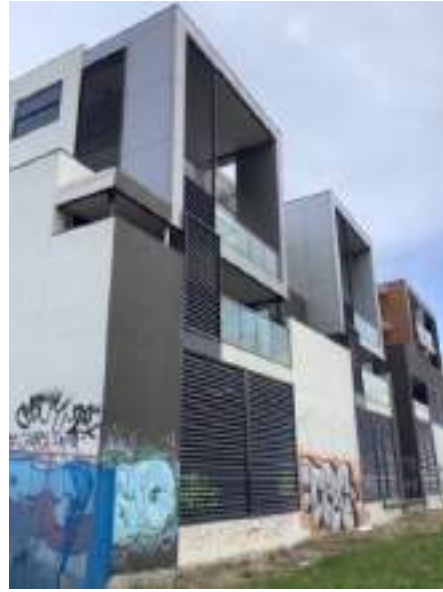
For your information 4.13

Location: Exterior West Side
Finding: Exterior Cracking
Exterior Cracking
